ADDENDUM NO. 2

Project:	PESC Fume Hood Recapitalization	Project / File No:	190001
Project Address:	2645 Dollarton Avenue, North Vancouver, BC	Date:	August 24 th , 2017
Tender Issue Date:	2017-07-28		
Tender Close Date:	2017-08-28	No. of Pages:	Twenty-nine written pages.

PROJECT-SPECIFIC HAZARDOUS BUILDING MATERIALS ASSESSMENT – SITE REVIEW REPORT

Project:	Fume Hood Recapitalization Project		
Client:	Public Services and Procurement Canada	Stantec Project #:	123220871
Stantec Site Assessor:	Keith Irwin	Date of Site Visit:	April 25, 2017
Location:	Pacific Environmental Science Center, 2645 Dollarton Avenue North Vancouver, BC	Issue Date:	May 16, 2017

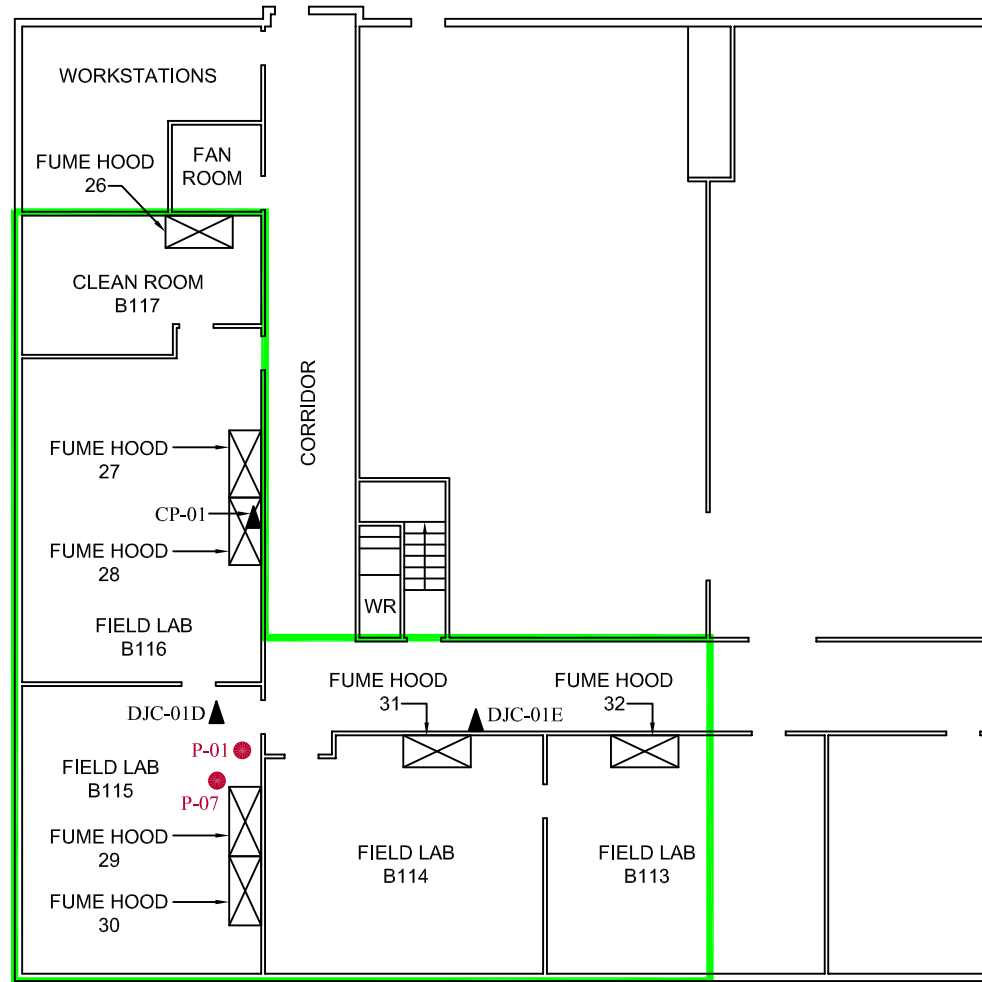
**MAIN FLOOR NORTH
FIELD OPERATIONS CENTRE
BLOCK B**

<p>FLOOR PLAN SHOWING HAZARDOUS BUILDING MATERIALS AND BULK SAMPLE LOCATIONS PACIFIC ENVIRONMENTAL SCIENCE CENTRE 2645 DOLLARTON AVENUE, NORTH VANCOUVER, BC</p>	Project No.: 123220871	1	
	Scale: N.T.S.		
	Date: 17/05/10		
	Dwn. By: CD <small>SL2017050177</small> VM/CS		
Client: PUBLIC SERVICES AND PROCUREMENT CANADA (PSPC)	App'd By: TW

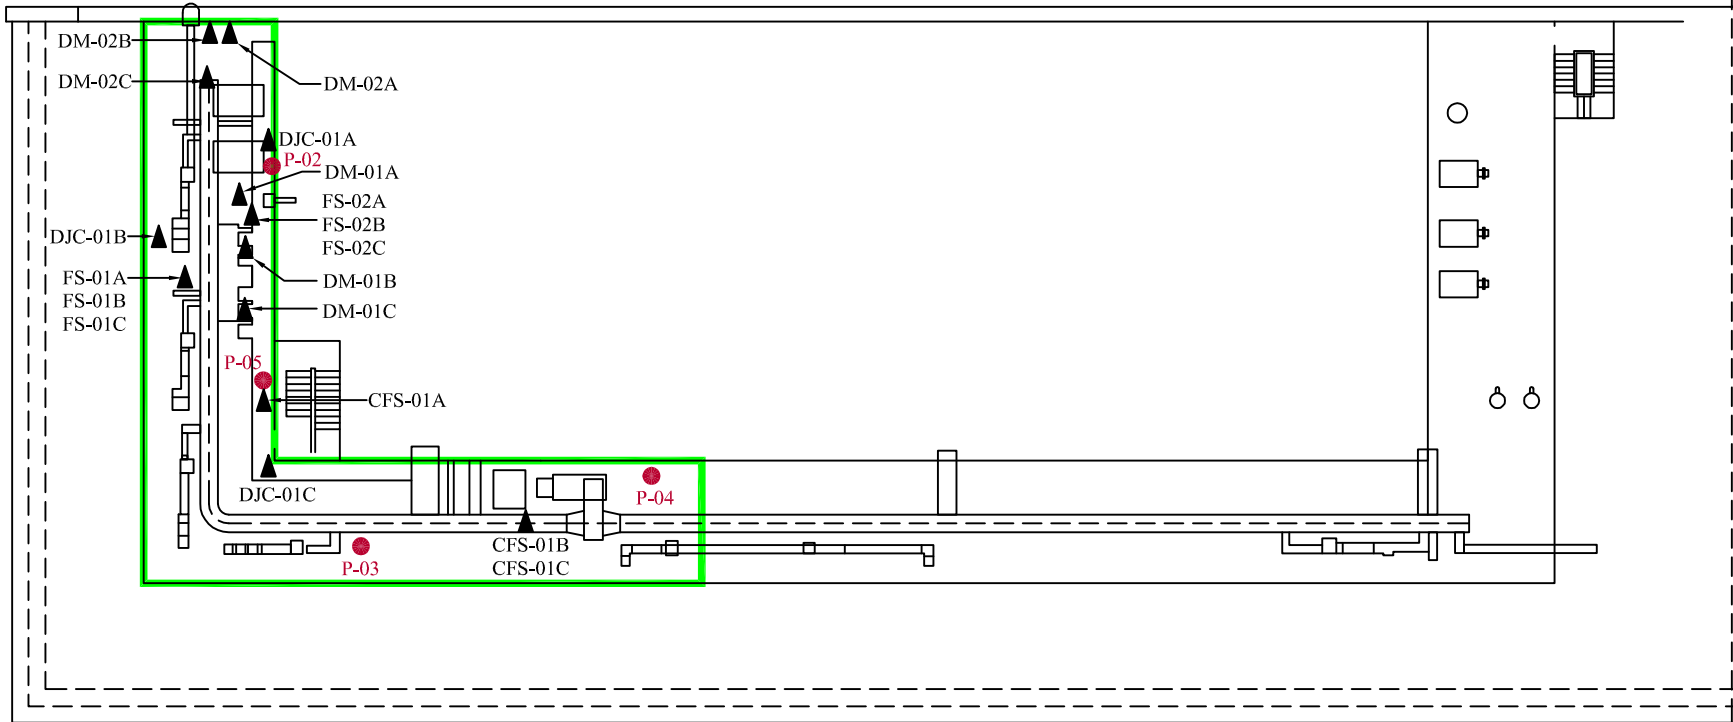
**MECHANICAL MEZZANINE
FIELD OPERATIONS CENTRE
BLOCK B**

<p>FLOOR PLAN SHOWING HAZARDOUS BUILDING MATERIALS AND BULK SAMPLE LOCATIONS PACIFIC ENVIRONMENTAL SCIENCE CENTRE 2645 DOLLARTON AVENUE, NORTH VANCOUVER, BC</p>	Project No.: 123220871	2	
	Scale: N.T.S.		
	Date: 17/05/10		
	Dwn. By: CD <small>SL2017050178</small> VM/CS		
Client: PUBLIC SERVICES AND PROCUREMENT CANADA (PSPC)	App'd By: TW

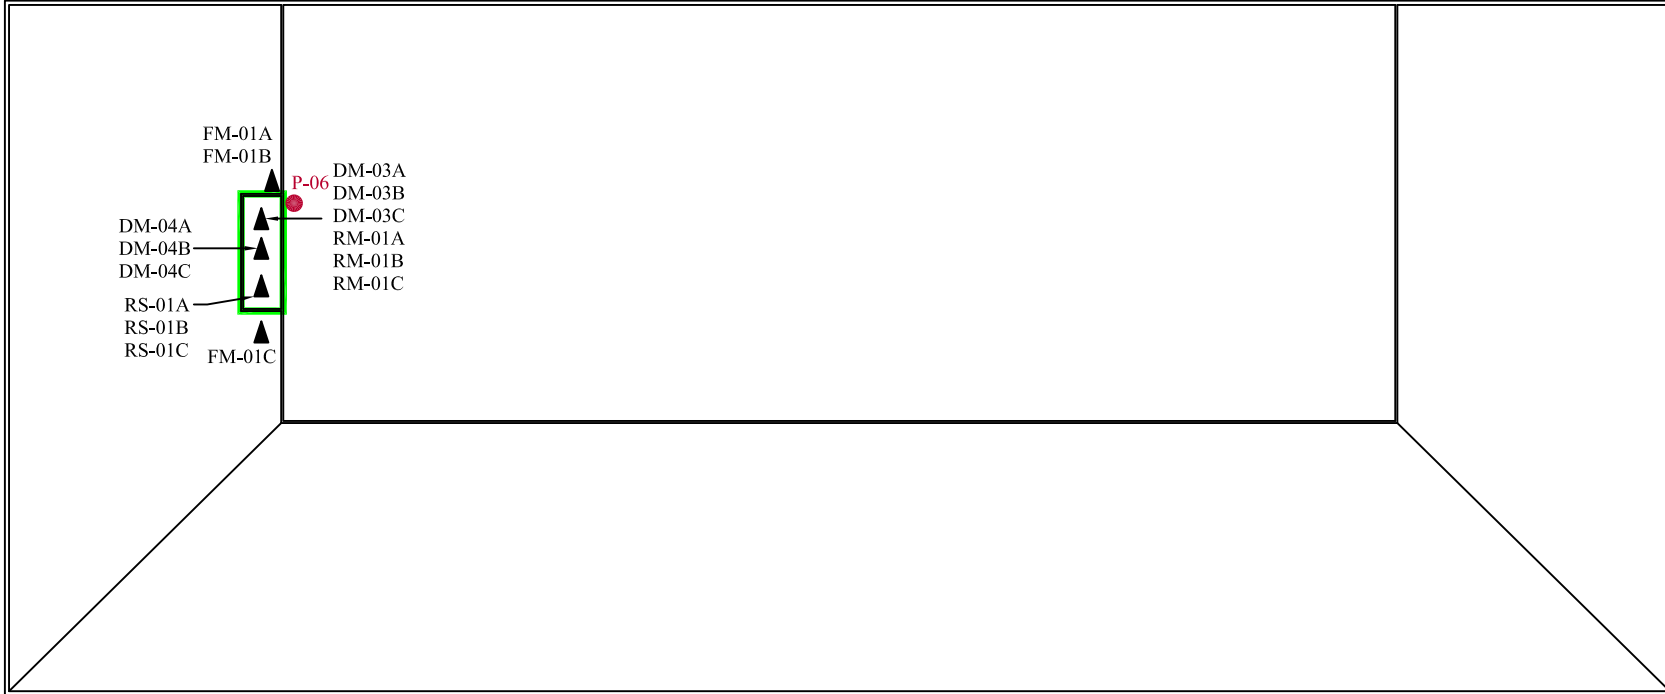
**ROOF
BLOCK B**

FLOOR PLAN SHOWING HAZARDOUS BUILDING MATERIALS AND BULK SAMPLE LOCATIONS PACIFIC ENVIRONMENTAL SCIENCE CENTRE 2645 DOLLARTON AVENUE, NORTH VANCOUVER, BC	Project No.: 123220871	Dwg. No.: 3	
	Scale: N.T.S.		
	Date: 17/05/10		
	Dwn. By: CD <small>SL2017050179 VM/CS</small>		
Client: PUBLIC SERVICES AND PROCUREMENT CANADA (PSPC)	App'd By: TW

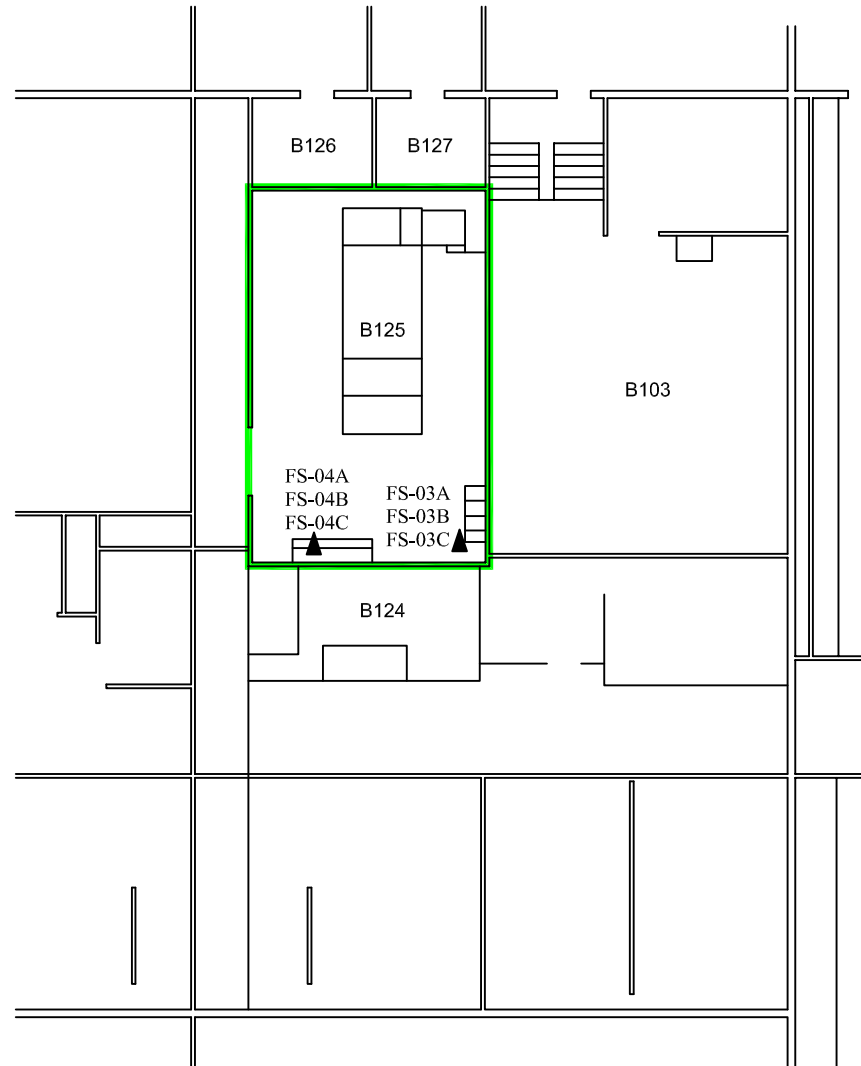
**MAIN FLOOR
MAIN ELECTRICAL ROOM B125
BLOCK B**

<p>FLOOR PLAN SHOWING HAZARDOUS BUILDING MATERIALS AND BULK SAMPLE LOCATIONS PACIFIC ENVIRONMENTAL SCIENCE CENTRE 2645 DOLLARTON AVENUE, NORTH VANCOUVER, BC</p>	Project No.: 123220871	<p>Dwg. No.: 4</p>	
	Scale: N.T.S.		
	Date: 17/05/10		
	Dwn. By: CD CS SL2017050180		
Client: PUBLIC SERVICES AND PROCUREMENT CANADA (PSPC)	App'd By: TW
