TPSGC/PWGSC

**Building Condition Report - Daniel J. MacDonald Site Charlottetown
P200153A**

161 Grafton
Daniel J. MacDonald Site Charlottetown P200153A
P200153-101-20000522
Charlottetown
Construction Year: 1984
Gross Area (SM): 16,435
Date of Most Recent Assessment: 06/02/17

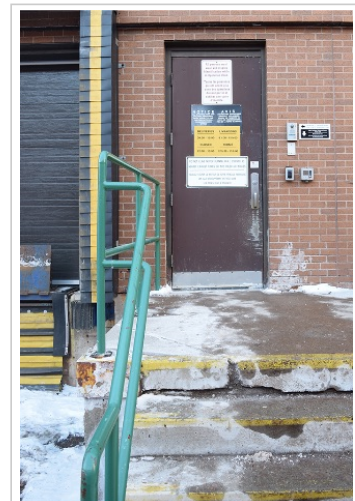
Exterior Stairs - Concrete - New

The steps were redone as part of the 2005 landscaping project. They are in good condition, with no replacement anticipated within the 20-year planning window.

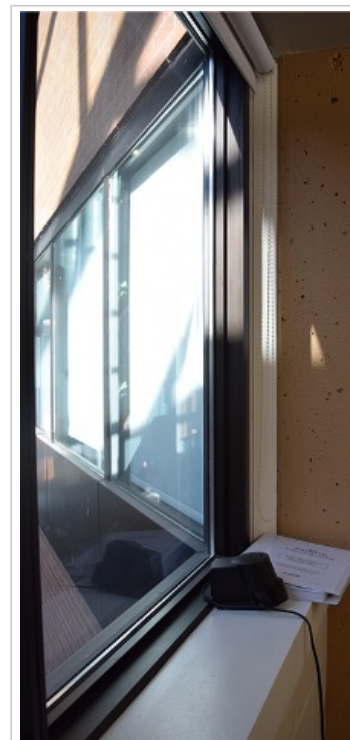
Aluminum Windows - New

Windows are in average condition given their age. No direct air or moisture infiltration was observed. Replacement is anticipated in the 10 to 20-year planning bracket. Given that this is a major expense and will make parts of the building temporarily unusable, careful phasing is recommended.

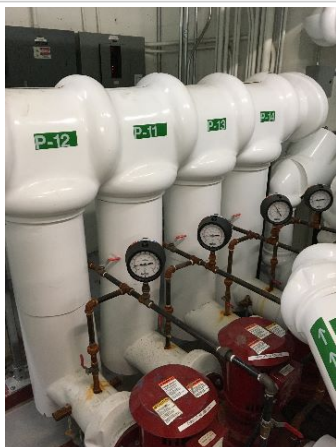
Chiller - Reciprocating - Air-Cooled - Chillers 1-4 & pumps

4 Carrier chillers, 75 tons each with a total capacity of 300 tons. Each individual chiller has its own circulator pump (P#11-P#14) which feeds a main chilled water loop. The chillers were replaced in 2011 and are in excellent condition. Chillers 1, 2 and 4 failed in 2013/14 repaired under warranty.

The 4 Carrier chillers were installed in 2011 and therefore in excellent condition. Based on a life expectancy of 20 years the chillers should be due for replacement by 2031.

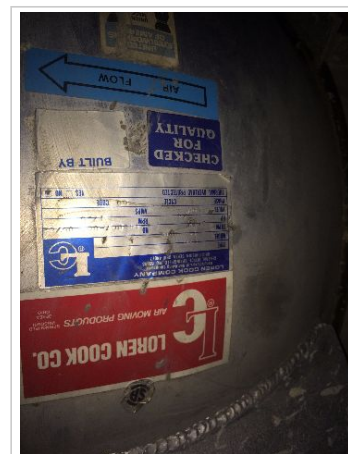
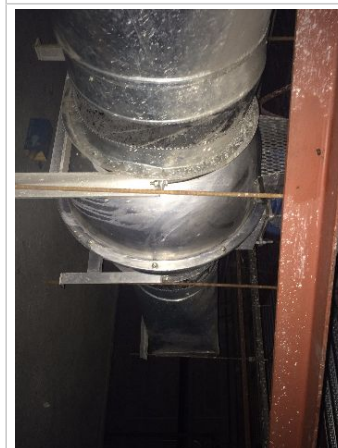
Exhaust System - General Building

Ventilation fans are in operational condition however original to the building and are over 30 years old. They have an expected service life of 25 years and as such they have exceeded their expected working life and require replacement.

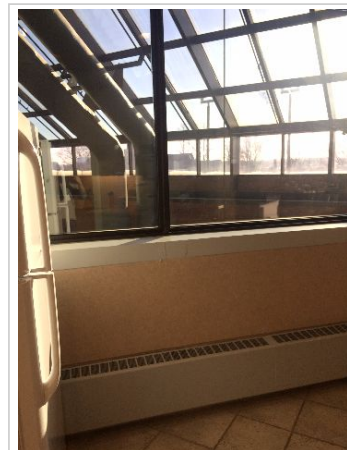
Perimeter Heat System - Hydronic Fin Tube

The baseboard units are original with the building and appear to be in fair condition. However all their valves are pneumatically controlled and consequently the valves and their controls have surpassed their expected working life and require replacement. The new valves should have electronic actuators which would require control upgrades as well.

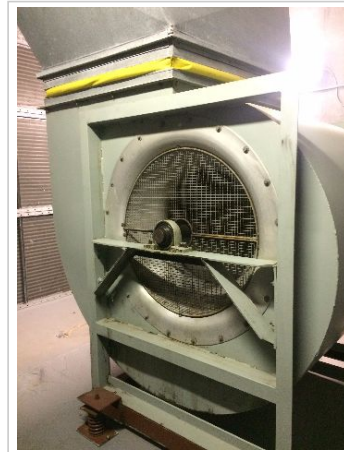
Central AHU - VAV System w/Distribution

The component is in generally poor to fair condition however the system is 30 years old and has reached the end of its expected working life. Many pneumatic VAV boxes have issues and no longer are able to be repaired due to lack of available parts. Many of the VAV boxes are manually held open by 'C' clamps and are no longer functional which would certainly be affecting the building's energy consumption.

All equipment listed is past service life and will continue to climb in maintenance costs annually. It is recommended the remainder of the original air handling units be replaced. In addition to the AHU replacements the original pneumatic VAV boxes should be replaced.

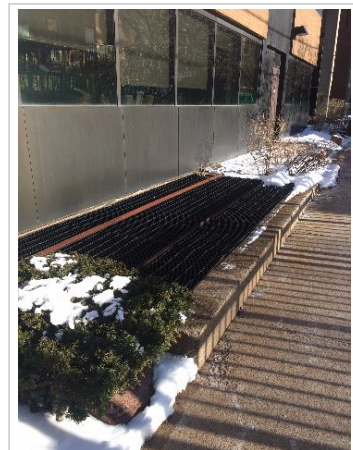
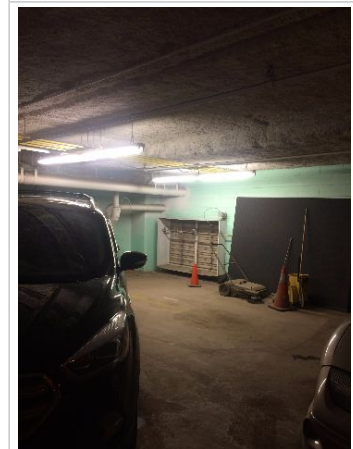
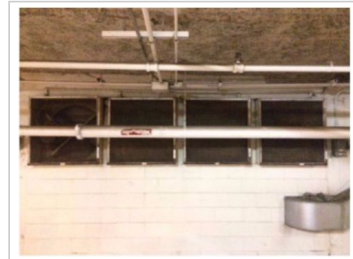
Exhaust System - Garage

The ventilation system in the garage except the CO sensors, is original with the building. Based on its appearance and on a life expectancy of 25 years the system is due for replacement.

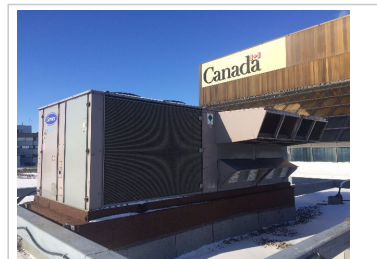
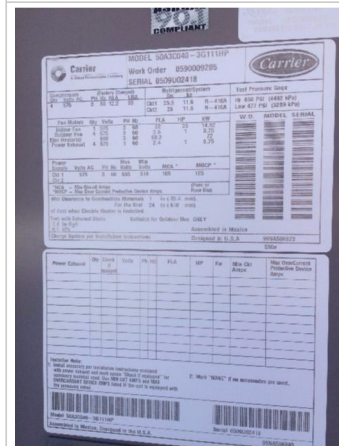
Rooftop Unitary AC - Elec. Heat/Cooling

The AHU-6 on the roof of the 3rd floor is in excellent condition as it was replaced in 2008. Based on a life expectancy of 25 years the unit should be due for replacement by 2033.

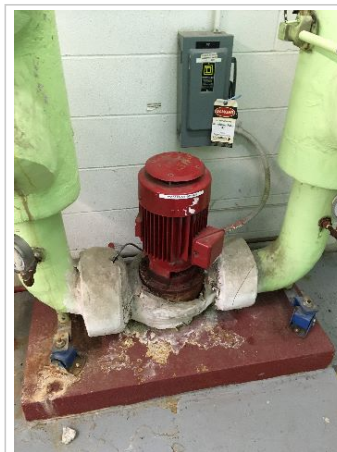
Cooling Distribution - Chilled Water Supply Pump #7

Pump #7 was replaced in 2001 and appears to be in good operating condition. Based on a life expectancy of 20 years the pump will be due for replacement by 2021.

Condition Rating	Good	Lifetime	20
Year Installed	2001	Years Remaining	4 (Observed)
Adjustment Factor	1	Unit Cost	\$527.25
Quantity	20	Units	LM
Replacement Cost	\$10,545

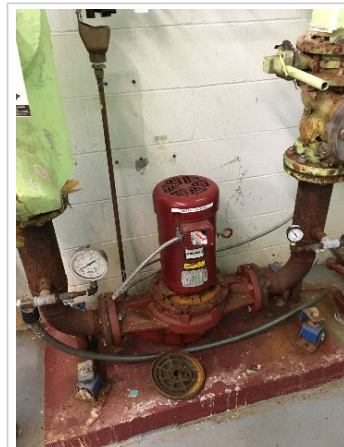
Cooling Distribution - Chilled water Supply Pump #6

Pump #6 is original with the building dating back to 1981. Based on a life expectancy of 20 years the pump is due for replacement.

Condition Rating	Poor	Lifetime	20
Year Installed	1981	Years Remaining	0 (Observed)
Adjustment Factor	1	Unit Cost	\$527.25
Quantity	20	Units	LM
Replacement Cost	\$10,545

Priority	1- Year 1	Category	I - Lifecycle
Estimated Cost	\$11,072	FY Action Date	2017

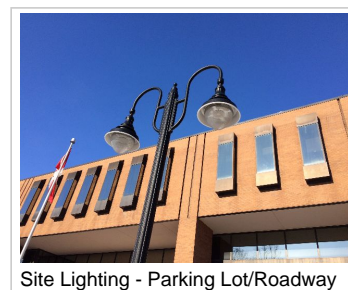
Site Lighting - Parking Lot/Roadway

Site lighting is in good condition and are energy efficient fixture models. Light poles and fixtures were installed in 2009 and appear to have been well maintained. Site lighting should be replaced at end of life expectancy.

Condition Rating	Good	Lifetime	15
Year Installed	2009	Years Remaining	10 (Observed)
Adjustment Factor	1	Unit Cost	\$3,597.33
Quantity	4	Units	Each
Replacement Cost	\$14,389
