**GEOTECHNICAL ENGINEERING REVIEW AND ASSESSMENT
OPERATION BUILDING KITCHEN UPGRADE**

**FORT LANGLEY NATIONAL HISTORIC SITE OF CANADA
LANGLEY, BC**

JOB No.: 217P553

DATE: AUGUST 10, 2017

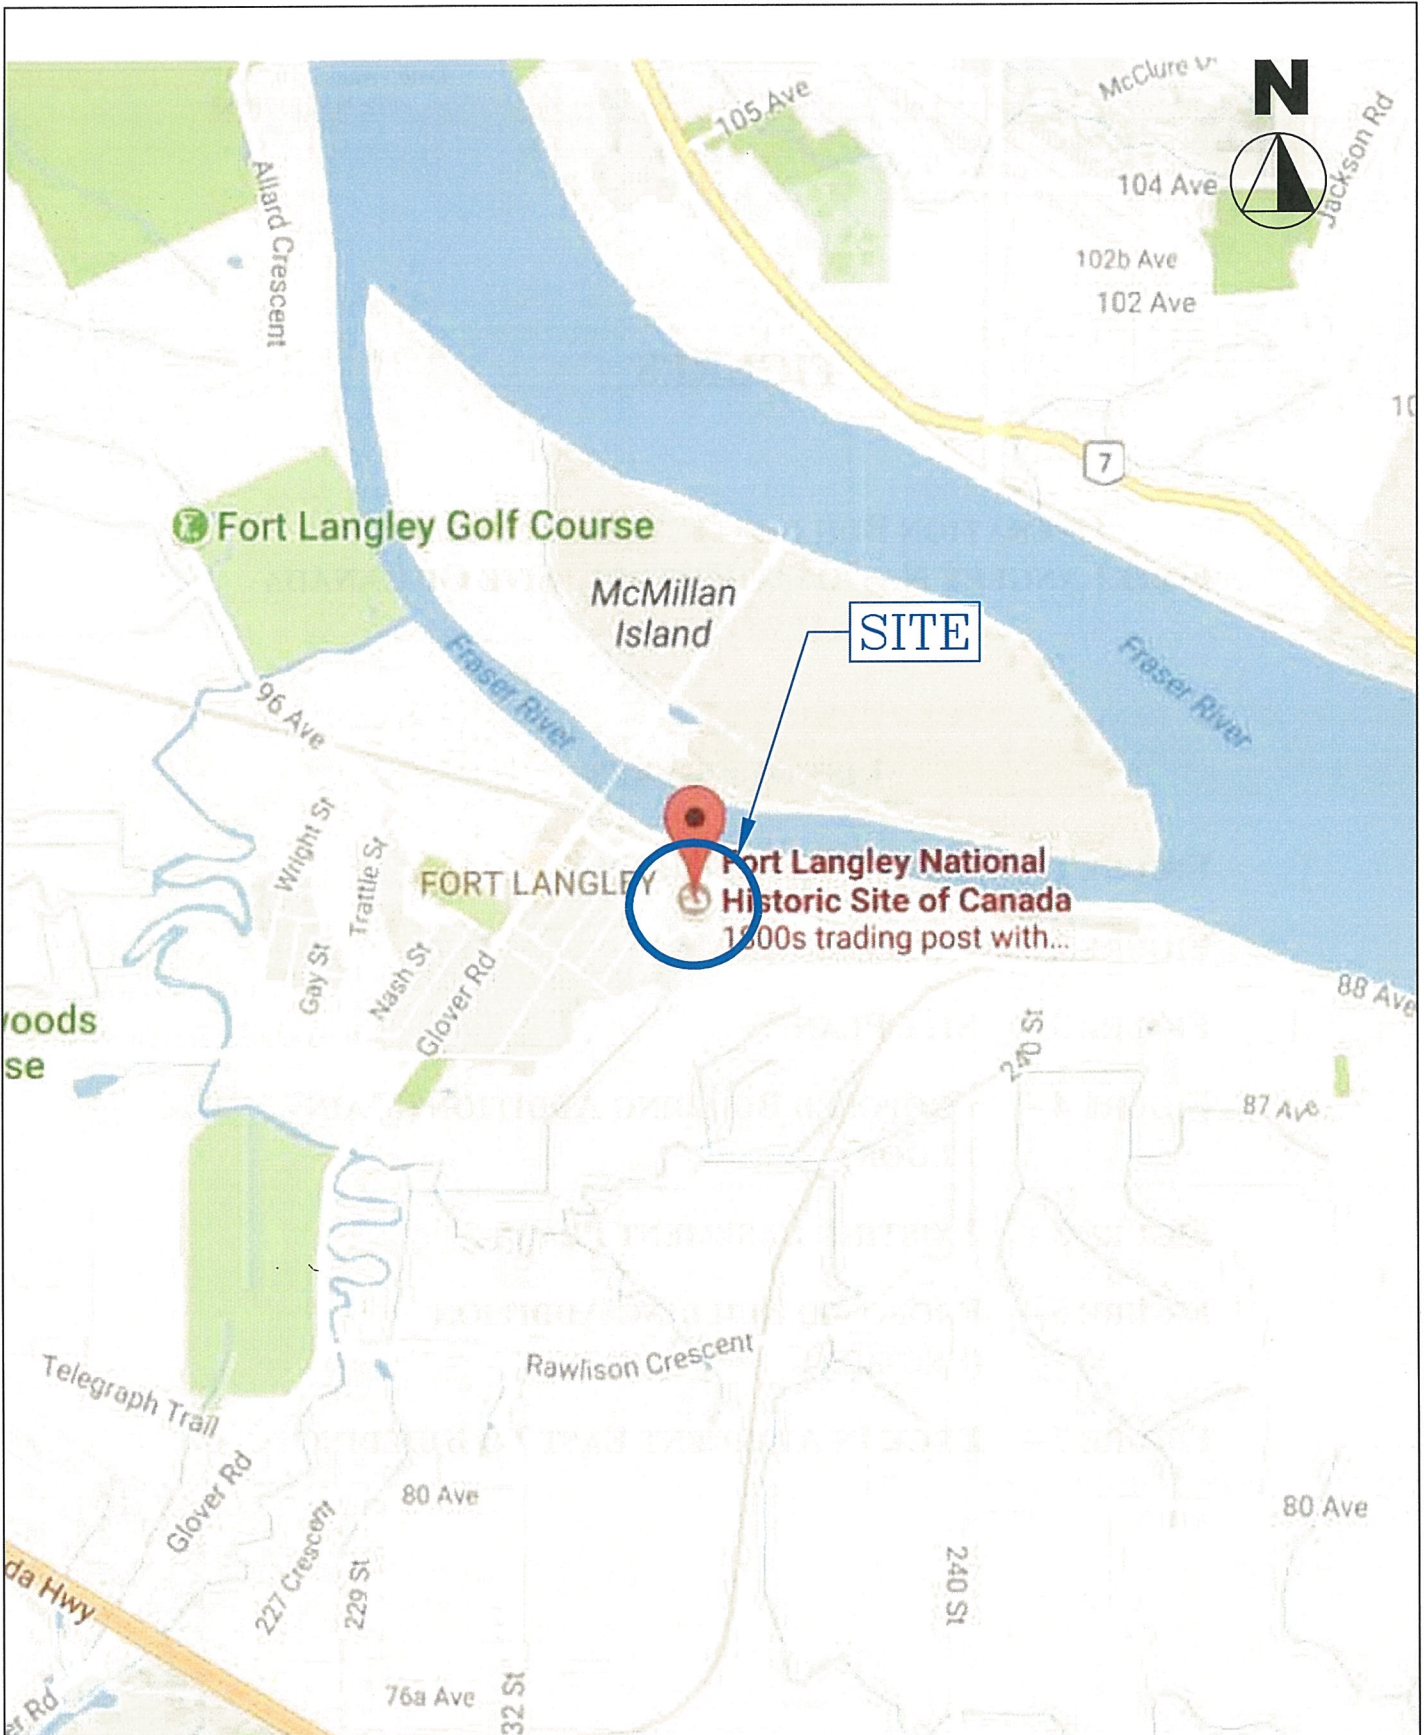
The Site is located within the Fort Langley Historical Park to the east side of Fort Langley Township, Fort Langley as shown in Figure 1 - Site Location Plan. The site is an operation building near to the 'Big House' as shown in Figure 2 - Site Plan.

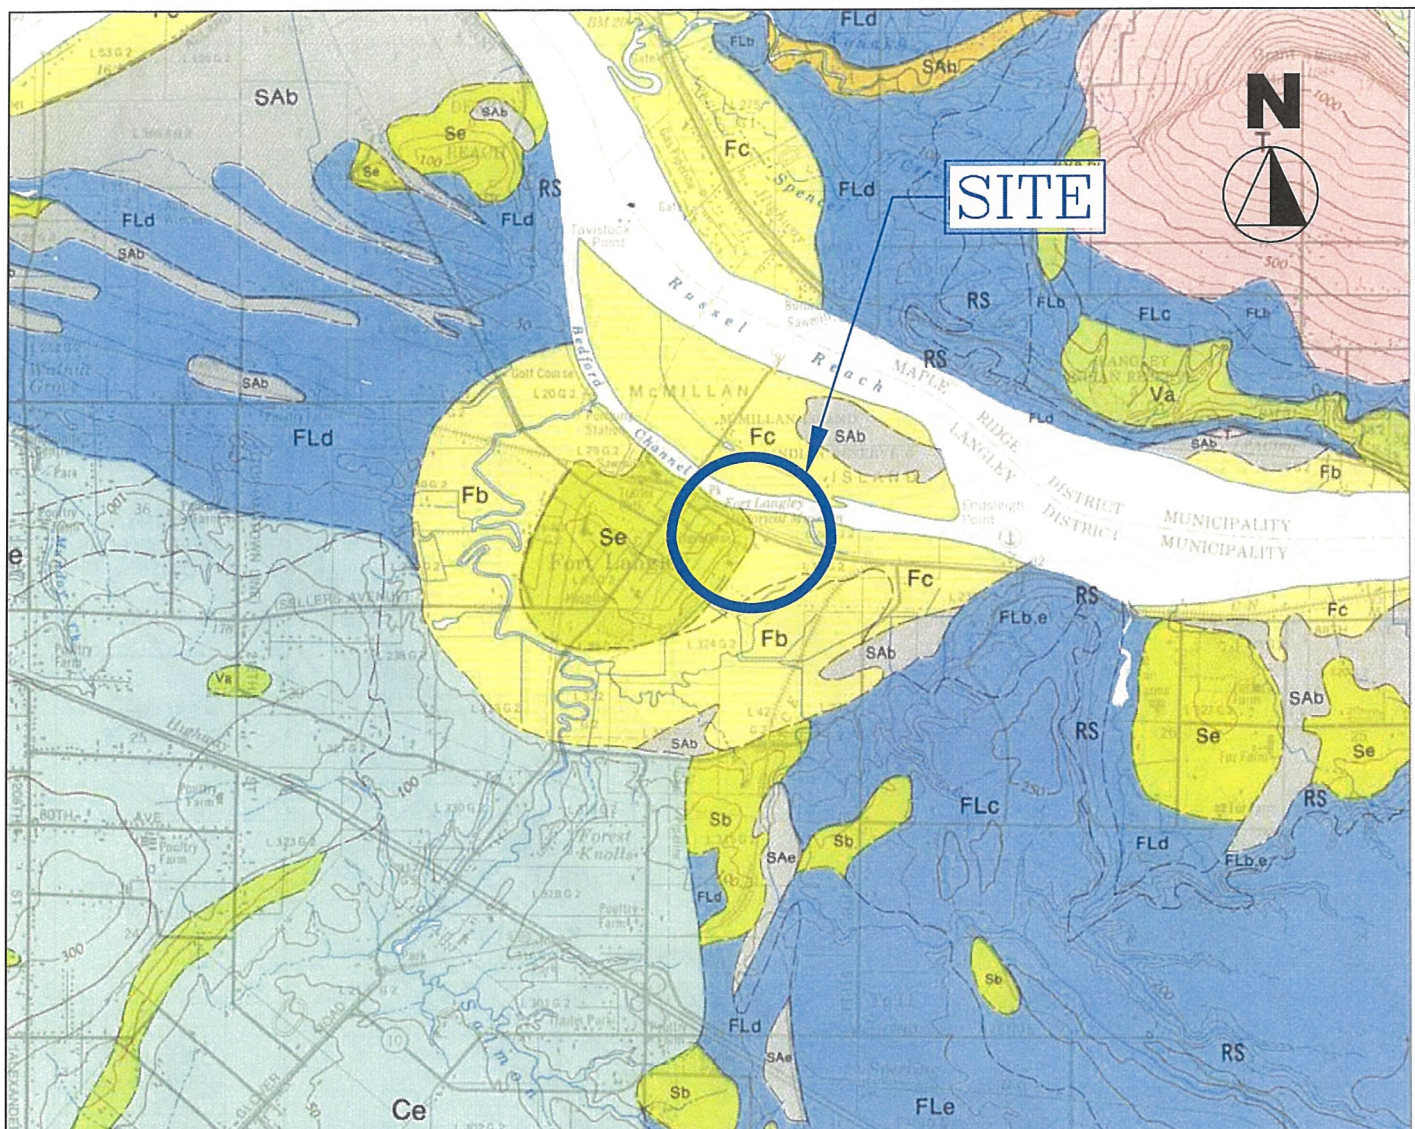
Dwg no: 217P553 - Figure 2

SUMAS DRIFT

Sa-e

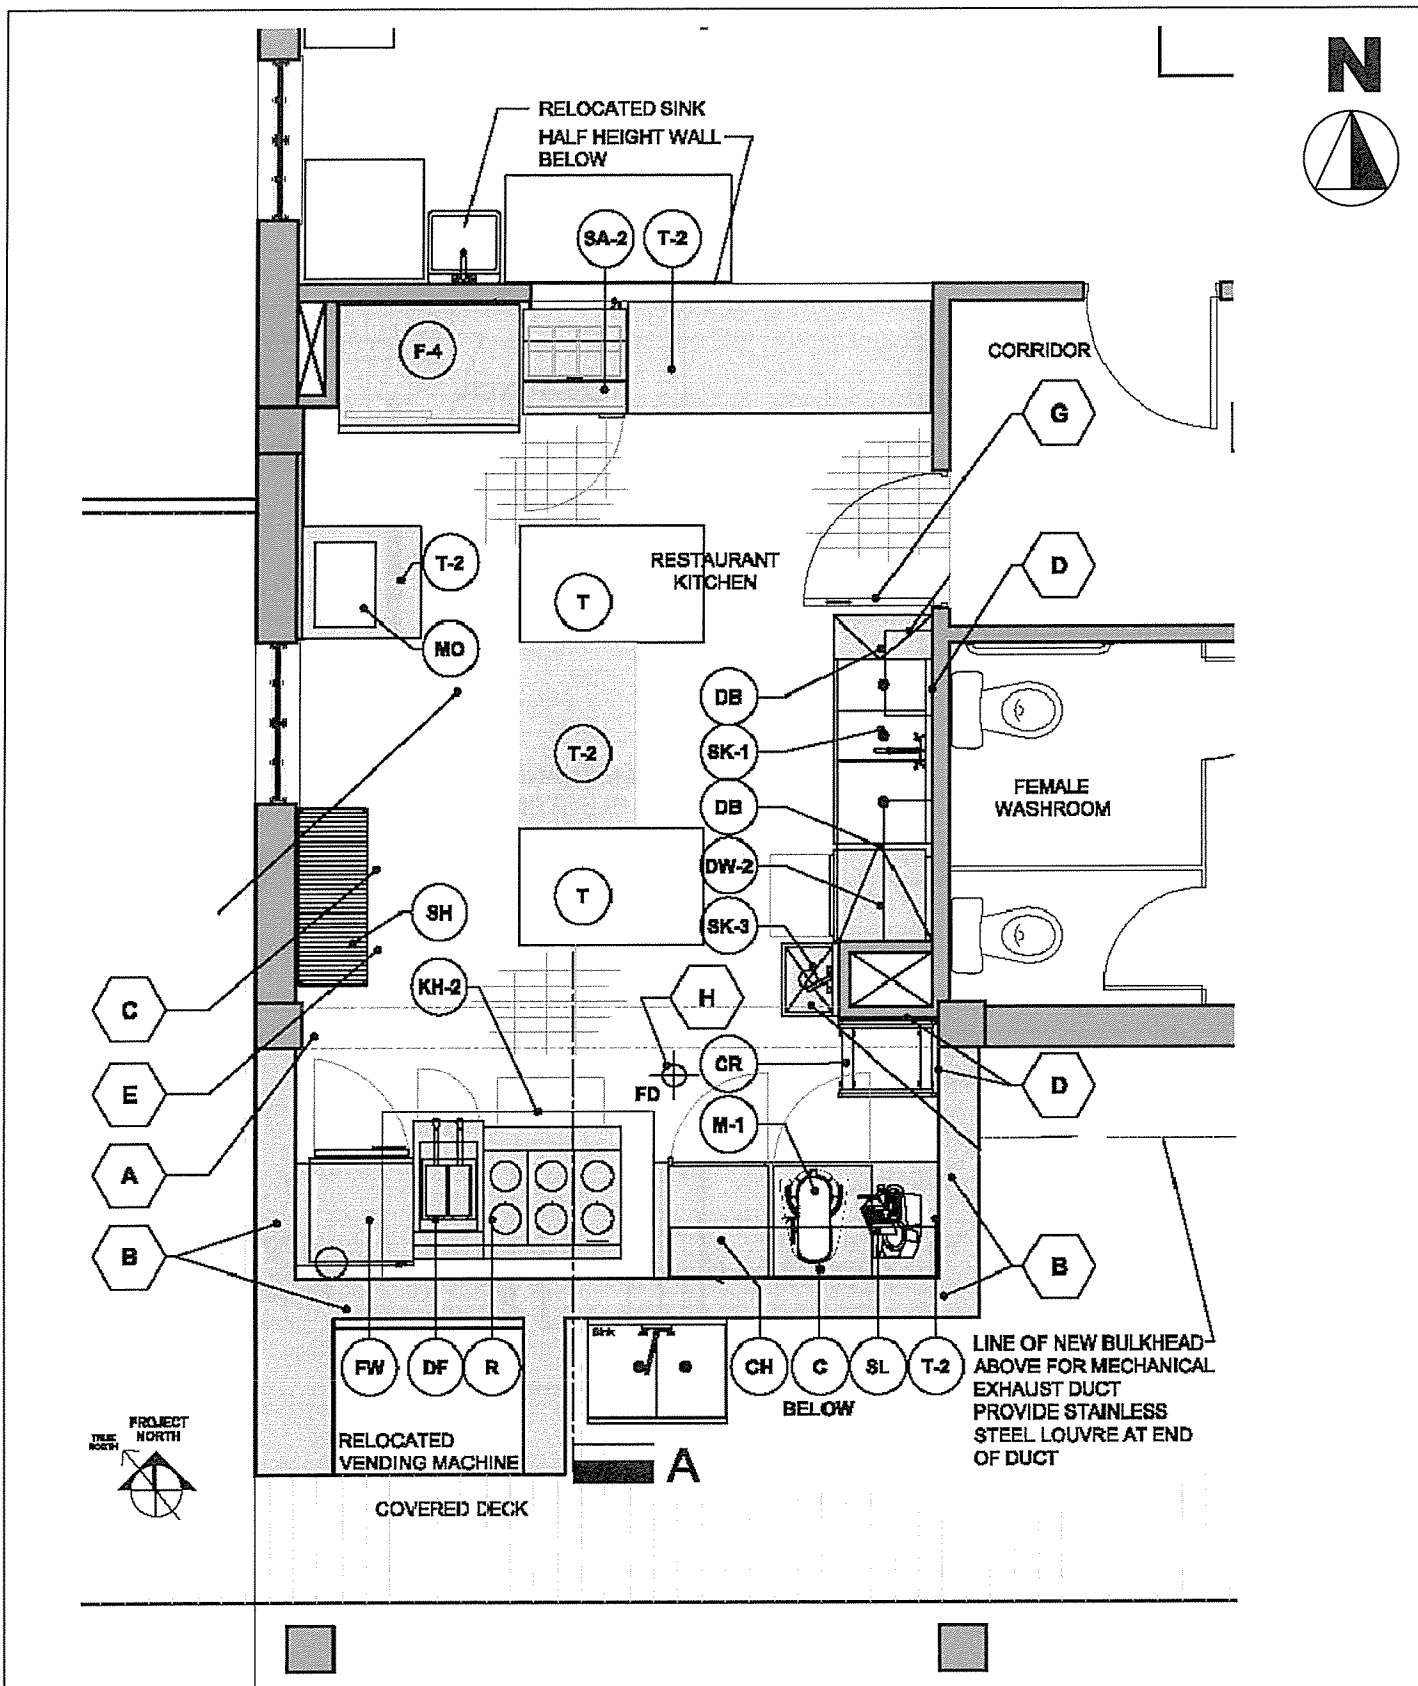
Dwg no: 217P553 - Figure 4

Operation Building Ground Floor- Proposed Kitchen Layout

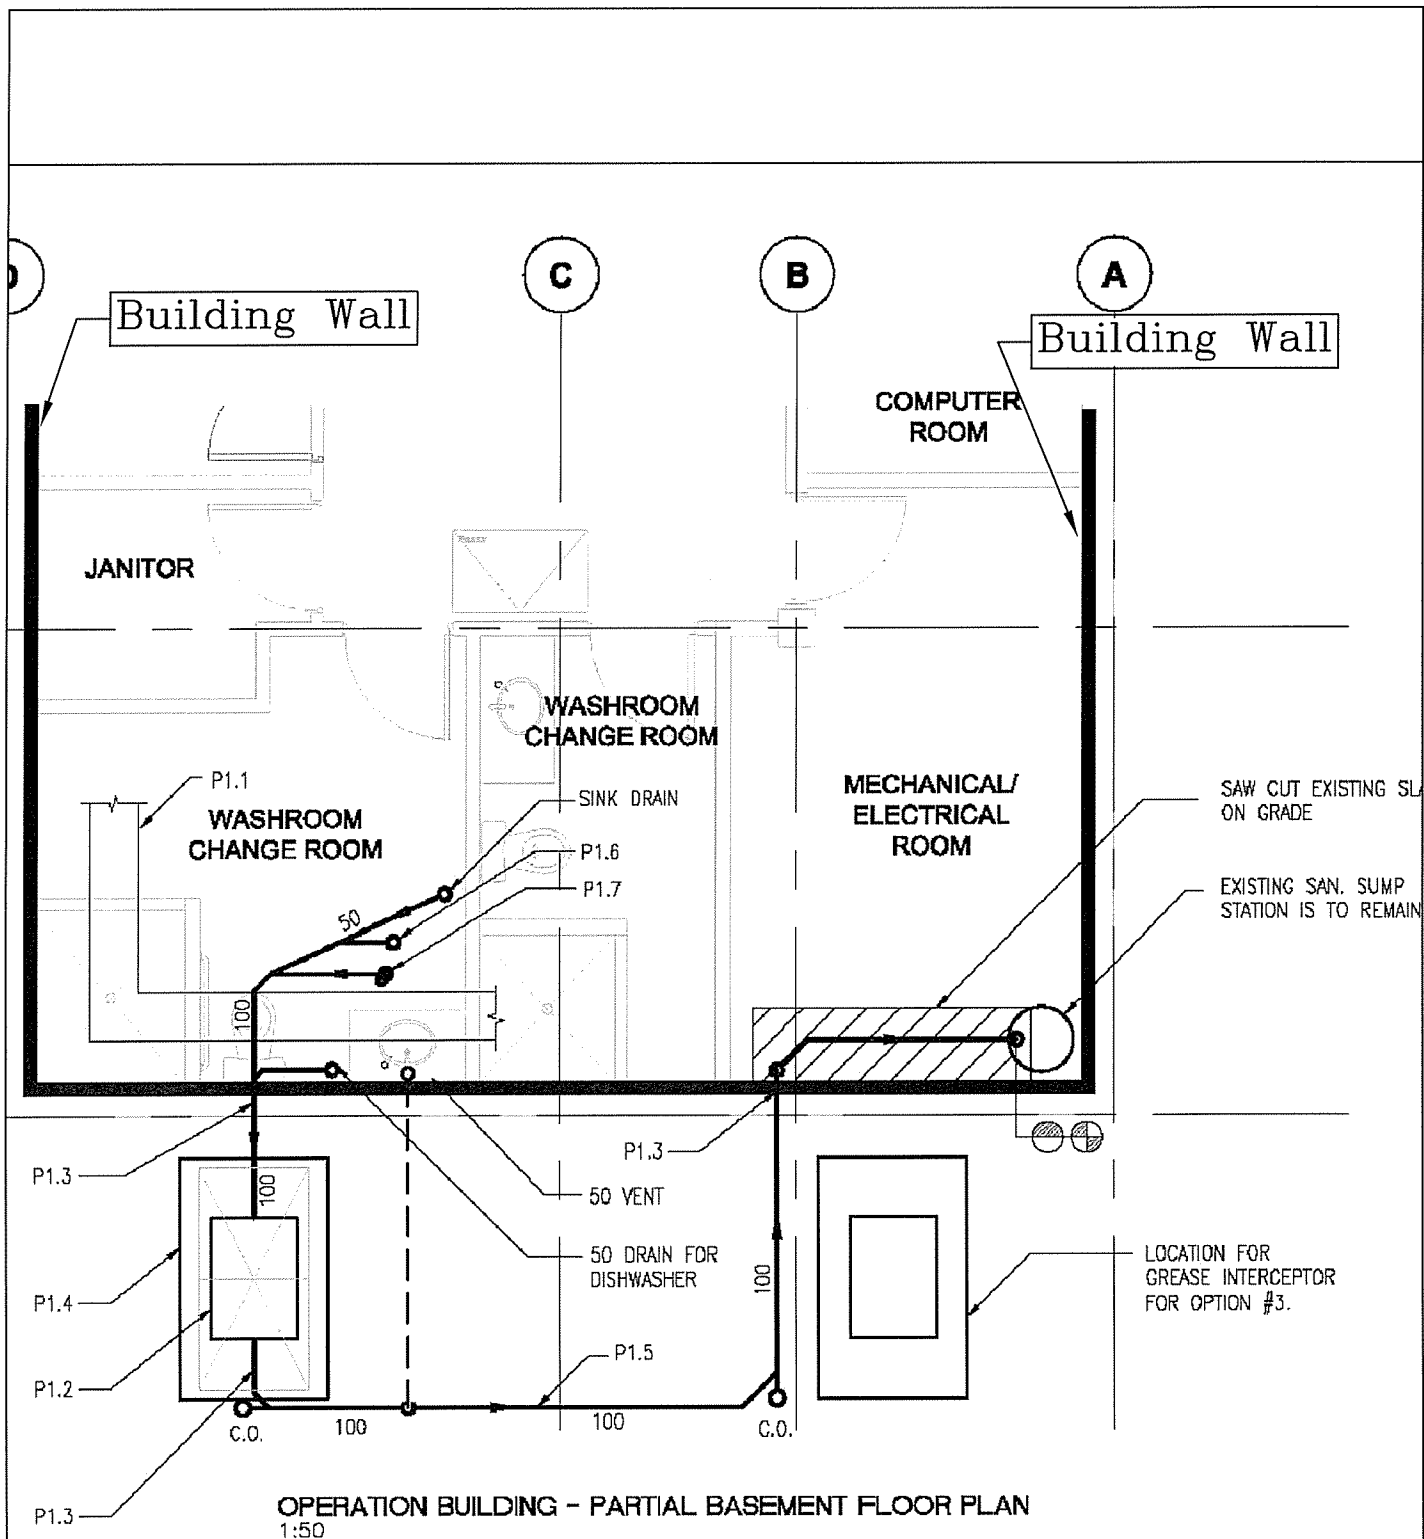
Dwg no: 217P553 - Figure 5

The basement at the south side of the existing building is occupied by washrooms and a Mechanical Room as shown in Figure 5 - Existing Basement Plan. A sump is noticed in the Mechanical Room as shown in Photo No. 5. JCI was informed by Park staff that flooding in the basement occur when the pump went malfunction. JCI was also informed that the sump will be removed and replace by a future drainage system operating by gravity fall to a new drainage system at the area.

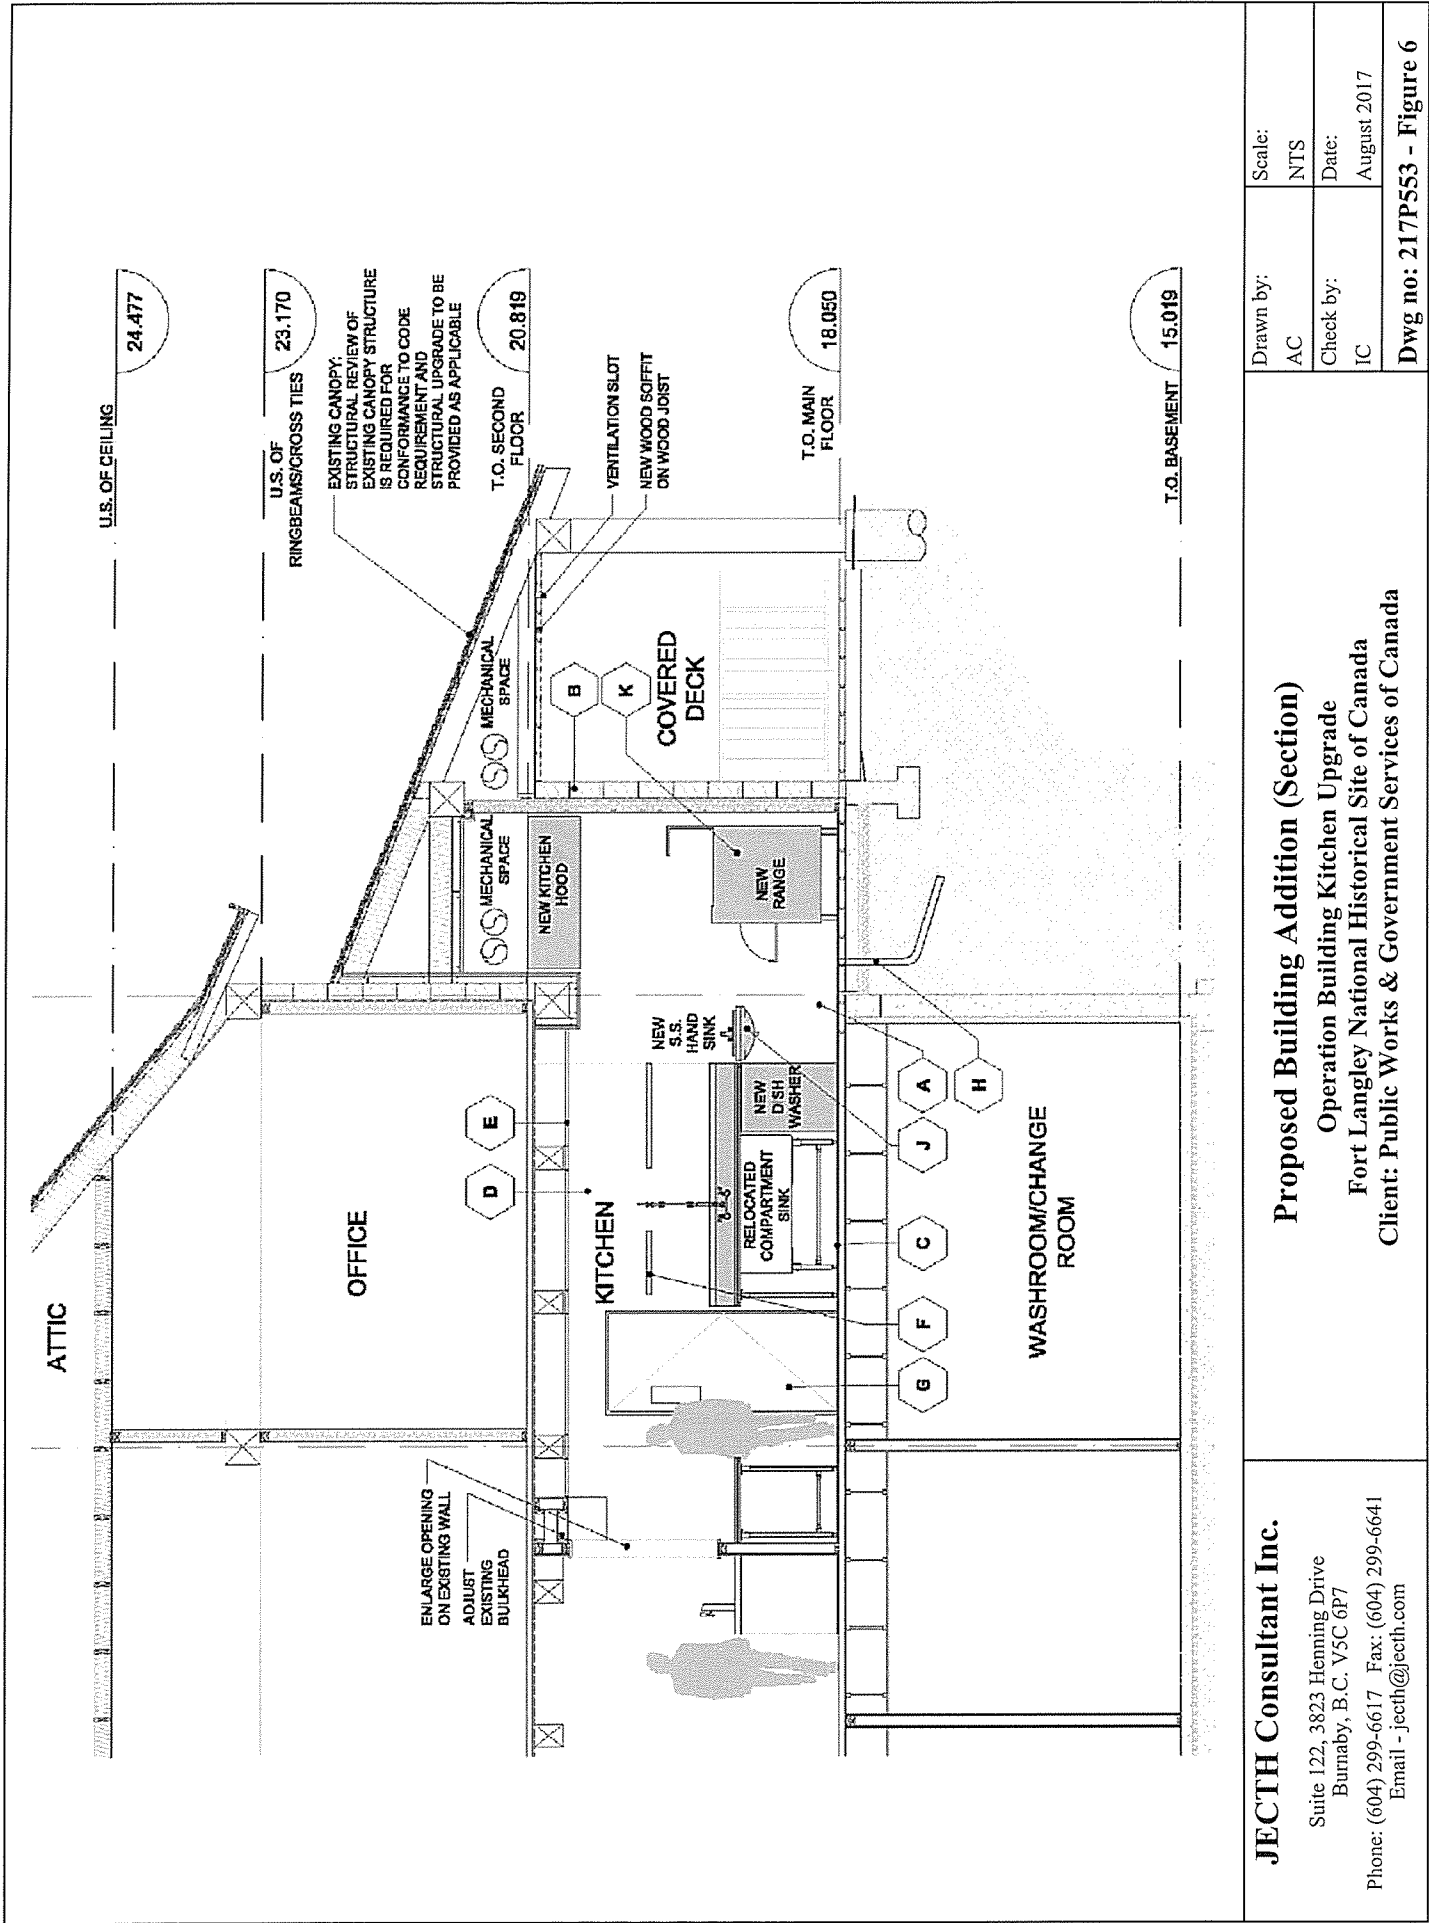
- Construction of a new building addition attached to the south side of building which involve construction of new external building walls with new foundations

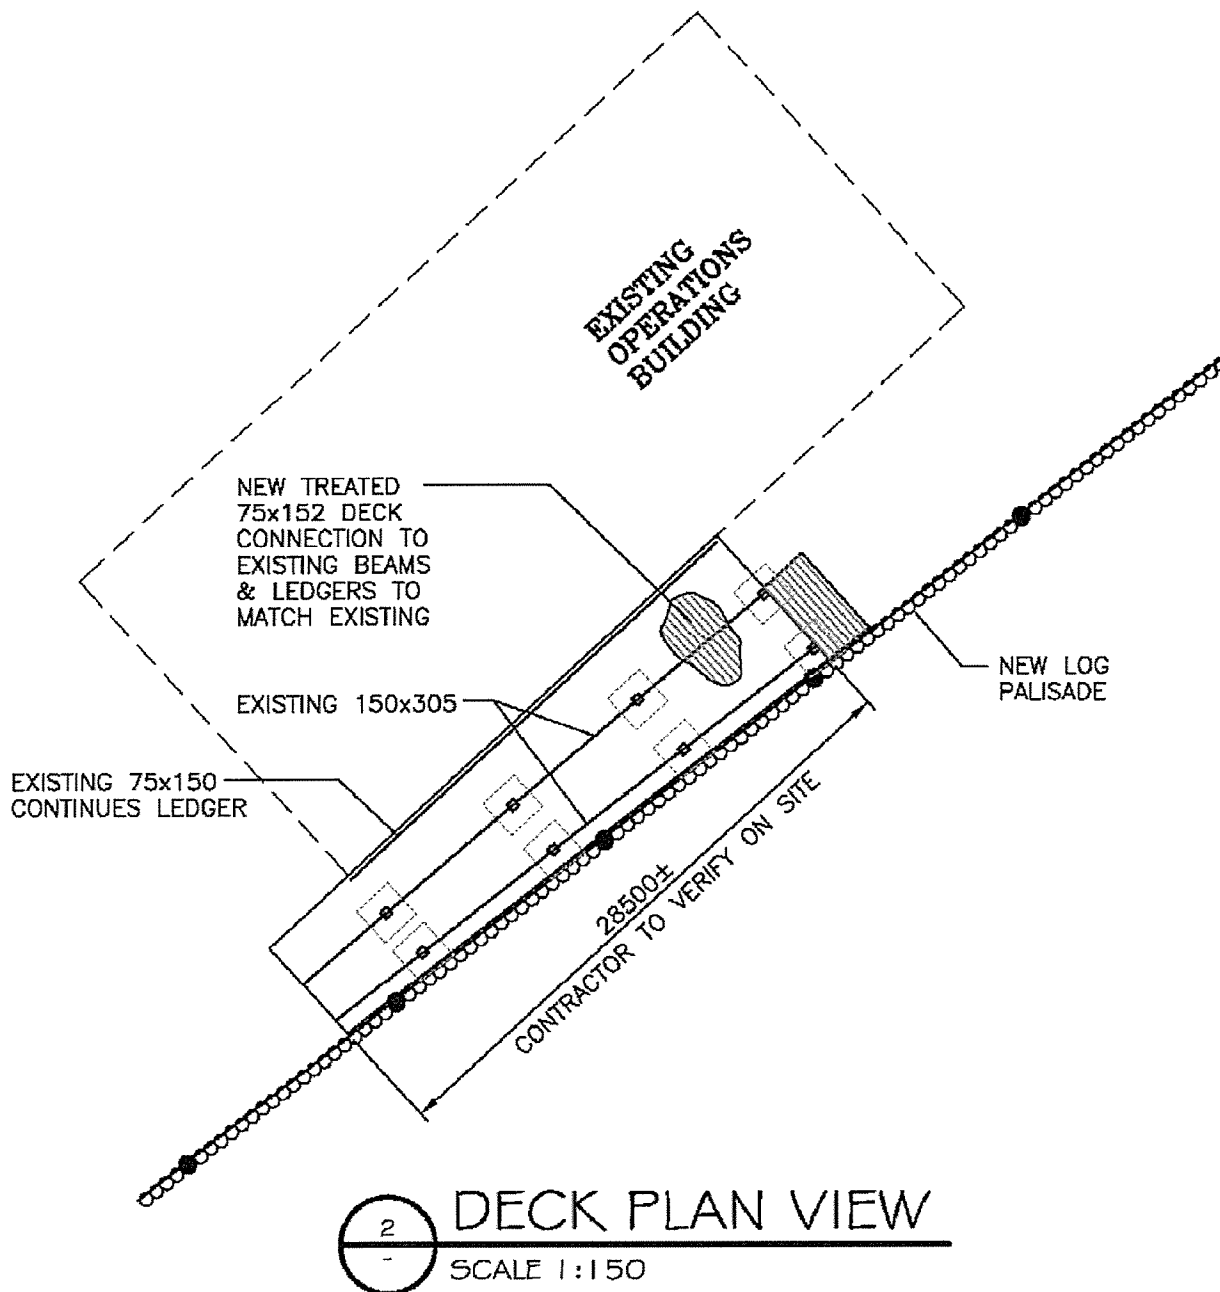
Dwg no: 217P553 - Figure 7

The site topography around the building is slightly sloping up from north to south along the building. It can be assessed by a gravel path to the main entrance at the east of the building. A suspended timber deck and a Log Palisade wall is observed in adjacent east of building as shown in Photo No.3. The deck is a suspended deck supported by concrete sonnet tube as shown in Photo No.4. Access to the basement can through doors along the deck.
