SITE SAMPLING DIAGRAM: #1 ADMINISTRATION OFFICE Basement

Project Name: Hazardous Materials Assessment

Project Location: Beaverlodge Research Centre

Project No.: 11166

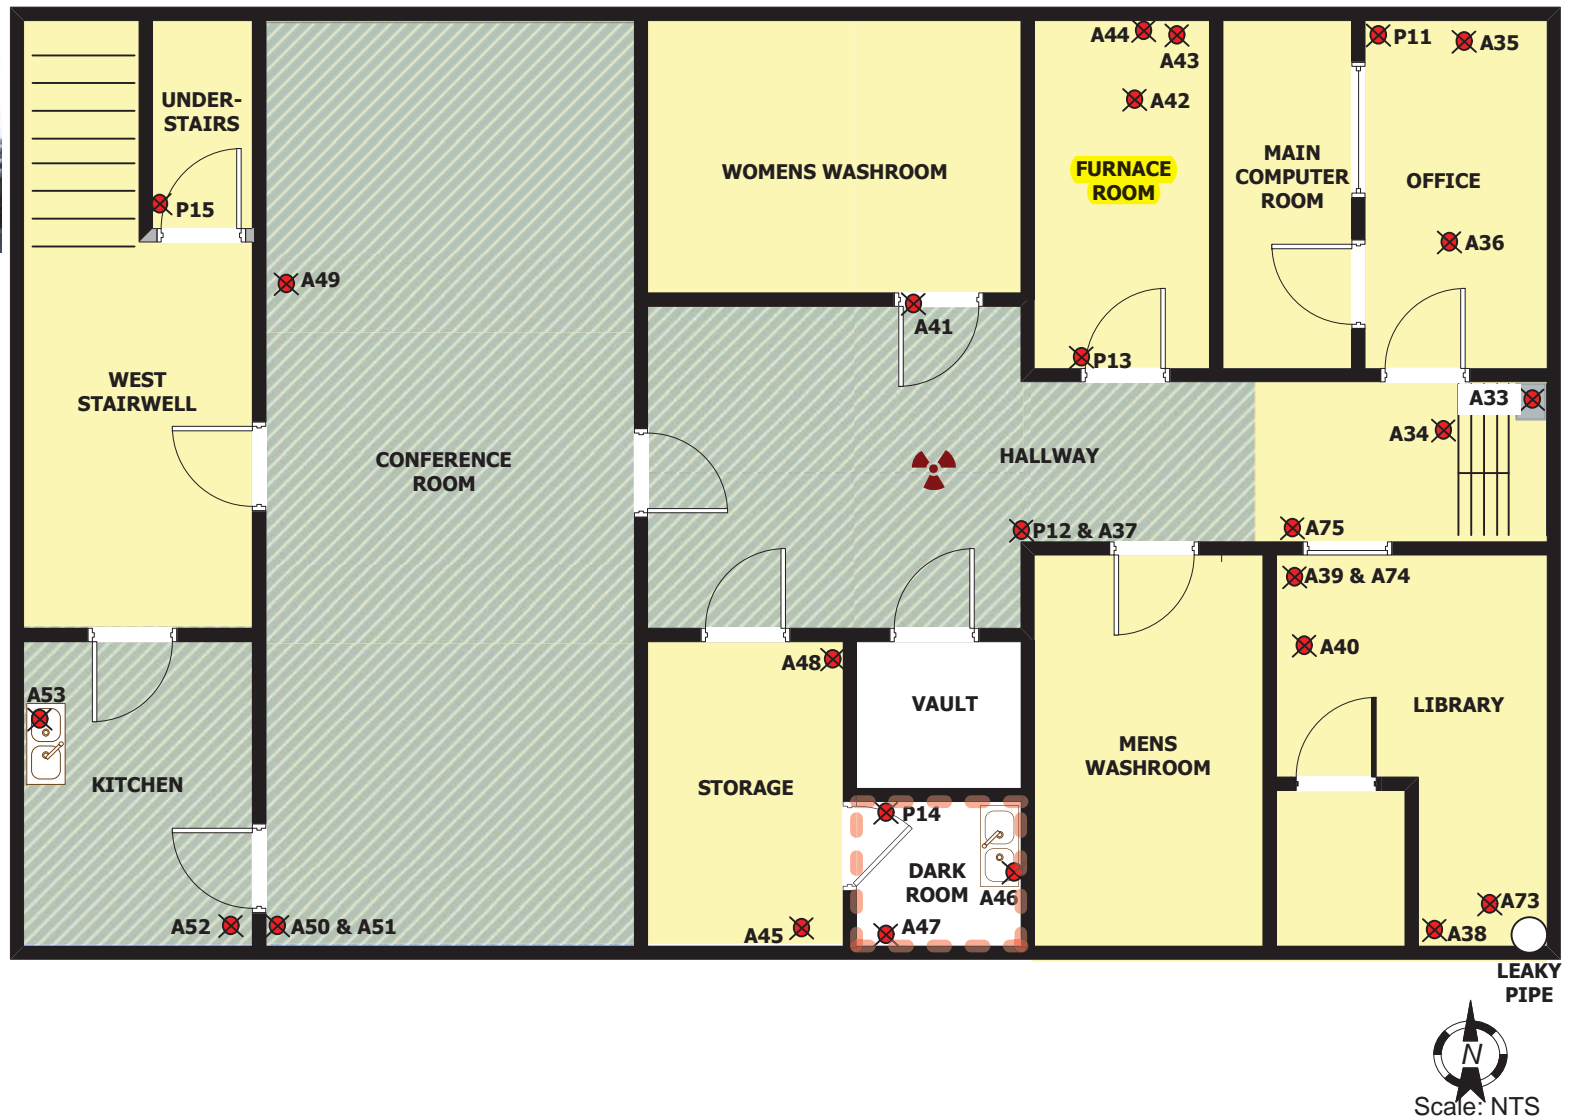
1: Administration Office	Bsmt	Basement Office	office	drywall	drywall	linoleum	-	blue	blue	blue speckle	-	-	-	-	blue	P11	office	Negative
												blue drywall mud	A35	ceiling	-	-	-	Negative
												blue speckle linoleum	A36	floor at drain	-	-	-	Negative

1: Administration Office	Bsmt	Main Computer Room	computer room	drywall	drywall	linoleum	-	blue	blue	blue speckle	-	-	-	-	-	-	-	-
1: Administration Office	Bsmt	Hallway	hallway	drywall	drywall/ cement	carpet/9x9 floor tile/ linoleum	smoke detector; 9m pipe insulation	white	white	light brown	-	-	-	-	white	P12	hall	Negative
												white drywall mud	A37	hall	-	-	-	Positive
												brown with white 9x9 floor tile	A41	hall floor	-	-	-	Positive
												brown with white 9x9 floor tile	A75	hall floor	-	-	-	Positive

1: Administration Office	Bsmt	Library	library	ceiling tile	wall wood board	carpet on cement	-	white	beige	-	12x12 grid and 12x12 holes	white pipe wrap	A38	pipe wrap	-	-	-	Negative
												white 12x12 holes ceiling tile	A39	ceiling	-	-	-	Negative
												white 12x12 grid ceiling tile	A40	ceiling	-	-	-	Negative
												white 12x12 grid ceiling tile	A73	west ceiling	-	-	-	Negative
												white 12x12 grid ceiling tile	A74	NE corner	-	-	-	Negative
