HAZARDOUS BUILDING MATERIALS ASSESSMENTS

Parks Canada Buildings
Kluane National Park
Haines Junction, YT

Project No.: 144901924

November 19, 2014

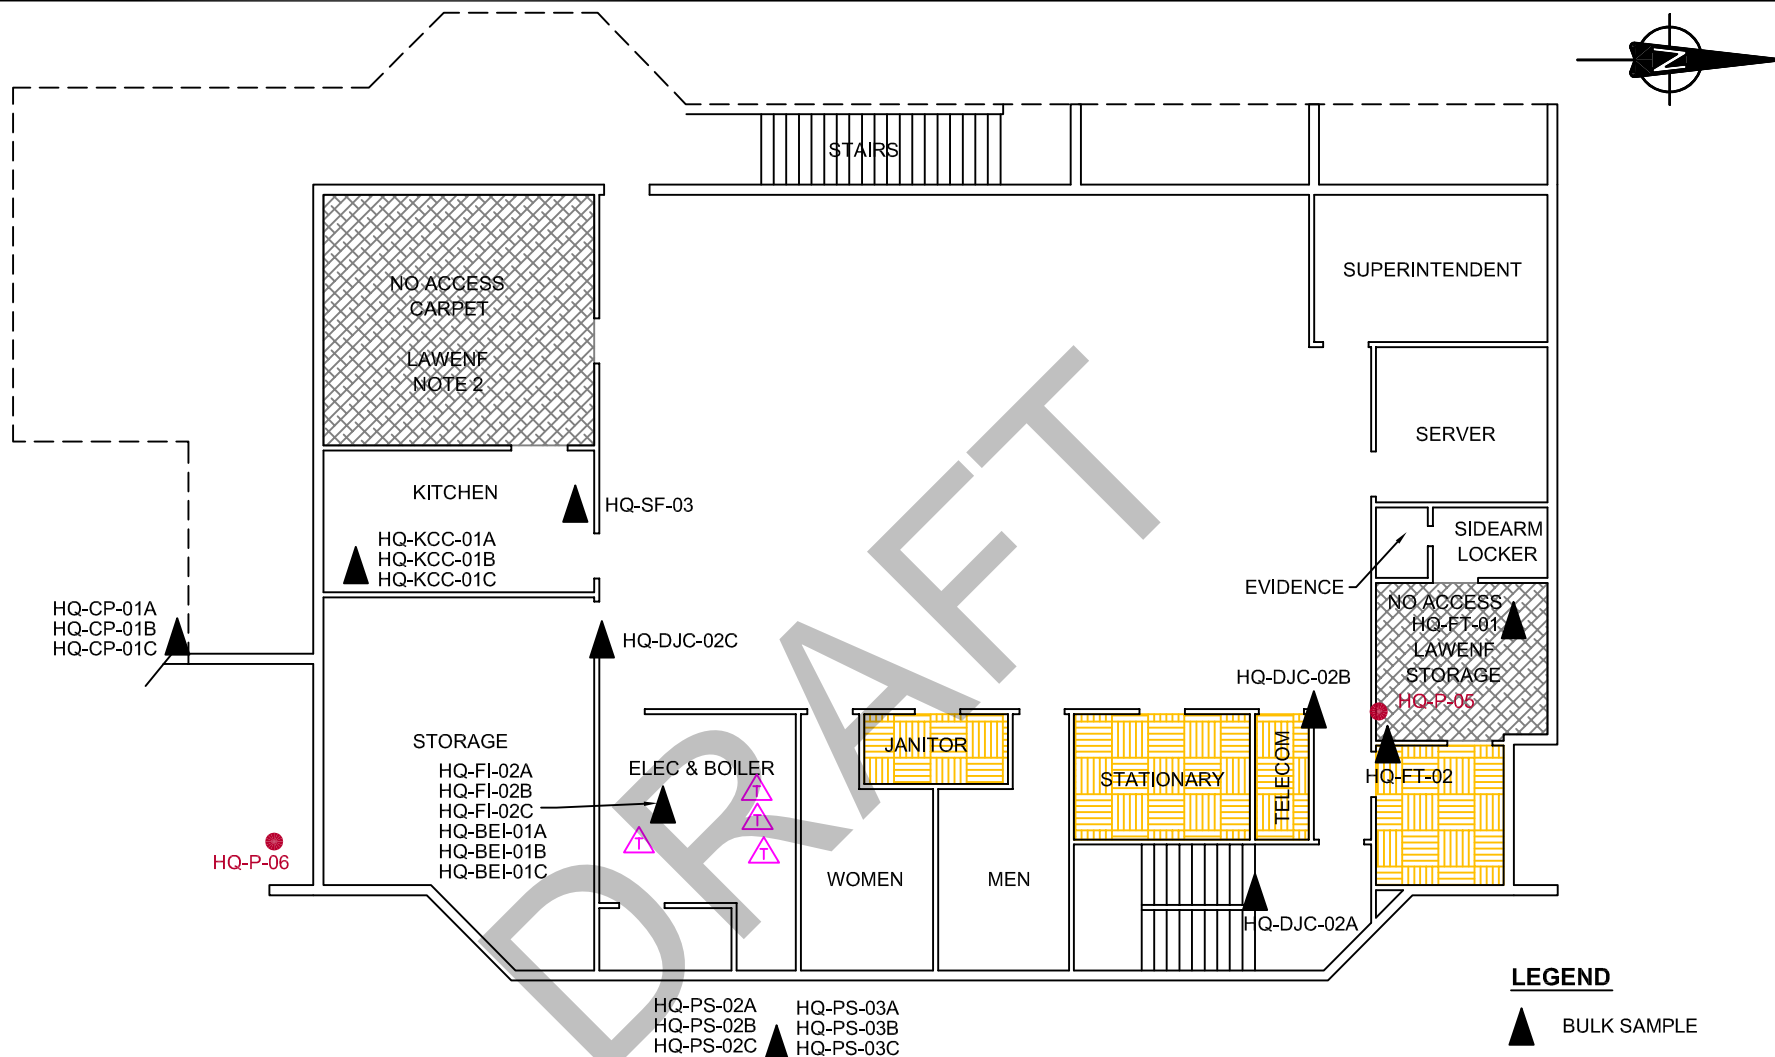
KNP HEADQUARTERS BUILDING LOWER LEVEL

- NOTES:** 1. BLACK WINDOW PANE CAULKING BETWEEN FRAMES AND GLASS PANES THROUGHOUT IS ACM.
 2. WHITE 2'X4' CEILING TILE (STANDARD FISSURE AND PINHOLE WITH LIGHT RED BACKING) THROUGHOUT IS ACM.
 3. CEMENT PANEL AROUND THE BASE OF EXTERIOR WALLS IS ACM.
 4. THIS DRAWING ILLUSTRATES SUPPORTING INFORMATION SPECIFIC TO A STANTEC CONSULTING LTD. REPORT AND MUST NOT BE USED FOR OTHER PURPOSES.

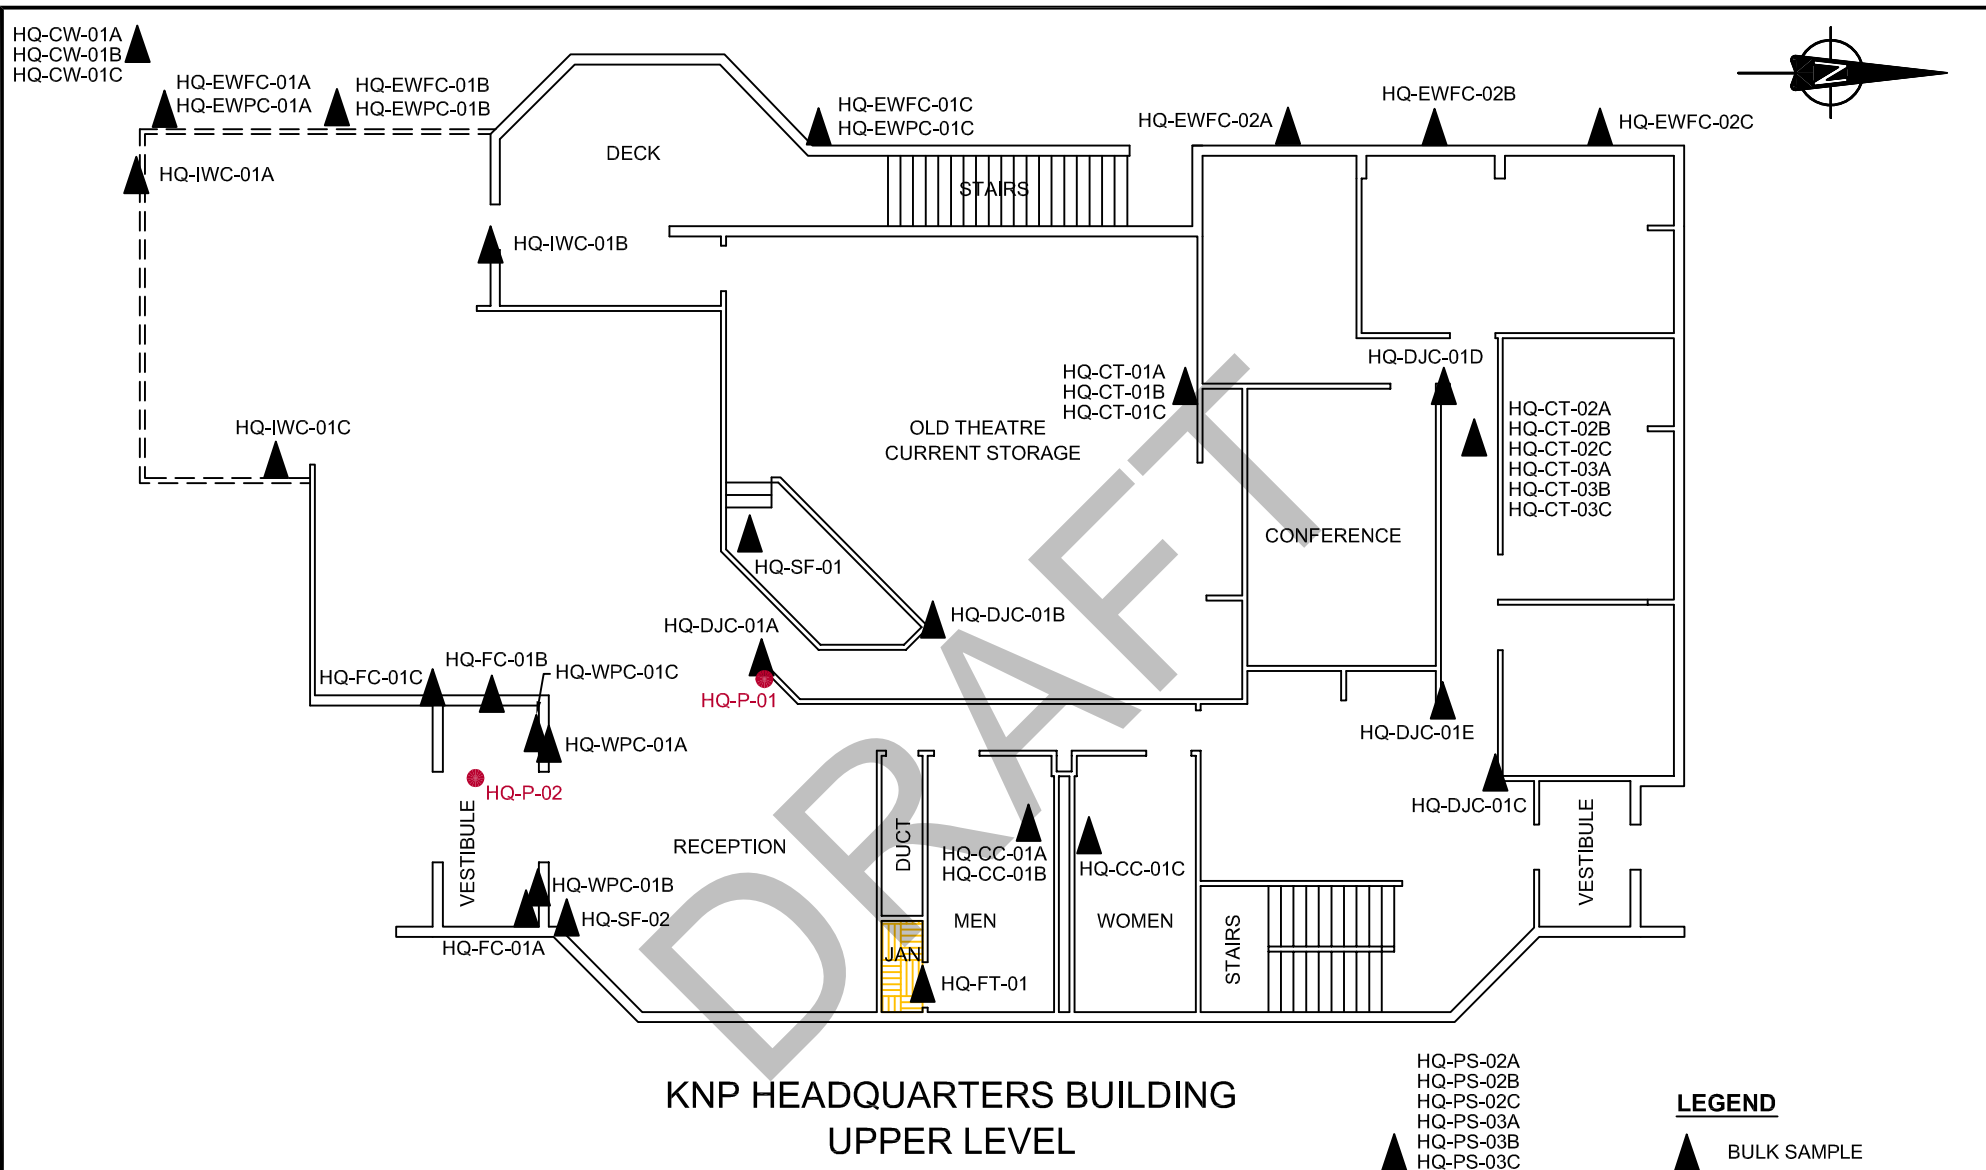
B2

- NOTES:**
1. BLACK WINDOW PANE CAULKING BETWEEN FRAMES AND GLASS PANES THROUGHOUT IS ACM.
 2. WHITE 2'X4' CEILING TILE (STANDARD FISSURE AND PINHOLE WITH LIGHT RED BACKING) THROUGHOUT IS ACM.
 3. CEMENT PANEL AROUND THE BASE OF EXTERIOR WALLS IS ACM.
 4. THIS DRAWING ILLUSTRATES SUPPORTING INFORMATION SPECIFIC TO A STANTEC CONSULTING LTD. REPORT AND MUST NOT BE USED FOR OTHER PURPOSES.

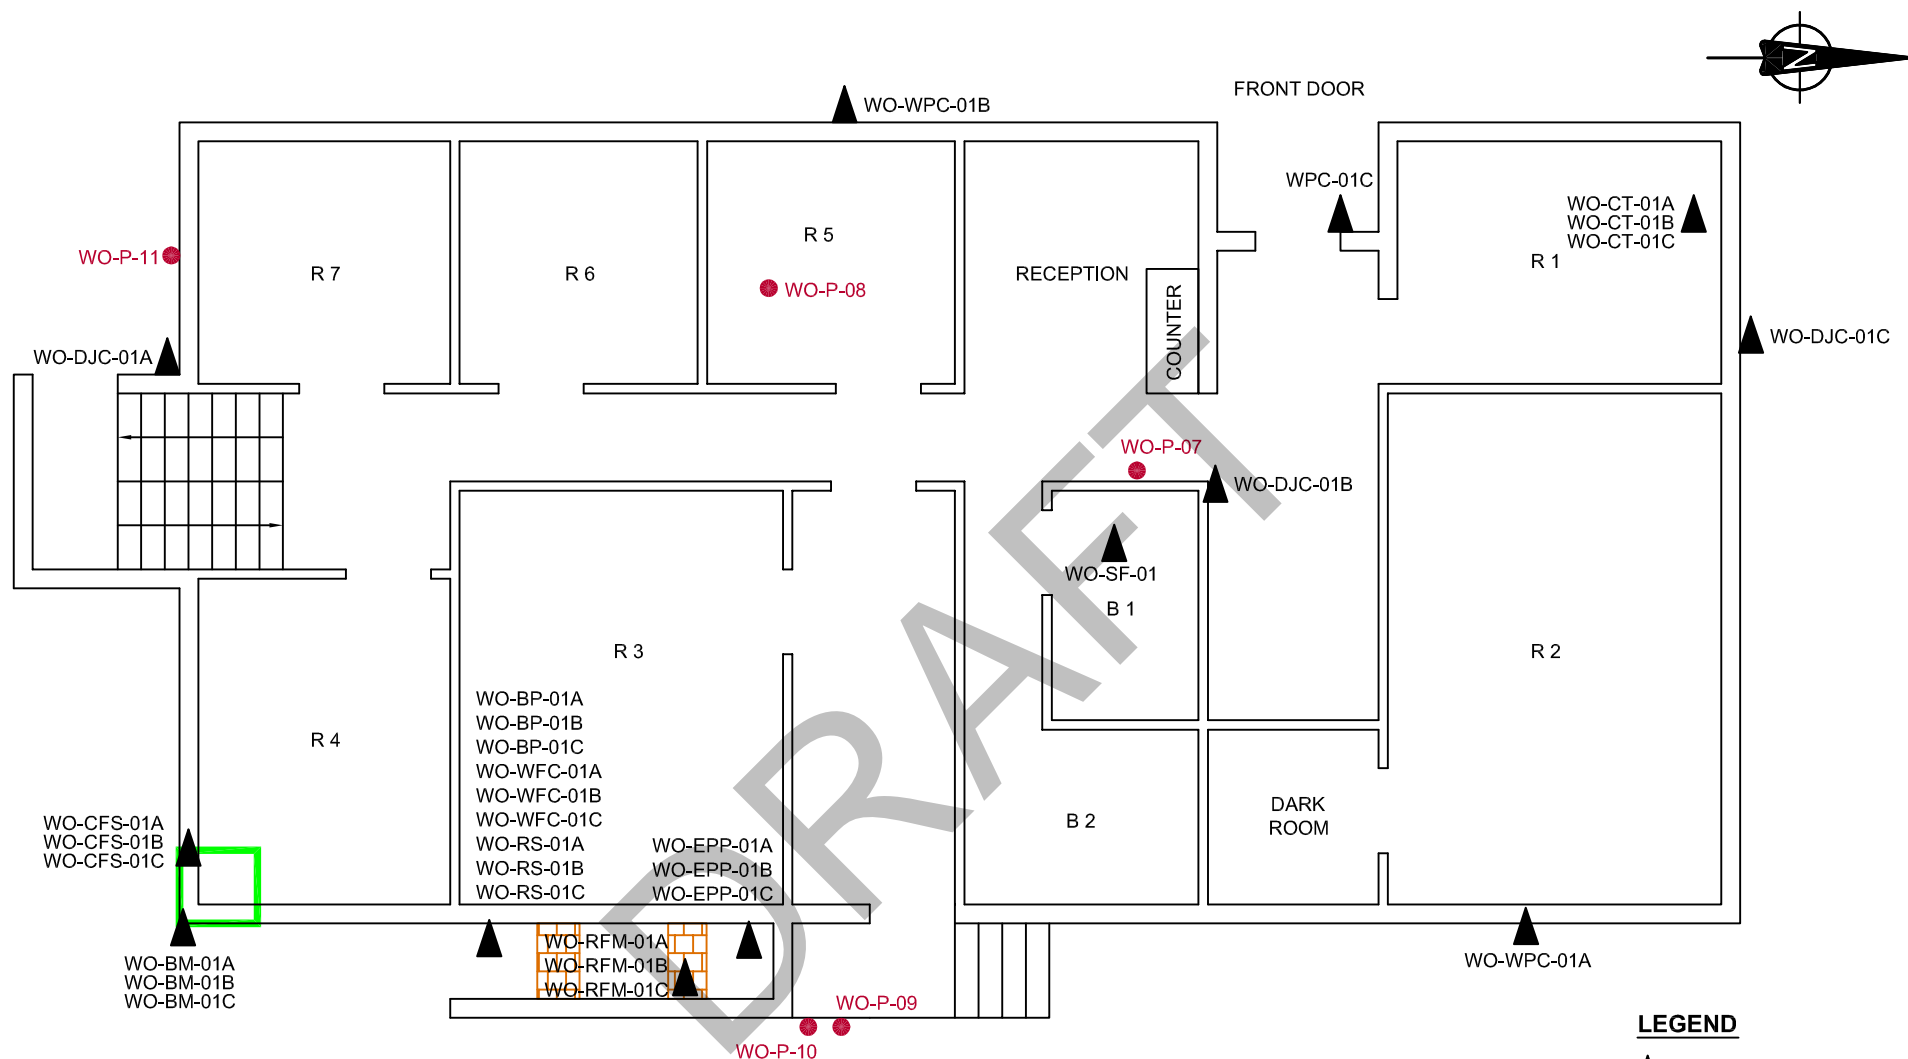
WARDENS OFFICE UPPER LEVEL

- NOTES:**
1. PIPE FITTING INSULATION ON ELBOWS +S AND VALVES THROUGHOUT IS ACM.
 2. CORRUGATED PAPER INSULATION ON STRAIGHT SECTIONS OF PIPE THROUGHOUT IS ACM.
 3. GREY WINDOW FRAME CAULKING BETWEEN FRAME AND THE BUILDING EXTERIOR THROUGHOUT IS ACM.
 4. BLACK WINDOW PANE CAULKING BETWEEN WINDOW FRAME AND GLASS PANE ON WINDOWS THROUGHOUT IS ACM.
 5. DRYWALL JOINT COMPOUND THROUGHOUT IS ACM.
 6. THIS DRAWING ILLUSTRATES SUPPORTING INFORMATION SPECIFIC TO A STANTEC CONSULTING LTD. REPORT AND MUST NOT BE USED FOR OTHER PURPOSES.

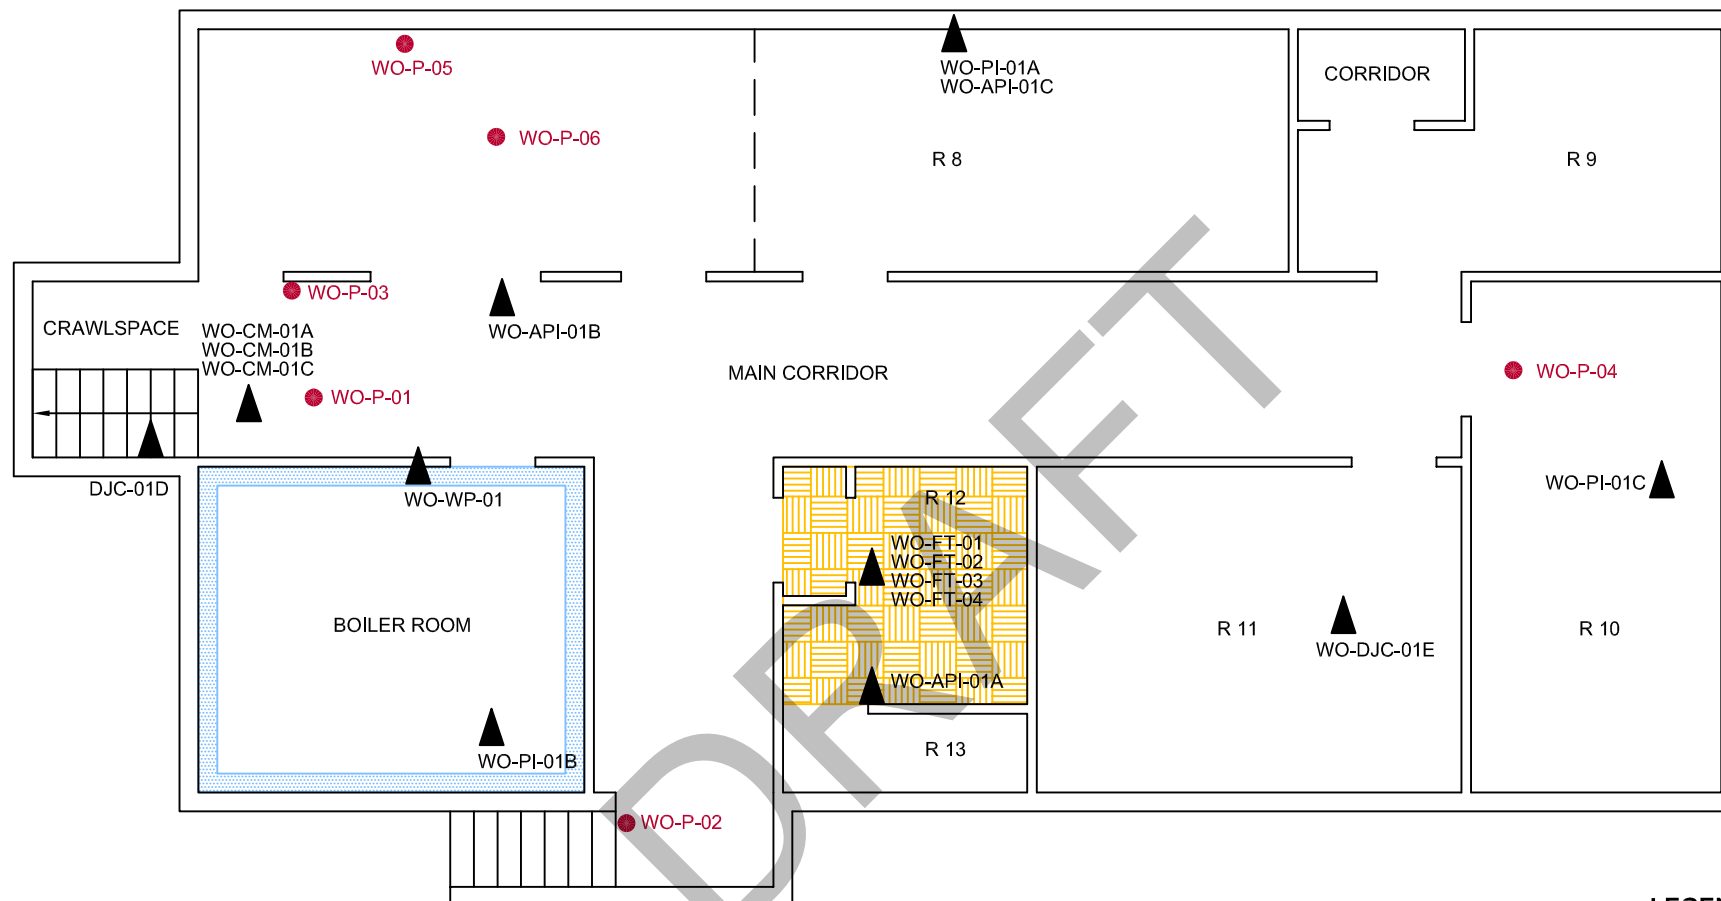
WARDENS OFFICE LOWER LEVEL

- NOTES:**
1. PIPE FITTING INSULATION ON ELBOWS †'S AND VALVES THROUGHOUT IS ACM.
 2. CORRUGATED PAPER INSULATION ON STRAIGHT SECTIONS OF PIPE THROUGHOUT IS ACM.
 3. GREY WINDOW FRAME CAULKING BETWEEN FRAME AND THE BUILDING EXTERIOR THROUGHOUT IS ACM.
 4. BLACK WINDOW PANE CAULKING BETWEEN WINDOW FRAME AND GLASS PANE ON WINDOWS THROUGHOUT IS ACM.
 5. DRYWALL JOINT COMPOUND THROUGHOUT IS ACM.
 6. THIS DRAWING ILLUSTRATES SUPPORTING INFORMATION SPECIFIC TO A STANTEC CONSULTING LTD. REPORT AND MUST NOT BE USED FOR OTHER PURPOSES.

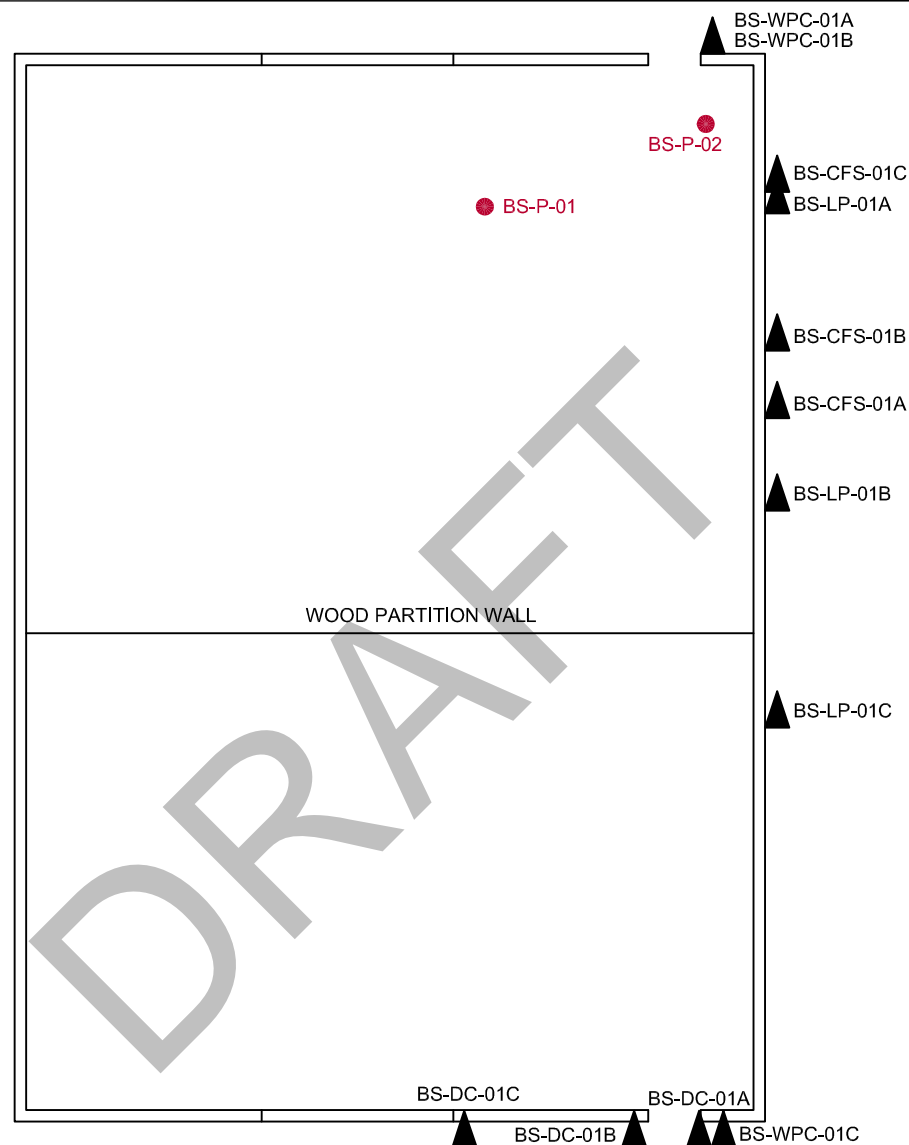
BUTLER STORAGE SHED

NOTES: 1. BLACK/GREY WINDOW PANE CAULKING BETWEEN WINDOW FRAME AND GLASS PANES THROUGHOUT IS ACM.

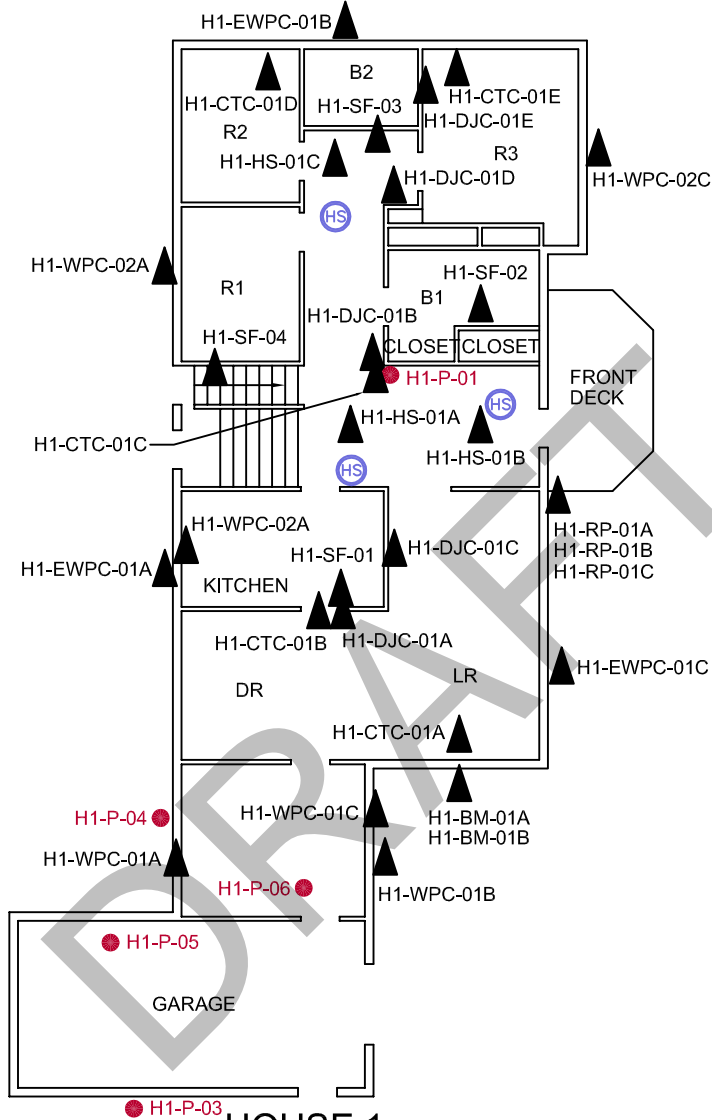
**HOUSE 1
MAIN FLOOR**

- NOTES:**
1. GREY WINDOW PANE CAULKING BETWEEN WINDOW FRAMES AND GLASS PANES THROUGHOUT THE MAIN HOUSE IS ACM.
 2. CEILING TEXTURE COAT THROUGHOUT IS ACM.
 3. DRYWALL JOINT COMPOUND THROUGHOUT IS ACM.
 4. THIS DRAWING ILLUSTRATES SUPPORTING INFORMATION SPECIFIC TO A STANTEC CONSULTING LTD. REPORT AND MUST NOT BE USED FOR OTHER PURPOSES.

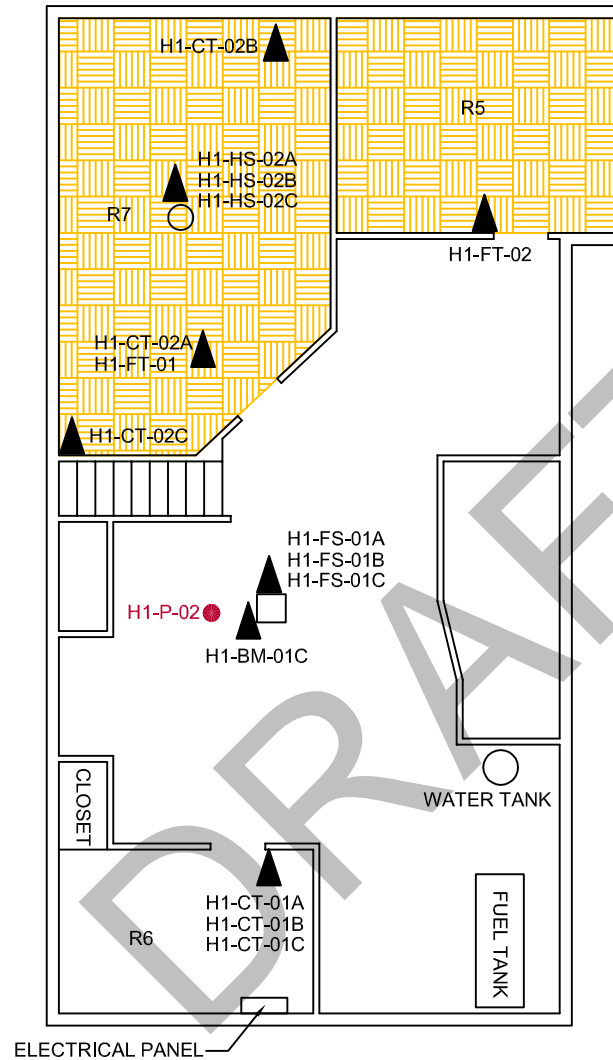
HOUSE 1 BASEMENT

- NOTES:**
1. GREY WINDOW PANE CAULKING BETWEEN WINDOW FRAMES AND GLASS PANES THROUGHOUT THE MAIN HOUSE IS ACM.
 2. CEILING TEXTURE COAT THROUGHOUT IS ACM.
 3. DRYWALL JOINT COMPOUND THROUGHOUT IS ACM.
 4. THIS DRAWING ILLUSTRATES SUPPORTING INFORMATION SPECIFIC TO A STANTEC CONSULTING LTD. REPORT AND MUST NOT BE USED FOR OTHER PURPOSES.

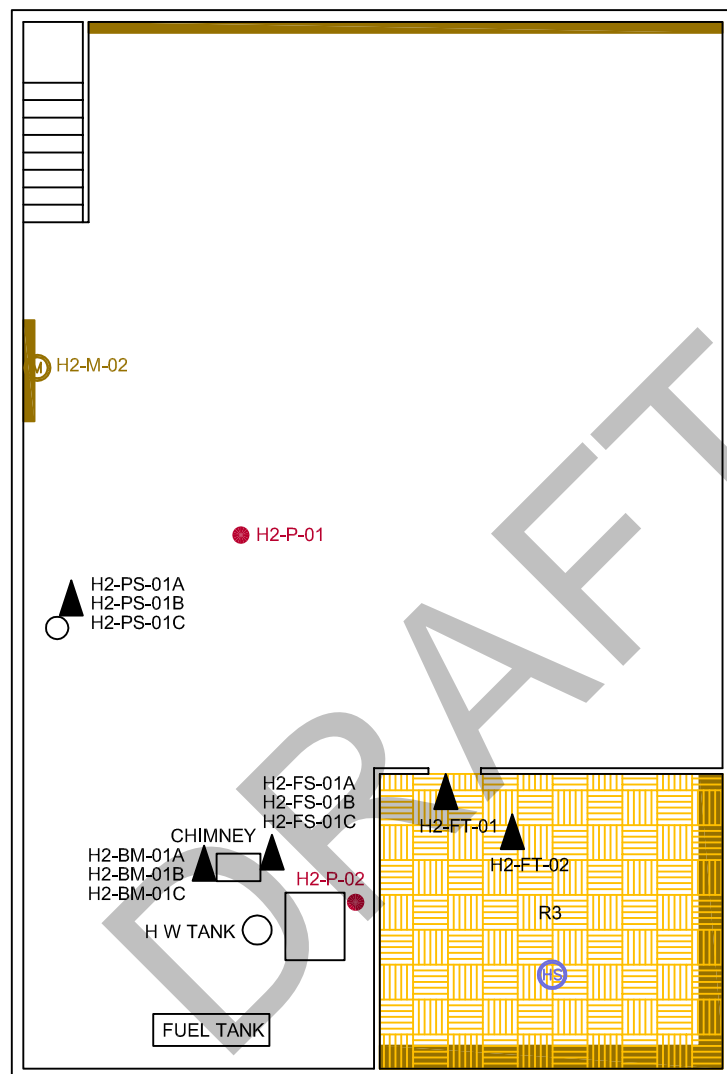
HOUSE 2
BASEMENT

- NOTES:**
1. GREY WINDOW PANE CAULKING BETWEEN WINDOW FRAMES AND GLASS PANES THROUGHOUT IS ACM.
 2. PIPE SEALANT IN CAST IRON BELL FITTINGS THROUGHOUT IS ACM.
 3. DRYWALL JOINT COMPOUND THROUGHOUT IS ACM.
 4. THIS DRAWING ILLUSTRATES SUPPORTING INFORMATION SPECIFIC TO A STANTEC CONSULTING LTD. REPORT AND MUST NOT BE USED FOR OTHER PURPOSES.

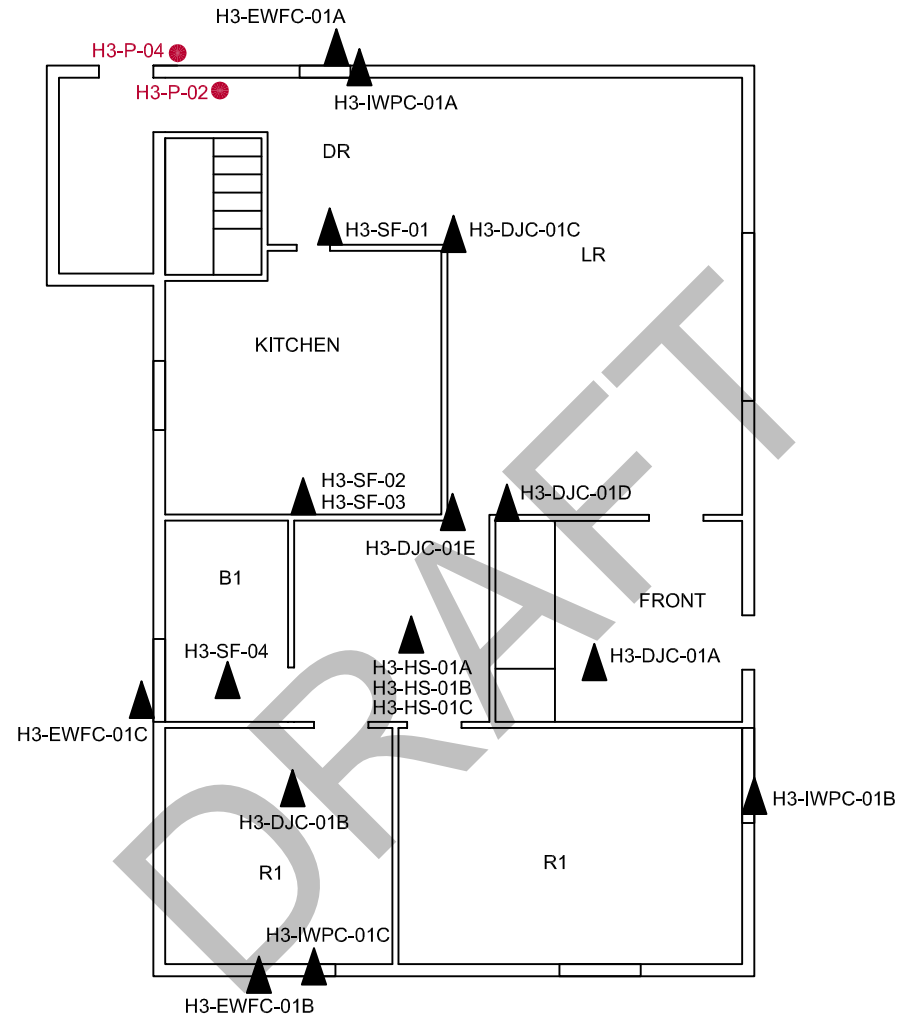
HOUSE 3 MAIN FLOOR

NOTES: 1. DRYWALL JOINT COMPOUND THROUGHOUT IS ACM.
2. GREY WINDOW PANE CAULKING BETWEEN WINDOW FRAMES AND GLASS PANES THROUGHOUT IS ACM.
3. THIS DRAWING ILLUSTRATES SUPPORTING INFORMATION SPECIFIC TO A STANTEC CONSULTING LTD. REPORT AND MUST NOT BE USED FOR OTHER PURPOSES.

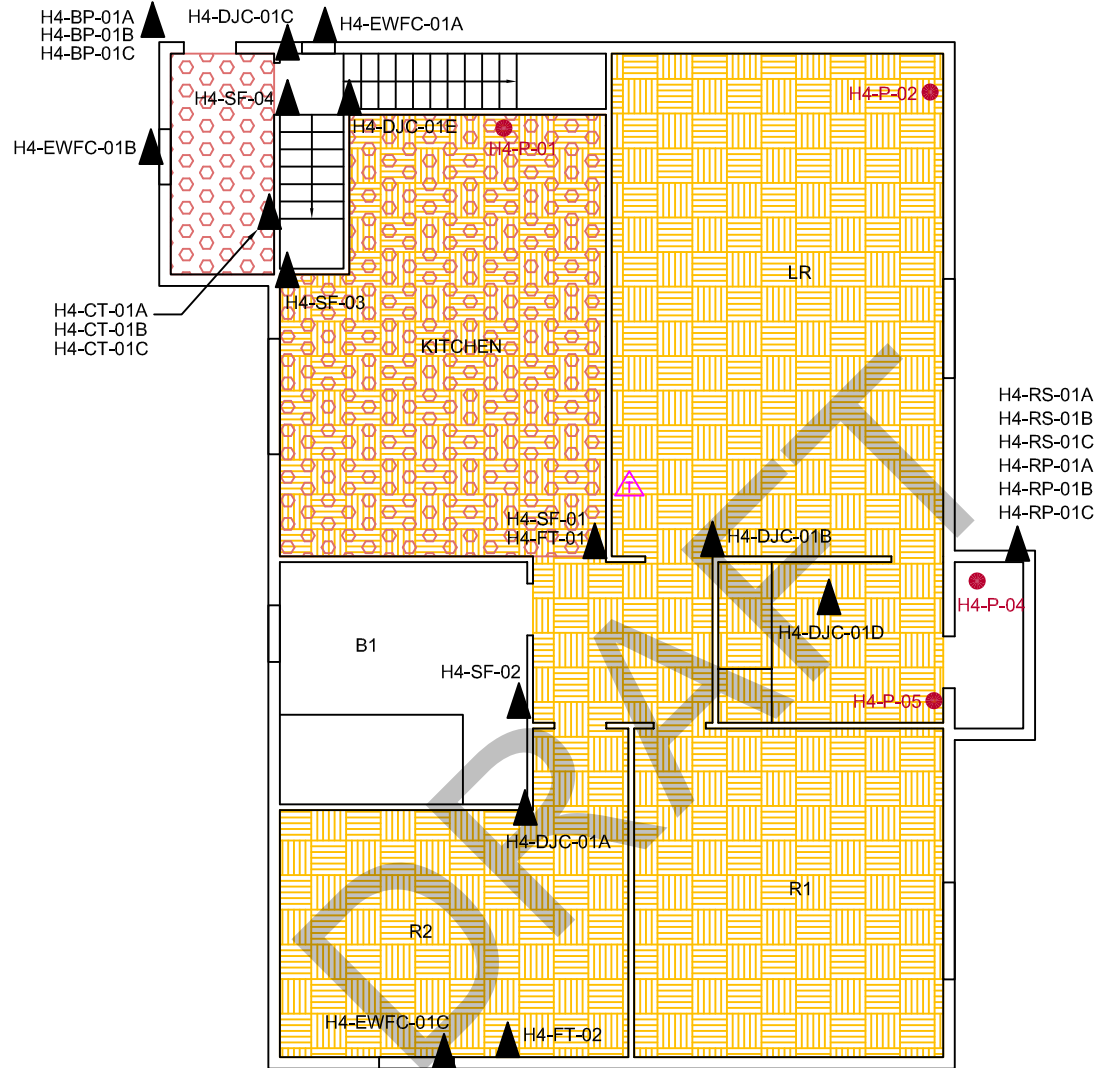
HOUSE 4
MAIN FLOOR

- NOTES:**
1. WHITE WOVEN TAPE ON SEAMS OF FURNACE DUCTING THROUGHOUT IS ACM.
 2. WHITE DUCT SHIELDS ON WOODEN JOISTS ABOVE FURNACE DUCTING IS ACM.
 3. BROWN WINDOW FRAME CAULKING BETWEEN WINDOW FRAMES AND EXTERIOR OF THE BUILDING IS ACM.
 4. DRYWALL JOINT COMPOUND THROUGHOUT IS ACM.
 5. THIS DRAWING ILLUSTRATES SUPPORTING INFORMATION SPECIFIC TO A STANTEC CONSULTING LTD. REPORT AND MUST NOT BE USED FOR OTHER PURPOSES.

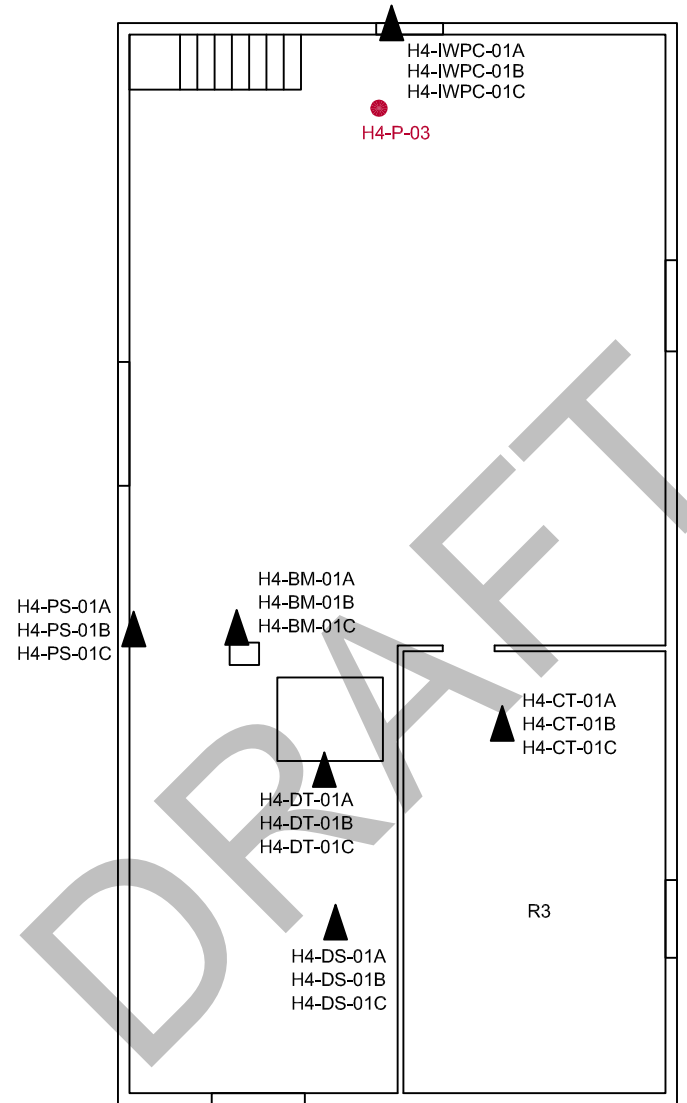
HOUSE 4 BASEMENT

- NOTES:**
1. WHITE WOVEN TAPE ON SEAMS OF FURNACE DUCTING THROUGHOUT IS ACM.
 2. WHITE DUCT SHIELDS ON WOODEN JOISTS ABOVE FURNACE DUCTING IS ACM.
 3. BROWN WINDOW FRAME CAULKING BETWEEN WINDOW FRAMES AND EXTERIOR OF THE BUILDING IS ACM.
 4. DRYWALL JOINT COMPOUND THROUGHOUT IS ACM.
 5. THIS DRAWING ILLUSTRATES SUPPORTING INFORMATION SPECIFIC TO A STANTEC CONSULTING LTD. REPORT AND MUST NOT BE USED FOR OTHER PURPOSES.
