PUBLIC SERVICES AND PROCUREMENT CANADA

KINGSTON MILLS LOCKS 46 TO 49 REHABILITATION INVESTIGATIVE GEOTECHNICAL REPORT

JUNE 27, 2018

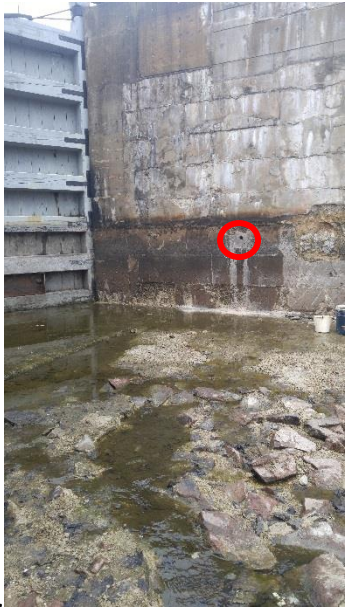
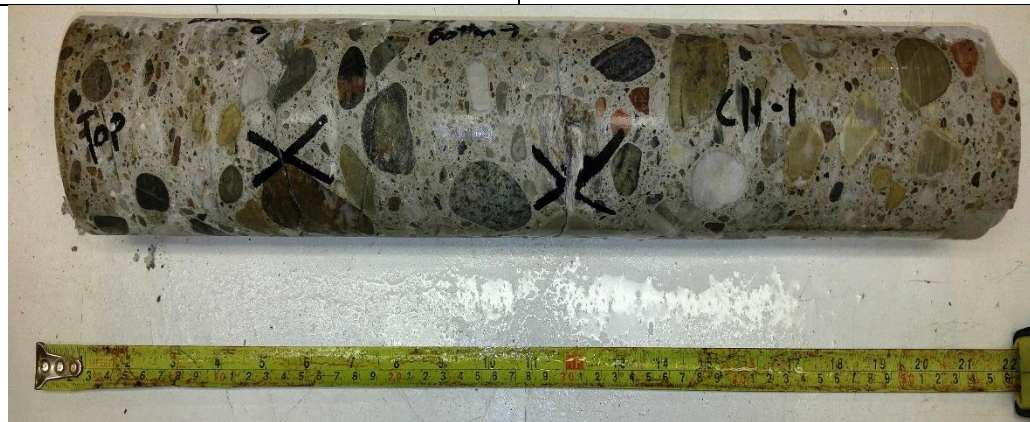
Core Location at East Pier

ID	CH 1
Date Cored	April 21, 2017
Lock	46
Location	Pier
Section	46E-PIE10
Direction Core Extracted	Horizontal
Tested	No
Total Hole Depth	490 mm
General Notes: Concrete 0 – 490 mm

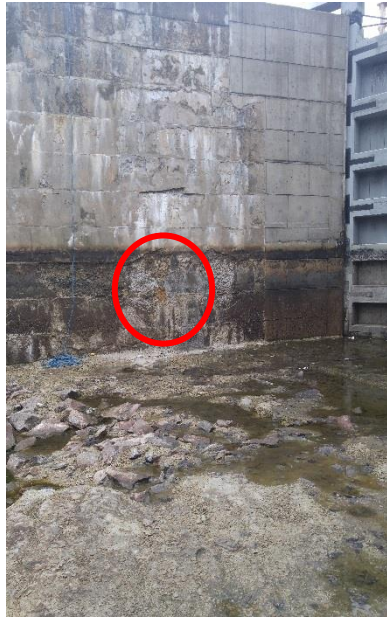
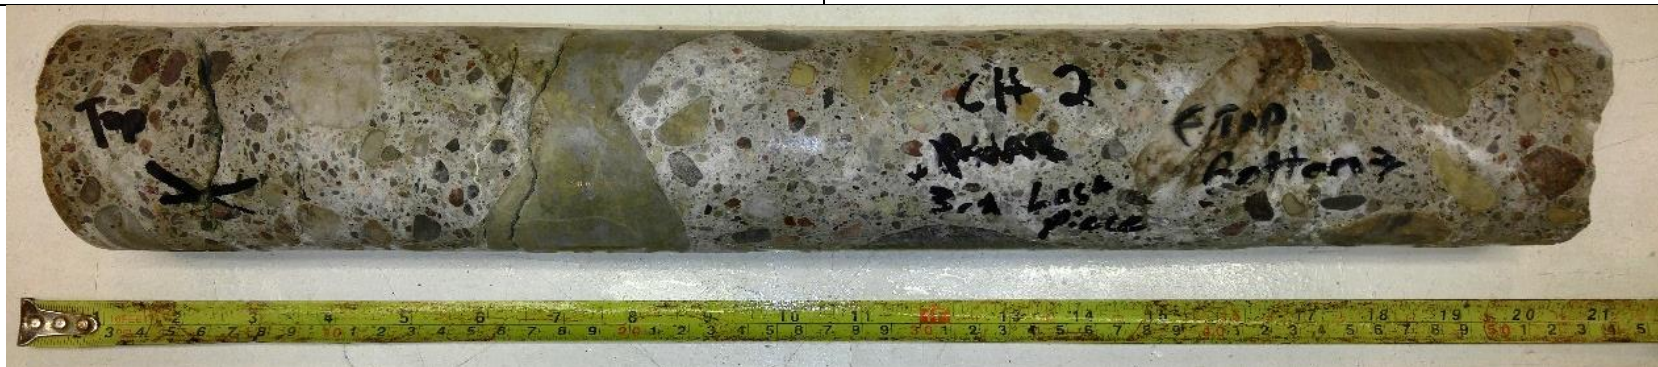
Core Location at West Pier

ID	CH 2
Date Cored	April 21, 2017
Lock	46
Location	Pier
Section	46W-PIE9
Direction Core Extracted	Horizontal
Tested	No
Total Hole Depth	470 mm
General Notes: 0 – 470 mm

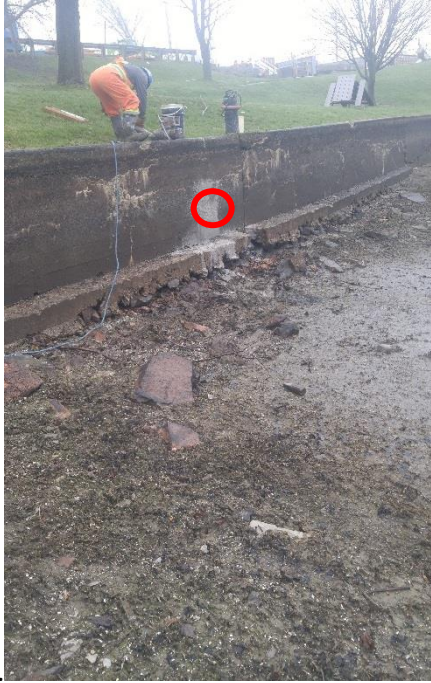
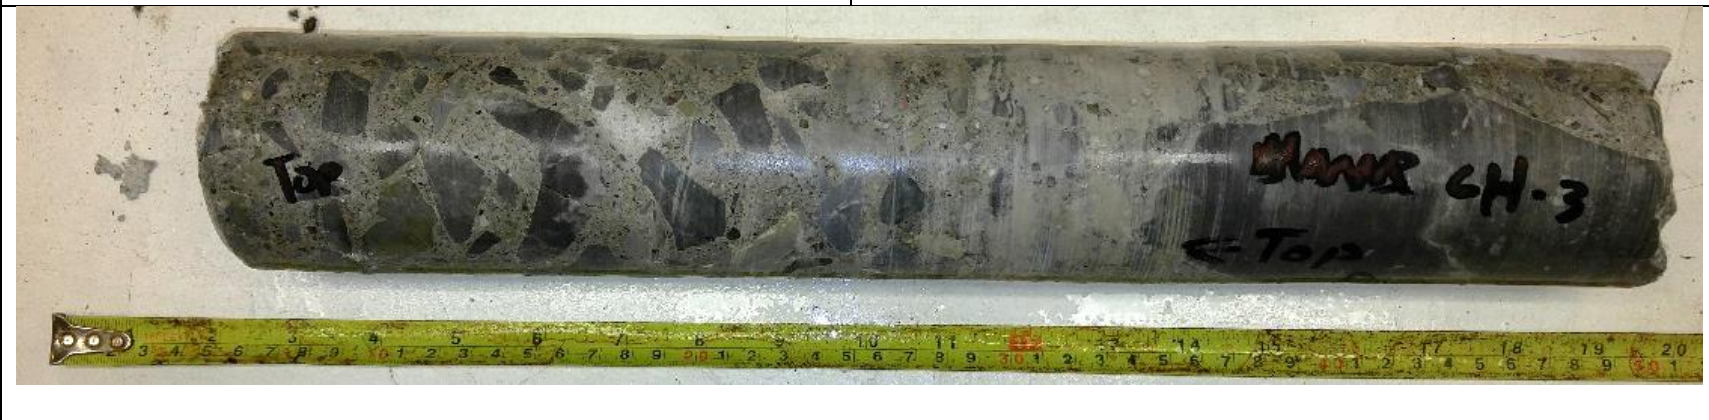
Core Location at North Basin Wall

ID	CH 3
Date Cored	April 21, 2017
Lock	Turning Basin
Location	Basin Wall
Section	BAS-NBW1
Direction Core Extracted	Horizontal
Tested	No
Total Hole Depth	410 mm
General Notes: Concrete 0 -410 mm

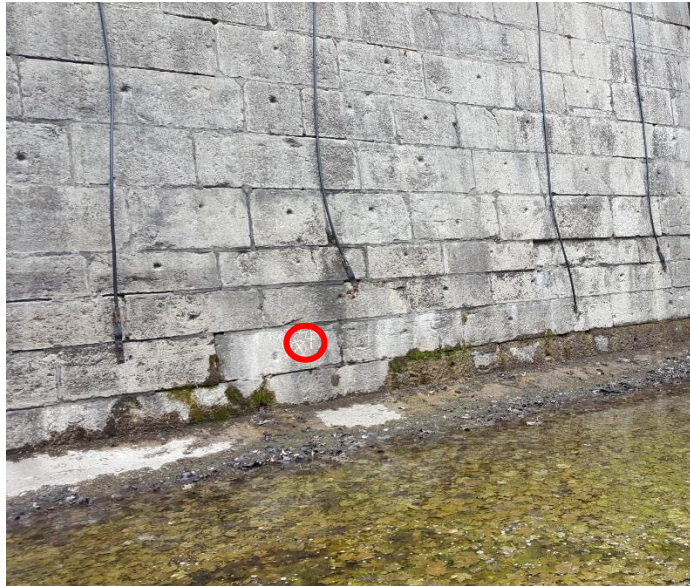
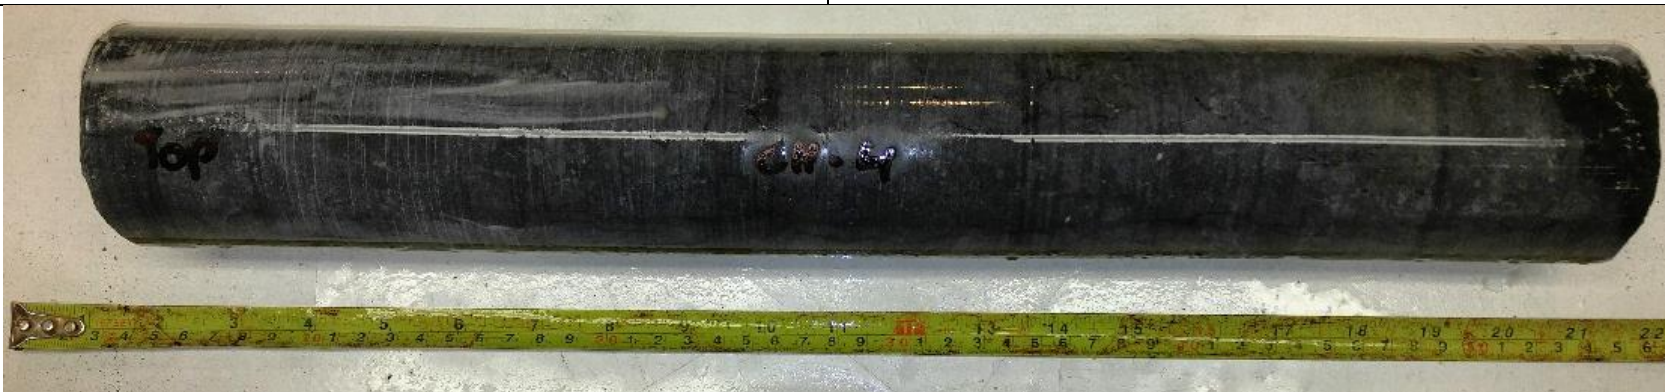
Core Location at West Chamber Wall

ID	CH 4
Date Cored	April 21, 2017
Lock	47
Location	Chamber Wall
Section	47W-CHW2
Direction Core Extracted	Horizontal
Tested	No
Total Hole Depth	470 mm
General Notes: Limestone 0 – 470 mm

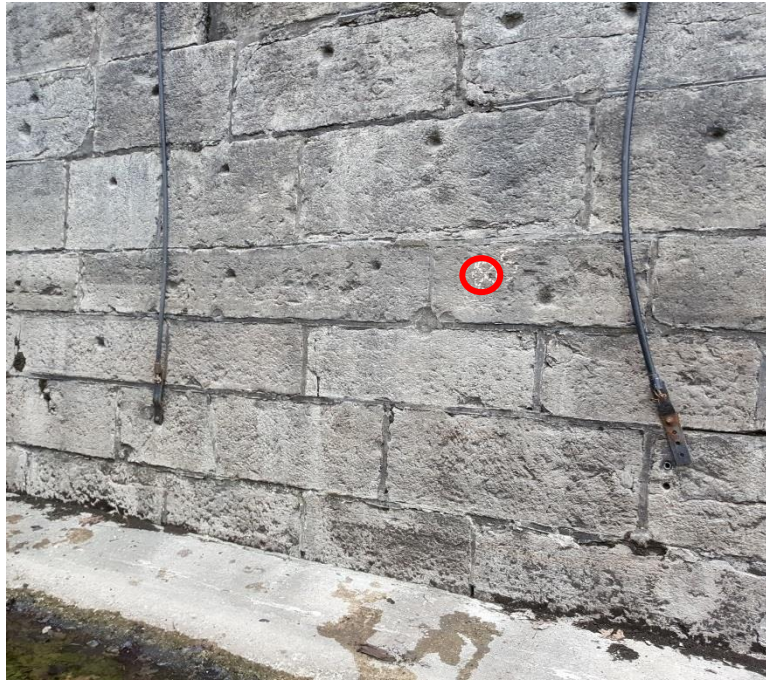
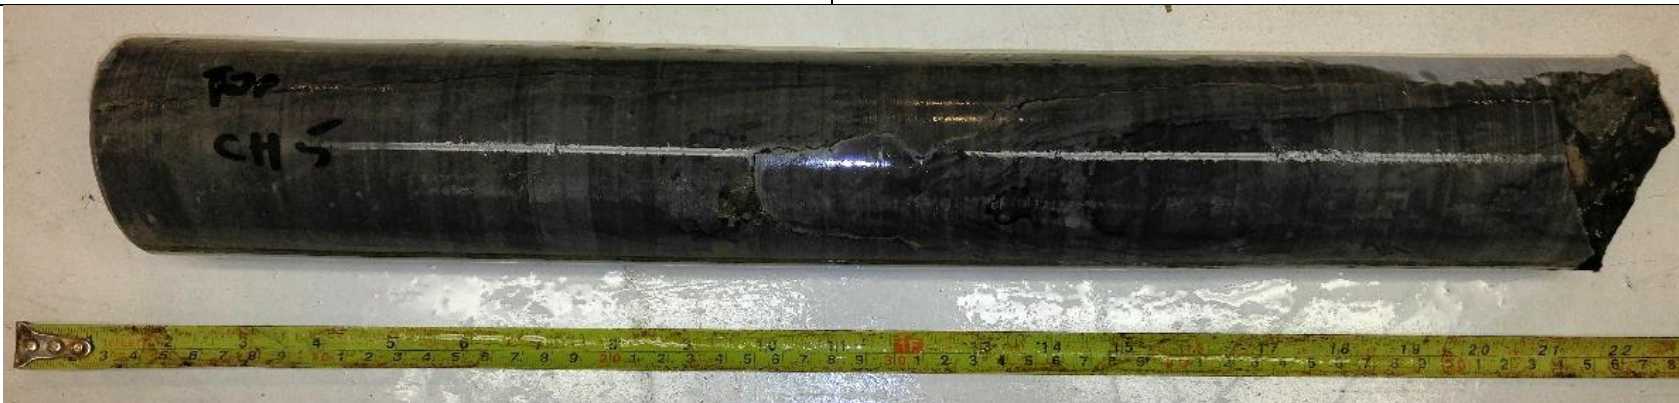
Core Location at West Chamber Wall

ID	CH 5
Date Cored	April 21, 2017
Lock	47
Location	Chamber Wall
Section	47W-CHW1
Direction Core Extracted	Horizontal
Tested	Yes
Total Hole Depth	480 mm
General Notes: Limestone 0 – 480 mm

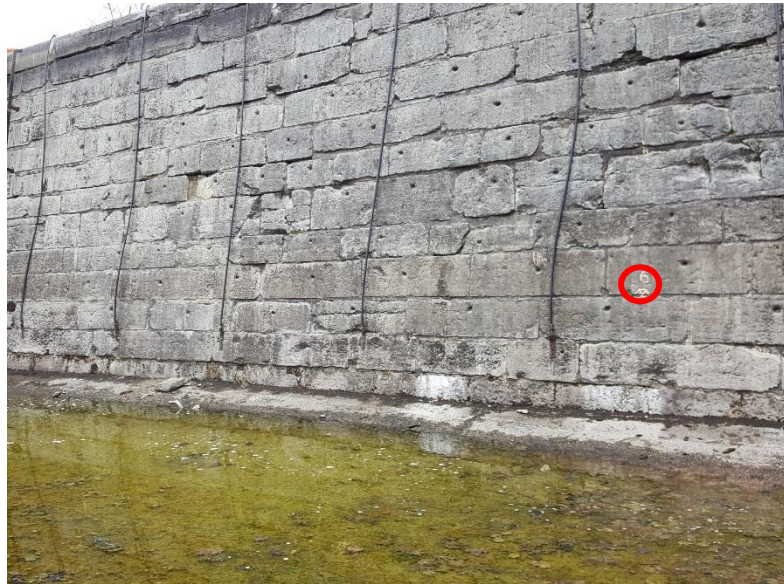
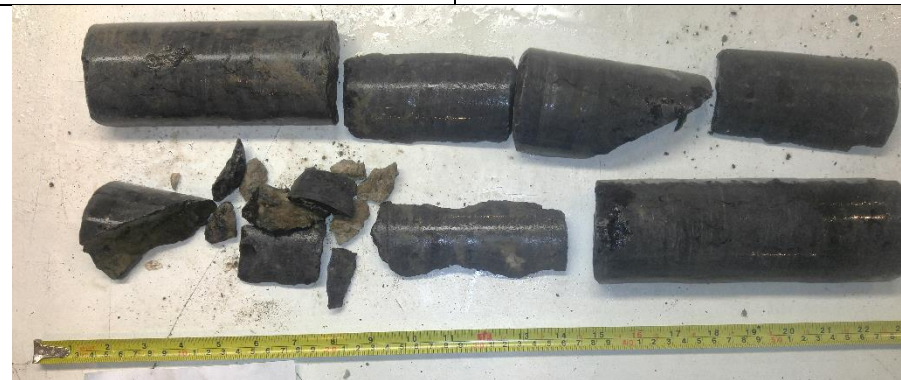
Core Location at East Chamber Wall

ID	CH 6
Date Cored	April 21, 2017
Lock	47
Location	Chamber Wall
Section	47E-CHW1
Direction Core Extracted	Horizontal
Tested	No
Total Hole Depth	500 mm
General Notes: Limestone 0 – 500 mm

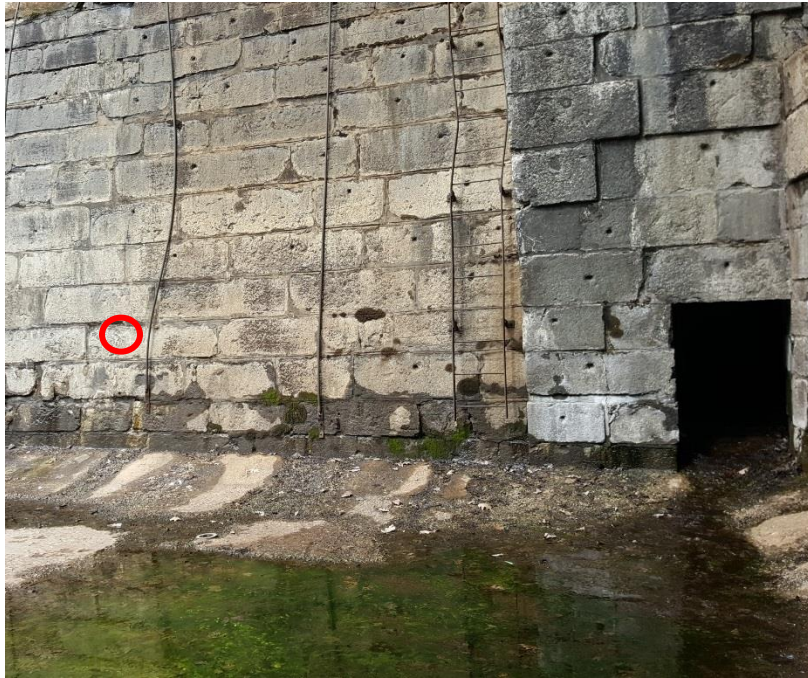
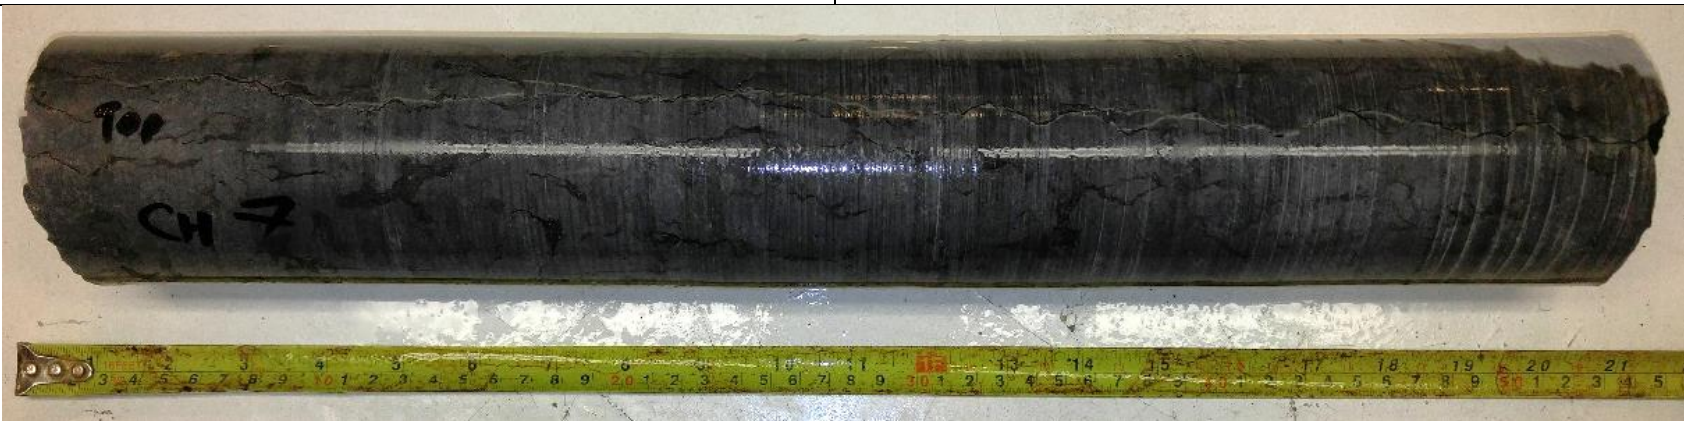
Core Location at West Chamber Wall

ID	CH 7
Date Cored	April 21, 2017
Lock	Chamber Wall
Location	48
Section	Chamber Wall
Direction Core Extracted	Horizontal
Tested	No
Total Hole Depth	480 mm
General Notes: Limestone 0 – 480 mm

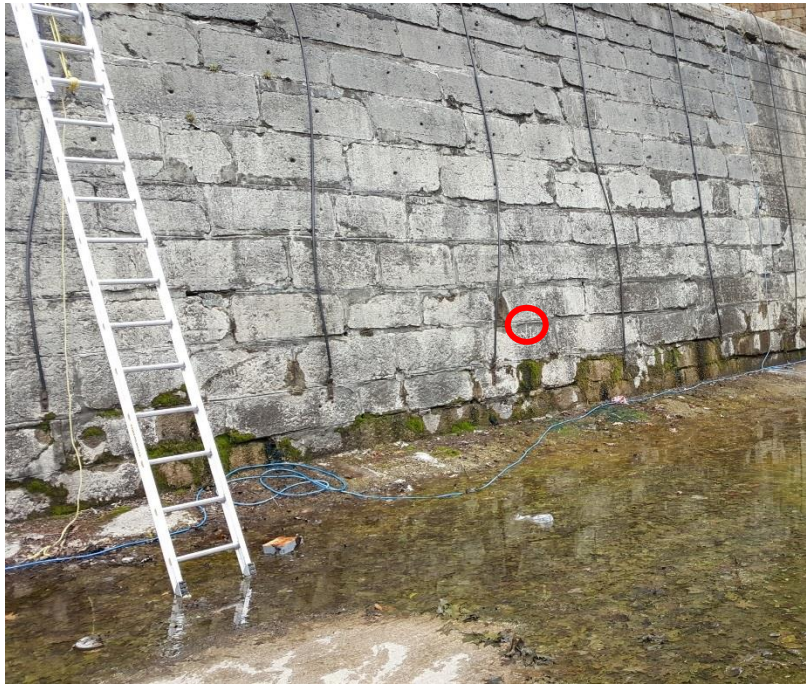
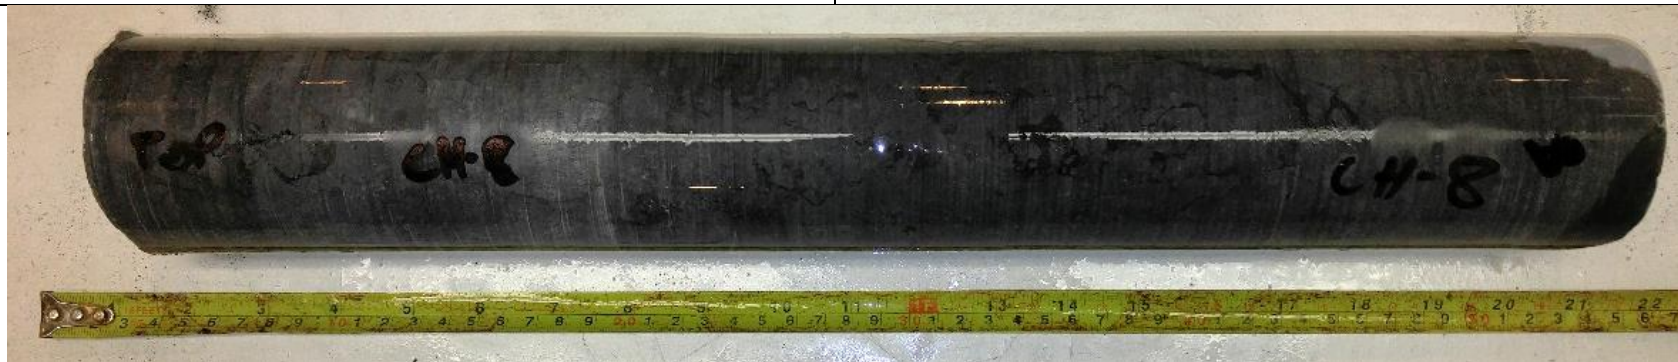
Core Location at West Chamber Wall

ID	CH 8
Date Cored	April 21, 2017
Lock	48
Location	Chamber Wall
Section	48W-CHW1
Direction Core Extracted	Horizontal
Tested	Yes
Total Hole Depth	480 mm
General Notes: Limestone 0 – 480 mm

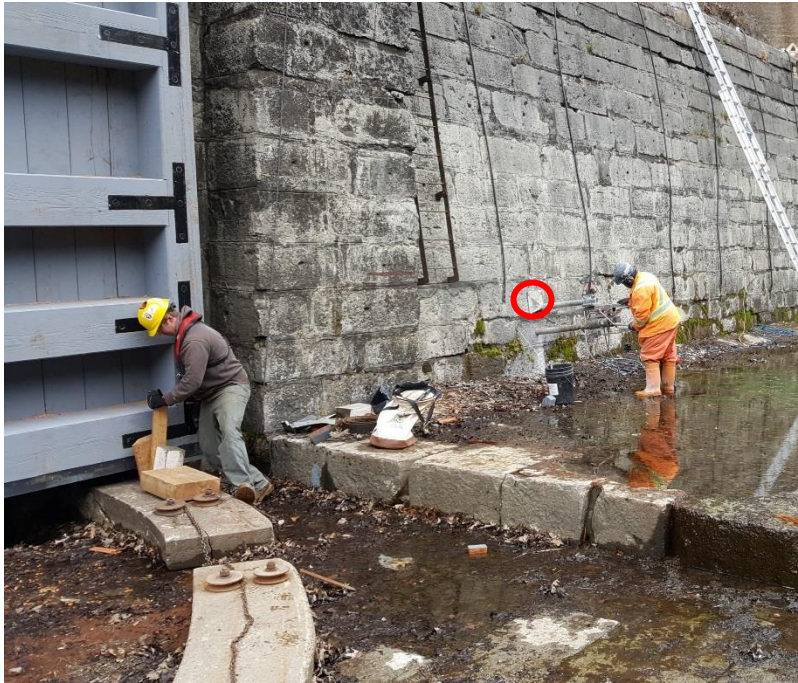
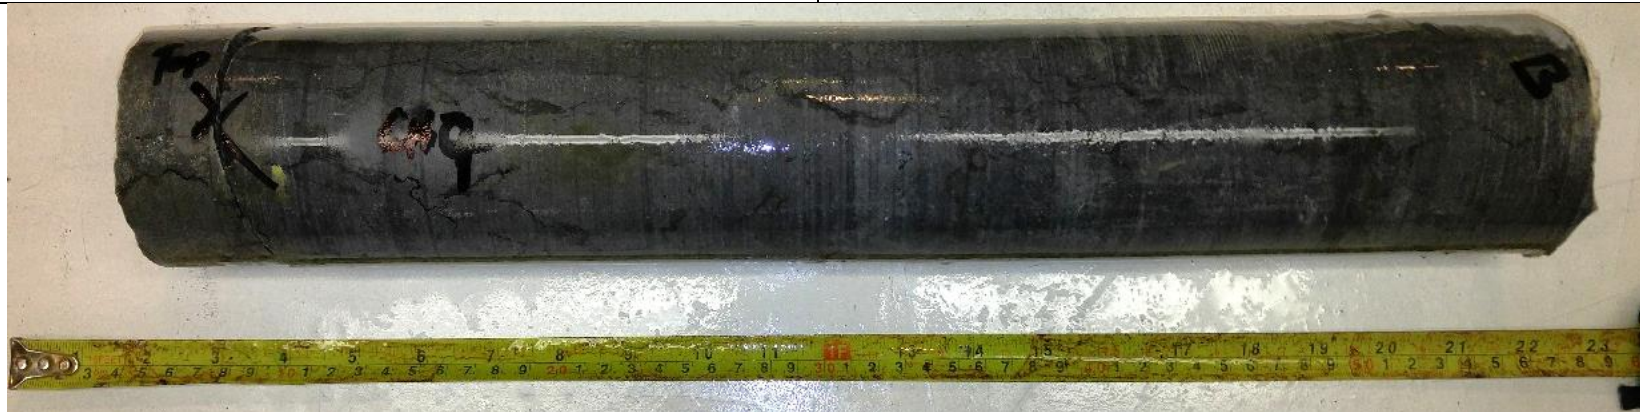
Core Location at West Chamber Wall

ID	CH 9
Date Cored	April 21, 2017
Lock	48
Location	Chamber Wall
Section	48W-CHW1
Direction Core Extracted	Horizontal
Tested	Yes
Total Hole Depth	480 mm
General Notes: Limestone 0 – 480 mm

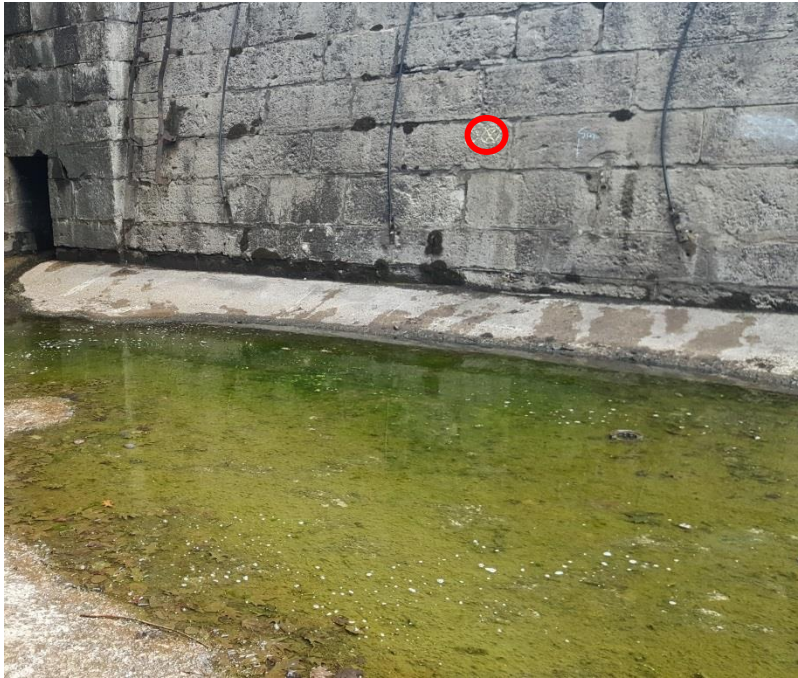
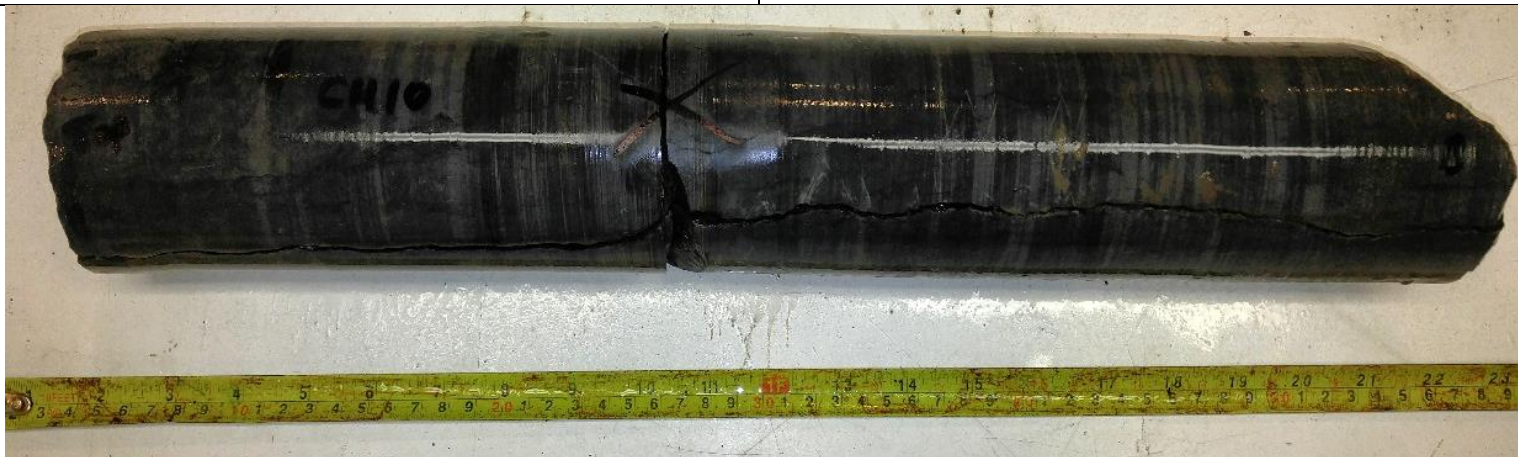
Core Location at East Chamber Wall

ID	CH 10
Date Cored	April 21, 2017
Lock	48
Location	Chamber Wall
Section	48E-CHW1
Direction Core Extracted	Horizontal
Tested	No
Total Hole Depth	480 mm
General Notes: Limestone 0 – 480 mm

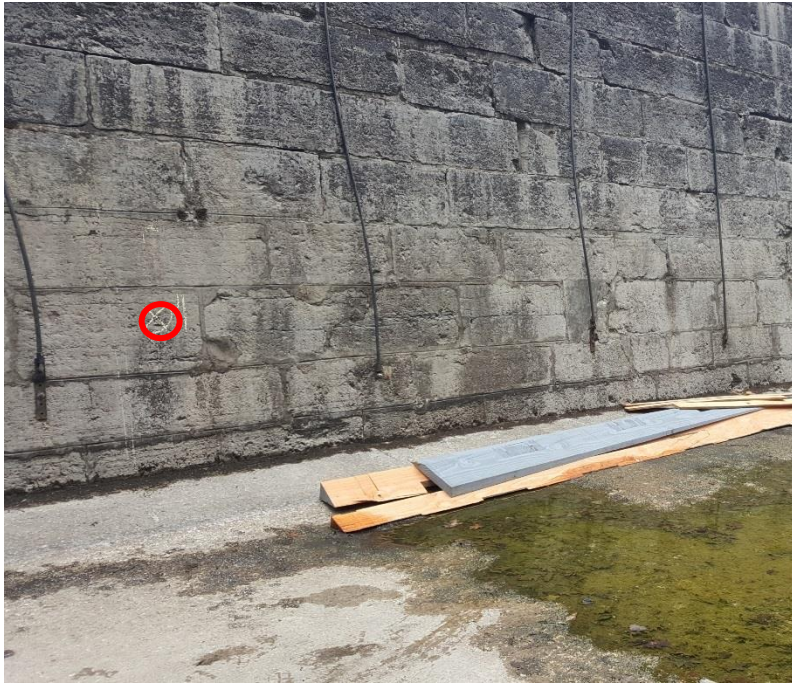
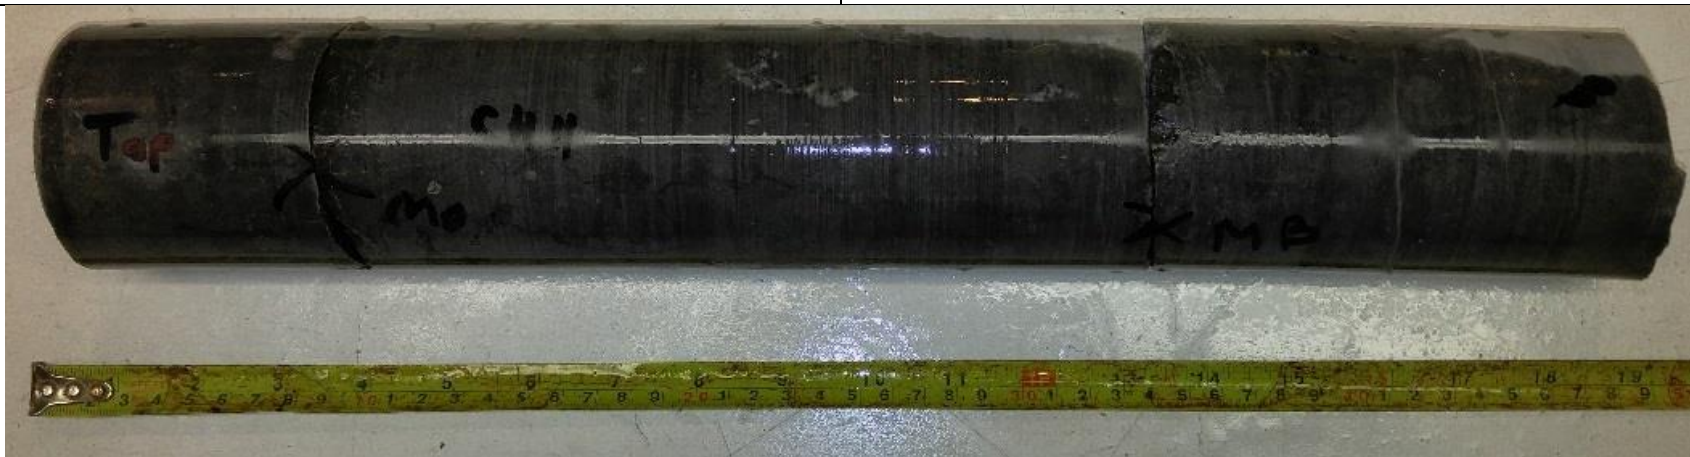
Core Location at East Chamber Wall

ID	CH 11
Date Cored	April 21, 2017
Lock	48
Location	Chamber Wall
Section	48E-CHW2
Direction Core Extracted	Horizontal
Tested	Yes
Total Hole Depth	440 mm
General Notes: Limestone 0 – 440 mm

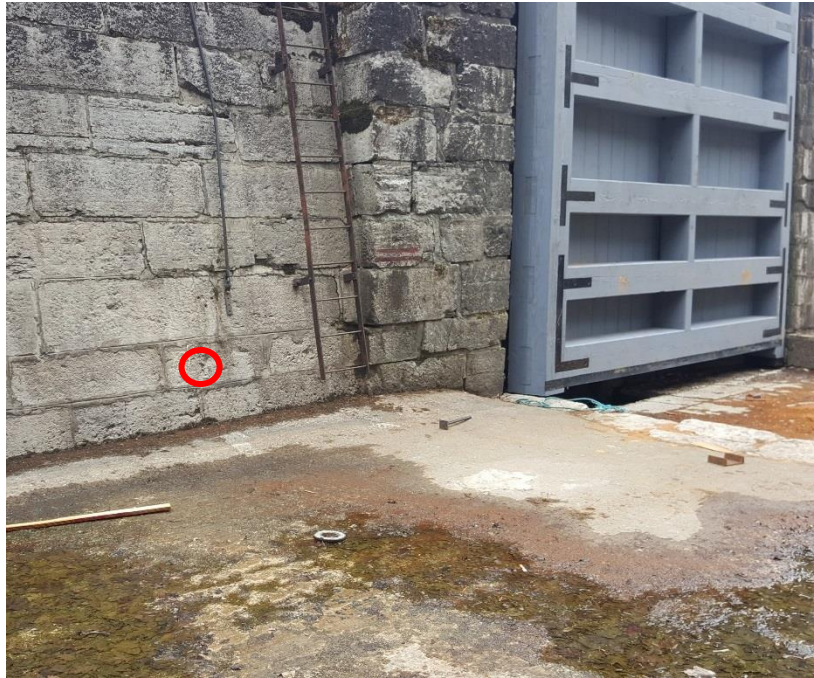
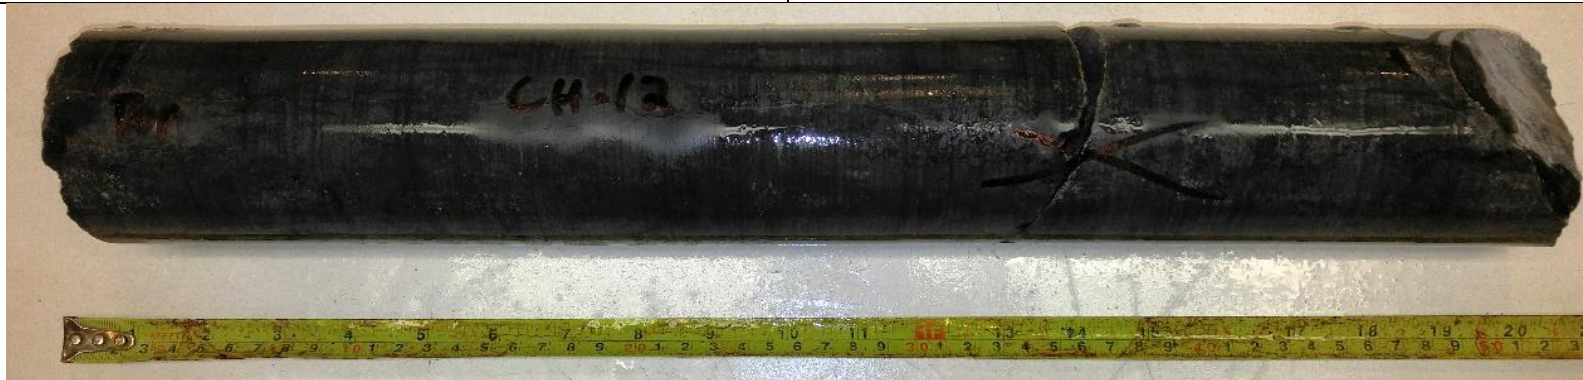
Core Location at East Chamber Wall

ID	CH 12
Date Cored	April 21, 2017
Lock	48
Location	Chamber Wall
Section	48E-CHW2
Direction Core Extracted	Horizontal
Tested	Yes
Total Hole Depth	480 mm
General Notes: Limestone 0 – 480 mm

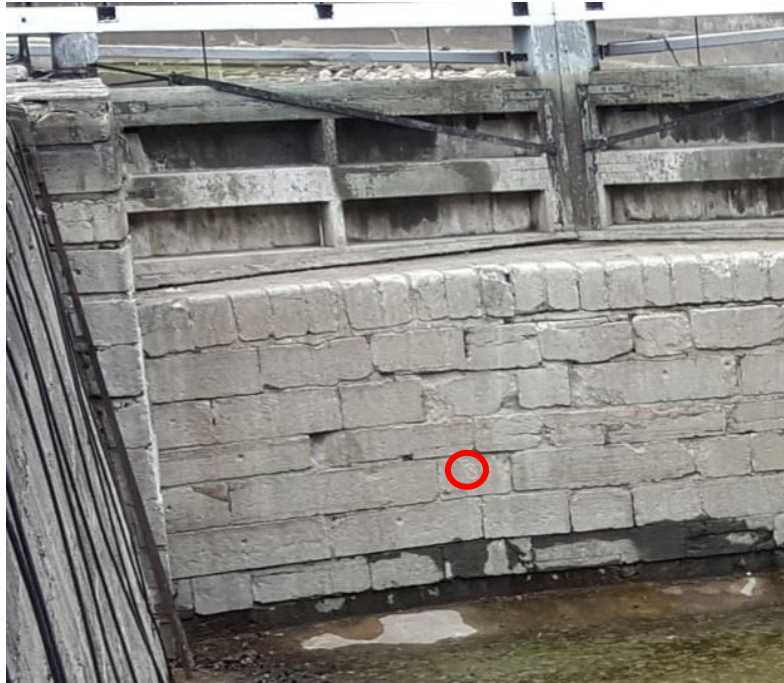
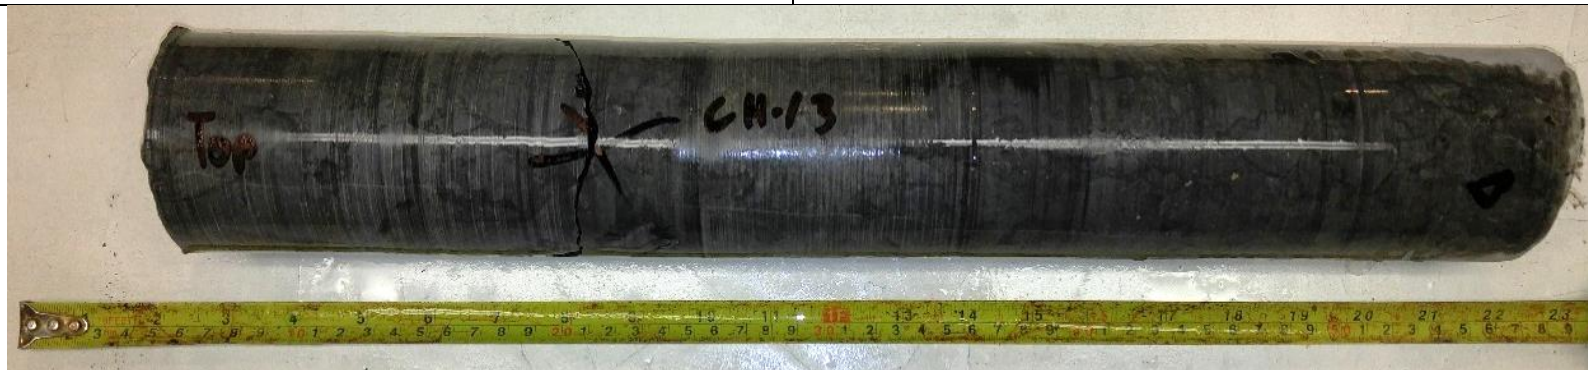
Core Location at Breast Wall

ID	CH 13
Date Cored	April 21, 2017
Lock	47
Location	Breast Wall
Section	47-BRE4
Direction Core Extracted	Horizontal
Tested	No
Total Hole Depth	480 mm
General Notes: Limestone 0 – 480 mm

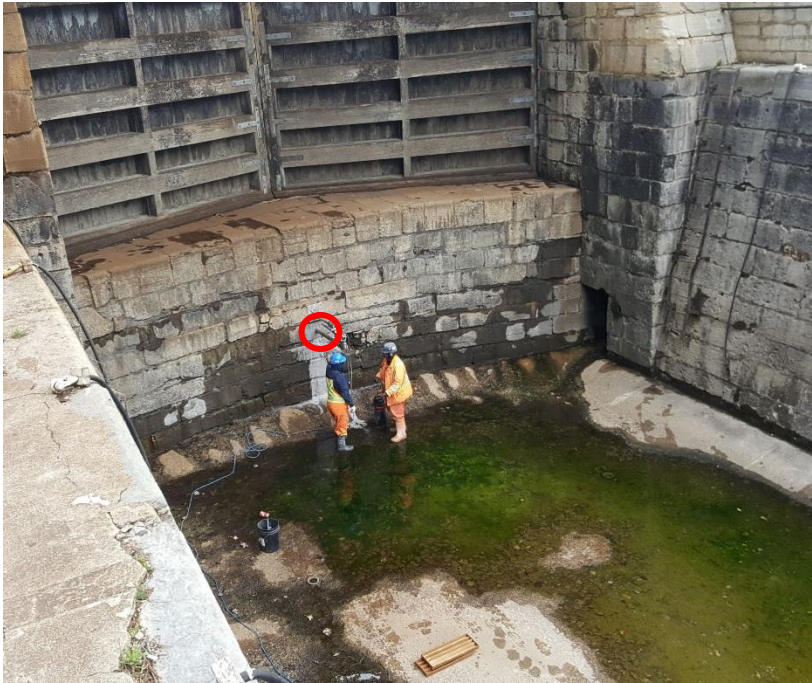
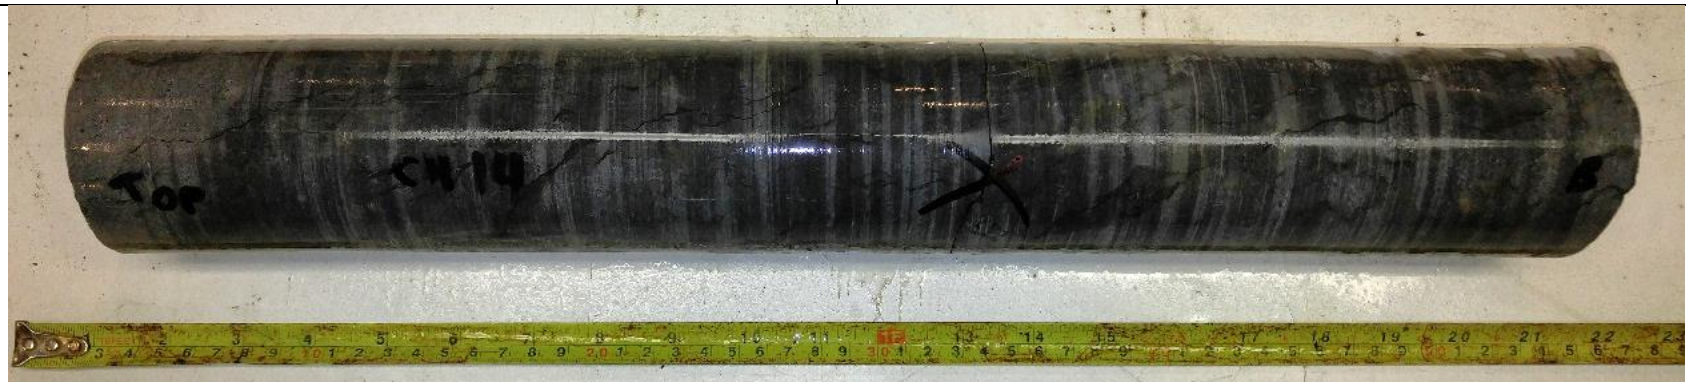
Core Location at Breast Wall

ID	CH 14
Date Cored	April 21, 2017
Lock	48
Location	Breast Wall
Section	48-BRE3
Direction Core Extracted	Horizontal
Tested	Yes
Total Hole Depth	480 mm
General Notes: Limestone 0 – 480 mm

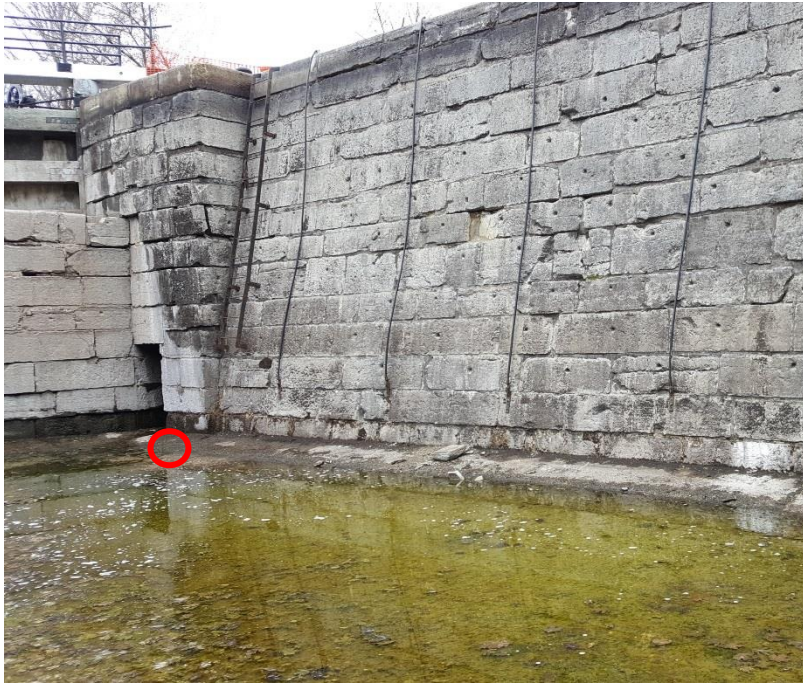
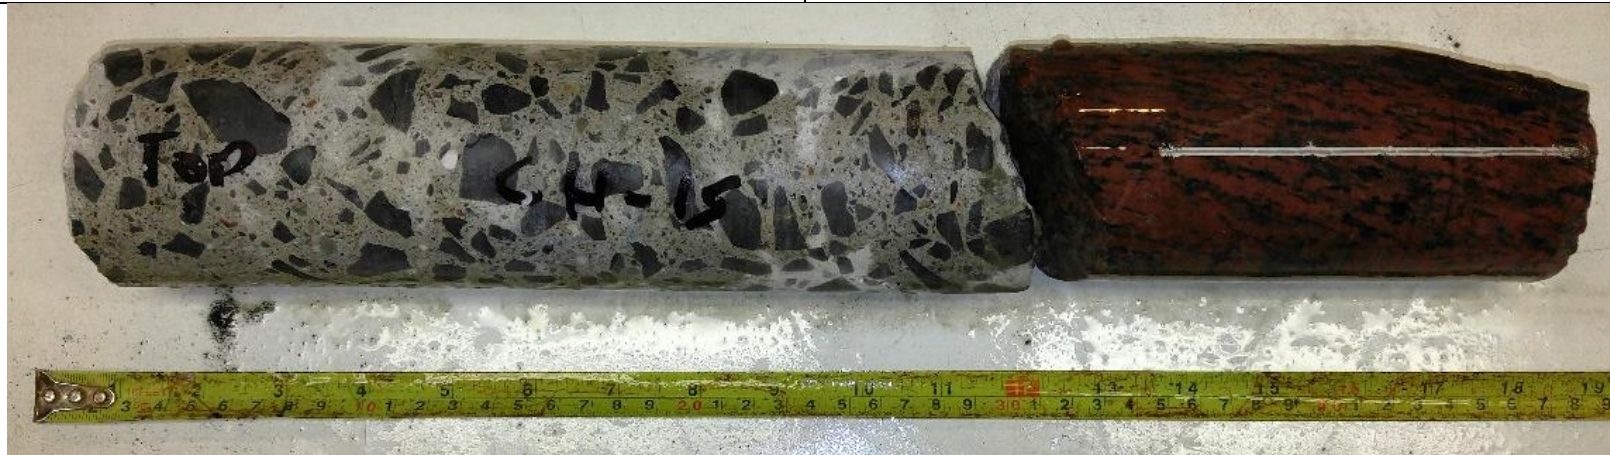
Core Location at Lock Floor

ID	CH 15
Date Cored	April 21, 2017
Lock	47
Location	Floor
Section	47 FLR
Direction Core Extracted	Vertical
Tested	NO
Total Hole Depth	480 mm
General Notes: Concrete 0 – 270 mm Granite 0 – 480 mm

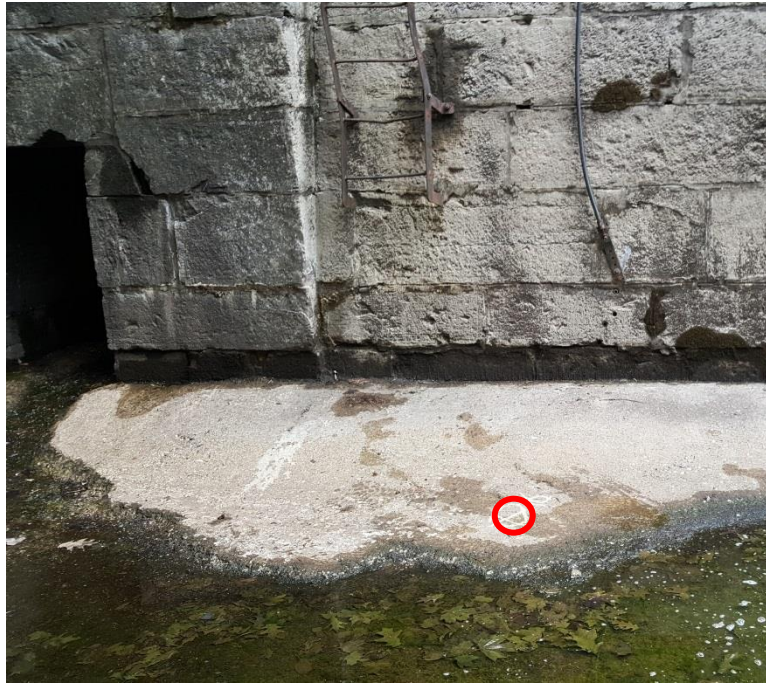
Core Location at Lock Floor

ID	CH 16
Date Cored	April 21, 2017
Lock	48
Location	Floor
Section	48 FLR
Direction Core Extracted	Vertical
Tested	No
Total Hole Depth	590 mm
General Notes:	
Concrete 0 -240 mm	
Granite 240 – 590 mm

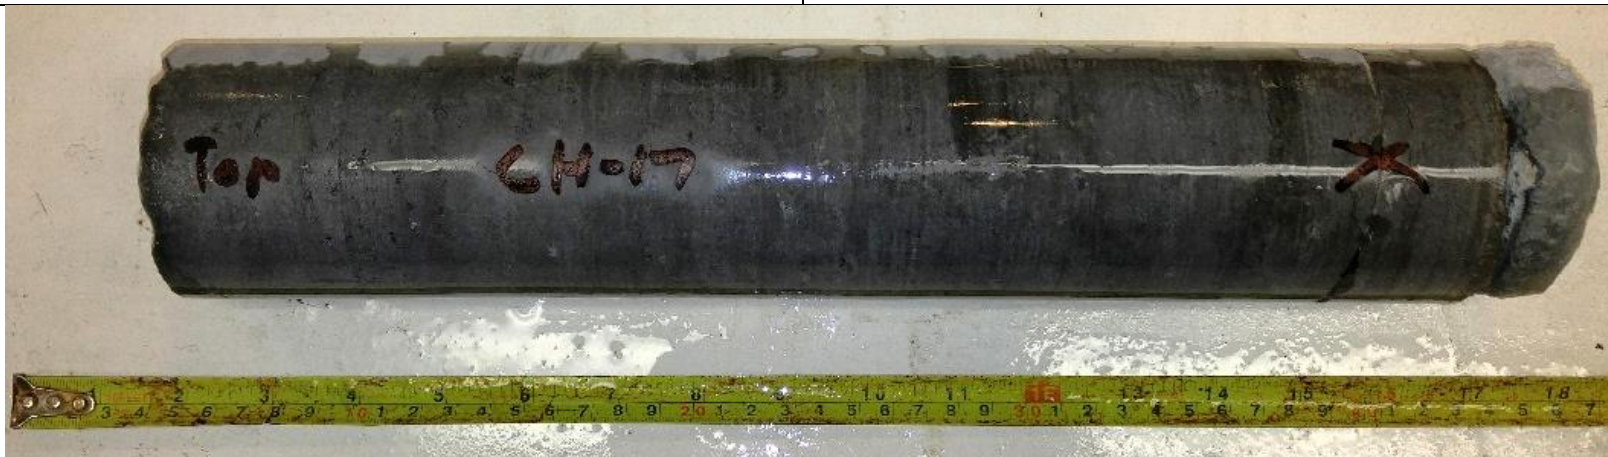
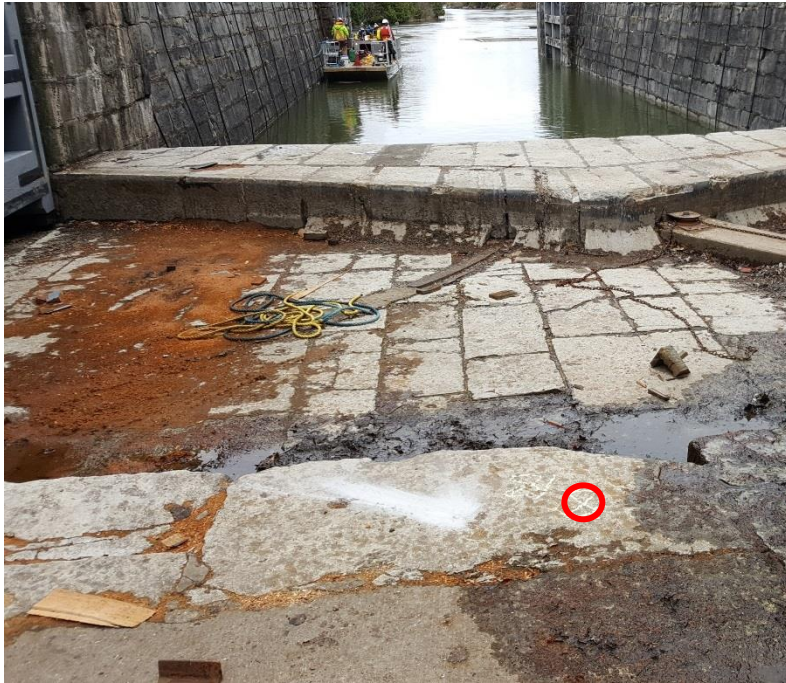
Core Location at Gate Recess Floor

ID	CH 17
Date Cored	April 21, 2017
Lock	47
Location	Gate Recess Floor
Section	47-GRF3
Direction Core Extracted	Vertical
Tested	Yes
Total Hole Depth	370
General Notes: Limestone 0 – 370 mm

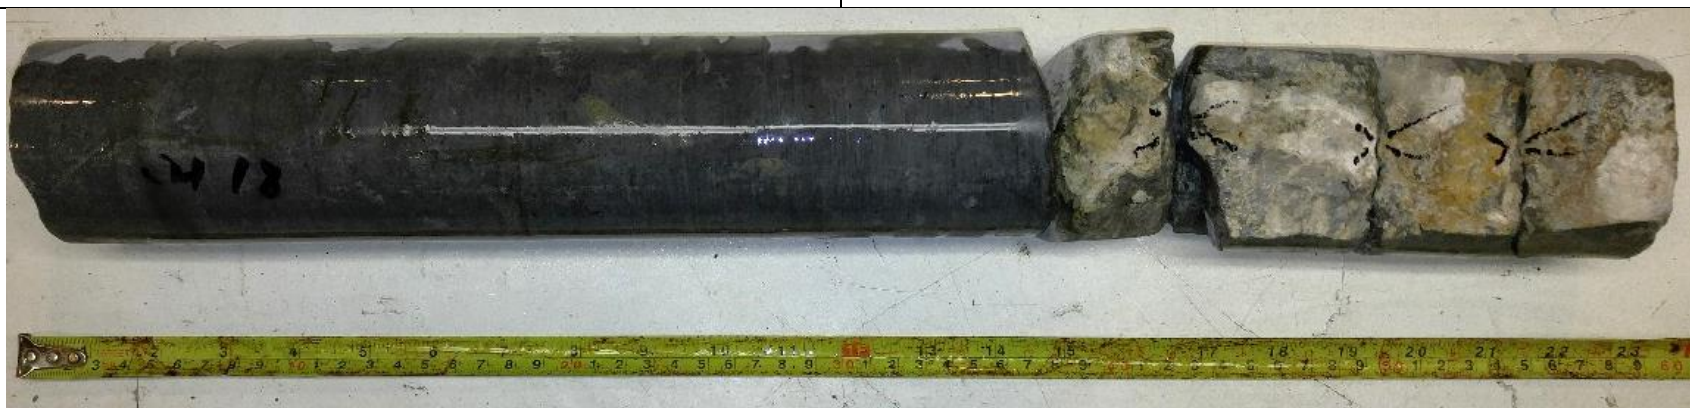
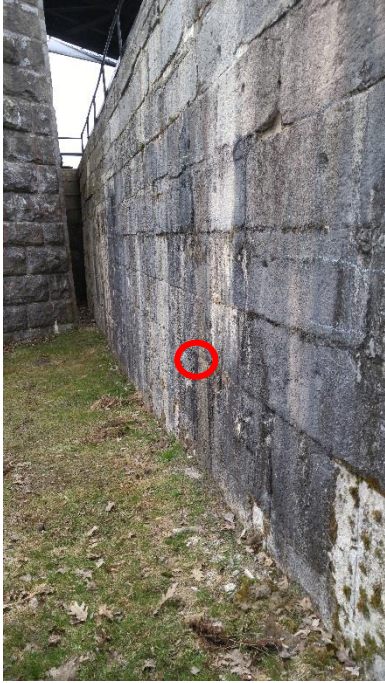
Core Location at Gate Recess Floor

ID	CH 18
Date Cored	April 21, 2017
Lock	48
Location	Gate Recess Floor
Section	48-GRF2
Direction Core Extracted	Vertical
Tested	Yes
Total Hole Depth	540 mm
General Notes: Limestone 0 – 540 mm

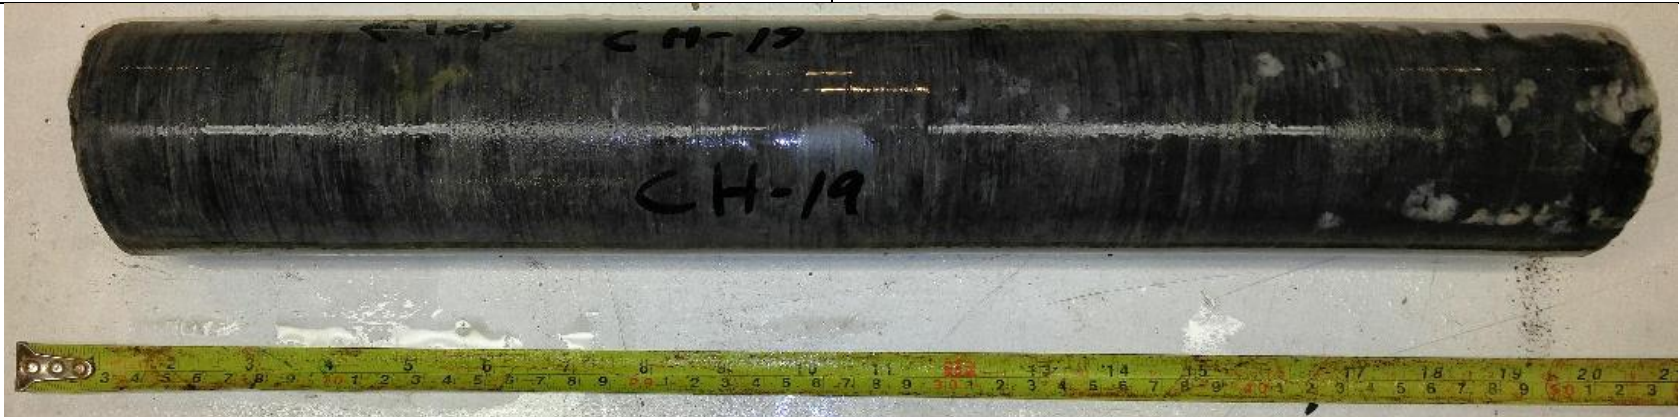
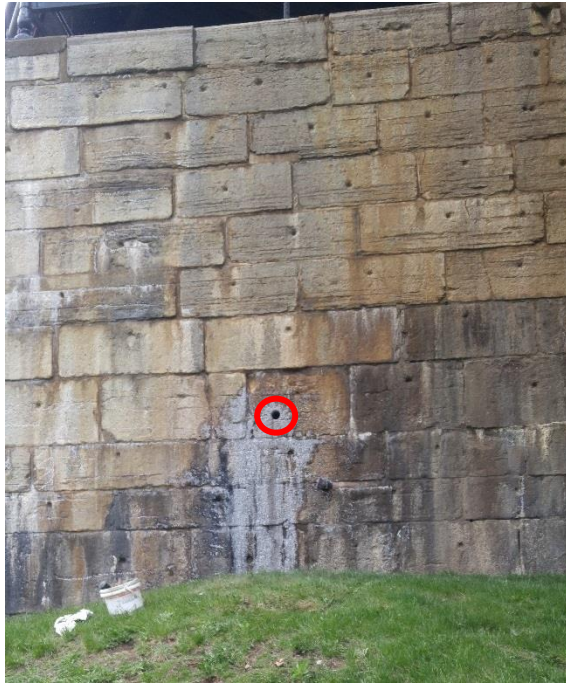
Core Location at East Chamber Wall

ID	CH 19
Date Cored	April 21, 2017
Lock	47
Location	Chamber Wall
Section	47E-CHW1
Direction Core Extracted	Horizontal
Tested	No
Total Hole Depth	440 mm
General Notes: Limestone 0 – 440 mm

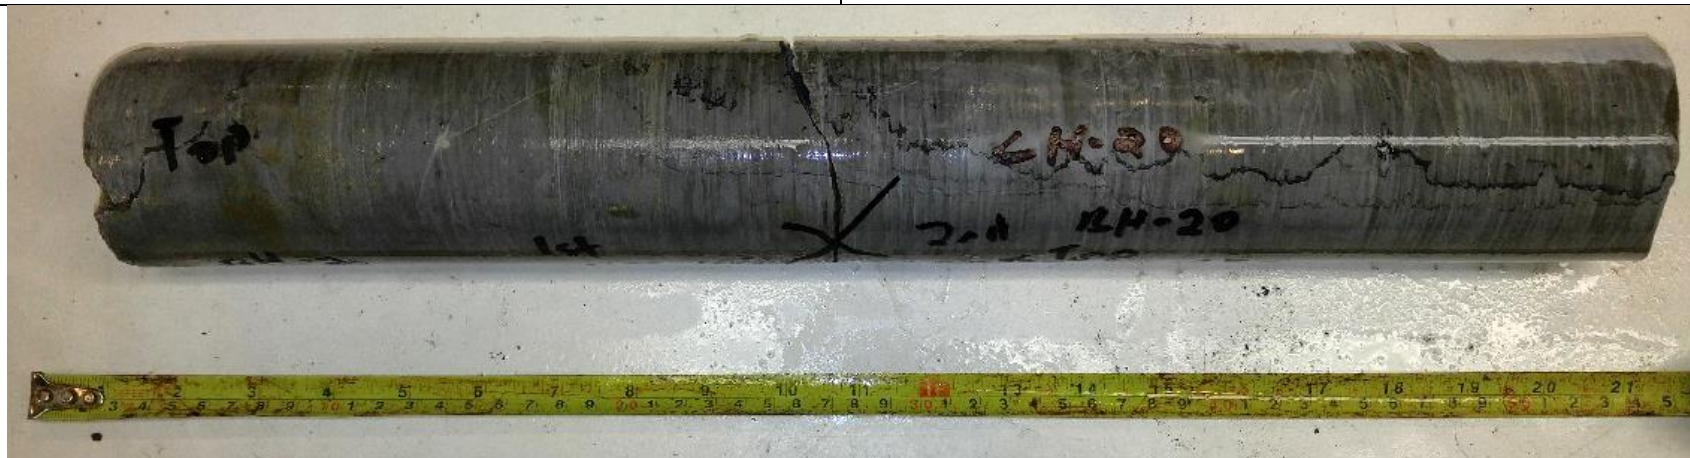
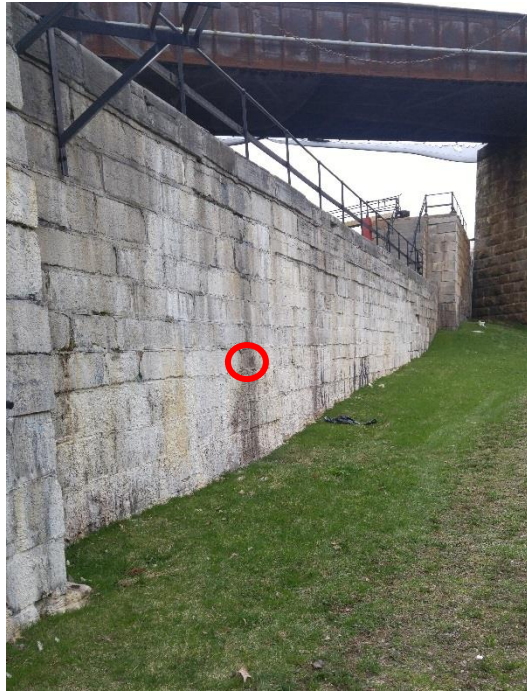
Core Location at East Pier

ID	CH 20
Date Cored	April 21, 2017
Lock	47
Location	Pier
Section	47E-PIE6
Direction Core Extracted	Horizontal
Tested	Yes
Total Hole Depth	480 mm
General Notes: Limestone 0 – 480 mm
