PUBLIC SERVICES AND PROCUREMENT CANADA

KINGSTON MILLS LOCKS 46 TO 49 REHABILITATION INVESTIGATIVE GEOTECHNICAL REPORT

JUNE 27, 2018

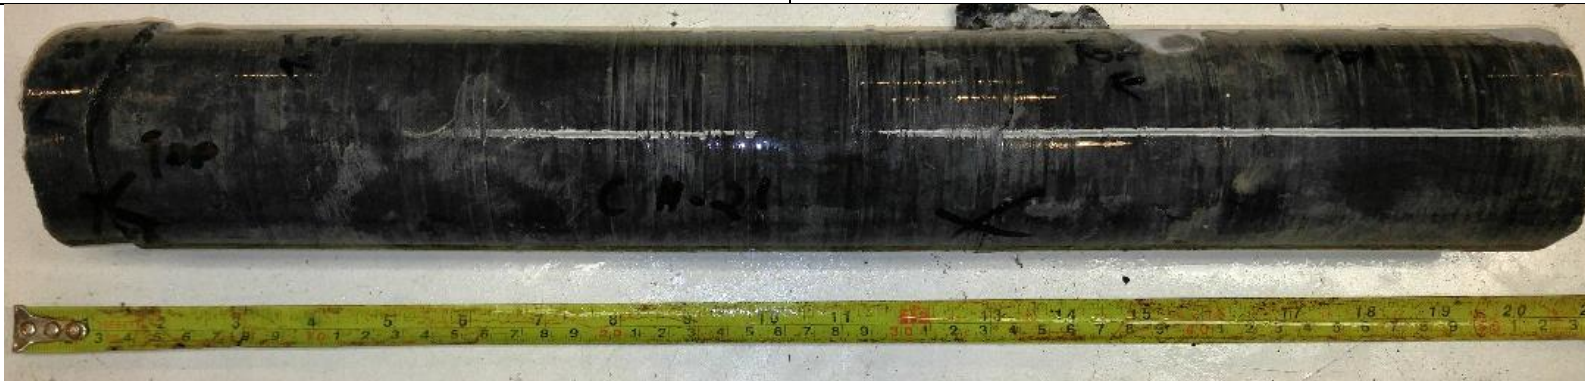
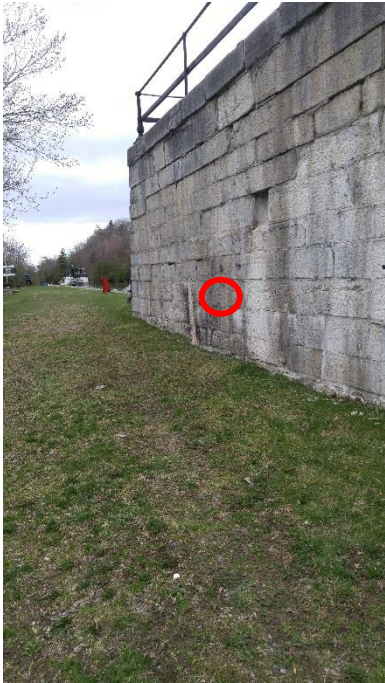
Core Location at East Chamber Wall

ID	CH 21
Date Cored	April 21, 2017
Lock	48
Location	Chamber Wall
Section	48E-CHW2
Direction Core Extracted	Horizontal
Tested	Yes
Total Hole Depth	470 mm
General Notes: Limestone 0 – 470 mm

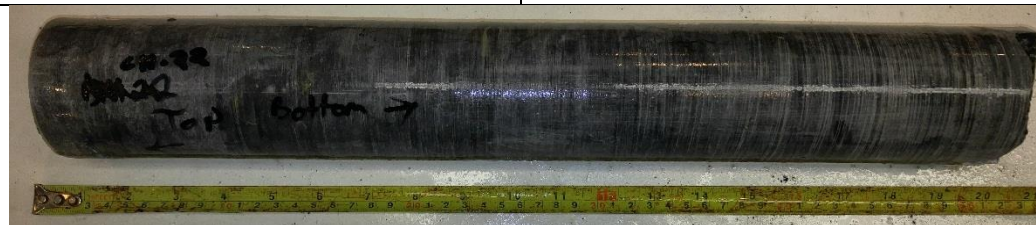
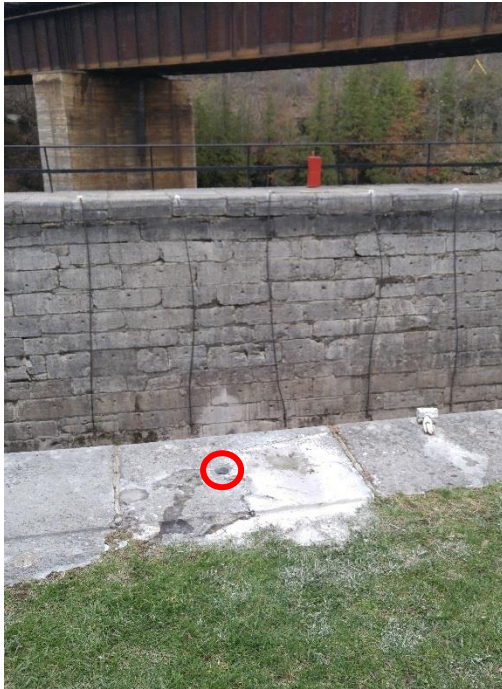
Core Location at West Gate Recess Wall

ID	CH 22
Date Cored	April 21, 2017
Lock	48
Location	Gate Recess Wall
Section	48E-GRW4
Direction Core Extracted	Horizontal
Tested	Yes
Total Hole Depth	480 mm
General Notes: Limestone 0 – 480 mm

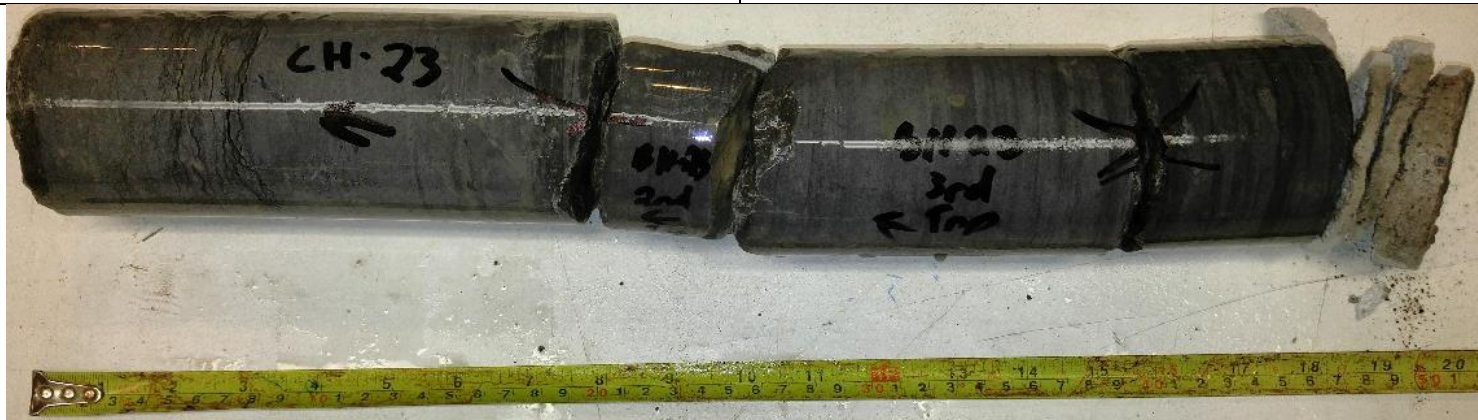
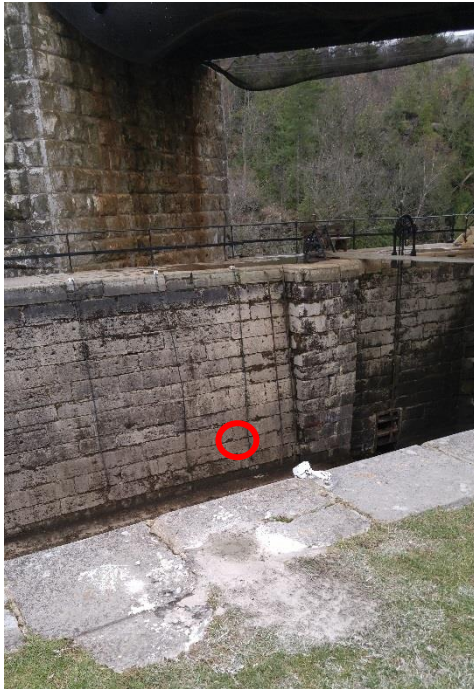
Core Location at West Chamber Wall

ID	CH 23
Date Cored	April 21, 2017
Lock	47
Location	Chamber Wall
Section	47W-CHW2
Direction Core Extracted	Vertical
Tested	Yes
Total Hole Depth	460 mm
General Notes:	
Limestone 0 – 420 mm	
Mortar 420 – 460 mm

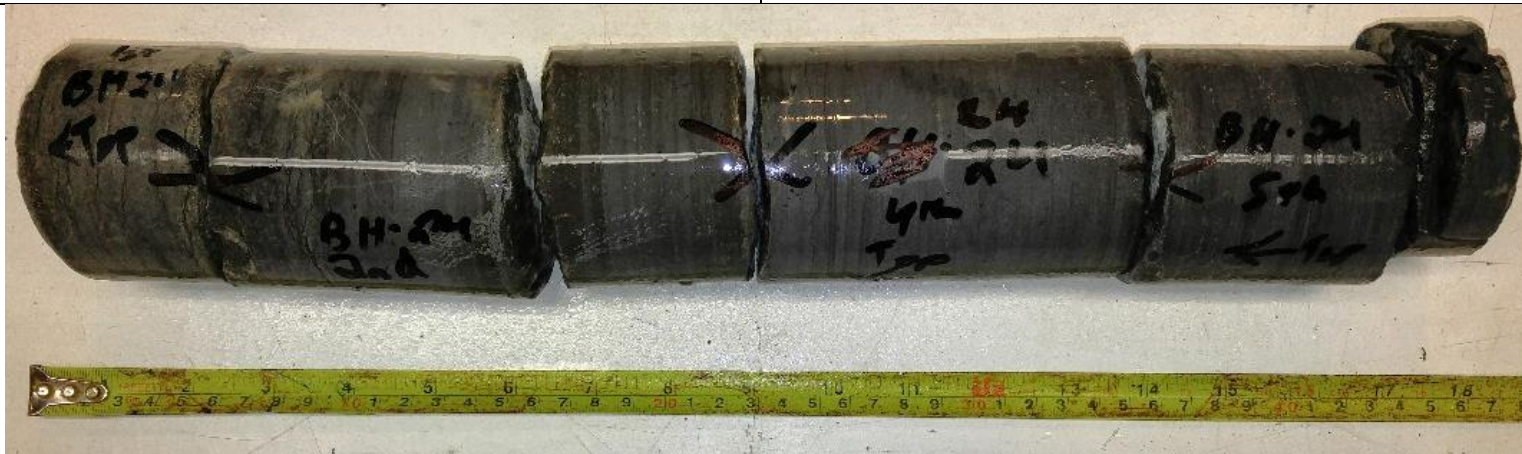
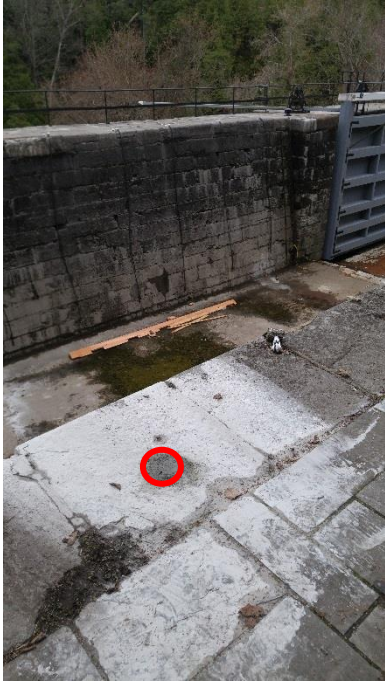
Core Location at West Chamber Wall

ID	CH 24
Date Cored	April 21, 2017
Lock	47
Location	Chamber Wall
Section	47W-CHW1
Direction Core Extracted	Vertical
Tested	Yes
Total Hole Depth	410 mm
General Notes: Limestone 0 – 410 mm

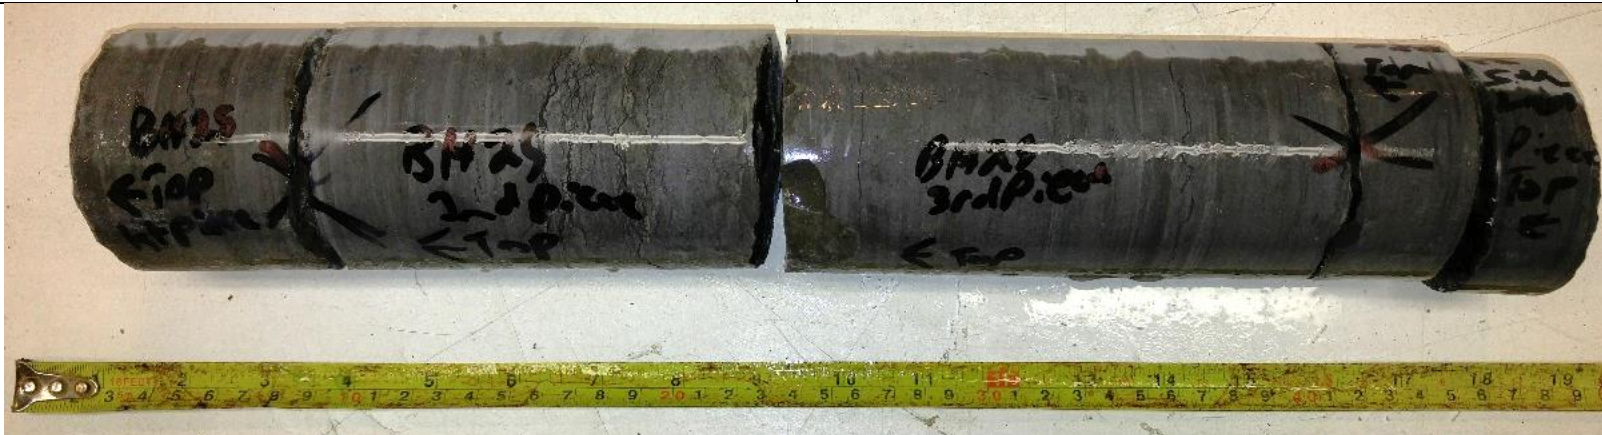
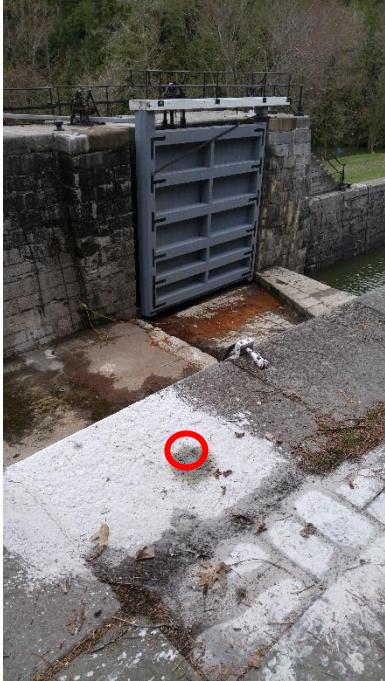
Core Location at West Chamber Wall

ID	CH 25
Date Cored	April 21, 2017
Lock	48
Location	Chamber Wall
Section	48W-CHW1
Direction Core Extracted	Vertical
Tested	Yes
Total Hole Depth	400 mm
General Notes: Limestone 0 – 400 mm

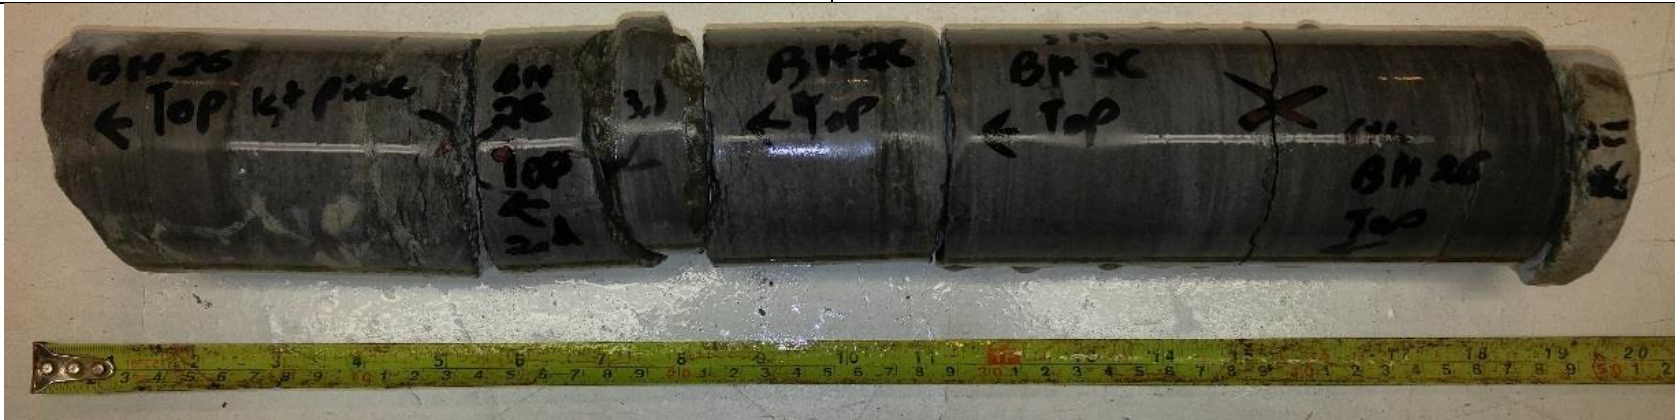
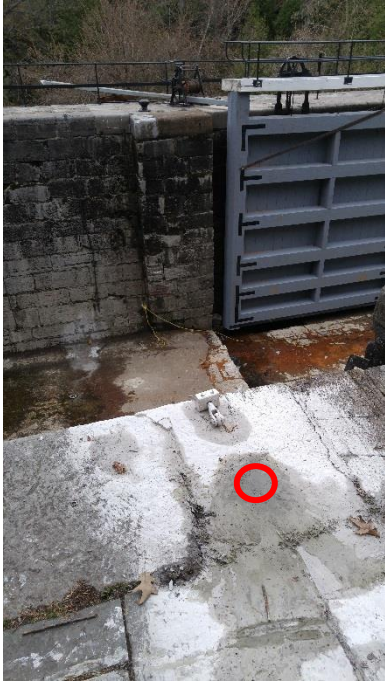
Core Location at West Chamber Wall

ID	CH 26
Date Cored	April 21, 2017
Lock	48
Location	Chamber Wall
Section	48W-CHW1
Direction Core Extracted	Vertical
Tested	No
Total Hole Depth	430 mm
General Notes:	
Limestone 0 – 410 mm	
Mortar/concrete 410 – 430 mm

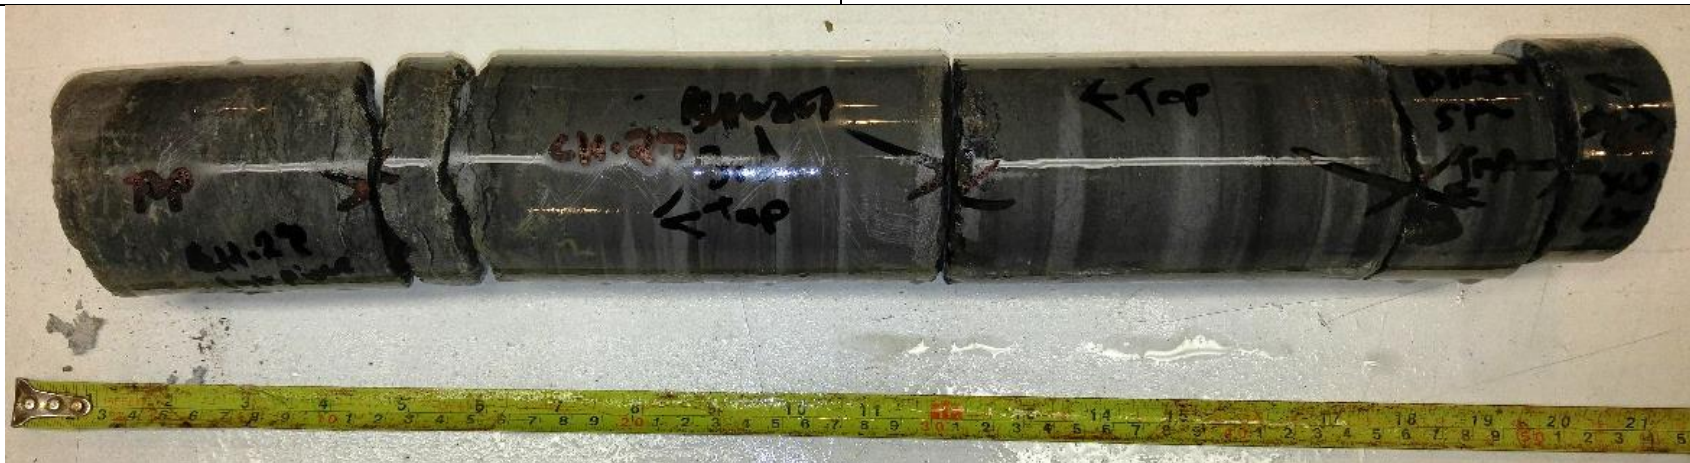
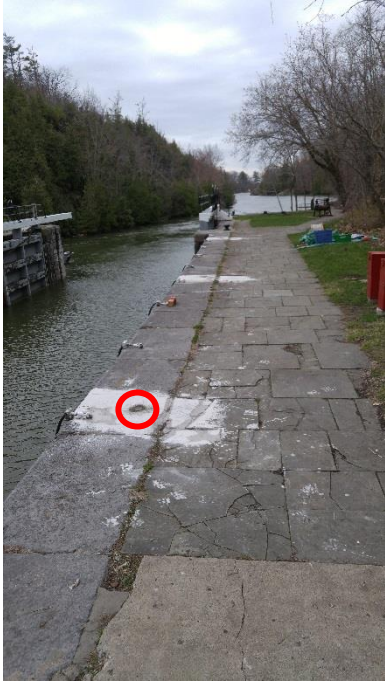
Core Location at West Chamber Wall

ID	CH 27
Date Cored	April 21, 2017
Lock	48
Location	Chamber Wall
Section	48W-CHW1
Direction Core Extracted	Vertical
Tested	Yes
Total Hole Depth	500 mm
General Notes: Limestone 0 – 500 mm

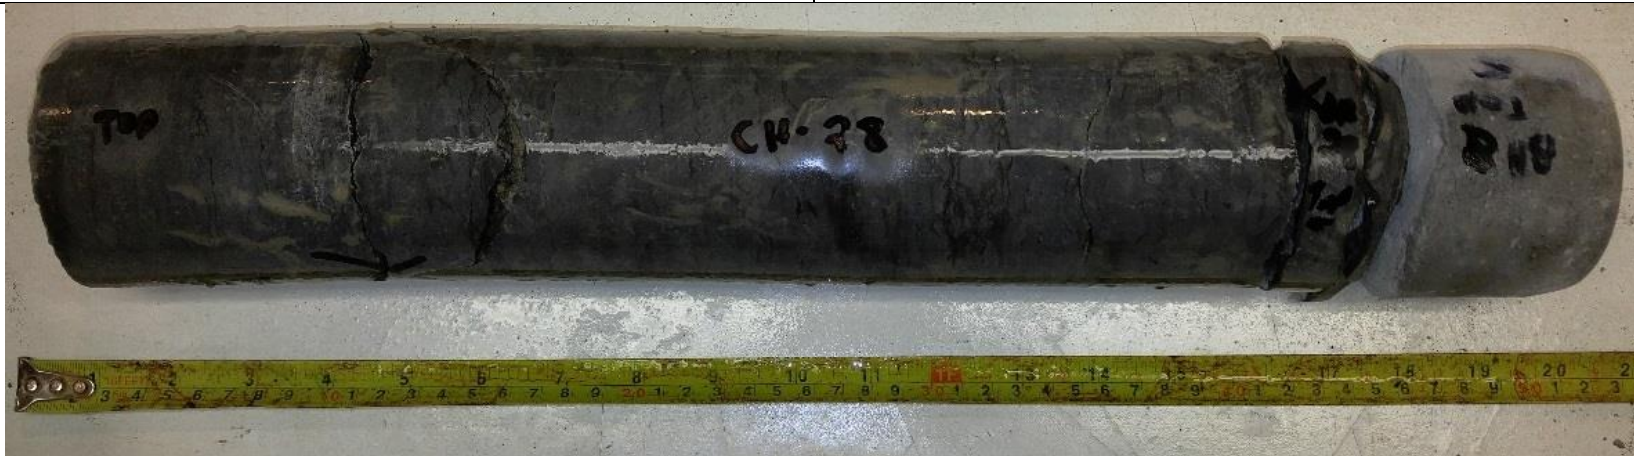
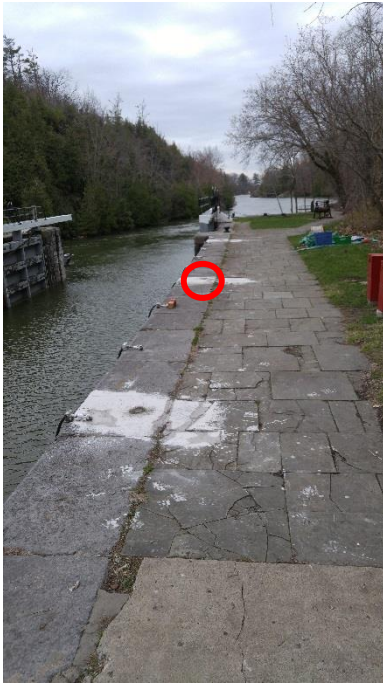
Core Location at West Chamber Wall

ID	CH 28
Date Cored	April 21, 2017
Lock	49
Location	Chamber Wall
Section	49W-CHW2
Direction Core Extracted	Vertical
Tested	Yes
Total Hole Depth	460mm
General Notes: Limestone 0 – 400 mm Mortar/concrete 400 – 460 mm

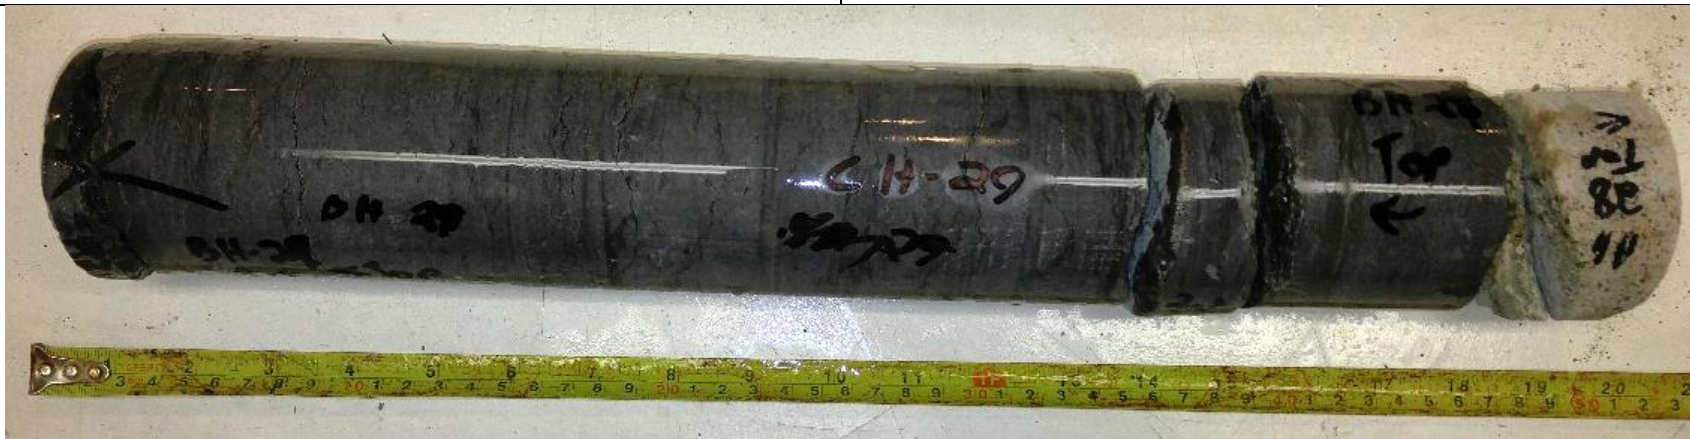
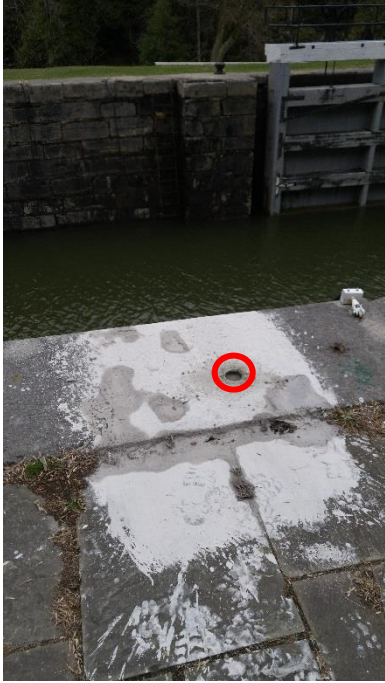
Core Location at West Chamber Wall

ID	CH 29
Date Cored	April 21, 2017
Lock	49
Location	Chamber Wall
Section	49W-CHW1
Direction Core Extracted	Vertical
Tested	No
Total Hole Depth	460 mm
General Notes:	
Limestone 0 – 400 mm	
Mortar 400 – 460 mm

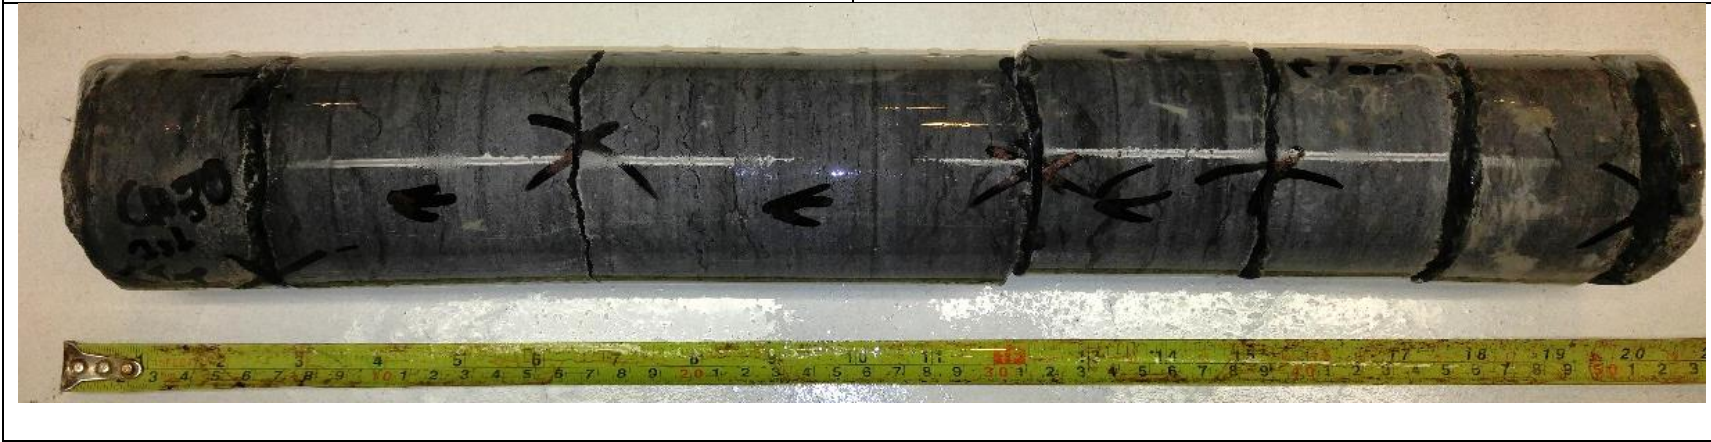
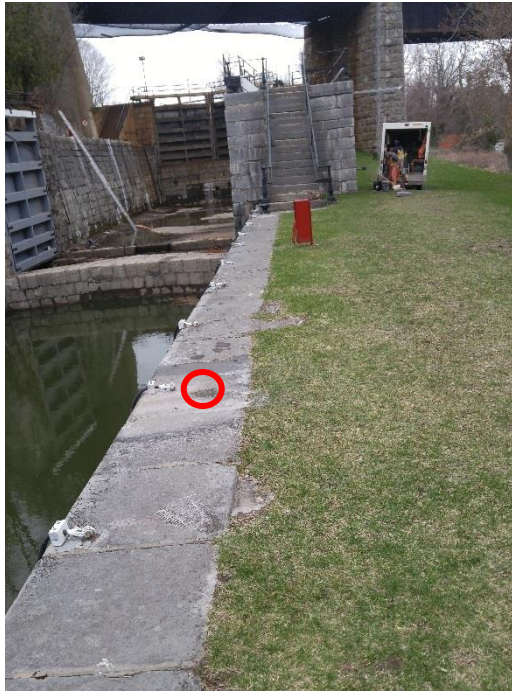
Core Location at West Chamber Wall

ID	CH 30
Date Cored	April 21, 2017
Lock	49
Location	Chamber Wall
Section	49W-CHW1
Direction Core Extracted	Vertical
Tested	Yes
Total Hole Depth	460 mm
General Notes: Limestone 0 – 460 mm

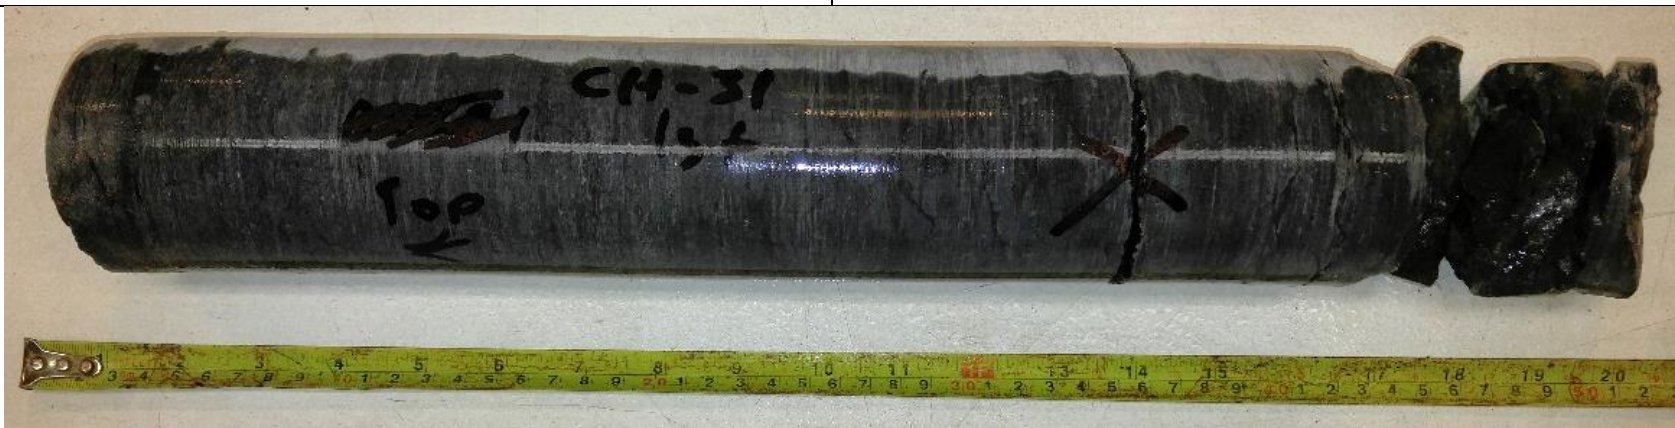
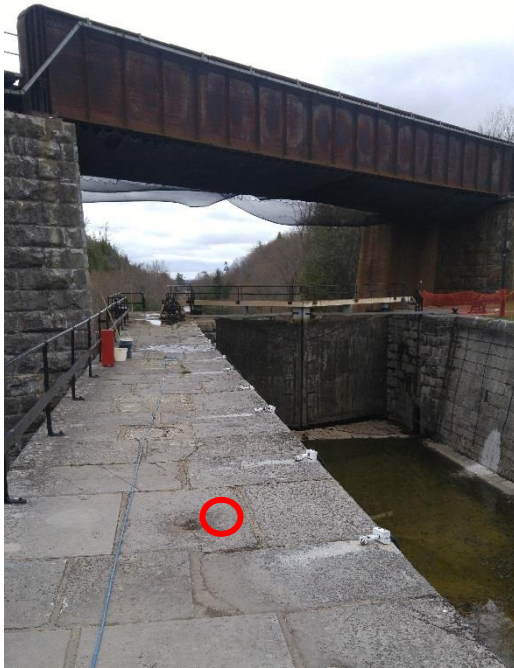
Core Location at East Chamber Wall

ID	CH 31
Date Cored	April 21, 2017
Lock	49
Location	Chamber Wall
Section	49E-CHW2
Direction Core Extracted	Vertical
Tested	Yes
Total Hole Depth	460 mm
General Notes: Limestone 0 – 460 mm

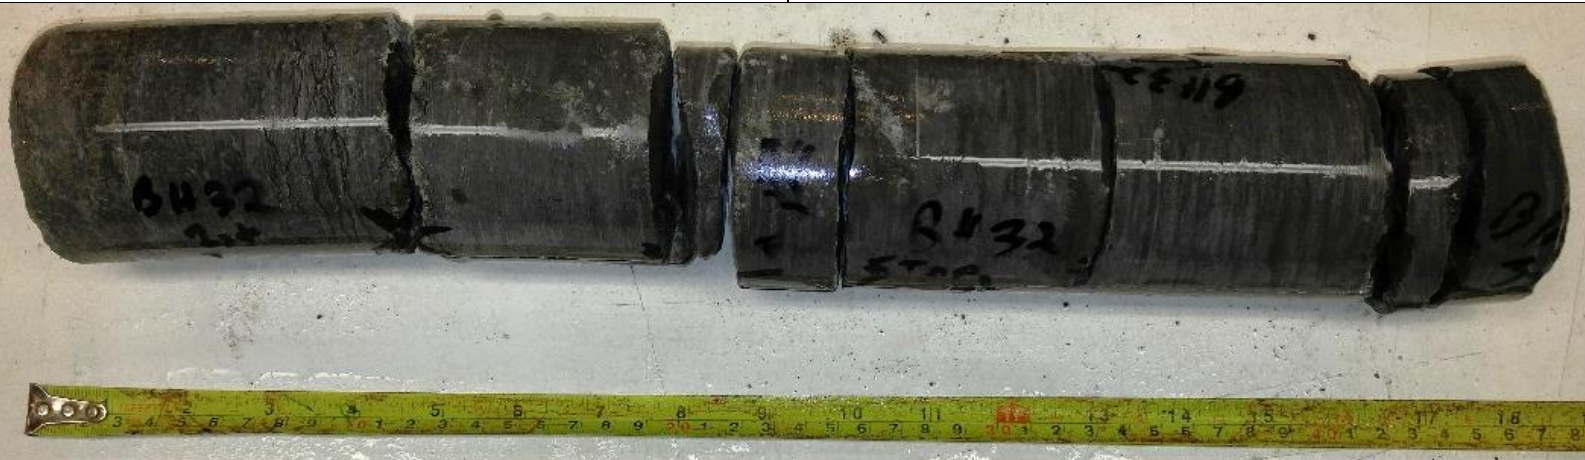
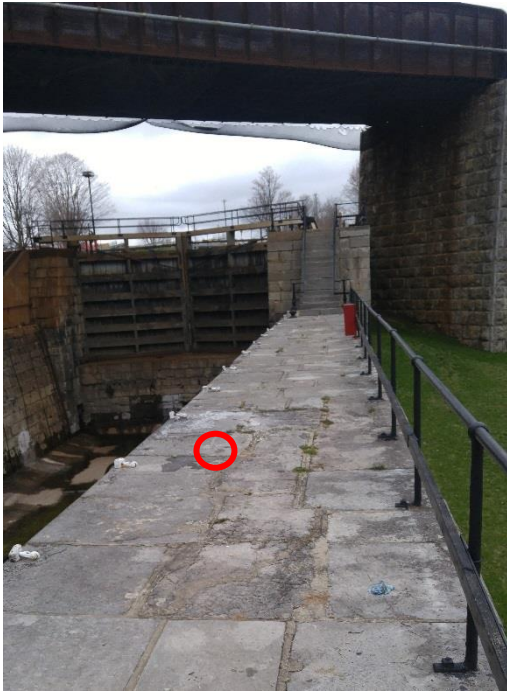
Core Location at East Chamber Wall

ID	CH 32
Date Cored	April 21, 2017
Lock	47
Location	Chamber Wall
Section	47E-CHW2
Direction Core Extracted	Vertical
Tested	Yes
Total Hole Depth	430 mm
General Notes: Limestone 0 – 430 mm

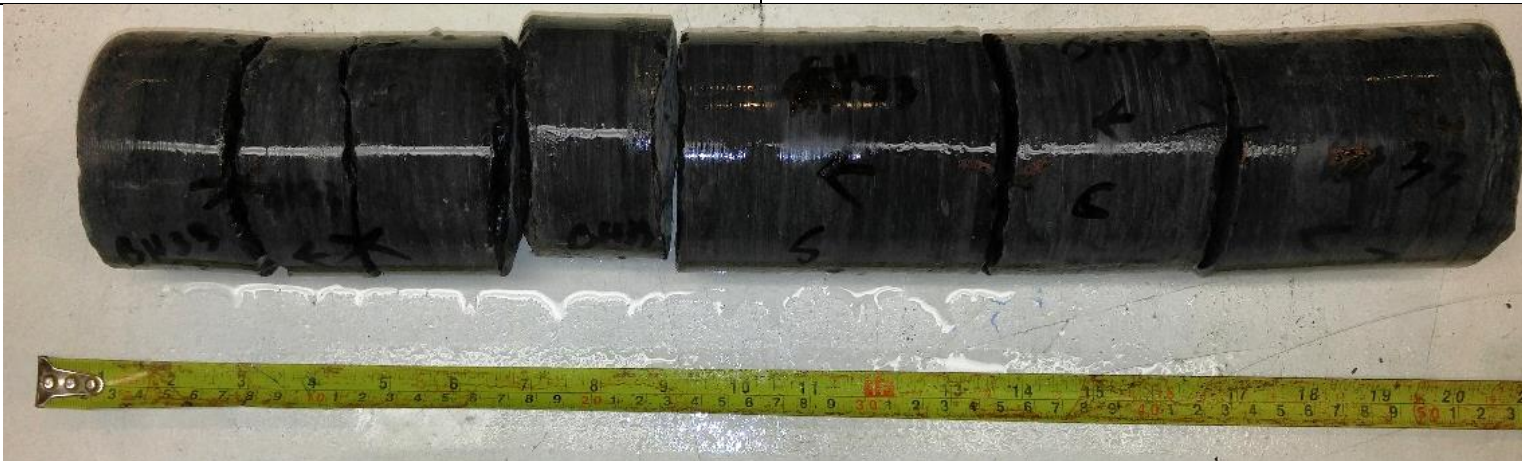
Core Location at East Chamber Wall

ID	CH 33
Date Cored	April 21, 2017
Lock	48
Location	Chamber Wall
Section	48E-CHW2
Direction Core Extracted	Vertical
Tested	Yes
Total Hole Depth	460 mm
General Notes: Limestone 0 – 460 mm

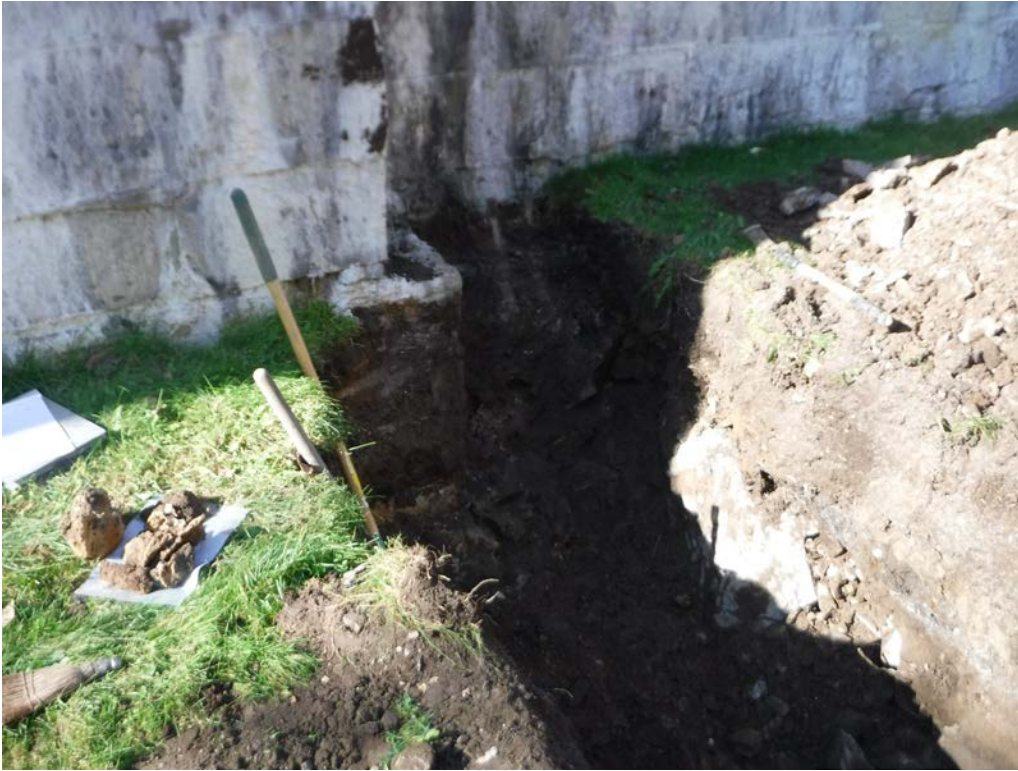
Test Pit #3 – Monolith #4 and back of lock chamber wall

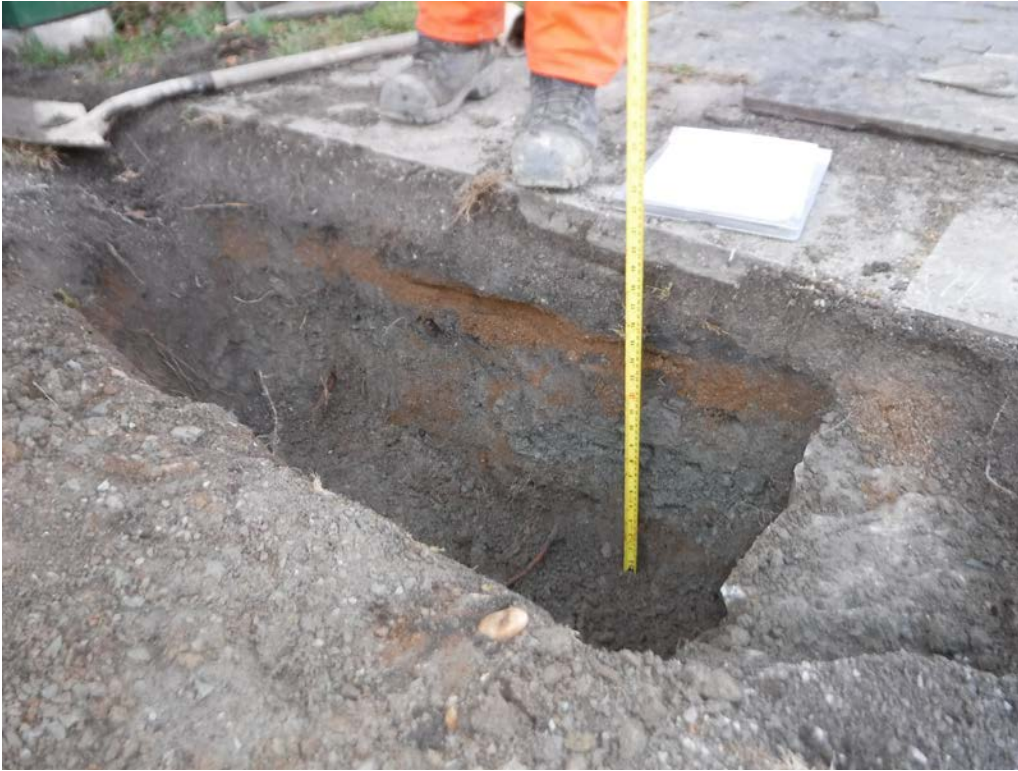
Test Pit #4 – Back of chamber wall

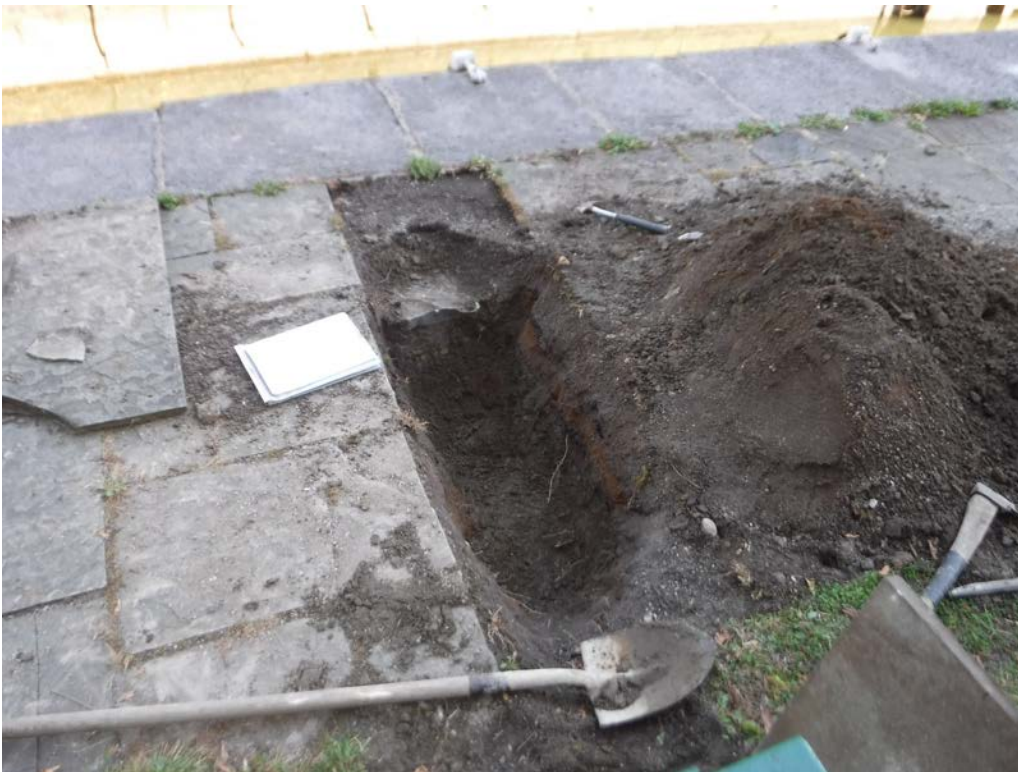
Test Pit #4 – Back of chamber wall

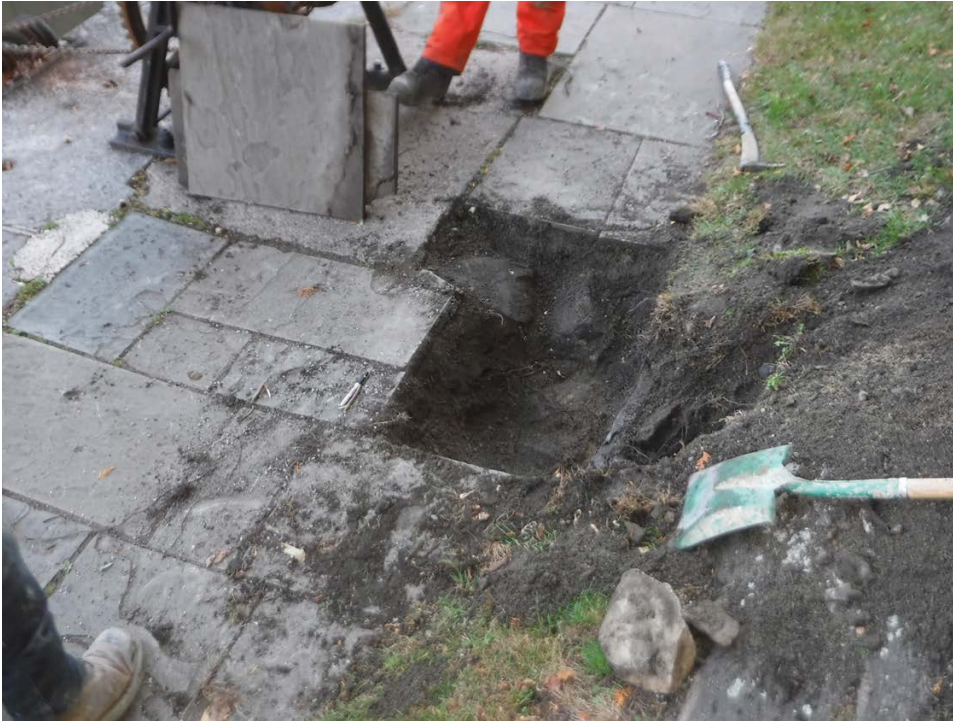
Test Pit #5 – Rubble behind wall to face of bedrock outcrop

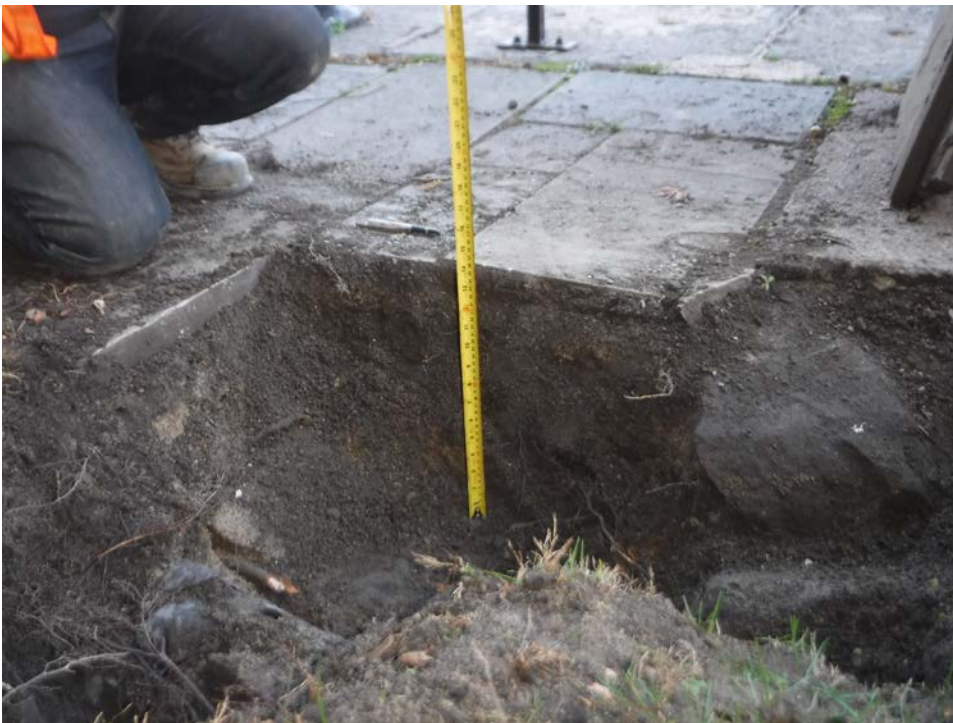
Test Pit #5 – Rubble behind wall to face of bedrock outcrop
