**Underwater Bridge Inspection  
Hamlet Swing Bridge  
Hamlet, ON**

**November 2-3, 2016**

**ASI Marine Proposal DH16-066**

**Underwater Inspection – Hamlet Swing Bridge  
1641 Muskoka District Road 49  
Hamlet, ON**

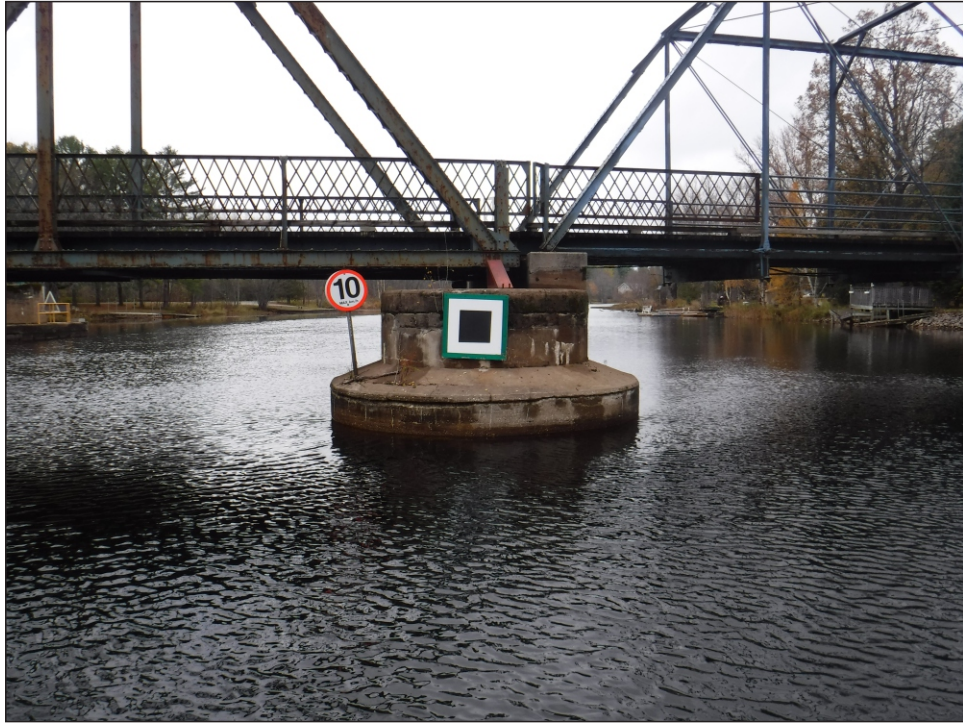
Image 1-13: South face of East Pier, looking north

The inspection of the east pier found the concrete cap to be subject to moderate spalling for the full circumference of the pier. The support structure was found to be encased by grout bags for the full circumference of the pier. The transition between the concrete cap and grout bags was found to range between 0.05 m to 0.25 m below surface. The grout bags continued to lake bottom with no undermining observed. As referenced in the previous inspection report, the grout bags were found to be brittle and easily broken therefore; the dive team did not penetrate the bags in order to avoid damage.
