HAZARDOUS BUILDING MATERIALS ASSESSMENTS

Parks Canada Buildings
Kluane National Park
Haines Junction, YT

Project No.: 144901924

November 26, 2014

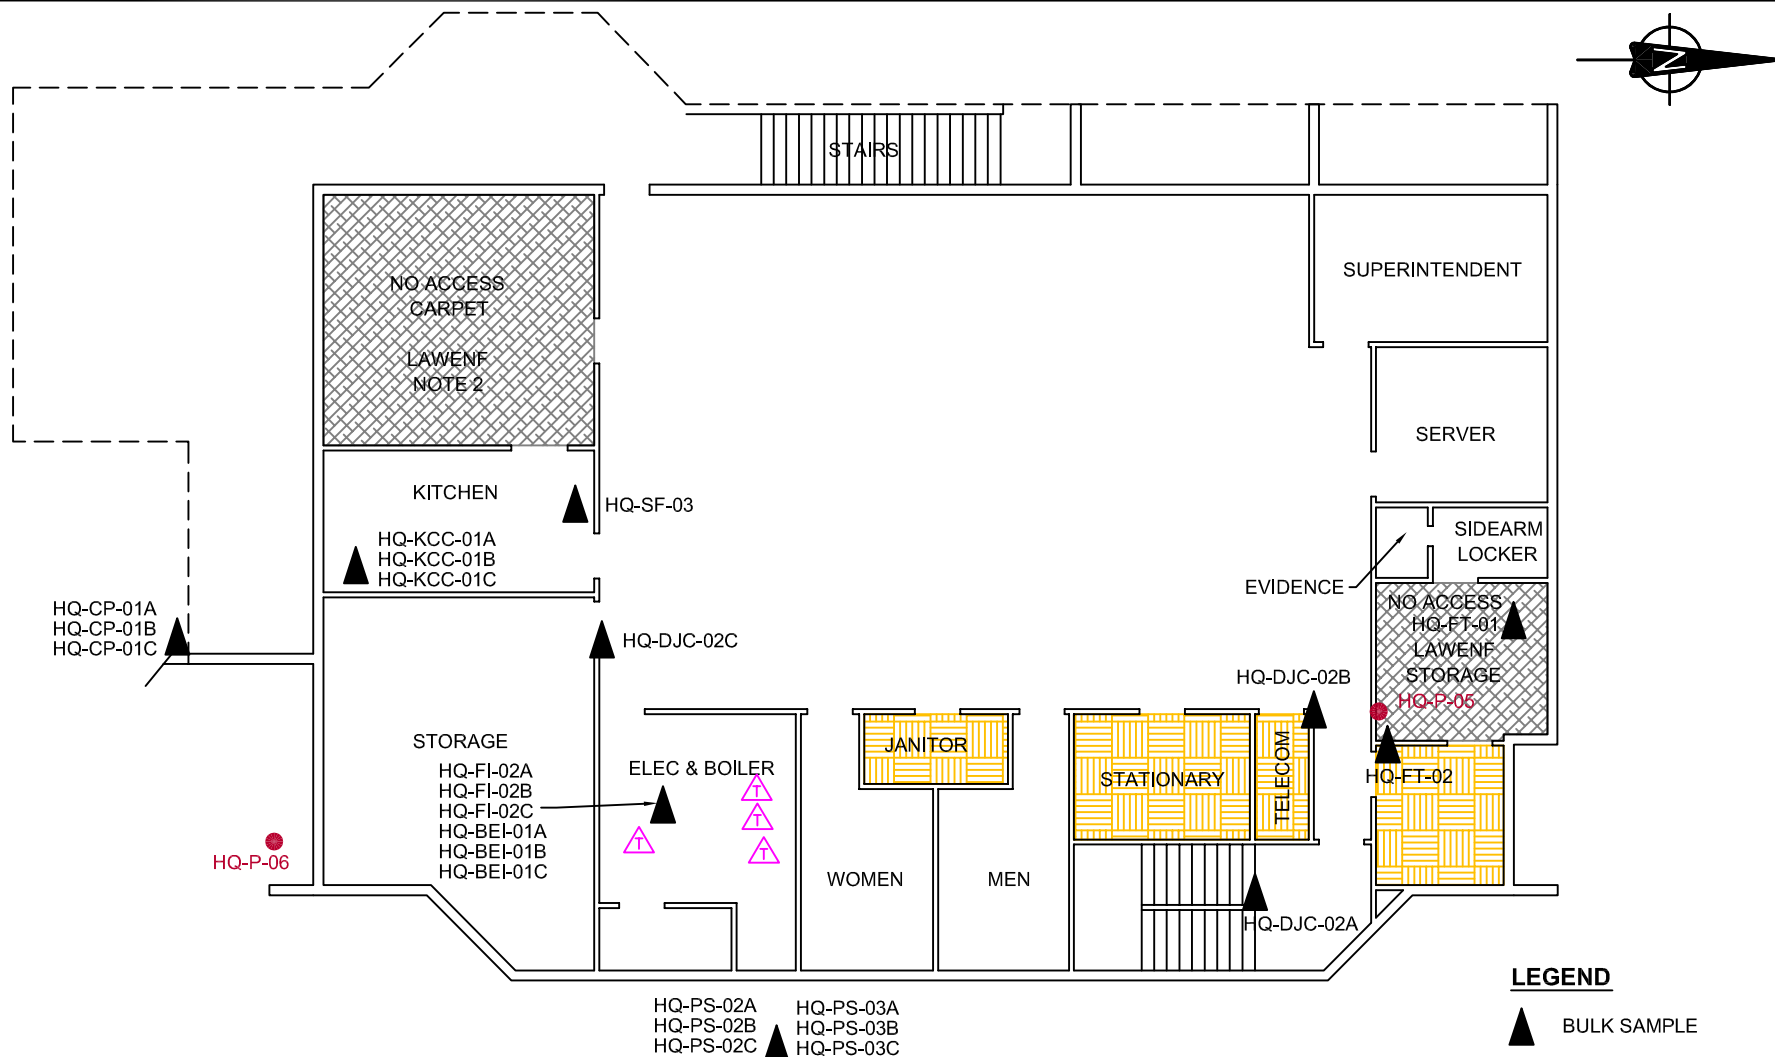
KNP HEADQUARTERS BUILDING LOWER LEVEL

- NOTES:** 1. BLACK WINDOW PANE CAULKING BETWEEN FRAMES AND GLASS PANES THROUGHOUT IS ACM.
 2. WHITE 2'X4' CEILING TILE (STANDARD FISSURE AND PINHOLE WITH LIGHT RED BACKING) THROUGHOUT IS ACM.
 3. CEMENT PANEL AROUND THE BASE OF EXTERIOR WALLS IS ACM.
 4. THIS DRAWING ILLUSTRATES SUPPORTING INFORMATION SPECIFIC TO A STANTEC CONSULTING LTD. REPORT AND MUST NOT BE USED FOR OTHER PURPOSES.

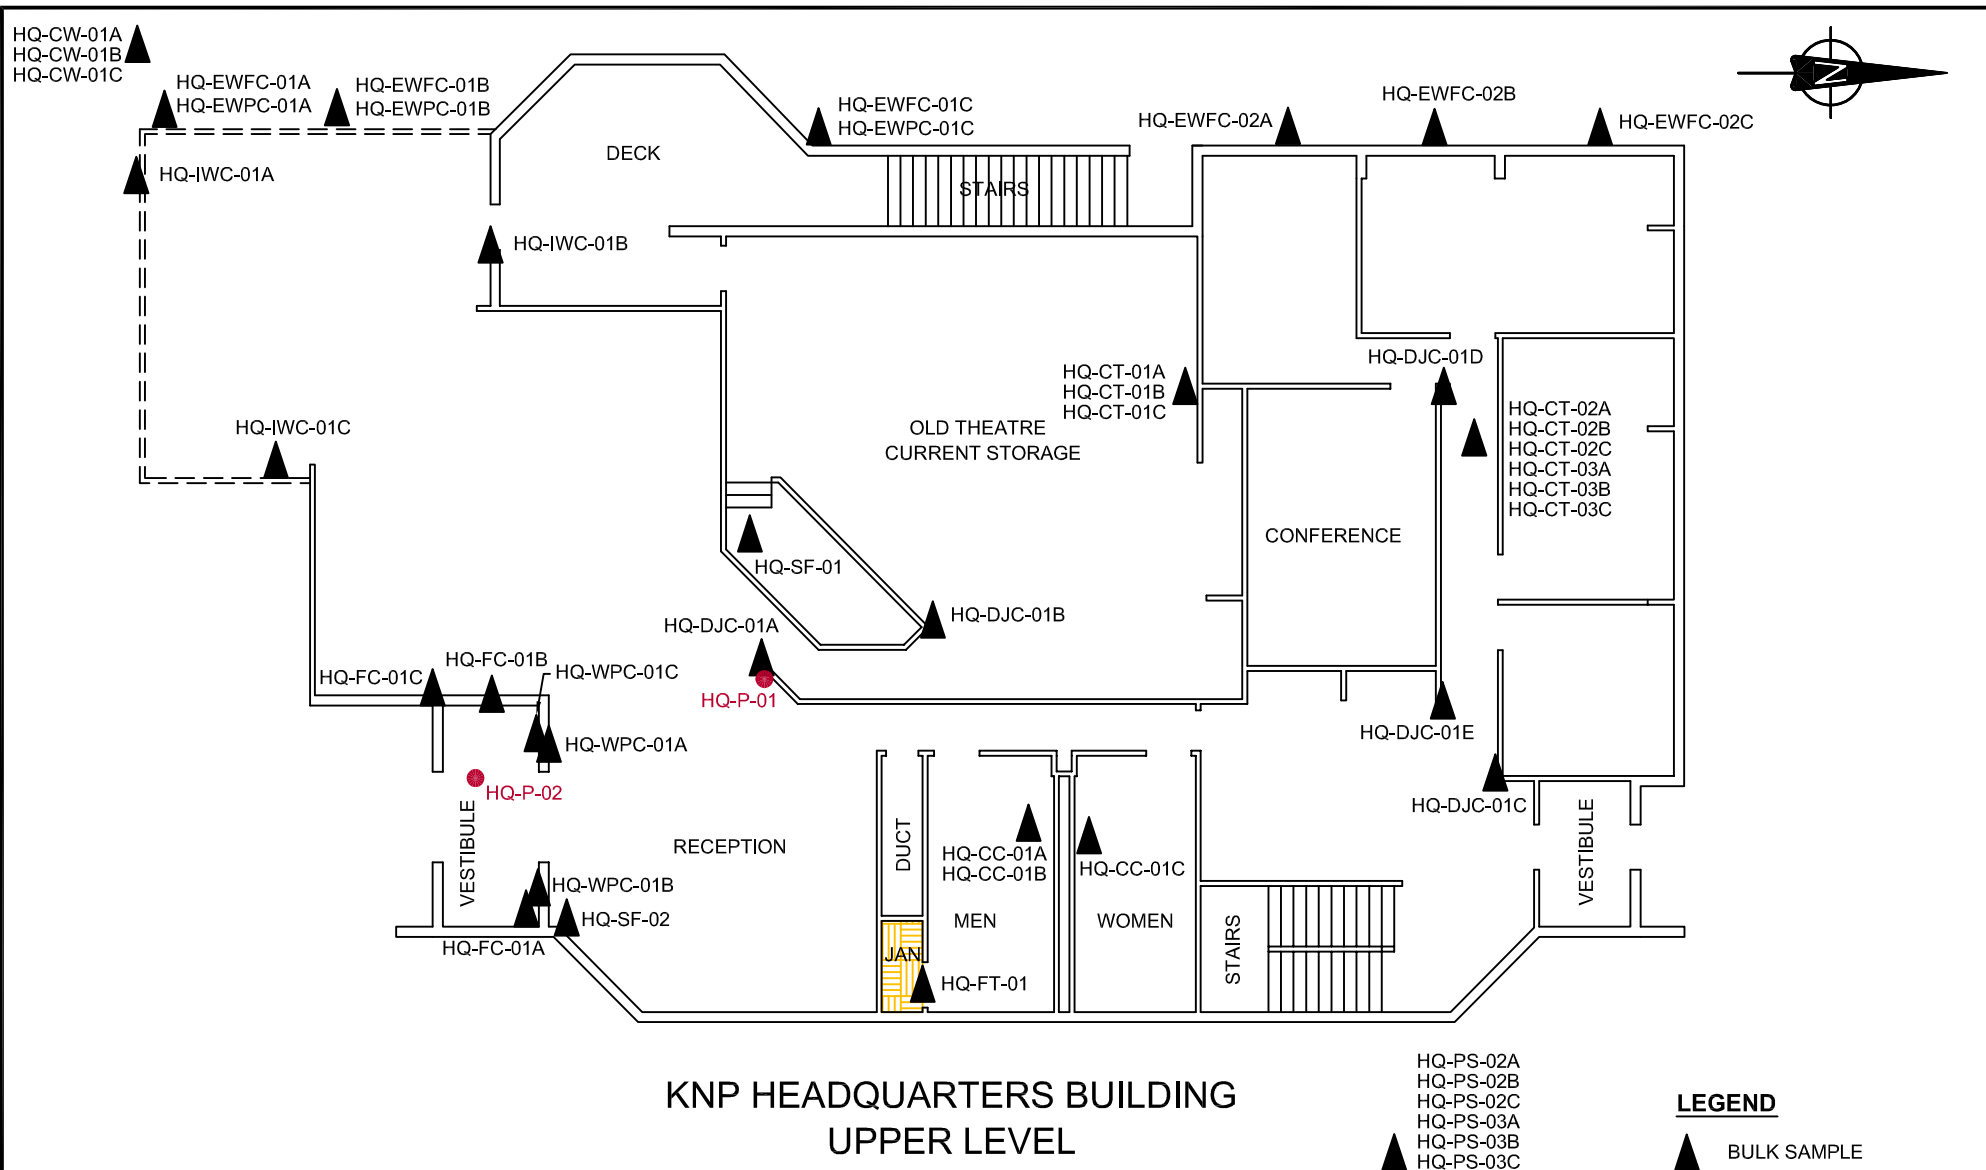
B2

- NOTES:** 1. BLACK WINDOW PANE CAULKING BETWEEN FRAMES AND GLASS PANES THROUGHOUT IS ACM.
 2. WHITE 2'X4' CEILING TILE (STANDARD FISSURE AND PINHOLE WITH LIGHT RED BACKING) THROUGHOUT IS ACM.
 3. CEMENT PANEL AROUND THE BASE OF EXTERIOR WALLS IS ACM.
 4. THIS DRAWING ILLUSTRATES SUPPORTING INFORMATION SPECIFIC TO A STANTEC CONSULTING LTD. REPORT AND MUST NOT BE USED FOR OTHER PURPOSES.

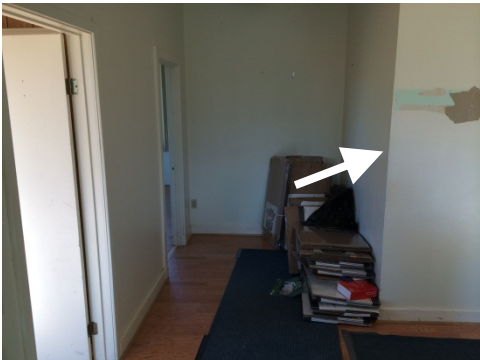
Friability	Non-friable	
Condition	Good	
Content	1.5% Chrysotile	
Drywall joint compound applied to walls throughout

Friability	Non-friable in-situ but may become friable when it is disturbed	
Condition	Good	
Content	3% Chrysotile

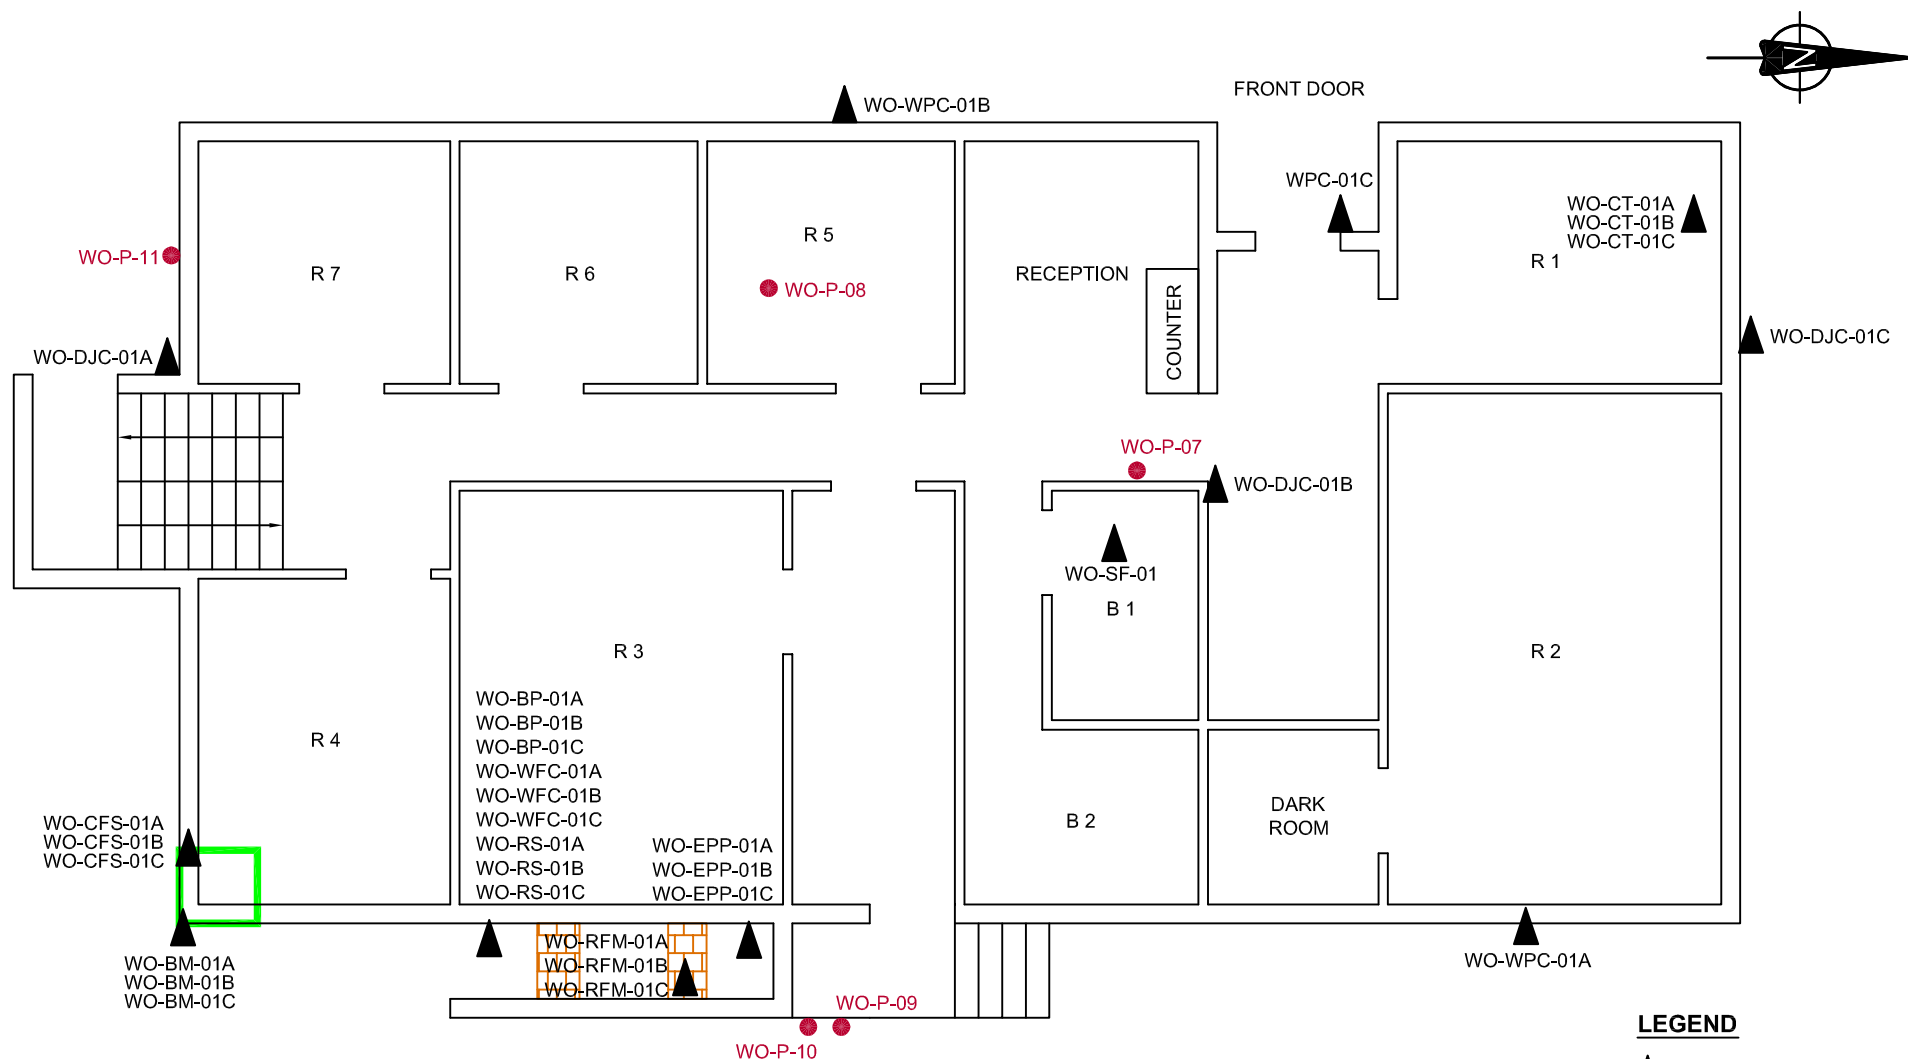
WARDENS OFFICE UPPER LEVEL

- NOTES:**
1. PIPE FITTING INSULATION ON ELBOWS +S AND VALVES THROUGHOUT IS ACM.
 2. CORRUGATED PAPER INSULATION ON STRAIGHT SECTIONS OF PIPE THROUGHOUT IS ACM.
 3. GREY WINDOW FRAME CAULKING BETWEEN FRAME AND THE BUILDING EXTERIOR THROUGHOUT IS ACM.
 4. BLACK WINDOW PANE CAULKING BETWEEN WINDOW FRAME AND GLASS PANE ON WINDOWS THROUGHOUT IS ACM.
 5. DRYWALL JOINT COMPOUND THROUGHOUT IS ACM.
 6. THIS DRAWING ILLUSTRATES SUPPORTING INFORMATION SPECIFIC TO A STANTEC CONSULTING LTD. REPORT AND MUST NOT BE USED FOR OTHER PURPOSES.

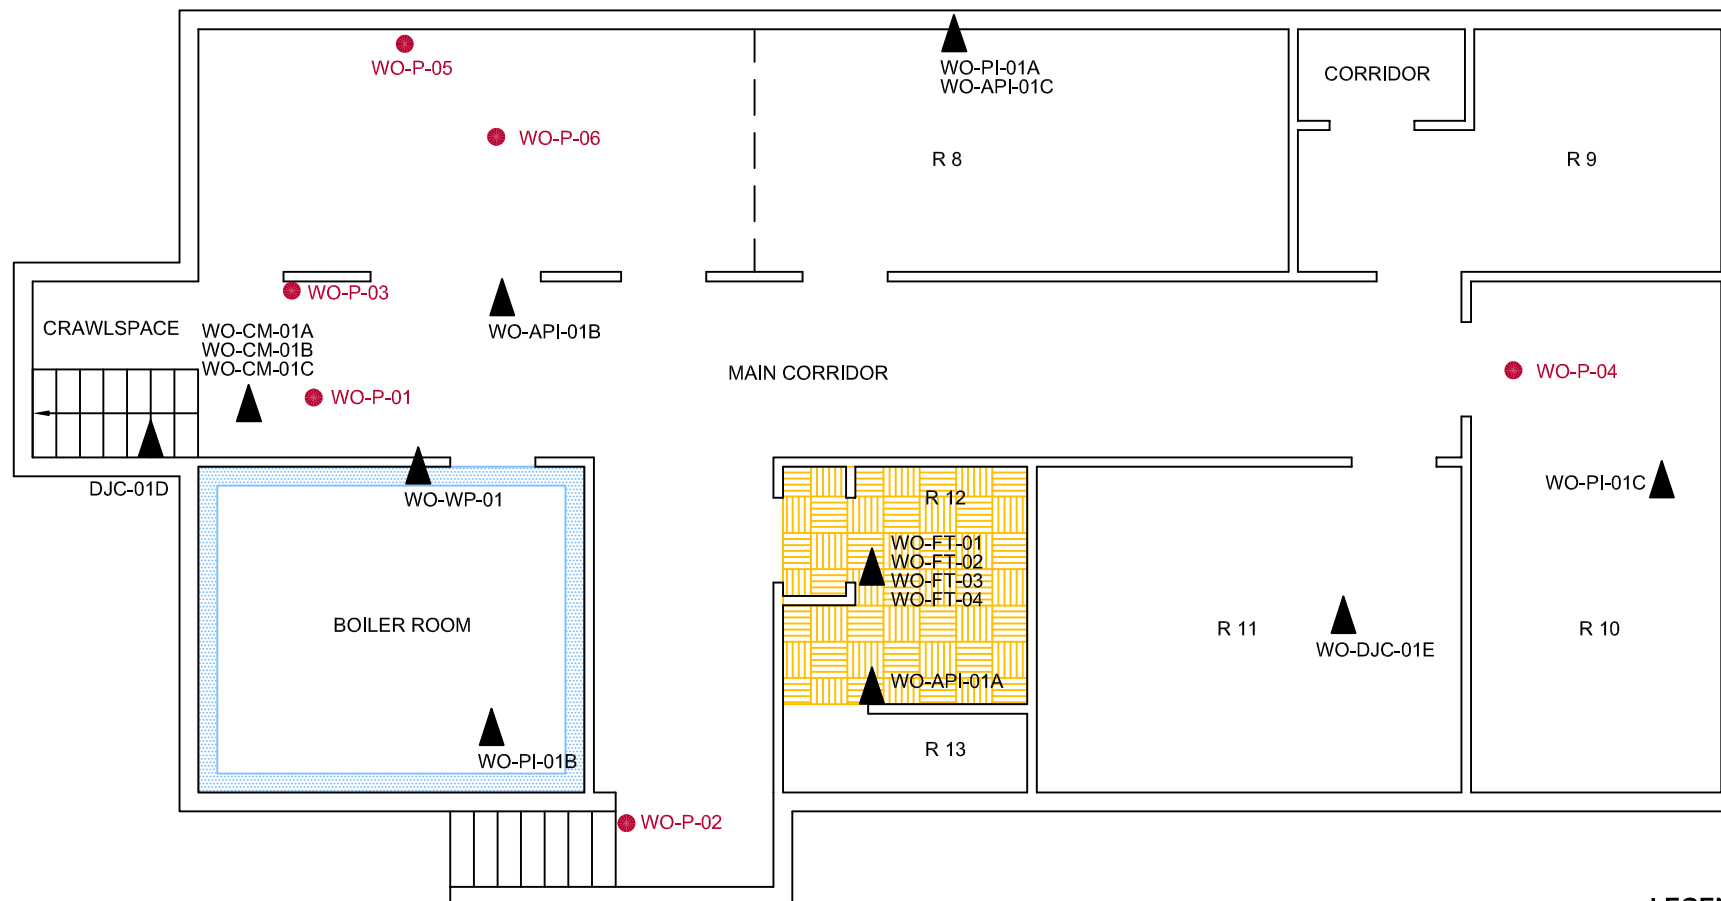
WARDENS OFFICE LOWER LEVEL

- NOTES:**
1. PIPE FITTING INSULATION ON ELBOWS †'S AND VALVES THROUGHOUT IS ACM.
 2. CORRUGATED PAPER INSULATION ON STRAIGHT SECTIONS OF PIPE THROUGHOUT IS ACM.
 3. GREY WINDOW FRAME CAULKING BETWEEN FRAME AND THE BUILDING EXTERIOR THROUGHOUT IS ACM.
 4. BLACK WINDOW PANE CAULKING BETWEEN WINDOW FRAME AND GLASS PANE ON WINDOWS THROUGHOUT IS ACM.
 5. DRYWALL JOINT COMPOUND THROUGHOUT IS ACM.
 6. THIS DRAWING ILLUSTRATES SUPPORTING INFORMATION SPECIFIC TO A STANTEC CONSULTING LTD. REPORT AND MUST NOT BE USED FOR OTHER PURPOSES.

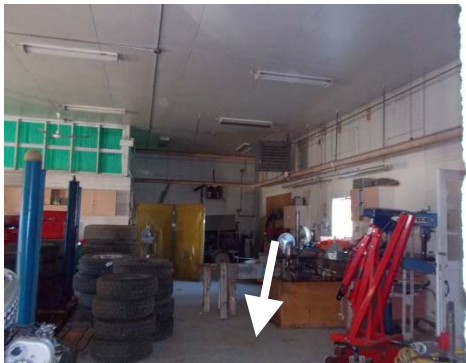
Identified LCP Description	Photo
<p>Grey paint on floors.</p> <p>This paint was observed to be in good condition (not bubbling, flaking or peeling).</p>

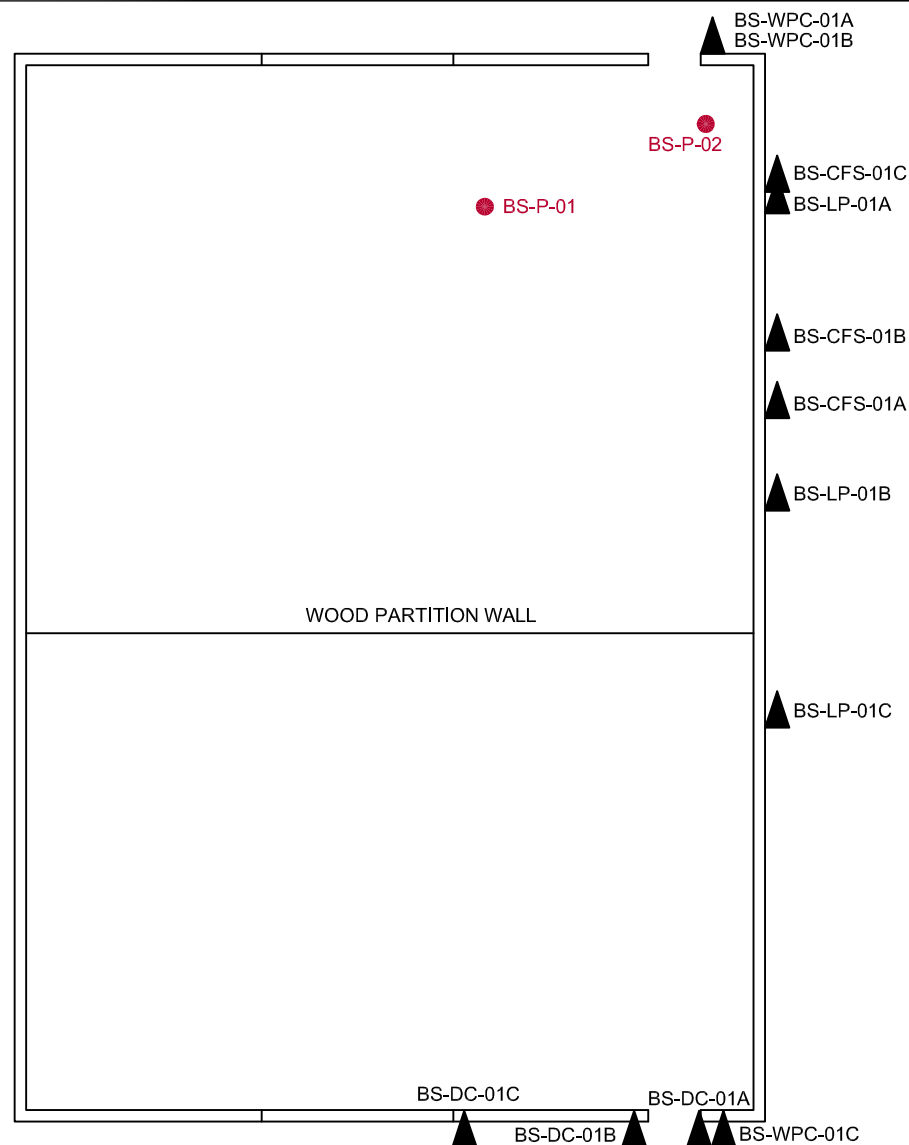
BUTLER STORAGE SHED

- NOTES:** 1. BLACK/GREY WINDOW PANE CAULKING BETWEEN WINDOW FRAME AND GLASS PANES THROUGHOUT IS ACM.
2. GREY/WHITE DOOR CAULKING AROUND EXTERIOR OF DOORS IS ACM.
3. THIS DRAWING ILLUSTRATES SUPPORTING INFORMATION SPECIFIC TO A STANTEC CONSULTING LTD. REPORT AND MUST NOT BE USED FOR OTHER PURPOSES.

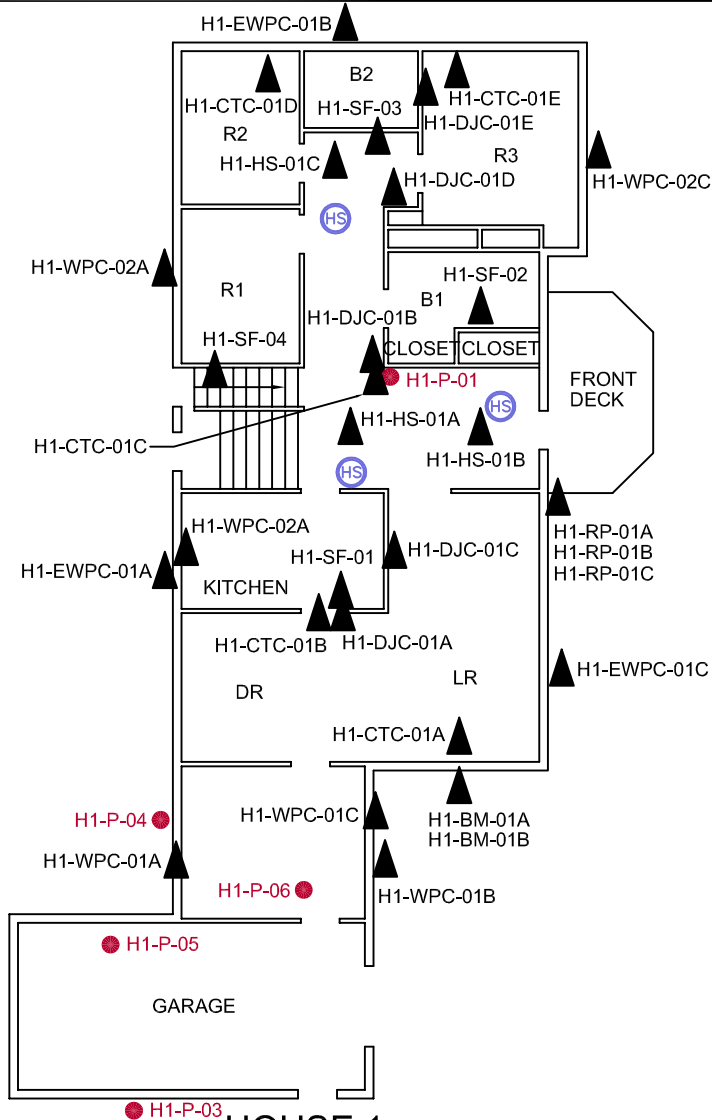
HOUSE 1 MAIN FLOOR

- NOTES:**
1. GREY WINDOW PANE CAULKING BETWEEN WINDOW FRAMES AND GLASS PANES THROUGHOUT THE MAIN HOUSE IS ACM.
 2. CEILING TEXTURE COAT THROUGHOUT IS ACM.
 3. DRYWALL JOINT COMPOUND THROUGHOUT IS ACM.
 4. THIS DRAWING ILLUSTRATES SUPPORTING INFORMATION SPECIFIC TO A STANTEC CONSULTING LTD. REPORT AND MUST NOT BE USED FOR OTHER PURPOSES.

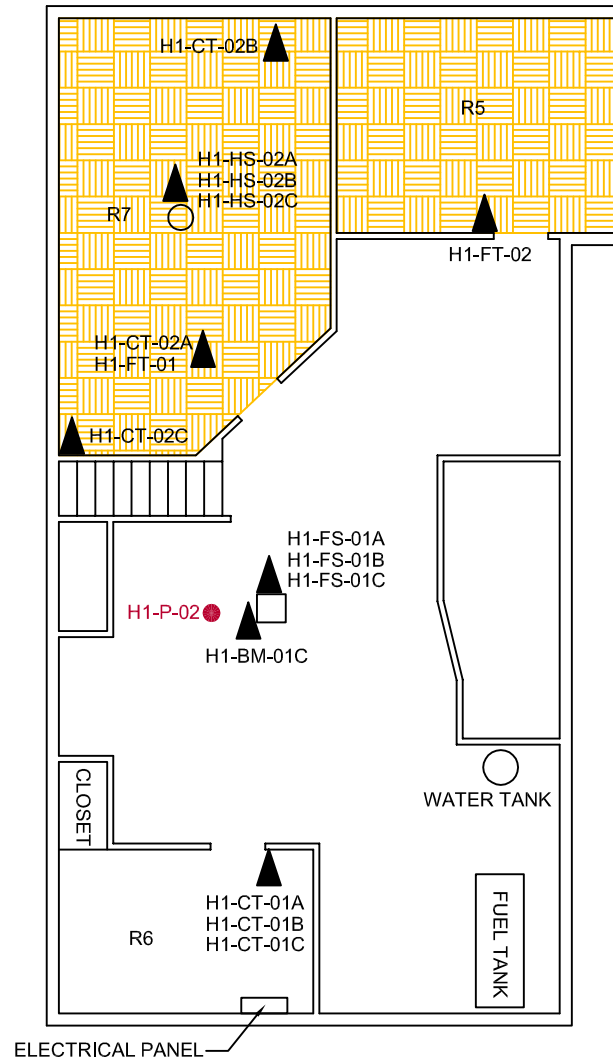
HOUSE 1 BASEMENT

- NOTES:**
1. GREY WINDOW PANE CAULKING BETWEEN WINDOW FRAMES AND GLASS PANES THROUGHOUT THE MAIN HOUSE IS ACM.
 2. CEILING TEXTURE COAT THROUGHOUT IS ACM.
 3. DRYWALL JOINT COMPOUND THROUGHOUT IS ACM.
 4. THIS DRAWING ILLUSTRATES SUPPORTING INFORMATION SPECIFIC TO A STANTEC CONSULTING LTD. REPORT AND MUST NOT BE USED FOR OTHER PURPOSES.

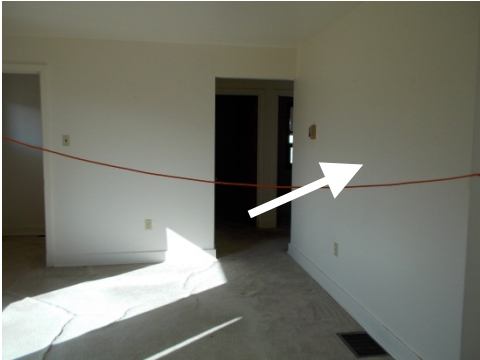
Identified ACM Description and Condition Information		Photo
Drywall joint compound throughout

Friability	Non-friable in situ can be made friable during removal	
Condition	Good	
Content	<1 - 3% Chrysotile	
Grey pipe sealant inside cast iron bell fittings in the basement		No photo
Friability	Non-friable	
Condition	Good	
Content	1.1% Chrysotile	
Grey window pane caulking between window frame and glass panes throughout

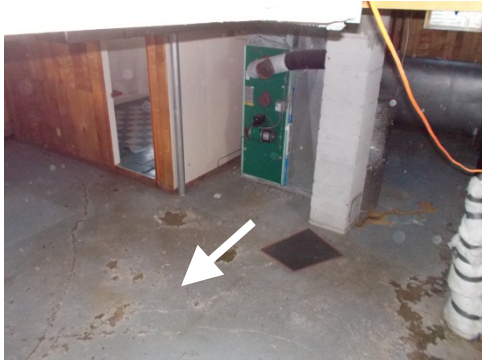
Identified LCP Description	Photo
Grey paint on the basement floor. This paint was observed to be in fair condition (minimal bubbling, flaking or peeling).

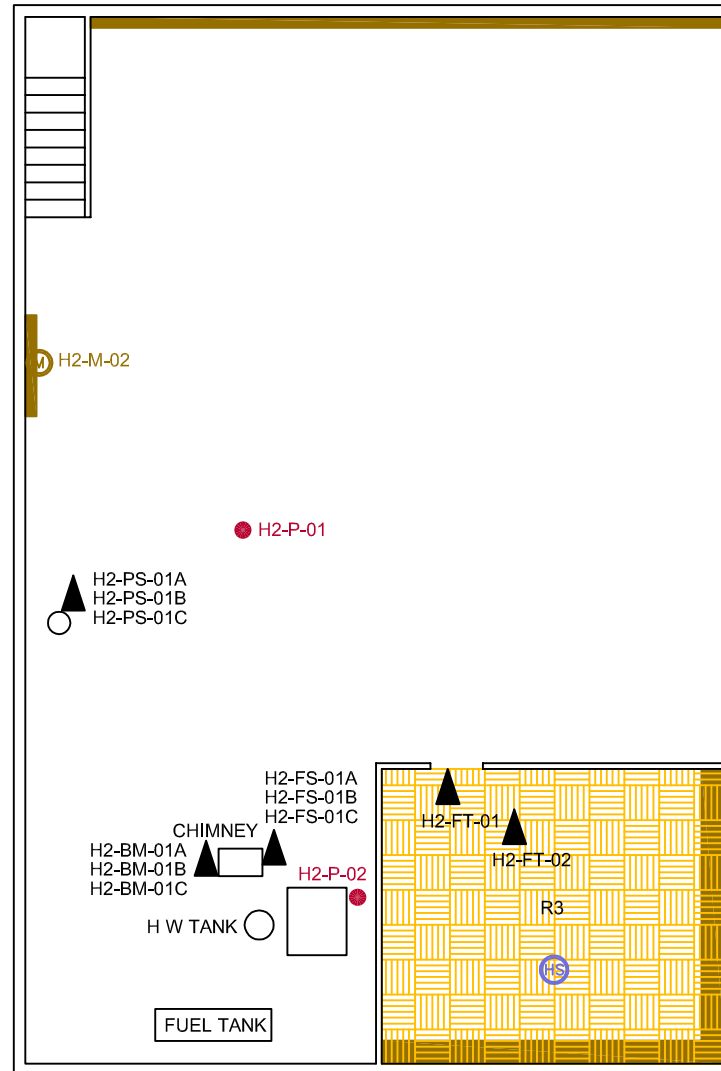
HOUSE 2 BASEMENT

- NOTES:**
1. GREY WINDOW PANE CAULKING BETWEEN WINDOW FRAMES AND GLASS PANES THROUGHOUT IS ACM.
 2. PIPE SEALANT IN CAST IRON BELL FITTINGS THROUGHOUT IS ACM.
 3. DRYWALL JOINT COMPOUND THROUGHOUT IS ACM.
 4. THIS DRAWING ILLUSTRATES SUPPORTING INFORMATION SPECIFIC TO A STANTEC CONSULTING LTD. REPORT AND MUST NOT BE USED FOR OTHER PURPOSES.

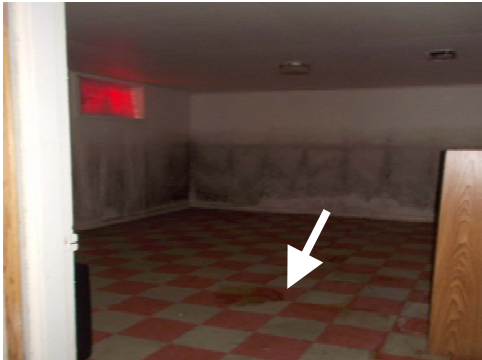
Identified ACM Description and Condition Information		Photo
9"x9" vinyl floor tile, both red and beige, in basement room 3

Friability	Non-friable	
Condition	Good	
Content	1.1 – 1.3% Chrysotile	
Drywall joint compound throughout

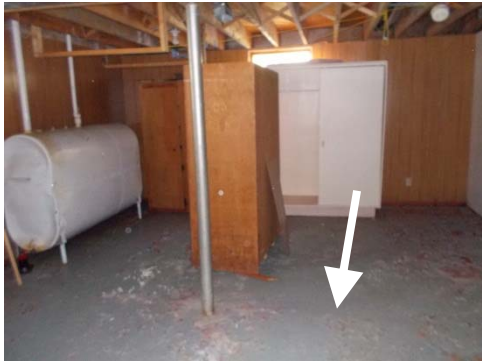
Identified LCP Description	Photo
<p>Grey paint on the basement floor.</p> <p>This paint was observed to be in fair condition (minimal bubbling, flaking or peeling).</p>

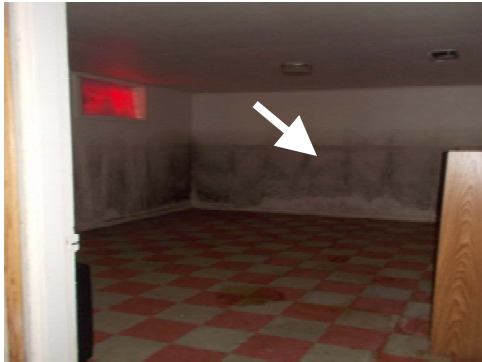
Identified Mould and/or Moisture Impacted Materials Description	Photo
Suspect mould growth was observed on the walls of basement room 3.

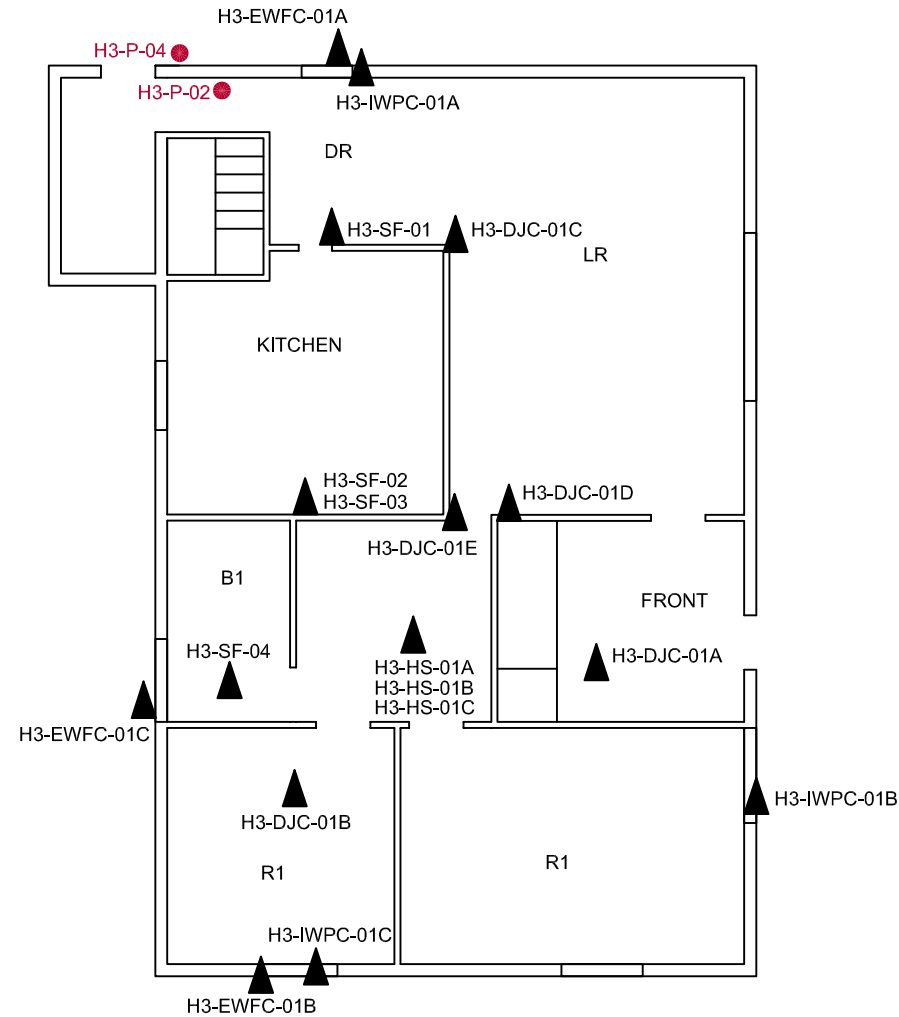
HOUSE 3 MAIN FLOOR

- NOTES:** 1. DRYWALL JOINT COMPOUND THROUGHOUT IS ACM.
2. GREY WINDOW PANE CAULKING BETWEEN WINDOW FRAMES AND GLASS PANES THROUGHOUT IS ACM.
3. THIS DRAWING ILLUSTRATES SUPPORTING INFORMATION SPECIFIC TO A STANTEC CONSULTING LTD. REPORT AND MUST NOT BE USED FOR OTHER PURPOSES.

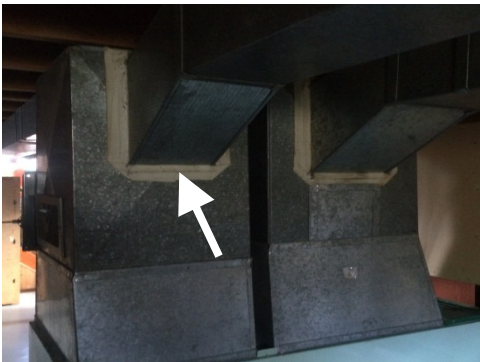
Identified ACM Description and Condition Information		Photo
White woven duct tape on seams of furnace ducting in the basement

Friability	Friable	
Condition	Good	
Content	55% Chrysotile	
White duct shields on wooden joists in the basement above furnace ducting

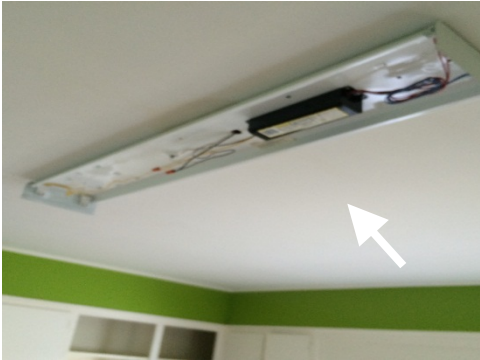
Identified ACM Description and Condition Information		Photo
Drywall joint compound throughout

Friability	Non-friable in situ; can be made friable during removal	
Condition	Good	
Content	2% Chrysotile

In general, identified hazardous building materials should be handled in accordance with the recommendations for demolition that are provided in Section 5 of the main body of this report.

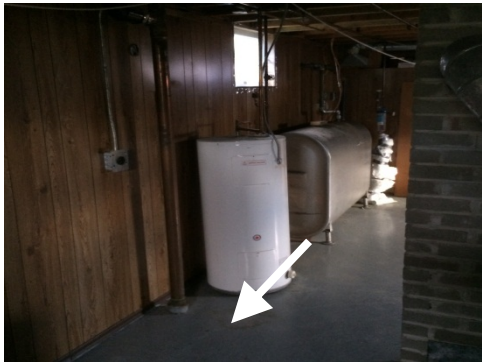
Identified LCP Description	Photo
Grey paint on the basement floor. This paint was observed to be in good condition (no bubbling, flaking or peeling).

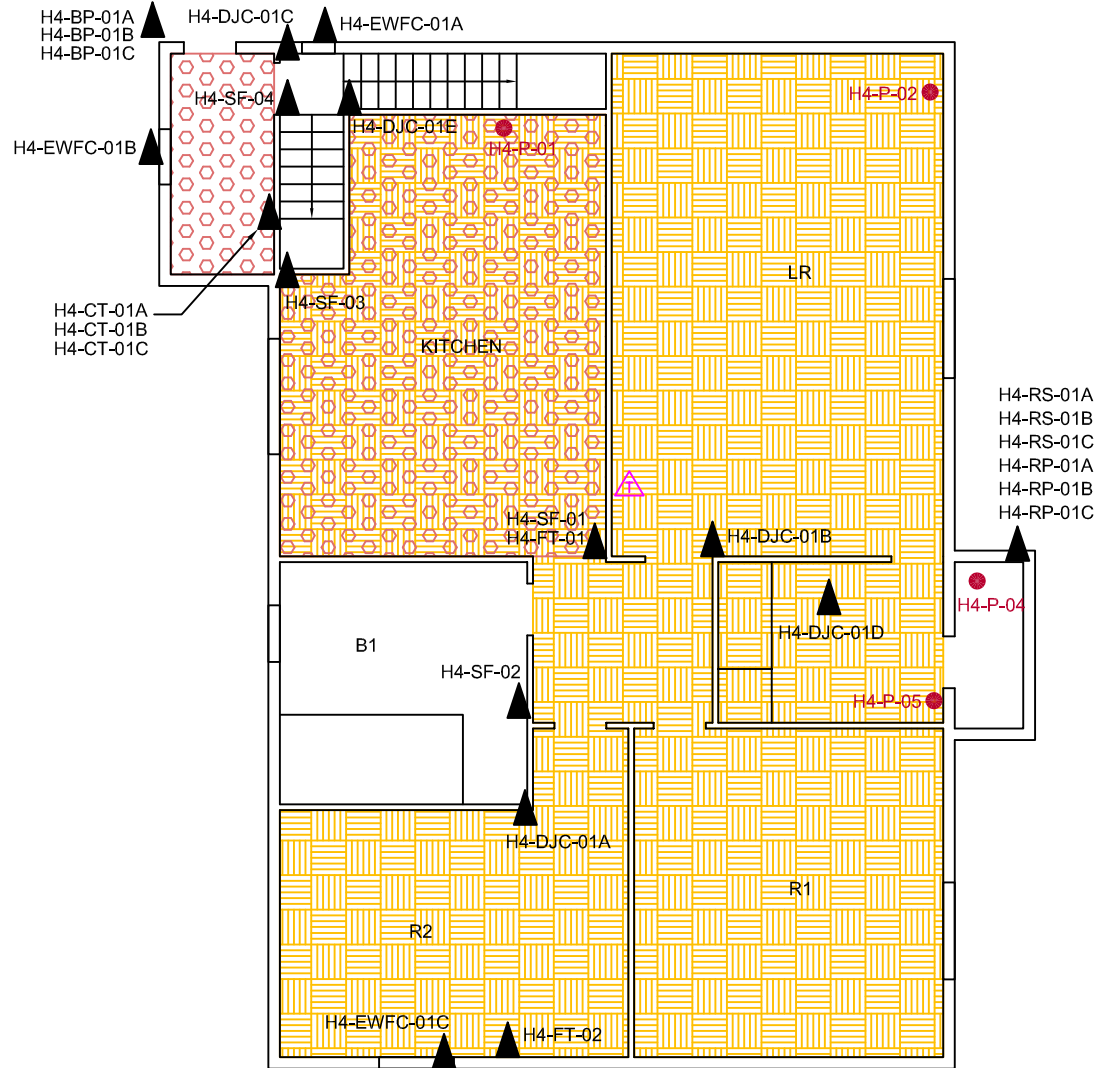
FLOOR PLAN SHOWING HAZARDOUS BUILDING MATERIALS AND BULK SAMPLE LOCATIONS

One (1) mercury-containing thermostat was observed in the living room, as indicated on the attached floor plan drawings.

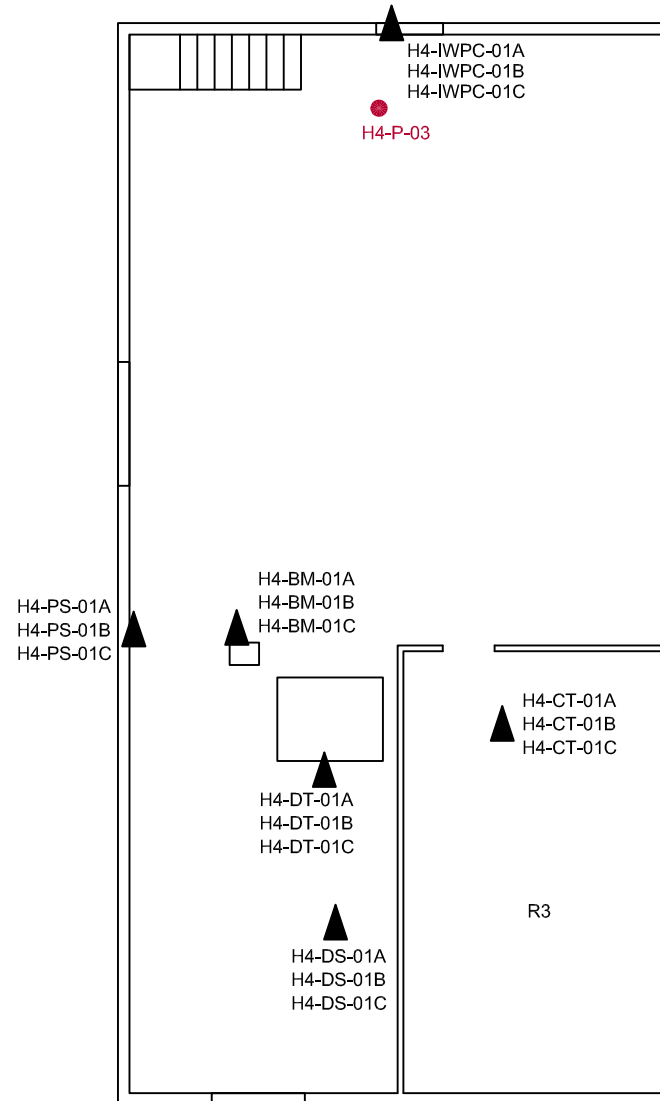
**FLOOR PLAN SHOWING HAZARDOUS BUILDING MATERIALS
AND BULK SAMPLE LOCATIONS**

- NOTES:**
1. WHITE WOVEN TAPE ON SEAMS OF FURNACE DUCTING THROUGHOUT IS ACM.
 2. WHITE DUCT SHIELDS ON WOODEN JOISTS ABOVE FURNACE DUCTING IS ACM.
 3. BROWN WINDOW FRAME CAULKING BETWEEN WINDOW FRAMES AND EXTERIOR OF THE BUILDING IS ACM.
 4. DRYWALL JOINT COMPOUND THROUGHOUT IS ACM.
 5. THIS DRAWING ILLUSTRATES SUPPORTING INFORMATION SPECIFIC TO A STANTEC CONSULTING LTD. REPORT AND MUST NOT BE USED FOR OTHER PURPOSES.
