Small Craft Harbours,  
Department of Fisheries and Oceans

## **Port Dalhousie, ON – East and West Piers Condition and Structural Evaluation Report**

60334134

March, 2015

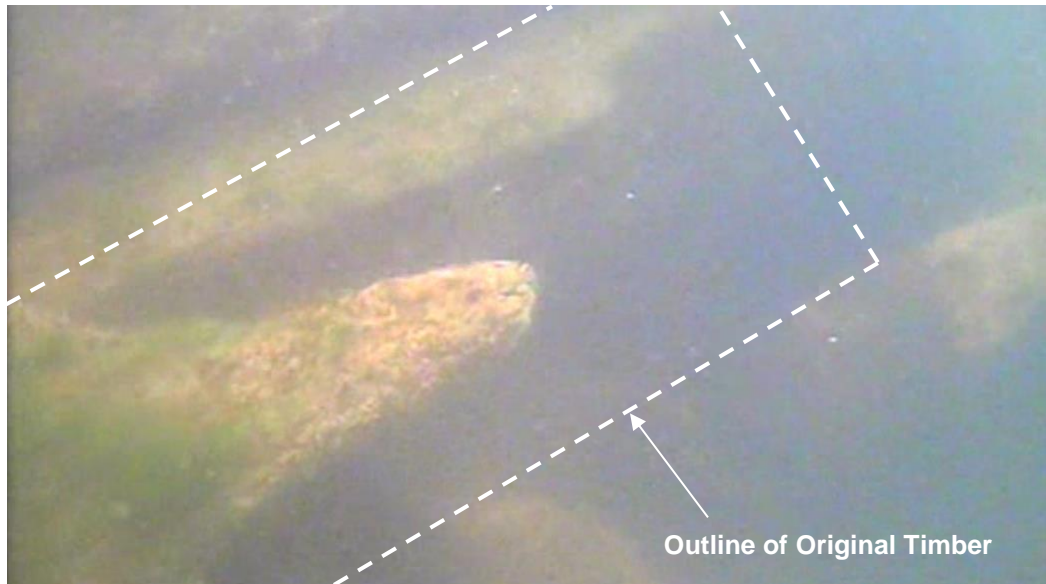
The majority of the timber cribs inspected by the ASI Group divers were observed to be in fair-to-poor condition. The ends of many of the timber headers (facing members) have decayed to such a degree that they are no longer securely fastened to the timber cross-ties. Ends of both headers and cross-ties have rotted and disintegrated around the steel spikes (See Figures 8 and 9 below, which contain enhanced photos from the underwater inspection). In other locations, the timber ends were found to be intact but severely rotted and easily disintegrated when probed, exposing the steel spikes that hold the crib walls together. During the underwater inspection, a section of crib facing, located at Station 0+465 on the east side of the West Pier, collapsed when a timber was probed by the diver. In many cases, the top two header timbers are missing from the crib (See Figure 10). In many places, the crib headers were observed to be bulging outward into the channel or were completely missing (see Figure 11 on page 13 for an illustrative example). In other places, the remains of the timber piles from the original fender system were observed to be the only thing holding the crib headers in place (see Figure 12 for an illustrative example). No signs of undermining of the timber cribs were observed, although this is likely due to the placement of a toe berm in front of portions of the crib facing during the 1993 repair.

**Figure 9: End of Timber Headers has Disintegrated at Connection**

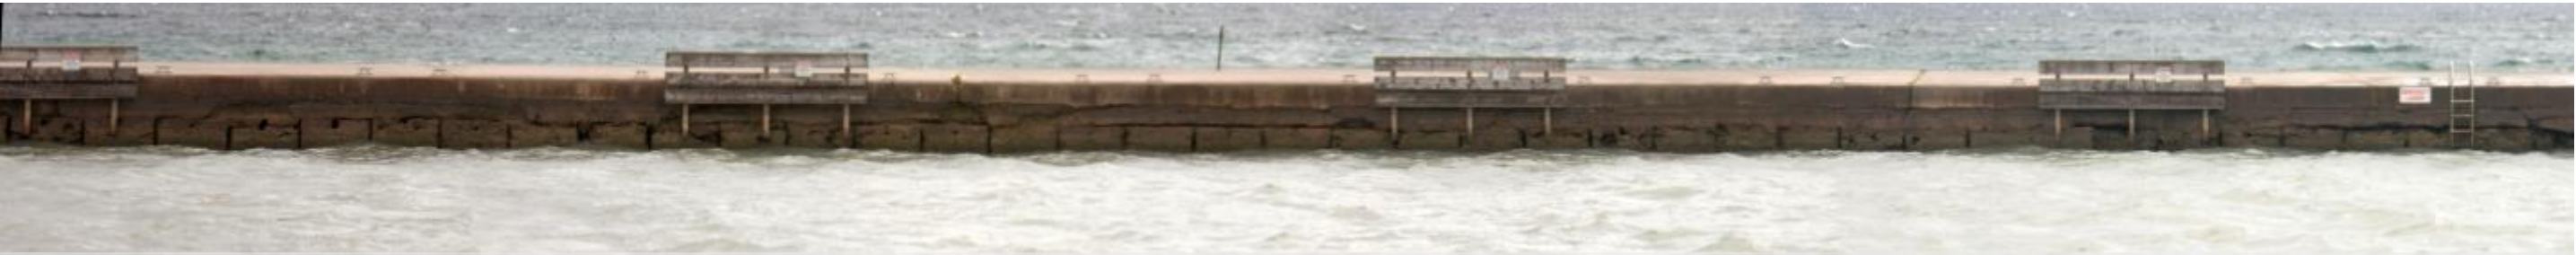
Station 0+490 to 0+545

Photo 4, Concrete Coping Above Water  
Port Dalhousie, ON - West Pier (Channel Side)  
December 2014

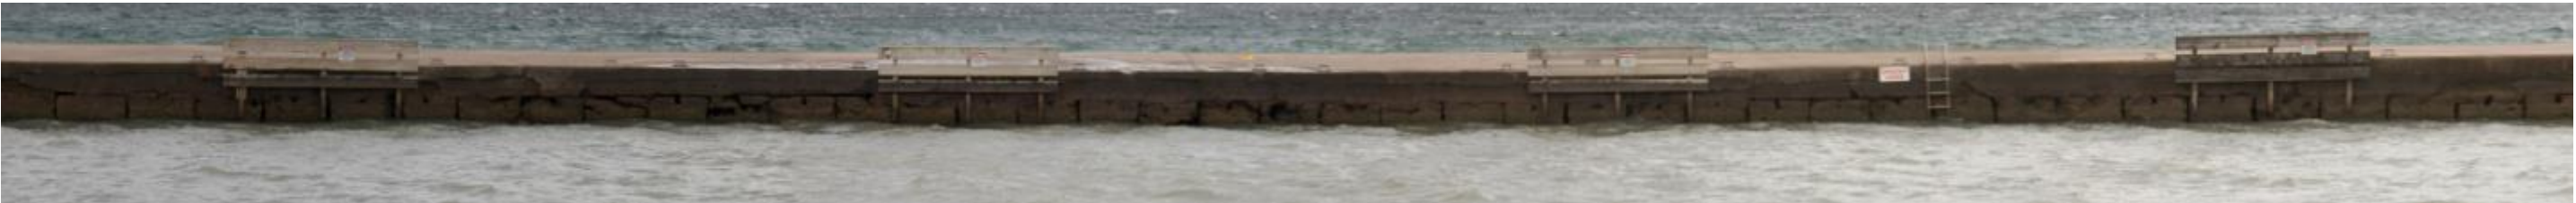
Station 0+450 to 0+500

Photo 5, Concrete Coping Above Water  
Port Dalhousie, ON - West Pier (Channel Side)  
December 2014

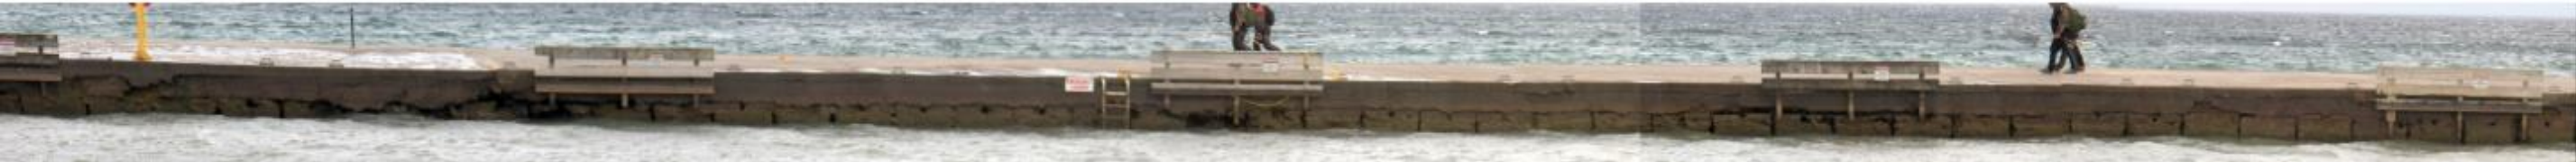
Station 0+400 to 0+460

Photo 6, Concrete Coping Above Water  
Port Dalhousie, ON - West Pier (Channel Side)  
December 2014

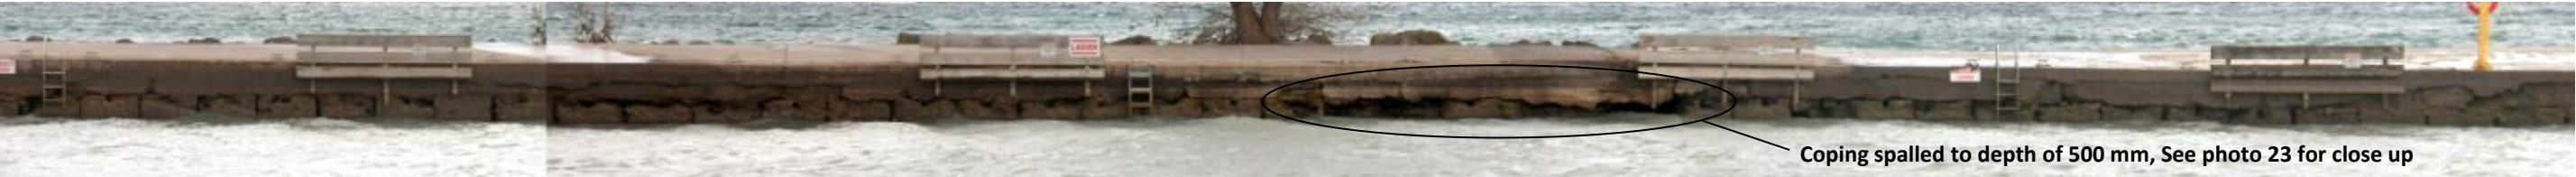
Station 0+360 to 0+400

Photo 7, Concrete Coping Above Water  
Port Dalhousie, ON - West Pier (Channel Side)  
December 2014

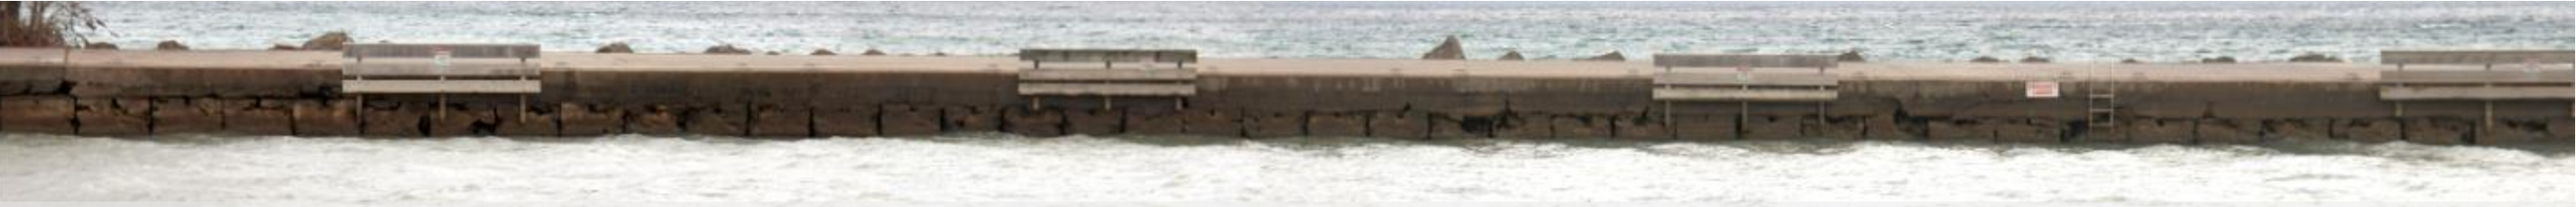
Station 0+315 to 0+365

Photo 8, Concrete Coping Above Water  
Port Dalhousie, ON - West Pier (Channel Side)  
December 2014

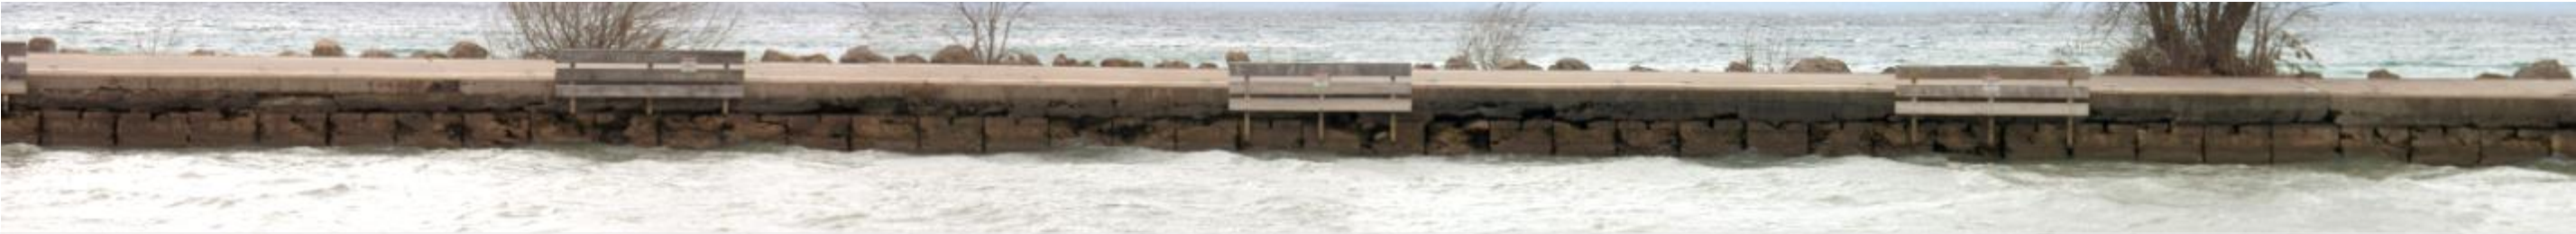
Station 0+275 to 0+325

Photo 9, Concrete Coping Above Water  
Port Dalhousie, ON - West Pier (Channel Side)  
December 2014

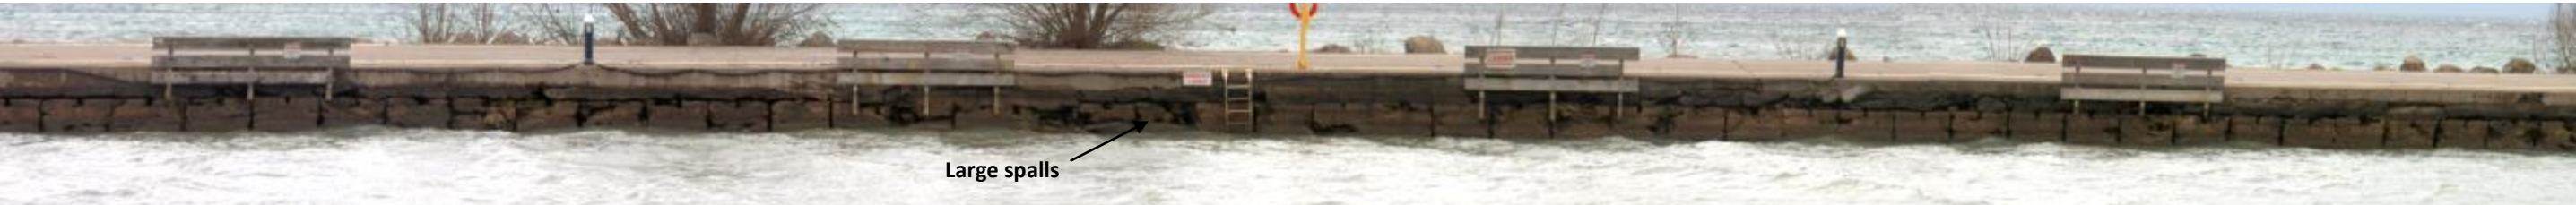
Station 0+230 to 0+280

Photo 10, Concrete Coping Above Water  
Port Dalhousie, ON - West Pier (Channel Side)  
December 2014

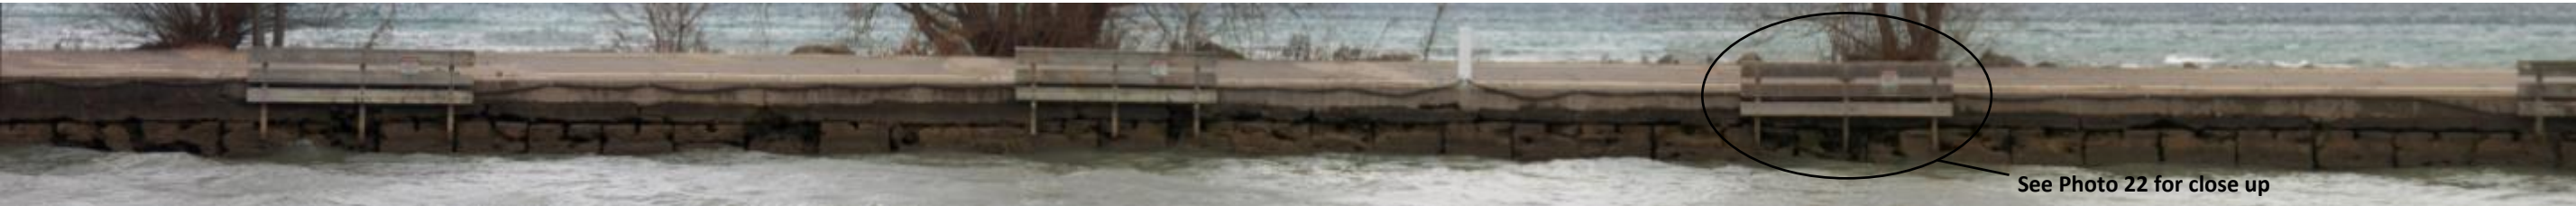
Station 0+185 to 0+230

Photo 11, Concrete Coping Above Water  
Port Dalhousie, ON - West Pier (Channel Side)  
December 2014

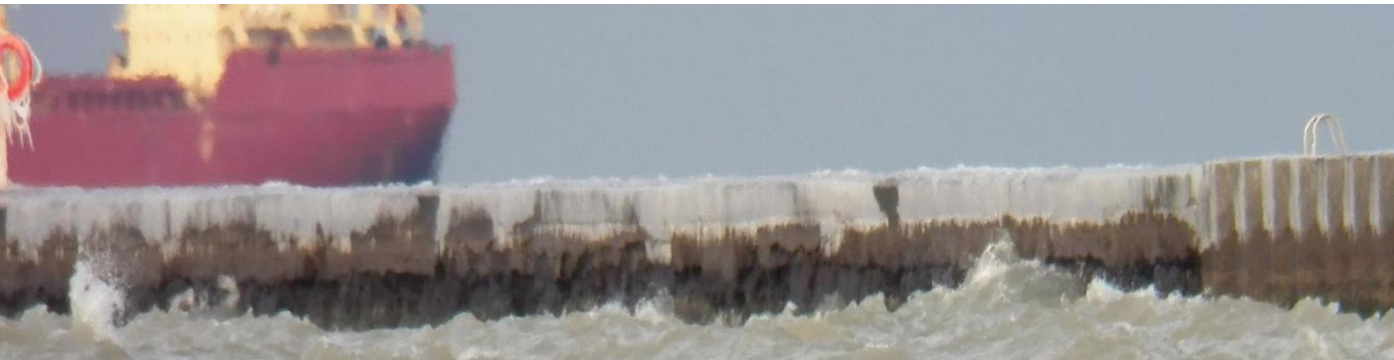
Station 0+600 to 0+575

Photo 16, Concrete Coping Above Water  
Port Dalhousie - West Pier (Lake Side)  
December 2014

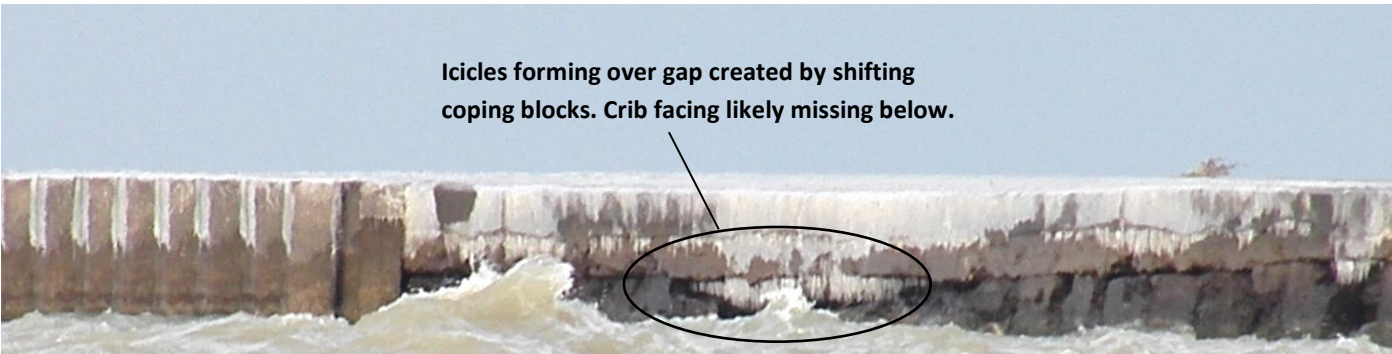
Station 0+560 to 0+525

Photo 17, Concrete Coping Above Water  
Port Dalhousie - West Pier (Lake Side)  
December 2014

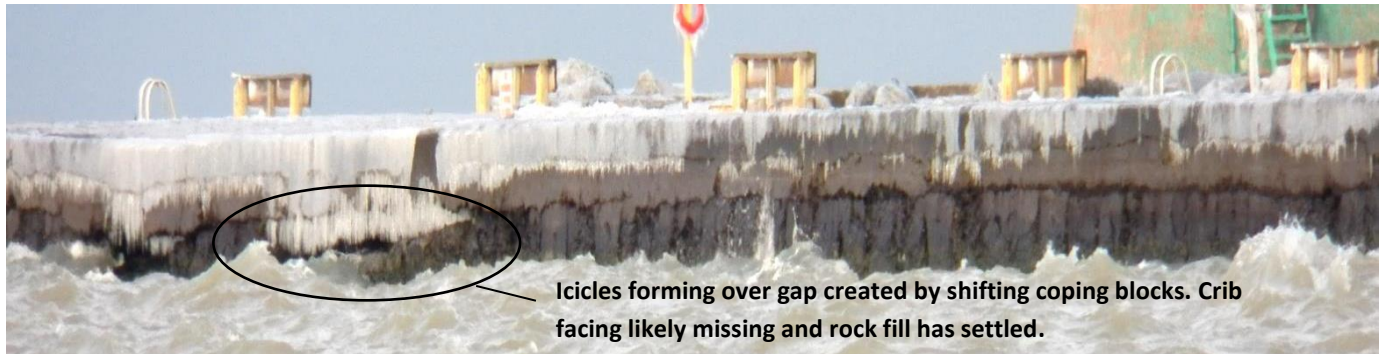
Station 0+520 to 0+480

Photo 18, Concrete Coping Above Water  
Port Dalhousie - West Pier (Lake Side)  
December 2014

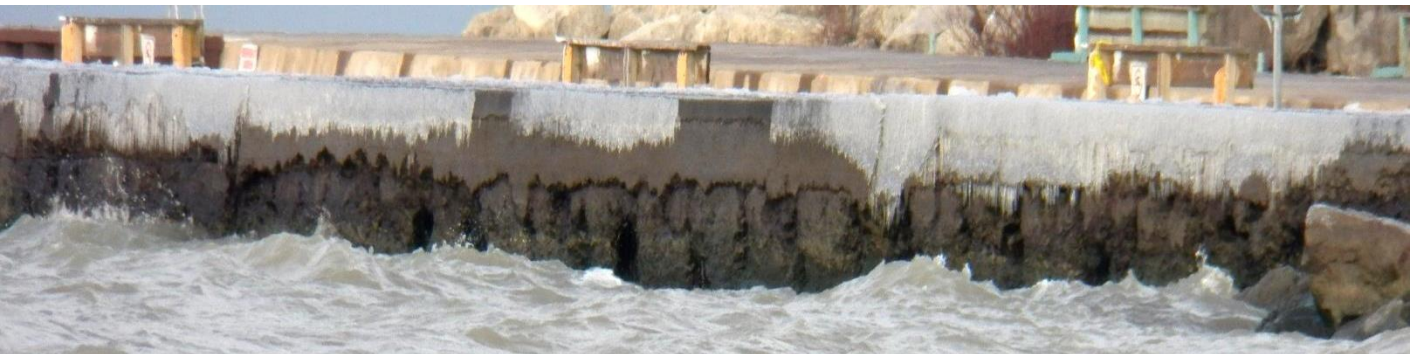
Station 0+400 to 0+360

Photo 19, Concrete Coping Above Water  
Port Dalhousie - West Pier (Lake Side)  
December 2014

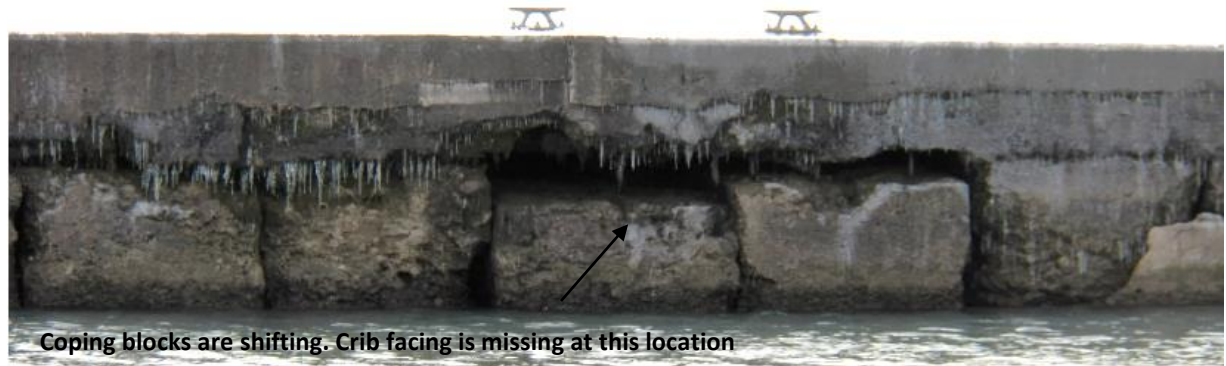
Station 0+520

Photo 20, Close up – See Photo 4  
Port Dalhousie - West Pier (Channel Side)  
December 2014

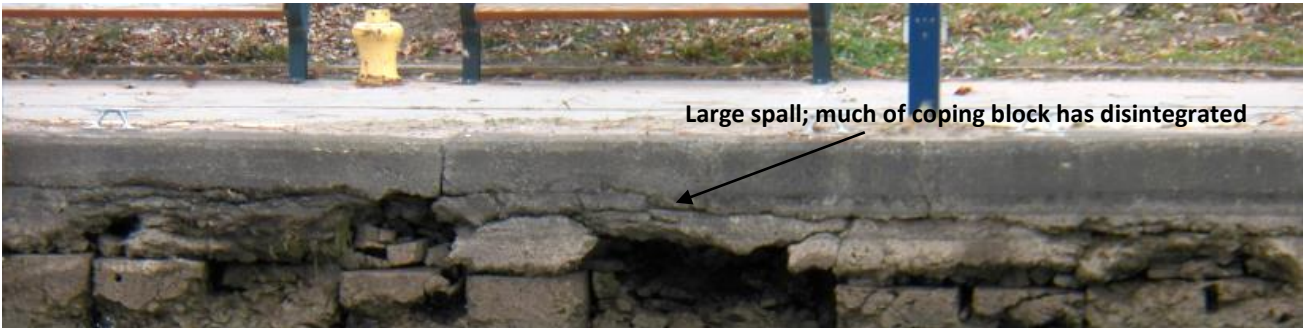
Station 0+020

Photo 21, Concrete Coping Above Water – See Photo 15  
Port Dalhousie - West Pier (Channel Side)  
December 2014

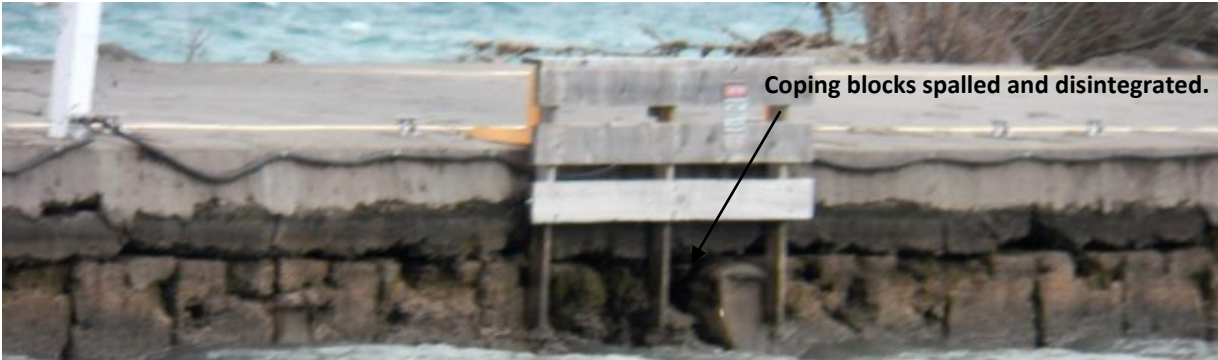
Station 0+170

Photo 22, Concrete Coping – See Photo 12  
Port Dalhousie - West Pier (Channel Side)  
December 2014

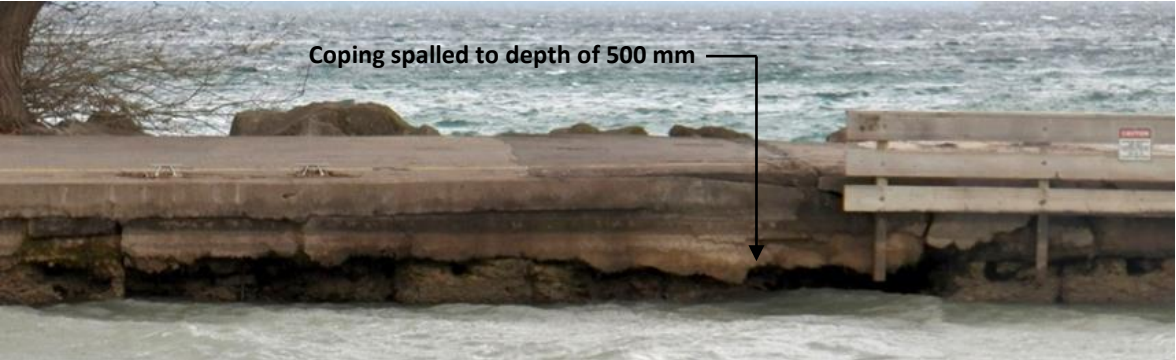
Station 0+335

Photo 23, Concrete Coping – See Photo 8  
Port Dalhousie - West Pier (Channel Side)  
December 2014

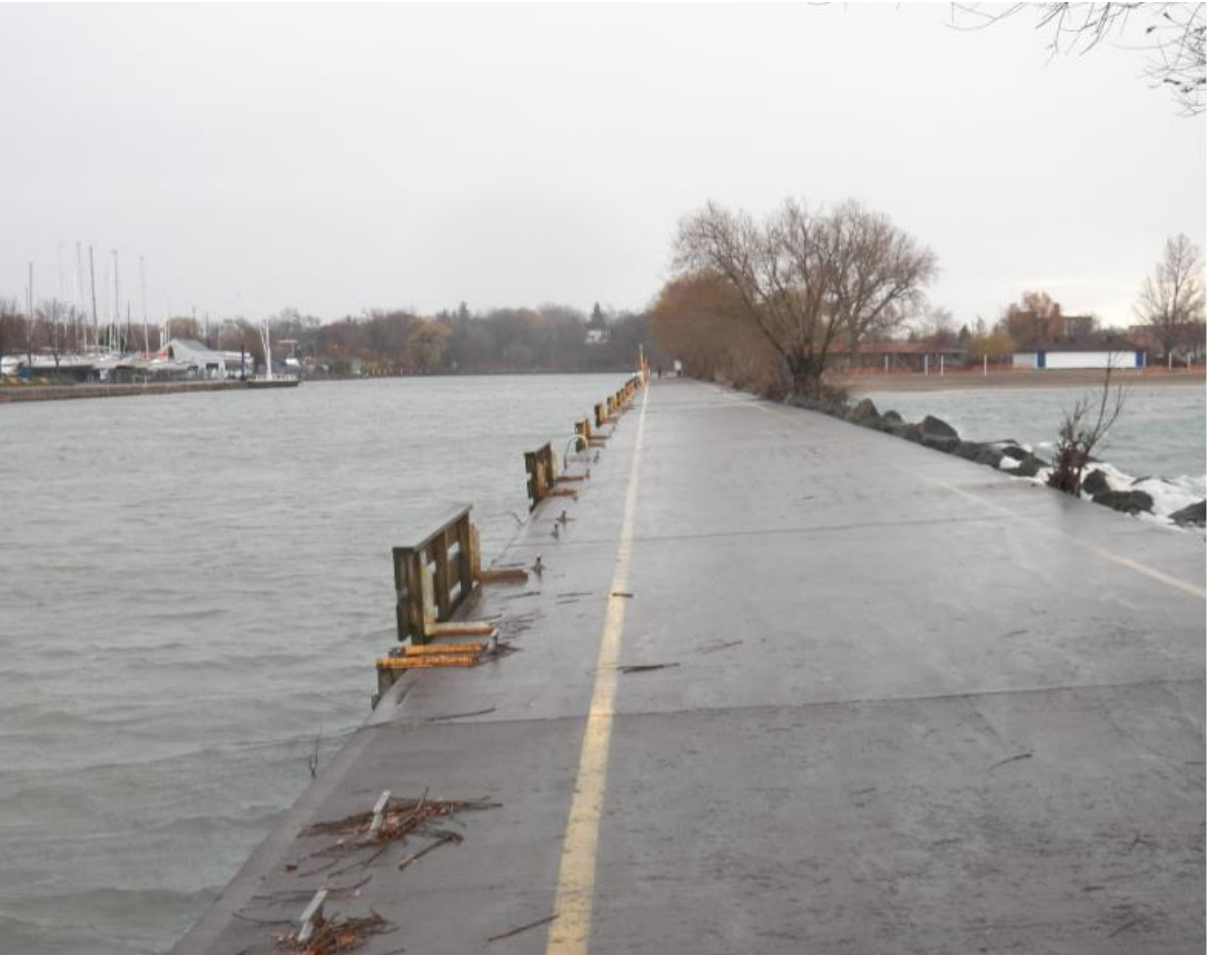
Station 0+400  
West Pier Looking South

Photo 24, Concrete Deck  
Port Dalhousie - West Pier  
December 2014

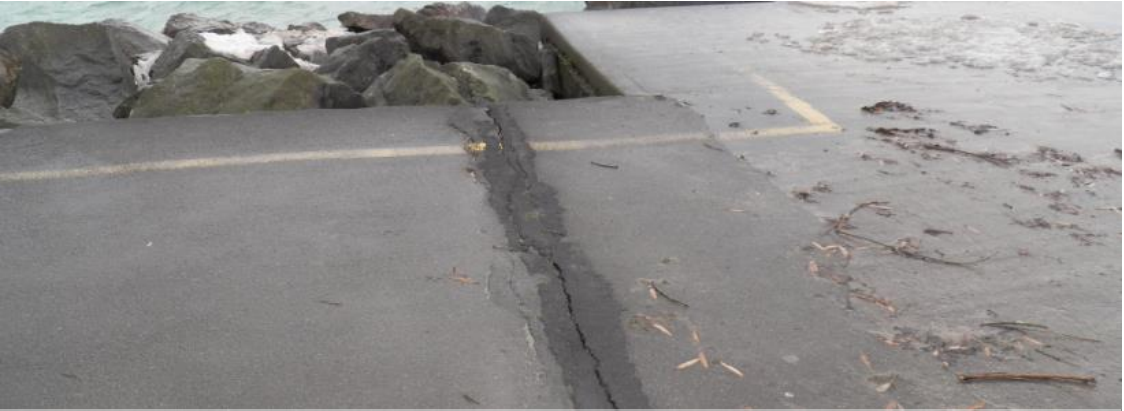
Station 0+345

Photo 25, Concrete Deck  
Port Dalhousie - West Pier  
December 2014

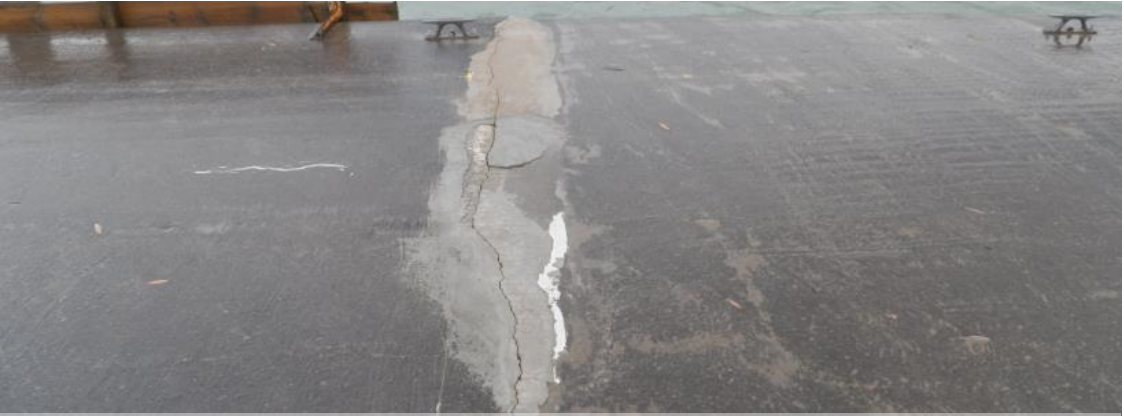
Station 0+475

Photo 26, Concrete Deck  
Port Dalhousie - West Pier  
December 2014

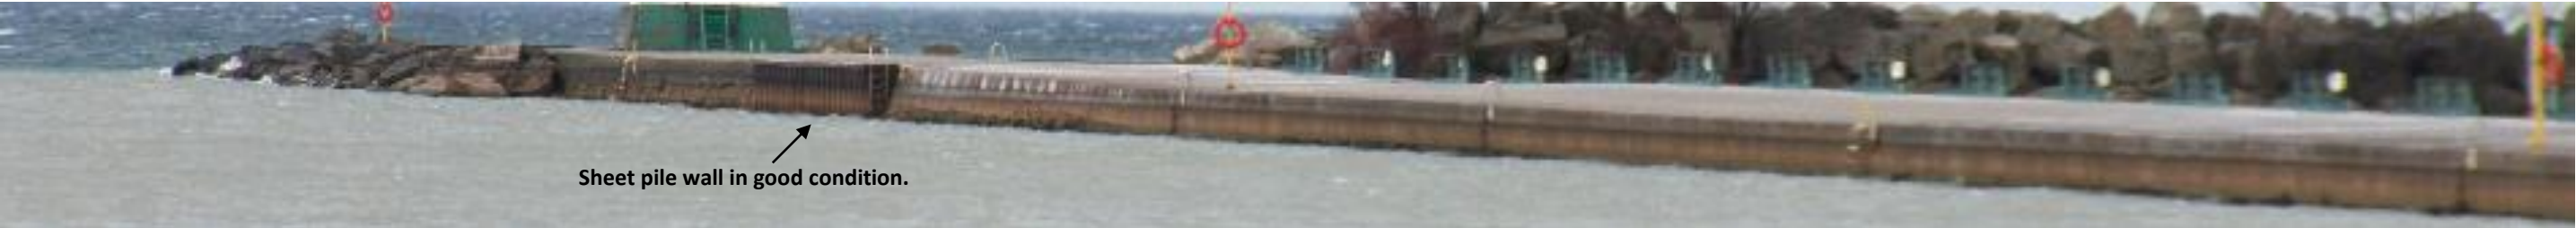
Station 0+680 to 0+300

Photo 27, Concrete Coping Above Water  
Port Dalhousie, ON - East Pier (Channel Side)  
December 2014

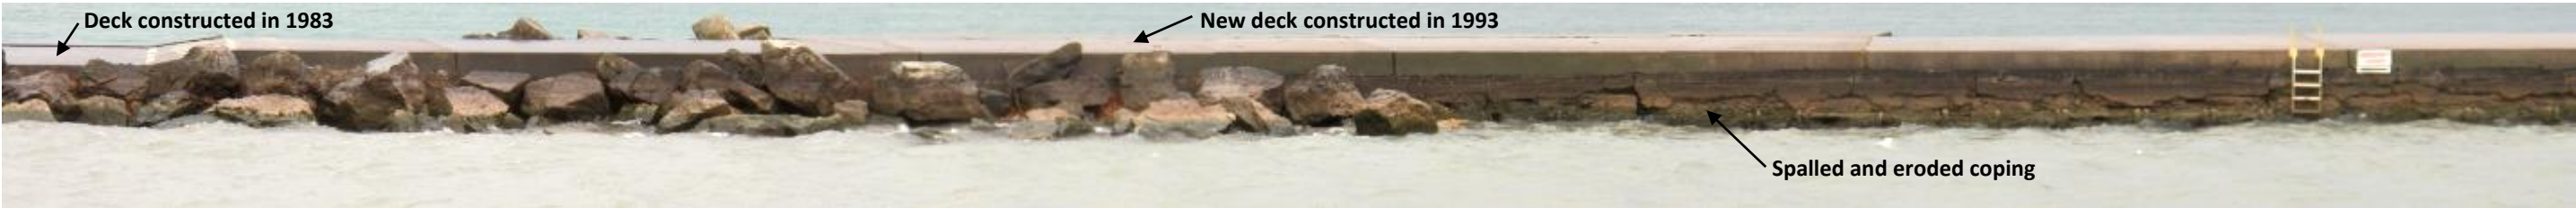
Station 0+610 to 0+560

Photo 28, Concrete Coping Above Water  
Port Dalhousie, ON - East Pier (Channel Side)  
December 2014

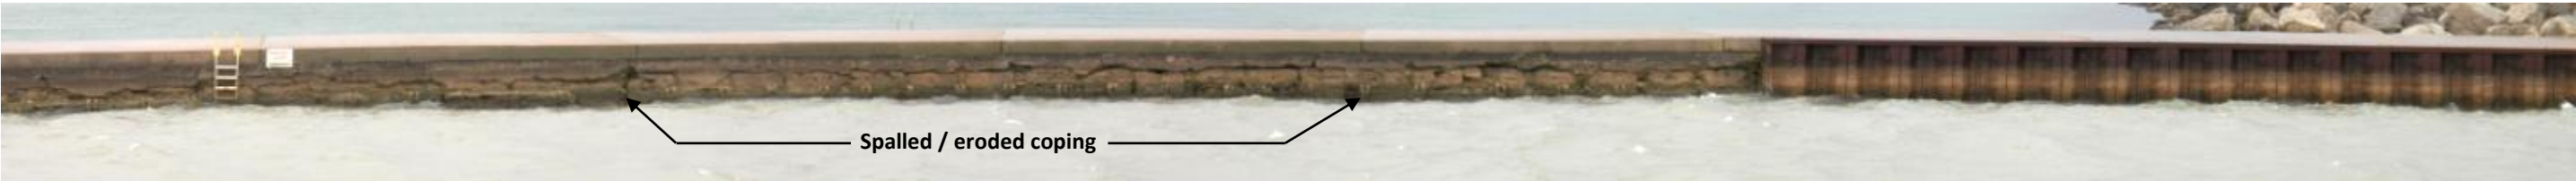
Station 0+570 to 0+510

Photo 29, Concrete Coping Above Water  
Port Dalhousie, ON - East Pier (Channel Side)  
December 2014

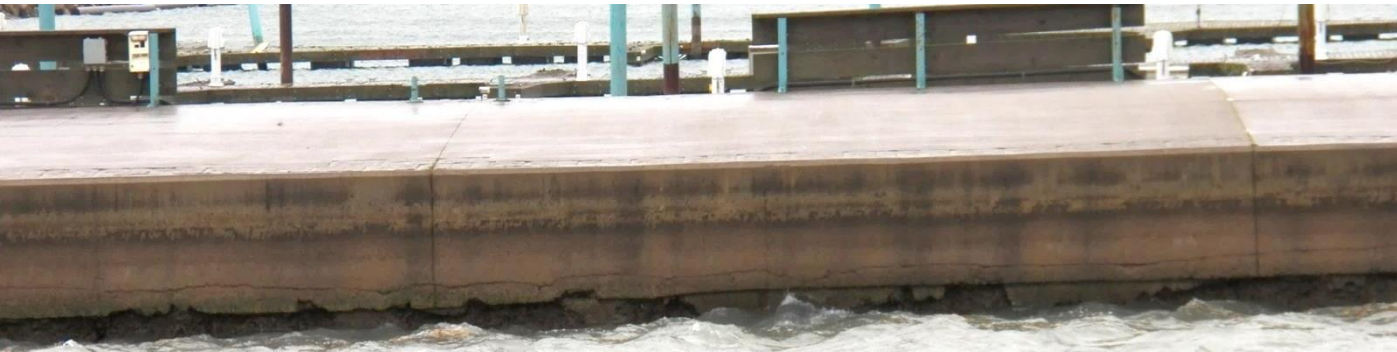
Photo 42, Concrete Coping Above Water, See photo 32  
Station 0+420 to 0+400  
Port Dalhousie - East Pier (Channel Side)  
December 2014

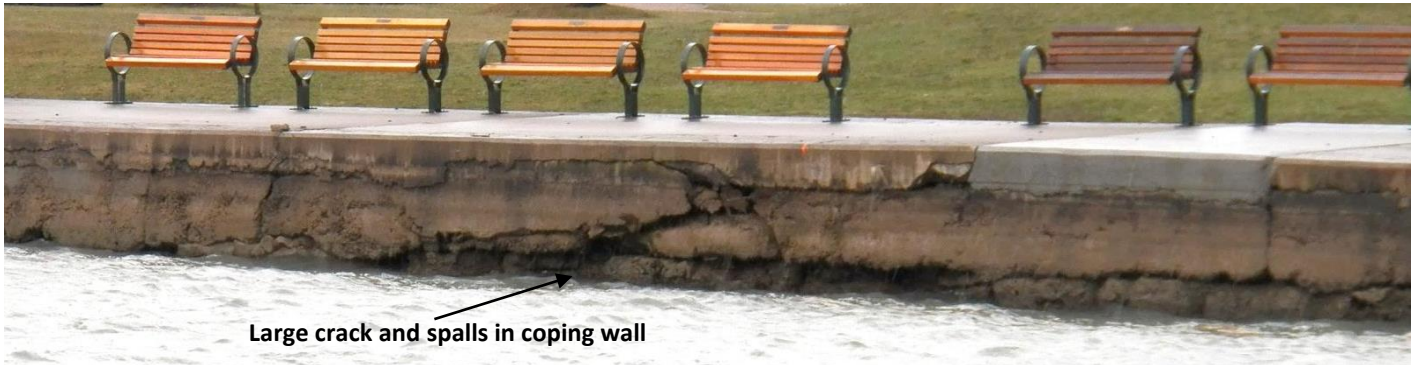
Photo 43, Concrete Coping Above Water, See photo 36  
Station 0+240 to 0+230  
Port Dalhousie -East Pier (Channel Side)  
December 2014

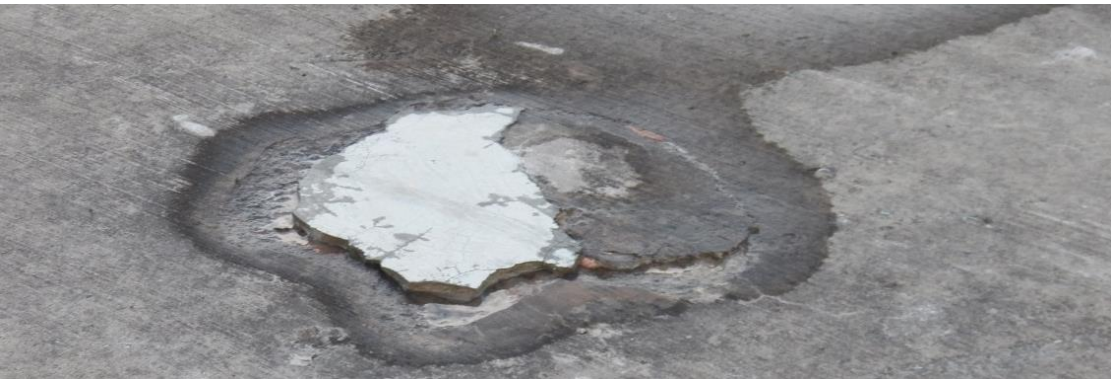
Photo 44, Delaminated Surface, Concrete Deck  
Station 0+235  
Port Dalhousie - East Pier  
December 2014

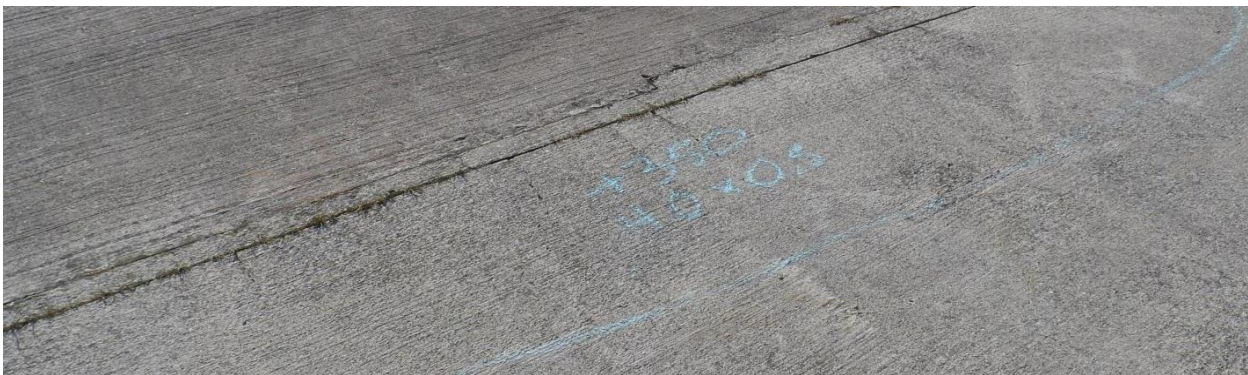
Photo 45, Delaminated Surface, Concrete Deck  
Station 0+350  
Port Dalhousie - East Pier  
December 2014

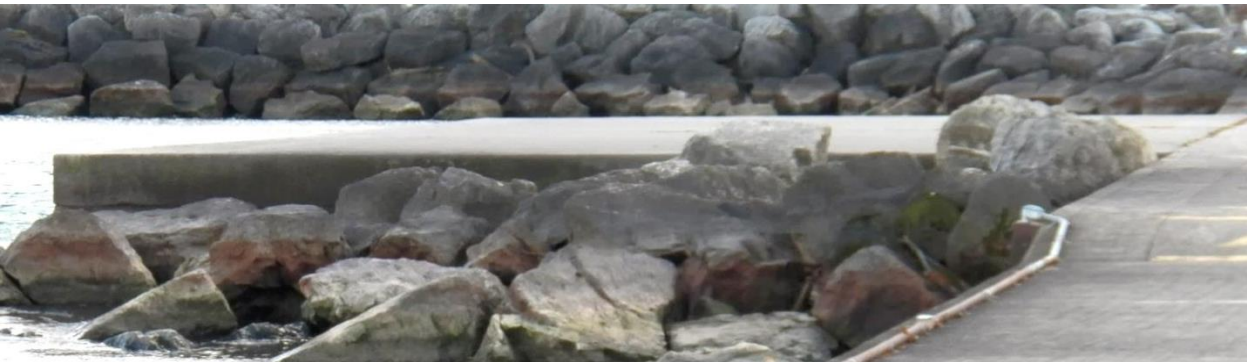
Photo 46, Existing Rock Fill Berm  
Station 0+590  
Port Dalhousie - East Pier (Lake Side)  
East Pier Looking South  
December 2014

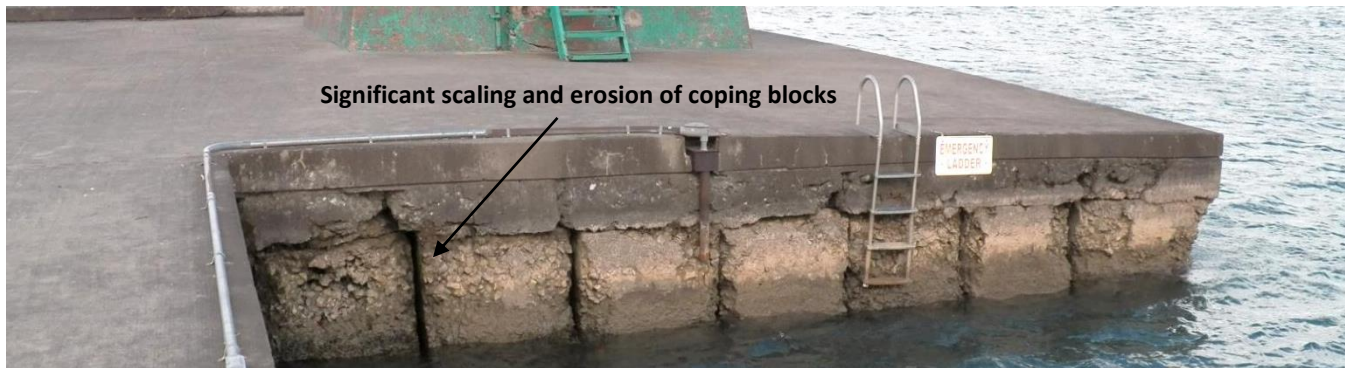
Photo 47, Concrete Coping Above Water  
Station 0+665  
Port Dalhousie - East Pier (Lake Side)  
December 2014

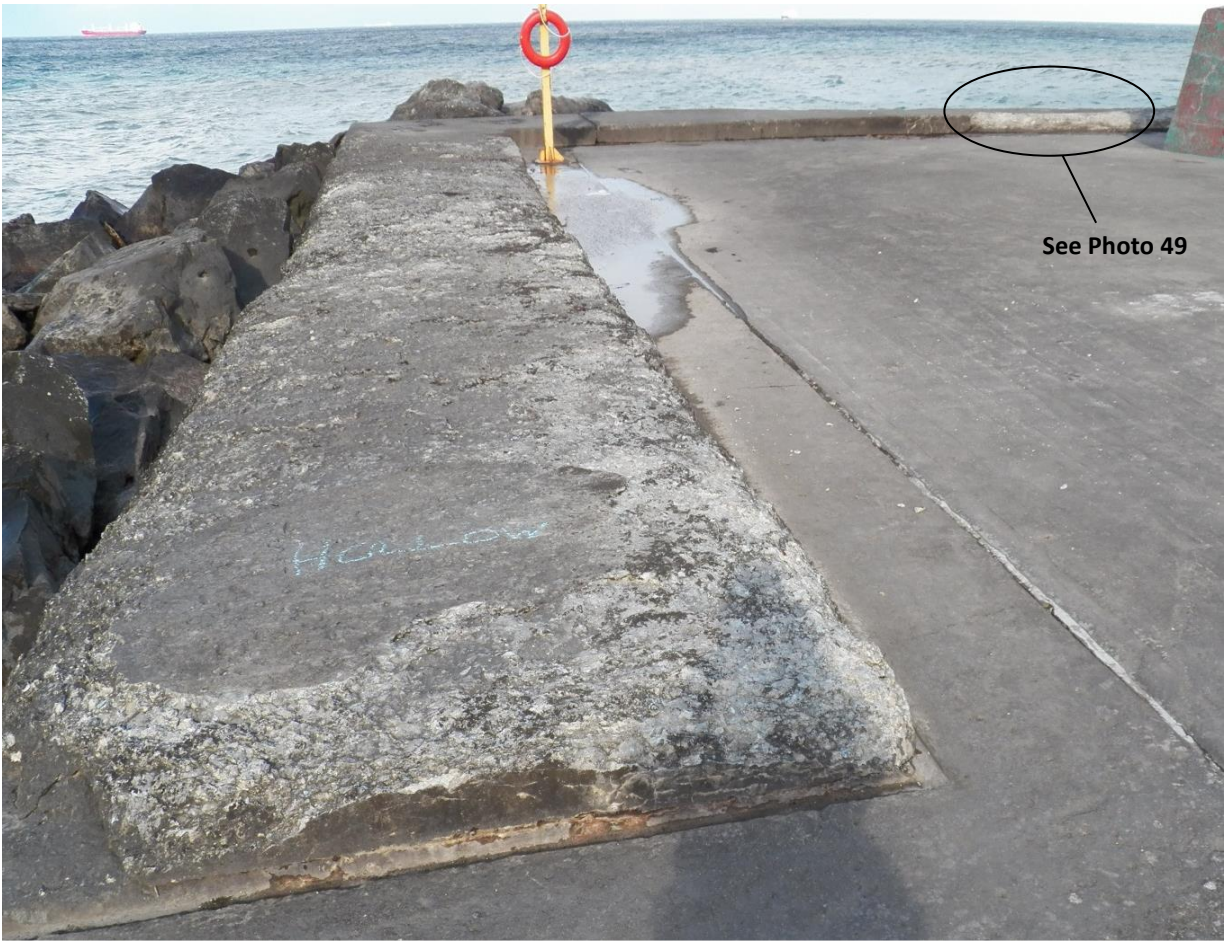
**Photo 48, Delaminated Surface, Concrete Deck  
Station 0+665 Port Dalhousie - East Pier  
December 2014**

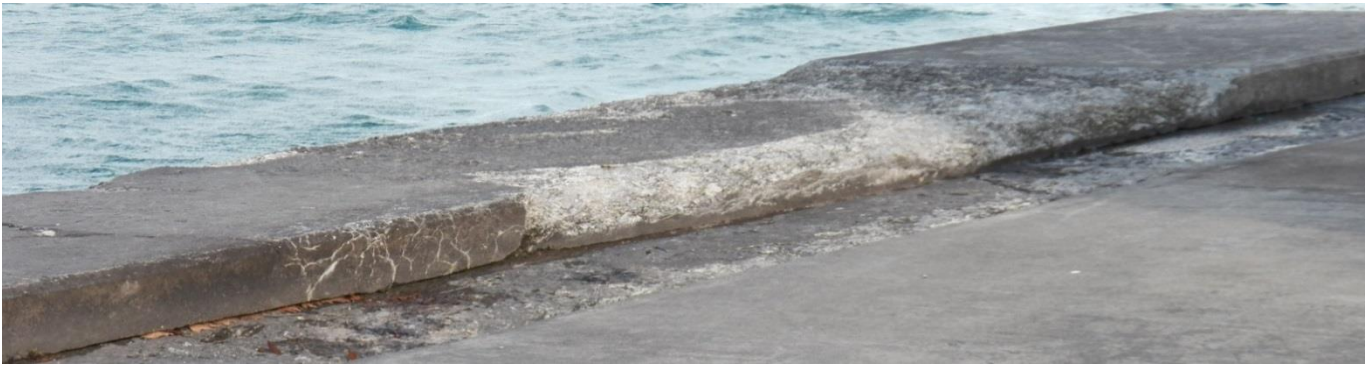
**Photo 49, Delaminated Surface, Concrete Deck  
Station 0+681 Port Dalhousie - East Pier  
December 2014**
