**DESIGNATED SUBSTANCES & HAZARDOUS MATERIALS SURVEY**

Fort George – Four Historic Buildings (Blockhouses)

51 Queens Parade, Niagara-on-the-Lake, ON

**ISSUED:** June 20, 2018

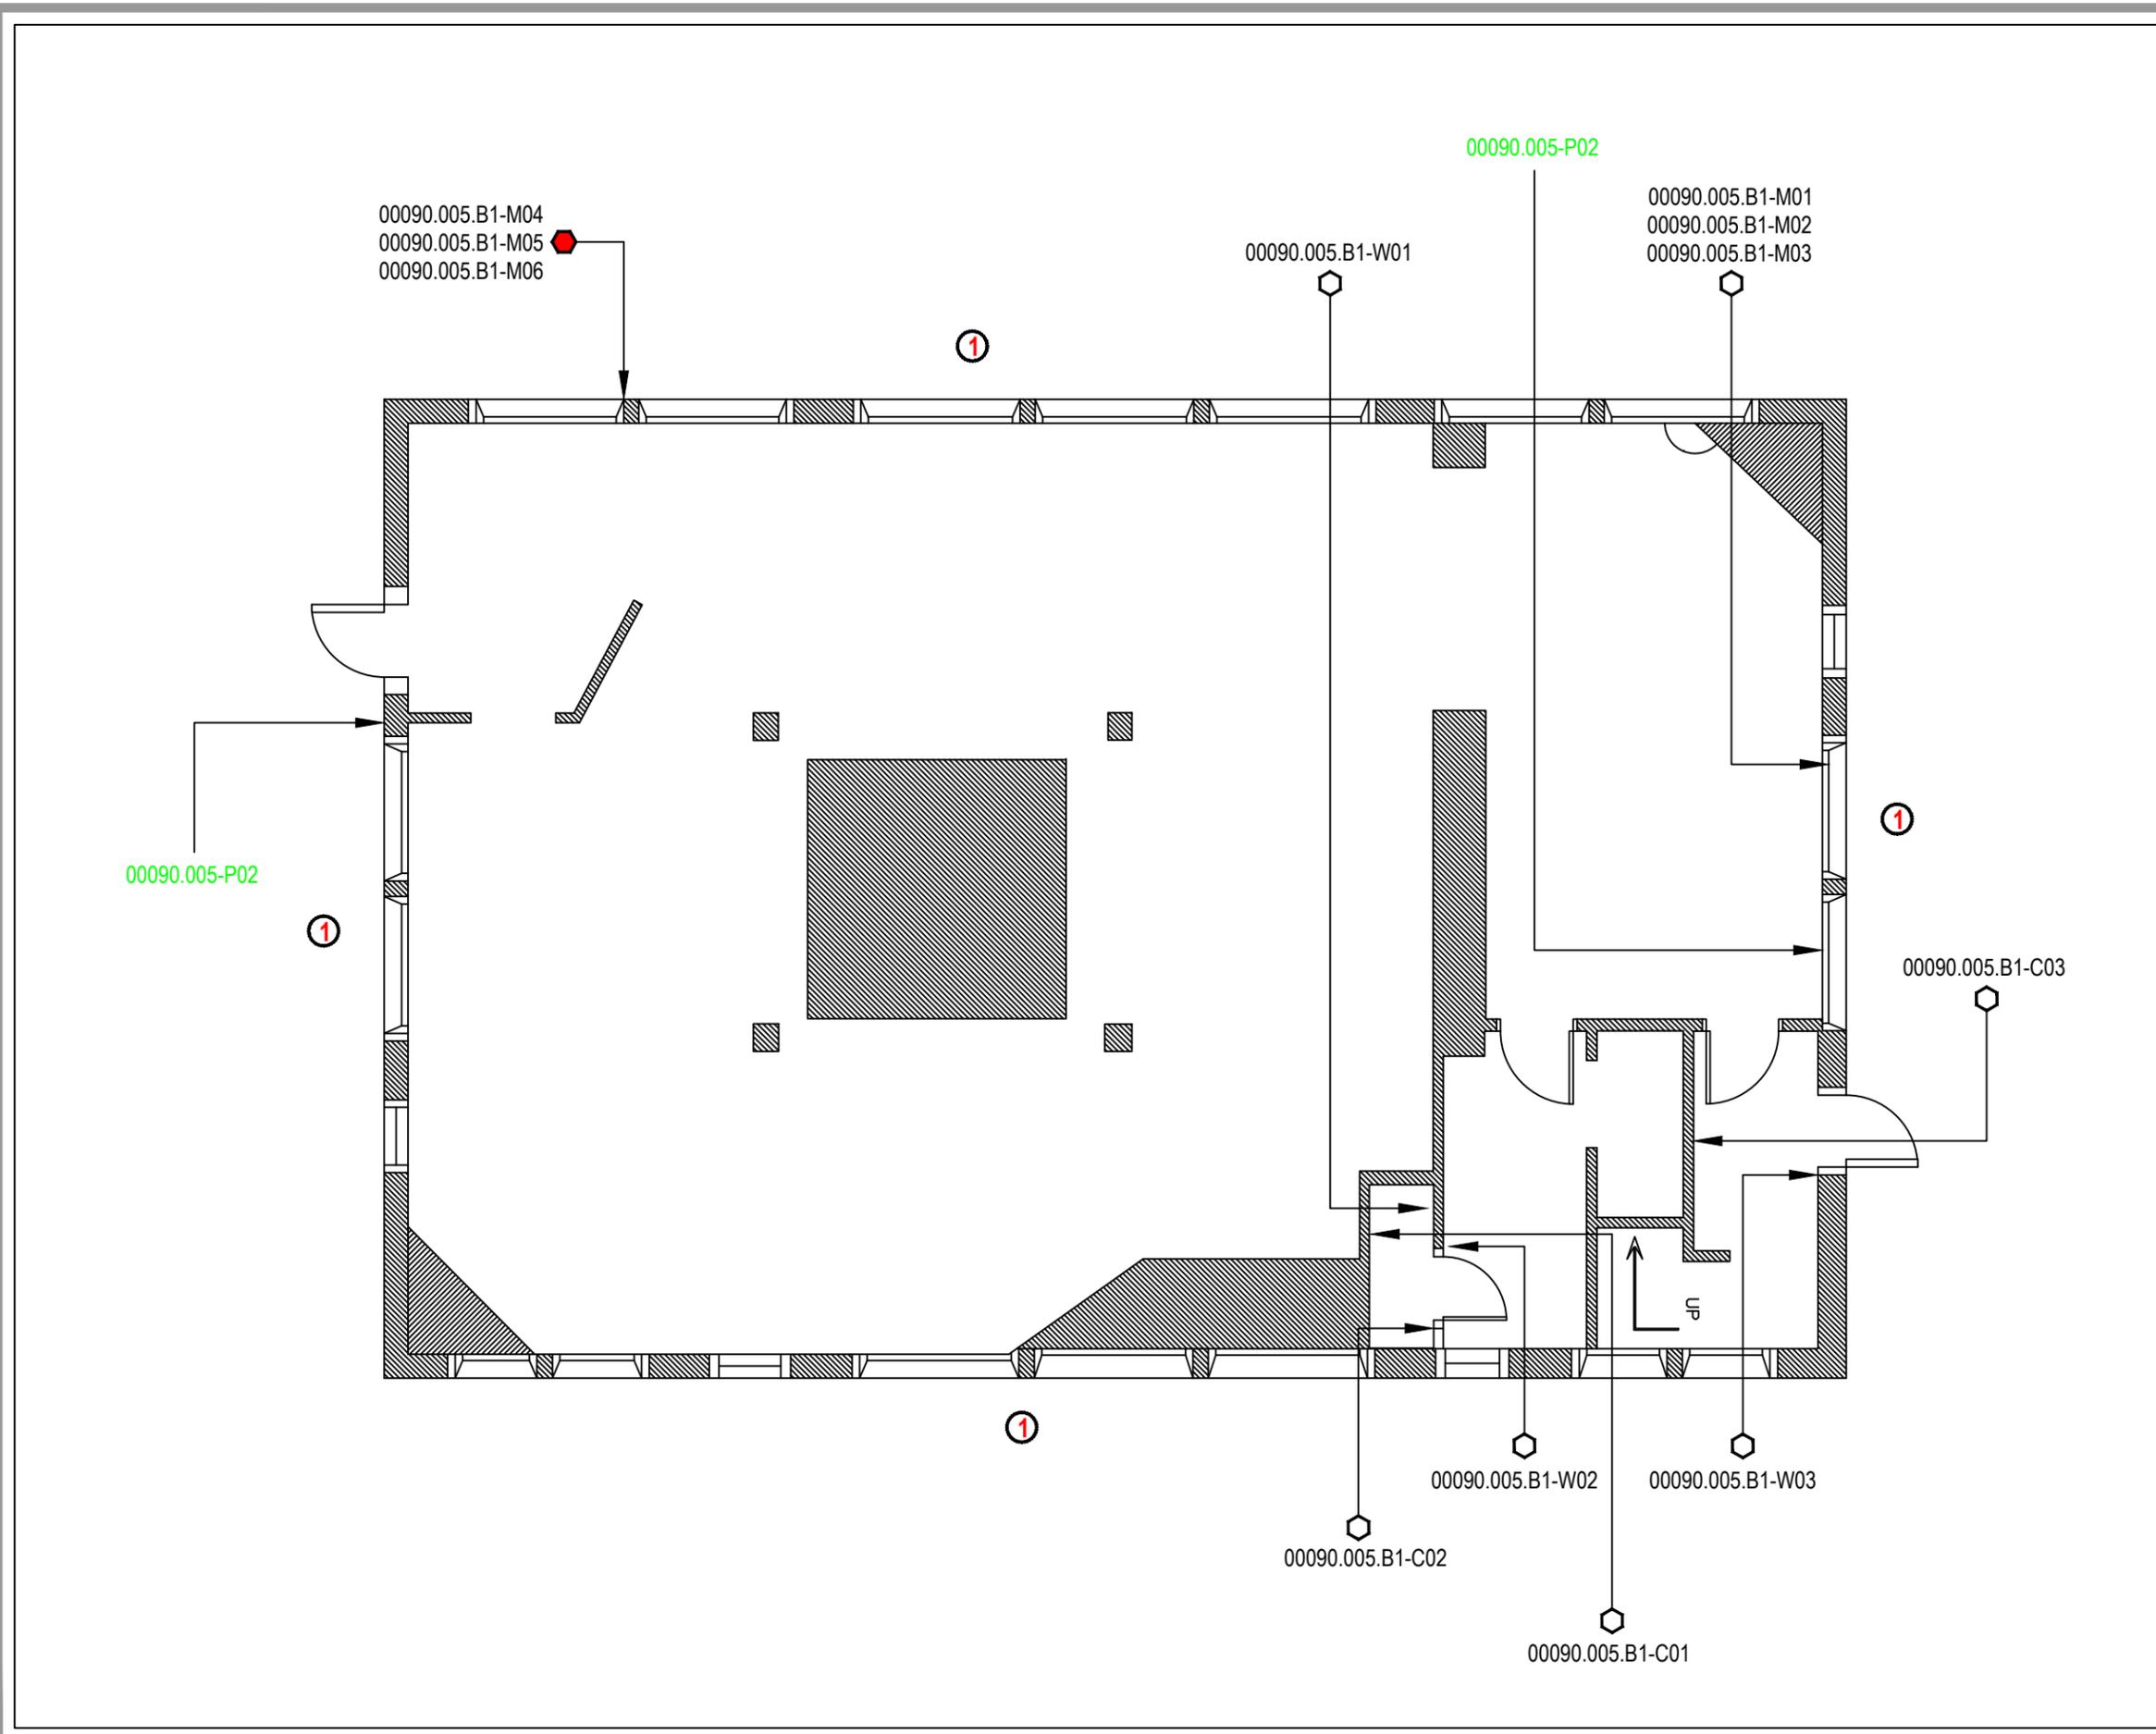
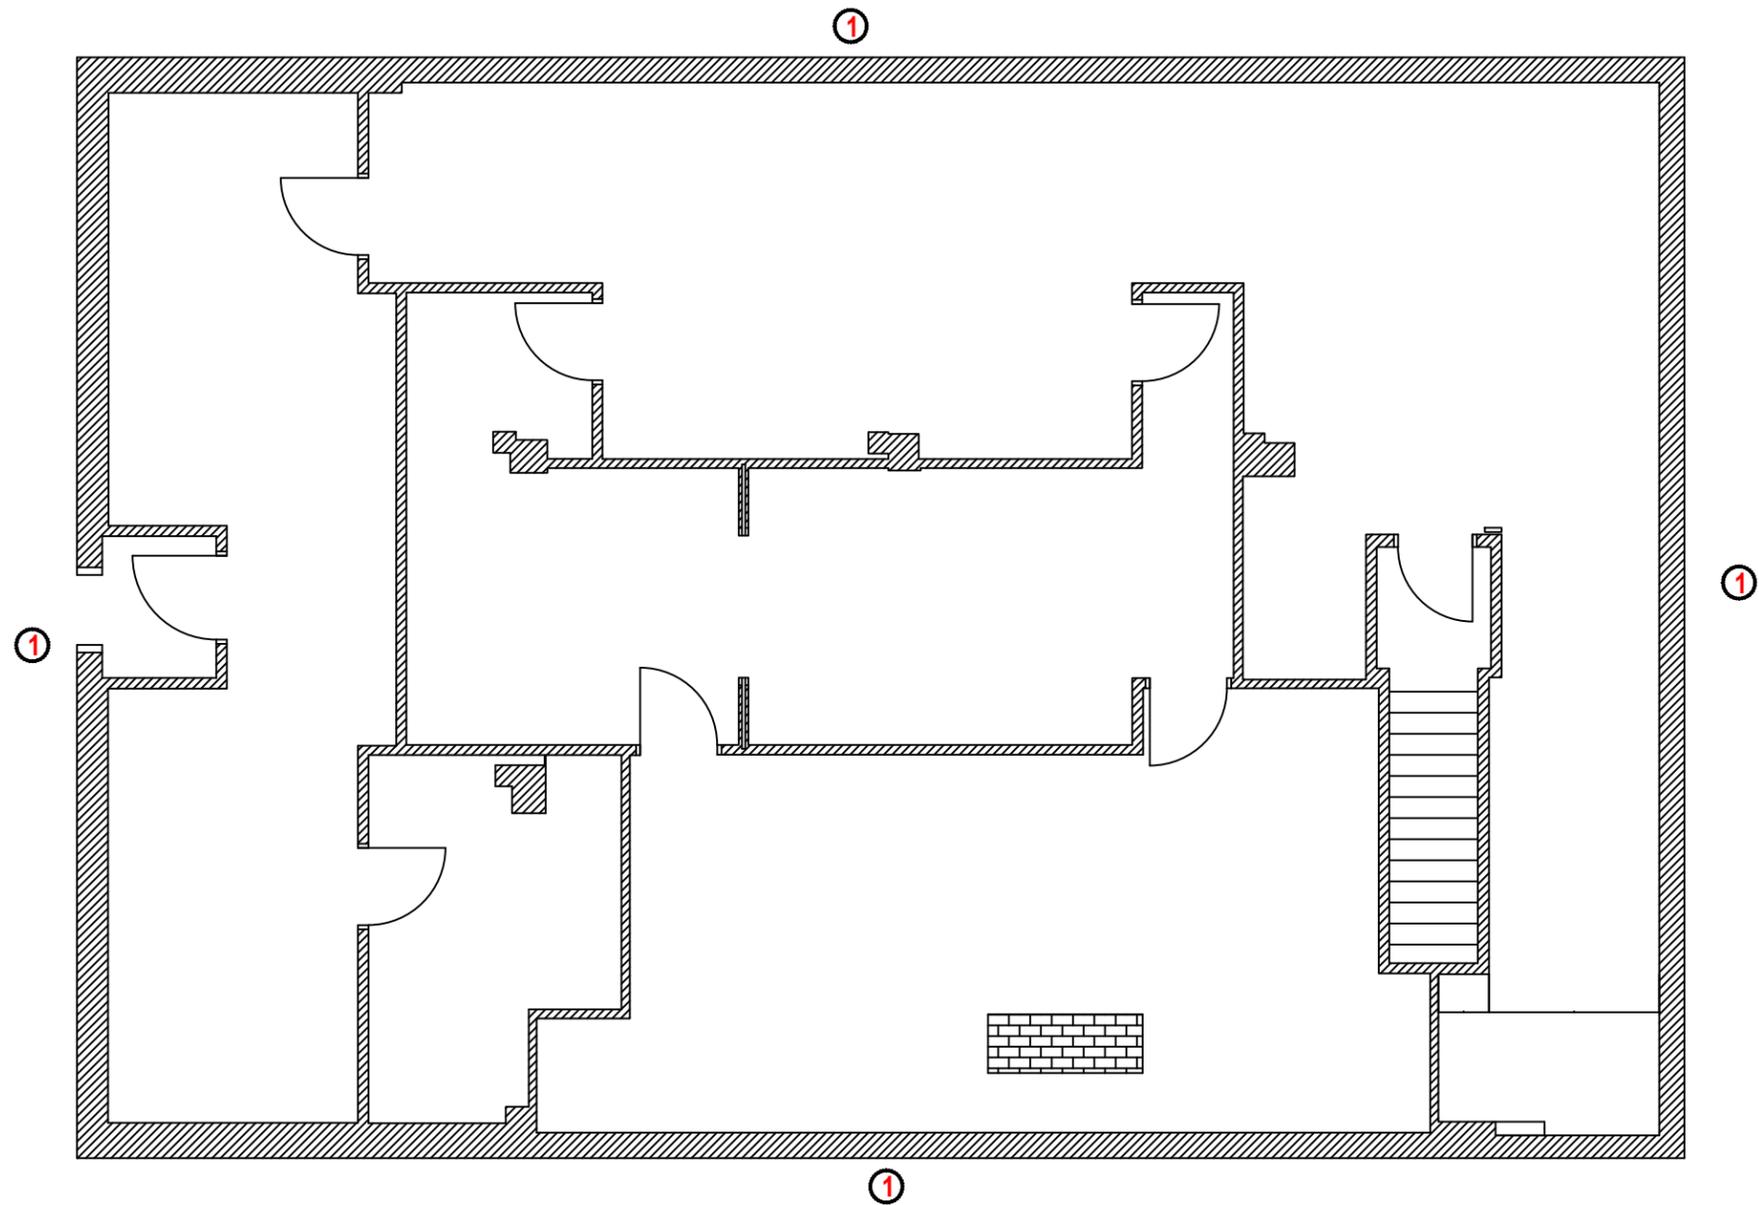
DWG #: **CP-FORTG-DSS-2018-01**

PAINT CODE	PAINT DESCRIPTION	ARSENIC ug/g	LEAD ug/g	MERCURY ug/g
01	GREY (EXT. CLAD)	N1	301	3
02	WHITE (INTERIOR)	N1	172	6

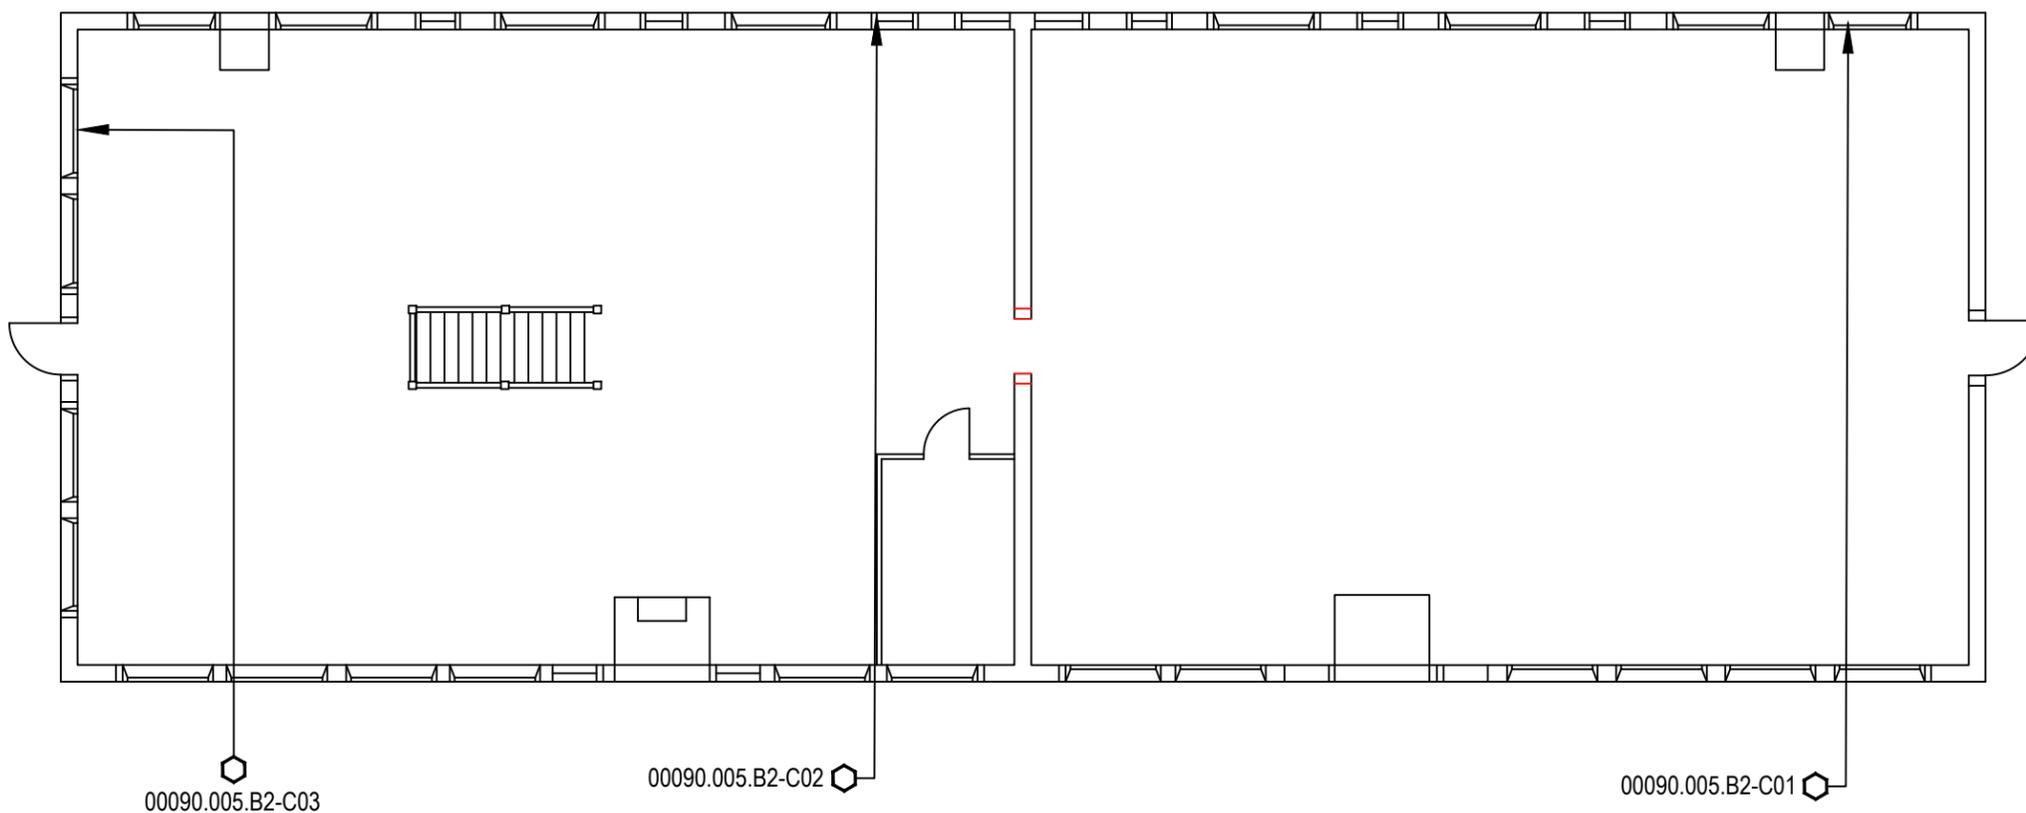
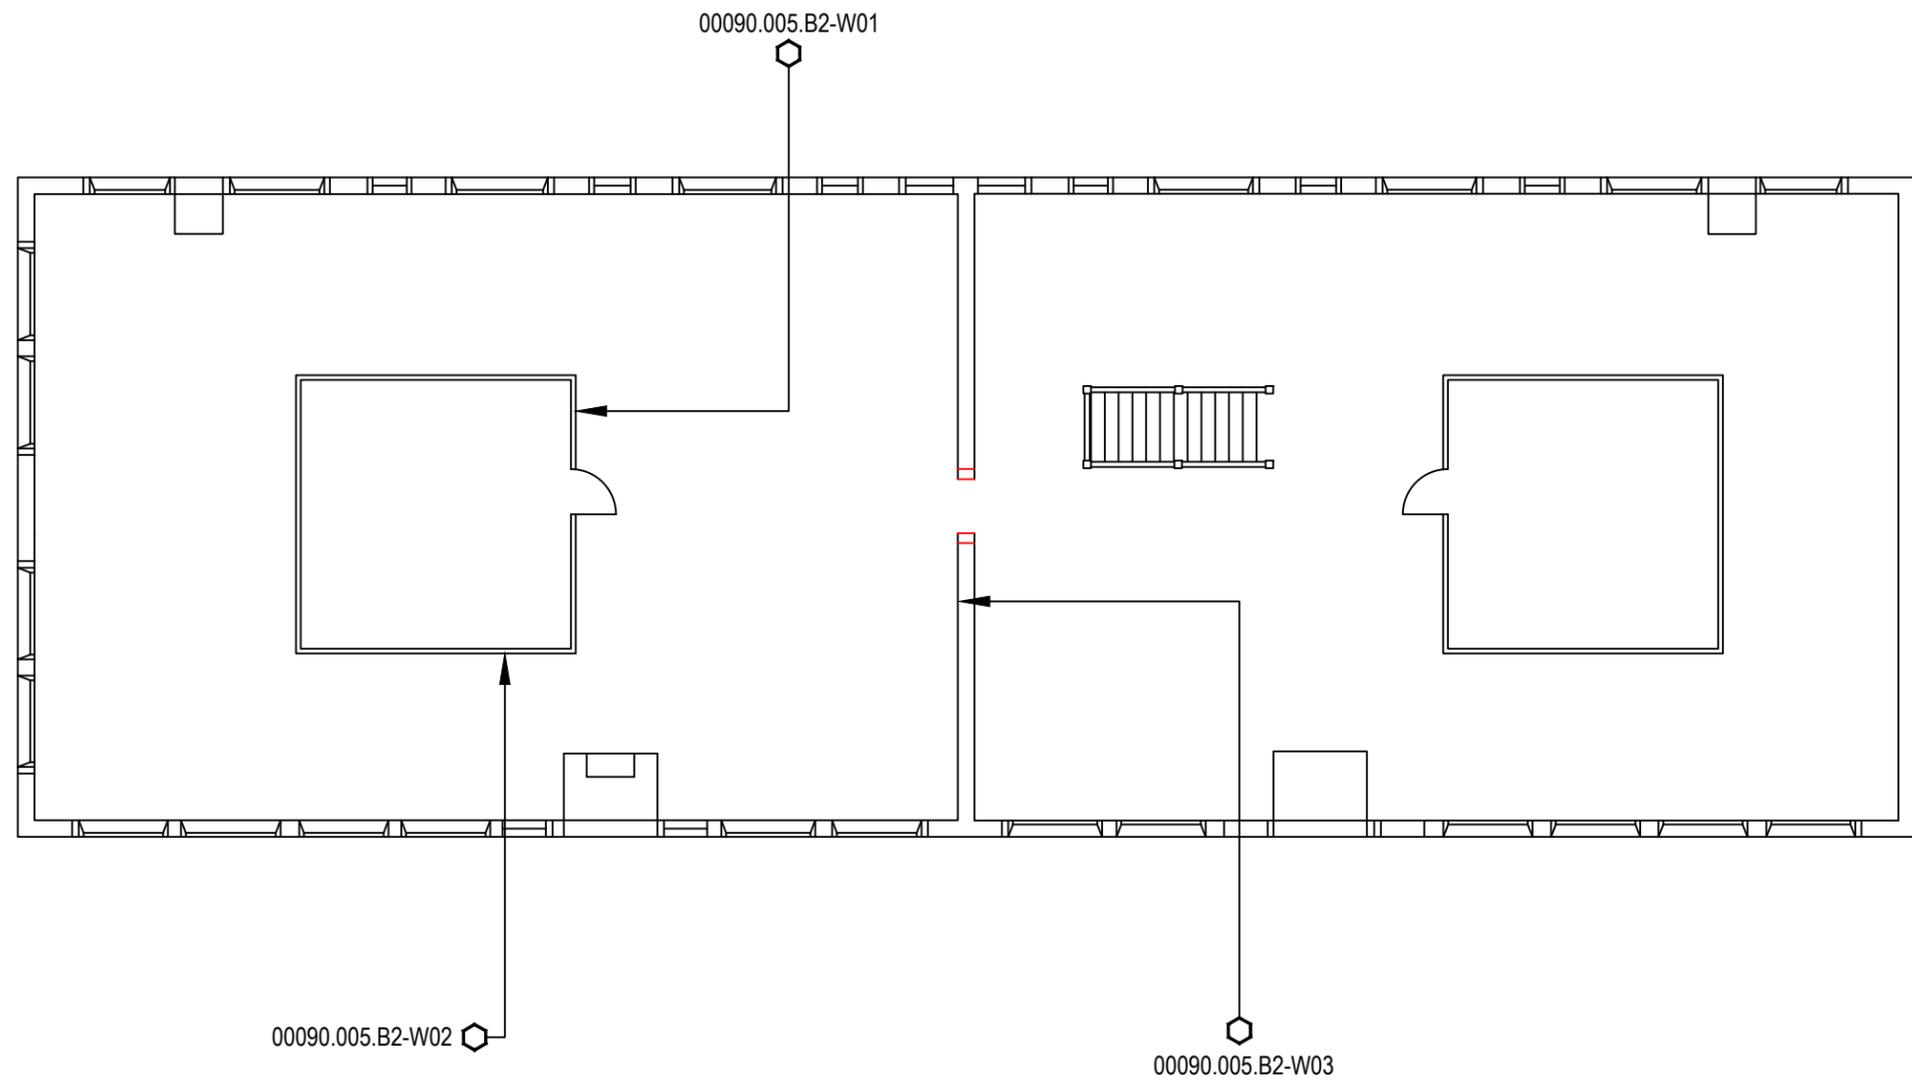
REV.	0	SCALE:	N. T. S.
DRAWN BY:	K. DOUGLAS	CHECKED BY:	S. HUSBAND
DATE:	JUNE 2018		
OESN JOB No:	00090.005		
DWG #:	<b>CP-FORTG-DSS-2018-04</b>		
<b>BLOCKHOUSE #2</b>

PAINT CODE	PAINT DESCRIPTION	ARSENIC ug/g	LEAD ug/g	MERCURY ug/g
01	GREY (EXT. CLAD)	N1	1090	25
02	WHITE (INTERIOR)	N1	10	N1
