**ESQUIMALT GRAVING DOCK
REPLACE MAIN DISTRIBUTION LINE (RMDL)
BC HYDRO (BCH) POINT OF DELIVERY (POD) SWITCHGEAR
ESQUIMALT, BRITISH COLUMBIA**

**APPENDIX A
PRE-CONSTRUCTION HAZARDOUS BUILDING
MATERIAL AND SURVEY REPORT**

Hazardous Building Material Assessment

Esquimalt Graving Dock – PWGSC Buildings

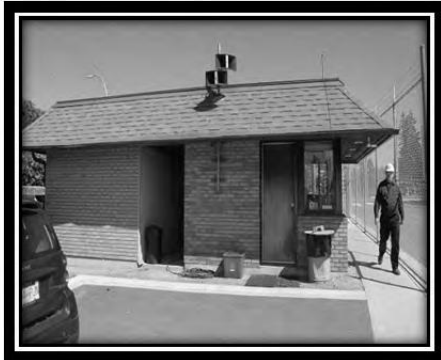
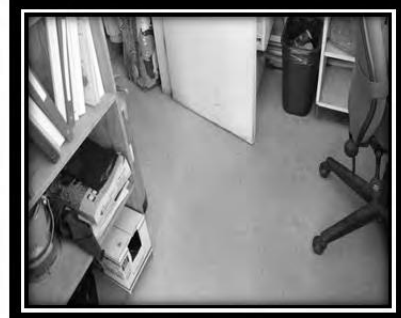
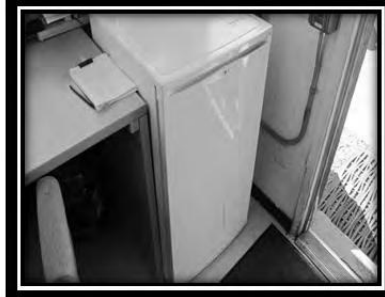
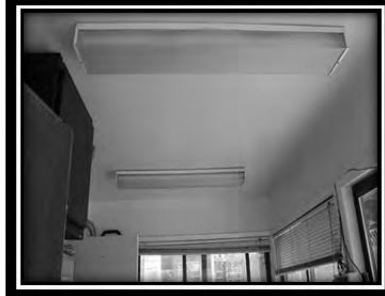
Building: 38 PWGSC Owned Guard House – Old Front Gate	
Area: Old Front Gate

Hazardous Materials Observed: <ul style="list-style-type: none">• Lead: [potential] Lead containing paint on walls and trim• Mercury containing equipment: Fluorescent light fixtures present• Ozone depleting substances: Fridge present• PCB's: [potential] Fluorescent light ballasts present• Mould: None observed

Samples: 15458-10: Roof Shingles No Asbestos Detected 15458-11: Sheet Flooring- No Asbestos Detected 15458-12: Drywall Joint Compound - No Asbestos Detected 15458-13 : Washroom - Drywall Joint Compound - No Asbestos Detected

Asbestos siding was not observed. Building envelope was brick and mortar.

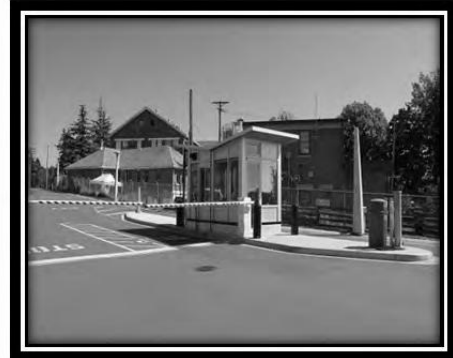
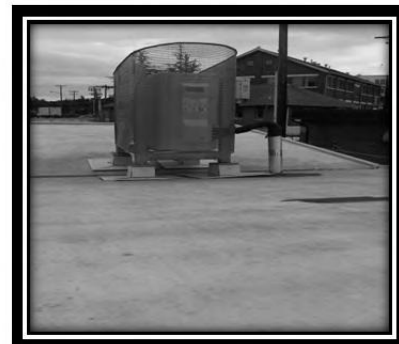
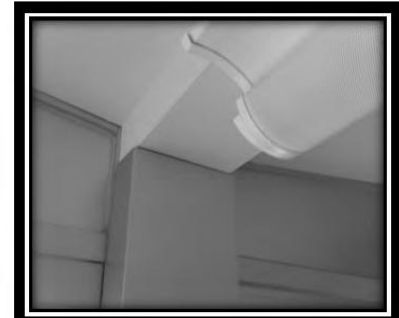
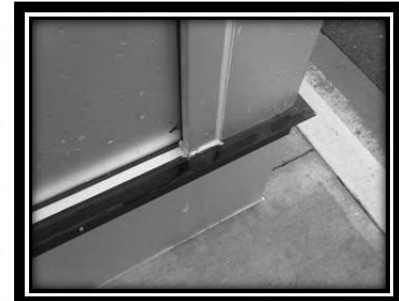
Building: 38 PWGSC Owned Guard House – Old Front Gate

15458-8: Drywall Joint Compound - No Asbestos Detected
15458-9 : Caulking – Exterior - No Asbestos Detected

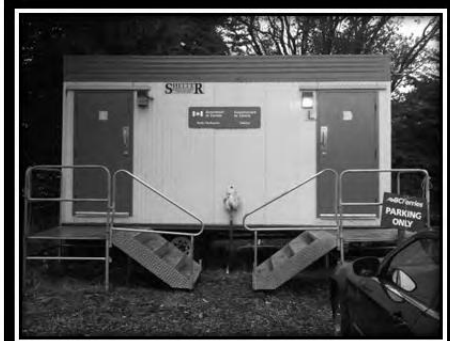
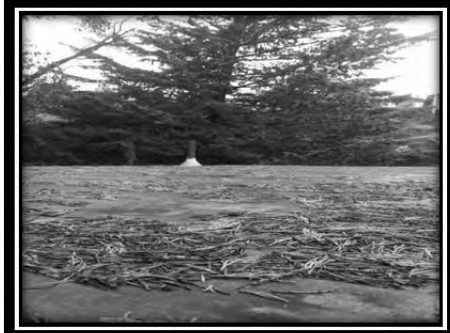
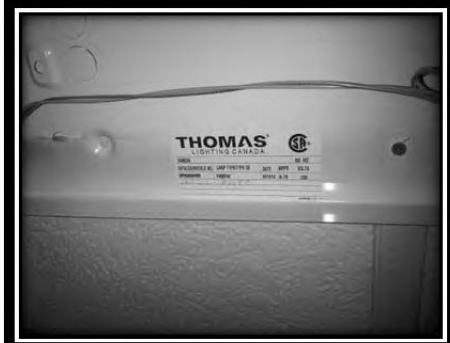
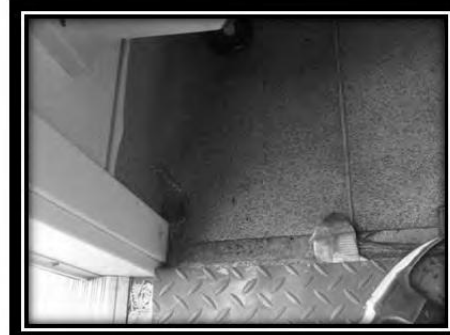
Building: 67 PWGSC Washroom Trailer (A Lot)

15458-01: Sheet Flooring - No Asbestos Detected
15458-02: Roof Membrane Caulking - No Asbestos Detected

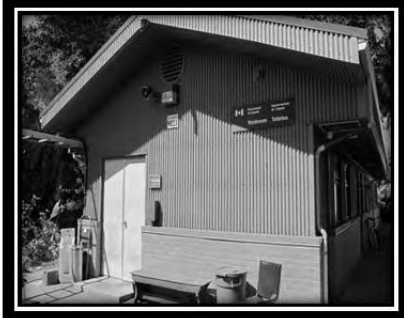
Building: 20 PWGSC Owned Main Washrooms	
<p>Room: Womens? ashroom</p> <p>Details:</p> <ul style="list-style-type: none"> • Estimated date of construction: 1997-1999 • Ceiling: Drywall • Walls: Cinder Block • Flooring: Concrete/Coating (Epoxy & Sealant) • Roof: Metal Sheeting

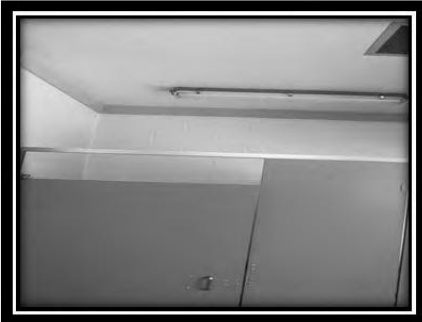
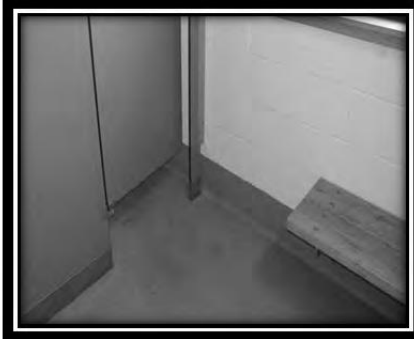
<p>Room: Men's Washroom</p> <p>Hazardous Materials Observed:</p> <ul style="list-style-type: none"> • Lead: [potential] Lead containing paint on walls and trim • Mercury containing equipment: Fluorescent light fixtures present • Ozone depleting substances: None Observed • PCB's: [potential] Fluorescent light ballasts present • Mould: None Observed <p>Samples: 15458-03: Drywall Joint Compound – Ceiling - No Asbestos Detected 15458-04: Beige Trowel on Flooring (Coating) - No Asbestos Detected</p>

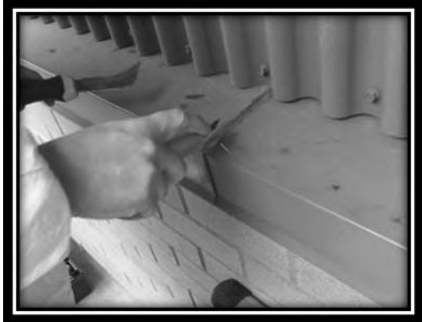
<p>Area: Exterior of Building</p> <p>Hazardous Materials Observed:</p> <ul style="list-style-type: none"> • Lead: [potential] Lead containing paint on walls and trim • Mercury containing equipment: Fluorescent light fixtures present • Ozone depleting substances: None Observed • PCB's: [potential] Fluorescent light ballasts present • Mould: None Observed <p>Samples: 15458-03: Drywall Joint Compound – Ceiling - No Asbestos Detected 15458-04: Beige Trowel on Flooring (Coating) - No Asbestos Detected</p>

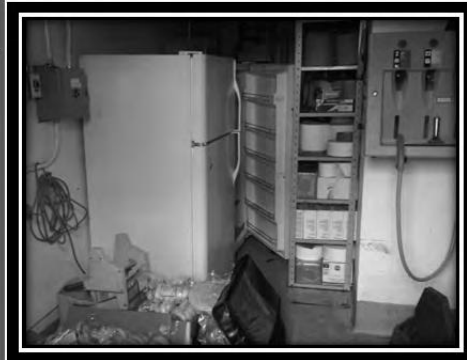
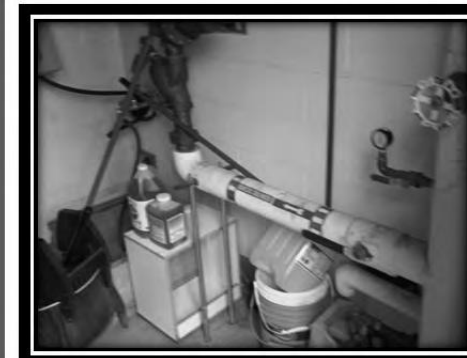
Room: Mechanical Room

15458-03: Drywall Joint Compound – Ceiling - No Asbestos Detected

15458-04: Beige Trowel on Flooring (Coating) - No Asbestos Detected

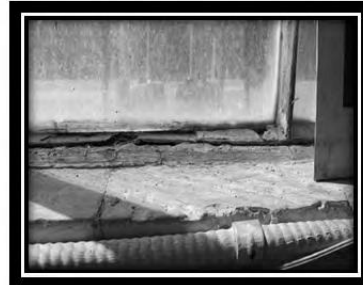
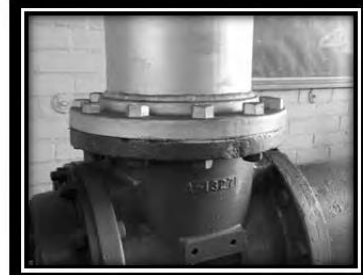
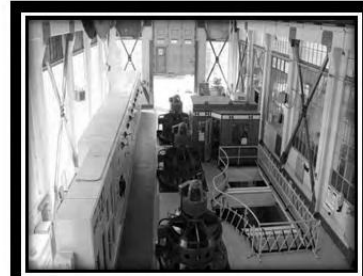
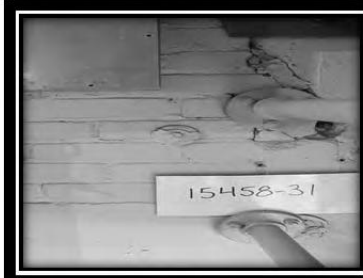
Area: Main Floor

15458-22: Caulking – Interior Window (Perimeter West Wall) - No Asbestos Detected
15458-24: Caulking – Exterior Window (Perimeter West Wall) - No Asbestos Detected
15458-25: Wall Coating – Interior Wall (Perimeter West Wall) - No Asbestos Detected
15458-26: Gasket – Compressor (A-13271) - No Asbestos Detected
15458-31: Brick Mortar – East Wall (Top of Stairs) - No Asbestos Detected

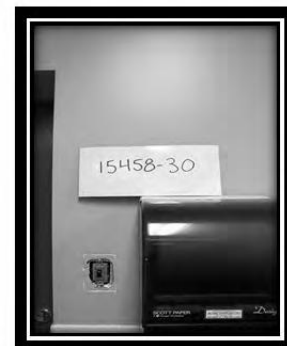
Area: Washroom (Main Floor)

15458-30: Drywall Joint Compound - No Asbestos Detected

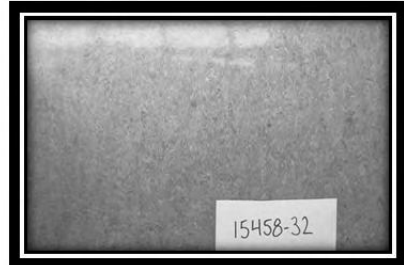
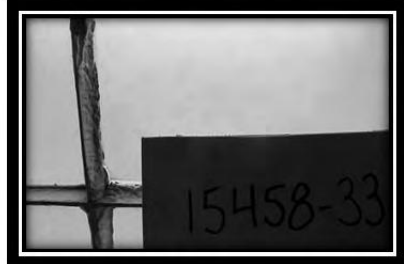
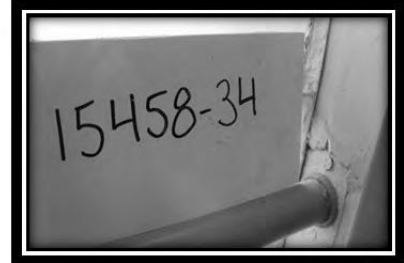
Area: Lunch Room (Second Floor)

- 15458-32: Sheet Flooring (Grey) & Mastic - No Asbestos Detected
- 15458-33: Caulking/Putty Window - No Asbestos Detected
- 15458-34: Cementitious Wall Coating - No Asbestos Detected

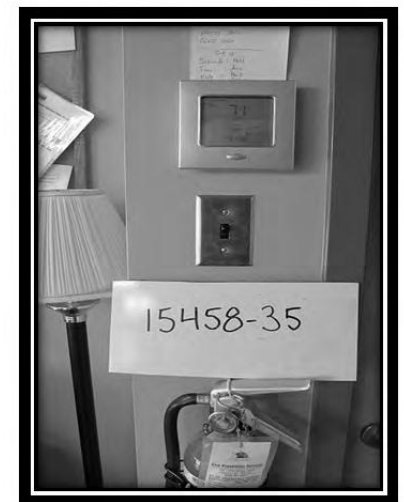
Area: Lunch Room (Second Floor)

- 15458-35: Drywall Joint Compound (West Wall) - No Asbestos Detected

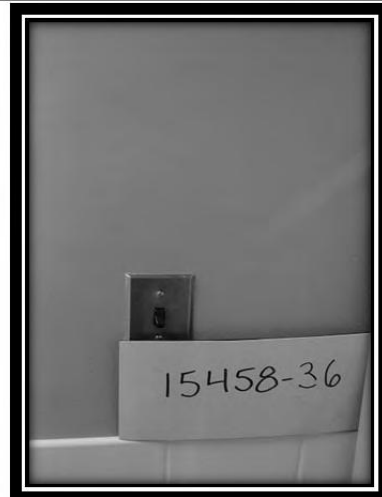
Area: Washroom (Second Floor)

15458-36: Drywall Joint Compound - No Asbestos Detected

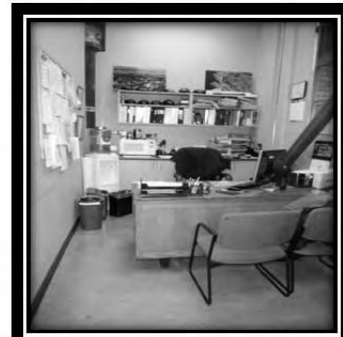
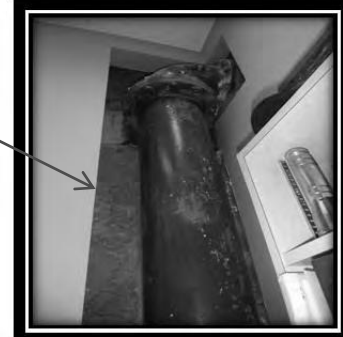
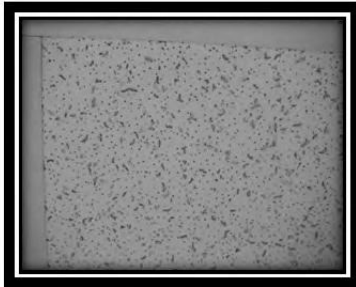
Area: Office (Main Floor)

15458-67: Drywall Joint Compound - No Asbestos Detected
15458-68: Concrete Cementitious - <1% Chrysotile Asbestos Content
15458-69: Acoustic Ceiling Tile - No Asbestos Detected

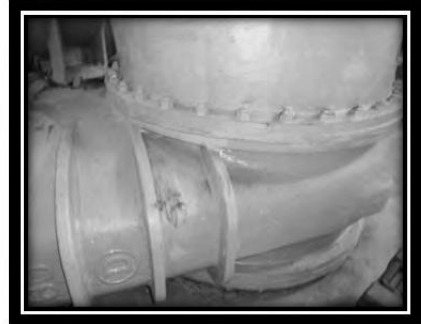
Area: Basement

15458-70: Gasket - No Asbestos Detected

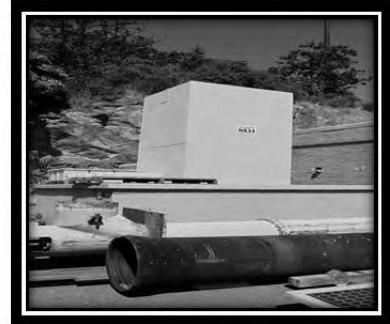
Area: PWGSC Penstock Structure

- Lead: [potential] Lead based paint on walls and equipment
- Mercury containing equipment: Fluorescent light fixtures present
- Ozone depleting substances: None Observed
- PCB's: [potential] Fluorescent light ballasts present
- Mould: None Observed

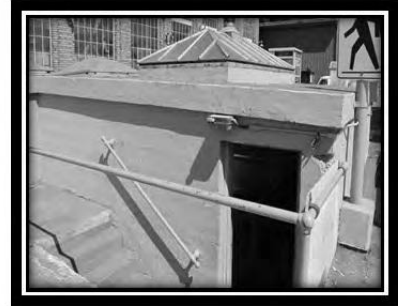
Building: 32 PWGSC Owned Middle Dock Stairwell

- Lead: [potential] Lead based paint on walls and equipment
- Mercury containing equipment: Fluorescent light fixtures present
- Ozone depleting substances: None Observed
- PCB's: [potential] Fluorescent light ballasts present
- Mould: None Observed

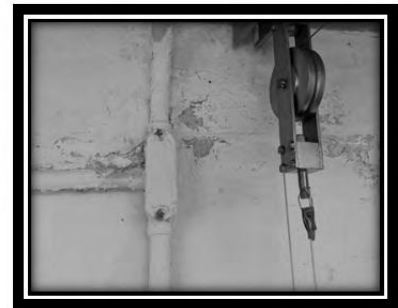
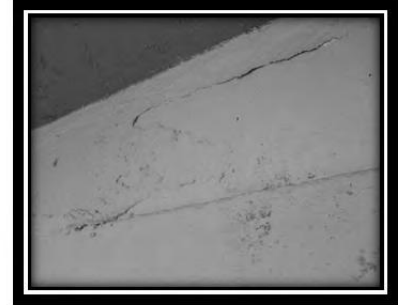
15458-17: Lead Paint 6.5% w.t. – Lt. Green - Interior Concrete Walls (South Wall)

15458-18: Wall Coating (South Wall) - No Asbestos Detected

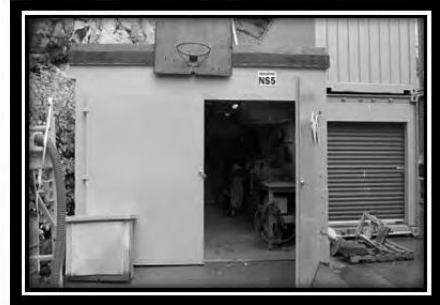
Building: 29 PWGSC Owned Welding Shop

- Lead: [potential] Lead based paint on walls and equipment
- Mercury containing equipment: Fluorescent light fixtures present
- Ozone depleting substances: None Observed
- PCB's: [potential] Fluorescent light ballasts present
- Mould: None Observed

15458-27: Lead Paint 1.9% w.t. – Yellow - South Interior Wall
15458-28: Cementitious Wall Coating (North Interior Wall) - No Asbestos Detected
15458-29: Lead Paint 0.27% w.t. – Lt. Green - South Interior Wall
Exhaust duct with black expansion gasket observed within Welding Shop and suspected of containing asbestos (not sampled).

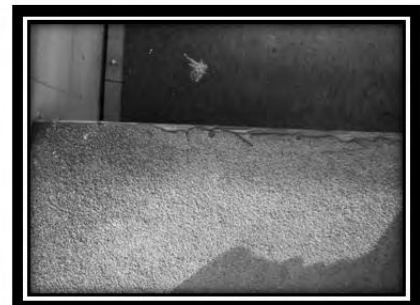
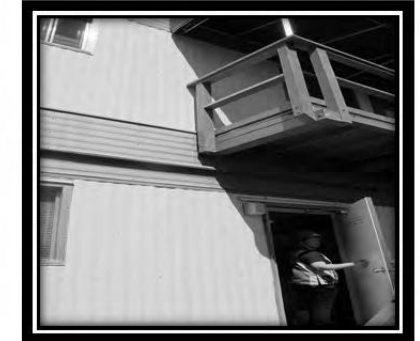
15458-38: Shingle/Grip Mat - No Asbestos Detected
15458-39: Sheet Flooring (Cream) & Mastic - No Asbestos Detected
15458-40: Door Caulking - No Asbestos Detected
15458-41: Window Caulking - No Asbestos Detected

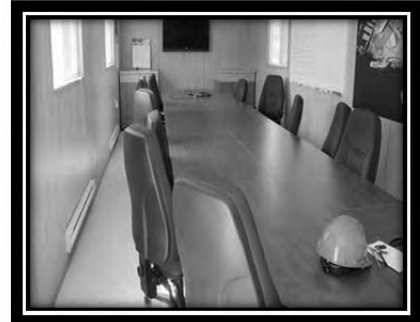
15458-37 Floor Tile – Grey 12"x12" & Mastic - No Asbestos Detected

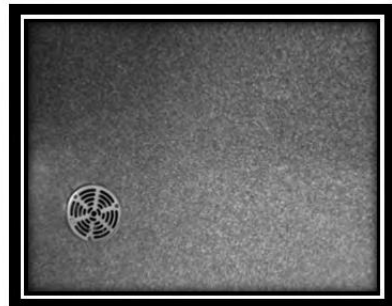
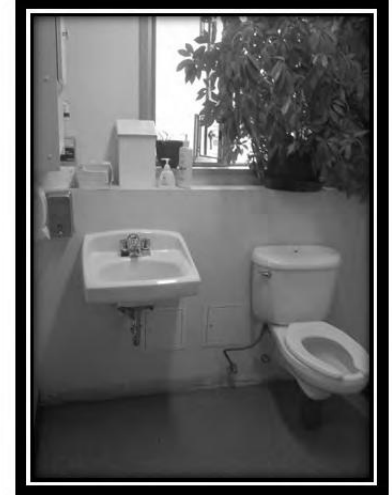
15458-42 Sheet Flooring (Green) & Mastic - No Asbestos Detected
15458-43 Drywall Joint Compound - No Asbestos Detected

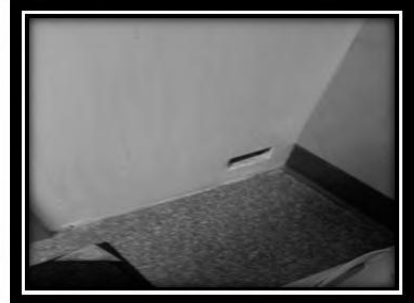
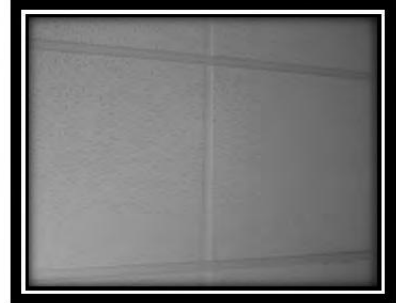
15458-44: Drywall Joint Compound - No Asbestos Detected
15458-45: Acoustic Ceiling Tile - No Asbestos Detected

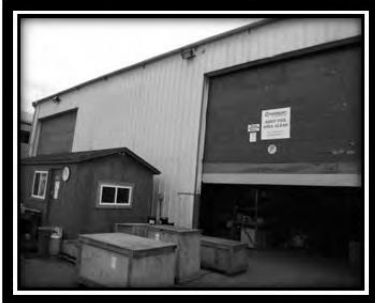
Building: 61 PWGSC Land Leased to Seaspan (Butler Buildings)	
Area: SJ39 Stores

<p>Details:</p> <ul style="list-style-type: none"> • Construction Date Unknown • Ceiling: Metal Sheeting • Walls: Wood Panel/Metal Sheeting • Flooring: Concrete • Roof: Metal Sheeting 	
<p>Hazardous Materials Observed:</p> <ul style="list-style-type: none"> • Lead: [potential] Lead based paint on walls and equipment • Mercury containing equipment: Fluorescent light fixtures present • Ozone depleting substances: None Observed • PCB's: [potential] Fluorescent light ballasts present • Mould: None Observed <p>Samples: 15458-58: Caulking (Exterior) - Chrysotile 7%</p>

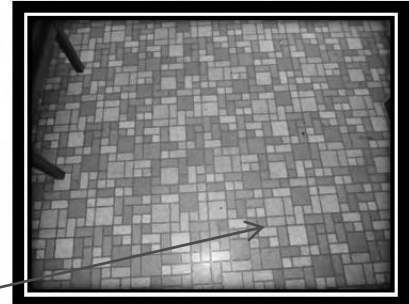
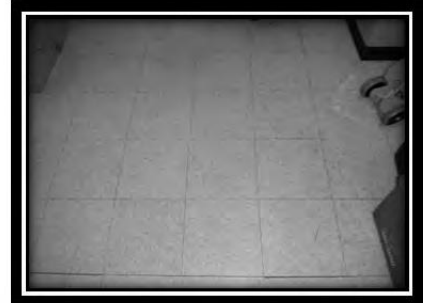
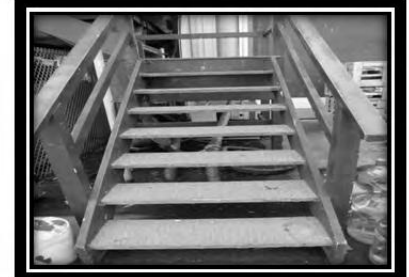
15458-60: Floor Tile – White 12"x12" - No Asbestos Content

15458-61: Coating (Balcony Steps) - No Asbestos Content

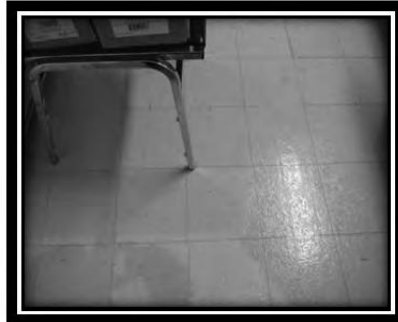
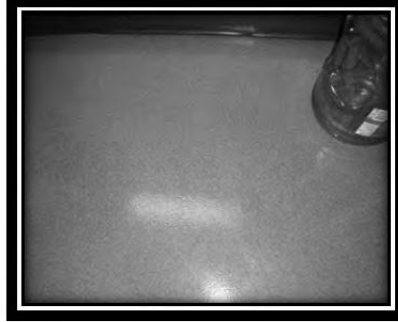
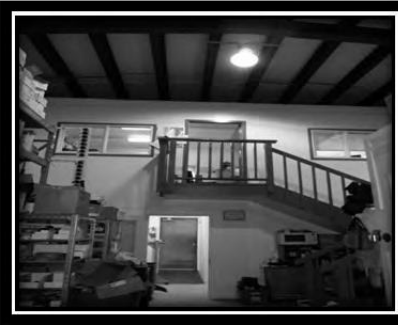
- 15458-62: Sheet Flooring (Beige) - No Asbestos Content
- 15458-63: Sheet Flooring (Blue) - No Asbestos Content
- 15458-64: Drywall Joint Compound - No Asbestos Content
- 15458-65: Drywall Joint Compound - No Asbestos Content
- 15458-66: Drywall Joint Compound - No Asbestos Content

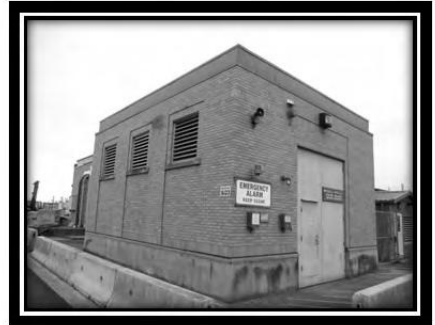
Building: 58 PWGSC Owned South Side Sub Station

- Lead: [potential] Lead based paint on walls and equipment
- Mercury containing equipment: Fluorescent light fixtures present
- Ozone depleting substances: None Observed
- PCB's: [potential] Fluorescent light ballasts present
- Mould: None Observed

Note: Expansion Gaskets observed in ducting are suspect of asbestos-containing. Not sampled.

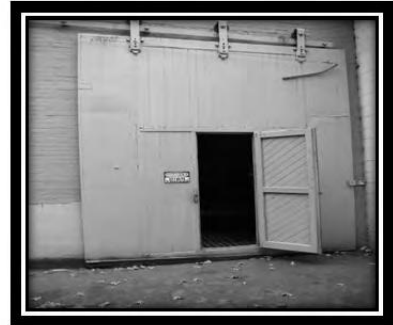
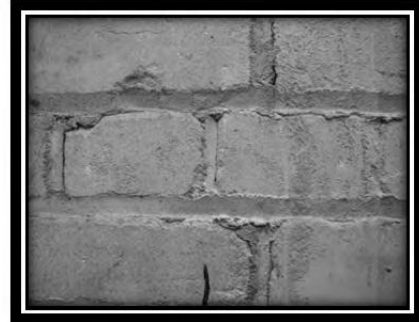
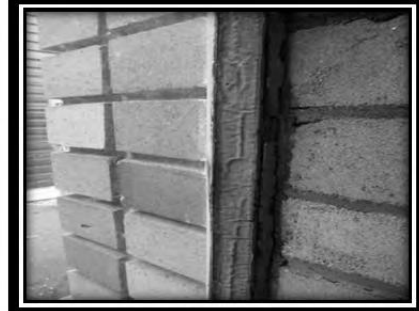
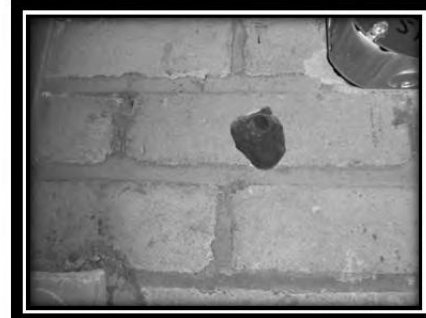
Area: Main Sub Station (Main Floor)

- Lead: [potential] Lead based paint on walls and equipment
- Mercury containing equipment: Fluorescent light fixtures present
- Ozone depleting substances: None Observed
- PCB's: [potential] Fluorescent light ballasts present
- Mould: None Observed

15458-77: Caulking (Window Frame) - No Asbestos Content

15458-78: Firestopping (Black Putty) - No Asbestos Content

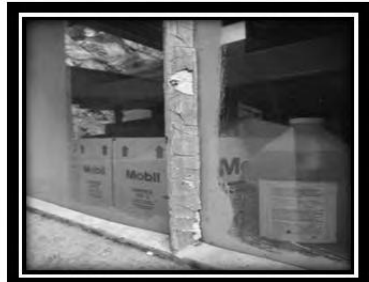
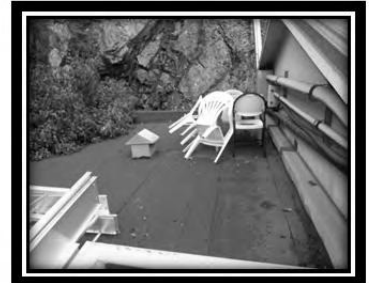
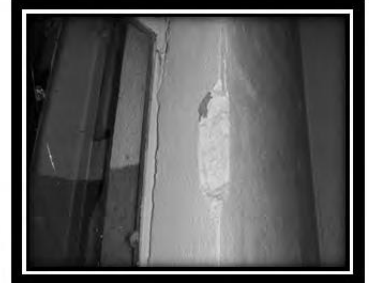
Area: Garage NS4 (Rear Building)

- Lead: [potential] Lead based paint on walls and equipment
- Mercury containing equipment: Fluorescent light fixtures present
- Ozone depleting substances: None Observed
- PCB's: [potential] Fluorescent light ballasts present
- Mould: None Observed

- 15458-79: Putty (Window Frame) - No Asbestos Content
15458-80: Roof Tar - No Asbestos Content
15458-81: Cementitious Wall Coating - No Asbestos Content

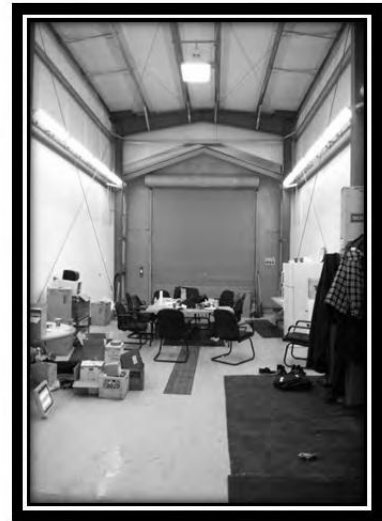
Area: Garage NS4 (Front Building)

- Lead: [potential] Lead based paint on walls and equipment
- Mercury containing equipment: Fluorescent light fixtures present
- Ozone depleting substances: Fridge observed
- PCB's: [potential] Fluorescent light ballasts present
- Mould: None Observed

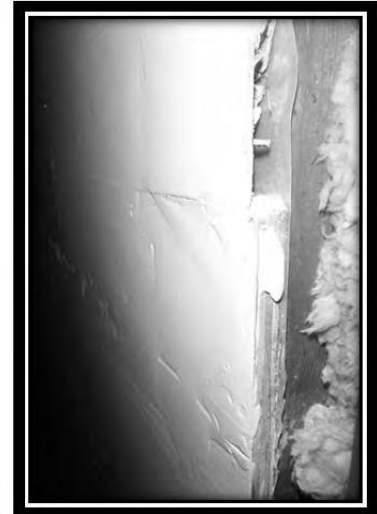
Area: Winch Building SJ22

- Lead: [potential] Lead based paint on walls and equipment
- Mercury containing equipment: None Observed
- Ozone depleting substances: Fridge observed
- PCB's: None Observed
- Mould: None Observed

15458-82: Drywall Joint Compound - No Asbestos Content

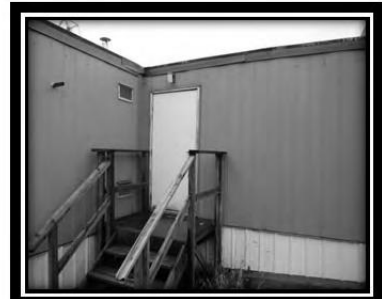
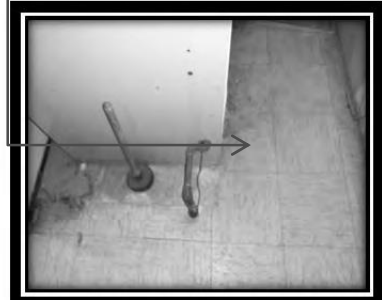
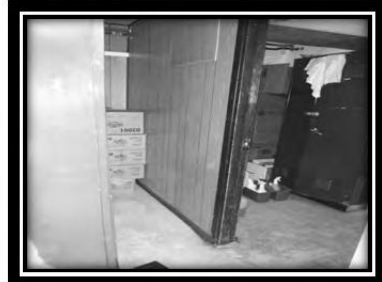
Area: Rear Storage Room

- Lead: [potential] Lead based paint on walls and equipment
- Mercury containing equipment: Fluorescent light fixtures present, Thermostat
- Ozone depleting substances: None Observed
- PCB's: [potential] Fluorescent light ballasts present
- Mould: None Observed

15458-83: Floor Tile (12"x12" White) & Mastic - Storage/Furnace Room – Chrysotile 3% Asbestos Content
15458-84: Sheet Flooring (Peach) & Mastic - Storage/Locker Area - No Asbestos Content

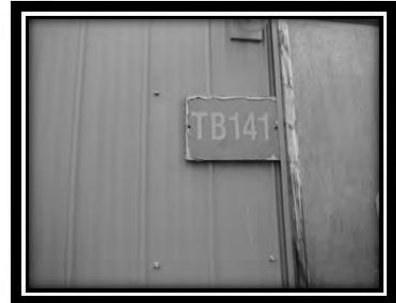
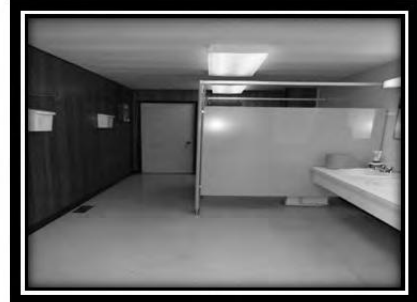
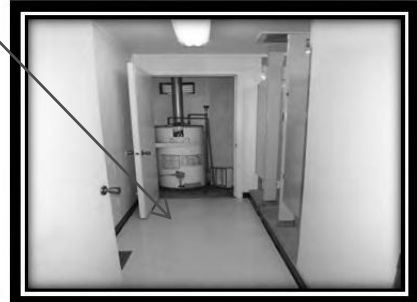
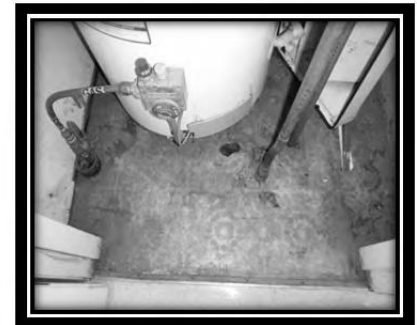
Area: Women's Washroom

- Lead: [potential] Lead based paint on walls and equipment
- Mercury containing equipment: Fluorescent light fixtures present, Thermostat
- Ozone depleting substances: None Observed
- PCB's: [potential] Fluorescent light ballasts present
- Mould: None Observed

15458-86: Drywall Joint Compound - No Asbestos Content

15458-87: Sheet Flooring (Layer 2) – Yellow/Brown - Chrysotile 15% Asbestos Content

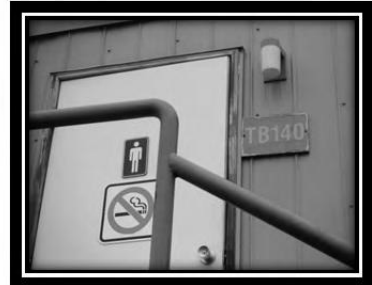
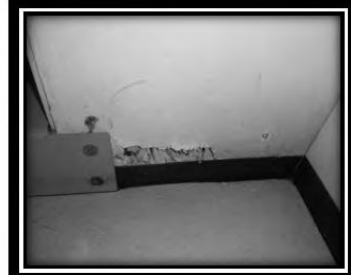
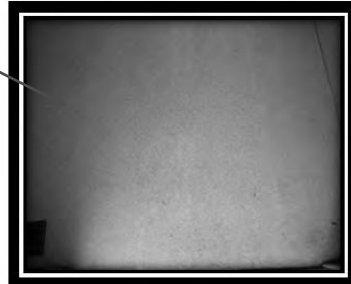
Area: Men's Washroom

- Lead: [potential] Lead based paint on walls and equipment
- Mercury containing equipment: Fluorescent light fixtures present, Thermostat
- Ozone depleting substances: None Observed
- PCB's: [potential] Fluorescent light ballasts present
- Mould: None Observed

- 15458-88: Drywall Joint Compound - No Asbestos Content
- 15458-89: Sheet Flooring (White) - No Asbestos Content
- 15458-89: Mastic - Chrysotile <1% Asbestos Content

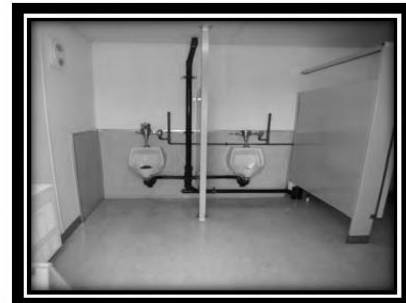
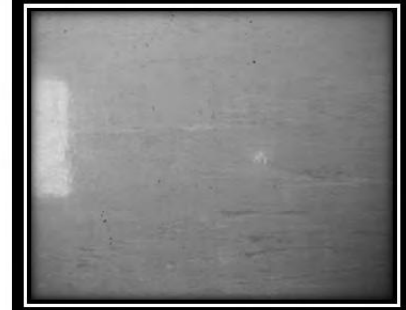
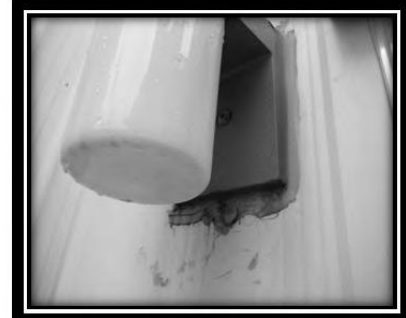
Area: Washroom Trailer Electrical Shop

- Lead: [potential] Lead based paint on walls and equipment
- Mercury containing equipment: None Observed
- Ozone depleting substances: None Observed
- PCB's: None Observed
- Mould: None Observed

- 15458-90: Caulking (Grey) - No Asbestos Content
- 15458-91: Sheet Flooring (Lt. Grey) - No Asbestos Content
- 15458-92: Caulking (Exterior) – Light Fixture - No Asbestos Content

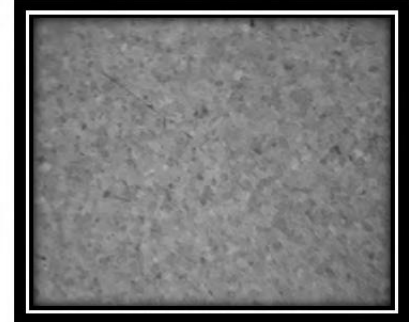
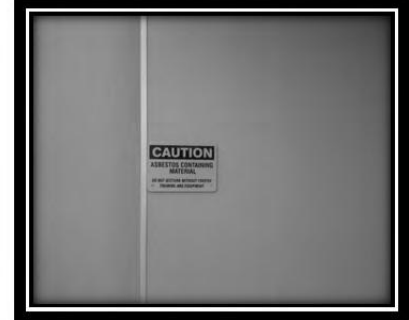
Area: Old Guard House NS35

- Lead: [potential] Lead based paint on walls and equipment
- Mercury containing equipment: Fluorescent light fixtures present
- Ozone depleting substances: None Observed
- PCB's: [potential] Fluorescent light ballasts present
- Mould: None Observed

15458-101: Sheet Flooring – Lt. Brown Mosaic - No Asbestos Content

Note: Asbestos-Containing Siding (Exterior) and soffits are asbestos containing transite

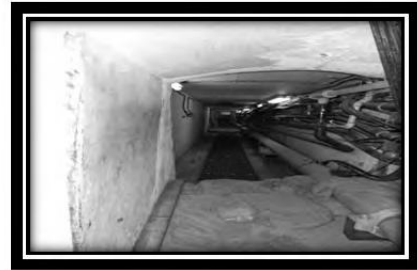
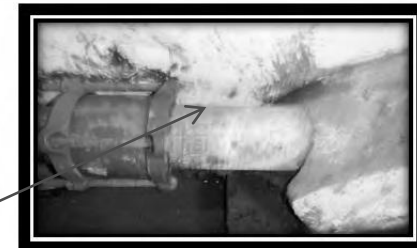
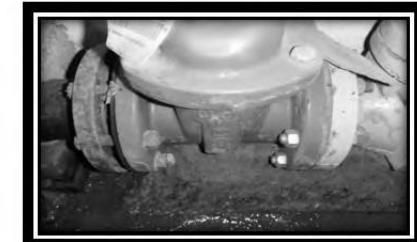
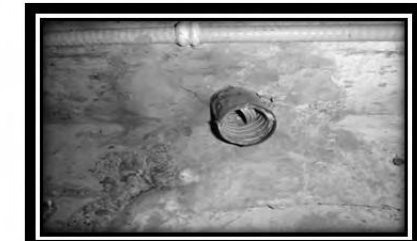
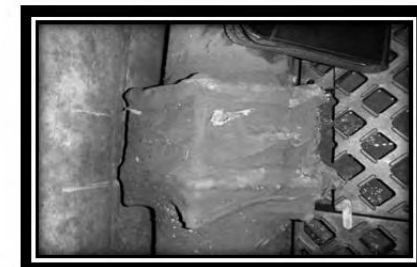
Area: Tunnels

15458-97: Firestopping - No Asbestos Content

15458-98: Canvass (Salt Water Line) - No Asbestos Content

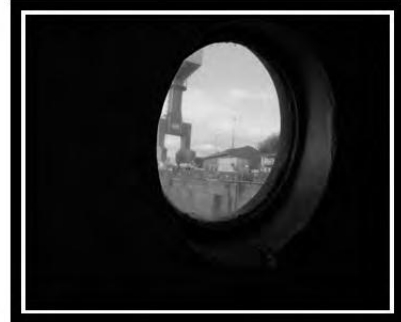
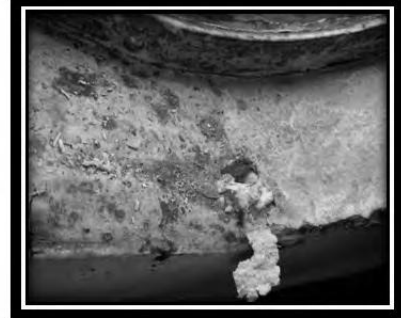
Area: Caissons

- Lead: [potential] Lead based paint on walls and equipment
- Mercury containing equipment: Fluorescent light fixtures present
- Ozone depleting substances: None Observed
- PCB's: [potential] Fluorescent light ballasts present
- Mould: None Observed

15458-99: Wall Insulation (Porthole) - No Asbestos Content
