Prepared for:
Canadian Coast Guard

CCGS SIR WILFRID LAURIER Asbestos Condition Report

**North West
Environmental Group Ltd.**

NWest Project No. 31632
Date Issued: March 31st, 2017

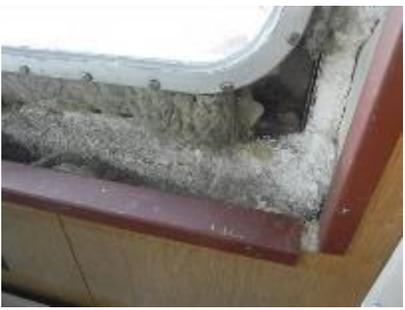
Non-asbestos marine panels over spray-applied fibrous insulation (Cafco-type).	No asbestos suspected in Cafco (14 out of 14 samples negative for asbestos). <ul style="list-style-type: none"> 31632-1, 2 Cafco (no asbestos detected).

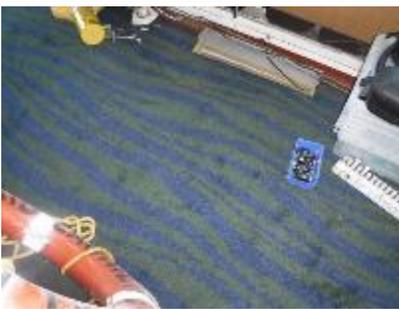
Deck	Carpet over deck screed.	No asbestos suspected in carpet or adhesives. Deck screed may contain asbestos.	N/A Exposed – good condition Concealed – unknown condition	N/A Non-friable	N/A C	N/A 7, or additional samples to rule out presence of asbestos.

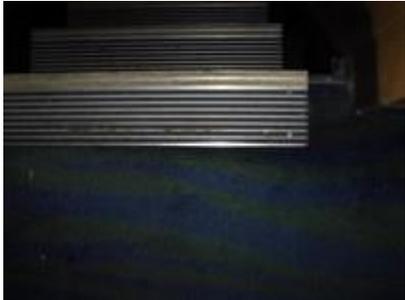
Bridge Deck							Stair Tower
Inspection Zone	Material	Hazardous Content	Condition	Friability	Accessibility	Recommended Action	Picture
Deck	Stair tread and carpet over deck screed.	No asbestos suspected in carpet or adhesives.	N/A	N/A	N/A	N/A

Resilient sheet flooring over deck screed.	Deck screed may contain asbestos.	Exposed – good condition Concealed – unknown condition	Non-friable	C	7, or additional samples to rule out presence of asbestos.	
Other	None observed.						
Comments	N/A

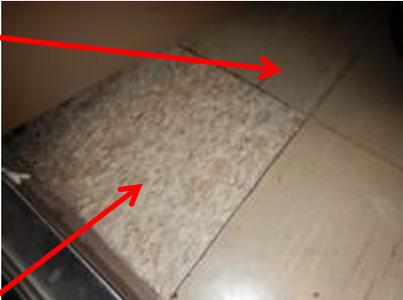
Bridge Deck							Locker (104)
Inspection Zone	Material	Hazardous Content	Condition	Friability	Accessibility	Recommended Action	Picture
Deck	Floor tile 1 (12" x 12" beige with light and dark streaks) over deck screed.	Floor tile 1 may contain asbestos.	Good	Non-friable	A	7

Floor tile 2 (12" x 12" beige with white and dark specks) over deck screed.	Floor tile 2 may contain asbestos.	Good	Non-friable	A	7	
		Deck screed may contain asbestos.	Exposed – good condition Concealed – unknown condition	Non-friable	C	7, or additional samples to rule out presence of asbestos.	
Other	None observed.	N/A	N/A	N/A	N/A	N/A	
Comments	N/A

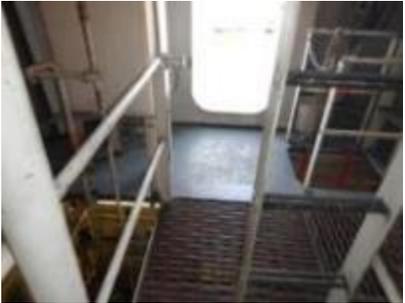
Officer's Deck							Funnel
Inspection Zone	Material	Hazardous Content	Condition	Friability	Accessibility	Recommended Action	Picture
Deck	Anti-skid coating.	Anti-skid coating (Intershield 6GV) is non-ACM as per manufacturer (see Appendix D).	N/A	N/A	N/A	N/A

Metal cat walk.	Remnants beneath newer layers may contain asbestos.* No suspect asbestos.	Remnant	Non-friable	Concealed	7	
Other	None observed.	N/A	N/A	N/A	N/A	N/A	
Comments	*As per the Chief Engineer, anti-skid coating was replaced since 2009, however, previous testing and clearance documentation was not provided. NWest cannot verify effectiveness of removal of previous applications of anti-skid that may have contained asbestos.

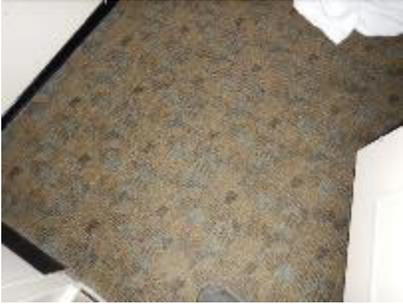
Officer's Deck							Chief Officer Bedroom (306)
Inspection Zone	Material	Hazardous Content	Condition	Friability	Accessibility	Recommended Action	Picture
Deck	Carpet over deck screed.	No asbestos suspected in carpet or adhesives. Deck screed may contain asbestos.	N/A Exposed – good condition Concealed – unknown condition	N/A Non-friable	N/A C	N/A 7, or additional samples to rule out presence of asbestos.

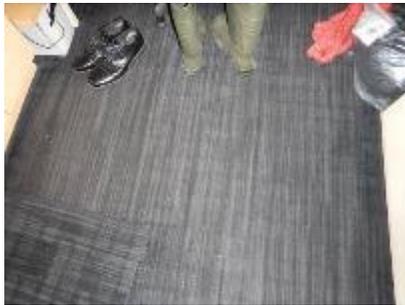
Officer's Deck							2 nd Officer (307)
Inspection Zone	Material	Hazardous Content	Condition	Friability	Accessibility	Recommended Action	Picture
Deck	Carpet and over deck screed.	No asbestos suspected in carpet or adhesives. Deck screed may contain asbestos.	N/A Exposed – good condition Concealed – unknown condition	N/A Non-friable	N/A C	N/A 7, or additional samples to rule out presence of asbestos.

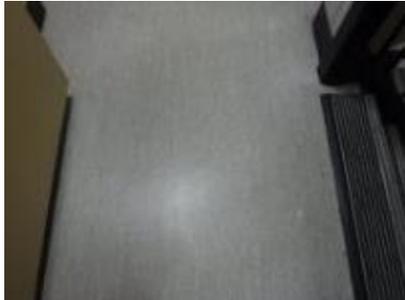
Officer's Deck							Alleyway (Rm 309)
Inspection Zone	Material	Hazardous Content	Condition	Friability	Accessibility	Recommended Action	Picture
Deck	Resilient sheet flooring over deck screed.	No asbestos suspected in sheet flooring or adhesives. Deck screed may contain asbestos.	N/A Exposed – good condition Concealed – unknown condition	N/A Non-friable	N/A C	N/A 7, or additional samples to rule out presence of asbestos.

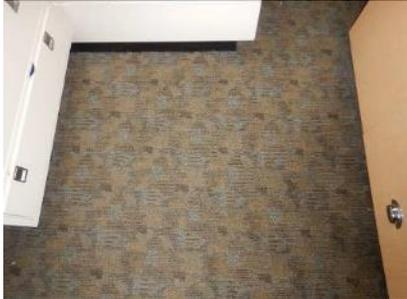
Officer's Deck							Commanding Officer (Work area and bedroom)
Inspection Zone	Material	Hazardous Content	Condition	Friability	Accessibility	Recommended Action	Picture
Deck	Carpet and over deck screed.	No asbestos suspected in carpet or adhesives.	N/A	N/A	N/A	N/A

Deck screed may contain asbestos.	Exposed – good condition Concealed – unknown condition	Non-friable	C	7, or additional samples to rule out presence of asbestos.	
Other	None observed.	N/A	N/A	N/A	N/A	N/A	
Comments	N/A

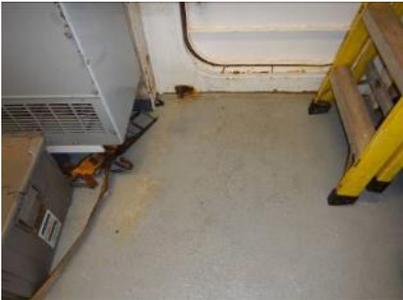
Lagging	None observed.	N/A	N/A	N/A	N/A	N/A	
Deck	Anti-skid coating.	Anti-skid coating (Intershield 6GV) is non-ACM as per manufacturer (see Appendix D). Remnants beneath newer layers may contain asbestos.	N/A	N/A	N/A	N/A

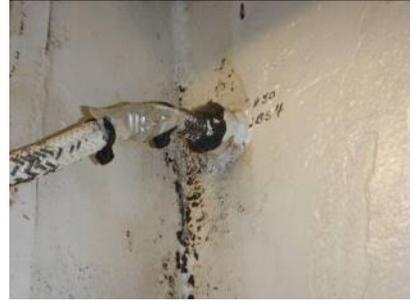
Officer's Deck							Auxiliary Electrical Room (Rm 316)
Inspection Zone	Material	Hazardous Content	Condition	Friability	Accessibility	Recommended Action	Picture
Other	Water sealant - black	Water sealant may contain asbestos	Good	Non-friable	A	7

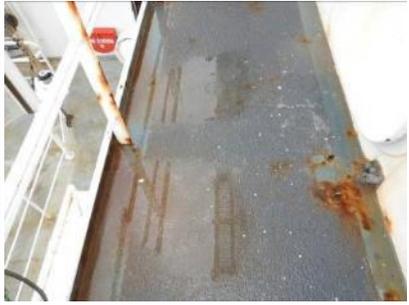
Officer's Deck							Outer Deck
Inspection Zone	Material	Hazardous Content	Condition	Friability	Accessibility	Recommended Action	Picture
Deck	Anti-skid coating.	Anti-skid coating (Intershield 6GV) is non-ACM as per manufacturer (see Appendix D). •28403-16 Anti-skid coating (no asbestos detected). Remnants beneath newer layers may contain asbestos.	N/A	N/A	N/A	N/A

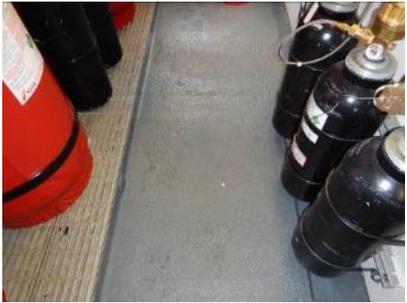
Officer's Deck							FM200 Room (Rm 318)
Inspection Zone	Material	Hazardous Content	Condition	Friability	Accessibility	Recommended Action	Picture
Lagging	None observed.	N/A	N/A	N/A	N/A	N/A	
Deck	Anti-skid coating.	Anti-skid coating (Intershield 6GV) is non-ACM as per manufacturer (see Appendix D). Remnants beneath newer layers may contain asbestos.	N/A	N/A	N/A	N/A

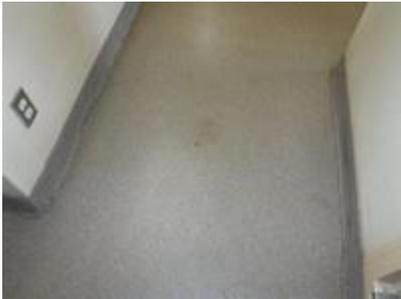
Officer's Deck							Alleyway Outside 322
Inspection Zone	Material	Hazardous Content	Condition	Friability	Accessibility	Recommended Action	Picture
Lagging	None observed.	N/A	N/A	N/A	N/A	N/A	
Deck	Resilient sheet flooring over deck screed.	No asbestos suspected in sheet flooring or adhesives. Deck screed may contain asbestos.	N/A Exposed – good condition Concealed – unknown condition	N/A Non-friable	N/A C	N/A 7, or additional samples to rule out presence of asbestos.

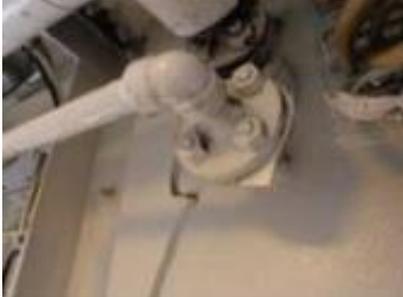
Boat Deck							Helio Workshop (Rm 401)
Inspection Zone	Material	Hazardous Content	Condition	Friability	Accessibility	Recommended Action	Picture
	Metal cladding over calcium silicate insulation.	No asbestos suspected (10 out of 10 samples negative for asbestos).	N/A	N/A	N/A	N/A	
Other	Gasket	28403-15 Gasket (no asbestos detected), however, untested gaskets must be treated as ACM until tested.	Good-poor	Non-friable	A	Poor: 3 Good: 5 or 7

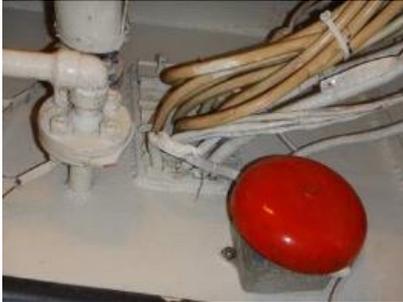
Penetration caulking - white	May contain asbestos.	Good	Non-friable	A	7

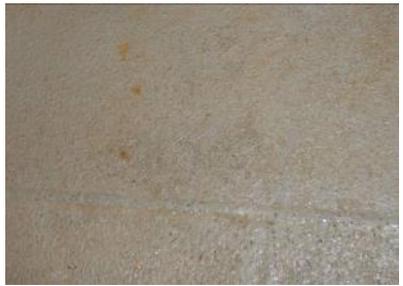
Deck	Anti-skid coating.	Anti-skid coating (Intershield 6GV) is non-ACM as per manufacturer (see Appendix D). Remnants beneath newer layers may contain asbestos.	N/A	N/A	N/A	N/A

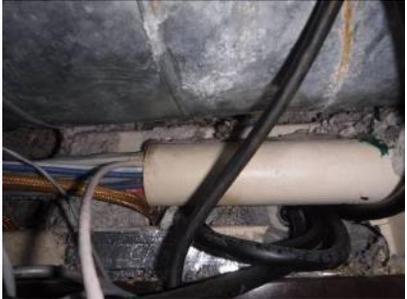
Boat Deck							CTD Room (Rm 408)
Inspection Zone	Material	Hazardous Content	Condition	Friability	Accessibility	Recommended Action	Picture
Deckhead	Perforated metal panels over spray-applied fibrous insulation (Cafco-type).	No asbestos suspected in Cafco (14 out of 14 samples negative for asbestos).	N/A	N/A	N/A	N/A

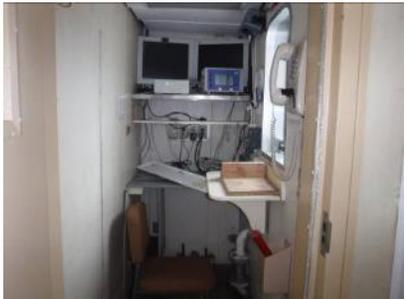
Bulkhead	Non-asbestos marine panels over spray-applied fibrous insulation (Cafco-type)	No asbestos suspected in panels or Fibreglass insulation. No asbestos suspected in Cafco (14 out of 14 samples negative for asbestos).	N/A	N/A	N/A	N/A

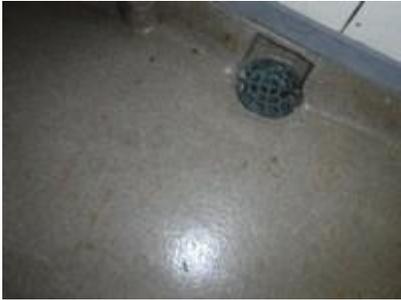
Boat Deck							CTD Room (Rm 408)
Inspection Zone	Material	Hazardous Content	Condition	Friability	Accessibility	Recommended Action	Picture
Deck	Epoxy over deck screed.	Epoxy (Rada) is non-ACM as per manufacturer. Deck screed (Polyspec) underneath Rada is non-ACM as per manufacturer (see Appendix D).	N/A	N/A	N/A	N/A

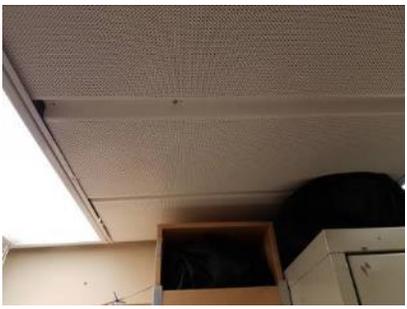
Boat Deck							Aft Lab (Rm 409)
Inspection Zone	Material	Hazardous Content	Condition	Friability	Accessibility	Recommended Action	Picture
Deckhead	Perforated metal deckhead panels over foil-faced fibrous insulation (Roxul-type).	No asbestos suspected in panels or insulation.	N/A	N/A	N/A	N/A

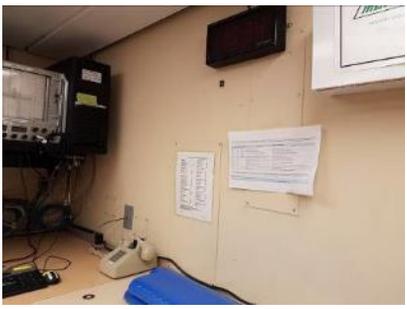
Bulkhead	Vinyl-covered wood marine panel.	No asbestos suspected in panels.	N/A	N/A	N/A	N/A

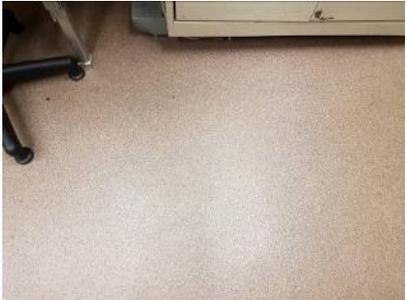
Boat Deck							Aft Lab (Rm 409)
Inspection Zone	Material	Hazardous Content	Condition	Friability	Accessibility	Recommended Action	Picture
Deck	Epoxy over deck screed.	Epoxy (Rada) is non-ACM as per manufacturer. Deck screed (Polyspec) underneath Rada is non-ACM as per manufacturer (see Appendix D).	N/A	N/A	N/A	N/A

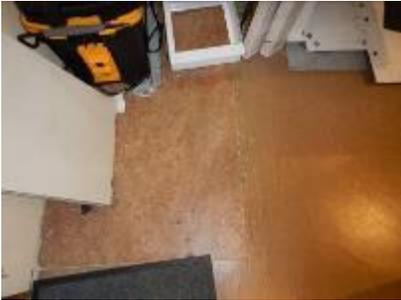
Boat Deck		Electronic Equipment Room (Rm 410)					
Inspection Zone	Material	Hazardous Content	Condition	Friability	Accessibility	Recommended Action	Picture
Deck	Resilient sheet flooring over deck screed.	No asbestos suspected in carpet or adhesives. Deck screed may contain asbestos.	N/A Exposed – good condition Concealed – unknown condition	N/A Non-friable	N/A C	N/A 7, or additional samples to rule out presence of asbestos.

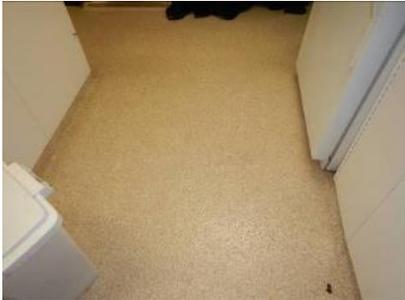
Boat Deck							Forward Lab (Rm 411)
Inspection Zone	Material	Hazardous Content	Condition	Friability	Accessibility	Recommended Action	Picture
Deck	Epoxy over deck screed	Epoxy (Rada) is non-ACM as per manufacturer. Deck screed (Polyspec) underneath Rada is non-ACM as per manufacturer (see Appendix D).	N/A	N/A	N/A	N/A

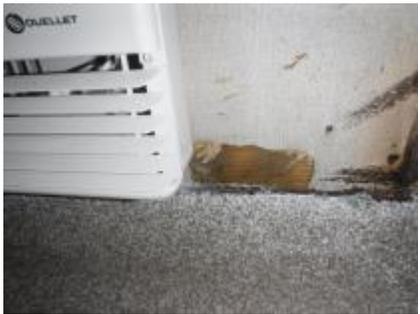
Other	Baseboards	No asbestos suspected (3 out of 3 samples negative for asbestos). <ul style="list-style-type: none"> • 28403-10 Baseboard adhesive, brown (no asbestos detected) 	N/A	N/A	N/A	N/A

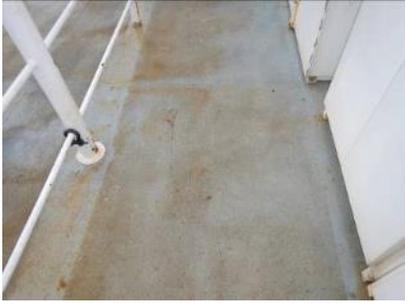
Boat Deck							Outer Deck
Inspection Zone	Material	Hazardous Content	Condition	Friability	Accessibility	Recommended Action	Picture
Deck	Anti-skid coating	Anti-skid coating (Intershield 6GV) is non-ACM as per manufacturer (see Appendix D). Remnants beneath newer layers may contain asbestos.	N/A	N/A	N/A	N/A

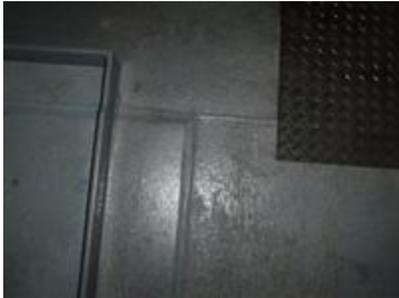
Boat Deck							Emergency Generator (Rm 416)
Inspection Zone	Material	Hazardous Content	Condition	Friability	Accessibility	Recommended Action	Picture
	Metal cladding over fibrous insulation.	Insulation may contain asbestos (not sampled – found to be in good condition).	N/A	N/A	N/A	N/A	
Deck	Anti-skid coating	Anti-skid coating (Intershield 6GV) is non-ACM as per manufacturer (see Appendix D). Remnants beneath newer layers may contain asbestos.	N/A	N/A	N/A	N/A

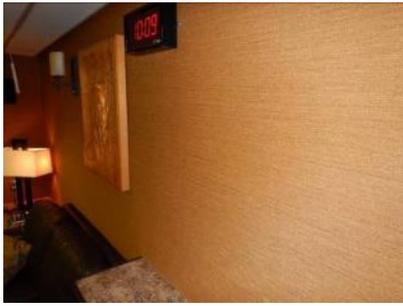
Bulkhead	Wallpaper-covered bulkhead panels (suspect non-asbestos marine panels based on other observations) over fibrous insulation (Fibreglass-type).	Marine panel may contain asbestos. (no access).	Good		A	7

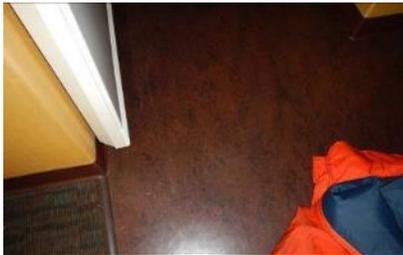
Lagging	None observed.	N/A	N/A	N/A	N/A	N/A	
Deck	Carpet and Resilient sheet flooring over deck screed.	No asbestos suspected in carpet or adhesives. • 31632-15: Carpet adhesive over deck screed (no asbestos)	N/A	N/A	N/A	N/A

Boat Deck							Officer's Lounge (Rm 422)
Inspection Zone	Material	Hazardous Content	Condition	Friability	Accessibility	Recommended Action	Picture
		detected).					
		No asbestos suspected in resilient sheet flooring	N/A	N/A	N/A	N/A	
		Deck screed may contain asbestos.	Exposed – good condition Concealed – unknown condition	Non-friable	C	7, or additional samples to rule out presence of asbestos.	
Other	Gasket	29314-4 Black gasket (contains asbestos)	Good	Non-friable	A	5 or 7	Photo not available
Comments	N/A

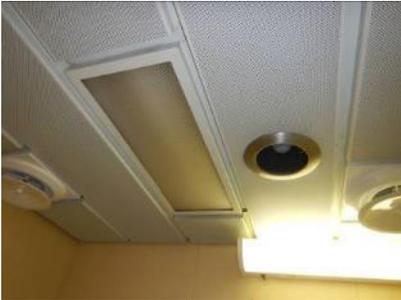
Boat Deck							Deck Washroom (Rm 425)
Inspection Zone	Material	Hazardous Content	Condition	Friability	Accessibility	Recommended Action	Picture
Deckhead	Perforated metal deckhead panels over foil-faced fibrous insulation (Fibreglass-type).	No asbestos suspected in panels or insulation.	N/A	N/A	N/A	N/A

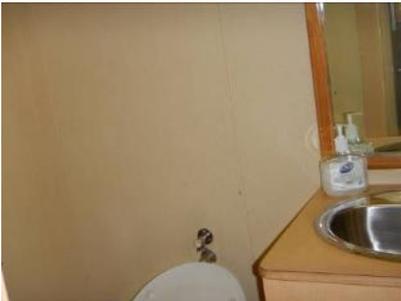
Bulkhead	Non-asbestos marine panels over fibrous insulation (Fibreglass-type).	No asbestos suspected in panels or insulation.	N/A	N/A	N/A	N/A

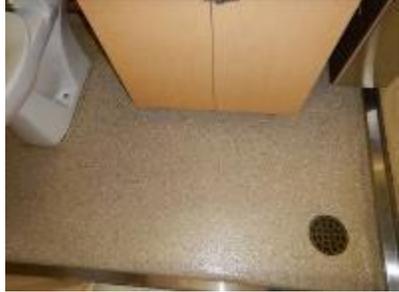
Boat Deck							Deck Washroom (Rm 425)
Inspection Zone	Material	Hazardous Content	Condition	Friability	Accessibility	Recommended Action	Picture
Deck	Epoxy over deck screed	Epoxy (Rada) is non-ACM as per manufacturer. Deck screed (Polyspec) underneath Rada is non-ACM as per manufacturer (see Appendix D).	N/A	N/A	N/A	N/A

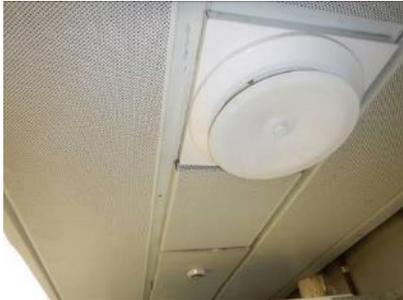
Boat Deck							Officer's Laundry (Rm 426)
Inspection Zone	Material	Hazardous Content	Condition	Friability	Accessibility	Recommended Action	Picture
Deckhead	Perforated metal deckhead panels over fibrous insulation (Fibreglass-type).	No asbestos suspected in panels or insulation.	N/A	N/A	N/A	N/A

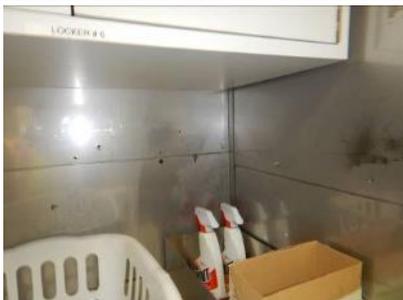
Bulkhead	Metal panel over fibrous insulation (Fibreglass-type).	No asbestos suspected in panels or insulation.	N/A	N/A	N/A	N/A

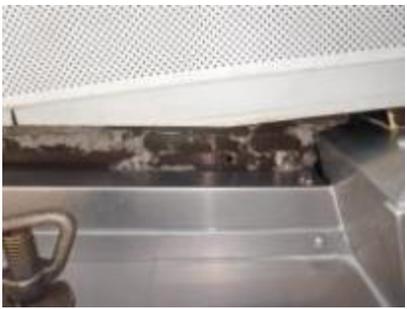
Boat Deck							Derrick Control Room (Rm 427)
Inspection Zone	Material	Hazardous Content	Condition	Friability	Accessibility	Recommended Action	Picture
Deckhead	Perforated metal deckhead panels over spray-applied fibrous insulation (Cafco-type).	No asbestos suspected in Cafco (14 out of 14 samples negative for asbestos). • 28403-5 Cafco (no asbestos detected).	N/A	N/A	N/A	N/A

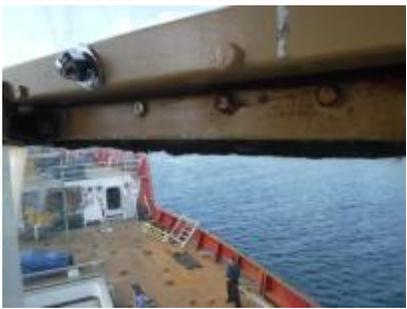
Painted metal (Forward 2')	No suspect asbestos.	N/A	N/A	N/A	N/A	
Bulkhead	Non-asbestos marine panels over fibrous insulation (Fibreglass-type).	No asbestos suspected in panels or insulation.	N/A	N/A	N/A	N/A

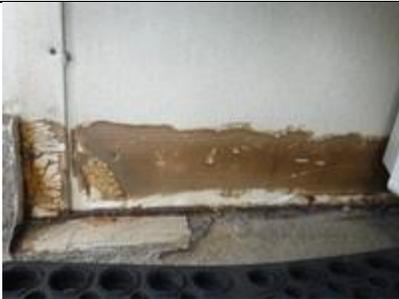
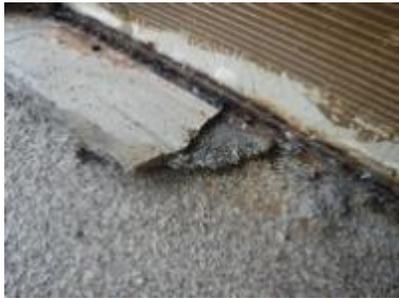
Deck	Epoxy and floor tile (beige) over deck screed.	<p>Epoxy (Rada) is non-ACM as per manufacturer. Deck screed (Polyspec) underneath Rada is non-ACM as per manufacturer (see Appendix D).</p> <ul style="list-style-type: none"> • 28403-3 Floor tile remnant - beige (no asbestos detected) • 28403-9 Deck screed remnant (no asbestos detected) 	Unknown	Non-friable	Concealed	7

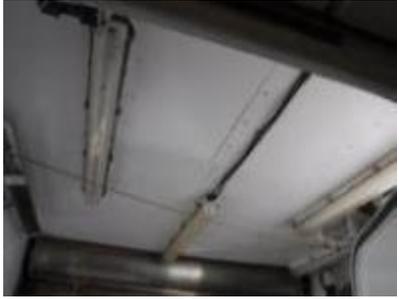
Boat Deck							Rosette Shelter (Rm 428)
Inspection Zone	Material	Hazardous Content	Condition	Friability	Accessibility	Recommended Action	Picture
Deckhead	Metal Panels	No suspect asbestos.	N/A	N/A	N/A	N/A

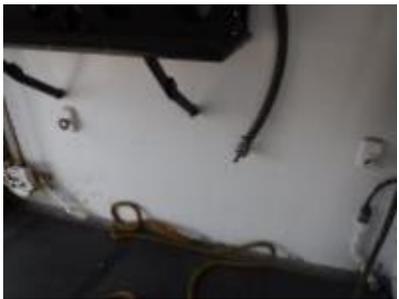
Bulkhead	Painted Metal	No suspect asbestos.	N/A	N/A	N/A	N/A

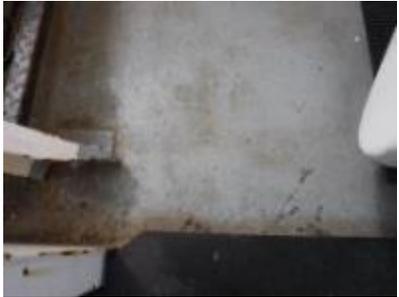
Boat Deck							Rosette Shelter (Rm 428)
Inspection Zone	Material	Hazardous Content	Condition	Friability	Accessibility	Recommended Action	Picture
Deck	Anti-skid coating	Anti-skid coating (Intershield 6GV) is non-ACM as per manufacturer (see Appendix D). Remnants beneath newer layers may contain asbestos.	N/A	N/A	N/A	N/A

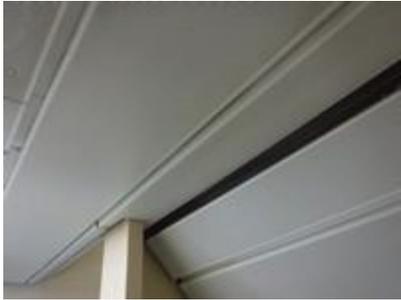
Boat Deck							Stairs
Inspection Zone	Material	Hazardous Content	Condition	Friability	Accessibility	Recommended Action	Picture
Deckhead	Perforated metal deckhead panels over fibrous insulation	No asbestos suspected in Cafco (14 out of 14 samples negative for asbestos).	N/A	N/A	N/A	N/A

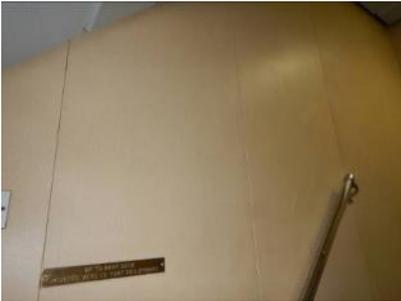
Bulkhead	Non-asbestos marine panels over fibrous insulation (Fibreglass-type).	No asbestos suspected in panels or insulation.	N/A	N/A	N/A	N/A

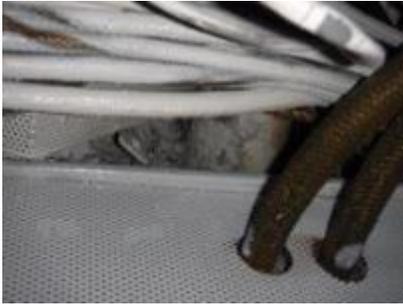
Boat Deck							Escape Trunk (Rm 503)
Inspection Zone	Material	Hazardous Content	Condition	Friability	Accessibility	Recommended Action	Picture
Deckhead	Perforated metal deckhead panels over spray-applied fibrous insulation (Cafco-type).	No asbestos suspected in Cafco (14 out of 14 samples negative for asbestos). <ul style="list-style-type: none"> 28403-1 Encapsulated Cafco (no asbestos detected). 	N/A	N/A	N/A	N/A

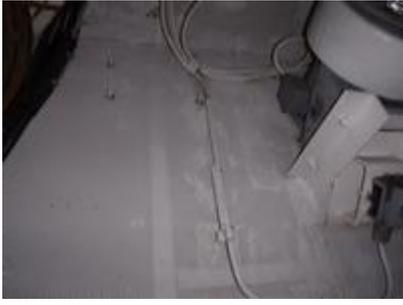
Bulkhead	Perforated metal deckhead panels over spray-applied fibrous insulation (Cafco-type).	No asbestos suspected in panels. No asbestos suspected in Cafco (14 out of 14 samples negative for asbestos).	N/A	N/A	N/A	N/A

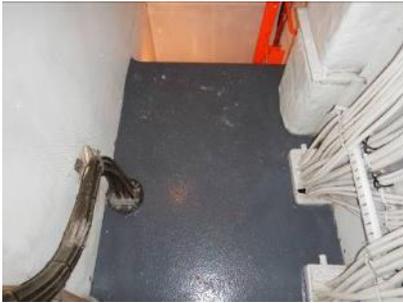
Boat Deck							Escape Trunk (Rm 503)
Inspection Zone	Material	Hazardous Content	Condition	Friability	Accessibility	Recommended Action	Picture
Lagging	Textile wrap over fibrous insulation	No asbestos suspected (5 out of 5 samples negative for asbestos).	N/A	N/A	N/A	N/A	
Deck	Anti-skid coating	Anti-skid coating (Intershield 6GV) is non-ACM as per manufacturer (see Appendix D). Remnants beneath newer layers may contain asbestos.	N/A	N/A	N/A	N/A

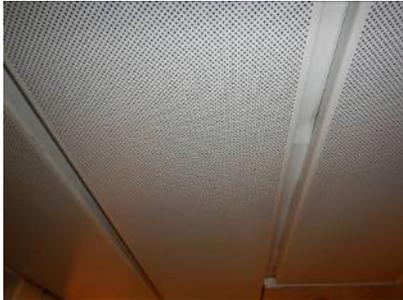
Upper Deck							Electronics Technician (Rm 504)
Inspection Zone	Material	Hazardous Content	Condition	Friability	Accessibility	Recommended Action	Picture
Deckhead	Perforated metal deckhead panels over foil-faced fibrous insulation (Roxul-type).	No asbestos suspected in panels or insulation.	N/A	N/A	N/A	N/A

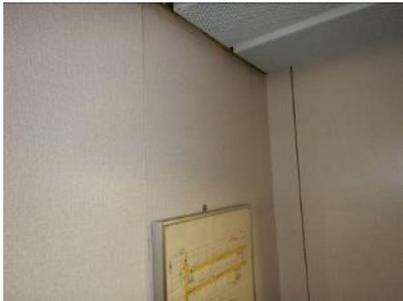
Bulkhead	Non-asbestos marine panels over fibrous insulation (Fibreglass-type).	No asbestos suspected in panels or insulation.	N/A	N/A	N/A	N/A

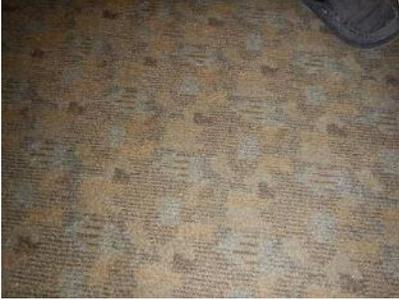
Upper Deck							Electronics Technician (Rm 504)
Inspection Zone	Material	Hazardous Content	Condition	Friability	Accessibility	Recommended Action	Picture
Deck	Carpet over deck screed	No asbestos suspected in carpet or adhesives.	N/A	N/A	N/A	N/A

Deck screed may contain asbestos.	Exposed – good condition Concealed – unknown condition	Non-friable	C	7, or additional samples to rule out presence of asbestos.	
Other	None observed.	N/A	N/A	N/A	N/A	N/A	
Comments	N/A

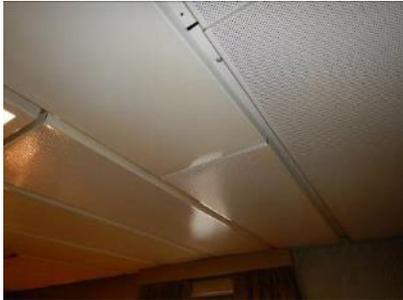
Upper Deck							Smoking Lounge (Rm 506)
Inspection Zone	Material	Hazardous Content	Condition	Friability	Accessibility	Recommended Action	Picture
Deckhead	Perforated metal deckhead panels over fibrous insulation (Fibreglass-type).	No asbestos suspected in panels or insulation.	N/A	N/A	N/A	N/A

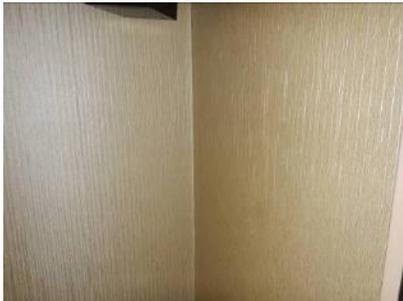
Bulkhead	Non-asbestos marine panels over fibrous insulation (Fibreglass-type).	No asbestos suspected in panels or insulation.	N/A	N/A	N/A	N/A

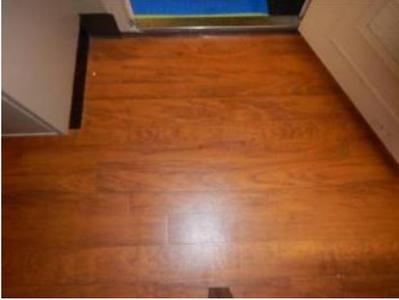
Upper Deck							Smoking Lounge (Rm 506)
Inspection Zone	Material	Hazardous Content	Condition	Friability	Accessibility	Recommended Action	Picture
Deck	Resilient sheet flooring over deck screed	No asbestos suspected in carpet or adhesives.	N/A	N/A	N/A	N/A

Deck screed may contain asbestos.	Exposed – good condition Concealed – unknown condition	Non-friable	C	7, or additional samples to rule out presence of asbestos.	
Other	None observed.	N/A	N/A	N/A	N/A	N/A	
Comments	N/A

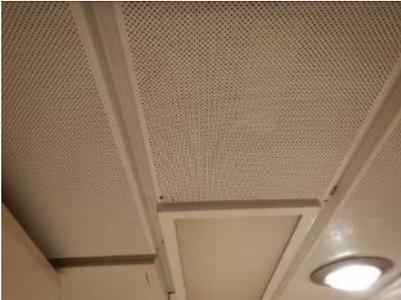
Upper Deck							Electronics Tech Washroom (507)
Inspection Zone	Material	Hazardous Content	Condition	Friability	Accessibility	Recommended Action	Picture
Deckhead	Perforated metal deckhead panels over fibrous insulation (Fibreglass-type).	No asbestos suspected in panels or insulation.	N/A	N/A	N/A	N/A

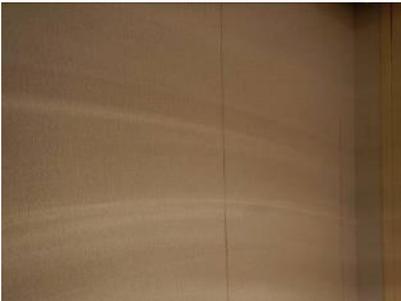
Bulkhead	Non-asbestos marine panels over fibrous insulation (Fibreglass-type).	No asbestos suspected in panels or insulation.	N/A	N/A	N/A	N/A

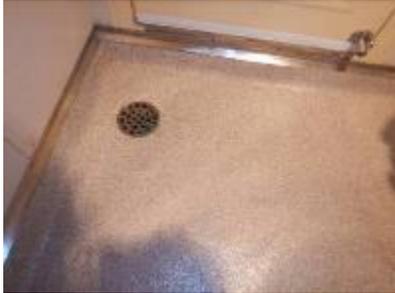
Upper Deck							Electronics Tech Washroom (507)
Inspection Zone	Material	Hazardous Content	Condition	Friability	Accessibility	Recommended Action	Picture
Deck	Epoxy over deck screed.	Epoxy (Rada) is non-ACM as per manufacturer. Deck screed (Polyspec) underneath Rada is non-ACM as per manufacturer (see Appendix D).	N/A	N/A	N/A	N/A

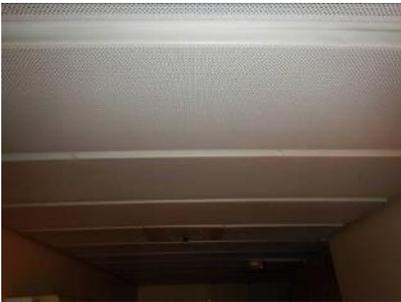
Upper Deck							Two Passengers (Rm 510)
Inspection Zone	Material	Hazardous Content	Condition	Friability	Accessibility	Recommended Action	Picture
Deckhead	Perforated metal deckhead panels over fibrous insulation (Fibreglass-type).	No asbestos suspected in panels or insulation.	N/A	N/A	N/A	N/A

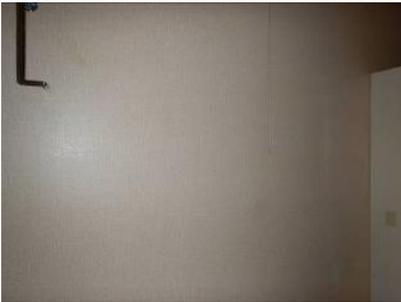
Bulkhead	Non-asbestos marine panels over fibrous insulation (Fibreglass-type).	No asbestos suspected in panels or insulation.	N/A	N/A	N/A	N/A

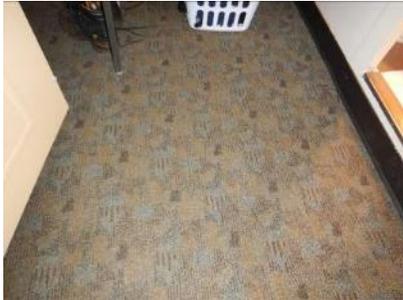
Upper Deck							Two Passengers (Rm 510)
Inspection Zone	Material	Hazardous Content	Condition	Friability	Accessibility	Recommended Action	Picture
Deck	Carpet over deck screed.	No asbestos suspected in carpet or adhesives.	N/A	N/A	N/A	N/A

Deck screed may contain asbestos.	Exposed – good condition Concealed – unknown condition	Non-friable	C	7, or additional samples to rule out presence of asbestos.	
Other	None observed.	N/A	N/A	N/A	N/A	N/A	
Comments	N/A

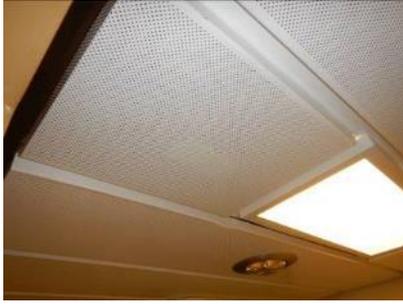
Upper Deck							Two Passengers Washroom (Rm 508)
Inspection Zone	Material	Hazardous Content	Condition	Friability	Accessibility	Recommended Action	Picture
Deckhead	Perforated metal deckhead panels over fibrous insulation (Fibreglass-type).	No asbestos suspected in panels or insulation.	N/A	N/A	N/A	N/A

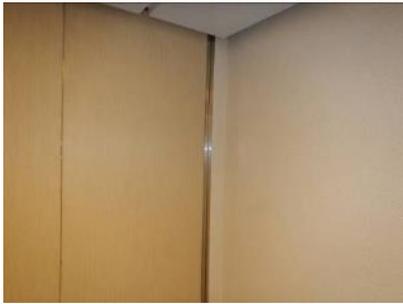
Bulkhead	Non-asbestos marine panels over fibrous insulation (Fibreglass-type).	No asbestos suspected in panels or insulation.	N/A	N/A	N/A	N/A

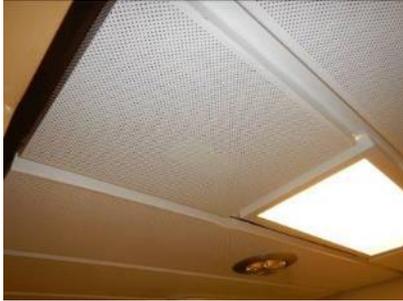
Upper Deck							Two Passengers Washroom (Rm 511)
Inspection Zone	Material	Hazardous Content	Condition	Friability	Accessibility	Recommended Action	Picture
Deckhead	Perforated metal deckhead panels over fibrous insulation (Fibreglass-type).	No asbestos suspected in panels or insulation.	N/A	N/A	N/A	N/A

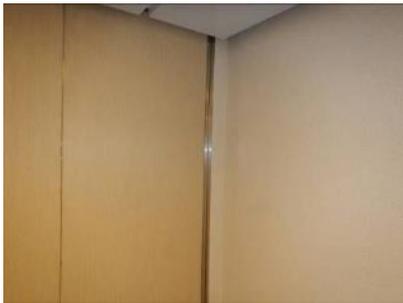
Bulkhead	Non-asbestos marine panels over fibrous insulation (Fibreglass-type).	No asbestos suspected in panels or insulation.	N/A	N/A	N/A	N/A

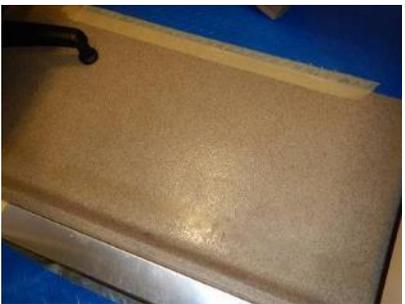
Upper Deck							Two Passengers Washroom (Rm 511)
Inspection Zone	Material	Hazardous Content	Condition	Friability	Accessibility	Recommended Action	Picture
Deck	Epoxy over deck screed.	Epoxy (Rada) is non-ACM as per manufacturer. Deck screed (Polyspec) underneath Rada is non-ACM as per manufacturer (see Appendix D).	N/A	N/A	N/A	N/A

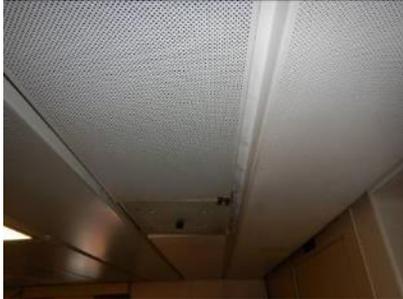
Upper Deck							Flight Engineer (Rm 512)
Inspection Zone	Material	Hazardous Content	Condition	Friability	Accessibility	Recommended Action	Picture
Deckhead	Perforated metal deckhead panels over fibrous insulation (Fibreglass-type).	No asbestos suspected in panels or insulation.	N/A	N/A	N/A	N/A

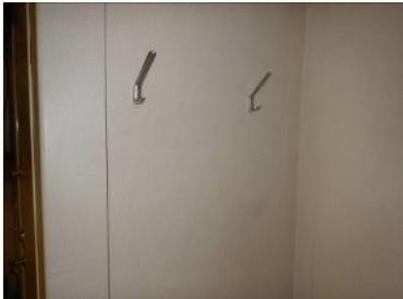
Bulkhead	Non-asbestos marine panels over fibrous insulation (Fibreglass-type).	No asbestos suspected in panels or insulation.	N/A	N/A	N/A	N/A

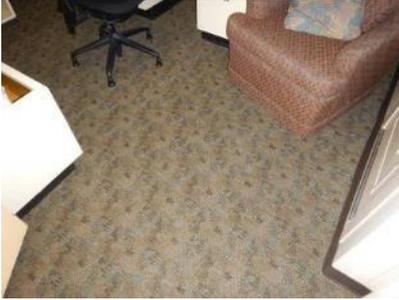
Deck screed may contain asbestos.	Exposed – good condition Concealed – unknown condition	Non-friable	C	7, or additional samples to rule out presence of asbestos.	
Other	None observed.	N/A	N/A	N/A	N/A	N/A	
Comments	N/A

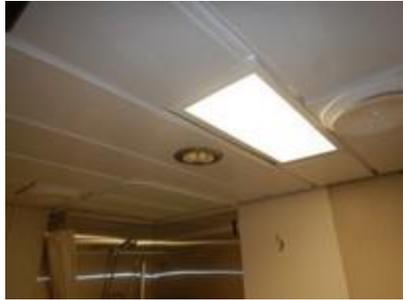
Upper Deck							Flight Engineer Washroom (Rm 513/515)
Inspection Zone	Material	Hazardous Content	Condition	Friability	Accessibility	Recommended Action	Picture
Deckhead	Perforated metal deckhead panels over fibrous insulation (Fibreglass-type).	No asbestos suspected in panels or insulation.	N/A	N/A	N/A	N/A

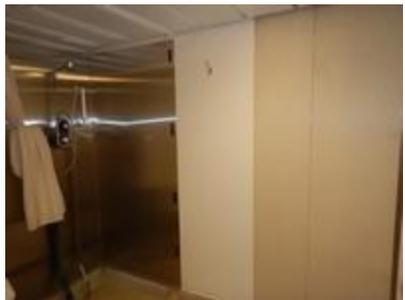
Bulkhead	Non-asbestos marine panels over fibrous insulation (Fibreglass-type).	No asbestos suspected in panels or insulation.	N/A	N/A	N/A	N/A

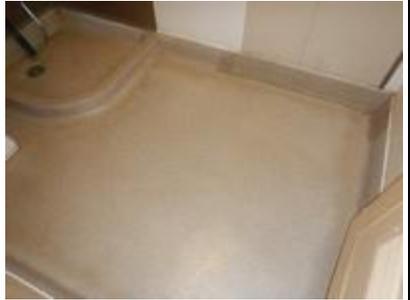
Upper Deck							Flight Engineer Washroom (Rm 513/515)
Inspection Zone	Material	Hazardous Content	Condition	Friability	Accessibility	Recommended Action	Picture
Deck	Epoxy over deck screed	Epoxy (Rada) is non-ACM as per manufacturer. Deck screed (Polyspec) underneath Rada is non-ACM as per manufacturer (see Appendix D).	N/A	N/A	N/A	N/A

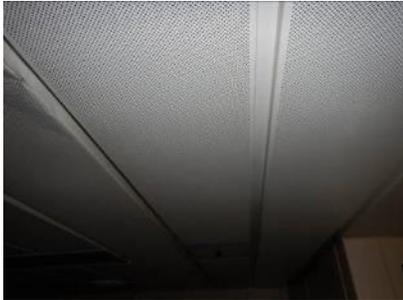
Upper Deck							Passenger Cabin (Rm 516)
Inspection Zone	Material	Hazardous Content	Condition	Friability	Accessibility	Recommended Action	Picture
Deckhead	Perforated metal deckhead panels over fibrous insulation (Fibreglass-type).	No asbestos suspected in panels or insulation.	N/A	N/A	N/A	N/A

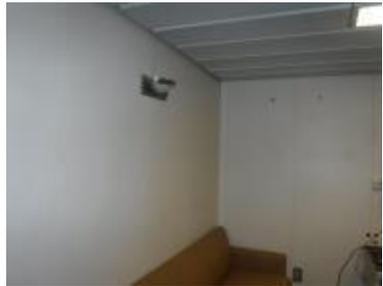
Bulkhead	Non-asbestos marine panels over fibrous insulation (Fibreglass-type).	No asbestos suspected in panels or insulation.	N/A	N/A	N/A	N/A

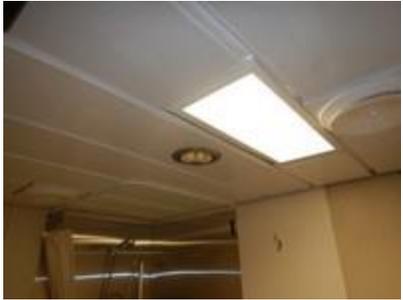
Upper Deck							Washroom (in 516 & 520) (Rm 517/521)
Inspection Zone	Material	Hazardous Content	Condition	Friability	Accessibility	Recommended Action	Picture
Deckhead	Perforated metal deckhead panels over fibrous insulation (Fibreglass-type).	No asbestos suspected in panels or insulation.	N/A	N/A	N/A	N/A

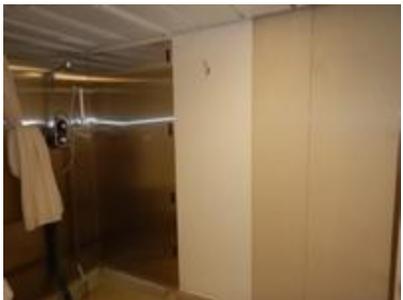
Bulkhead	Non-asbestos marine panels over fibrous insulation (Fibreglass-type).	No asbestos suspected in panels or insulation.	N/A	N/A	N/A	N/A

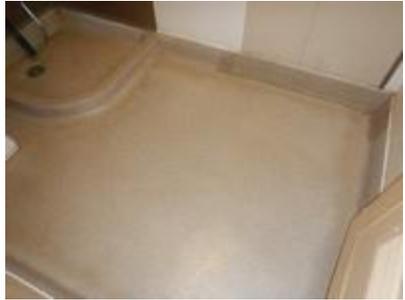
Upper Deck							Washroom (in 516 & 520) (Rm 517/521)
Inspection Zone	Material	Hazardous Content	Condition	Friability	Accessibility	Recommended Action	Picture
Deck	Epoxy over deck screed.	Epoxy (Rada) is non-ACM as per manufacturer. Deck screed (Polyspec) underneath Rada is non-ACM as per manufacturer (see Appendix D).	N/A	N/A	N/A	N/A

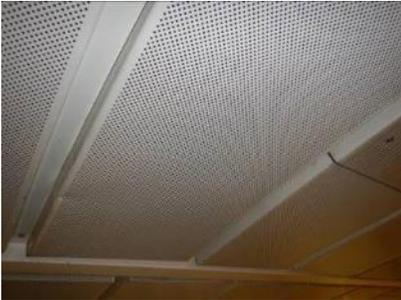
Upper Deck							Ship Office (Rm 518)
Inspection Zone	Material	Hazardous Content	Condition	Friability	Accessibility	Recommended Action	Picture
Deckhead	Perforated metal deckhead panels over fibrous insulation (Fibreglass-type).	No asbestos suspected in panels or insulation.	N/A	N/A	N/A	N/A

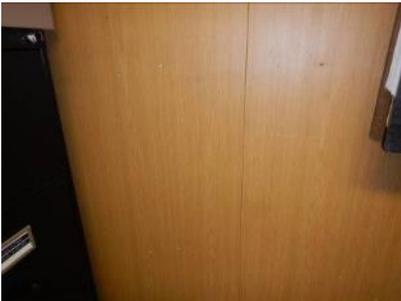
Bulkhead	Non-asbestos marine panels (wood) over fibrous insulation (Fibreglass-type).	No asbestos suspected in panels or insulation.	N/A	N/A	N/A	N/A

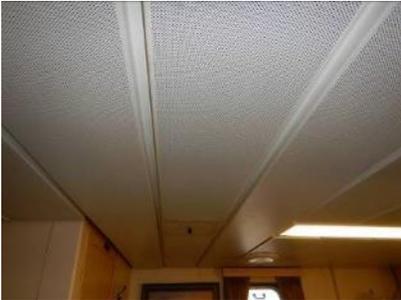
Upper Deck							Logistics Officer (Rm 520)
Inspection Zone	Material	Hazardous Content	Condition	Friability	Accessibility	Recommended Action	Picture
Deckhead	Perforated metal deckhead panels over fibrous insulation (Fibreglass-type).	No asbestos suspected in panels or insulation.	N/A	N/A	N/A	N/A

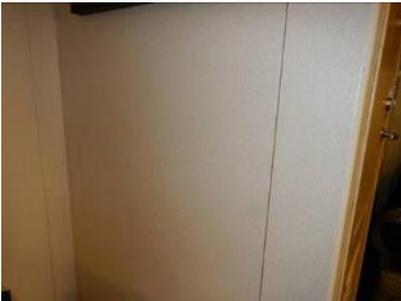
Bulkhead	Non-asbestos marine panels over fibrous insulation (Fibreglass-type).	No asbestos suspected in panels or insulation.	N/A	N/A	N/A	N/A

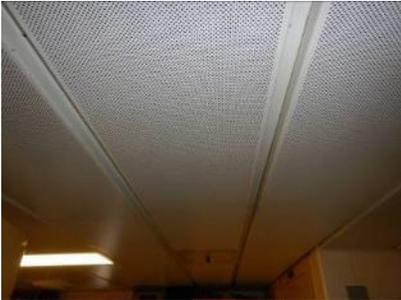
Upper Deck							Electrical Officer (Rm 522)
Inspection Zone	Material	Hazardous Content	Condition	Friability	Accessibility	Recommended Action	Picture
Deckhead	Perforated metal deckhead panels over fibrous insulation (Fibreglass-type).	No asbestos suspected in panels or insulation.	N/A	N/A	N/A	N/A

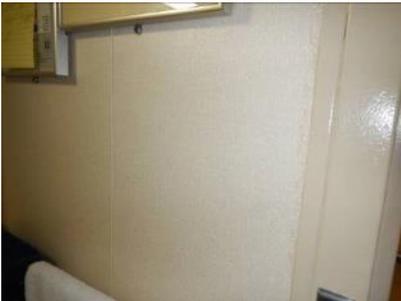
Bulkhead	Non-asbestos marine panels over fibrous insulation (Fibreglass-type).	No asbestos suspected in panels or insulation.	N/A	N/A	N/A	N/A

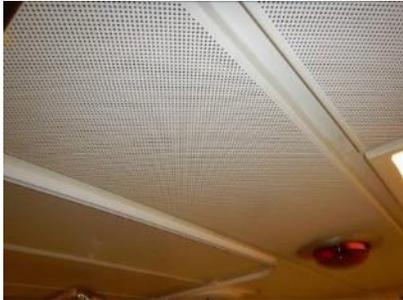
Upper Deck							Washroom (in 522 & 524) (Rm 523/535)
Inspection Zone	Material	Hazardous Content	Condition	Friability	Accessibility	Recommended Action	Picture
Deckhead	Perforated metal deckhead panels over fibrous insulation (Fibreglass-type).	No asbestos suspected in panels or insulation.	N/A	N/A	N/A	N/A

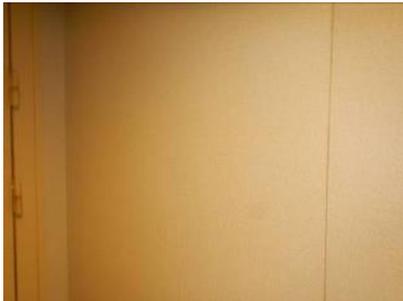
Bulkhead	Non-asbestos marine panels over fibrous insulation (Fibreglass-type).	No asbestos suspected in panels or insulation.	N/A	N/A	N/A	N/A

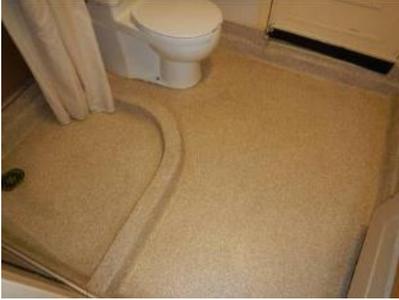
Upper Deck							Washroom (in 522 & 524) (Rm 523/535)
Inspection Zone	Material	Hazardous Content	Condition	Friability	Accessibility	Recommended Action	Picture
Deck	Epoxy over deck screed.	Epoxy (Rada) is non-ACM as per manufacturer. Deck screed (Polyspec) underneath Rada is non-ACM as per manufacturer (see Appendix D).	N/A	N/A	N/A	N/A

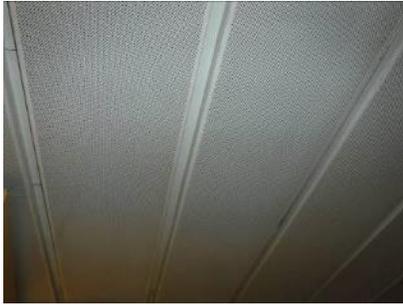
Upper Deck							Medical Officer Cabin (Rm 524)
Inspection Zone	Material	Hazardous Content	Condition	Friability	Accessibility	Recommended Action	Picture
Deckhead	Perforated metal deckhead panels over fibrous insulation (Fibreglass-type).	No asbestos suspected in panels or insulation.	N/A	N/A	N/A	N/A

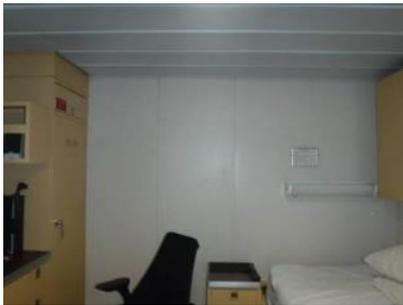
Bulkhead	Non-asbestos marine panels over fibrous insulation (Fibreglass-type).	No asbestos suspected in panels or insulation.	N/A	N/A	N/A	N/A

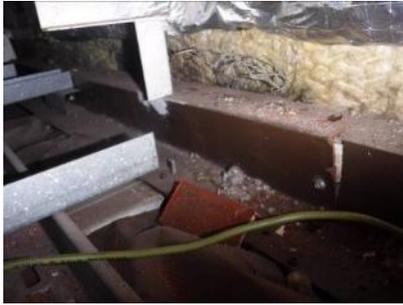
Upper Deck							Port Alleyway
Inspection Zone	Material	Hazardous Content	Condition	Friability	Accessibility	Recommended Action	Picture
Deckhead	Perforated metal deckhead panels over fibrous insulation (Roxul-type).	No asbestos suspected in panels or insulation.	N/A	N/A	N/A	N/A

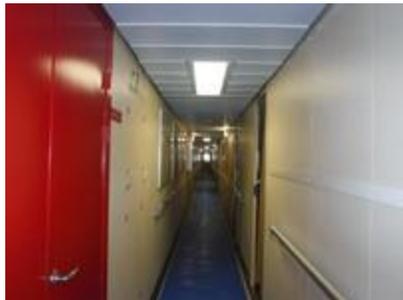
Bulkhead	Non-asbestos marine panels over fibrous insulation (Fibreglass-type).	No asbestos suspected in panels or insulation.	N/A	N/A	N/A	N/A

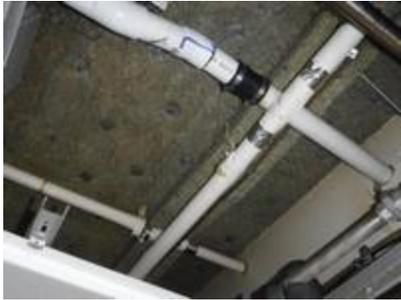
Upper Deck							Fwd Athwartship Alleyway
Inspection Zone	Material	Hazardous Content	Condition	Friability	Accessibility	Recommended Action	Picture
Deckhead	Perforated metal deckhead panels over fibrous insulation (Roxul-type).	No asbestos suspected in panels or insulation.	N/A	N/A	N/A	N/A

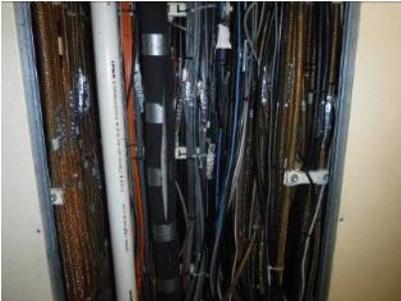
Bulkhead	Non-asbestos marine panels over spray-applied fibrous insulation (Cafco-type).	No asbestos suspected in Cafco (14 out of 14 samples negative for asbestos).	N/A	N/A	N/A	N/A

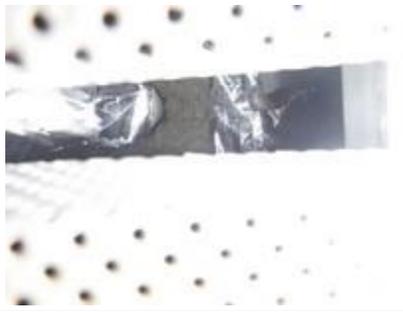
Upper Deck							Quarter Master (Rm 528)
Inspection Zone	Material	Hazardous Content	Condition	Friability	Accessibility	Recommended Action	Picture
Deckhead	Perforated metal deckhead panels over fibrous insulation (Roxul-type).	No asbestos suspected in panels or insulation.	N/A	N/A	N/A	N/A

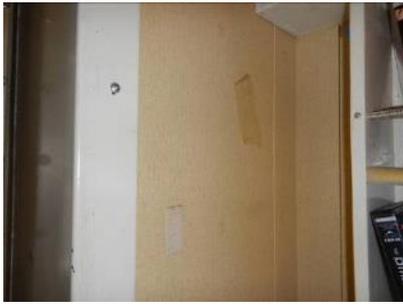
Bulkhead	Non-asbestos marine panels over fibrous insulation (Fibreglass-type).	No asbestos suspected in panels or insulation.	N/A	N/A	N/A	N/A

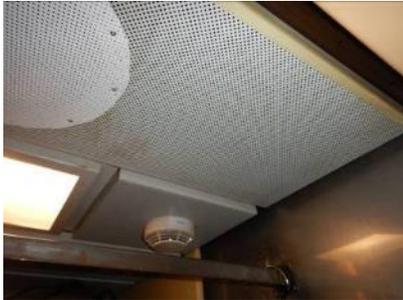
Upper Deck							SAR Locker (Rm 531)
Inspection Zone	Material	Hazardous Content	Condition	Friability	Accessibility	Recommended Action	Picture
Deckhead	Perforated metal deckhead panels over foil-faced fibrous insulation (Fibreglass-type).	No asbestos suspected in panels or insulation.	N/A	N/A	N/A	N/A

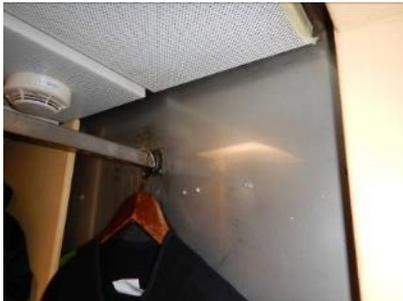
Bulkhead	Metal	No suspect asbestos.	N/A	N/A	N/A	N/A

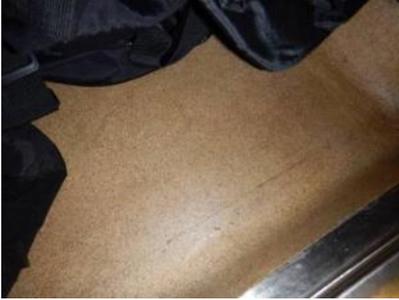
Upper Deck							SAR Locker (Rm 531)
Inspection Zone	Material	Hazardous Content	Condition	Friability	Accessibility	Recommended Action	Picture
Deck	Epoxy over deck screed.	Epoxy (Rada) is non-ACM as per manufacturer. Deck screed (Polyspec) underneath Rada is non-ACM as per manufacturer (see Appendix D).	N/A	N/A	N/A	N/A

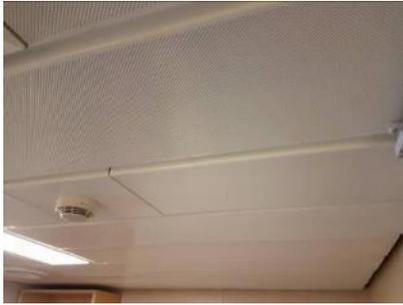
Upper Deck							Storekeeper (Rm 532)
Inspection Zone	Material	Hazardous Content	Condition	Friability	Accessibility	Recommended Action	Picture
Deckhead	Perforated metal deckhead panels over fibrous insulation (Fibreglass-type).	No asbestos suspected in panels or insulation.	N/A	N/A	N/A	N/A

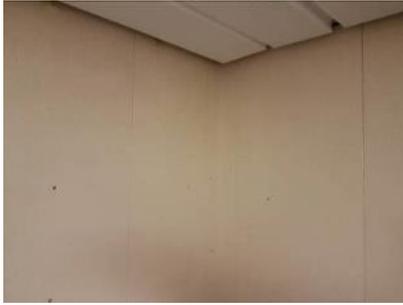
Bulkhead	Non-asbestos marine panels over fibrous insulation (Fibreglass-type).	No asbestos suspected in panels or insulation.	N/A	N/A	N/A	N/A

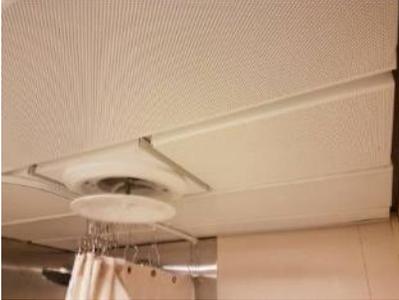
Upper Deck							Washroom (Rm 533/536)
Inspection Zone	Material	Hazardous Content	Condition	Friability	Accessibility	Recommended Action	Picture
Deckhead	Perforated metal deckhead panels over fibrous insulation (Fibreglass-type).	No asbestos suspected in panels or insulation.	N/A	N/A	N/A	N/A

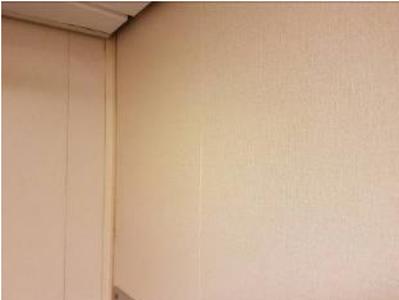
Bulkhead	Non-asbestos marine panels over fibrous insulation (Fibreglass-type).	No asbestos suspected in panels or insulation.	N/A	N/A	N/A	N/A

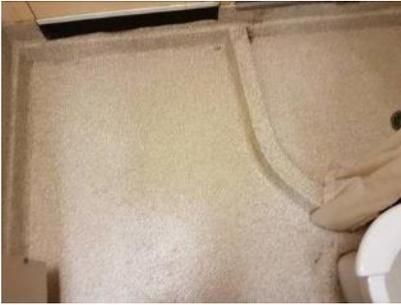
Upper Deck							Washroom (Rm 533/536)
Inspection Zone	Material	Hazardous Content	Condition	Friability	Accessibility	Recommended Action	Picture
Deck	Epoxy over deck screed.	Epoxy (Rada) is non-ACM as per manufacturer. Deck screed (Polyspec) underneath Rada is non-ACM as per manufacturer (see Appendix D).	N/A	N/A	N/A	N/A

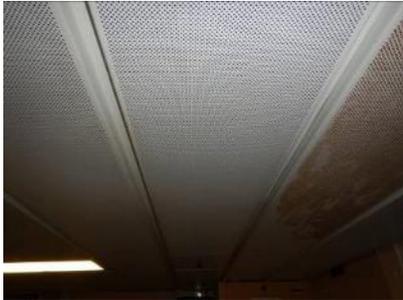
Upper Deck							Boatswain (Rm 535)
Inspection Zone	Material	Hazardous Content	Condition	Friability	Accessibility	Recommended Action	Picture
Deckhead	Perforated metal deckhead panels over fibrous insulation (Fibreglass-type).	No asbestos suspected in panels or insulation.	N/A	N/A	N/A	N/A

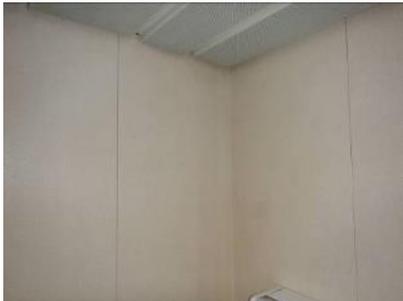
Bulkhead	Non-asbestos marine panels over fibrous insulation (Fibreglass-type).	No asbestos suspected in panels or insulation.	N/A	N/A	N/A	N/A

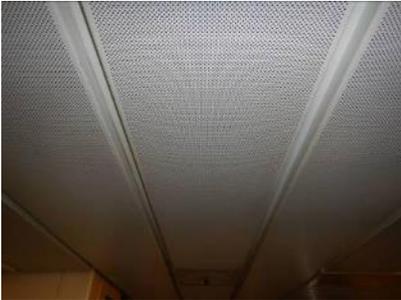
Upper Deck							3 rd Engineer's Cabin (Rm 537)
Inspection Zone	Material	Hazardous Content	Condition	Friability	Accessibility	Recommended Action	Picture
Deckhead	Perforated metal deckhead panels over fibrous insulation (Fibreglass-type).	No asbestos suspected in panels or insulation.	N/A	N/A	N/A	N/A

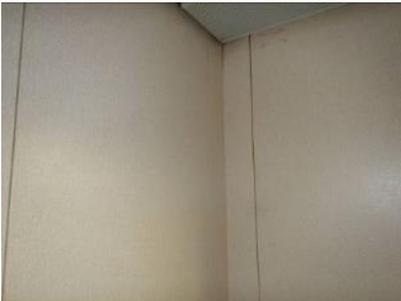
Bulkhead	Non-asbestos marine panels over fibrous insulation (Fibreglass-type).	No asbestos suspected in panels or insulation.	N/A	N/A	N/A	N/A

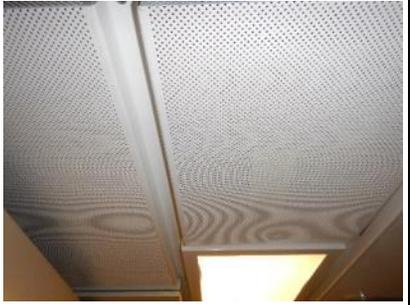
Upper Deck							3 rd Engineer's Cabin Washroom (Rm 538/542)
Inspection Zone	Material	Hazardous Content	Condition	Friability	Accessibility	Recommended Action	Picture
Deckhead	Perforated metal deckhead panels over fibrous insulation (Fibreglass-type).	No asbestos suspected in panels or insulation.	N/A	N/A	N/A	N/A

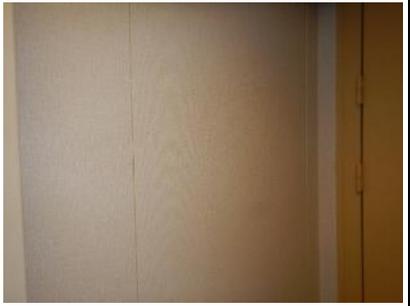
Bulkhead	Non-asbestos marine panels over fibrous insulation (Fibreglass-type).	No asbestos suspected in panels or insulation.	N/A	N/A	N/A	N/A

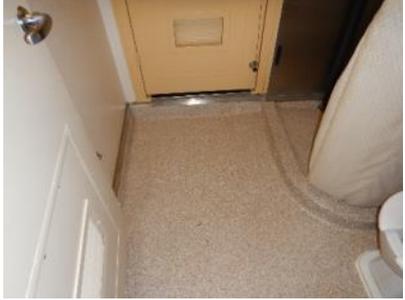
Upper Deck							3 rd Engineer's Cabin Washroom (Rm 538/542)
Inspection Zone	Material	Hazardous Content	Condition	Friability	Accessibility	Recommended Action	Picture
Deck	Epoxy over deck screed.	Epoxy (Rada) is non-ACM as per manufacturer. Deck screed (Polyspec) underneath Rada is non-ACM as per manufacturer (see Appendix D).	N/A	N/A	N/A	N/A

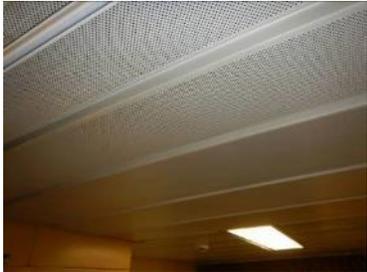
Upper Deck							Two Passengers (Rm 539)
Inspection Zone	Material	Hazardous Content	Condition	Friability	Accessibility	Recommended Action	Picture
Deckhead	Perforated metal deckhead panels over fibrous insulation (Fibreglass-type).	No asbestos suspected in panels or insulation.	N/A	N/A	N/A	N/A

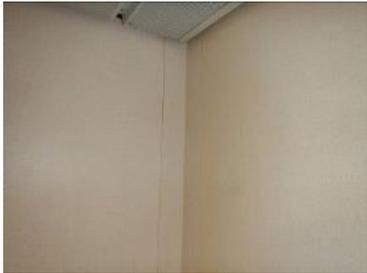
Bulkhead	Non-asbestos marine panels over fibrous insulation (Fibreglass-type).	No asbestos suspected in panels or insulation.	N/A	N/A	N/A	N/A

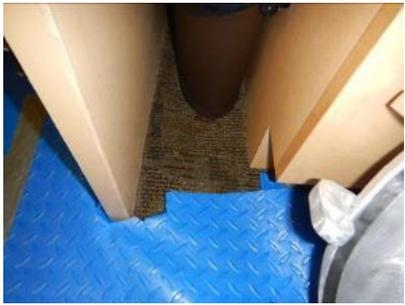
Lagging	None observed.	N/A	N/A	N/A	N/A	N/A	
Deck	Carpet over deck screed.	No asbestos suspected in carpet or adhesives.	N/A	N/A	N/A	N/A

Deck screed may contain asbestos.	Exposed – good condition Concealed – unknown condition	Non-friable	C	7, or additional samples to rule out presence of asbestos.

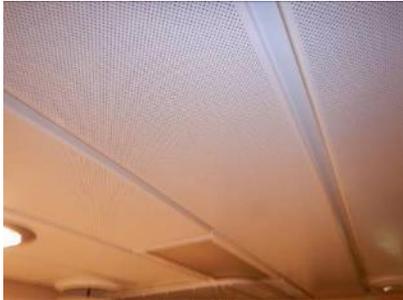
Upper Deck							Washroom (in 508 & 510) (Rm 540/509)
Inspection Zone	Material	Hazardous Content	Condition	Friability	Accessibility	Recommended Action	Picture
Deckhead	Perforated metal deckhead panels over fibrous insulation (Fibreglass-type).	No asbestos suspected in panels or insulation.	N/A	N/A	N/A	N/A

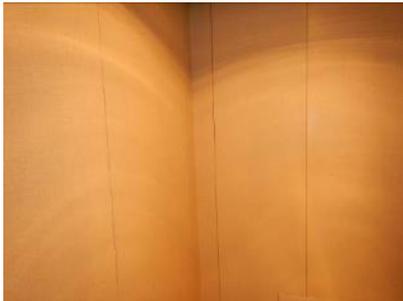
Bulkhead	Non-asbestos marine panels over fibrous insulation (Fibreglass-type).	No asbestos suspected in panels or insulation.	N/A	N/A	N/A	N/A
