Prepared for:
Canadian Coast Guard

CCGS SIR WILFRID LAURIER Asbestos Condition Report

**North West
Environmental Group Ltd.**

NWest Project No. 31632
Date Issued: March 31st, 2017

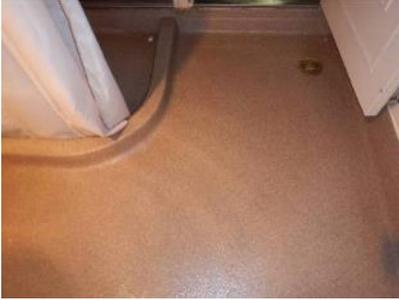
Upper Deck							Washroom (in 508 & 510) (Rm 540/509)
Inspection Zone	Material	Hazardous Content	Condition	Friability	Accessibility	Recommended Action	Picture
Deck	Epoxy over deck screed.	Epoxy (Rada) is non-ACM as per manufacturer. Deck screed (Polyspec) underneath Rada is non-ACM as per manufacturer (see Appendix D).	N/A	N/A	N/A	N/A

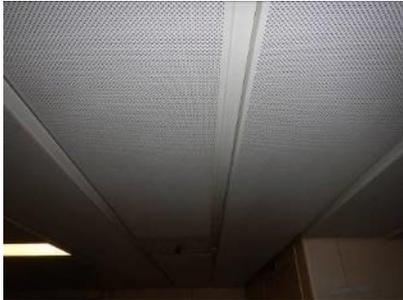
Upper Deck							2 nd Engineer's Cabin (Rm 541)
Inspection Zone	Material	Hazardous Content	Condition	Friability	Accessibility	Recommended Action	Picture
Deckhead	Perforated metal deckhead panels over fibrous insulation (Fibreglass-type).	No asbestos suspected in panels or insulation.	N/A	N/A	N/A	N/A

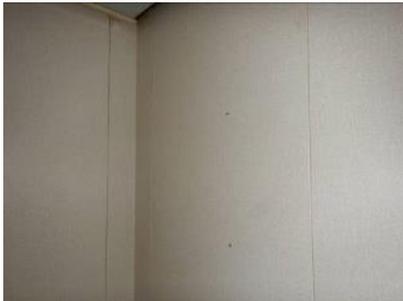
Bulkhead	Non-asbestos marine panels over fibrous insulation (Fibreglass-type).	No asbestos suspected in panels or insulation.	N/A	N/A	N/A	N/A

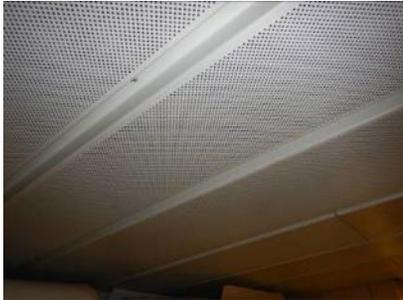
Upper Deck							Engineer's Office (Rm 543)
Inspection Zone	Material	Hazardous Content	Condition	Friability	Accessibility	Recommended Action	Picture
Deckhead	Perforated metal deckhead panels over fibrous insulation (Fibreglass-type).	No asbestos suspected in panels or insulation.	N/A	N/A	N/A	N/A

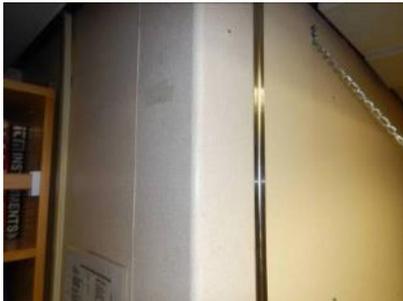
Bulkhead	Non-asbestos marine panels over fibrous insulation (Fibreglass-type).	No asbestos suspected in panels or insulation.	N/A	N/A	N/A	N/A

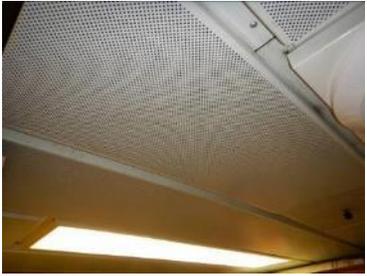
Upper Deck							Deck Office (Rm 545)
Inspection Zone	Material	Hazardous Content	Condition	Friability	Accessibility	Recommended Action	Picture
Deckhead	Perforated metal deckhead panels over fibrous insulation (Fibreglass-type).	No asbestos suspected in panels or insulation.	N/A	N/A	N/A	N/A

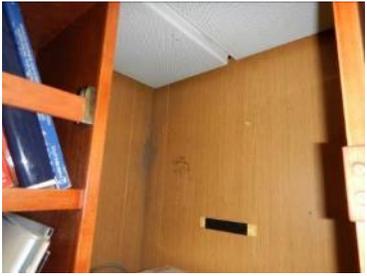
Bulkhead	Non-asbestos marine panels over fibrous insulation (Fibreglass-type).	No asbestos suspected in panels or insulation.	N/A	N/A	N/A	N/A

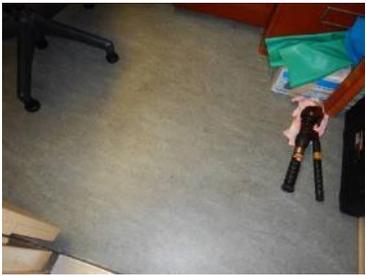
Lagging	None observed.	N/A	N/A	N/A	N/A	N/A	
Deck	Resilient sheet flooring over deck screed.	No asbestos suspected in sheet flooring or adhesives.	N/A	N/A	N/A	N/A

Deck screed may contain asbestos.	Exposed – good condition Concealed –	Non-friable	C	7, or additional samples to rule out presence of asbestos.

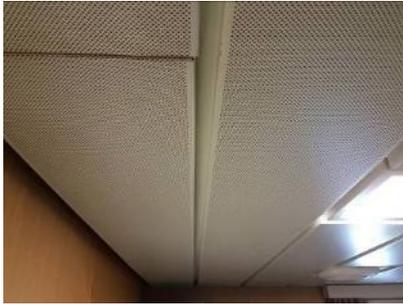
Upper Deck							Senior Engineer (Rm 546)
Inspection Zone	Material	Hazardous Content	Condition	Friability	Accessibility	Recommended Action	Picture
Deckhead	Perforated metal deckhead panels over fibrous insulation (Fibreglass-type).	No asbestos suspected in panels or insulation.	N/A	N/A	N/A	N/A

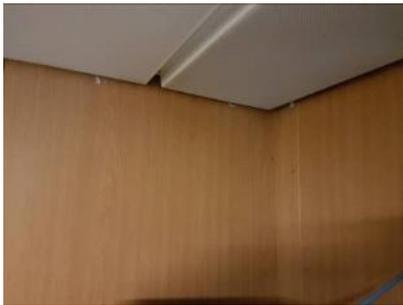
Bulkhead	Non-asbestos marine panels over fibrous insulation (Fibreglass-type).	No asbestos suspected in panels or insulation.	N/A	N/A	N/A	N/A

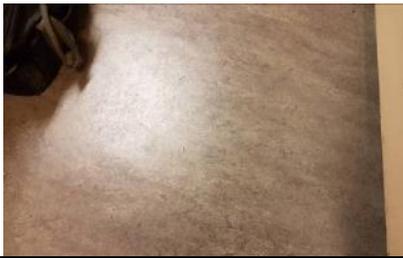
Lagging	None observed.	N/A	N/A	N/A	N/A	N/A	
Deck	Resilient sheet flooring over deck screed.	No asbestos suspected in sheet flooring or adhesives. Deck screed may contain asbestos.	N/A Exposed – good condition Concealed –	N/A Non-friable	N/A C	N/A 7, or additional samples to rule out presence of asbestos.

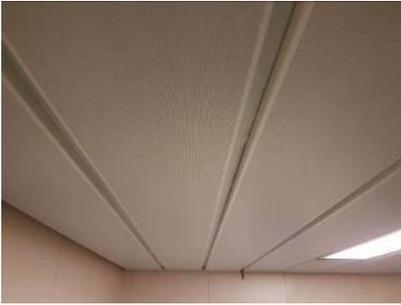
Upper Deck							Cabin (Rm 547)
Inspection Zone	Material	Hazardous Content	Condition	Friability	Accessibility	Recommended Action	Picture
Deckhead	Perforated metal deckhead panels over fibrous insulation (Fibreglass-type).	No asbestos suspected in panels or insulation.	N/A	N/A	N/A	N/A

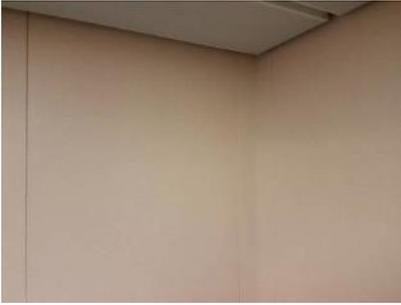
Bulkhead	Non-asbestos marine panels over fibrous insulation (Fibreglass-type).	No asbestos suspected in panels or insulation.	N/A	N/A	N/A	N/A

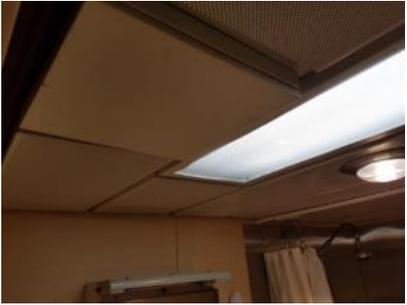
Upper Deck							Washroom (Rm 548)
Inspection Zone	Material	Hazardous Content	Condition	Friability	Accessibility	Recommended Action	Picture
Deckhead	Perforated metal deckhead panels over fibrous insulation (Fibreglass-type).	No asbestos suspected in panels or insulation.	N/A	N/A	N/A	N/A

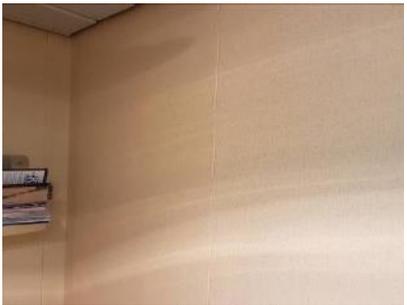
Bulkhead	Non-asbestos marine panels over fibrous insulation (Fibreglass-type).	No asbestos suspected in panels or insulation.	N/A	N/A	N/A	N/A

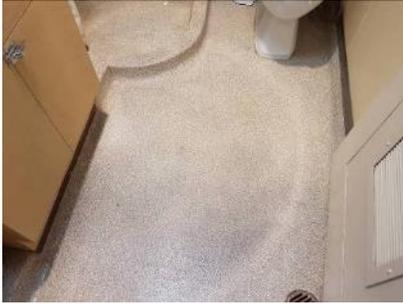
Upper Deck							Washroom (Rm 548)
Inspection Zone	Material	Hazardous Content	Condition	Friability	Accessibility	Recommended Action	Picture
Deck	Epoxy over deck screed.	Epoxy (Rada) is non-ACM as per manufacturer. Deck screed (Polyspec) underneath Rada is non-ACM as per manufacturer (see Appendix D).	N/A	N/A	N/A	N/A

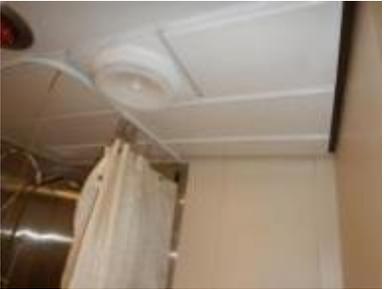
Upper Deck							Deck Washroom (Rm 549)
Inspection Zone	Material	Hazardous Content	Condition	Friability	Accessibility	Recommended Action	Picture
Deckhead	Perforated metal deckhead panels over fibrous insulation (Fibreglass-type).	No asbestos suspected in panels or insulation.	N/A	N/A	N/A	N/A

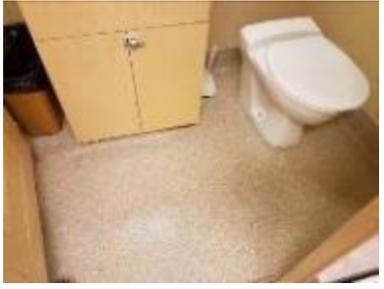
Bulkhead	Non-asbestos marine panels over fibrous insulation (Fibreglass-type).	No asbestos suspected in panels or insulation.	N/A	N/A	N/A	N/A	
Lagging	None observed.	N/A	N/A	N/A	N/A	N/A	
Deck	Epoxy over deck screed.	Epoxy (Rada) is non-ACM as per manufacturer. Deck screed (Polyspec) underneath Rada is non-ACM as per manufacturer (see Appendix D).	N/A	N/A	N/A	N/A

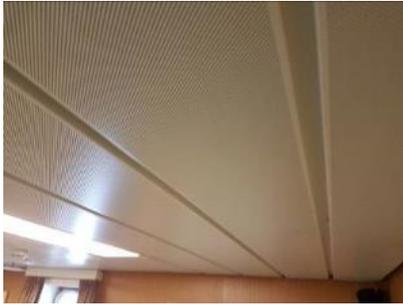
Upper Deck							Chief Engineer – Day Room (Rm 550)
Inspection Zone	Material	Hazardous Content	Condition	Friability	Accessibility	Recommended Action	Picture
Deckhead	Perforated metal deckhead panels over fibrous insulation (Fibreglass-type).	No asbestos suspected in panels or insulation.	N/A	N/A	N/A	N/A

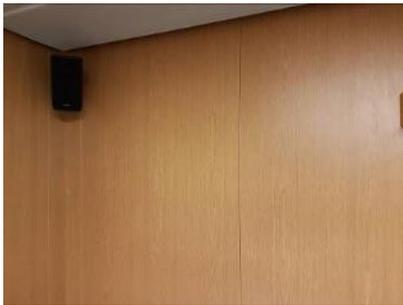
Bulkhead	Non-asbestos marine panels over fibrous insulation (Fibreglass-type).	No asbestos suspected in panels or insulation.	N/A	N/A	N/A	N/A

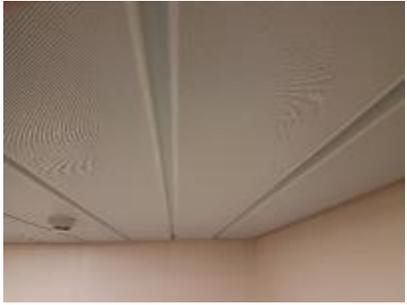
Upper Deck							Chief Engineer – Night Room (Rm 551)
Inspection Zone	Material	Hazardous Content	Condition	Friability	Accessibility	Recommended Action	Picture
Deckhead	Perforated metal deckhead panels over fibrous insulation (Fibreglass-type).	No asbestos suspected in panels or insulation.	N/A	N/A	N/A	N/A

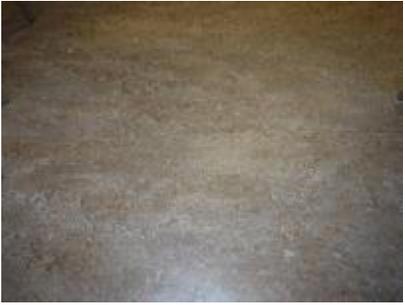
Deck screed may contain asbestos.	Exposed – good condition Concealed – unknown condition	Non-friable	C	7, or additional samples to rule out presence of asbestos.	
Other	None observed.	N/A	N/A	N/A	N/A	N/A	
Comments	N/A

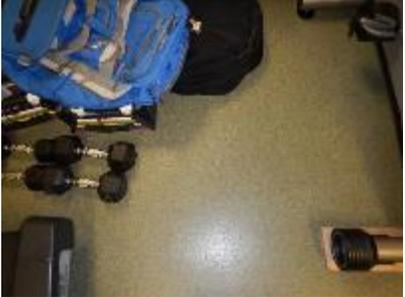
Main Deck		Miscellaneous Stores Lobby (Gym; 604)					
Inspection Zone	Material	Hazardous Content	Condition	Friability	Accessibility	Recommended Action	Picture
Deck	Anti-skid coating.	Anti-skid coating (Intershield 6GV) is non-ACM as per manufacturer (see Appendix D). Remnants beneath newer layers may contain asbestos.	N/A	N/A	N/A	N/A

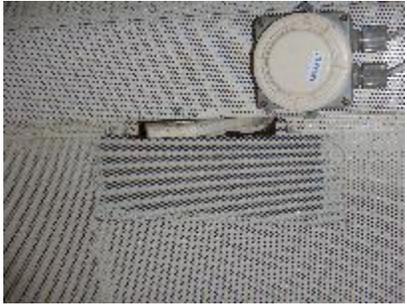
Main Deck		Stairway to Prop Motor Room Flat (Rm 611)					
Inspection Zone	Material	Hazardous Content	Condition	Friability	Accessibility	Recommended Action	Picture
Deckhead	Perforated metal over foil-faced fibrous insulation (Roxul-type).	No asbestos suspected in panels or insulation.	N/A	N/A	N/A	N/A

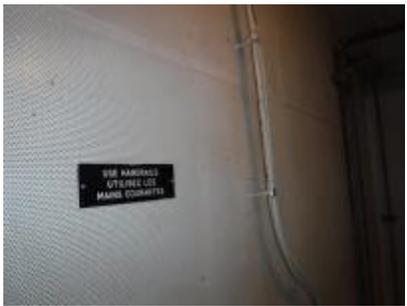
Bulkhead	Perforated metal over foil-faced fibrous insulation (Roxul-type).	No asbestos suspected in panels or insulation.	N/A	N/A	N/A	N/A

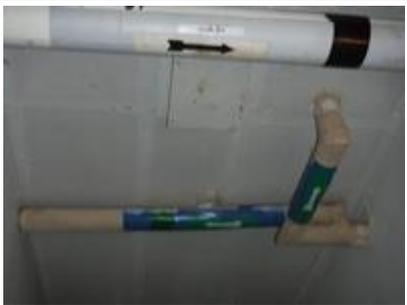
Lagging	Text over fibrous insulation (Fibreglass-type).	No asbestos suspected (5 out of 5 samples negative for asbestos).	N/A	N/A	N/A	N/A

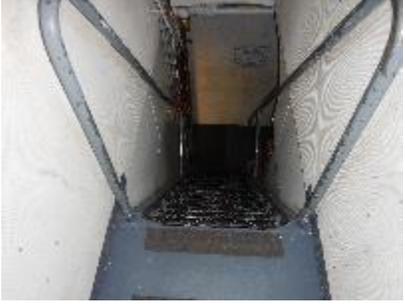
Main Deck							Stairway to Prop Motor Room Flat (Rm 611)
Inspection Zone	Material	Hazardous Content	Condition	Friability	Accessibility	Recommended Action	Picture
Deck	Painted metal.	No suspect asbestos.	N/A	N/A	N/A	N/A

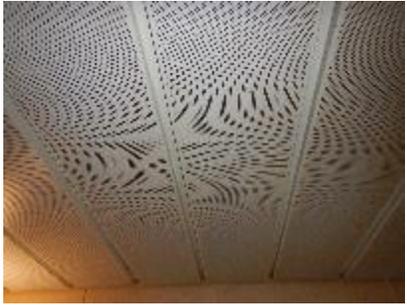
Main Deck							Two Seaman's Cabin (Rm 612)
Inspection Zone	Material	Hazardous Content	Condition	Friability	Accessibility	Recommended Action	Picture
Deckhead	Perforated metal deckhead panels over foil-faced fibrous insulation (Roxul-type).	No asbestos suspected in panels or insulation.	N/A	N/A	N/A	N/A

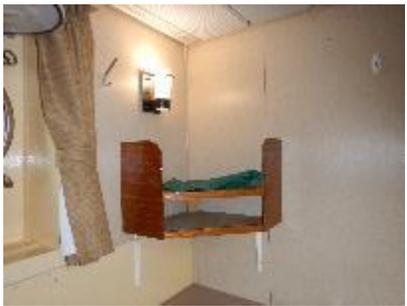
Bulkhead	Non-asbestos marine panels over fibrous insulation (Fibreglass-type).	No asbestos suspected in panels or insulation.	N/A	N/A	N/A	N/A

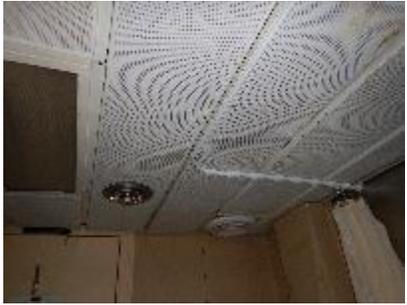
Main Deck							Two Seaman Washroom (Rm 613)
Inspection Zone	Material	Hazardous Content	Condition	Friability	Accessibility	Recommended Action	Picture
Deckhead	Perforated metal deckhead panels over foil-faced fibrous insulation (Fibreglass-type).	No asbestos suspected in panels or insulation.	N/A	N/A	N/A	N/A

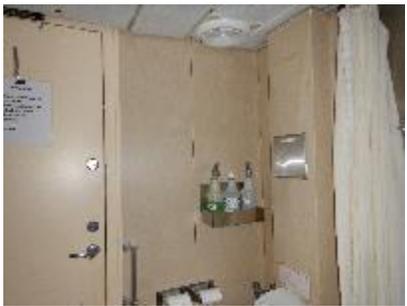
Bulkhead	Non-asbestos marine panels.	No asbestos suspected in panels or insulation.	N/A	N/A	N/A	N/A

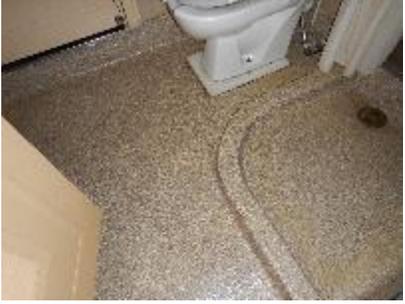
Main Deck							Two Seaman Washroom (Rm 613)
Inspection Zone	Material	Hazardous Content	Condition	Friability	Accessibility	Recommended Action	Picture
Deck	Epoxy over deck screed.	Epoxy (Rada) is non-ACM as per manufacturer. Deck screed (Polyspec) underneath Rada is non-ACM as per manufacturer (see Appendix D).	N/A	N/A	N/A	N/A

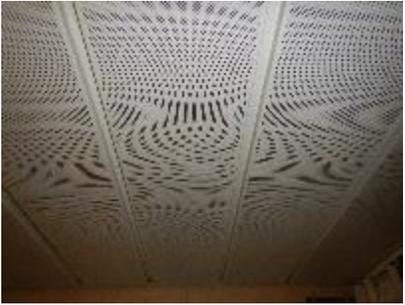
Main Deck							Two Seaman Cabin (Rm 614)
Inspection Zone	Material	Hazardous Content	Condition	Friability	Accessibility	Recommended Action	Picture
Deckhead	Perforated metal deckhead panels over foil-faced fibrous insulation (Roxul-type).	No asbestos suspected in panels or insulation.	N/A	N/A	N/A	N/A

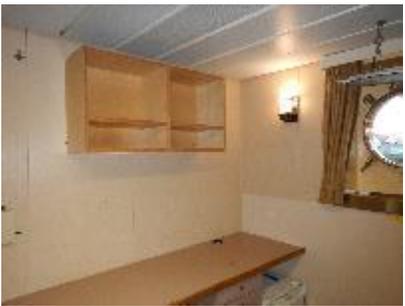
Bulkhead	Non-asbestos marine panels over fibrous insulation (Fibreglass-type).	No asbestos suspected in panels or insulation.	N/A	N/A	N/A	N/A

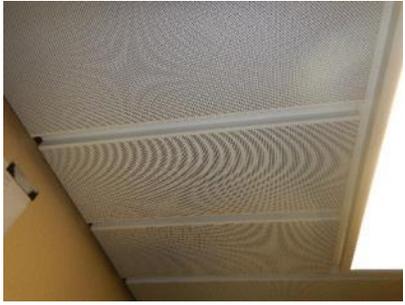
Main Deck							Canteen
Inspection Zone	Material	Hazardous Content	Condition	Friability	Accessibility	Recommended Action	Picture
Deckhead	Perforated metal deckhead panels over foil-faced fibrous insulation (Roxul-type).	No asbestos suspected in panels or insulation.	N/A	N/A	N/A	N/A

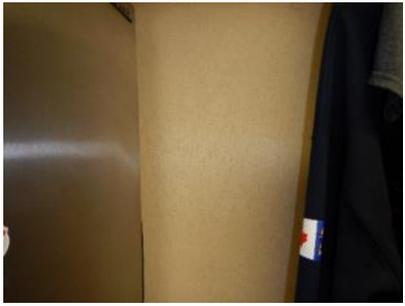
Bulkhead	Non-asbestos marine panels over fibrous insulation (Fibreglass-type).	No asbestos suspected in panels or insulation.	N/A	N/A	N/A	N/A

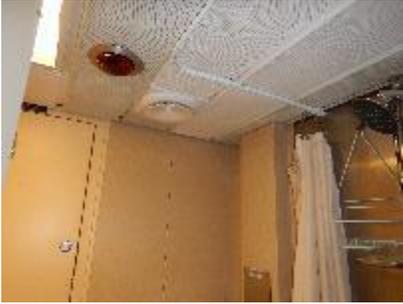
Main Deck							Washroom in 615 & 617 (Rm 616)
Inspection Zone	Material	Hazardous Content	Condition	Friability	Accessibility	Recommended Action	Picture
Deckhead	Perforated metal deckhead panels over fibrous insulation (Fibreglass-type).	No asbestos suspected in panels or insulation.	N/A	N/A	N/A	N/A

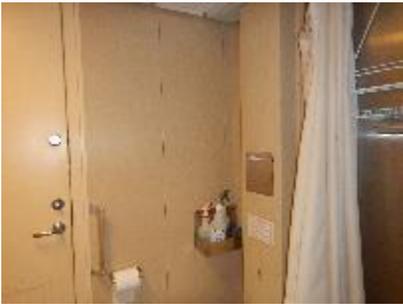
Bulkhead	Non-asbestos marine panels over fibrous insulation (Fibreglass-type). Metal panel.	No asbestos suspected in panels or insulation.	N/A	N/A	N/A	N/A

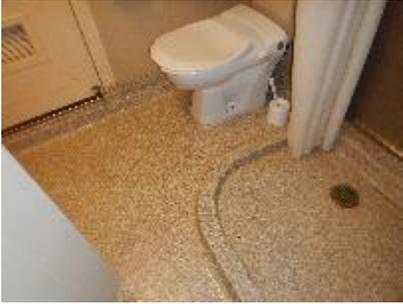
Main Deck							Washroom in 615 & 617 (Rm 616)
Inspection Zone	Material	Hazardous Content	Condition	Friability	Accessibility	Recommended Action	Picture
Deck	Epoxy over deck screed.	Epoxy (Rada) is non-ACM as per manufacturer. Deck screed (Polyspec) underneath Rada is non-ACM as per manufacturer (see Appendix D).	N/A	N/A	N/A	N/A

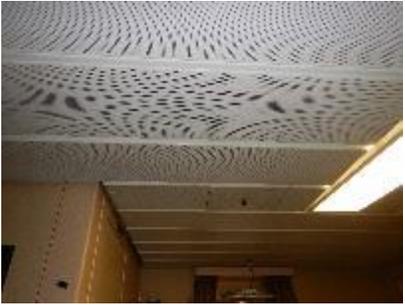
Main Deck							Two Leading Seaman Cabin (Rm 617)
Inspection Zone	Material	Hazardous Content	Condition	Friability	Accessibility	Recommended Action	Picture
Deckhead	Perforated metal deckhead panels over foil-faced fibrous insulation (Roxul-type).	No asbestos suspected in panels or insulation.	N/A	N/A	N/A	N/A

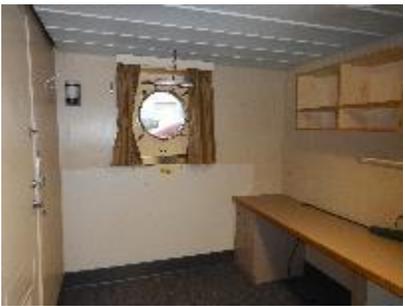
Bulkhead	Non-asbestos marine panels over fibrous insulation (Fibreglass-type). Non-asbestos marine panels over fibrous insulation (Roxul-type).	No asbestos suspected in panels or insulation.	N/A	N/A	N/A	N/A

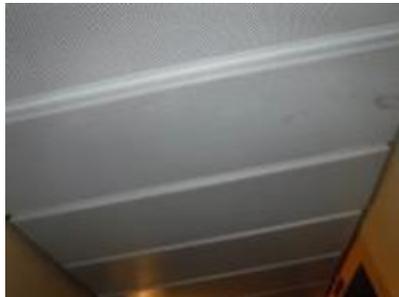
Main Deck							Port Alleyway
Inspection Zone	Material	Hazardous Content	Condition	Friability	Accessibility	Recommended Action	Picture
Deckhead	Perforated metal deckhead panels over fibrous insulation (Fibreglass-type).	No asbestos suspected in panels or insulation.	N/A	N/A	N/A	N/A

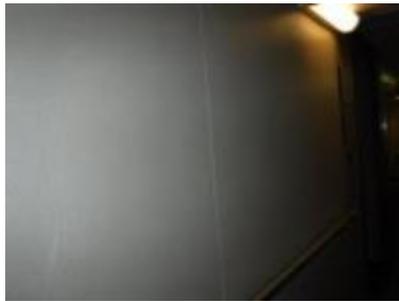
Bulkhead	Non-asbestos marine panels over fibrous insulation (Fibreglass-type). Non-asbestos marine panels over fibrous insulation (Roxul-type).	No asbestos suspected in panels or insulation.	N/A	N/A	N/A	N/A

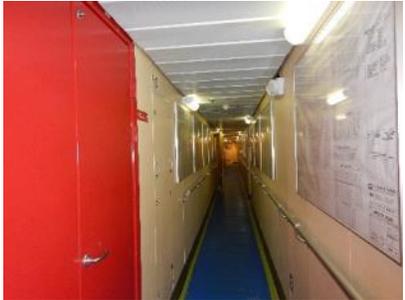
Main Deck							Aft Arthwartship Allyway
Inspection Zone	Material	Hazardous Content	Condition	Friability	Accessibility	Recommended Action	Picture
Deckhead	Perforated metal deckhead panels over fibrous insulation (Fibreglass-type).	No asbestos suspected in panels or insulation.	N/A	N/A	N/A	N/A

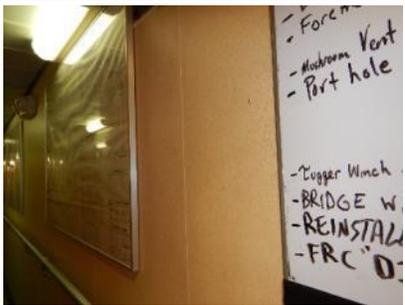
Bulkhead	Non-asbestos marine panels over fibrous insulation (Fibreglass-type). Non-asbestos marine panels over fibrous insulation (Roxul-type).	No asbestos suspected in panels or insulation.	N/A	N/A	N/A	N/A

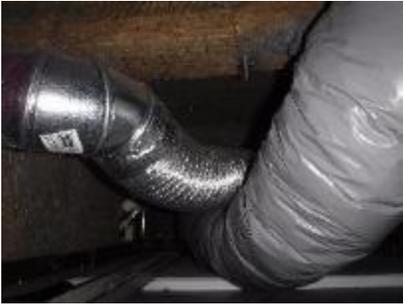
Main Deck							Crew's Laundry (Rm 619)
Inspection Zone	Material	Hazardous Content	Condition	Friability	Accessibility	Recommended Action	Picture
Deckhead	Perforated metal deckhead panels over foil-faced fibrous insulation (Roxul-type).	No asbestos suspected in panels or insulation.	N/A	N/A	N/A	N/A

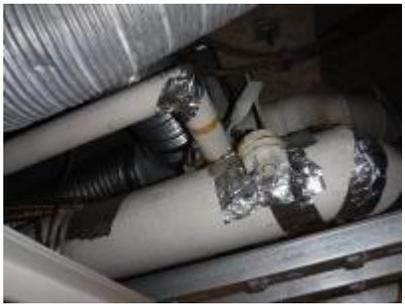
Lagging	Textile wrap over fibrous insulation (Fibreglass-type). Plastic over fibrous insulation (Fibreglass-type)	No asbestos suspected (5 out of 5 samples negative for asbestos).	N/A	N/A	N/A	N/A

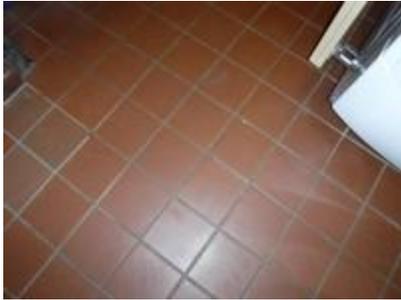
Main Deck							Crew's Laundry (Rm 619)
Inspection Zone	Material	Hazardous Content	Condition	Friability	Accessibility	Recommended Action	Picture
Deck	Ceramic tile over deck screed.	Ceramic tile grout and leveling compound may contain asbestos. Destructive sampling required.	Good	Non-friable	A	7

Deck screed may contain asbestos.	Exposed – good condition Concealed – unknown condition	Non-friable	C	7, or additional samples to rule out presence of asbestos.	
Other	None observed.	N/A	N/A	N/A	N/A	N/A	
Comments	N/A

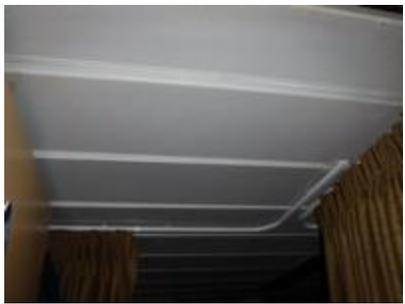
Main Deck							Two Seaman (Rm 615)
Inspection Zone	Material	Hazardous Content	Condition	Friability	Accessibility	Recommended Action	Picture
Deckhead	Perforated metal deckhead panels over foil-faced fibrous insulation (Roxul-type).	No asbestos suspected in panels or insulation.	N/A	N/A	N/A	N/A

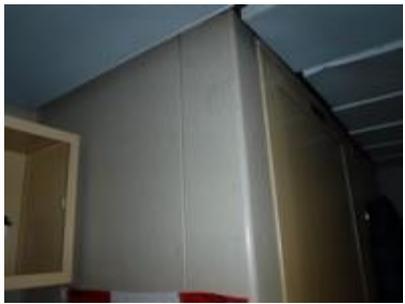
Bulkhead	Non-asbestos marine panels over fibrous insulation (Fibreglass-type).	No asbestos suspected in panels or insulation.	N/A	N/A	N/A	N/A

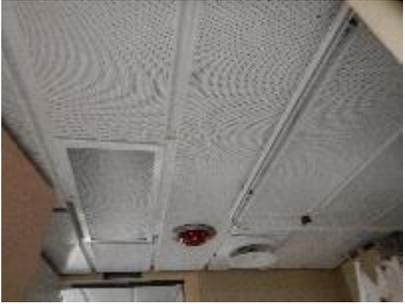
Main Deck							Two Leading Seaman Washroom (Room 622, in Rm 620)
Inspection Zone	Material	Hazardous Content	Condition	Friability	Accessibility	Recommended Action	Picture
Deckhead	Perforated metal deckhead panels over fibrous insulation (Fibreglass-type).	No asbestos suspected in panels or insulation.	N/A	N/A	N/A	N/A

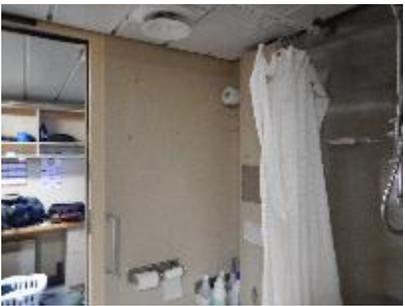
Bulkhead	Non-asbestos marine panels over fibrous insulation (Fibreglass-type).	No asbestos suspected in panels or insulation.	N/A	N/A	N/A	N/A

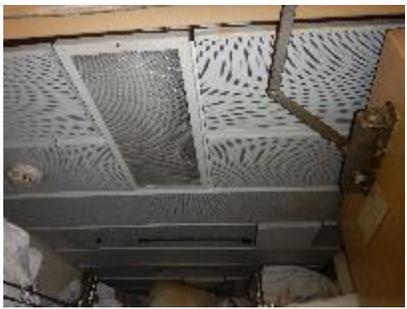
Main Deck							Linen Locker (Rm 624)
Inspection Zone	Material	Hazardous Content	Condition	Friability	Accessibility	Recommended Action	Picture
Deckhead	Perforated metal deckhead panels over foil-faced fibrous insulation (Roxul-type).	No asbestos suspected in panels or insulation.	N/A	N/A	N/A	N/A

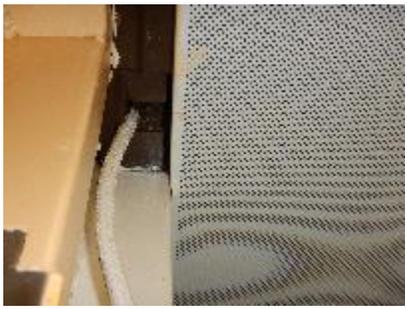
Bulkhead	Painted metal.	No suspect asbestos.	N/A	N/A	N/A	N/A

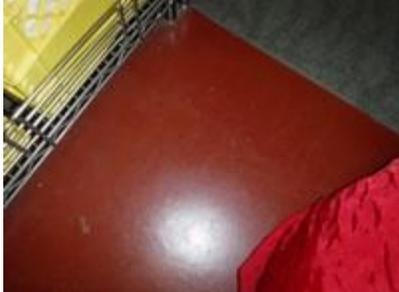
Main Deck							Linen Locker (Rm 624)
Inspection Zone	Material	Hazardous Content	Condition	Friability	Accessibility	Recommended Action	Picture
Deck	Painted metal.	No suspect asbestos.	N/A	N/A	N/A	N/A

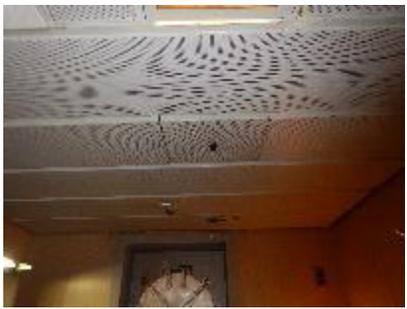
Main Deck							Deck Locker (Rm 625)
Inspection Zone	Material	Hazardous Content	Condition	Friability	Accessibility	Recommended Action	Picture
Deckhead	Perforated metal deckhead panels over fibrous insulation (Fibreglass-type).	No asbestos suspected in panels or insulation.	N/A	N/A	N/A	N/A

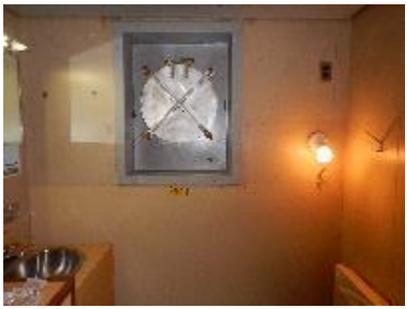
Bulkhead	Painted metal.	No suspect asbestos.	N/A	N/A	N/A	N/A

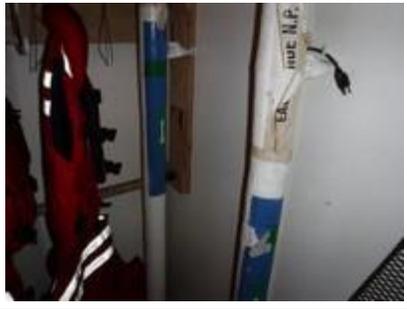
Lagging	Textile wrap over fibrous insulation (Fibreglass-type).	No asbestos suspected (5 out of 5 samples negative for asbestos).	N/A	N/A	N/A	N/A

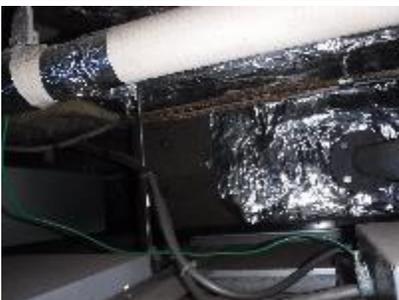
Main Deck							Leading Seaman Cabin (Rm 628)
Inspection Zone	Material	Hazardous Content	Condition	Friability	Accessibility	Recommended Action	Picture
Lagging	Grey paint on pipe.	No asbestos detected. <ul style="list-style-type: none"> • 31632-24: Leading seaman's cabin – Grey paint on pipe (No asbestos detected). • 31632-25 White pipe coating (no asbestos detected). 	N/A	N/A	N/A	N/A

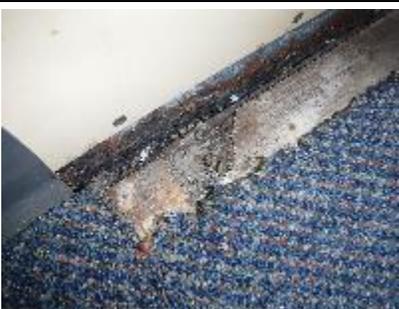
White coating on pipe.	May contain asbestos (as pipe insulation remnant).	Good	Friable	C	7	
Deck	Carpet over deck screed.	No asbestos suspected in carpet or adhesives.	N/A	N/A	N/A	N/A

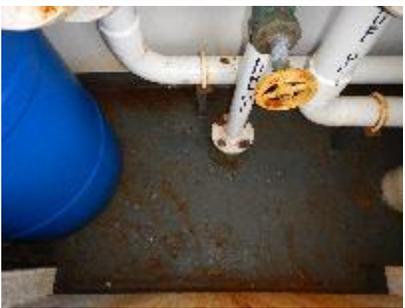
Main Deck							Fuel Bunker Station (Rm 668)
Inspection Zone	Material	Hazardous Content	Condition	Friability	Accessibility	Recommended Action	Picture
Deck	Anti-skid coating.	Anti-skid coating (Intershield 6GV) is non-ACM as per manufacturer (see Appendix D). Remnants beneath newer layers may contain asbestos.	N/A	N/A	N/A	N/A

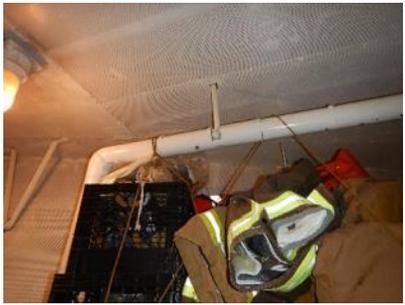
Lagging	Metal cladding over calcium silicate.	No asbestos suspected (10 out of 10 samples negative for asbestos).	N/A	N/A	N/A	N/A

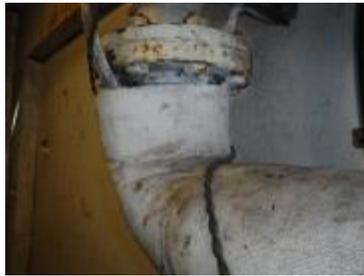
Painted metal.		N/A	N/A	N/A	N/A	
Lagging	Metal cladding over calcium silicate insulation.	No asbestos suspected (10 out of 10 samples negative for asbestos). • 28403-24 Pipe insulation, calcium silicate (no asbestos detected)	N/A	N/A	N/A	N/A

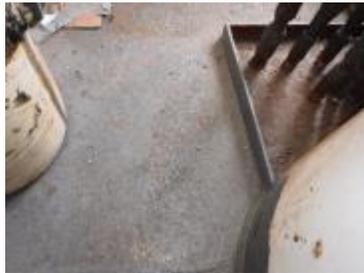
Deck	Anti-skid coating.	Anti-skid coating (Intershield 6GV) is non-ACM as per manufacturer (see Appendix D). Remnants beneath newer layers may contain asbestos.	N/A	N/A	N/A	N/A

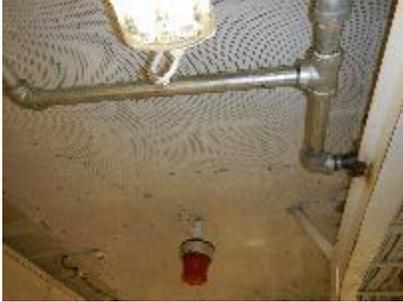
Main Deck							Steering Gear Compartment (Rm 640)
Inspection Zone	Material	Hazardous Content	Condition	Friability	Accessibility	Recommended Action	Picture
Deckhead	Perforated metal over spray-applied fibrous insulation (Cafco-type).	No asbestos suspected in Cafco (14 out of 14 samples negative for asbestos). <ul style="list-style-type: none">28667-1, 2, 3 Cafco (no asbestos detected).	N/A	N/A	N/A	N/A

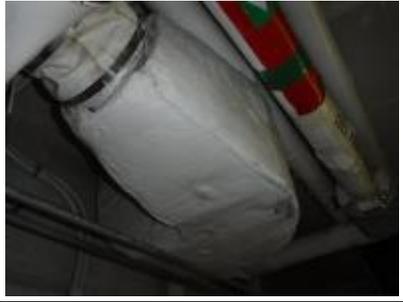
Lagging	Textile wrap over fibrous insulation (Fibreglass-type). Metal cladding over calcium silicate insulation.	No asbestos suspected (5 out of 5 samples negative for asbestos). No asbestos suspected (10 out of 10 samples negative for asbestos). <ul style="list-style-type: none">28403-26 Calsil pipe insulation	N/A	N/A	N/A	N/A

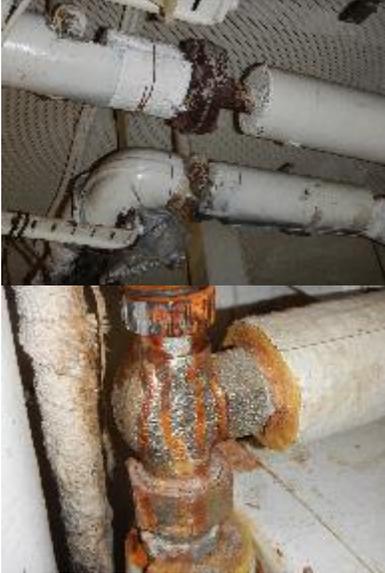
Main Deck							Steering Gear Compartment (Rm 640)
Inspection Zone	Material	Hazardous Content	Condition	Friability	Accessibility	Recommended Action	Picture
	Hi-temperature jacket.	(no asbestos detected).

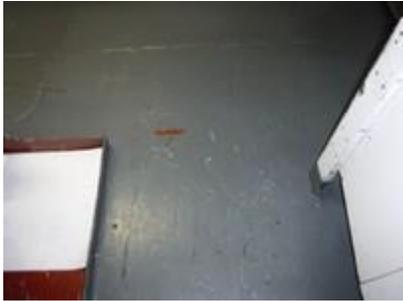
Deck	Painted metal.	No suspect asbestos.	N/A	N/A	N/A	N/A

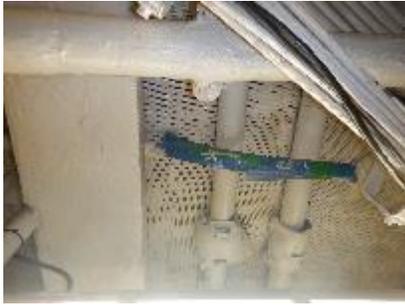
Main Deck							Stores Handling Compartment (Rm 641)
Inspection Zone	Material	Hazardous Content	Condition	Friability	Accessibility	Recommended Action	Picture
Deckhead	Perforated metal over spray-applied fibrous insulation (Cafco-type). Painted metal.	No asbestos suspected in Cafco (14 out of 14 samples negative for asbestos).	N/A	N/A	N/A	N/A

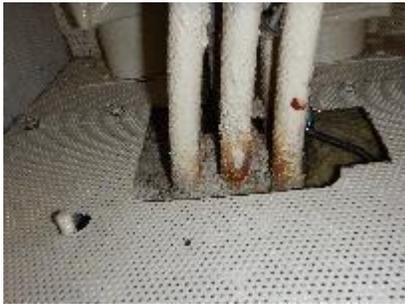
Bulkhead	Perforated metal over spray-applied fibrous insulation (Cafco-type). Painted metal.	No asbestos suspected in Cafco (14 out of 14 samples negative for asbestos).	N/A	N/A	N/A	N/A

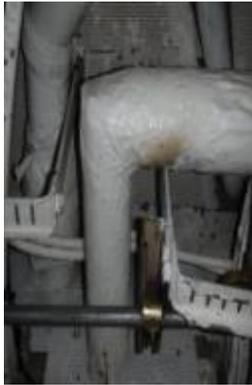
Main Deck							Stores Handling Compartment (Rm 641)
Inspection Zone	Material	Hazardous Content	Condition	Friability	Accessibility	Recommended Action	Picture
	High temperature jacketing	No suspect asbestos	N/A	N/A	N/A	N/A	
	Metal cladding over calcium silicate insulation.	No asbestos suspected (10 out of 10 samples negative for asbestos).	N/A	N/A	N/A	N/A

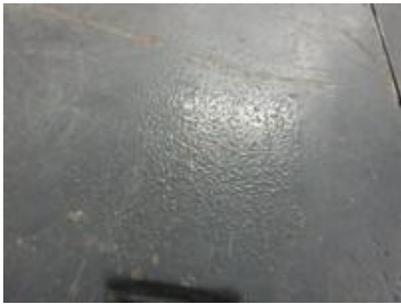
Deck	Painted metal.	No suspect asbestos.	N/A	N/A	N/A	N/A	
	Anti-skid coating.	Anti-skid coating (Intershield 6GV) is non-ACM as per manufacturer (see Appendix D). However, remnants beneath newer layers May contain asbestos.	N/A	N/A	N/A	N/A

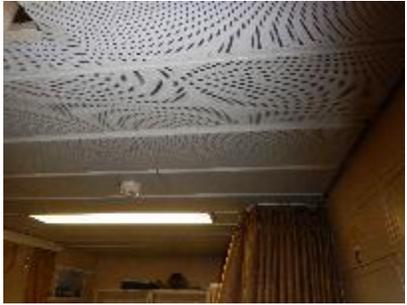
Main Deck							Two Stewards Cabin (Rm 642)
Inspection Zone	Material	Hazardous Content	Condition	Friability	Accessibility	Recommended Action	Picture
Deckhead	Perforated metal over fibrous insulation (Fibreglass-type).	No asbestos suspected in panels or insulation.	N/A	N/A	N/A	N/A

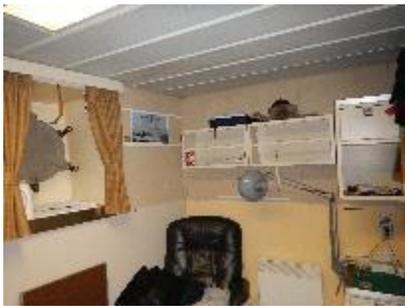
Bulkhead	Non-asbestos marine panels over fibrous insulation (Fibreglass-type).	No asbestos suspected in panels or insulation.	N/A	N/A	N/A	N/A

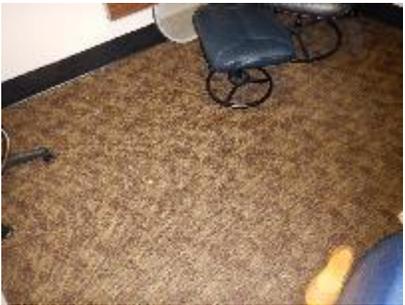
Main Deck							Two Stewards Cabin (Rm 642)
Inspection Zone	Material	Hazardous Content	Condition	Friability	Accessibility	Recommended Action	Picture
Deck	Carpet over deck screed.	No asbestos suspected in carpet or adhesives.	N/A	N/A	N/A	N/A

Deck screed may contain asbestos.	Exposed – good condition Concealed – unknown condition	Non-friable	C	7, or additional samples to rule out presence of asbestos.	
		Deck screed may contain asbestos.	Exposed – good condition Concealed – unknown condition	Non-friable	C	7, or additional samples to rule out presence of asbestos.	
Other	None observed.	N/A	N/A	N/A	N/A	N/A	
Comments	N/A

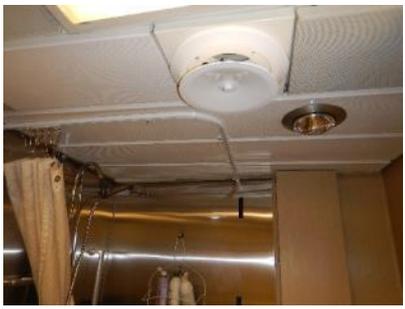
Main Deck							Two Stewards Cabin Washroom (Rm 643)
Inspection Zone	Material	Hazardous Content	Condition	Friability	Accessibility	Recommended Action	Picture
Deckhead	Perforated metal over fibrous insulation (Fibreglass-type).	No asbestos suspected in panels or insulation.	N/A	N/A	N/A	N/A

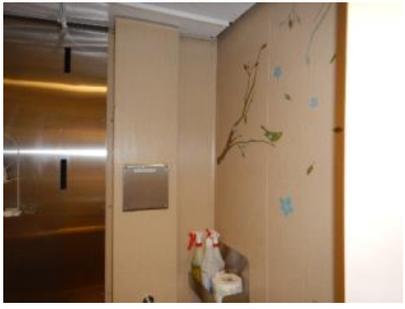
Perforated metal over fibrous insulation (Roxul-type).	No asbestos suspected in panels or insulation.	N/A	N/A	N/A	N/A	
Bulkhead	Non-asbestos marine panels over fibrous insulation (Fibreglass-type).	No asbestos suspected in panels or insulation.	N/A	N/A	N/A	N/A

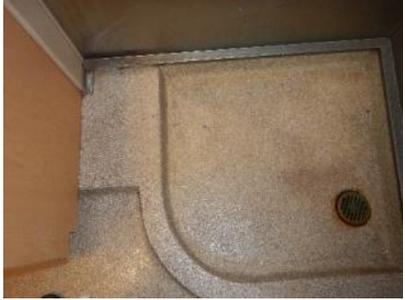
Main Deck							Two Stewards Cabin Washroom (Rm 643)
Inspection Zone	Material	Hazardous Content	Condition	Friability	Accessibility	Recommended Action	Picture
Deck	Epoxy over deck screed.	Epoxy (Rada) is non-ACM as per manufacturer. Deck screed (Polyspec) underneath Rada is non-ACM as per manufacturer (see Appendix D).	N/A	N/A	N/A	N/A

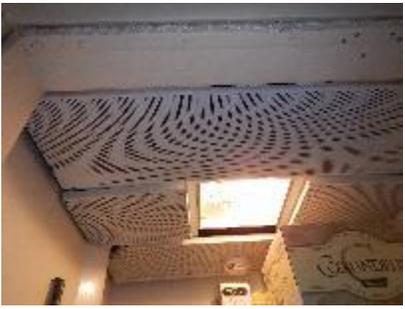
Main Deck							Bond Locker (Rm 646)
Inspection Zone	Material	Hazardous Content	Condition	Friability	Accessibility	Recommended Action	Picture
Deckhead	Perforated metal deckhead panels over fibrous insulation (Fibreglass-type).	No asbestos suspected in panels or insulation.	N/A	N/A	N/A	N/A

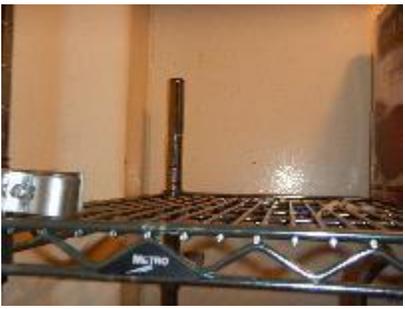
Bulkhead	Painted metal.	No suspect asbestos.	N/A	N/A	N/A	N/A

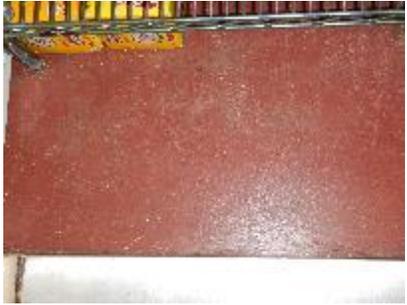
Main Deck							Bond Locker (Rm 646)
Inspection Zone	Material	Hazardous Content	Condition	Friability	Accessibility	Recommended Action	Picture
Deck	Painted metal.	No suspect asbestos.	N/A	N/A	N/A	N/A

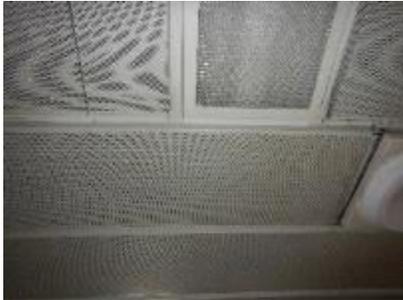
Main Deck							Two Oilers Cabin (Rm 647)
Inspection Zone	Material	Hazardous Content	Condition	Friability	Accessibility	Recommended Action	Picture
Deckhead	Perforated metal over fibrous insulation (Fibreglass-type).	No asbestos suspected in panels or insulation.	N/A	N/A	N/A	N/A

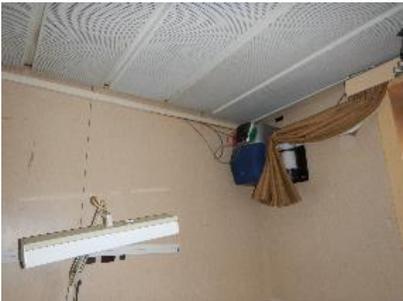
Bulkhead	Non-asbestos marine panels over fibrous insulation (Fibreglass-type).	No asbestos suspected in panels or insulation.	N/A	N/A	N/A	N/A

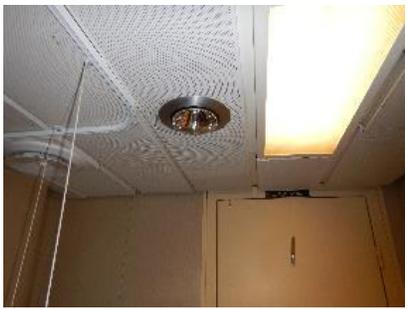
Main Deck							Washroom in Rooms 643, 644 (Rm 648/645)
Inspection Zone	Material	Hazardous Content	Condition	Friability	Accessibility	Recommended Action	Picture
Deckhead	Perforated metal over fibrous insulation (Fibreglass-type).	No asbestos suspected in panels or insulation.	N/A	N/A	N/A	N/A

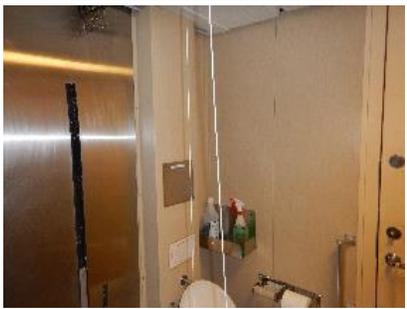
Bulkhead	Non-asbestos marine panels over fibrous insulation (Fibreglass-type).	No asbestos suspected in panels or insulation.	N/A	N/A	N/A	N/A

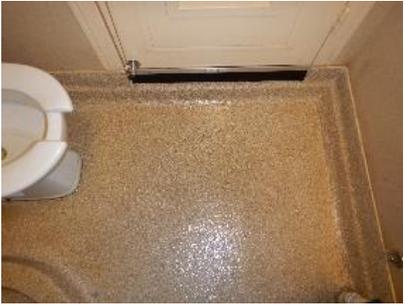
Main Deck							Washroom in Rooms 643, 644 (Rm 648/645)
Inspection Zone	Material	Hazardous Content	Condition	Friability	Accessibility	Recommended Action	Picture
Deck	Epoxy over deck screed.	Epoxy (Rada) is non-ACM as per manufacturer. Deck screed (Polyspec) underneath Rada is non-ACM as per manufacturer (see Appendix D).	N/A	N/A	N/A	N/A

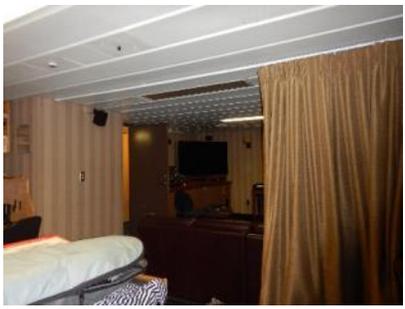
Main Deck							Crew's Lounge (Room 649/614)
Inspection Zone	Material	Hazardous Content	Condition	Friability	Accessibility	Recommended Action	Picture
Deckhead	Perforated metal deckhead panels over fibrous insulation (Fibreglass-type).	No asbestos suspected in panels or insulation.	N/A	N/A	N/A	N/A

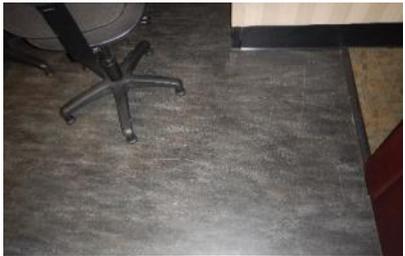
Lagging	None observed.	N/A	N/A	N/A	N/A	N/A	
Deck	Resilient sheet flooring over deck screed.	No asbestos suspected in sheet flooring or adhesives. Deck screed may contain asbestos.	N/A Exposed – good condition Concealed	N/A Non-friable	N/A C	N/A 7, or additional samples to rule out

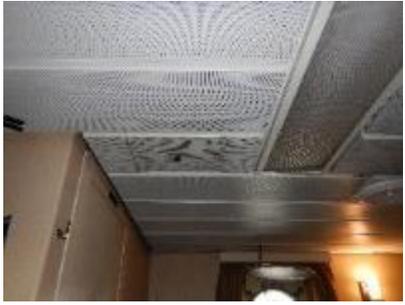
Main Deck							Two Oilers Cabin (Rm 650)
Inspection Zone	Material	Hazardous Content	Condition	Friability	Accessibility	Recommended Action	Picture
Deckhead	Perforated metal deckhead panels over fibrous insulation (Fibreglass-type).	No asbestos suspected in panels or insulation.	N/A	N/A	N/A	N/A

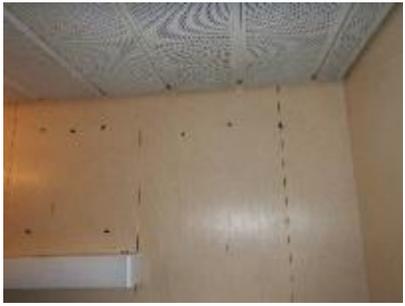
Bulkhead	Non-asbestos marine panels over fibrous insulation (Fibreglass-type).	No asbestos suspected in panels or insulation.	N/A	N/A	N/A	N/A

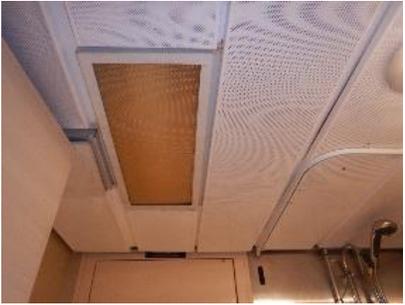
Main Deck							Washroom in Rooms 650,632 (Rm 651/653)
Inspection Zone	Material	Hazardous Content	Condition	Friability	Accessibility	Recommended Action	Picture
Deckhead	Perforated metal deckhead panels over fibrous insulation (Fibreglass-type).	No asbestos suspected in panels or insulation.	N/A	N/A	N/A	N/A

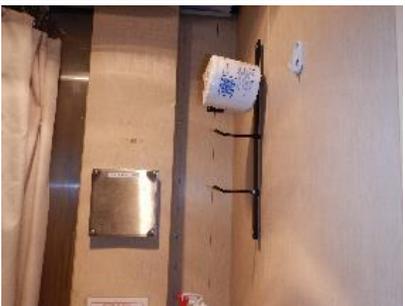
Bulkhead	Non-asbestos marine panels over fibrous insulation (Fibreglass-type).	No asbestos suspected in panels or insulation.	N/A	N/A	N/A	N/A

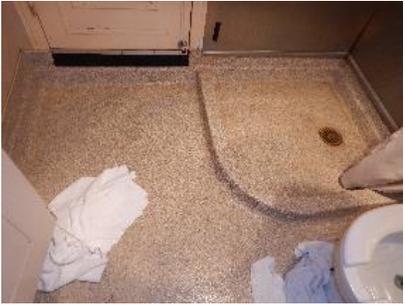
Main Deck							Washroom in Rooms 650,632 (Rm 651/653)
Inspection Zone	Material	Hazardous Content	Condition	Friability	Accessibility	Recommended Action	Picture
Deck	Epoxy over deck screed.	Epoxy (Rada) is non-ACM as per manufacturer. Deck screed (Polyspec) underneath Rada is non-ACM as per manufacturer (see Appendix D).	N/A	N/A	N/A	N/A

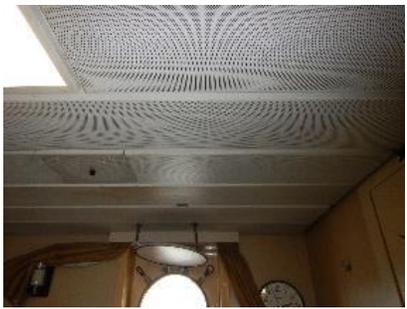
Main Deck							Two Oilers Cabin (Rm 652)
Inspection Zone	Material	Hazardous Content	Condition	Friability	Accessibility	Recommended Action	Picture
Deckhead	Perforated metal deckhead panels over fibrous insulation (Fibreglass-type).	No asbestos suspected in panels or insulation.	N/A	N/A	N/A	N/A

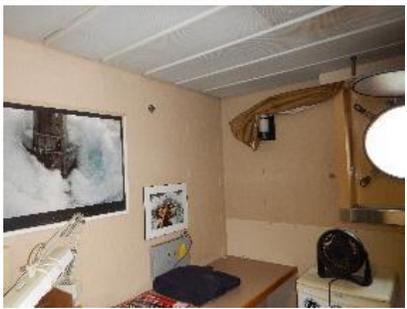
Bulkhead	Non-asbestos marine panels over fibrous insulation (Fibreglass-type).	No asbestos suspected in panels or insulation.	N/A	N/A	N/A	N/A

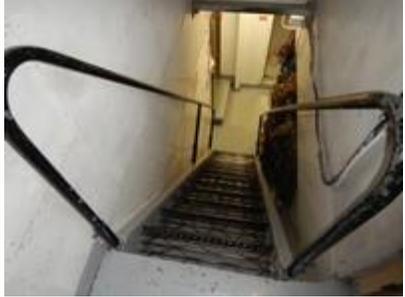
Main Deck							Stairs to Engine Room Flat (Rm 654)
Inspection Zone	Material	Hazardous Content	Condition	Friability	Accessibility	Recommended Action	Picture
Deckhead	Perforated metal over foil-faced fibrous insulation (Roxul-type).	No asbestos suspected in panels or insulation.	N/A	N/A	N/A	N/A

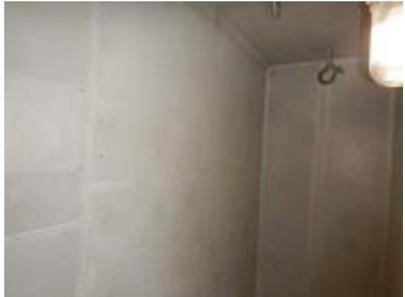
Bulkhead	Perforated metal over foil-faced fibrous insulation (Roxul-type).	No asbestos suspected in panels or insulation.	N/A	N/A	N/A	N/A

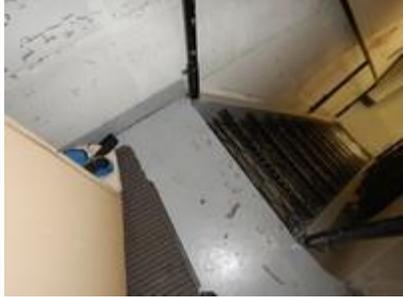
Main Deck							Stairs to Engine Room Flat (Rm 654)
Inspection Zone	Material	Hazardous Content	Condition	Friability	Accessibility	Recommended Action	Picture
Deck	Painted metal.	No suspect asbestos.	N/A	N/A	N/A	N/A

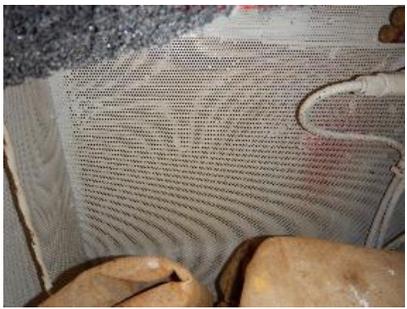
Main Deck							Paint Store
Inspection Zone	Material	Hazardous Content	Condition	Friability	Accessibility	Recommended Action	Picture
Deckhead	Perforated metal over spray-applied fibrous insulation (Cafco-type).	No asbestos suspected in Cafco (14 out of 14 samples negative for asbestos). <ul style="list-style-type: none">28403-19 Cafco (no asbestos detected).	N/A	N/A	N/A	N/A

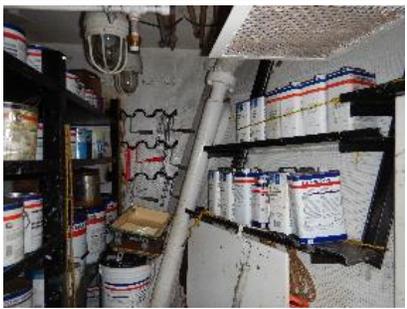
Bulkhead	Perforated metal over spray-applied fibrous insulation (Cafco-type).	No asbestos suspected in Cafco (14 out of 14 samples negative for asbestos).	N/A	N/A	N/A	N/A

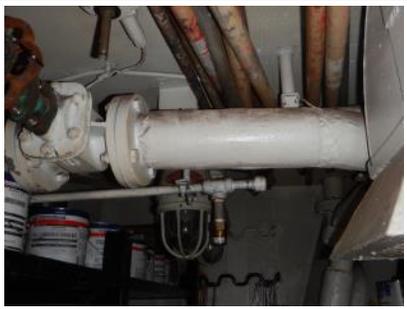
Lagging	Textile over fibrous insulation (Fibreglass-type)	No asbestos suspected (5 out of 5 samples negative for asbestos).	N/A	N/A	N/A	N/A

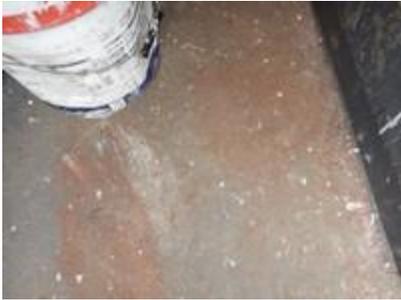
Main Deck							Paint Store
Inspection Zone	Material	Hazardous Content	Condition	Friability	Accessibility	Recommended Action	Picture
Deck	Anti-skid coating.	Anti-skid coating (Intershield 6GV) is non-ACM as per manufacturer (see Appendix D). However, remnants beneath newer layers May contain asbestos.	N/A	N/A	N/A	N/A

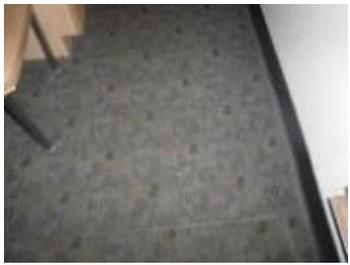
Lagging	None observed.	N/A	N/A	N/A	N/A	N/A	
Deck	Carpet over deck screed.	No asbestos suspected in carpet or adhesives.	N/A	N/A	N/A	N/A

Deck screed may contain asbestos.	Exposed – good condition Concealed – unknown condition	Non-friable	C	7, or additional samples to rule out presence of asbestos.

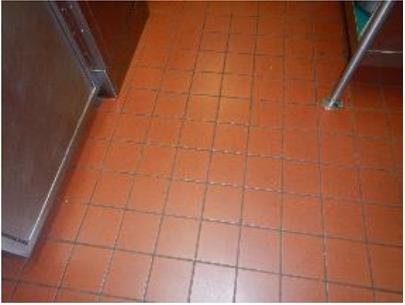
Deck	Ceramic tile over deck screed	Ceramic tile grout and leveling compound may contain asbestos. Destructive sampling required.	Good	Non-friable	A	7

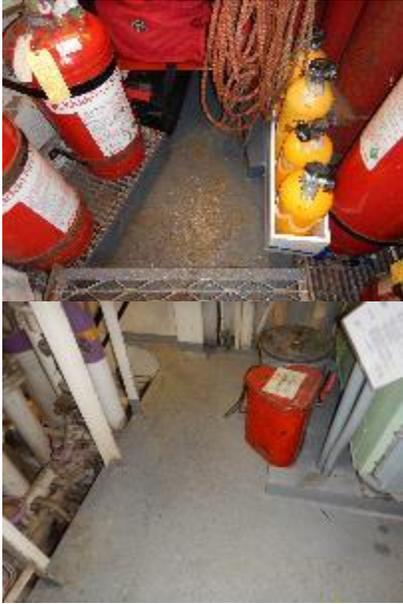
Main Deck							CO2 – PM 200 Room (Rm 669)
Inspection Zone	Material	Hazardous Content	Condition	Friability	Accessibility	Recommended Action	Picture
Deck	Anti-skid coating.	Anti-skid coating (Intershield 6GV) is non-ACM as per manufacturer (see Appendix D). However, remnants beneath newer layers May contain asbestos.	N/A	N/A	N/A	N/A

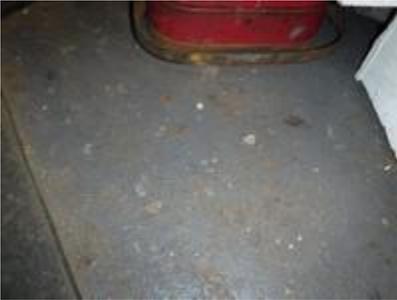
Deck	Anti-skid coating.	Anti-skid coating (Intershield 6GV) is non-ACM as per manufacturer (see Appendix D). • 28403-21: Anti-skid coating (No asbestos detected). However, remnants beneath newer layers May contain asbestos.	N/A	N/A	N/A	N/A

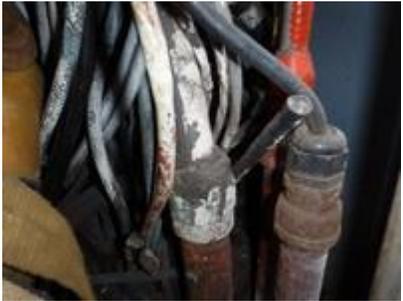
Other	Water Sealant	Asbestos detected in water sealant based on sample results: <ul style="list-style-type: none"> • 28403-22 Water Sealant, white (contains asbestos). 	Fair	Non-friable	Access (A) Accessible	Action 7: Monitor in place with routine surveillance.

Surfaces of sealant has blackened.
Comments	N/A

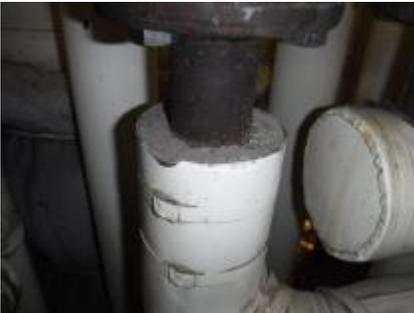
Main Deck							Engine Room Casing (Rm 673)
	Paper wrap over fibrous insulation (Fibreglass-type).	No suspect asbestos.	N/A	N/A	N/A	N/A	
	Metal cladding over calcium silicate insulation.	No asbestos suspected (10 out of 10 samples negative for asbestos). <ul style="list-style-type: none"> • 28403-27, 28 Calsil pipe insulation (no asbestos detected). 	N/A	N/A	N/A	N/A

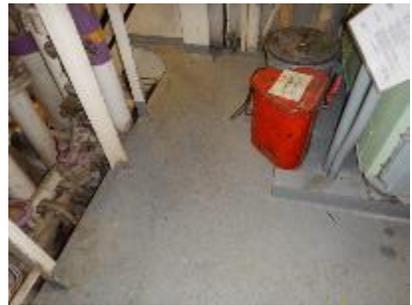
Main Deck							Engine Room Casing (Rm 673)
Deck	Anti-skid coating	Anti-skid coating (Intershield 6GV) is non-ACM as per manufacturer (see Appendix D). • 28403-36: Anti-skid coating (No asbestos detected). However, remnants beneath newer layers May contain asbestos.	N/A	N/A	N/A	N/A

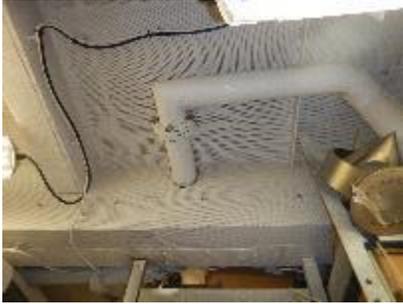
Lower Deck							Central Stores (Rm 701)
Inspection Zone	Material	Hazardous Content	Condition	Friability	Accessibility	Recommended Action	Picture
Deckhead	Perforated metal over spray-applied fibrous insulation (Cafco-type).	No asbestos suspected in Cafco (14 out of 14 samples negative for asbestos).	N/A	N/A	N/A	N/A

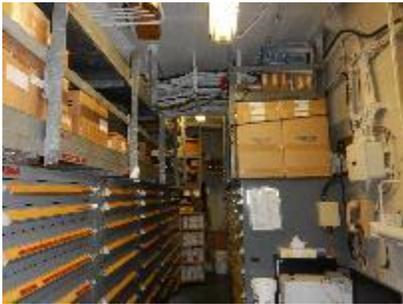
Bulkhead	Painted metal.	No suspect asbestos.	N/A	N/A	N/A	N/A

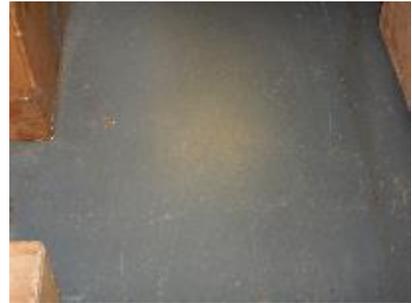
Lower Deck							Central Stores (Rm 701)
Inspection Zone	Material	Hazardous Content	Condition	Friability	Accessibility	Recommended Action	Picture
	Metal cladding over calcium silicate insulation.	No asbestos suspected (10 out of 10 samples negative for asbestos).	N/A	N/A	N/A	N/A	
Deck	Anti-skid coating.	Anti-skid coating (Intershield 6GV) is non-ACM as per manufacturer (see Appendix D). However, remnants beneath newer layers May contain asbestos.	N/A	N/A	N/A	N/A

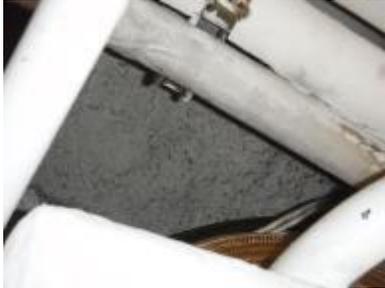
Lower Deck							Upper Engine Room Flat (Rm 702)
Inspection Zone	Material	Hazardous Content	Condition	Friability	Accessibility	Recommended Action	Picture
Deckhead	Metal panels over spray-applied fibrous insulation (Cafco-type).	No asbestos suspected in Cafco (14 out of 14 samples negative for asbestos).	N/A	N/A	N/A	N/A

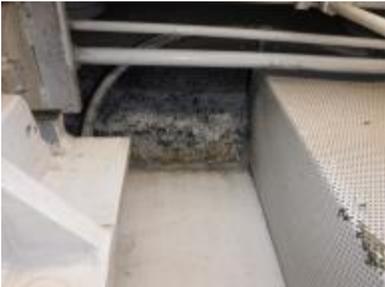
Bulkhead	Metal panels over spray-applied fibrous insulation (Cafco-type).	No asbestos suspected in Cafco (14 out of 14 samples negative for asbestos).	N/A	N/A	N/A	N/A

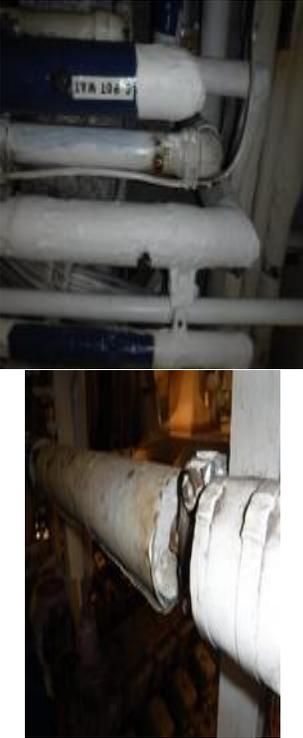
Lower Deck				Upper Engine Room Flat (Rm 702)			
Inspection Zone	Material	Hazardous Content	Condition	Friability	Accessibility	Recommended Action	Picture
Lagging	Metal cladding over calcium silicate insulation.	No asbestos suspected (10 out of 10 samples negative for asbestos). • 28403-30: Pipe insulation – Calsil (no asbestos detected).	N/A	N/A	N/A	N/A
