Prepared for:
Canadian Coast Guard

CCGS SIR WILFRID LAURIER Asbestos Condition Report

**North West
Environmental Group Ltd.**

NWest Project No. 31632
Date Issued: March 31st, 2017

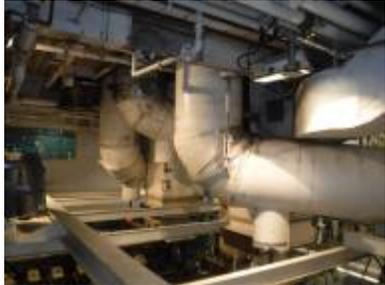
Lower Deck							Upper Engine Room Flat (Rm 702)
Inspection Zone	Material	Hazardous Content	Condition	Friability	Accessibility	Recommended Action	Picture
Deck	Painted metal.	No suspect asbestos.	N/A	N/A	N/A	N/A	Photograph not available
Other	Heating, Ventilation, and Air Conditioning (HVAC) system – Textile over Fibreglass	No suspect asbestos.	N/A	N/A	N/A	N/A

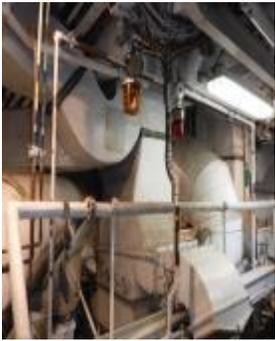
Uptakes – Metal cladding over calcium silicate insulation (assumed) and high temperature jacketing	No asbestos suspected (10 out of 10 samples negative for asbestos).	N/A	N/A	N/A	N/A

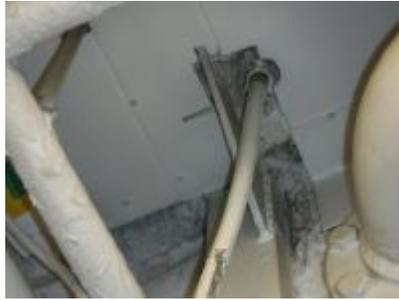
Lower Deck							Stairs to Main Deck
Inspection Zone	Material	Hazardous Content	Condition	Friability	Accessibility	Recommended Action	Picture
Deckhead	Metal panels over spray-applied fibrous insulation (Cafco-type).	<ul style="list-style-type: none"> No asbestos suspected in Cafco (14 out of 14 samples negative for asbestos). 	N/A	N/A	N/A	N/A

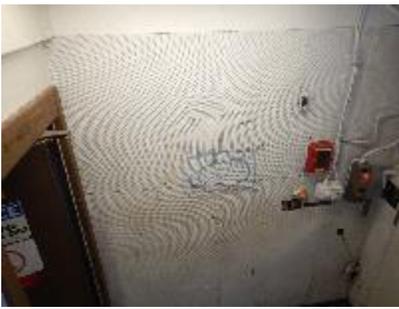
Bulkhead	Metal panels over spray-applied fibrous insulation (Cafco-type).	<ul style="list-style-type: none"> No asbestos suspected in Cafco (14 out of 14 samples negative for asbestos). 	N/A	N/A	N/A	N/A

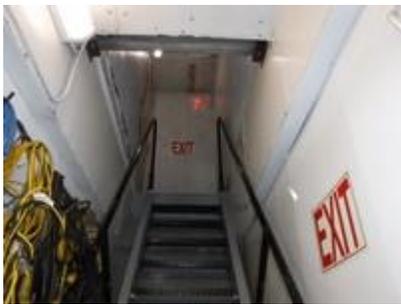
Lower Deck							Stairs to Main Deck
Inspection Zone	Material	Hazardous Content	Condition	Friability	Accessibility	Recommended Action	Picture
Deck	Painted metal.	No suspect asbestos.	N/A	N/A	N/A	N/A

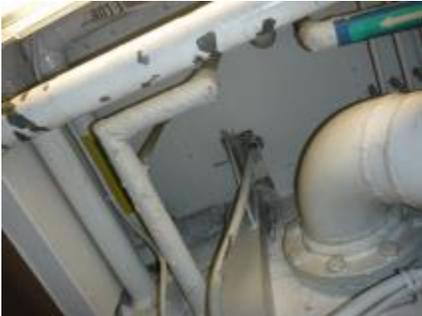
Lower Deck							Fuel Gauge Room
Inspection Zone	Material	Hazardous Content	Condition	Friability	Accessibility	Recommended Action	Picture
Deckhead	Metal panels over spray-applied fibrous insulation (Cafco-type).	No asbestos suspected in Cafco (14 out of 14 samples negative for asbestos).	N/A	N/A	N/A	N/A

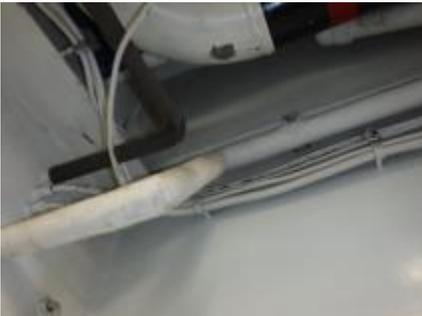
Bulkhead	Metal panels over spray-applied fibrous insulation (Cafco-type).	No asbestos suspected in Cafco (14 out of 14 samples negative for asbestos).	N/A	N/A	N/A	N/A

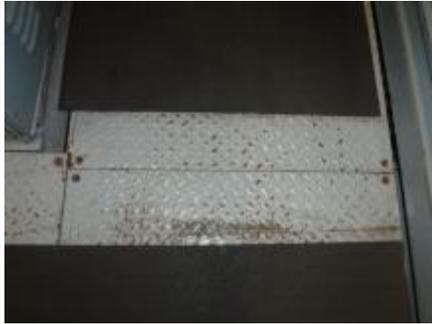
Lower Deck							Fuel Gauge Room
Inspection Zone	Material	Hazardous Content	Condition	Friability	Accessibility	Recommended Action	Picture
Deck	Painted metal.	No suspect asbestos.	N/A	N/A	N/A	N/A

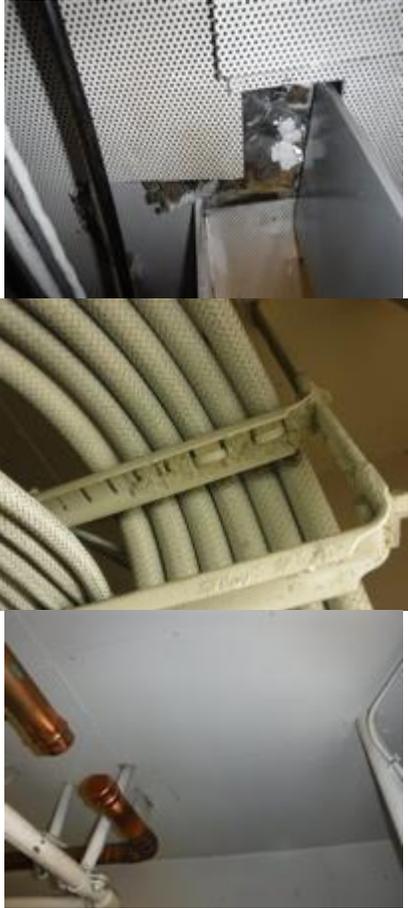
Lower Deck							Propulsion Room (Rm 702)
Inspection Zone	Material	Hazardous Content	Condition	Friability	Accessibility	Recommended Action	Picture
Deckhead	Metal panels over spray-applied fibrous insulation (Cafco-type).	No asbestos suspected in Cafco (14 out of 14 samples negative for asbestos).	N/A	N/A	N/A	N/A

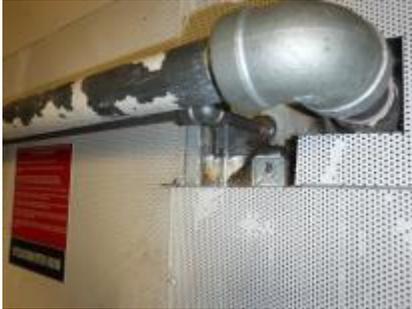
Lower Deck							Propulsion Room (Rm 702)
Inspection Zone	Material	Hazardous Content	Condition	Friability	Accessibility	Recommended Action	Picture
Bulkhead	Perforated metal over foil-faced fibrous insulation (Roxul-type).	No suspect asbestos.	N/A	N/A	N/A	N/A

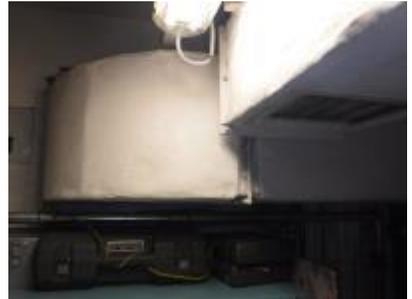
Painted metal.						
Lagging	Textile wrap over fibrous insulation (Fibreglass-type).	No asbestos suspected (5 out of 5 samples negative for asbestos).	N/A	N/A	N/A	N/A

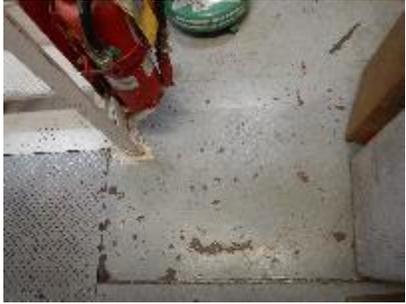
Lower Deck							Propulsion Room (Rm 702)
Inspection Zone	Material	Hazardous Content	Condition	Friability	Accessibility	Recommended Action	Picture
Deck	Painted metal.	No suspect asbestos.	N/A	N/A	N/A	N/A

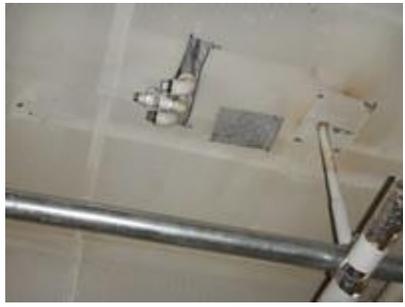
Lower Deck							Winch Compartment (Rm 703)
Inspection Zone	Material	Hazardous Content	Condition	Friability	Accessibility	Recommended Action	Picture
Deckhead	Perforated metal over spray-applied fibrous insulation (Cafco-type).	No asbestos suspected in Cafco (14 out of 14 samples negative for asbestos).	N/A	N/A	N/A	N/A

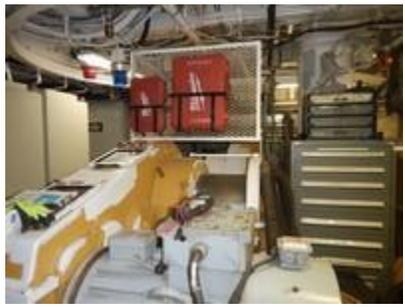
Bulkhead	Perforated metal over spray-applied fibrous insulation (Cafco-type).	No asbestos suspected in Cafco (14 out of 14 samples negative for asbestos). <ul style="list-style-type: none">• 31632-30 Cafco (no asbestos detected).	N/A	N/A	N/A	N/A

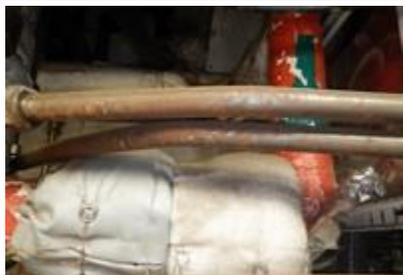
Painted metal.	No suspect asbestos.	N/A	N/A	N/A	N/A	
Lagging	Metal cladding over calcium silicate insulation.	No asbestos suspected (10 out of 10 samples negative for asbestos).	N/A	N/A	N/A	N/A

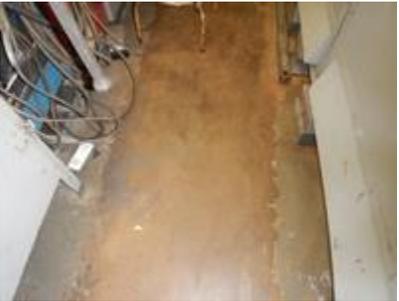
Lower Deck							Winch Compartment (Rm 703)
Inspection Zone	Material	Hazardous Content	Condition	Friability	Accessibility	Recommended Action	Picture
Lagging	Hi-temperature jacket.	N/A	N/A	N/A	N/A	N/A	
Deck	Painted metal. Checker plate metal.	No suspect asbestos.	N/A	N/A	N/A	N/A

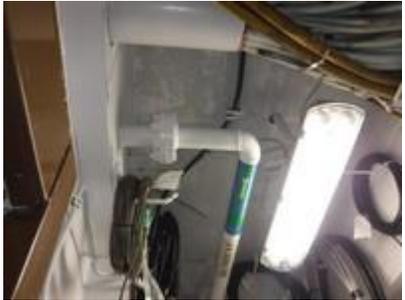
Lower Deck							Electrical Store Room (Rm 705)
Inspection Zone	Material	Hazardous Content	Condition	Friability	Accessibility	Recommended Action	Picture
Deckhead	Perforated metal over spray-applied fibrous insulation (Cafco-type).	No asbestos suspected in Cafco (14 out of 14 samples negative for asbestos).	N/A	N/A	N/A	N/A

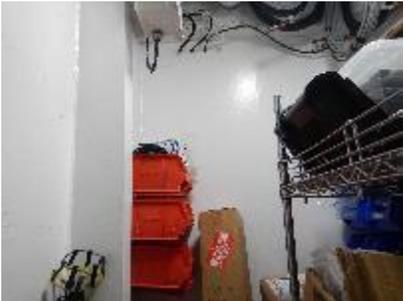
Bulkhead	Perforated metal over spray-applied fibrous insulation (Cafco-type). Painted metal.	No asbestos suspected in Cafco (14 out of 14 samples negative for asbestos).	N/A	N/A	N/A	N/A

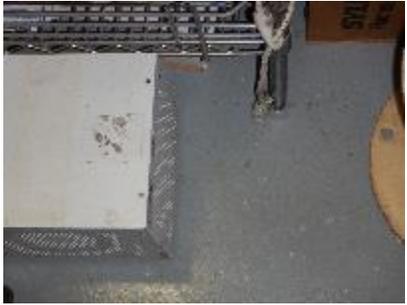
Lower Deck							Electrical Store Room (Rm 705)
Inspection Zone	Material	Hazardous Content	Condition	Friability	Accessibility	Recommended Action	Picture
Deck	Painted metal.	No suspect asbestos.	N/A	N/A	N/A	N/A

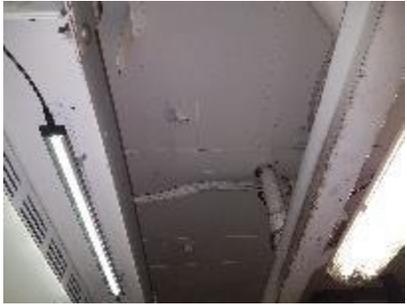
Lower Deck							Transformer Room (Rm 707)
Inspection Zone	Material	Hazardous Content	Condition	Friability	Accessibility	Recommended Action	Picture
Deckhead	Metal panels over spray-applied fibrous insulation (Cafco-type).	No asbestos suspected in Cafco (14 out of 14 samples negative for asbestos).	N/A	N/A	N/A	N/A

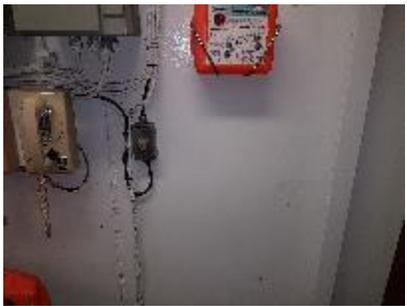
Bulkhead	Perforated metal over spray-applied fibrous insulation (Cafco-type). Metal panels over spray-applied fibrous insulation (Cafco-type). Painted metal.	No asbestos suspected in Cafco (14 out of 14 samples negative for asbestos). No suspect asbestos.	N/A	N/A	N/A	N/A

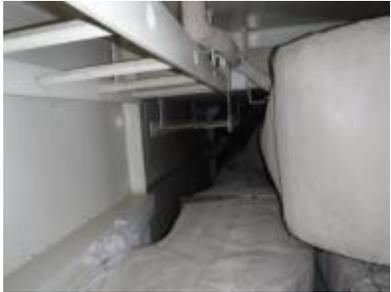
Lower Deck							Transformer Room (Rm 707)
Inspection Zone	Material	Hazardous Content	Condition	Friability	Accessibility	Recommended Action	Picture
Lagging	Textile wrap over fibrous insulation (Fibreglass-type).	No asbestos suspected (5 out of 5 samples negative for asbestos).	N/A	N/A	N/A	N/A

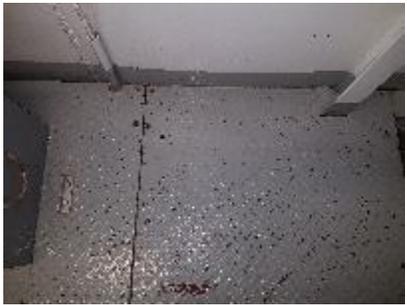
Textile wrap over calcium silicate.	No asbestos suspected (10 out of 10 samples negative for asbestos).	N/A	N/A	N/A	N/A	
Deck	Checker plate metal	No suspect asbestos.	N/A	N/A	N/A	N/A

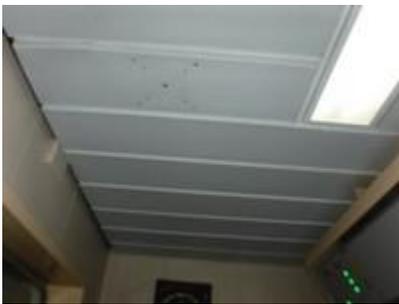
Lower Deck		Machinery Control Room (Upper) (Rm 708)					
Inspection Zone	Material	Hazardous Content	Condition	Friability	Accessibility	Recommended Action	Picture
Deckhead	Perforated metal over spray-applied fibrous insulation (Cafco-type).	No asbestos suspected in Cafco (14 out of 14 samples negative for asbestos).	N/A	N/A	N/A	N/A

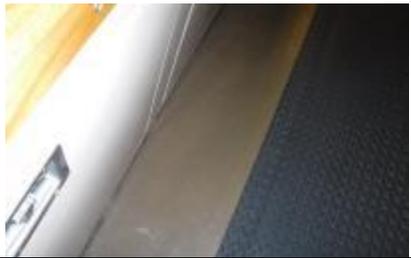
Lagging	None observed.	N/A	N/A	N/A	N/A	N/A	
Deck	Anti-skid coating	Anti-skid coating (Intershield 6GV) is non-ACM as per manufacturer (see Appendix D). • 28403-32:Anti-skid coating (No asbestos detected).	N/A	N/A	N/A	N/A

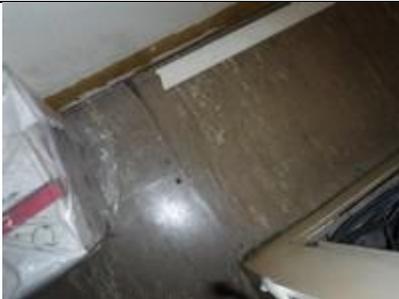
Floor Tile (12" x 12" Brown with white streaks.	No asbestos detected in Floor Tile (12" x 12" Brown with white streaks: •28403-31: Floor tile 12" x 12" brown with white streaks (No asbestos detected).	N/A	N/A	N/A	N/A	
Other	Baseboard	No asbestos suspected (3 out of 3 samples negative for asbestos): • 28403-33 Baseboard Adhesive (brown) (no asbestos detected)	N/A	N/A	N/A	N/A	
Comments	N/A

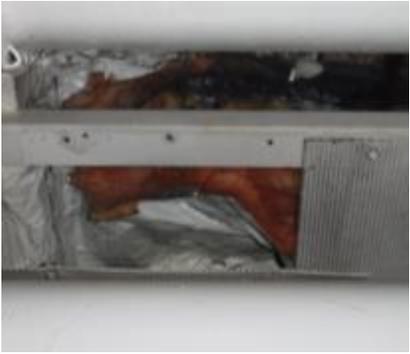
Lower Deck							Engine Room (Lower)
Inspection Zone	Material	Hazardous Content	Condition	Friability	Accessibility	Recommended Action	Picture
Deckhead	Painted metal.	No suspect asbestos.	N/A	N/A	N/A	N/A

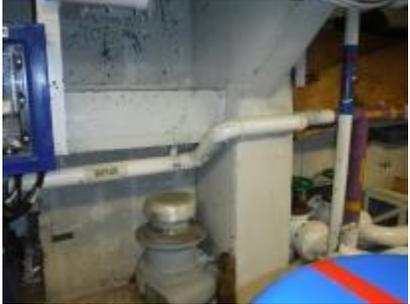
Perforated metal over fibrous insulation (Fibreglass-type).	No asbestos detected based on samples: • 28008-1 Foil-faced Fibreglass insulation (no asbestos detected).	N/A	N/A	N/A	N/A	
Bulkhead	Painted metal.	No suspect asbestos.	N/A	N/A	N/A	N/A

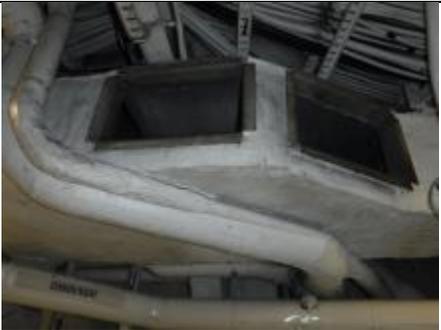
Alco SEI Blanket.	<ul style="list-style-type: none"> • 31632-35 Alco SEI Blanket (no asbestos detected). 	N/A	N/A	N/A	N/A	
	Main exhaust stack blanket.	<ul style="list-style-type: none"> • 31632-27 Exhaust stack mount (0.5% chrysotile asbestos). • 31632-36 Main exhaust stack blanket (no asbestos detected). 	N/A	N/A	N/A	N/A	
	Metal cladding over calcium silicate insulation.	No asbestos suspected (10 out of 10 samples negative for asbestos).	N/A	N/A	N/A	N/A	
	Textile wrap over calcium silicate.						
	Textile wrap over fibrous insulation (Fibreglass-type).	No asbestos suspected (5 out of 5 samples negative for asbestos).	N/A	N/A	N/A	N/A

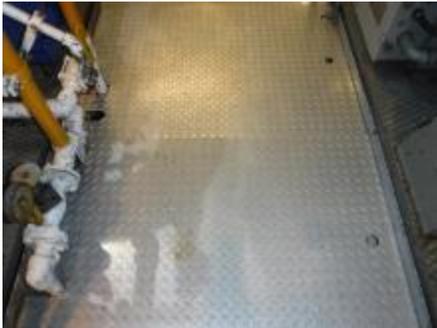
Lower Deck							Engine Room (Lower)
Inspection Zone	Material	Hazardous Content	Condition	Friability	Accessibility	Recommended Action	Picture
	Hi-temperature jacket.	No suspected asbestos.	N/A	N/A	N/A	N/A	
Deck	Checker plate metal.	No suspect asbestos.	N/A	N/A	N/A	N/A

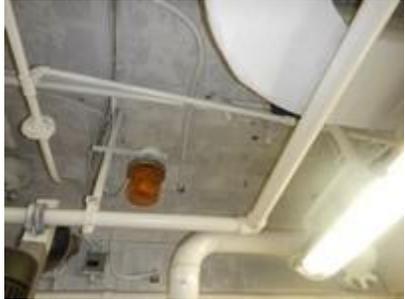
Lower Deck							Engineer's Workshop (Rm 710)
Inspection Zone	Material	Hazardous Content	Condition	Friability	Accessibility	Recommended Action	Picture
Deckhead	Perforated metal over spray-applied fibrous insulation (Cafco-type).	No asbestos suspected in Cafco (14 out of 14 samples negative for asbestos).	N/A	N/A	N/A	N/A

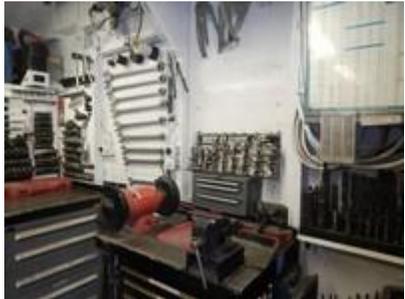
Bulkhead	Perforated metal over spray-applied fibrous insulation (Cafco-type).	No asbestos suspected in Cafco (14 out of 14 samples negative for asbestos). • 31632-31 Cafco (no asbestos detected).	N/A	N/A	N/A	N/A

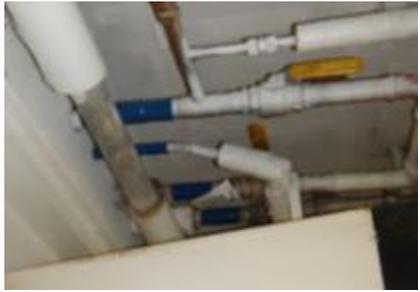
Lower Deck							Engineer's Workshop (Rm 710)
Inspection Zone	Material	Hazardous Content	Condition	Friability	Accessibility	Recommended Action	Picture
	Painted metal.		N/A	N/A	N/A	N/A	
Lagging	Textile wrap over fibrous insulation (Fibreglass-type).	No asbestos suspected (5 out of 5 samples negative for asbestos).	N/A	N/A	N/A	N/A

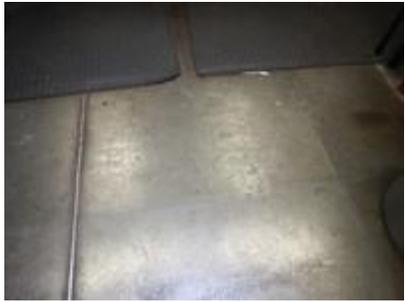
Deck	Painted metal.	No suspect asbestos.	N/A	N/A	N/A	N/A

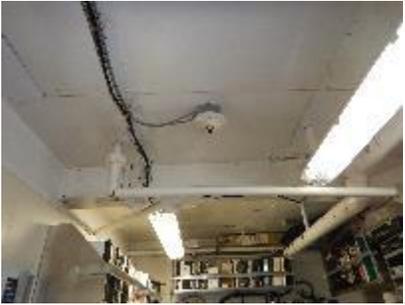
Lower Deck							Electrical Workshop (Rm 711)
Inspection Zone	Material	Hazardous Content	Condition	Friability	Accessibility	Recommended Action	Picture
Deckhead	Metal panels over spray-applied fibrous insulation (Cafco-type).	No asbestos suspected in Cafco (14 out of 14 samples negative for asbestos).	N/A	N/A	N/A	N/A

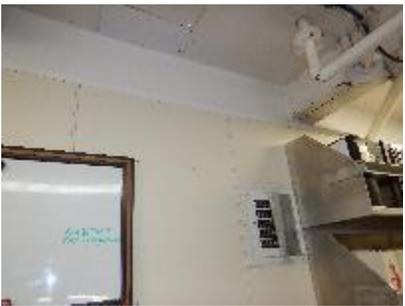
Bulkhead	Metal panels over spray-applied fibrous insulation (Cafco-type).	No asbestos suspected in Cafco (14 out of 14 samples negative for asbestos).	N/A	N/A	N/A	N/A

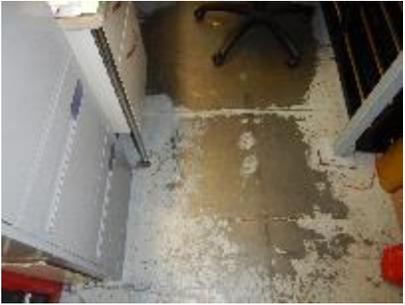
Lower Deck							Electrical Workshop (Rm 711)
Inspection Zone	Material	Hazardous Content	Condition	Friability	Accessibility	Recommended Action	Picture
Deck	Painted metal.	No suspect asbestos.	N/A	N/A	N/A	N/A

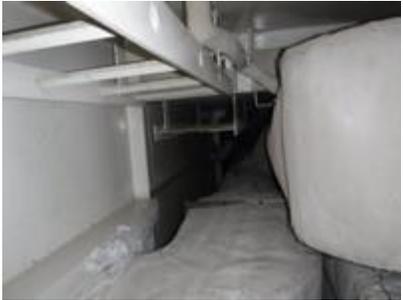
Lower Deck							Vent Trunk (in Transformer Room) (Rm 712)
Inspection Zone	Material	Hazardous Content	Condition	Friability	Accessibility	Recommended Action	Picture
Deckhead	Painted metal.	No suspect asbestos.	N/A	N/A	N/A	N/A

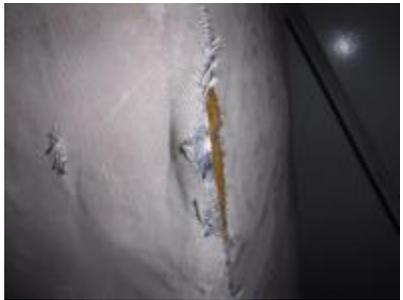
Bulkhead	Painted metal.	No suspect asbestos.	N/A	N/A	N/A	N/A	Photograph not available
Lagging	Textile wrap over fibrous insulation (Fibreglass-type).	No asbestos suspected (5 out of 5 samples negative for asbestos).	N/A	N/A	N/A	N/A

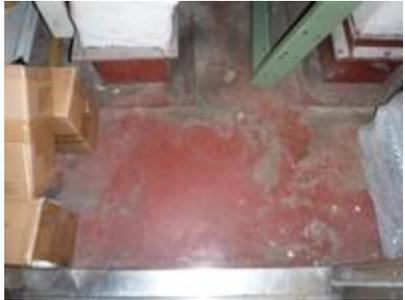
Lower Deck							Vent Trunk (in Transformer Room) (Rm 712)
Inspection Zone	Material	Hazardous Content	Condition	Friability	Accessibility	Recommended Action	Picture
Deck	Painted metal.	No suspect asbestos.	N/A	N/A	N/A	N/A

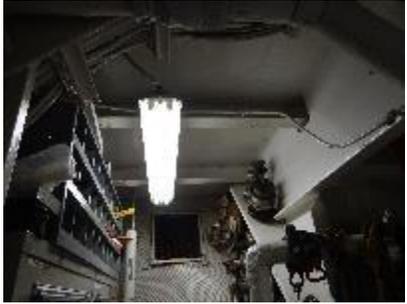
Tank Top							Sewage Compartment (Rm 801)
Inspection Zone	Material	Hazardous Content	Condition	Friability	Accessibility	Recommended Action	Picture
Deckhead	Painted metal.	No suspect asbestos.	N/A	N/A	N/A	N/A

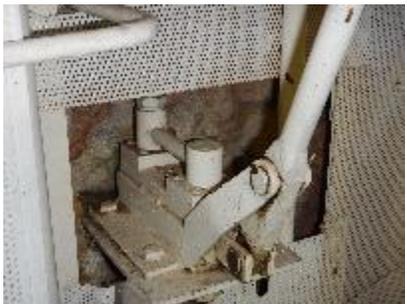
Bulkhead	Perforated metal over fibrous insulation (Fibreglass-type). Painted metal.	No suspect asbestos.	N/A	N/A	N/A	N/A

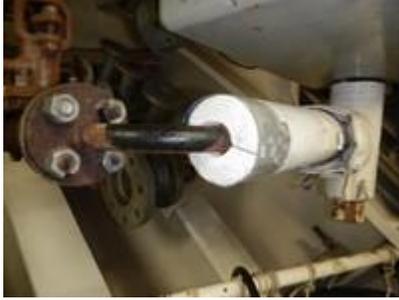
Tank Top							Sewage Compartment (Rm 801)
Inspection Zone	Material	Hazardous Content	Condition	Friability	Accessibility	Recommended Action	Picture
Lagging	Metal cladding over calcium silicate insulation.	No asbestos suspected (10 out of 10 samples negative for asbestos).	N/A	N/A	N/A	N/A

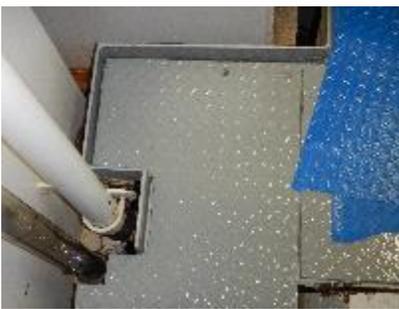
Deck	Checker plate metal	No suspect asbestos.	N/A	N/A	N/A	N/A

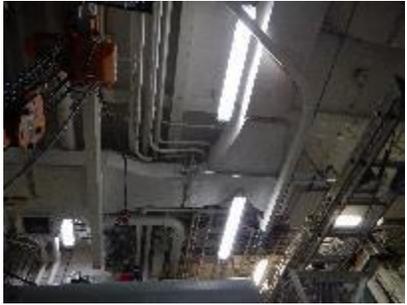
Tank Top							Propulsion Motor Room (Rm 802)
Inspection Zone	Material	Hazardous Content	Condition	Friability	Accessibility	Recommended Action	Picture
Deckhead	Perforated metal over fibrous insulation (Fibreglass-type). Painted metal.	No suspect asbestos.	N/A	N/A	N/A	N/A

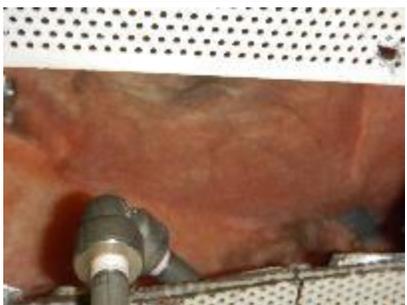
Bulkhead	Perforated metal over fibrous insulation (Fibreglass-type). Painted metal.	No suspect asbestos.	N/A	N/A	N/A	N/A

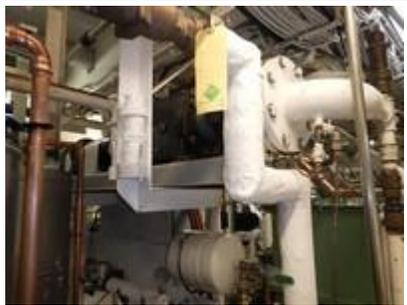
Lagging	Metal cladding over calcium silicate insulation. Textile wrap over fibrous insulation (Fibreglass-type).	No asbestos suspected (10 out of 10 samples negative for asbestos). • 31632-11, 33, 34 Calsil pipe insulation (no asbestos detected). No asbestos suspected (5 out of 5 samples negative	N/A	N/A	N/A	N/A

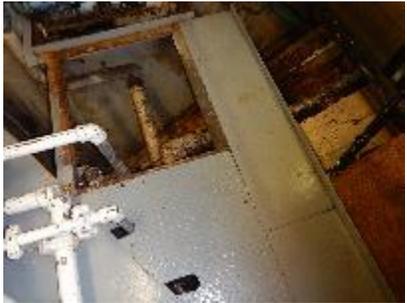
Tank Top							Propulsion Motor Room (Rm 802)
Inspection Zone	Material	Hazardous Content	Condition	Friability	Accessibility	Recommended Action	Picture
	Hi-temperature jacket.	for asbestos). No suspect asbestos.					
Deck	Checker plate metal.	No suspect asbestos.	N/A	N/A	N/A	N/A

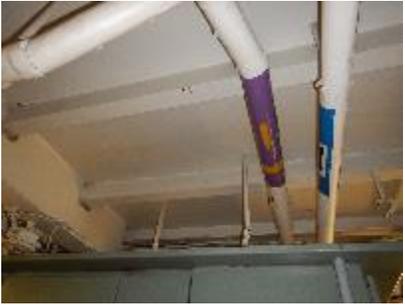
Tank Top							Converter Room (Rm 803)
Inspection Zone	Material	Hazardous Content	Condition	Friability	Accessibility	Recommended Action	Picture
Deckhead	Painted metal.	No suspect asbestos. • 28403-35 Cafco (no asbestos detected).	N/A	N/A	N/A	N/A

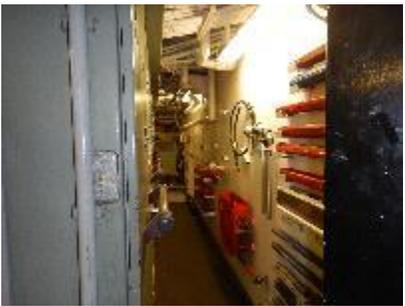
Bulkhead	Perforated metal over fibrous insulation (Fibreglass-type). Painted metal.	No suspect asbestos.	N/A	N/A	N/A	N/A

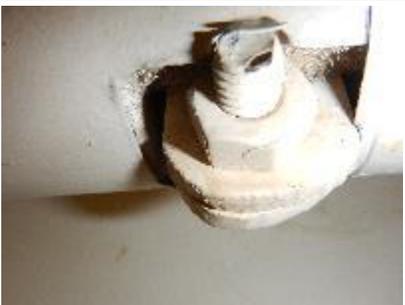
Lagging	Metal cladding over calcium silicate insulation. Textile wrap over fibrous insulation (Fibreglass-type).	No asbestos suspected (10 out of 10 samples negative for asbestos). No asbestos suspected (5 out of 5 samples negative for asbestos).	N/A	N/A	N/A	N/A

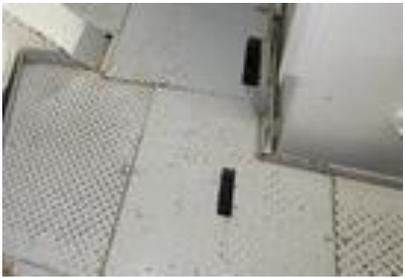
Tank Top							Converter Room (Rm 803)
Inspection Zone	Material	Hazardous Content	Condition	Friability	Accessibility	Recommended Action	Picture
Deck	Checker plate metal.	No suspect asbestos.	N/A	N/A	N/A	N/A

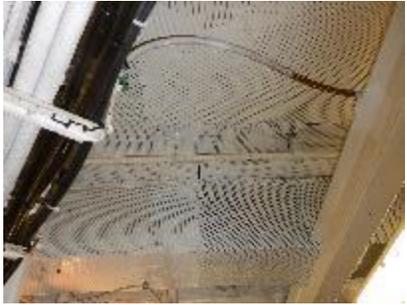
Tank Top							Purifier Room (Rm 804)
Inspection Zone	Material	Hazardous Content	Condition	Friability	Accessibility	Recommended Action	Picture
Deckhead	Perforated metal over fibrous insulation (Fibreglass-type).	No suspect asbestos.	N/A	N/A	N/A	N/A

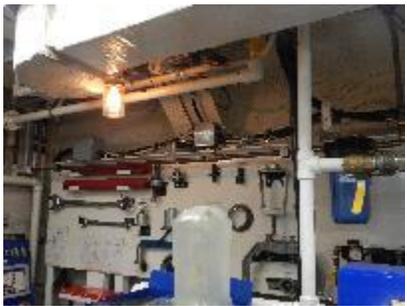
Bulkhead	Perforated metal over fibrous insulation (Fibreglass-type). Painted metal.	No suspect asbestos.	N/A	N/A	N/A	N/A

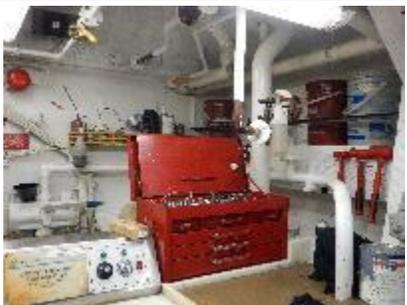
Lagging	Metal cladding over calcium silicate insulation. Textile wrap over fibrous insulation (Fibreglass-type).	No asbestos suspected (10 out of 10 samples negative for asbestos). No asbestos suspected (5 out of 5 samples negative for asbestos). No suspect asbestos.	N/A	N/A	N/A	N/A

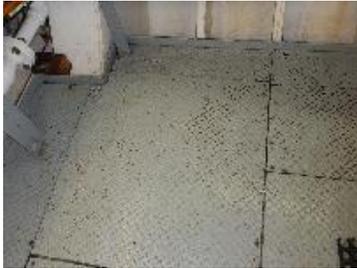
Tank Top							Purifier Room (Rm 804)
Inspection Zone	Material	Hazardous Content	Condition	Friability	Accessibility	Recommended Action	Picture
	Hi-temperature jacket.						
Deck	Checker plate metal.	No suspect asbestos.	N/A	N/A	N/A	N/A
