BID DOCUMENTS AND SPECIFICATIONS

CCIW - 867 LAKESHORE ROAD, BURLINGTON
WTC ROOF REPLACEMENT

JUNE 15, 2018

ROOF CONDITION ASSESSMENT REPORT

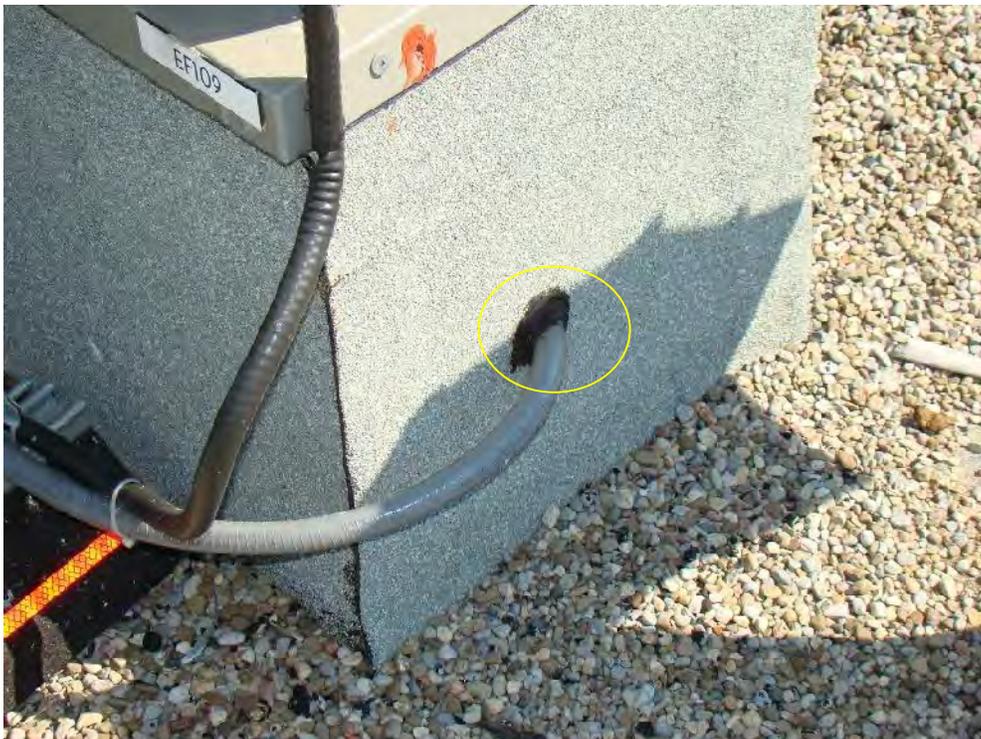
Photograph 10: Roof Area 1.1 – Electrical conduit penetrations at the new equipment have been fed through the sides of the support curbs which will tend to be an ongoing maintenance item.

5. Various pieces of new mechanical equipment have been installed in the northeast corner of the roof (photograph 9) and appear to have been flashed into the existing roof using acceptable materials and installation methods. Electrical conduit penetrations at the new equipment have been fed through the sides of the support curbs which will tend to be an ongoing maintenance item (photograph 10).

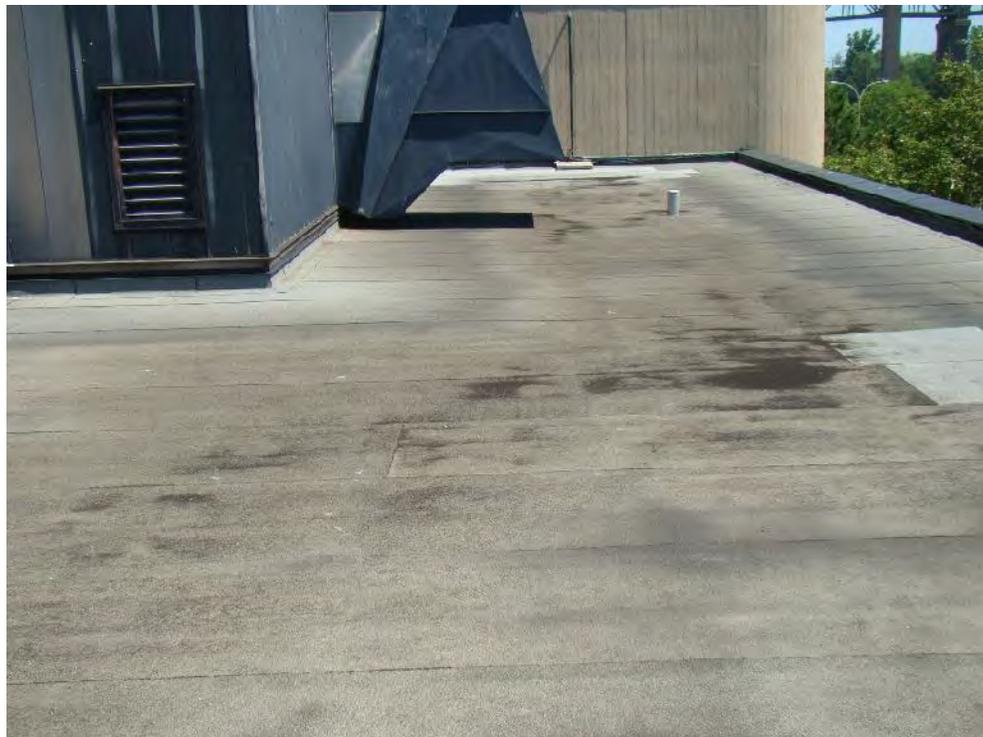
Photograph 16: Roof Area 1.2 – View looking east along the south portion of the roof showing evidence of ponding. Tapered insulation is directing water into the central portion of the roof.

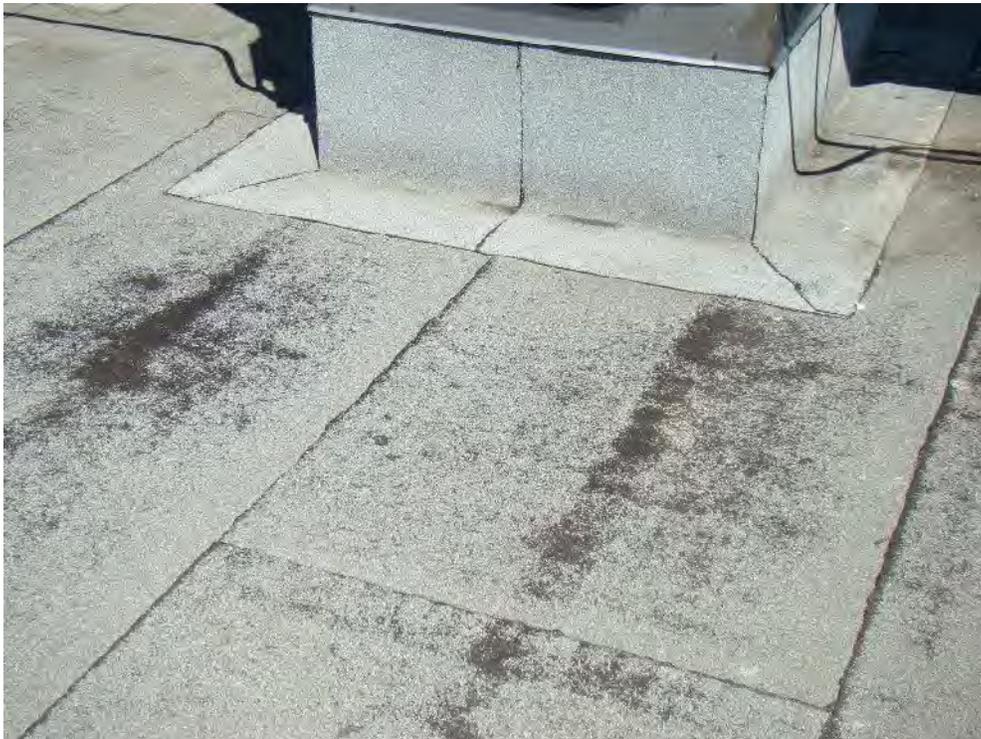
Photograph 34: Roof Area 1.2 – Granule loss is typical around mechanical curbs due to regular foot traffic patterns.

4. The membrane exhibits widespread and severe granule surface loss and weathering (photographs 33, 34, 35 and 36). This condition is related to advanced aging of the membrane, exposure to prolonged ponding and erosion due to regular foot traffic patterns and wind scouring (this roof would be exposed to high winds due to its proximity to open water).

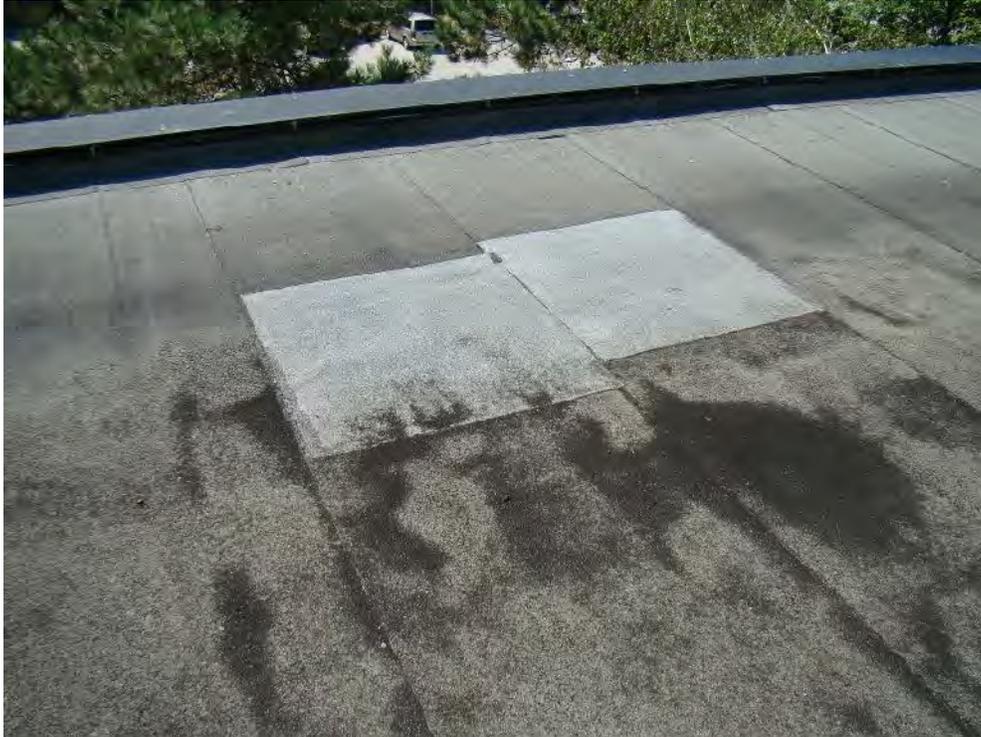
Photograph 35: Roof Area 1.2 – Granule surface loss due to prolonged ponding.

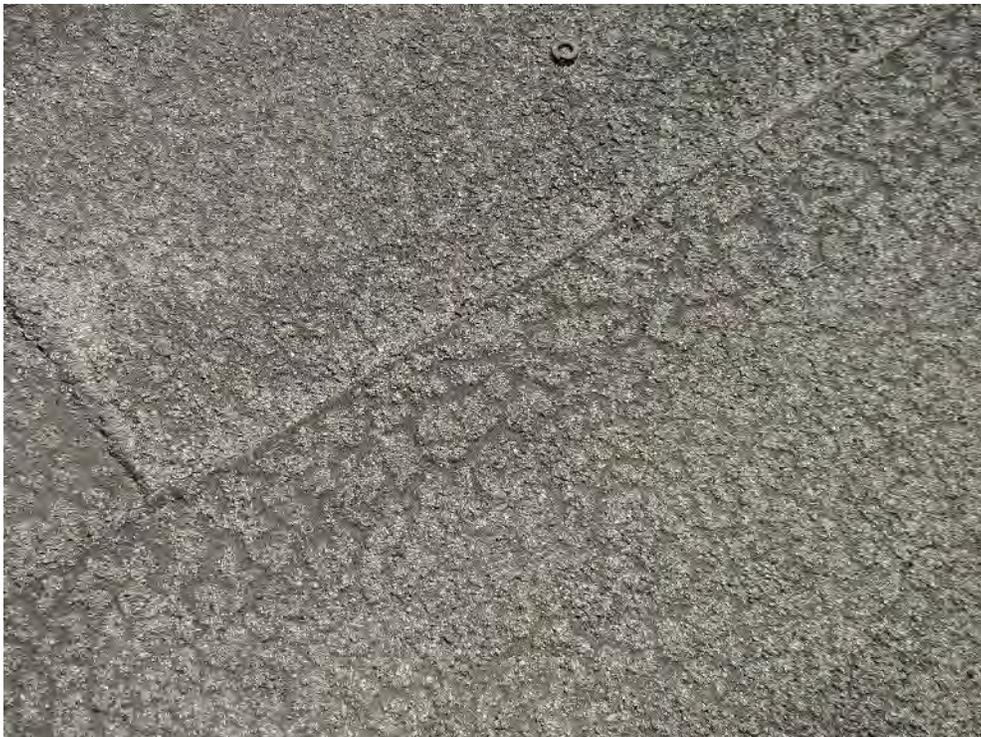
Photograph 36: Roof Area 1.2 – Severe surface deterioration and cracking, typical of advanced aging.

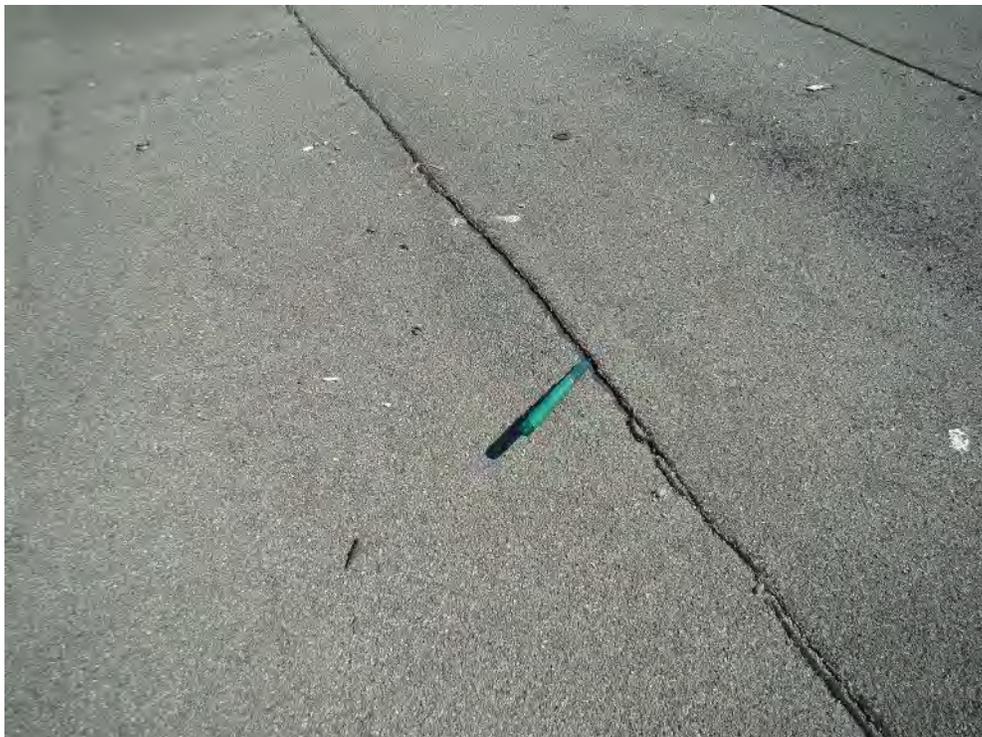
Photograph 38: Roof Area 1.2 – Severe blistering is causing developing membrane laps to delaminate and be susceptible to water entry.

5. Widespread membrane blistering exists within the field of the roof (photographs 37, 38 and 39) and is indicative of poor adhesion of the membrane to the insulation substrate or delamination between the base and cap sheet membranes due to moisture infiltration. Severe blistering is causing developing membrane laps to delaminate and be susceptible to water entry.

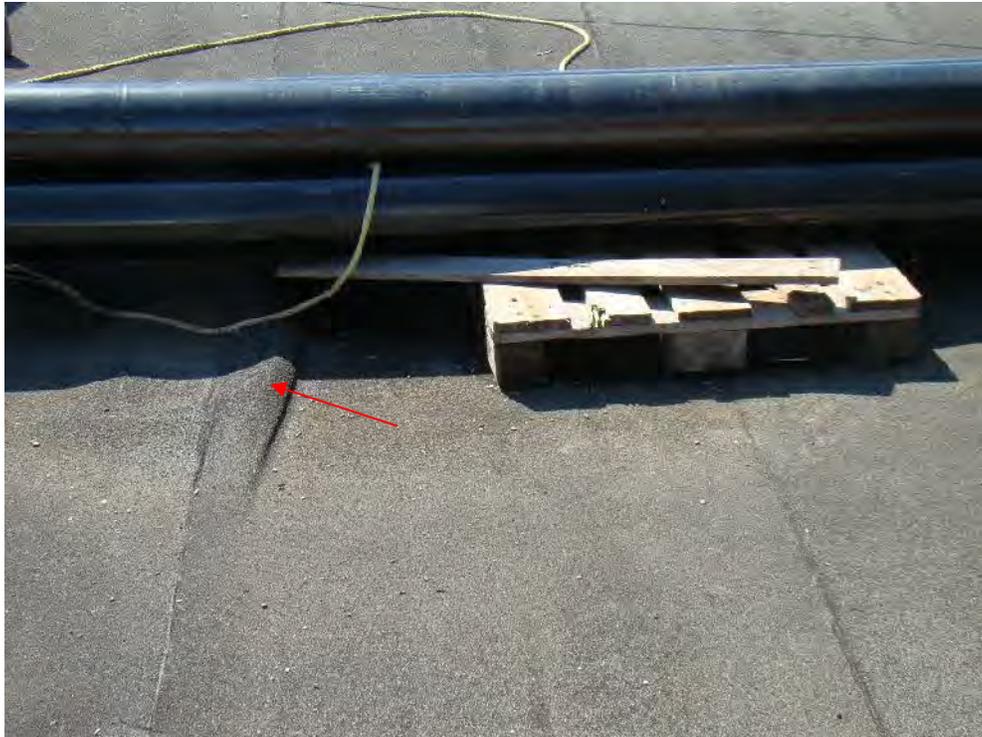
Photograph 39: Roof Area 1.2 – Membrane blister has been crushed under the weight of construction materials stockpiled on the roof. This condition will likely cause membrane damage and water entry.

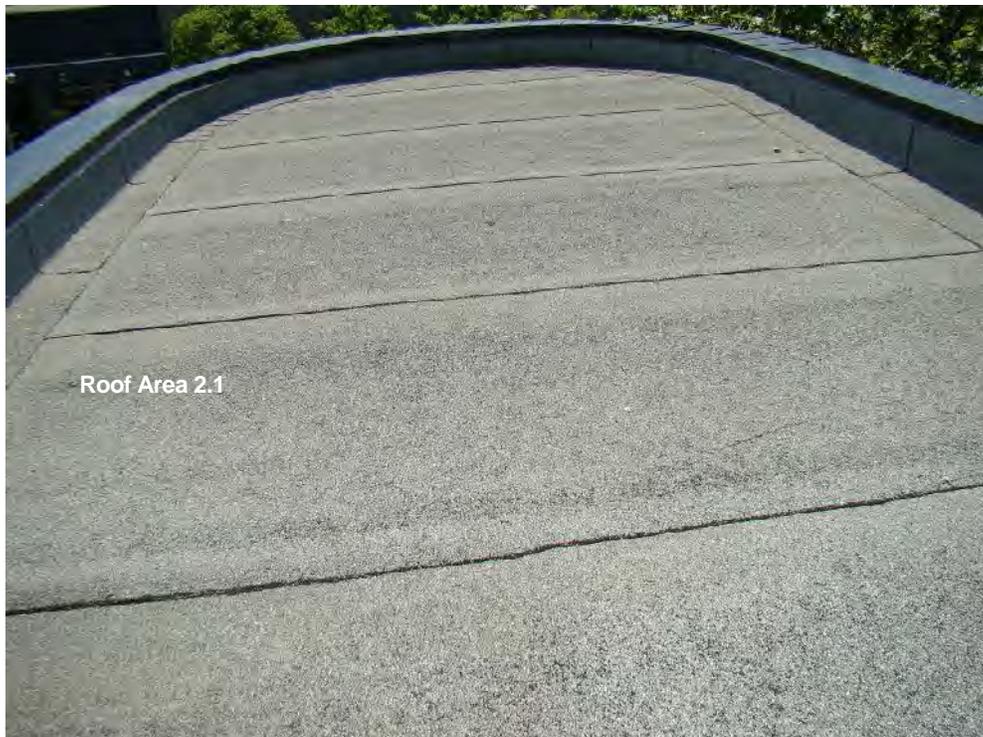
Photograph 54: Roof Area 2.1 – Overall view at roof level showing general granule surface loss.

3. The cap sheet membrane appears weathered and worn with general granule surface loss throughout all roof areas (photographs 54, 58 and 63).
4. The east parapet flashings on roof area 2.2 have been removed to facilitate construction of the new addition. It appears that minimal protection from water entry has been provided along the edge (photograph 59). Construction debris is scattered throughout roof area 2.2 and is obstructing the drainage scupper (photographs 60 and 61).

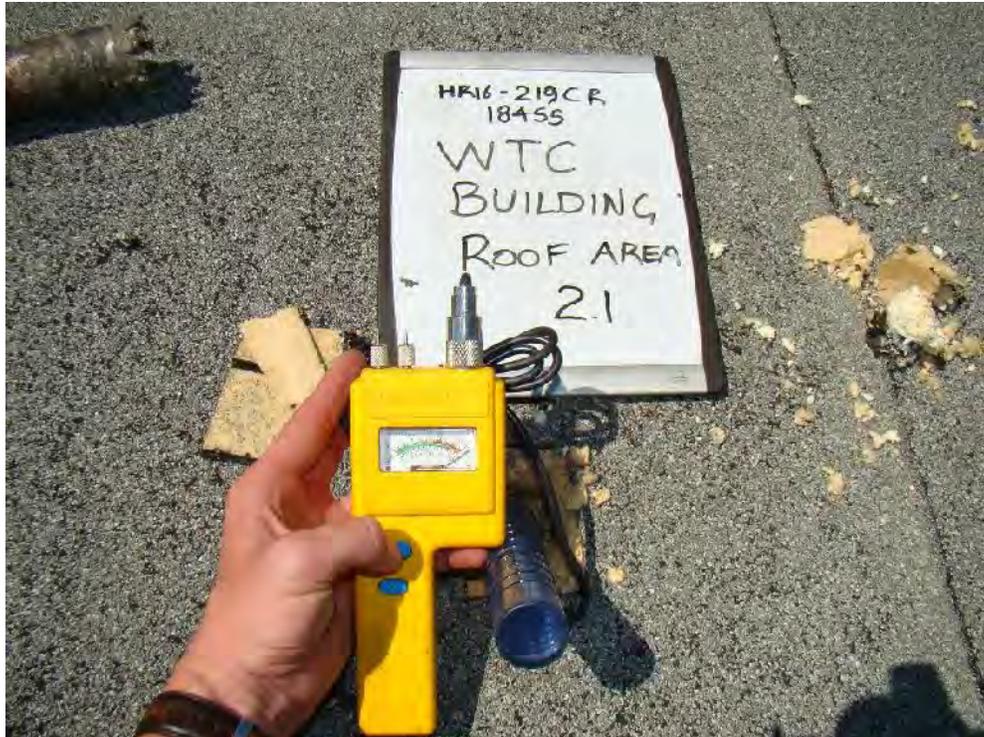
Photograph 55: Roof Area 2.1 *Test Cut* – High moisture levels were detected within the base layer of polyisocyanurate insulation.

1. The existing roof systems on these areas are assessed to be in poor condition with limited service life remaining.
2. Cut testing of the roof assembly over the west stairwell (roof area 2.1) revealed moisture contaminated insulation below the membrane (photographs 55 and 56).

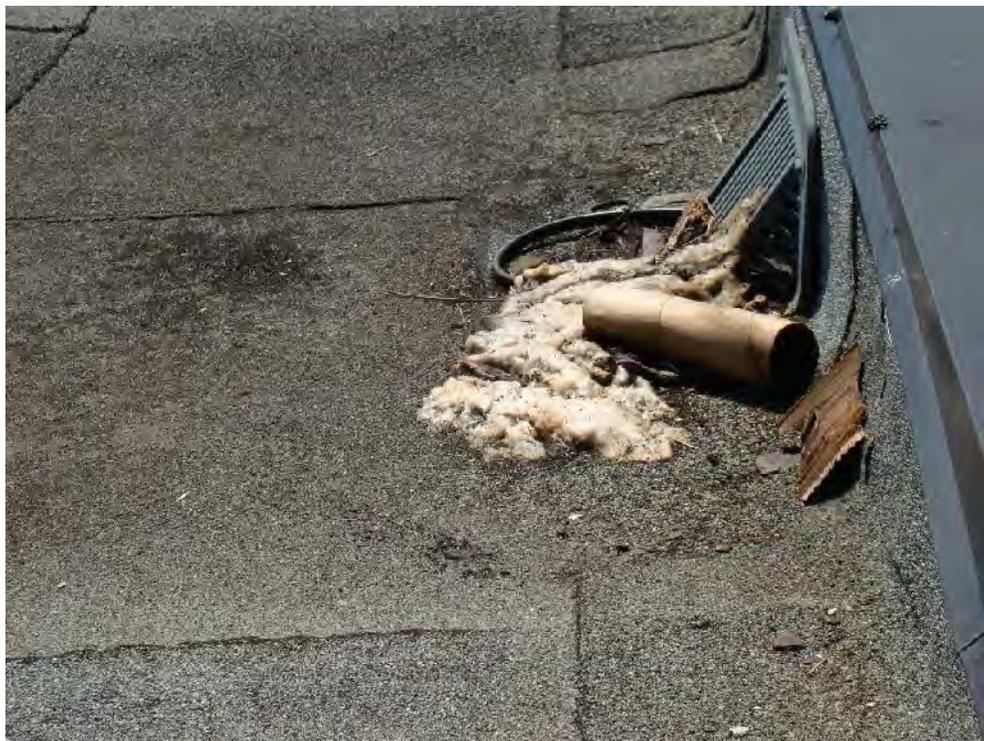
Photograph 60: Roof Area 2.2 – Debris is obstructing the drainage scupper.

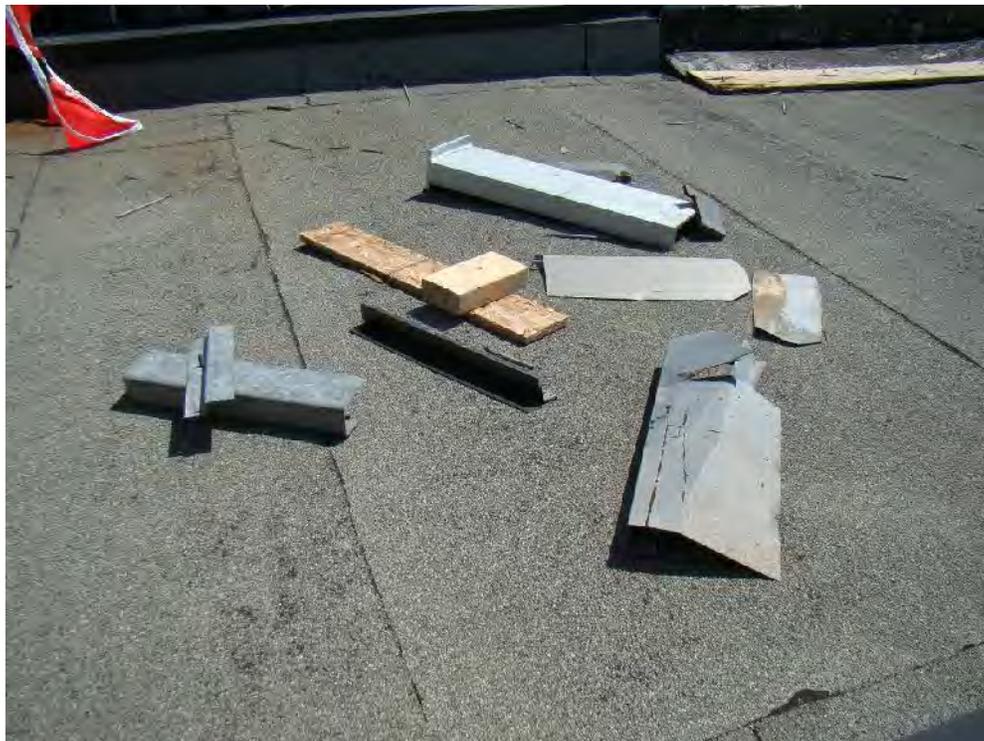
Photograph 61: Roof Area 2.2 – Construction debris is scattered throughout roof area.

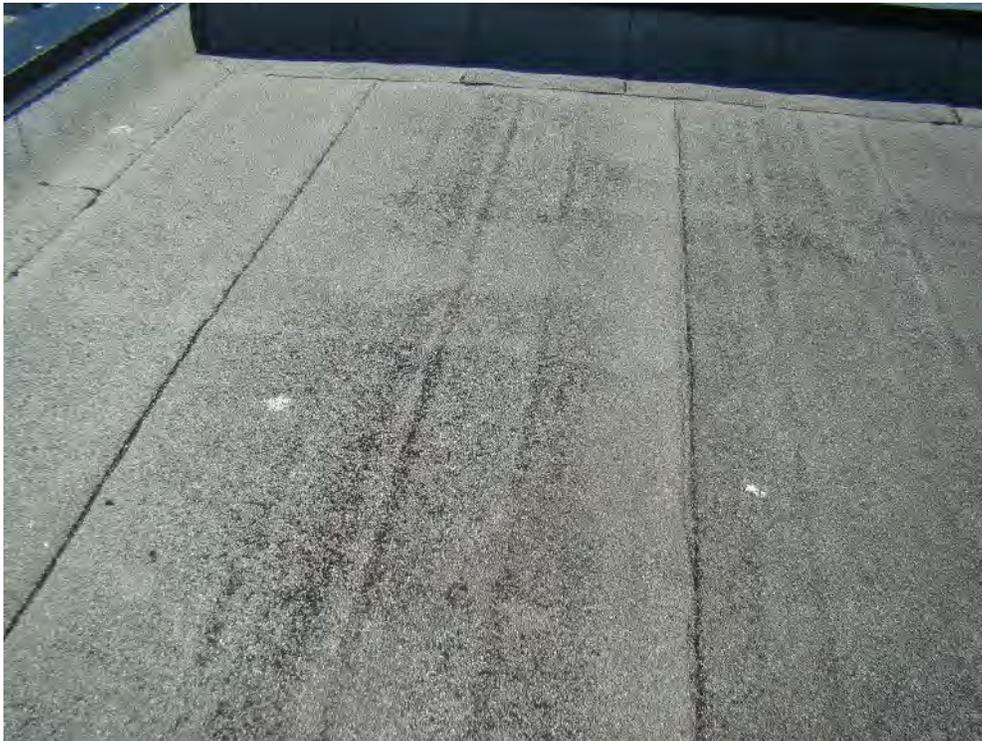
Photograph 63: Roof Area 2.3 – The cap sheet membrane appears weathered and worn with general granule surface loss throughout

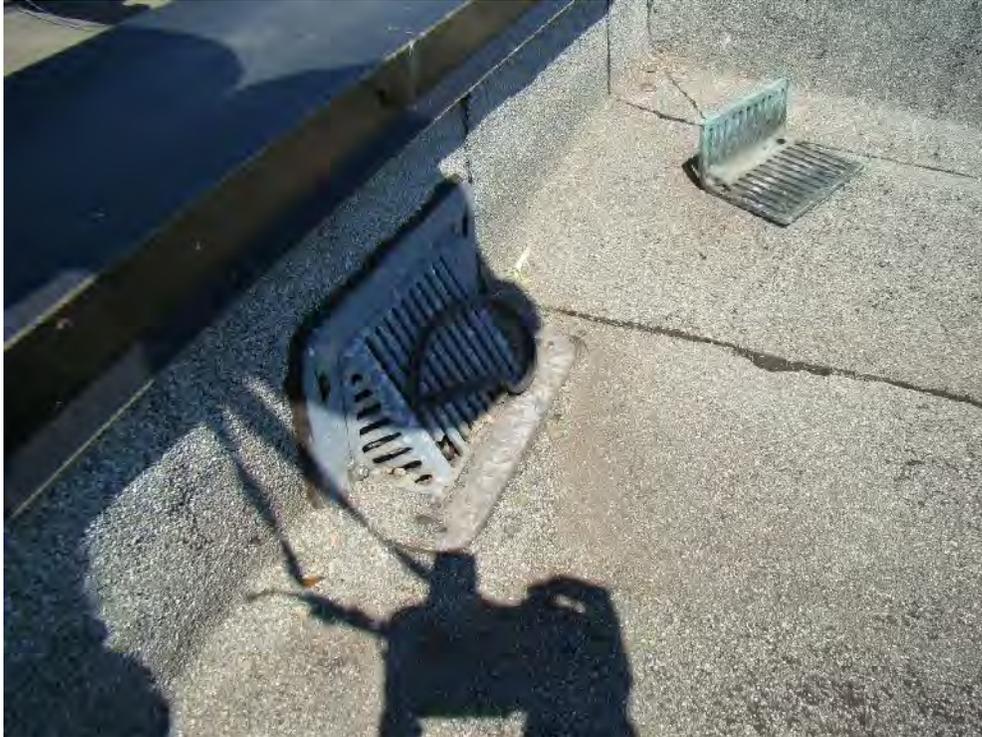
Photograph 65: Roof Area 2.3 – Minor debris accumulation at drainage scupper.

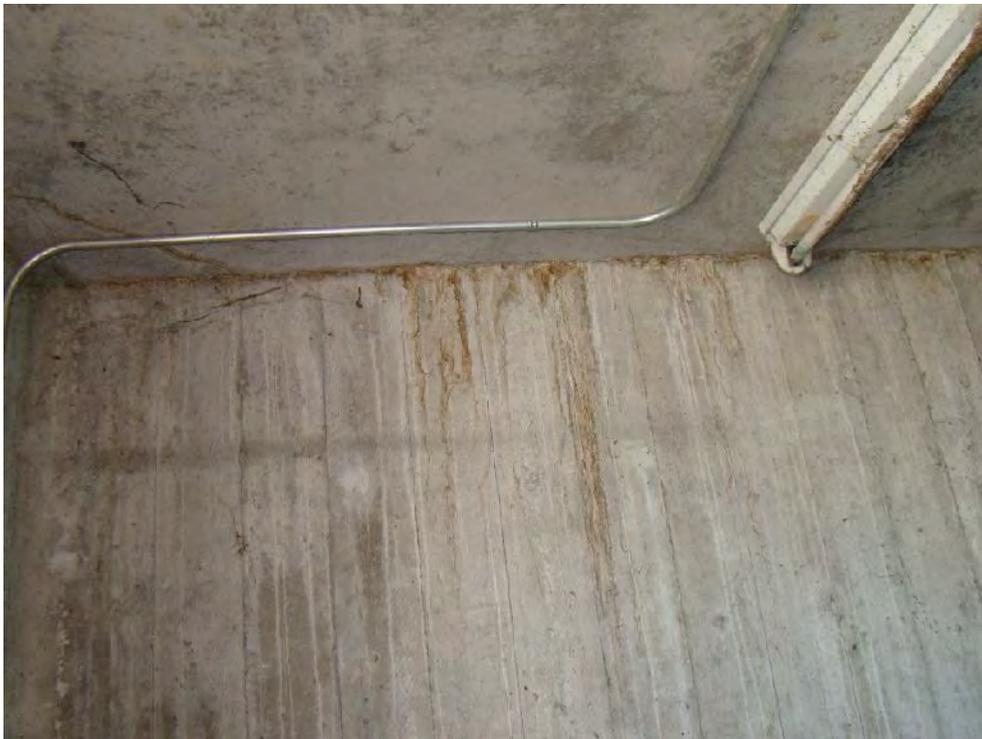
Photograph 66: Roof Area 2.3 – Evidence of moisture staining along the east wall indicates previous leakage.

5. Membrane wrinkling and blistering was evident on roof area 2.3 (photograph 64).
6. Evidence of moisture staining along the east wall indicates previous leakage (photograph 66).

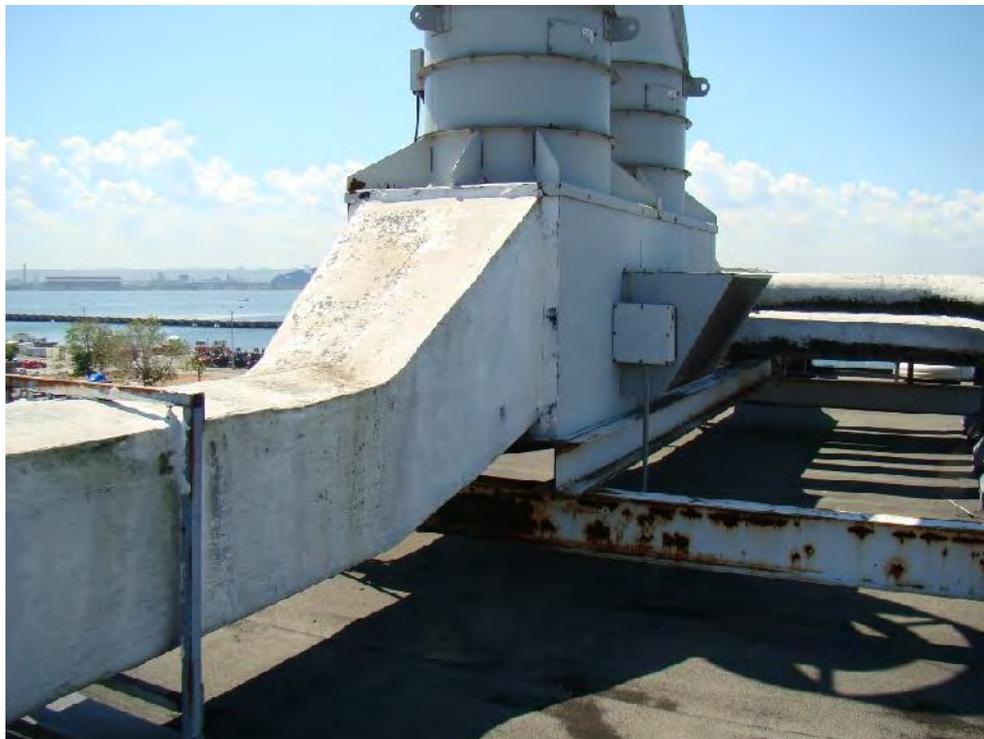
Photograph 68: Roof Area 3.1 – The roof is covered with a heavy concentration of mechanical equipment and ductwork which would tend to increase roof replacement costs significantly.

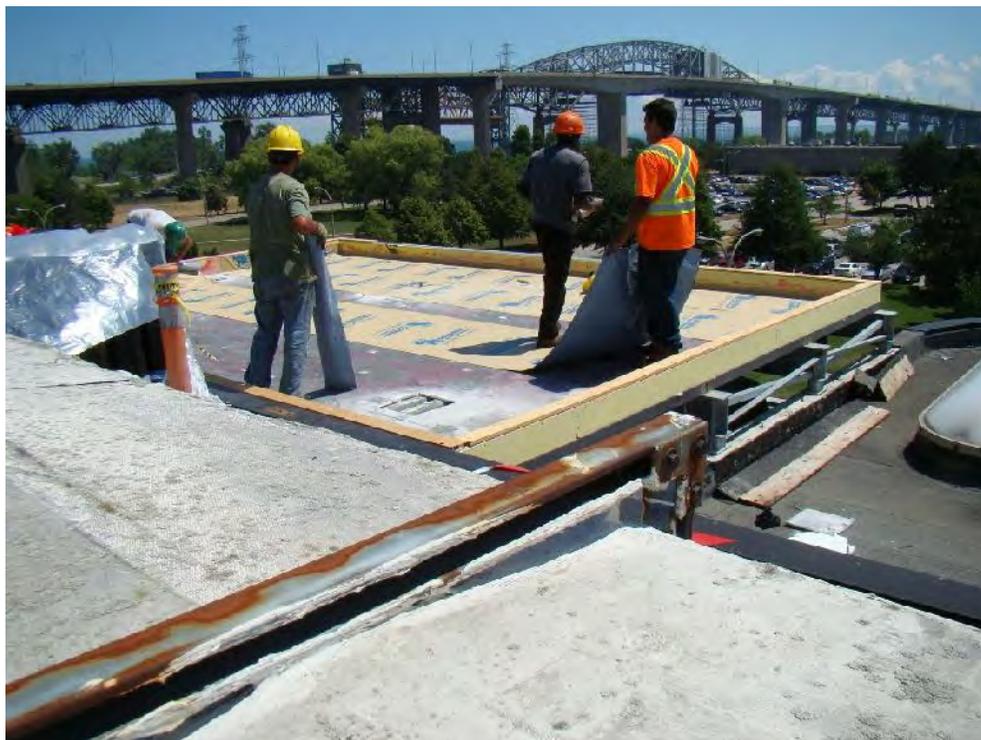
Photograph 82: Roof Area 3.1 – View of the small mechanical room addition. Roofing application was in progress at the time of IRC's site visit.
