## **Hazardous Building Materials Assessment**

Exeter Radar Station  
41651 Thames Road, Exeter,  
Ontario

January 31, 2019

Pinchin File: 229221.004

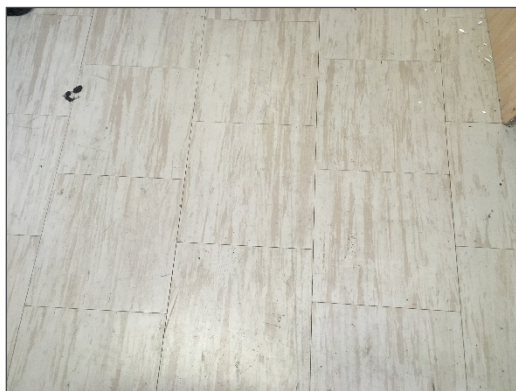
Size, Pattern, Colour and Photo #	Location #	Sample Number	Asbestos Type (tile)	Asbestos Type (mastic)
12"x12", cream and brown streaks, Photo 1	Location 14	Previously identified 0006A-C	Chrysotile	None Detected
12"x12", pink and black specks, Photo 2	Locations 1 and 2	Previously identified 0007A-C	None Detected	None Detected

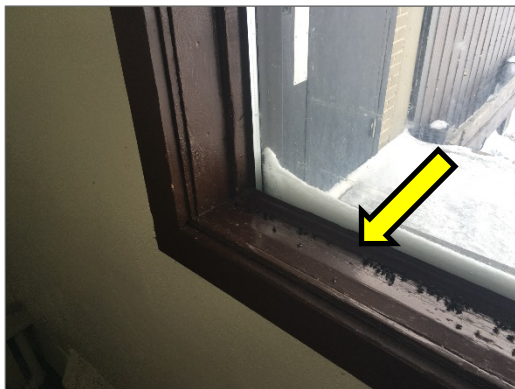
Material, Colour and Photo #	Location (Location #)	Sample Number	Asbestos Type
Caulking, brown, Photo 1	Located around interior side of windows throughout the building (Locations 1, 2, 3 and 4)	0005A-C	None Detected
Sealant, butyl tape, Photo 2	Located around the door window on the exterior door within Location 3	0008A-C	None Detected
Caulking, white, Photo 3	Located around the exterior door within Location 14	0009A-C	None Detected
Caulking, black, Photo 4	Located around exterior side of windows throughout the building (Locations 1, 2, 3 and 4)	0014A-C	None Detected
Caulking, hard grey, Photo 5	Located around the exterior side of glass block windows throughout the building (Locations 5, 6, 7, 13 and 14)	0015A-C	Chrysotile
Window glazing, white, Photo 6	Located around glass and wood frames of windows within Locations 3 and 10	0016A-C	None Detected
Caulking, brown, Photo 7	Located around roof flashing and over screws on roof flashing	0017A-C	Chrysotile

Caulking and sealants are non-friable materials and in good condition.
