Addendum No.1

Description: F1700-184013 CCG Workshops Maintenance Building HVAC Refurbishment

HAZARDOUS BUILDING MATERIALS ASSESSMENTS

Stantec Consulting Ltd. (Stantec) was retained by Public Services and Procurement Canada (PSPC) on behalf of Fisheries and Oceans Canada (DFO) to conduct hazardous building materials assessments within 6 buildings at the Victoria Coast Guard Base located at 25 Huron Street, Victoria, British Columbia (BC).

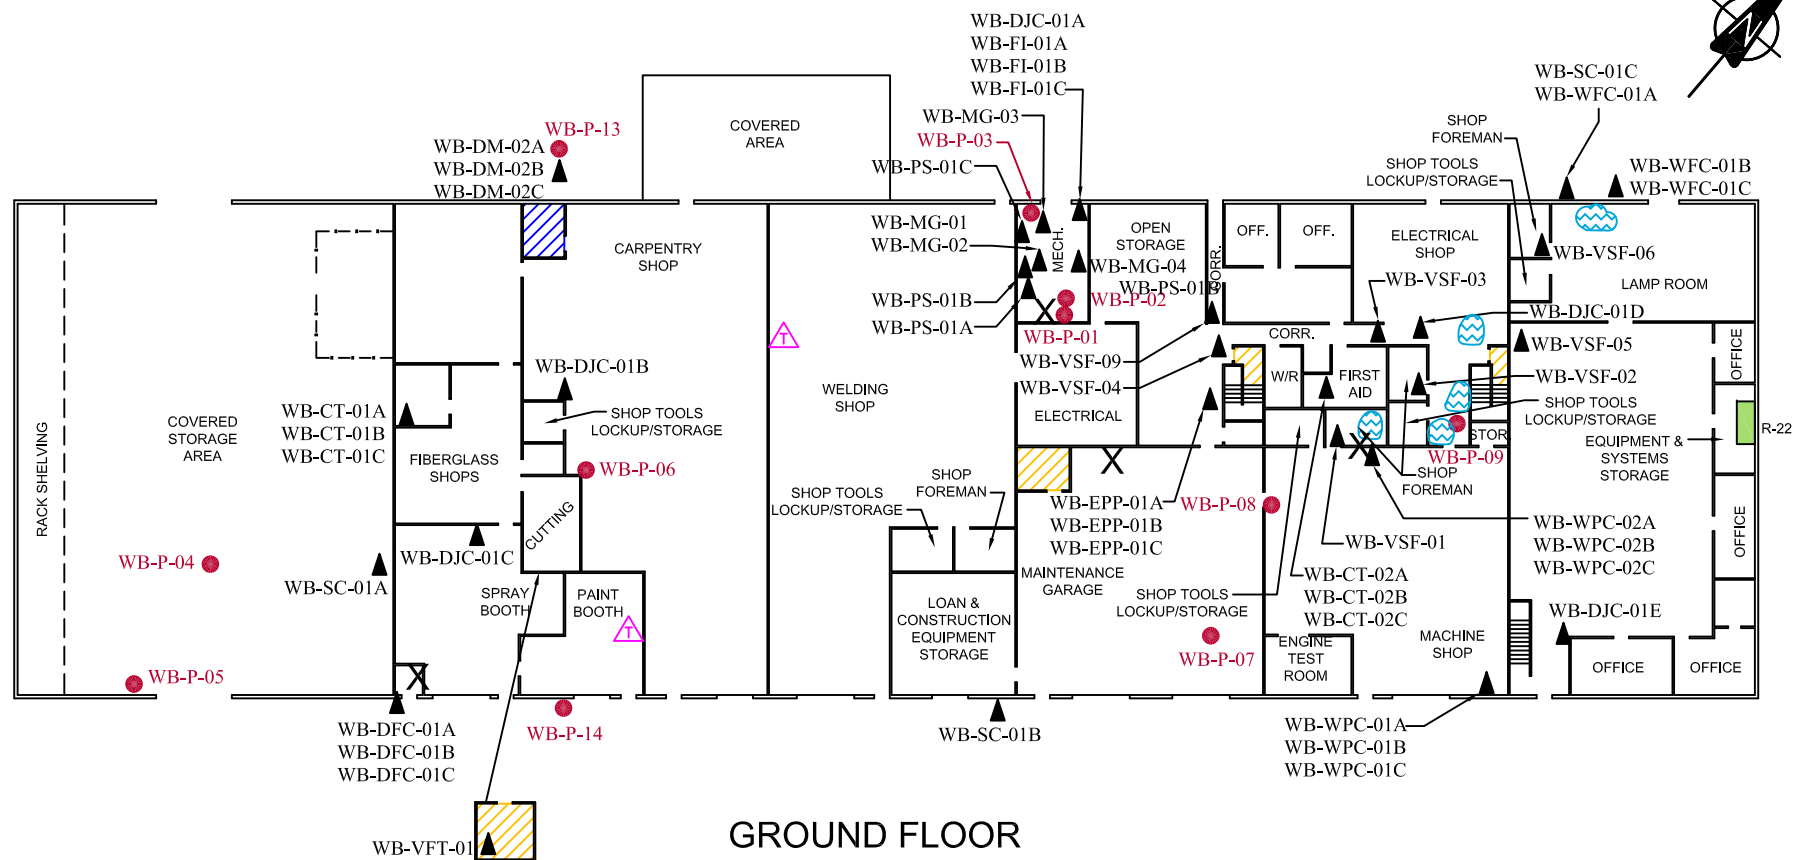
**GROUND FLOOR
WORKSHOP BUILDING**

- Remove and dispose of moisture impacted ceiling tiles with new tiles. If staining re-appears on the new tiles, the source of moisture should be identified and corrected.
 - This work can be conducted by regular facility maintenance staff, if conducted prior to the onset of mould growth
