Hazardous Building Materials Assessments

6 Buildings/Structures at the Victoria
Coast Guard Base, 25 Huron Street,
Victoria, BC

March 18, 2019

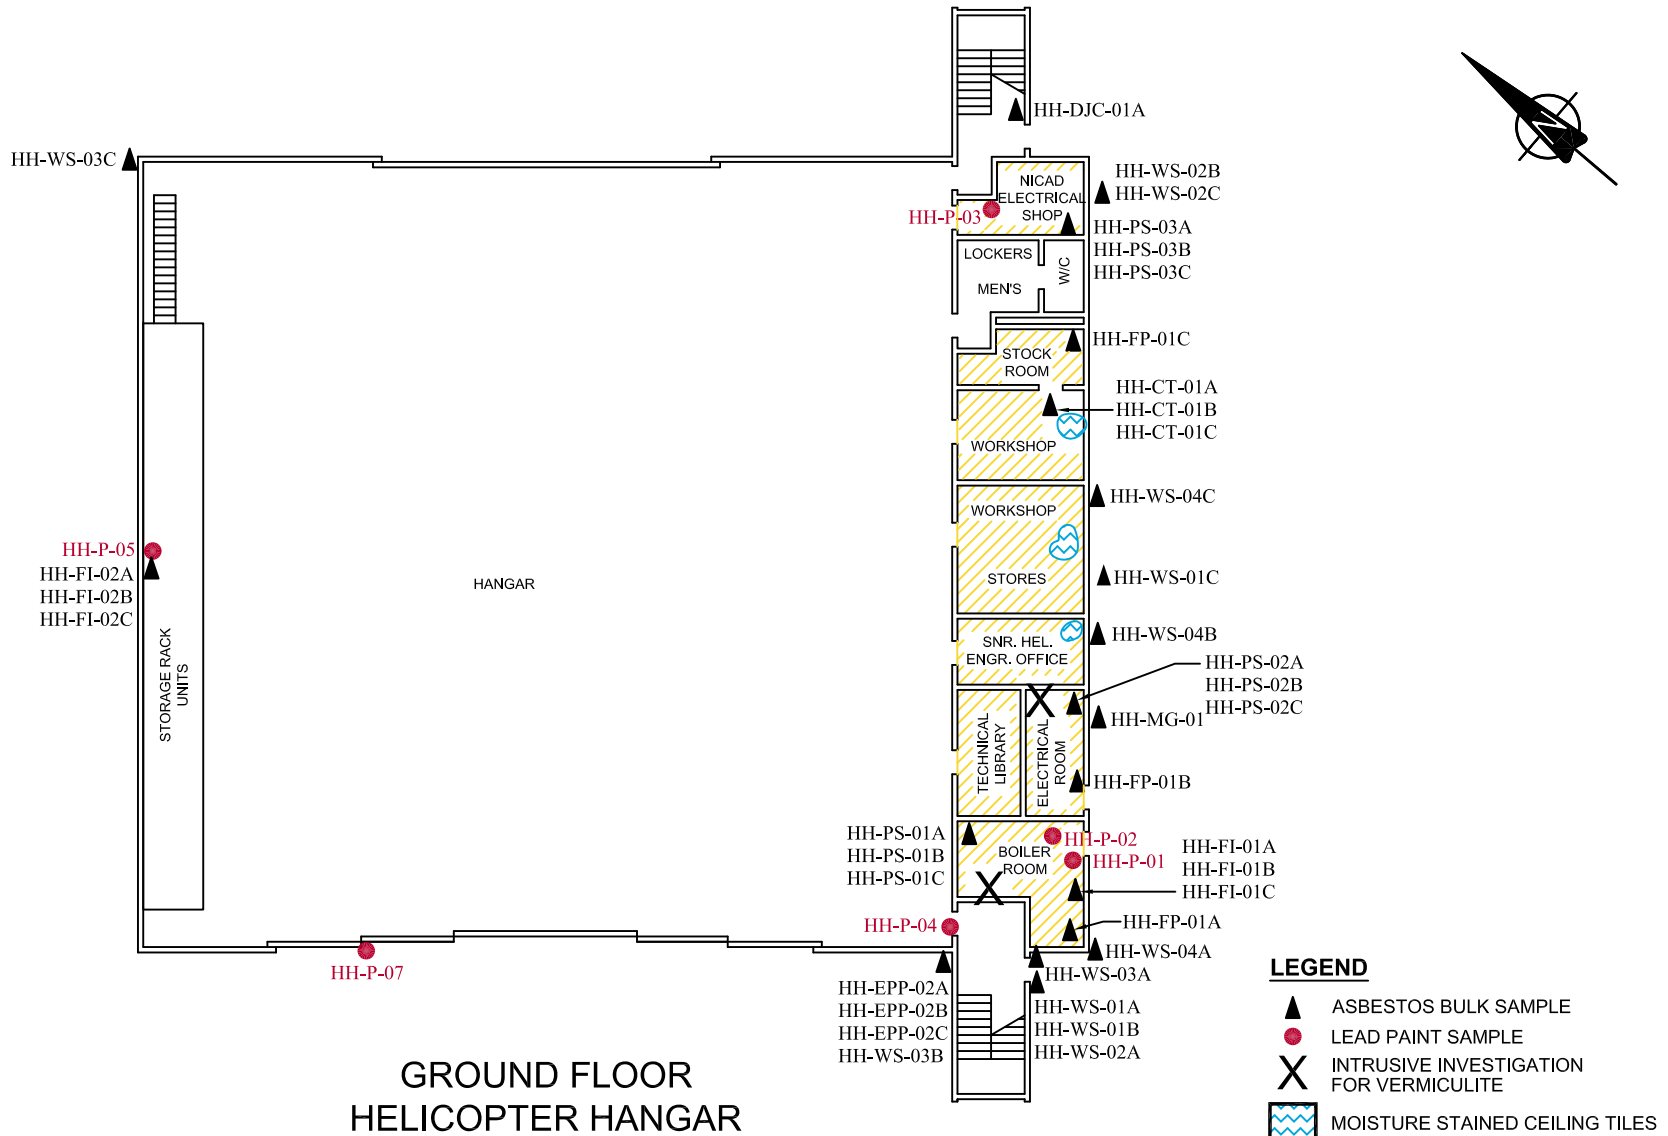
**GROUND FLOOR
HELICOPTER HANGAR**

- NOTES:** 1. GREY WALL SEALANT APPLIED TO EXTERIOR CONCRETE VERTICAL SEAMS IS ASBESTOS-CONTAINING.
 2. BLACK WINDOW PANE CAULKING THROUGHOUT IS ASBESTOS-CONTAINING.
 3. THIS DRAWING ILLUSTRATES SUPPORTING INFORMATION SPECIFIC TO A STANTEC CONSULTING LTD. REPORT AND MUST NOT BE USED FOR OTHER PURPOSES.

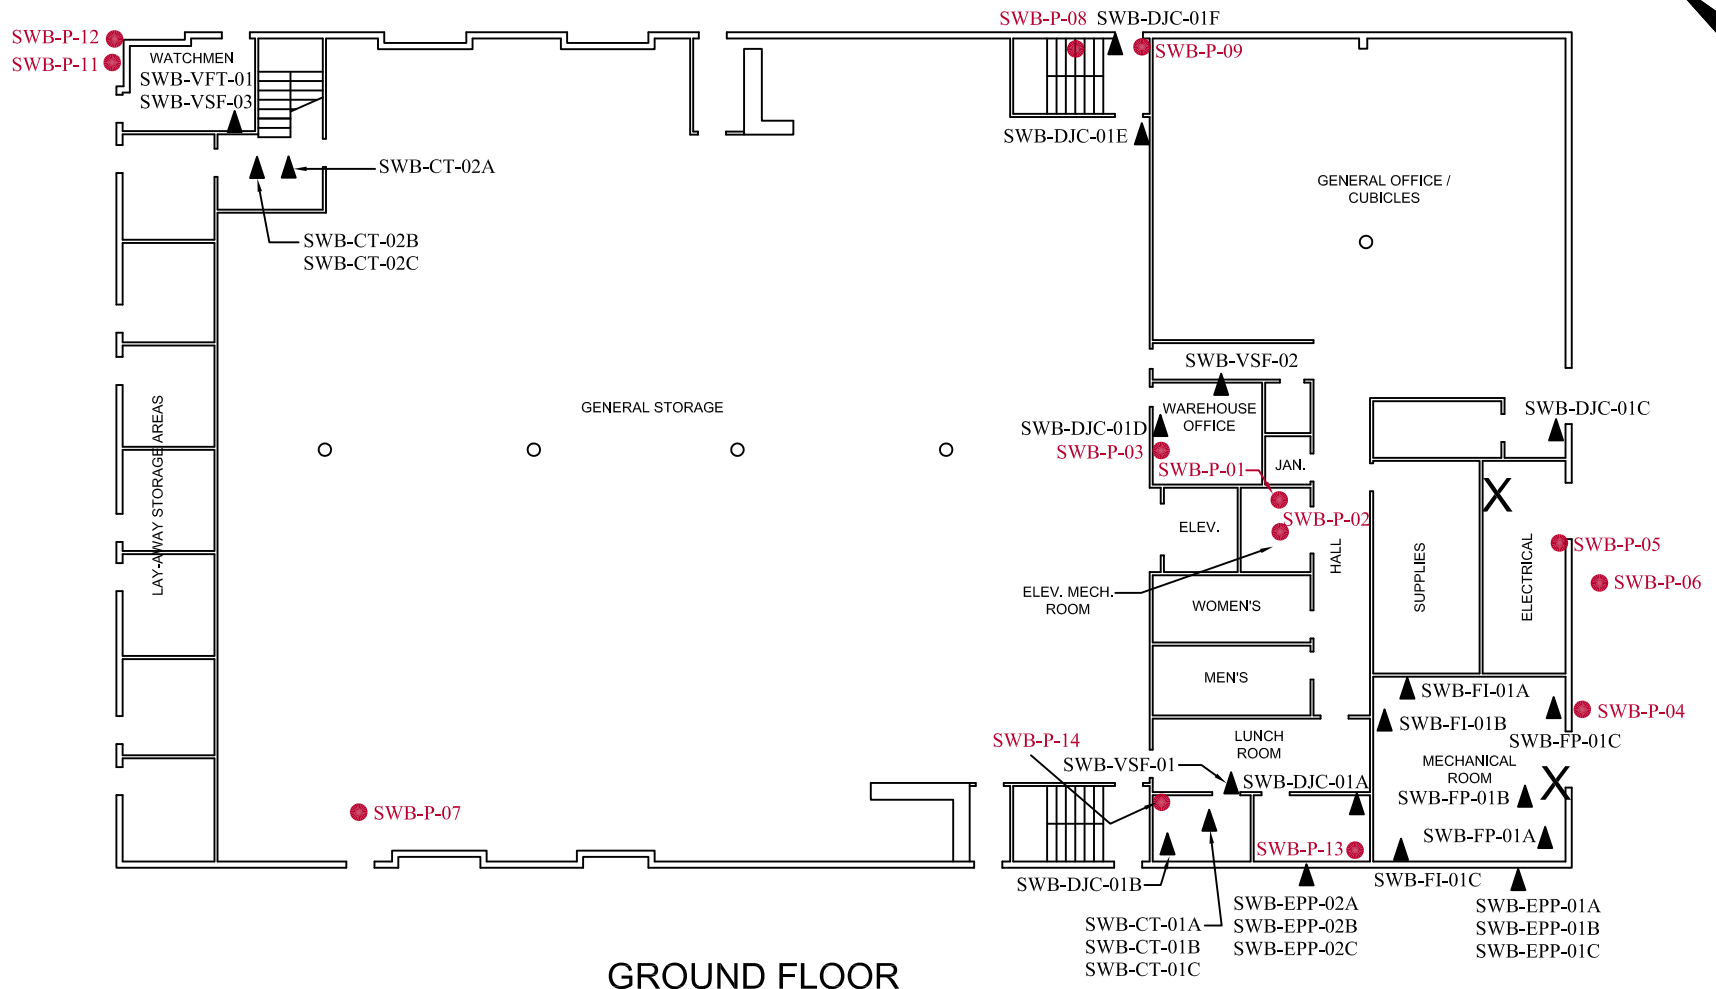
**GROUND FLOOR
STORES/WAREHOUSE BUILDING**

NOTES: 1. DRYWALL JOINT COMPOUND APPLIED TO WALLS AND CEILINGS THROUGHOUT IS ASBESTOS-CONTAINING.
2. THIS DRAWING ILLUSTRATES SUPPORTING INFORMATION SPECIFIC TO A STANTEC CONSULTING LTD. REPORT AND MUST NOT BE USED FOR OTHER PURPOSES.

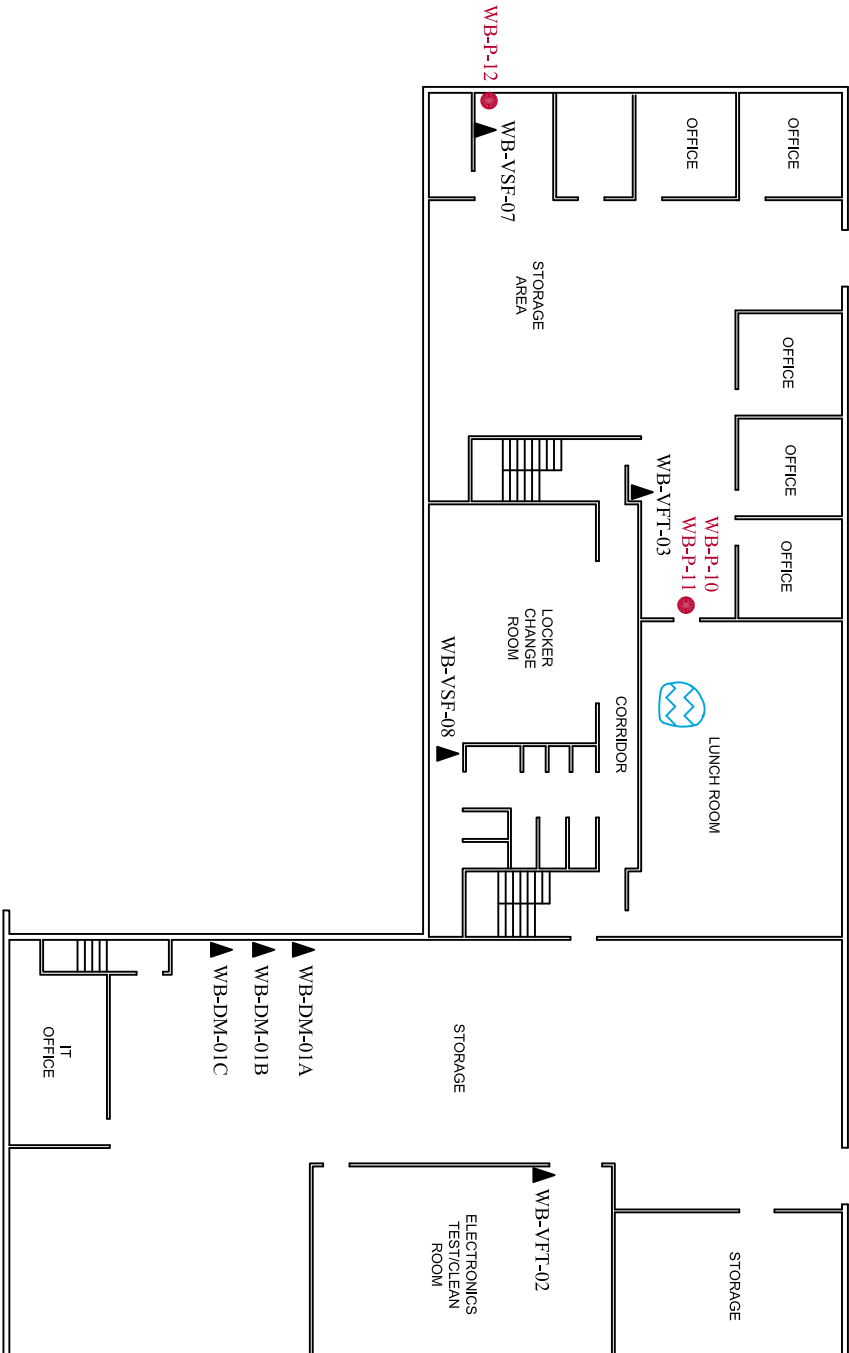
**MEZZANINE
WORKSHOP BUILDING**

- NOTES:**
1. GREY WINDOW PANE CAULKING APPLIED TO WINDOWS THROUGHOUT IS ASBESTOS-CONTAINING.
 2. BLACK MECHANICAL GASKETS ON PIPE FLANGES THROUGHOUT IS ASBESTOS-CONTAINING.
 3. THIS DRAWING ILLUSTRATES SUPPORTING INFORMATION SPECIFIC TO A STANTEC CONSULTING LTD. REPORT AND MUST NOT BE USED FOR OTHER PURPOSES.
