**RCMP Anahim Lake
Housing Renovations**

**Pre-Demolition Hazardous
Building Materials Assessment**

RCMP Mobile Home #4, 6665 Christensen
Road, Anahim Lake, BC

September 16, 2019

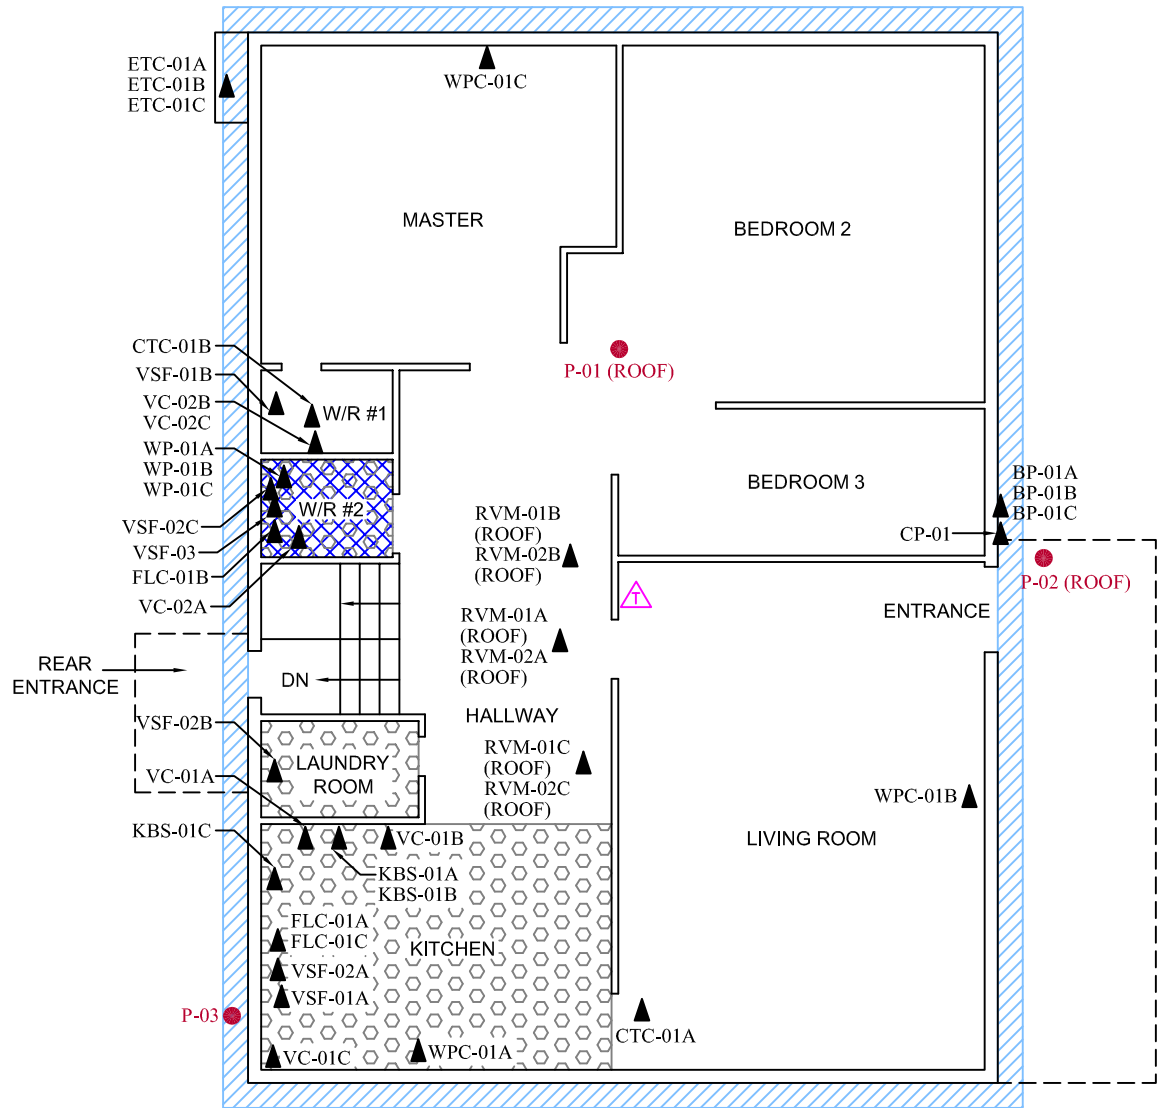
MOBILE HOME #4 - MAIN FLOOR

NOTES: 1. BLACK STICKY WINDOW PANE CAULKING APPLIED BETWEEN WINDOW GLASS AND FRAMES ON WINDOWS THROUGHOUT IS ASBESTOS-CONTAINING.
 2. GREY MASTIC APPLIED TO PERIMETER SEAMS OF ROOFTOP VENTS IS ASBESTOS-CONTAINING.
 3. THIS DRAWING ILLUSTRATES SUPPORTING INFORMATION SPECIFIC TO A STANTEC CONSULTING LTD. REPORT AND MUST NOT BE USED FOR OTHER PURPOSES.

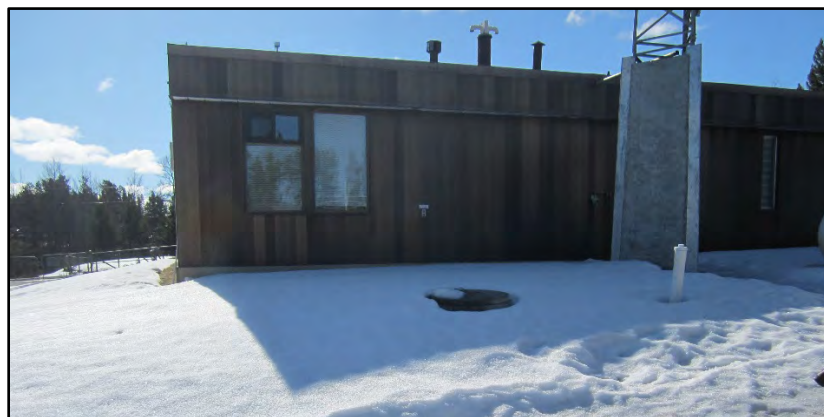
Figure 1: Septic Tank Lid and Cleanout

The ex-detachment and two mobile homes have individual septic systems consisting of septic tanks and fields. The two systems servicing the mobile homes were not inspected as these will be decommissioned when mobile homes are removed. The ex-detachment has a septic tank and field located to the north of the building. Approximate locations shown on C-001 are based on as-built information from 1983.01.15 As-Built Drawing (see Figure 2 attached at the end of this report). The approximate septic tank locations are supported by visual findings of tank covers. There were no above ground indications of septic disposal fields, therefore as-built drawings were assumed correct for design purposes. There is a white PVC cleanout pipe located north of the building between the building and septic tank.

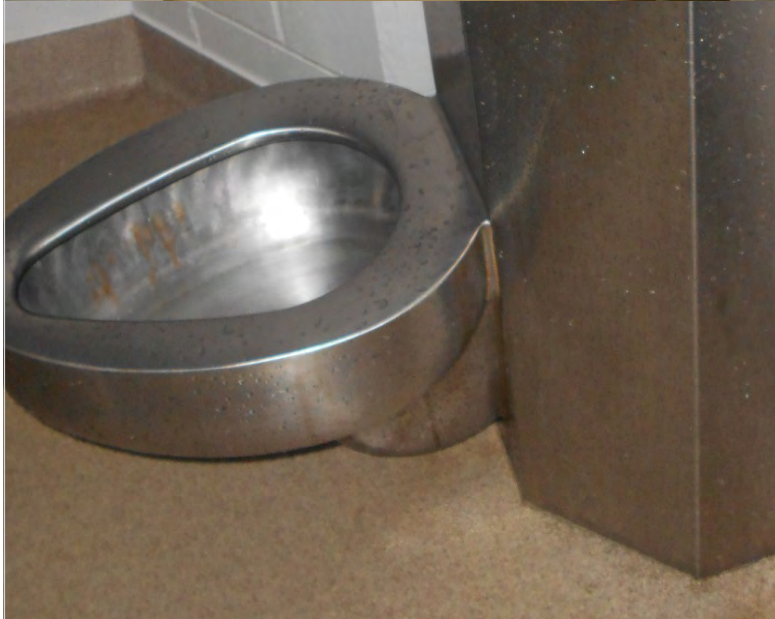
some staining on toilets

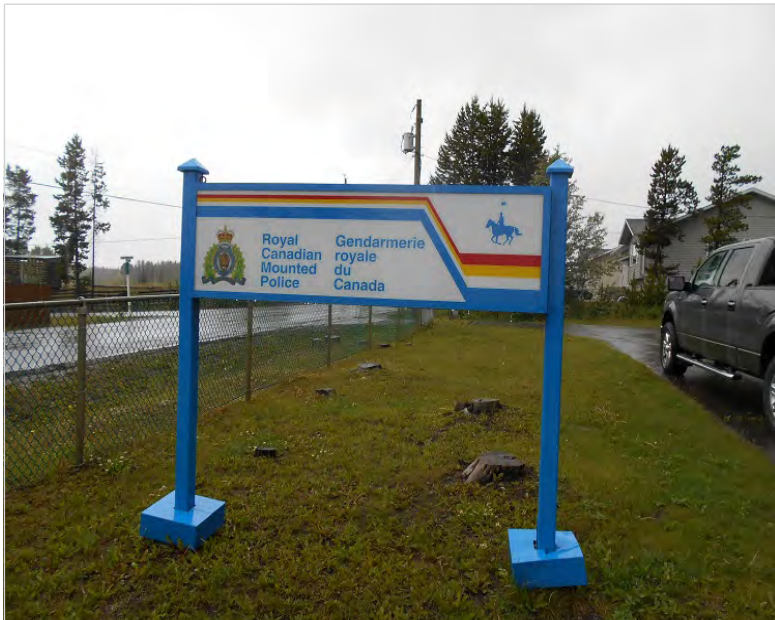
some stumps in the front of the compound

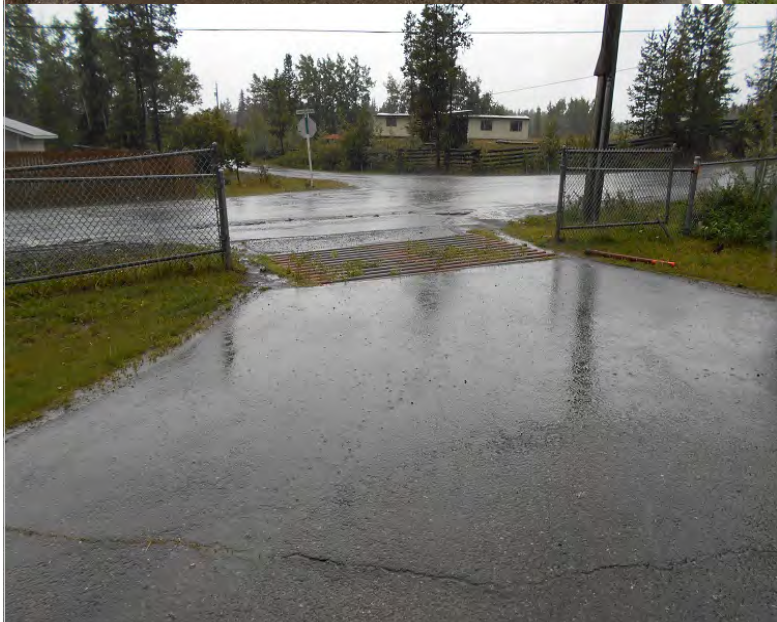
minor asphalt cracking and undersized cattle guard

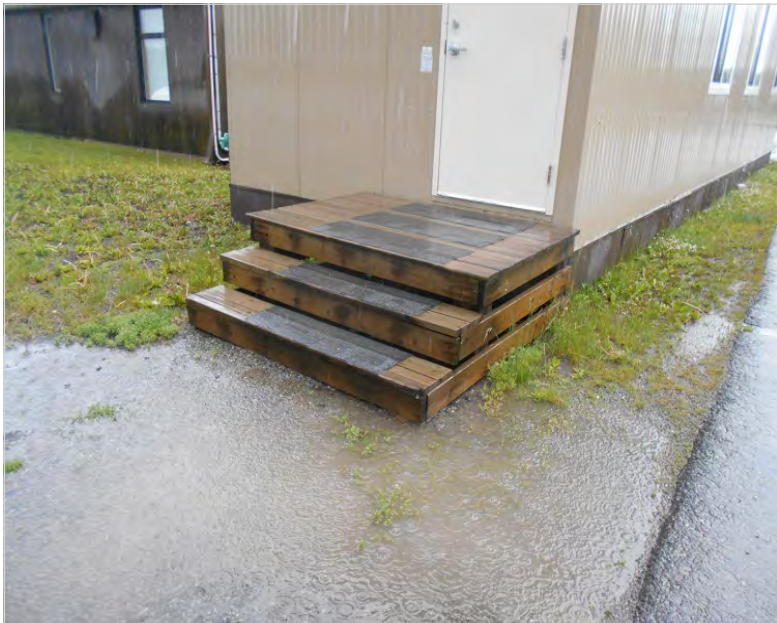
large puddle at foot of small deck

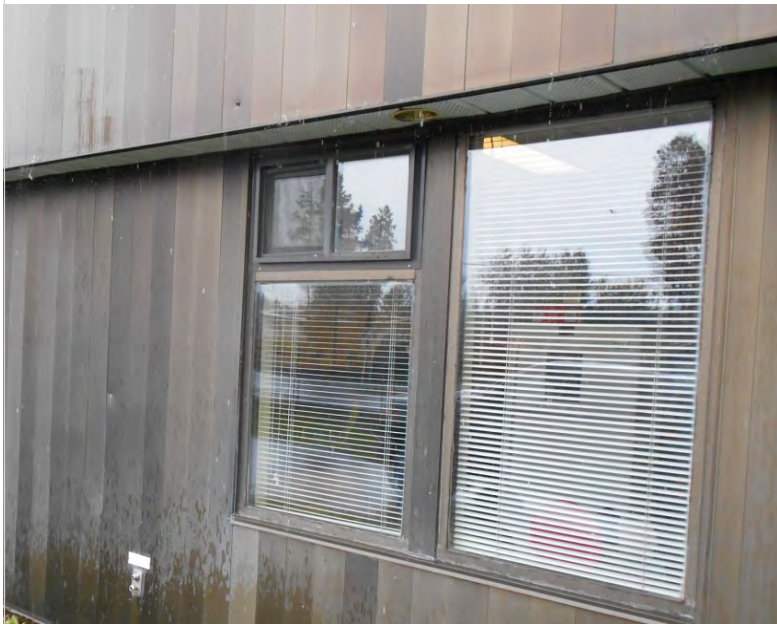
3 - Satisfactory condition-reliable N The main buildings windows are anodized aluminum in wor MEDIUM

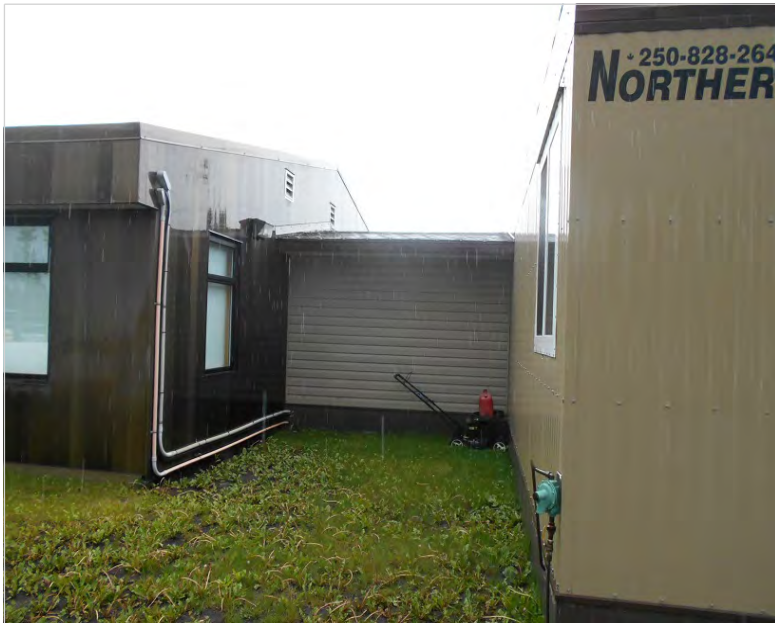
Building Exterior 91270-80-800-000001		3 - Satisfactory condition-reliable N	Varies types of siding exist here- the main building utilize	MEDIUM					
---------------------------------------	--	---------------------------------------	--	--------	--	--	--	--	--

vinyl siding shown

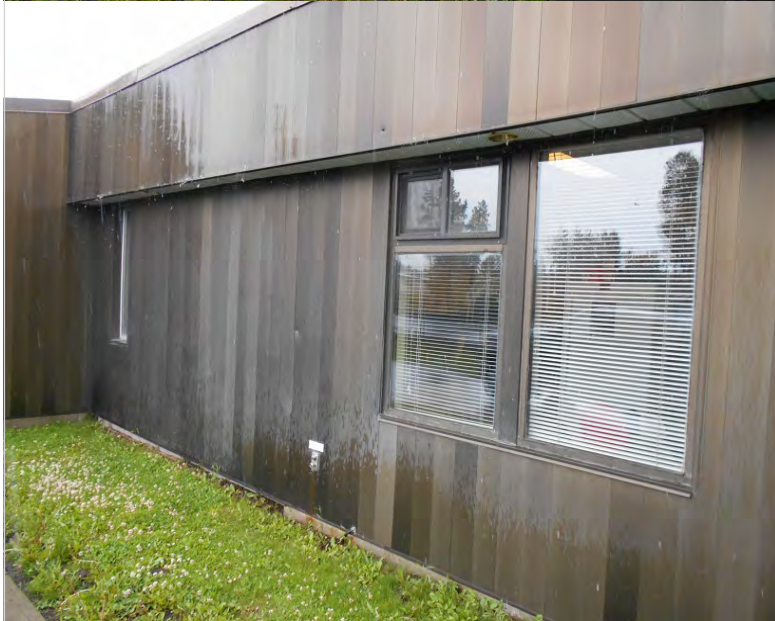
anodized metal on the main building

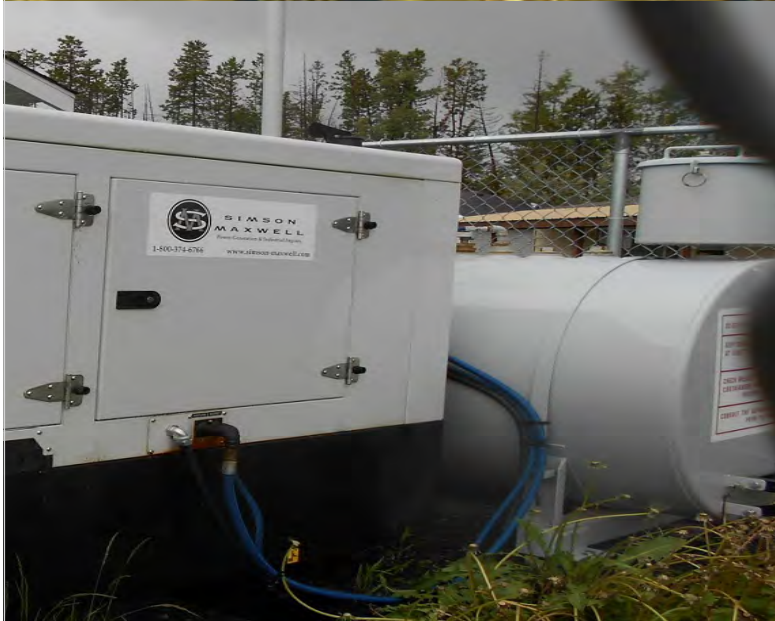
Fuel Storage System - AST - <2500L 91270-72-498-00000 inside fenced compound 3 - Satisfactory condition-reliable N Generator diesel fuel tank is an above ground "Tidy Tank" MEDIUM

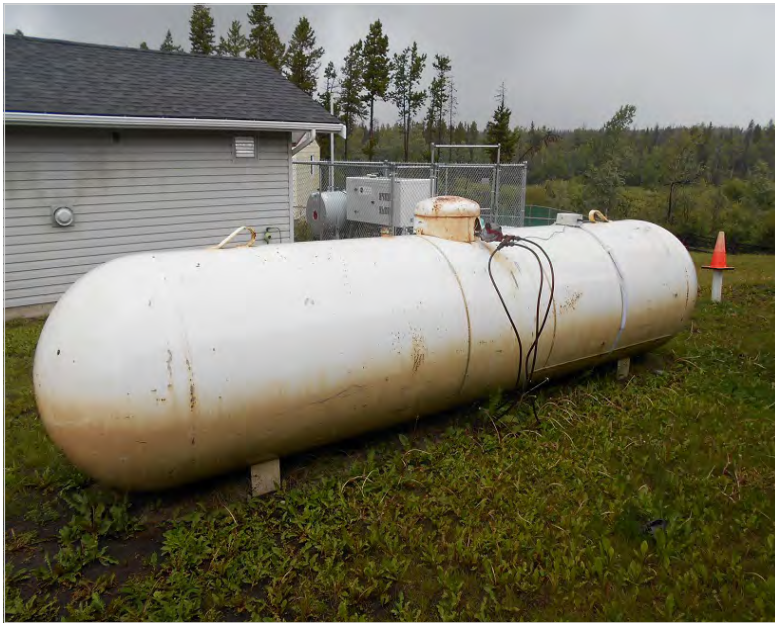
Fuel Storage Tank - Propane-Natural Gas 91270-73-497-00	North of Building	3 - Satisfactory condition-reliable N	Propane tank 1000G remains the property and responsibility	MEDIUM
---	-------------------	---------------------------------------	--	--------

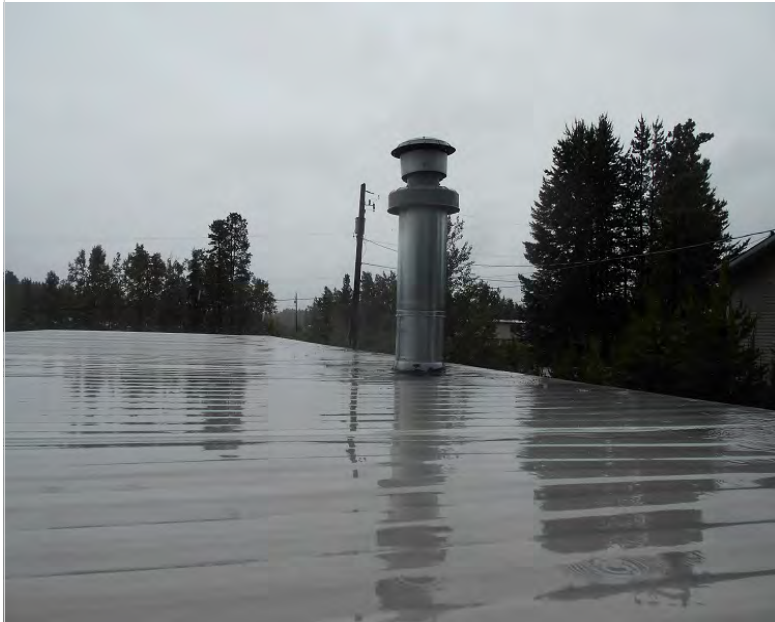
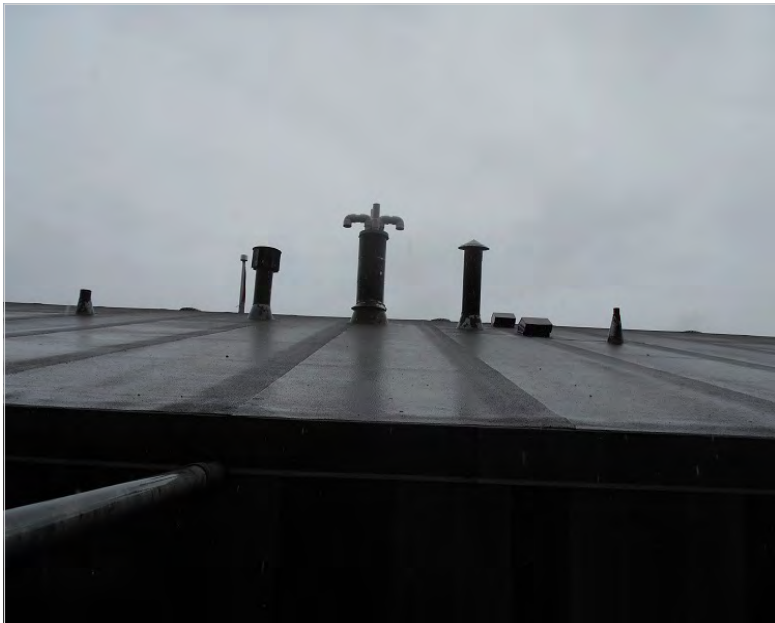
Chimneys and Stacks [F1] Furnace Closet 3 - Satisfactory PVC venting off of high eff. MEDIUM
91270-80-810-000001 condition-reliable N furnaces exits up through old

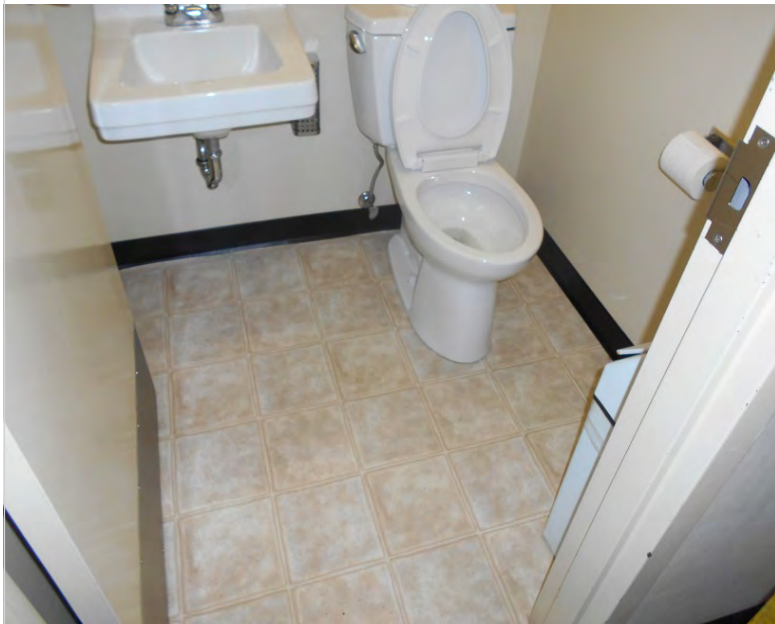
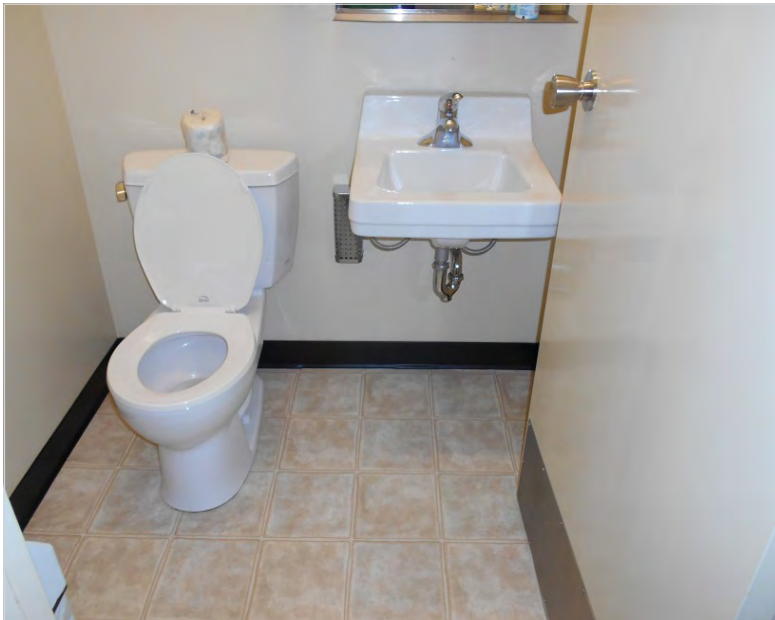
Washrooms 91270-99-989-000001 3 - Satisfactory condition-reliable N Mechanically washroom are in good working order no issues MEDIUM

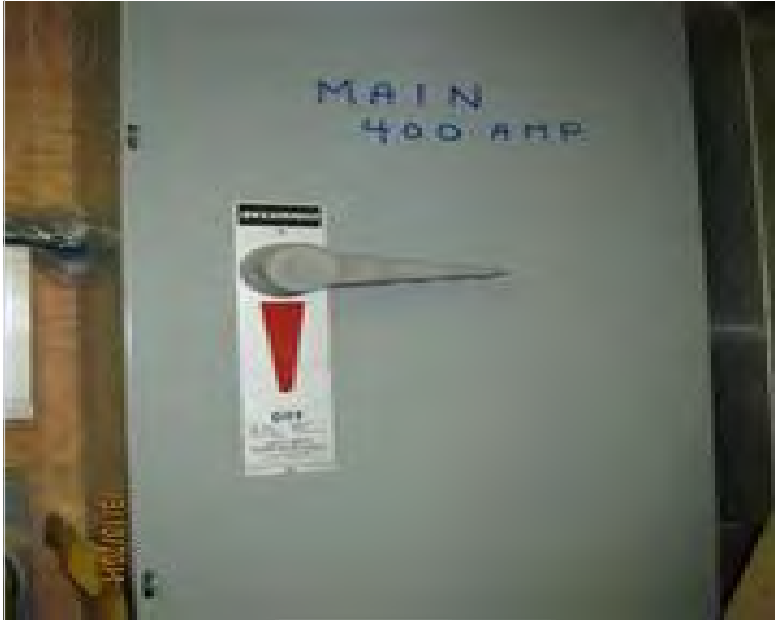
Disconnect - Main #1 (MAIN 3) 91270-05-205-00001	Hall Electric Closet	3 - Satisfactory condition-reliable N	Sylvania 400 amp service. Disconnect Cat#A5022N. No s	MEDIUM					
--	----------------------	---------------------------------------	---	--------	--	--	--	--	--

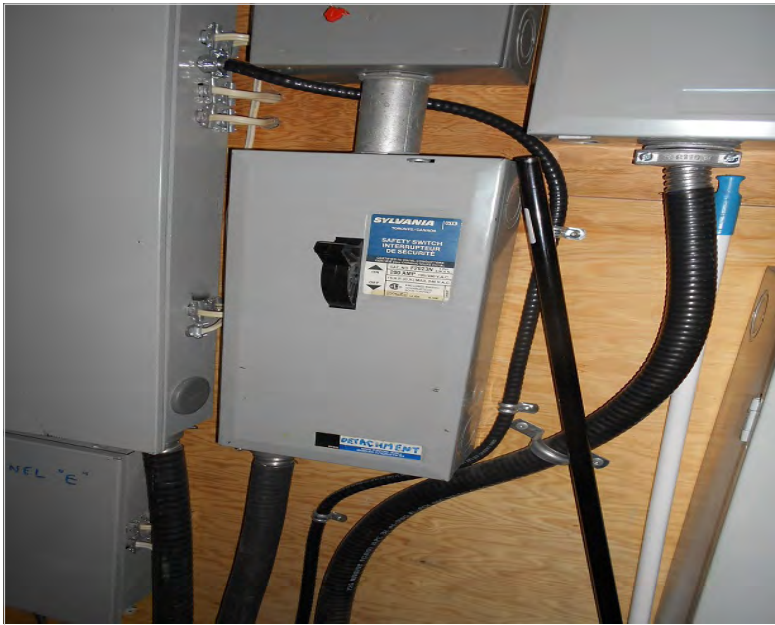
Disconnect - Main #2 91270-05-205-00002	Hall Electrical Closet	3 - Satisfactory condition-reliable N	Panel A-Sylvania 200amp. Cat#40200.	MEDIUM					
---	------------------------	---------------------------------------	-------------------------------------	--------	--	--	--	--	--

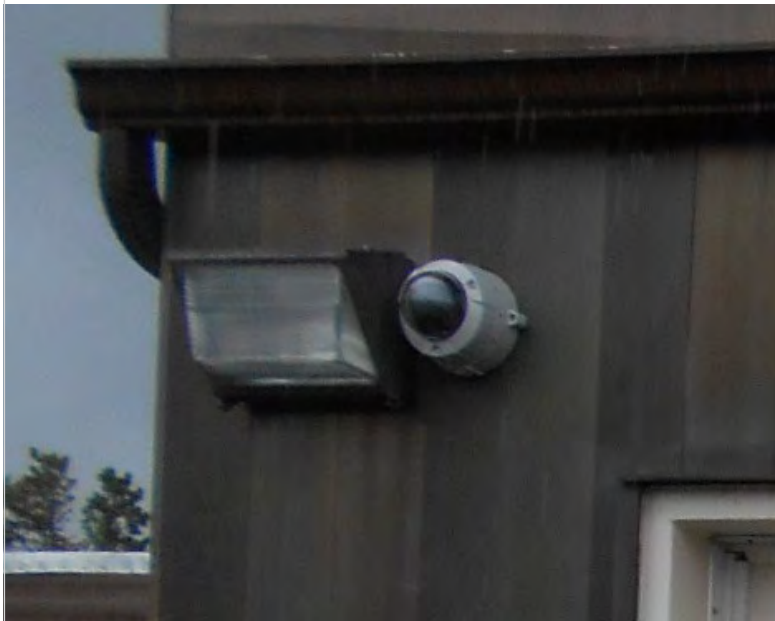
Lighting Exterior 91270-05-380-000001 3 - Satisfactory condition-reliable N Exterior lighting checked and working @ time of inspection MEDIUM

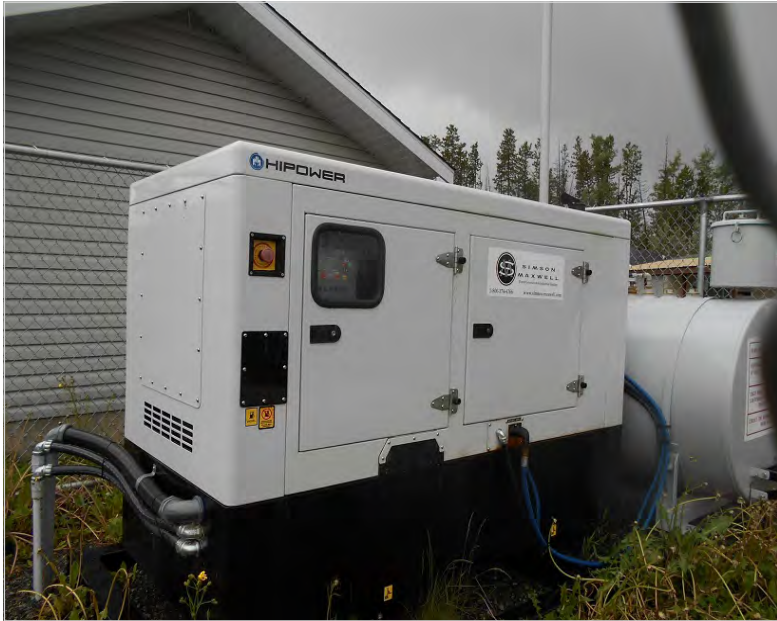
Standby Generator none FL&S 91270-10-251-000001 Inside fenced compound 3 - Satisfactory condition-reliable N Generator located behind detachment in a small area se MEDIUM
