Building Condition Report - Winnipeg Tax Centre Site Winnipeg P600009A

66 Stapon
Winnipeg Tax Centre Site Winnipeg P600009A
P600009-101-60000321
Winnipeg
Construction Year: 1979
Gross Area (SM): 31,710
Date of Most Recent Assessment: 1/18/17

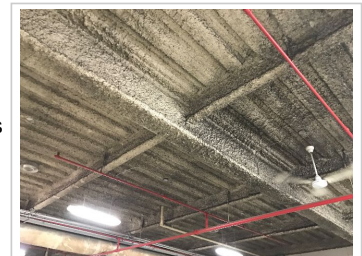
Frame - Concrete + Steel - Steel structure and deck

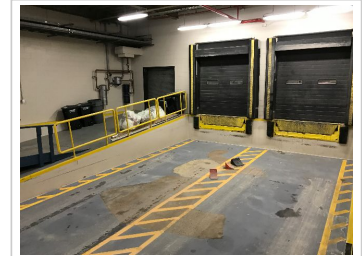
Slab above Grade - Concrete -
Concrete slab at loading dock

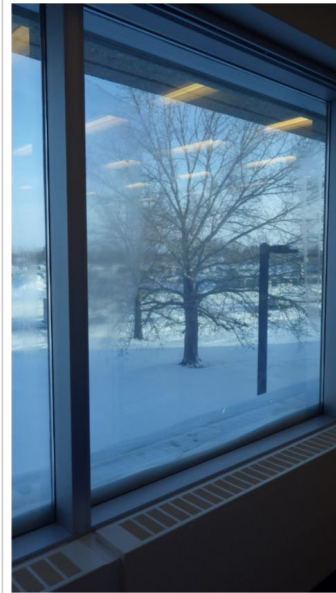
Aluminum Windows - Condensation build-up with-in the sealed glazing unit.

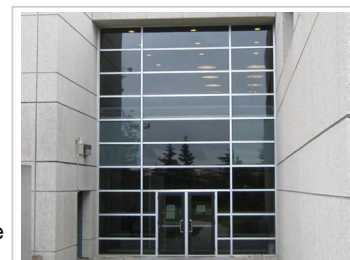
The aluminum door frames and sealed glazing units are 38 years in age, we recommend that they be replaced in 2024.

Oct.26-28 021 (Small).jpg - West side aluminum framed glazed doors.

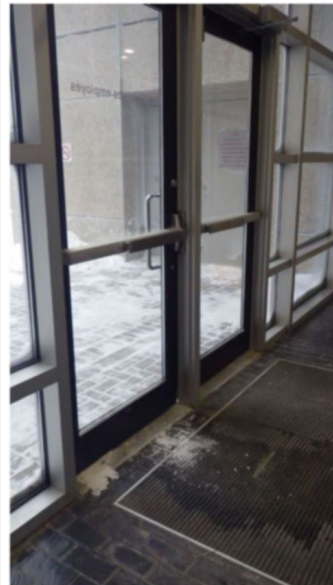
Glazed Doors - Glazed bronze aluminum doors at the west employee building entrance.

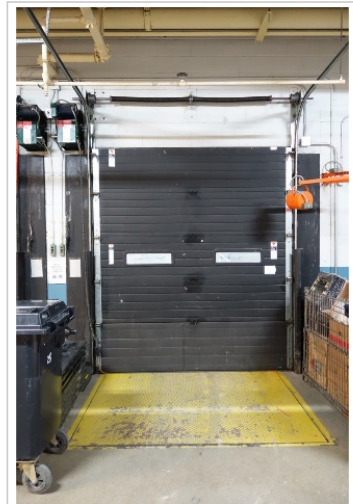
Doors and operators appear to be in average condition. The fire rated coiling doors of the shipping/receiving area are open in the day and closed at night and have fusible links for operation in a fire situation. It was reported that the coiling door at the loading dock was replaced approximately ten years ago. The anticipated replacement date for the remaining doors is 2022.

Overhead Door - Interior - View of interior overhead door from loading dock

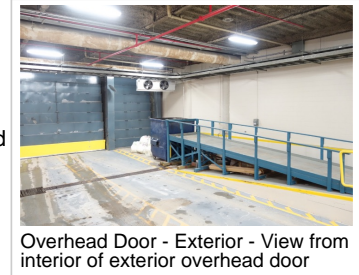
The doors and door operators appear to be in average condition. Continue repair and maintenance and replacement of parts can extend the anticipated life cycle beyond the 20 year BCR's event period to 2032.

Overhead Door - Exterior - View from interior of exterior overhead door

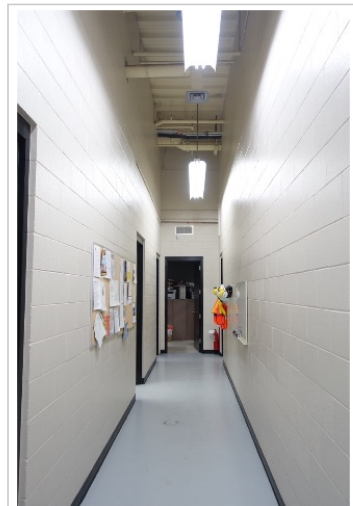
Appear to be in good condition. The walls are anticipated to last the life of the structure and beyond the 20 year budget period.

Concrete Block Partition - Typical concrete block interior wall

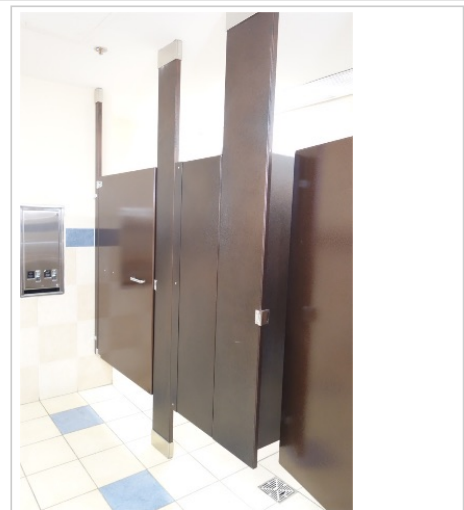
Washroom Partitions - Typical interior washroom partition

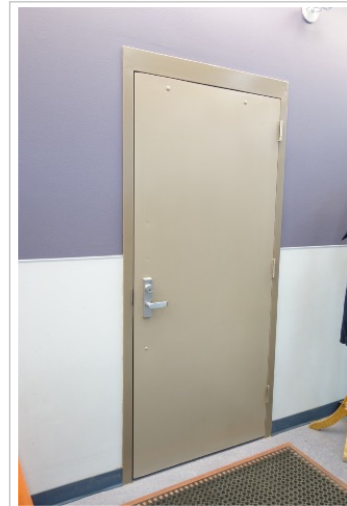
The doors, frames and hardware are generally in good condition. Some doors have been replaced. (computer lab) The anticipated replacement date is 2039.

Replace hollow metal doors and frames - Typical interior metal door and frame

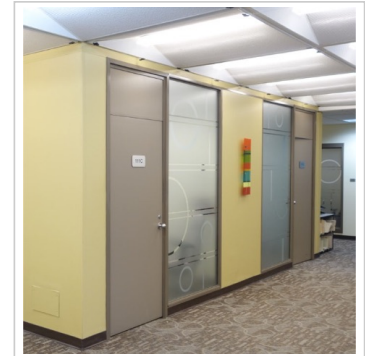
Interior doors, frames and other miscellaneous metal finishes. - Typical interior metal doors and frames

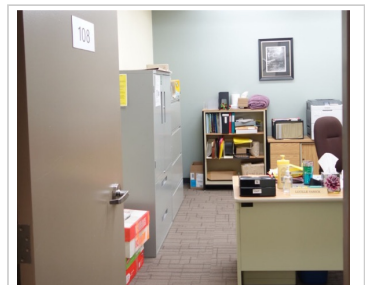
Interior Door Hardware - Typical interior door hardware

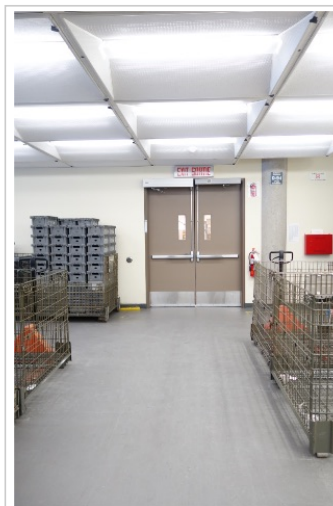
The door hardware will reach their anticipated life cycle. Generally the existing hardware is in good condition. Anticipated date of door hardware replacement is 2029.

Replace interior hardware on metal doors - View of Interior Door with panic hardware

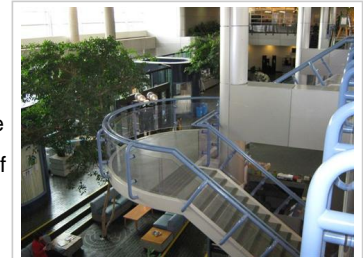
The stairs are in good condition and with regular maintenance shall last the life of the building. Some of the maintenance that is required includes either replacement or re-gluing of the tread and riser finishes (resilient flooring) as well as the stair nosing which is a code requirement. No replacement of the stair structure is offered.

Oct.26-28 066 (Small).jpg - The central feature staircase in the lobby.

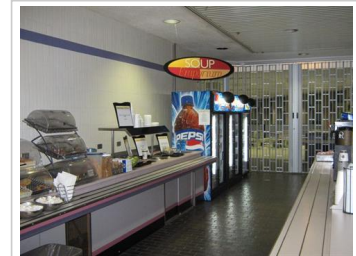
The ceramic wall tiling appears to be in good condition. It was reported the wall tiling in the washrooms was replaced approximately ten to fifteen years ago. The anticipated replacement date is 2029.

Oct.26-28 106 (Small).jpg - Ceramic wall tiling in the food service areas of the cafeteria.

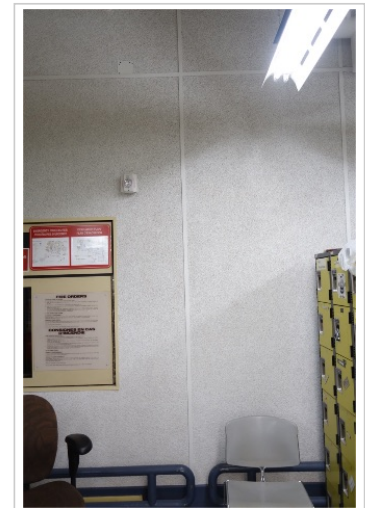
The vinyl covering is generally in good condition. In some areas, rather than recover or replace the vinyl, it was painted over. Unless there is a decor change or office layout rearrangement, it is not anticipated that the vinyl wall coverings will be replaced. As such, no event is included.

Vinyl Wall Covering - Typical interior vinyl wall covering

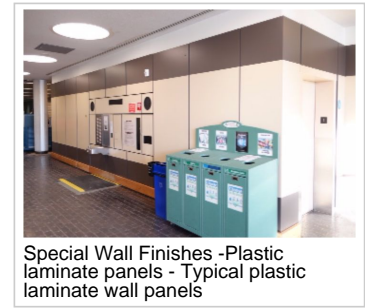
The building interior utilizes durable material finishes throughout and appear to be in fair condition. However normal wear and use have caused some small, localized damage to areas. Some panels have been painted. The anticipated replacement date is 2026.

Special Wall Finishes -Plastic laminate panels - Typical plastic laminate wall panels

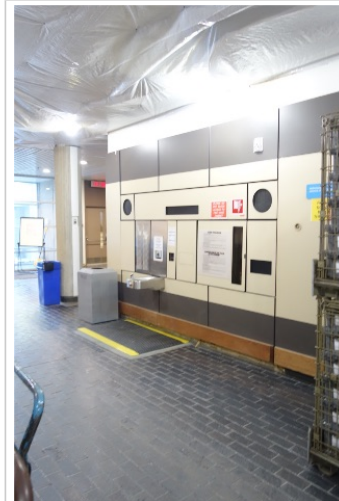
Special Wall Finishes -Plastic laminate panels - Typical plastic laminate wall panels

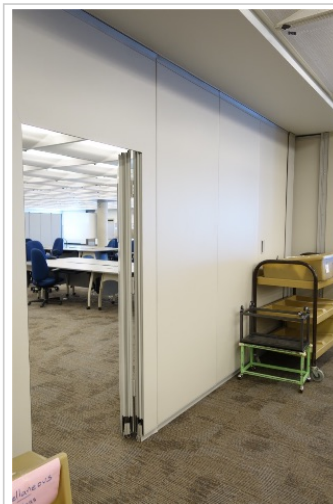
The partition is in good condition. The anticipated replacement date is 2029.

Special Wall Finishes- Folding Partition - Typical interior folding partition

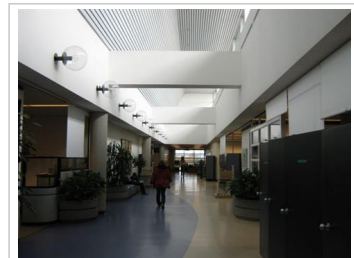
Linoleum has been replaced in the stairwells.

Oct.26-28 058 (Small).jpg - A variety of interior finishes, note the central second level corridor linoleum flooring.

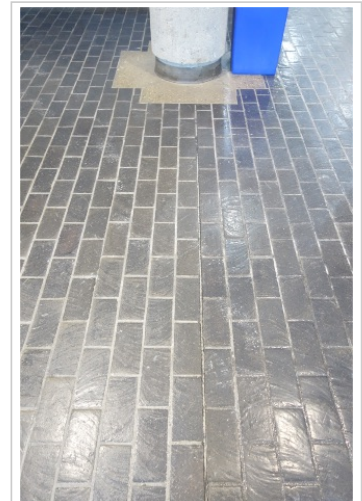
The floor tiles appear to be in average condition. It was reported the floor tiles were replaced with Ceramic Floor tiles in the washrooms approximately ten to fifteen years ago. The anticipated replacement date is 2055.

Quarry Tile Floor - Quarry tile in main floor corridor

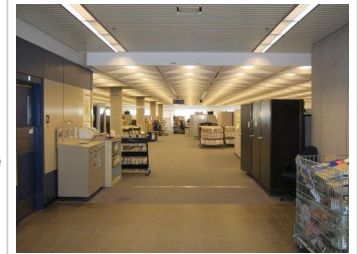
Oct.26-28 075 (Small).jpg - A variety of interior finishes, note the carpet tiles in the office area.

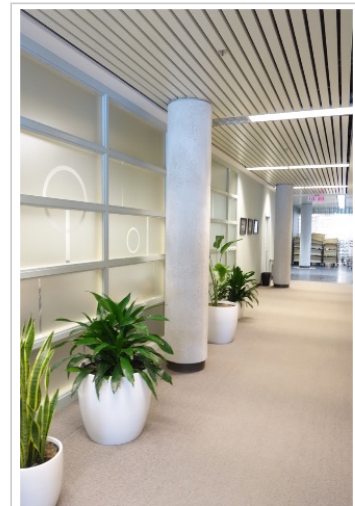
Carpeting - Carpet tile in corridor

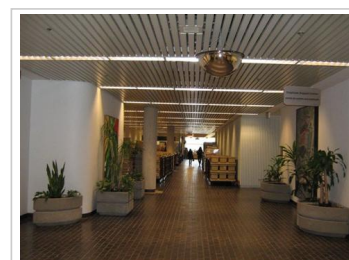
The linear ceiling is generally in good condition. With regular maintenance and repair it will not require replacement within the 20 year budget period. It should be noted that some Linear Metal Ceiling was stained at the East and West end of the main corridor.

Oct.26-28 098 (Small).jpg - The linear metal ceiling of the main level central corridor.

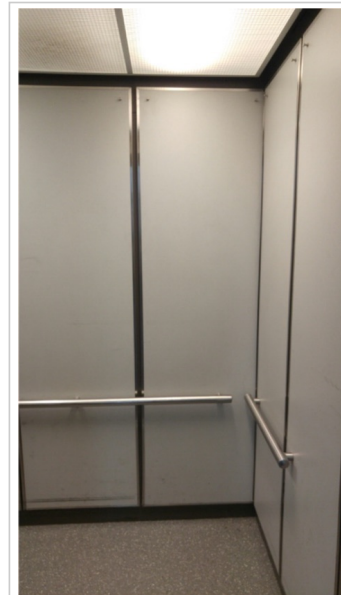
Upgrade both elevators - doors & cylinders - Elevator #2 Interior Cab

PW126911 raised/ Shelf Ready/Project includes new door operator and new controller. Regular PM being conducted and will continue to assess.

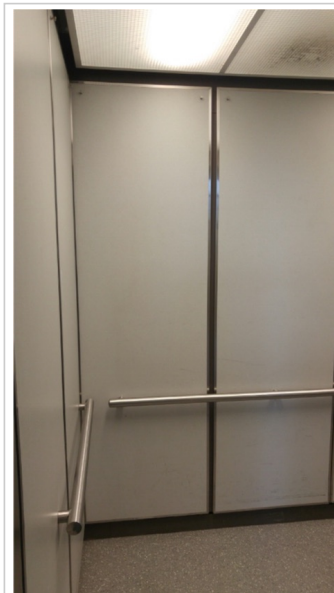
Upgrade both elevators - doors & cylinders - Elevator #1 Interior Cab

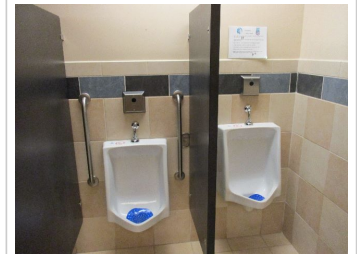
Plumbing Fixtures and Accessories - Washrooms - Urinal with auto-flush - representative of average unit

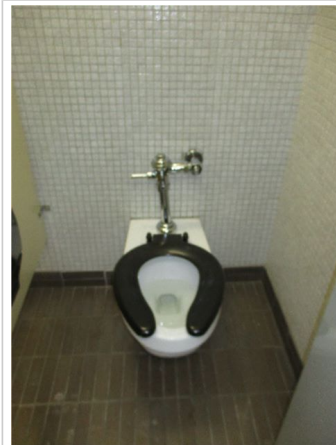
Plumbing Fixtures and Accessories - Washrooms - Maintenance staff WC-basement

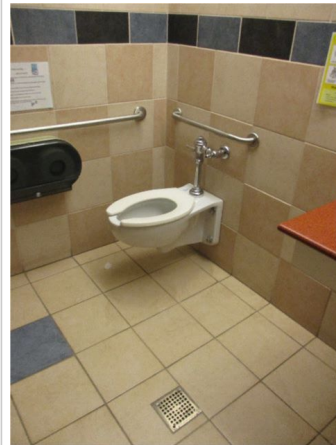
Plumbing Fixtures and Accessories - Washrooms -
Typical fixture - office area

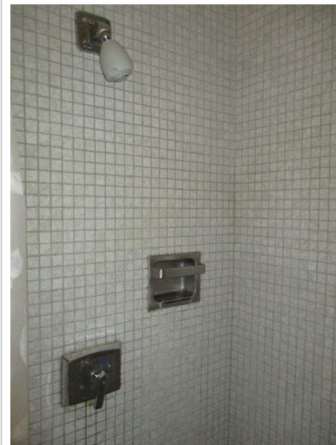
Plumbing Fixtures and Accessories - Washrooms -
Mechanical staff shower-basement

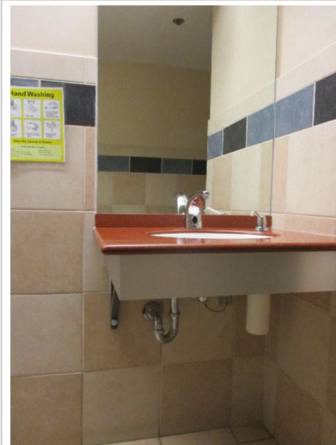
Plumbing Fixtures and Accessories - Washrooms -
Fixture on main floor

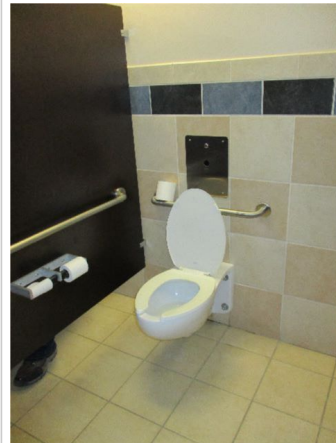
Plumbing Fixtures and Accessories - Washrooms -
Typical fixture in office areas.

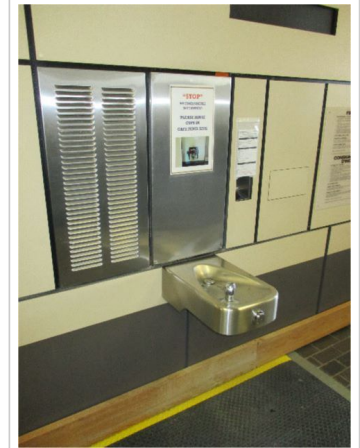
Water Coolers - Wall-Mounted - Typical - original unit - R12 refrigerant

Replace existing water coolers with new dual-height refrigerated stations.

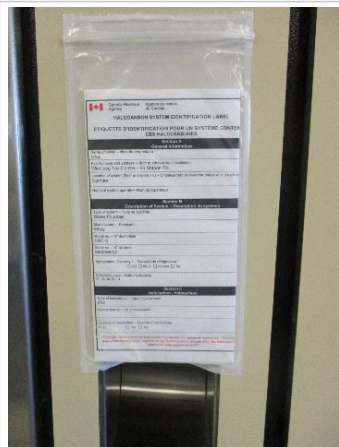
Water Coolers - Wall-Mounted - Posted information of R-12 refrigerant at fountains

A refrigerant leak would be a violation of the Federal Halocarbon Regulations (2003). Effective Jan 1, 2005, small refrigeration systems are not allowed to be charged, a failure of the fountain refrigeration system would not be rechargeable.

Replace existing drinking fountains with new dual height stations with integral bottle filling stations.

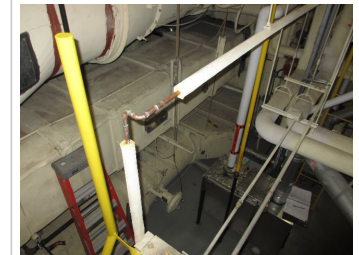
Water Dist Complete - Average - exposed section of copper DCW

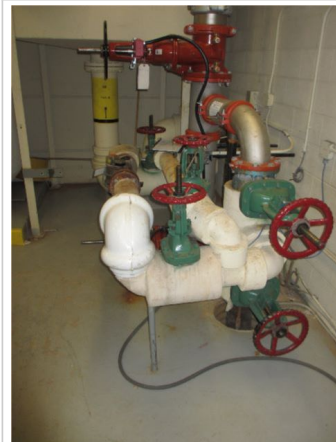
Water Dist Complete - Average - Utility connection

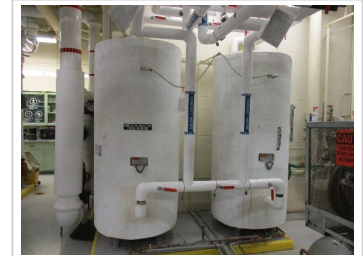
The storage tanks are beginning to deteriorate with some evidence of rusting or leaking having occurred. No fresh leaks observed. Kitchen hot water tank (on the right) is valved off as kitchen is not currently in service. Copper piping connected to the bottom of the kitchen tank is corroding with evidence of previous leak issues.

Water Storage Tanks - DHW - Domestic water storage tanks

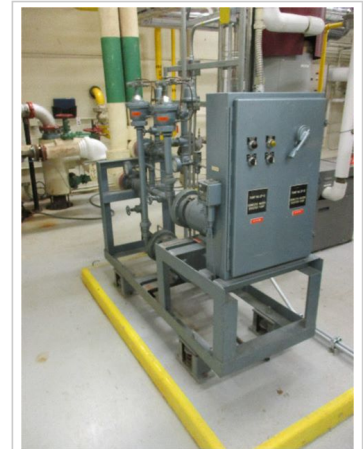
Booster pump system - Domestic Water - Basement Mechanical room: Both pumps are 30 years of age and do not appear to be used frequently. No issues observed.

Plumbing Pumps - Domestic Water Booster Pumps

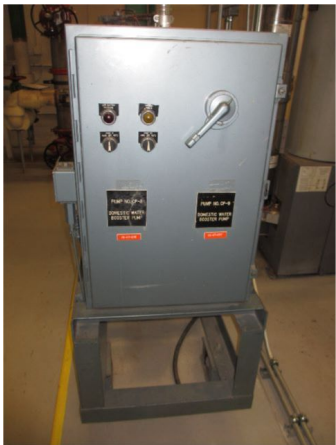
Plumbing Pumps - DCW booster control system

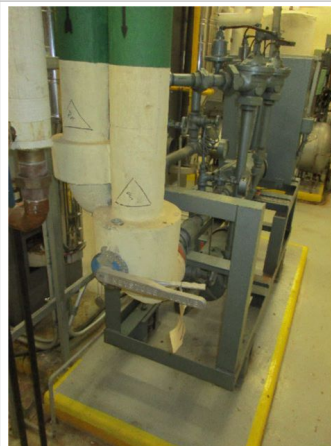
Plumbing Pumps - Domestic DCW Booster Pumps-
Basement mech rm

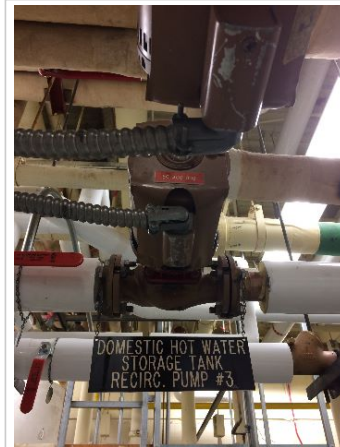
Replace 4 hot water circulator pumps - DHW pump 3

Four domestic hot water circulator pumps to be replace based on lifecycle schedule.

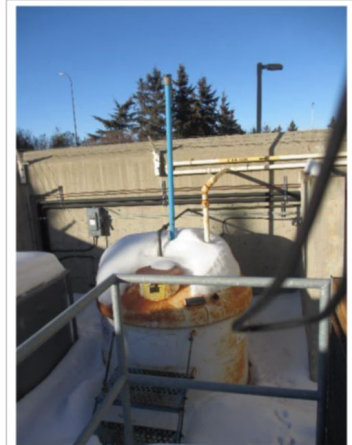
Exterior surface is showing signs of rusting and rusting on piping and fittings. Replace within 4 years.

Aboveground Fuel Tank - Steel - 2000 liter - Generator diesel fuel tank-2000 liter

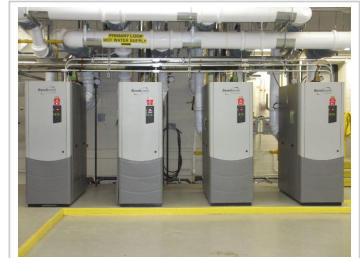
03.1A-050 Boilers - Heating system condensing boilers

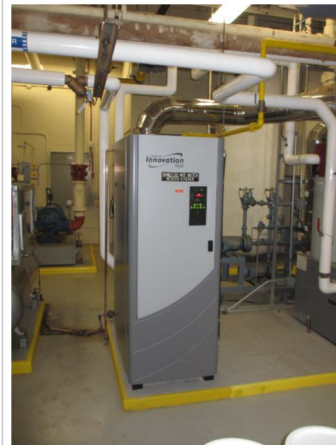
03.1A-050 Boilers - Heating system condensing boiler

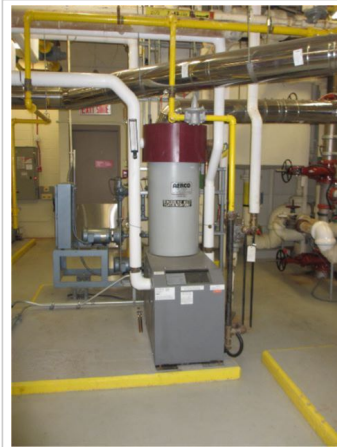
03.1A-050 Boilers - DHW boiler

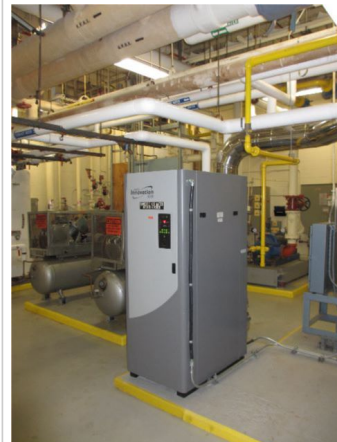
03.1A-050 Boilers - Heating system condensing boiler

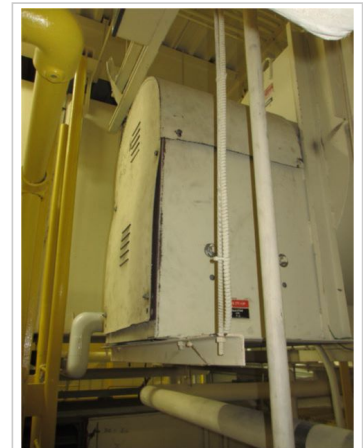
Ventilation Fans - F-18 (PH1)

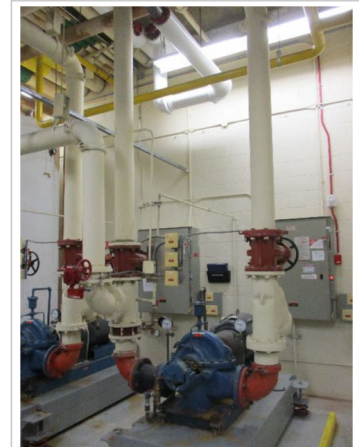
The Arthur Lietch company was sold out to Taco and parts may be difficult to source without an existing manufacturer's support.

Fire Pumps - Fire pump in mechanical room

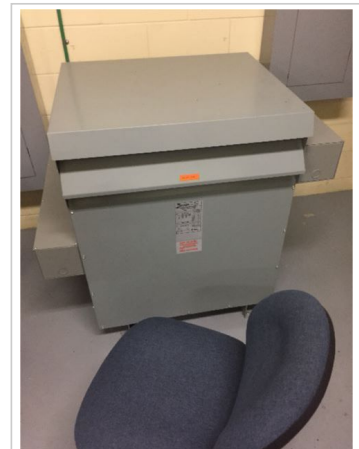
The transformers appear to be in good condition. Individual transformers will begin to experience failures and will be replaced over the next 10 to 30 years. The estimated cost for replacement is based on the replacement of all 11 transformers in 2029

Secondary Transformer -
600V-120/208V Transformer

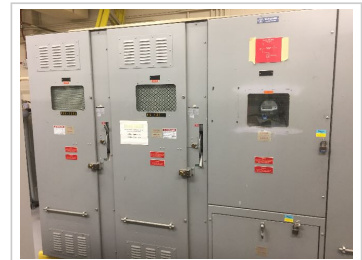
The primary switch gear is in good condition and should be tested on a regular basis. Equipment should last until 2044.

Primary Switch Gear - Primary Switchgear

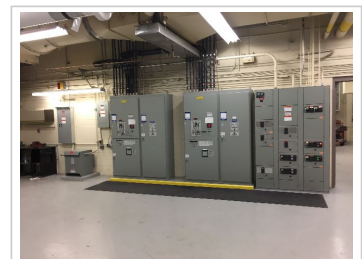
The Motor Control Centres are in good condition. Most of the MCCs are original with a new section added to the units in the 4 mechanical penthouses in 1996. Complete replacement of the MCCs is not anticipated although individual starters may require upgrading.

MCC - MCC #1 Main Floor

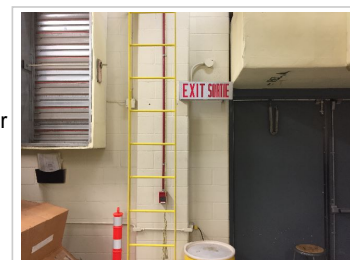
All red letter EXIT SORTIE signs appear in good condition. All signs on main and second floor appear to match. Exit signs in penthouses use smaller letters. When signs are replaced, they will be the green Pictogram signs to conform to the current code.

Exit Lighting - Bilingual exit sign

Replace exit signs throughout the building to keep with current code.

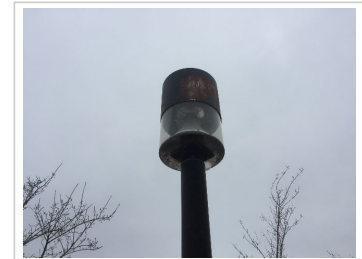
Exterior light fixtures are presently in good condition but are expected to be replaced.

Exterior Lighting - Decorative pole mounted light

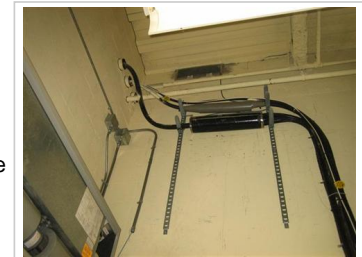
Some pieces of equipment appeared to be dirty and dusty. Maintenance routines should be implemented to keep equipment clean, helping with cooling of equipment to prolong life and minimize failures. Equipment is rated as average but should last until 2044 with regular maintenance.

IMG_0041 (Small).JPG - Communications service to the building.

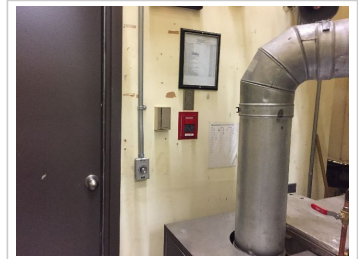
At time of review there was a 'Trouble' signal noticed on the display of the panel. This was known to site staff and was in the process of being rectified. The last fire alarm test was reviewed with minor deficiencies that have been rectified according to site staff.

Overall the system is rated as good.

Fire Alarm System - Manual Pull Station

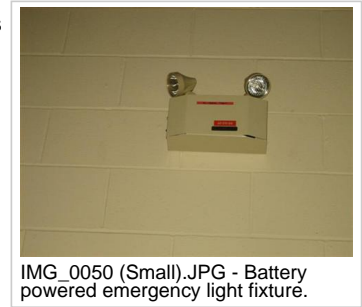
Battery packs appear to be end of life, are rated as poor and should be replaced. Emergency lighting battery packs should be tested regularly to confirm system is still able to provide 30 minutes of run time.

Emergency Lighting Renewal

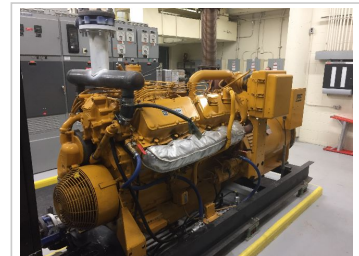
The generators are in good condition and are tested monthly. The transfer switches were replaced in 1997 and are in very good condition. Since the replacement date is estimated to be 2047, and is beyond this BCR's 30 year replacement cycle, no event is offered.

Emergency Power System - Diesel Generator

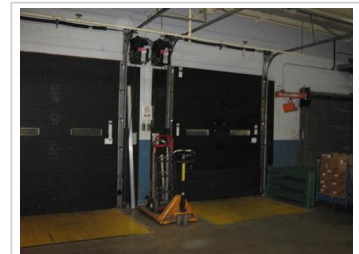
The dock equipment is operable but is showing signs of wear through years of heavy use. It is rated as being in fair condition. Based on an anticipated remaining functional life of two years, the dock equipment should be replaced in 2019.

Oct.26-28 080 (Small).jpg - Two dock levelers in the shipping/receiving area.

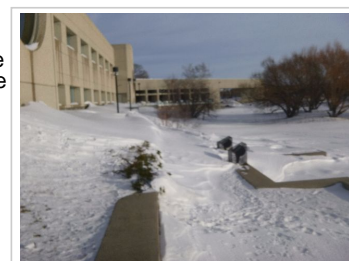
The retaining walls appear to be in good condition with no signs of distress observed where reviewed. No replacement recommendations are made at this time as the retaining walls are expected to last the full lifespan of the building.

Concrete Reinforced Retaining Wall - View of exterior concrete retaining walls

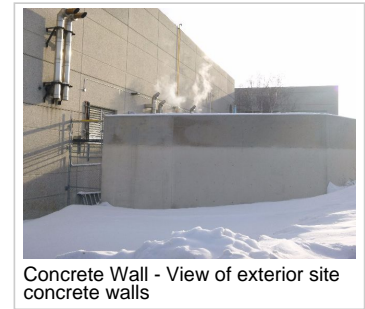
Concrete Wall - View of exterior site concrete walls

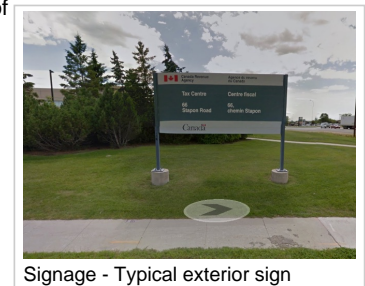
All signs appear to be in good condition. No visible deterioration was noted. The illuminated sign is approximately 19 years old. The estimated replacement date is 2028. The street signage support posts should be maintained on an annual basis to ensure the steel does not deteriorate.

Signage - Typical exterior sign

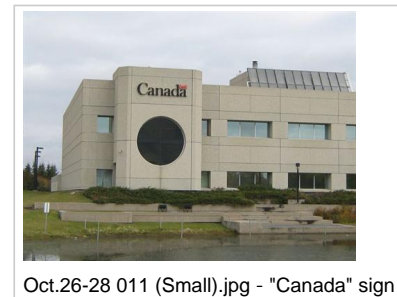
Oct.26-28 011 (Small).jpg - "Canada" sign

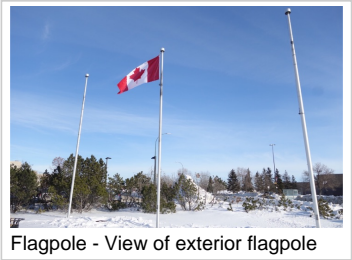
The flagpoles are in excellent condition. There are no requirements or consideration for replacement within the 20 year systems planning window as they should last until 2042.

Flagpole - View of exterior flagpole

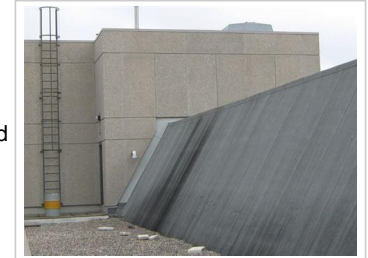
The ladders appear to be in good condition, solid and secure. The anticipated replacement date of 2054 is beyond the 20 year budget period. However, to ensure continued service, it is recommended that the metal surfaces be painted every ten years.

Oct.26-28 044 (Small).jpg - One of four ladders to each penthouse roof.
