**Upper Kawartha DSR
Burleigh Falls Dam
2014 Geotechnical Site Investigation Report**
FINAL

**KGS Group 13-0006-012
December 2015**

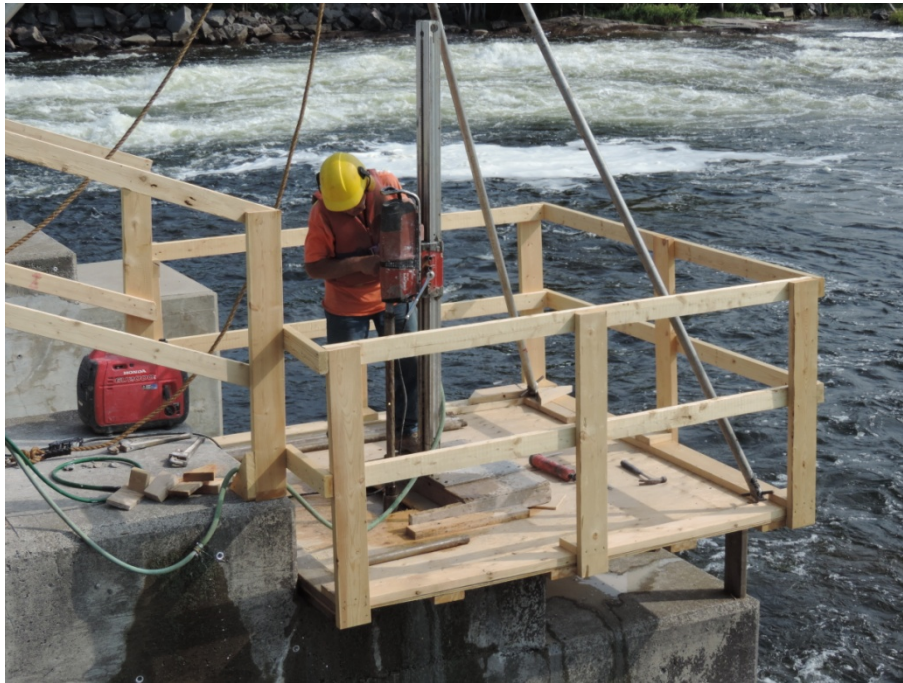
PHOTO 3.1-1
PORTABLE DRILL RIG AT CH14-103

All of the test holes were completed using a portable drill rig equipped with casing-wash boring and coring capabilities as shown on Photos 3.1-1 and 3.1-2.

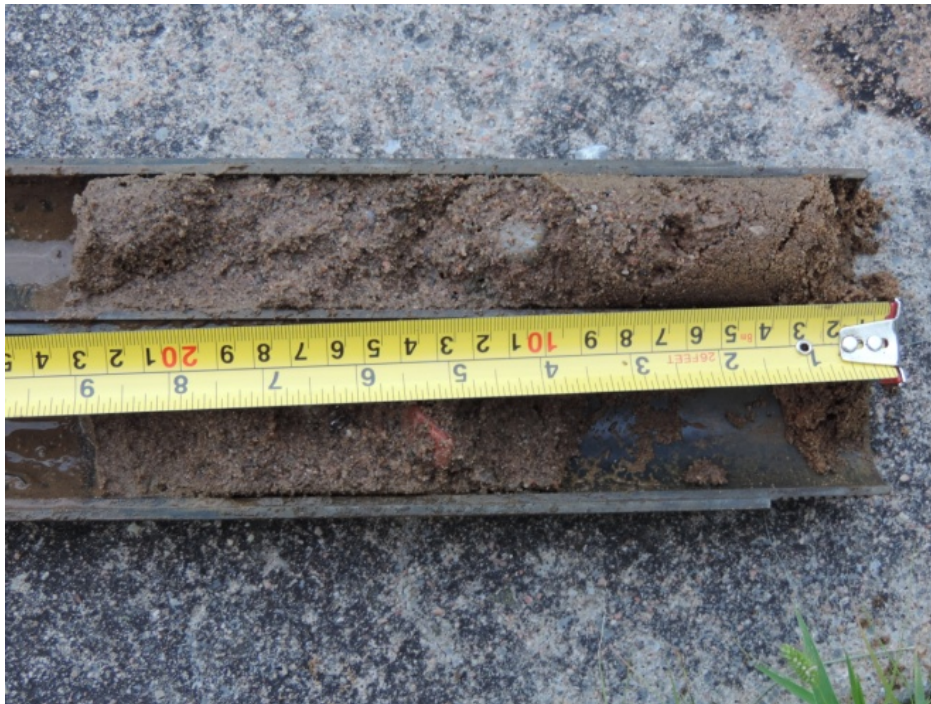
TH 14-101 Sample 2 (6'3"-8'3")
SPT count (7,6,32,23) Recovery 9"

Corrected SPT N-values of approximately 4 blows per 300 mm (ranging between 1 and 6) were recorded in the sand fill. It should be noted that at depths between 2.2 m and 2.7 m in TH14-101 gravel and cobble sized rockfill material was encountered during drilling and elevated SPT values ranging from 23 to 32 were recorded.

North (Left) Earthfill Embankment
Sand Fill

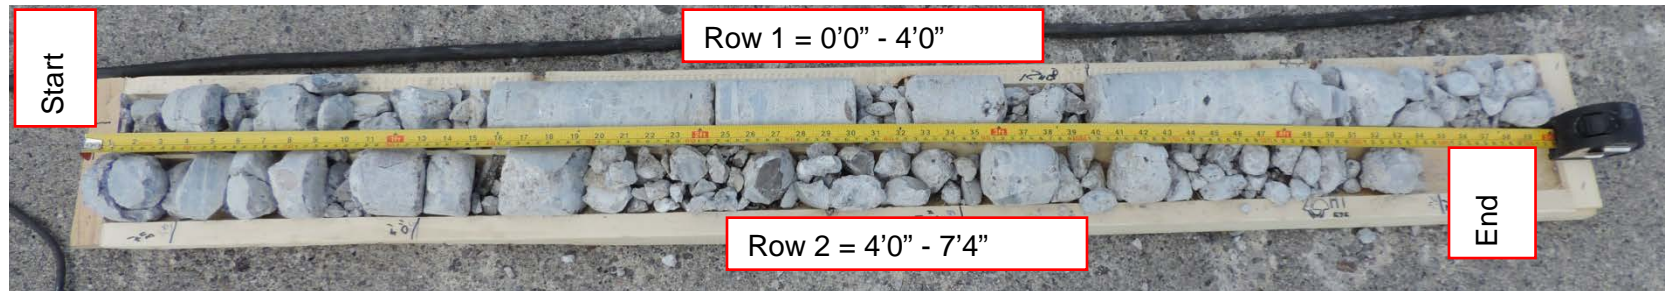
CH 14-102 Concrete core sample (0'0"- 7'4")

Numerous construction joints were noted throughout the structure during coring activities. Signs of possible seepage along a construction joint at 7.5 m depth was noted at CH14-102 and CH14-103, both located on Pier #1.

Spillway Concrete Structure
Pier # 1

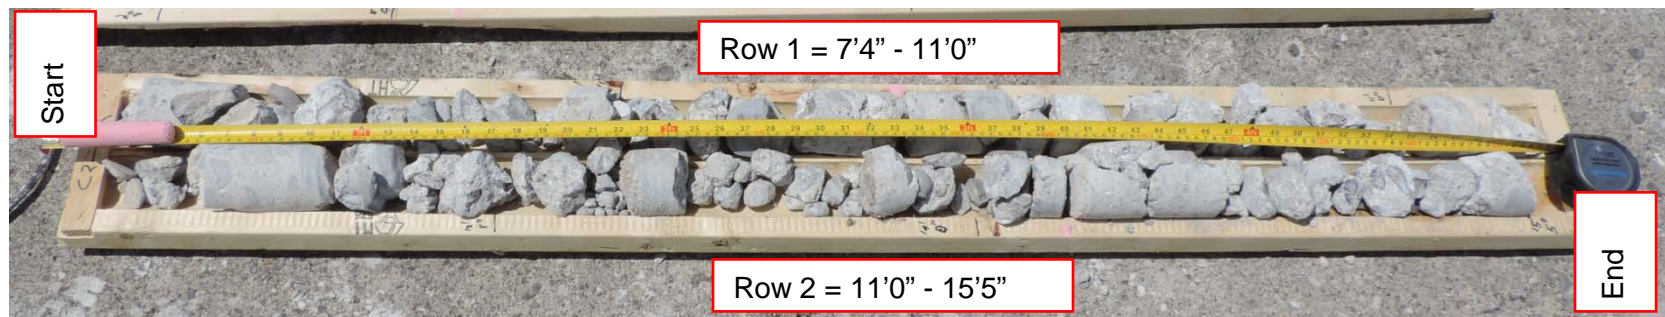
CH 14-102 Concrete core sample (7'4"- 15'5")

Spillway Concrete Structure
Pier # 1
