Foreshore File No.: 9047-R-01.1

Re: Concrete Float Inspection

Please find below the results of Foreshore's inspection of the Department of Fisheries and Oceans Small Craft Harbours' concrete float located in Steveston Harbour, British Columbia (see Images 1 and 2). The purpose of the inspection was to determine the general condition of the float.

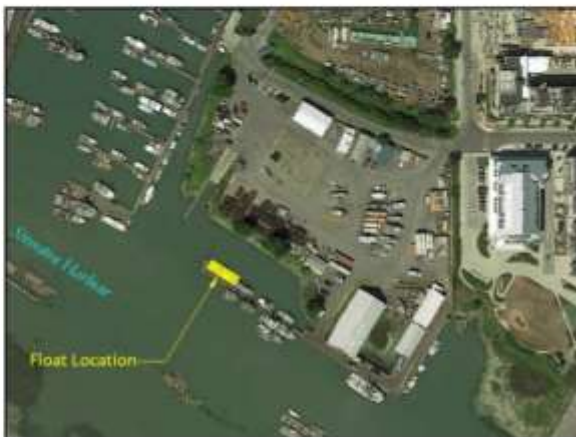
Image 1. Concrete float location in Steveston Harbour at Foot of No. 2 Road.

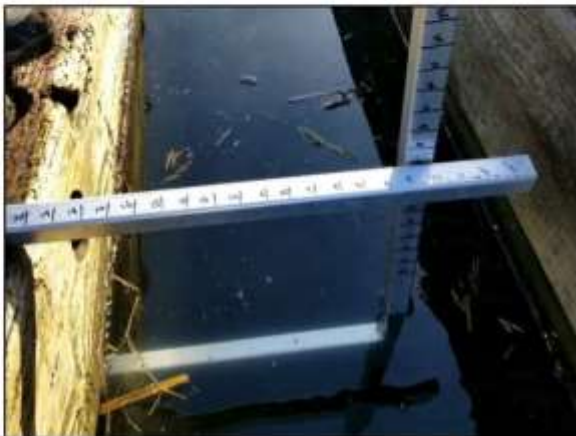
Image 5. Remote measuring device provides a measure of the elevation and horizontal distance of float hull relative to the edge of the concrete deck.

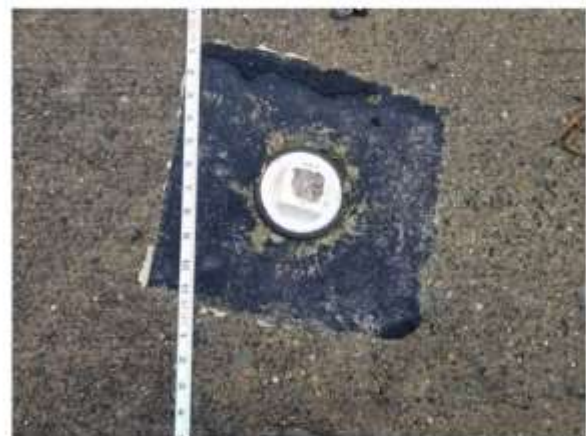
Image 6. Deck bung with removeable plastic cap and internal sleeve set into concrete deck.

All test holes and sampled deck bungs indicate the chambers between the bulkheads contain Styrofoam. Dip stick tests show the Styrofoam fills the chamber from the underside of the concrete deck down to the bottom of the bilge. The lower regions of the Styrofoam are wet. As there are cracks and openings in the surface and the float is filled with Styrofoam, the water present in the chambers could be the result of rainfall or river water.
