# DESIGNATED SUBSTANCE AND HAZARDOUS MATERIALS ASSESSMENT REPORT

ADMINISTRATIVE BUILDING #2, SAINT-  
REGIS, AKWESASNE

MARCH 31, 2020

PROJECT NO.: 181-09302-15  
DATE: MARCH 31, 2020

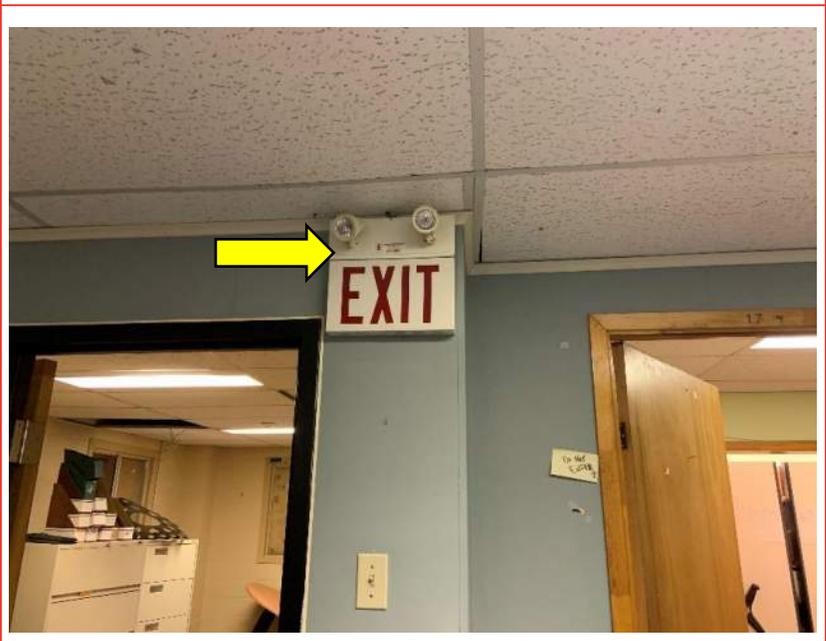
A close-up photograph of a thermostat mounted on a light-colored, textured wall. The thermostat is a small, rectangular device with a circular dial. A yellow arrow points to the center of the dial.
<u>14</u>	Batteries in emergency lighting presumed to contain lead-acid.

A photograph of an emergency exit sign mounted on a wall. The sign is rectangular with the word "EXIT" in red letters. Above the sign are two circular emergency lights. A yellow arrow points to the batteries located above the sign.
