Addendum No. 1

Date: September 2, 2020
Addendum No.: 01
Project No.: R.21850.003
Henry Traill Community Correctional Centre, Kingston Ontario

REVISED Hazardous Building Materials Assessment

Exterior Façade Replacement
Henry Trail Correctional Centre
(HTCC)
1453 Bath Road, Kingston,
Ontario

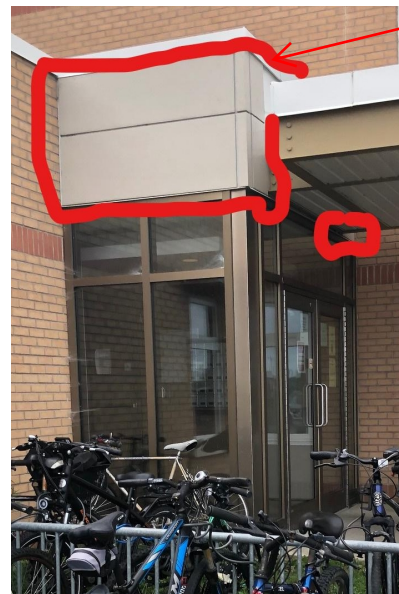
3 PHOTO
SK-1 NTS

EXTENT OF NEW VINYL SIDING TO REPLACE EXISTING CEMENT BOARD CLADDING

REFER TO SHEET A106 FOR TYPICAL VINYL ASSEMBLY DETAILS. WORK INCLUDES DEMOLITION OF EXISTING CEMENT BOARD PANELS AND SUBSTRATES AS ILLUSTRATED IN SHEET A103.

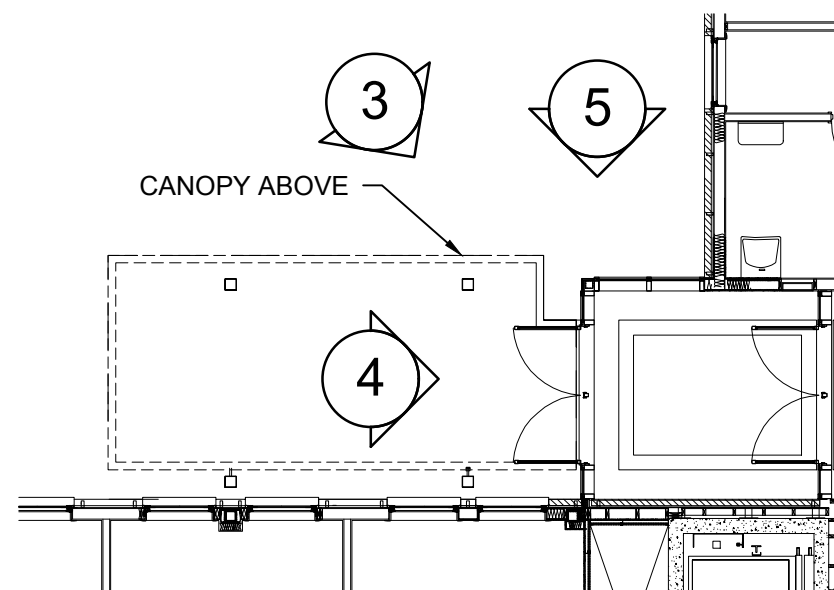
2 CANOPY PLAN
SK-1 SCALE: 1:100

DETAIL 2- ENLARGED PLAN AT CANOPY
