**FINAL MODIFIED PHASE I ENVIRONMENTAL SITE
ASSESSMENT AND HAZARDOUS MATERIALS SURVEY**

**DALVAY ASSETS
PRINCE EDWARD ISLAND NATIONAL PARK
DALVAY, QUEENS COUNTY, PEI**

**PUBLIC WORKS AND GOVERNMENT SERVICES CANADA FOR
PARKS CANADA**

JANUARY 13, 2011

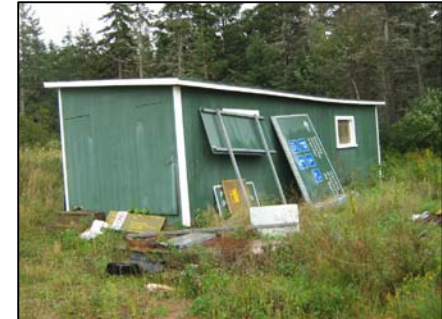
PHOTO 23 - VIEW FACING SOUTHEAST TOWARD ASSET NO. 216 (SIGN BUILDING)

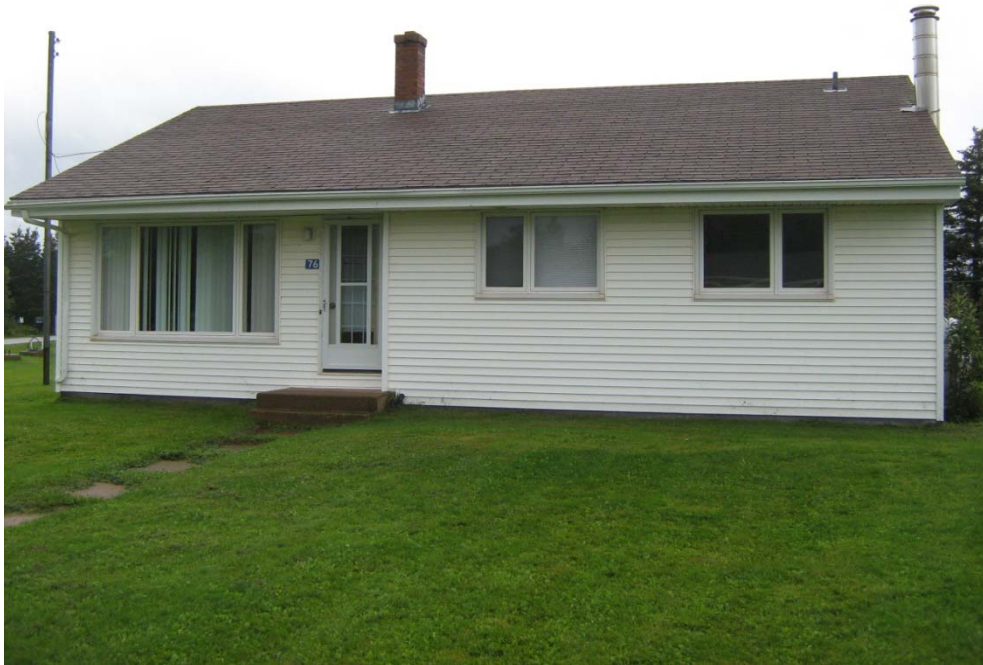
PHOTO 1: Asset 217 – Staff House #5– photo facing North.

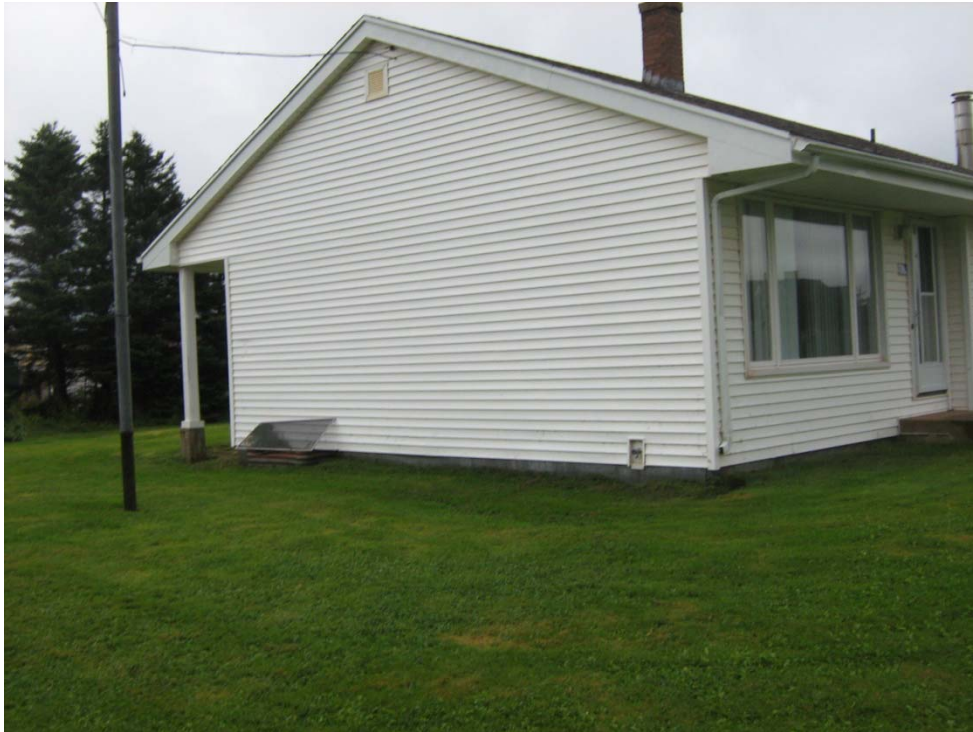
PHOTO 3: Asset 217 – Staff House #5 – photo facing east.

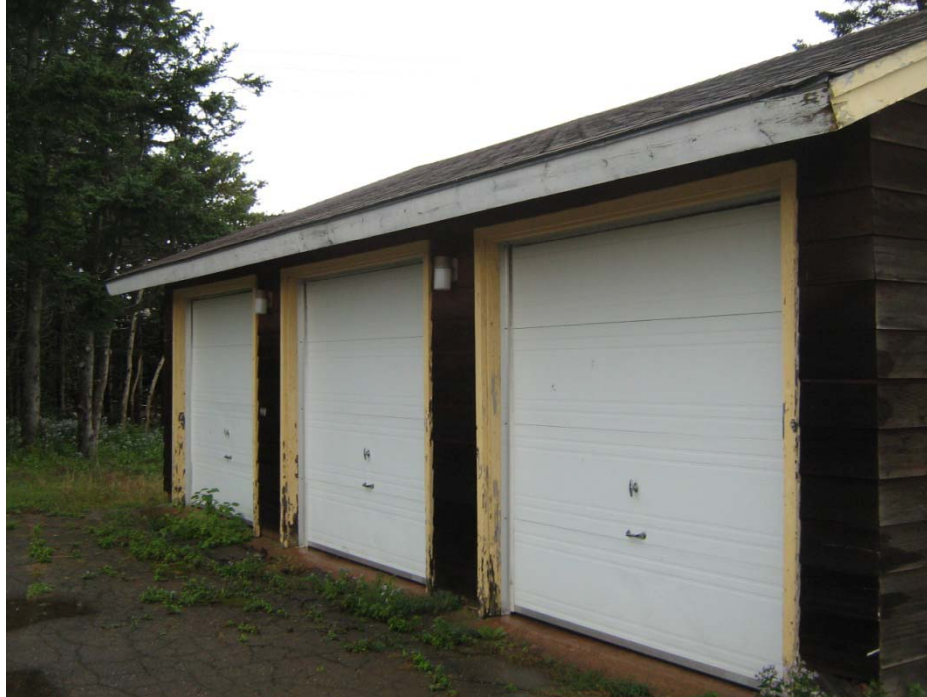
PHOTO 6: Asset 217 – Garage Associated with Staff House #5 – photo facing east

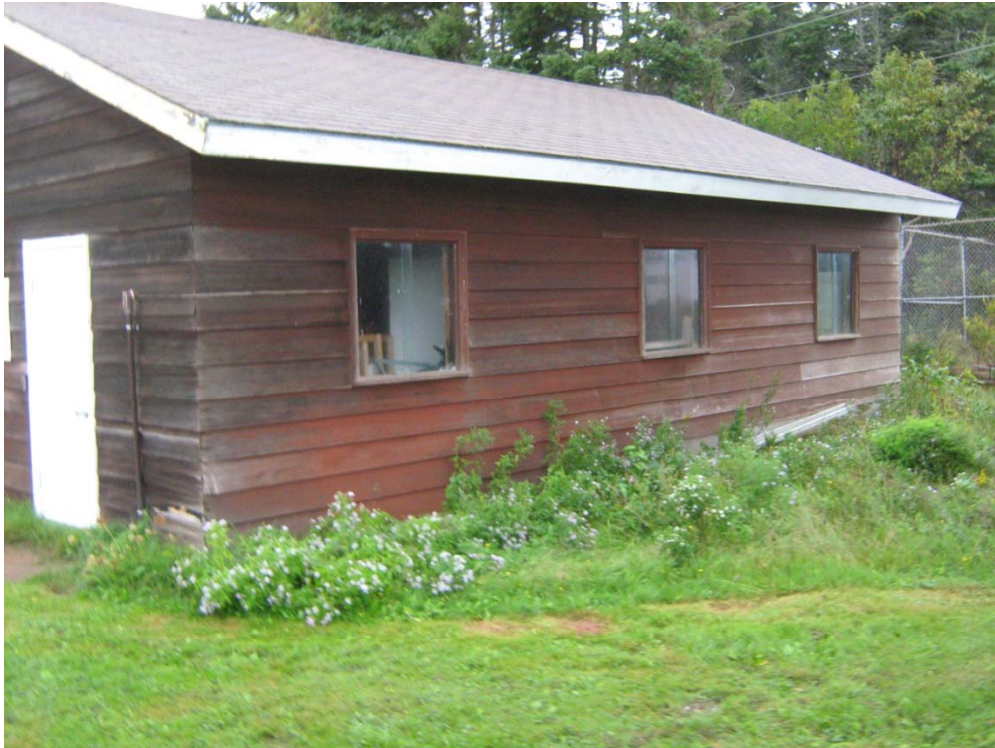
PHOTO 7: Asset 217 – Garage Associated with Staff House #5 – photo facing northwest

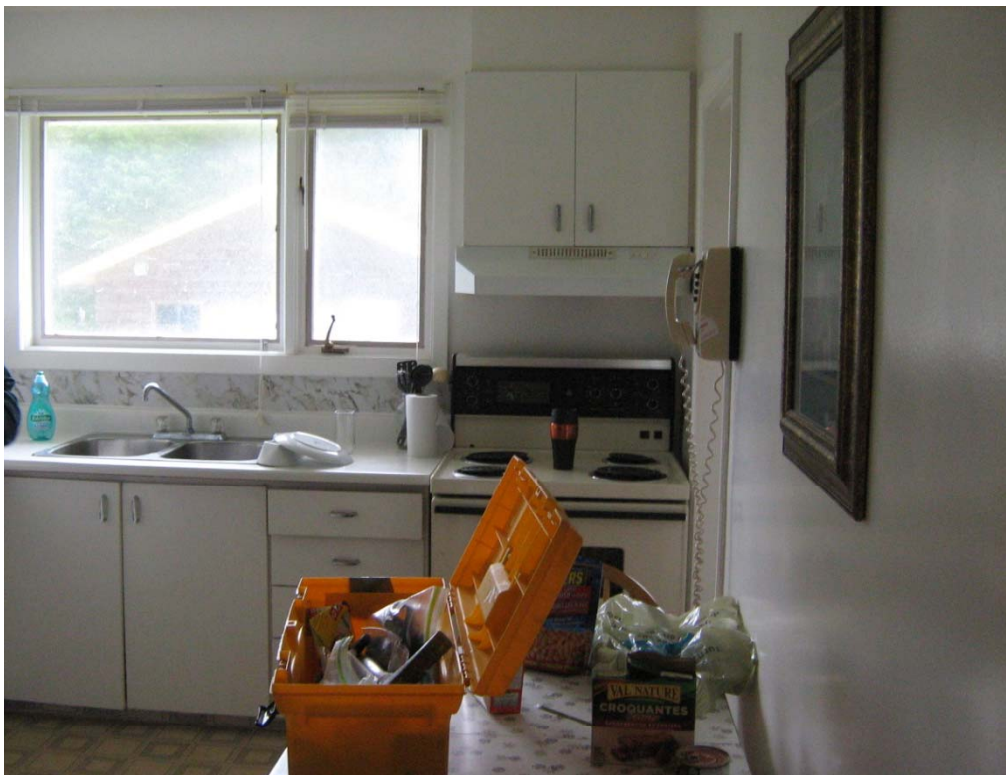
PHOTO 8: Asset 217 – Kitchen – Staff House #5.

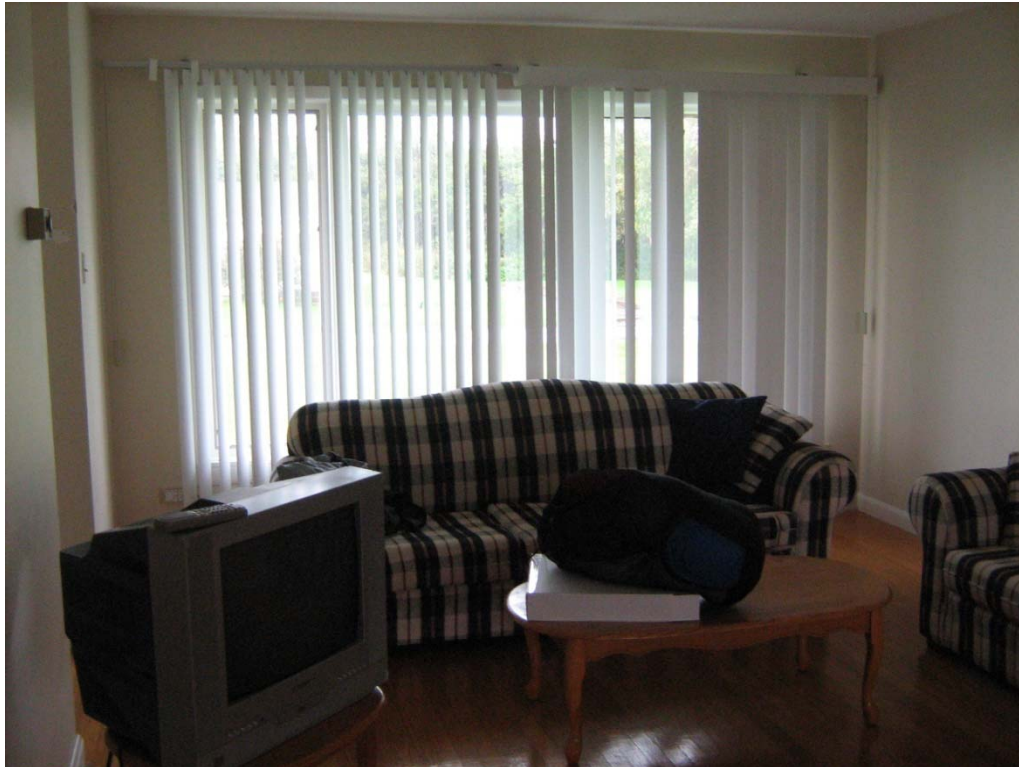
PHOTO 11: Asset 217 – Living Room – Staff House #5.

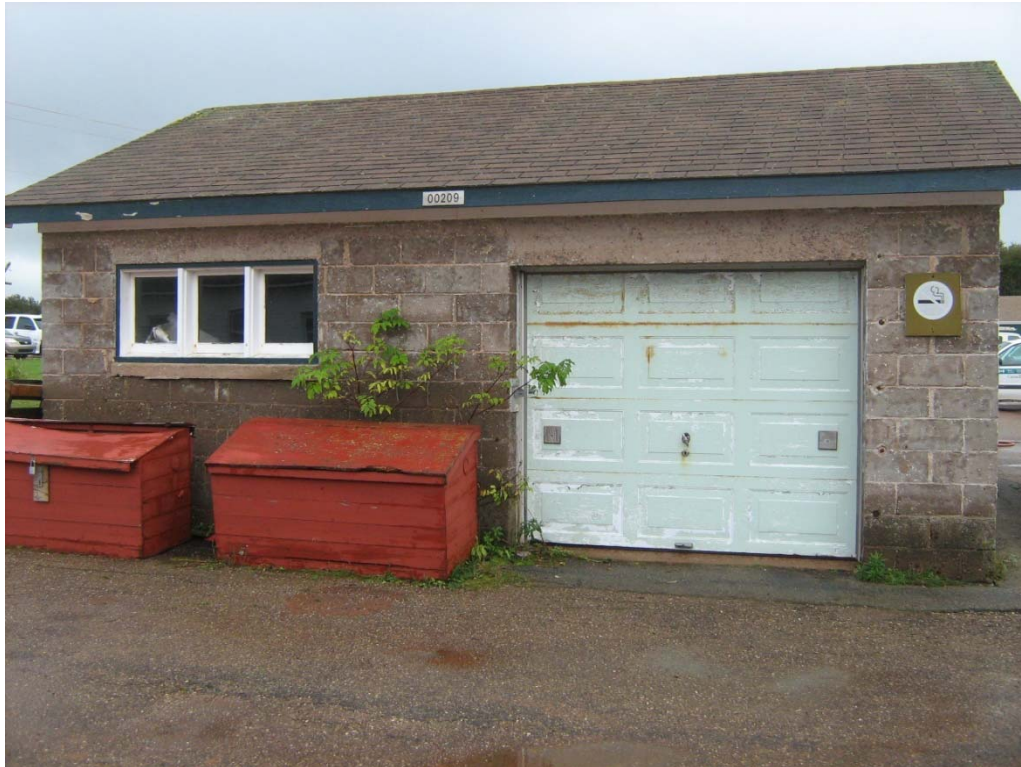
PHOTO 19: Asset 209 – Chemical Storage Building – photo facing west.

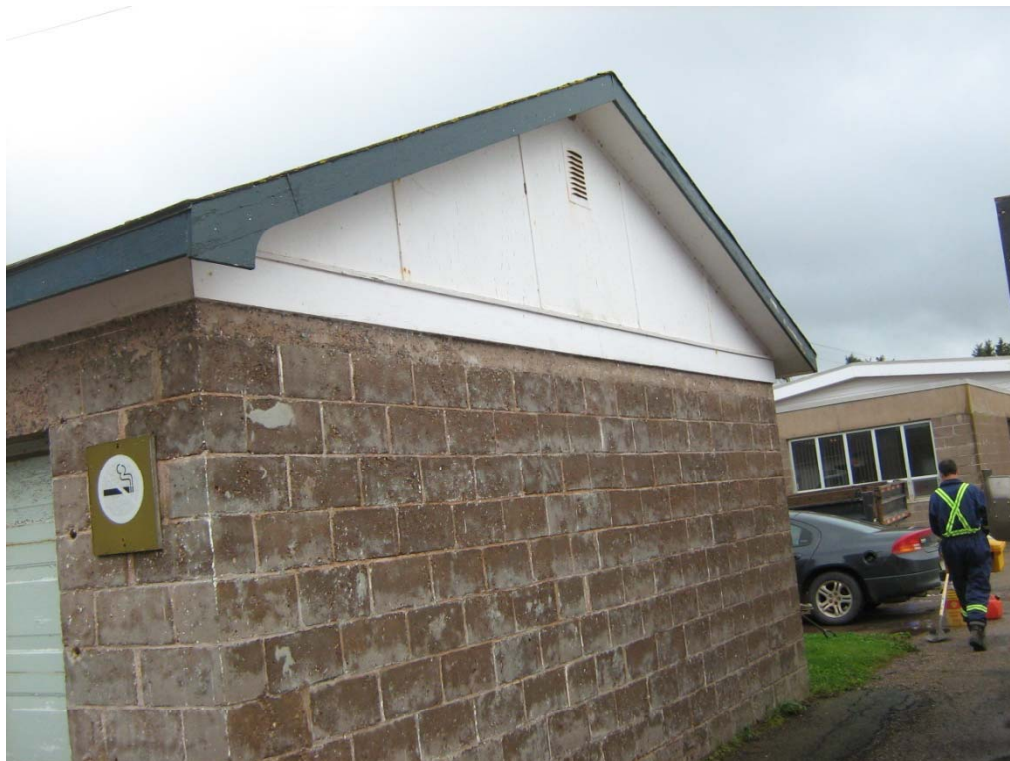
PHOTO 20: Asset 209 – Chemical Storage Building – photo facing southwest.

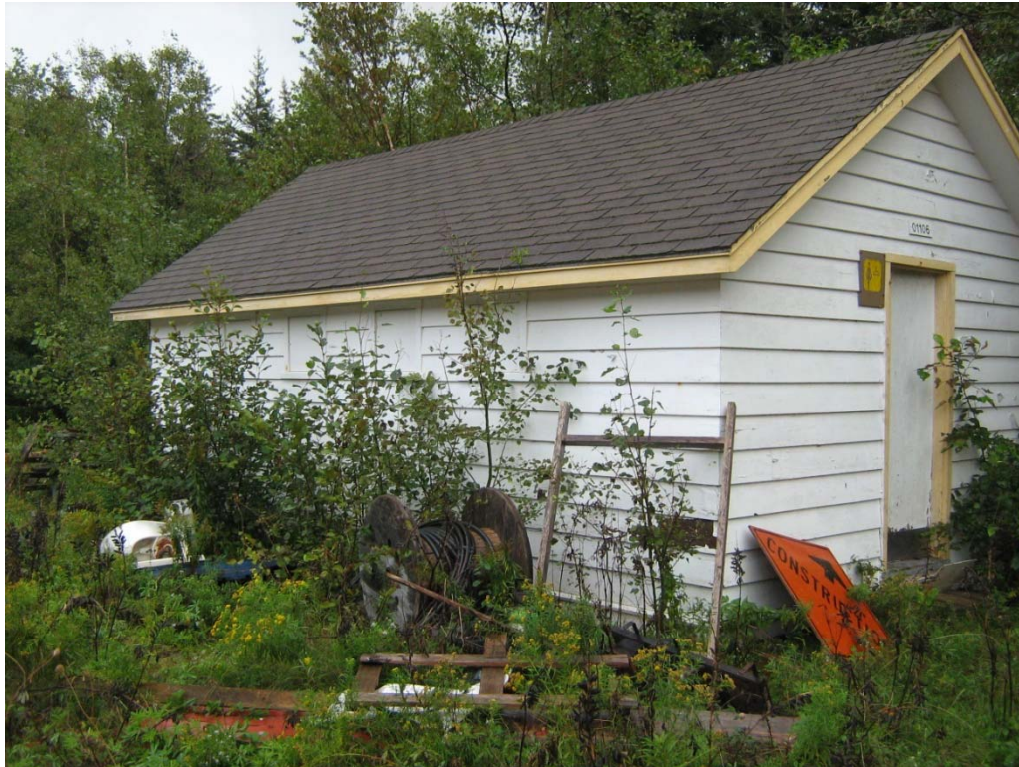
PHOTO 21: Asset 218 – Change House – photo facing southeast.

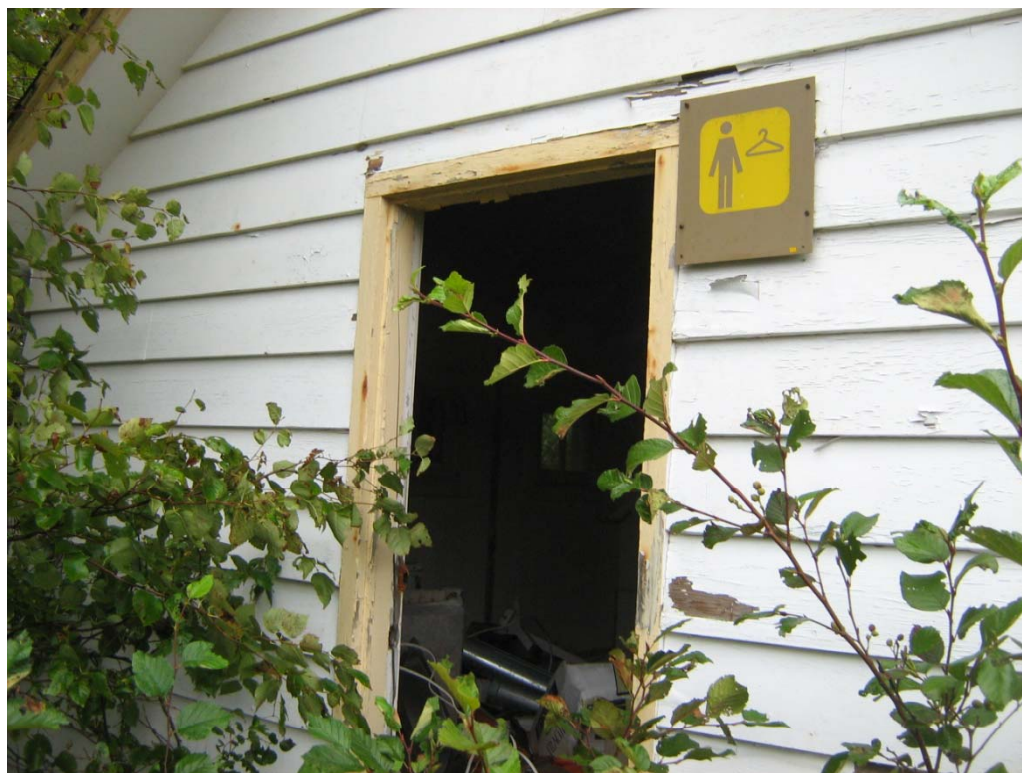
PHOTO 22: Asset 218 – Change House – photo facing west.

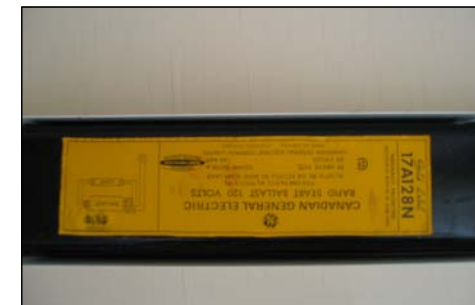
Photo 7: Fluorescent Light Ballast Suspected to Contain PCBs
