GESTION DES MATIÈRES DANGEREUSES

NGCC PIERRE RADISSON

RAPPORT FINAL

PROJET N° : 171-09529-52
DATE : NOVEMBRE 2019

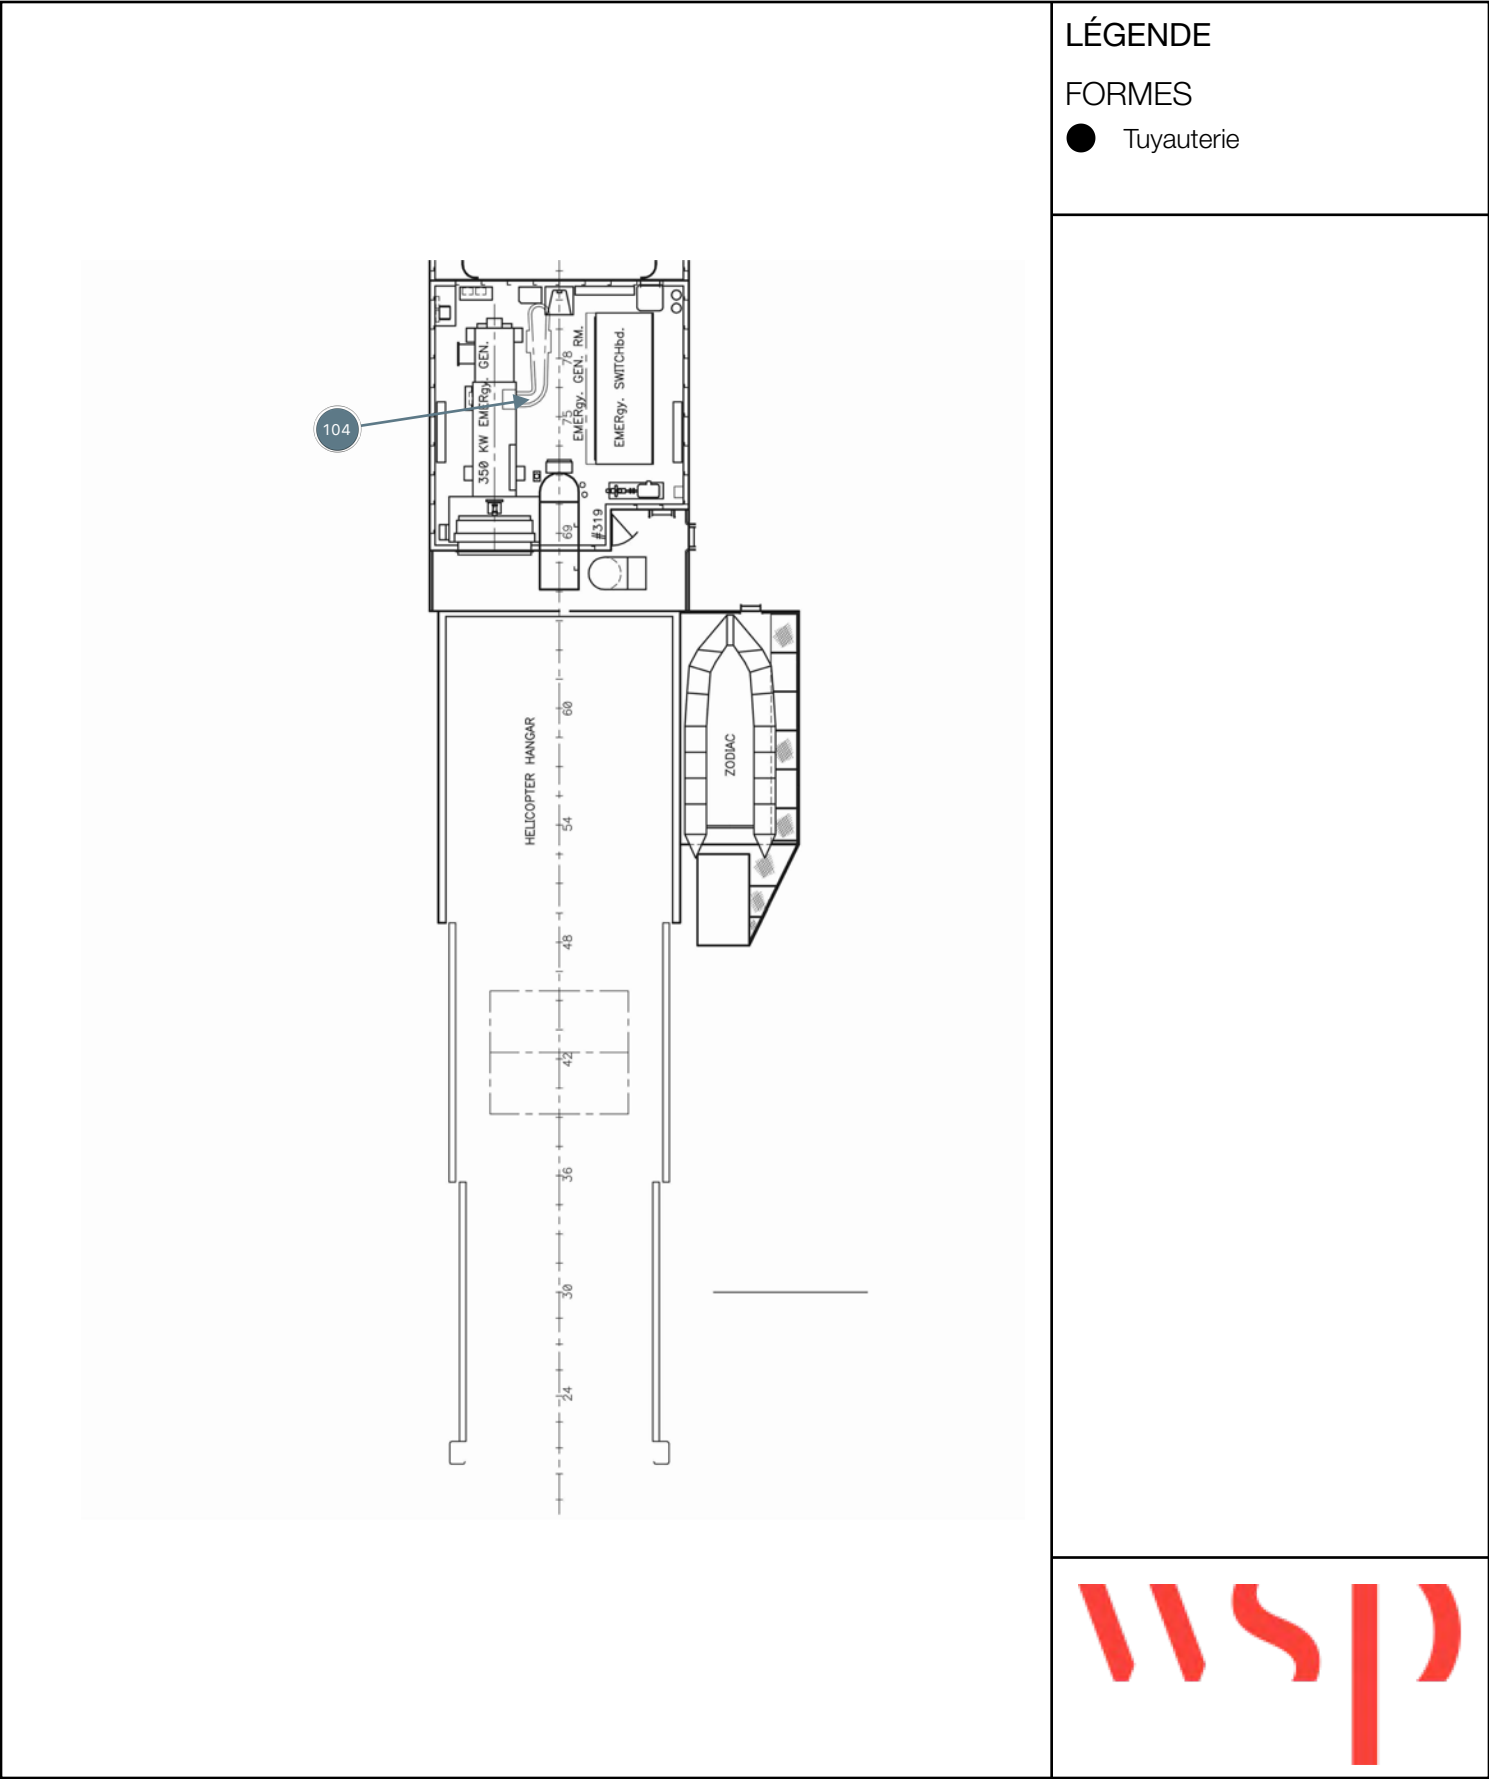
C-PONT DES OFFICIERS_ARRIÈRE

Tuyauterie
Échappement — Génératrice d'urgence — Irrégulière et rectiligne — Canevas et magnésie — 22 po. — 12 m. lin. — Officiers — Salle des génératrices — 319 — N/A
Alexandre.Caza - 2017-06-29 12:58

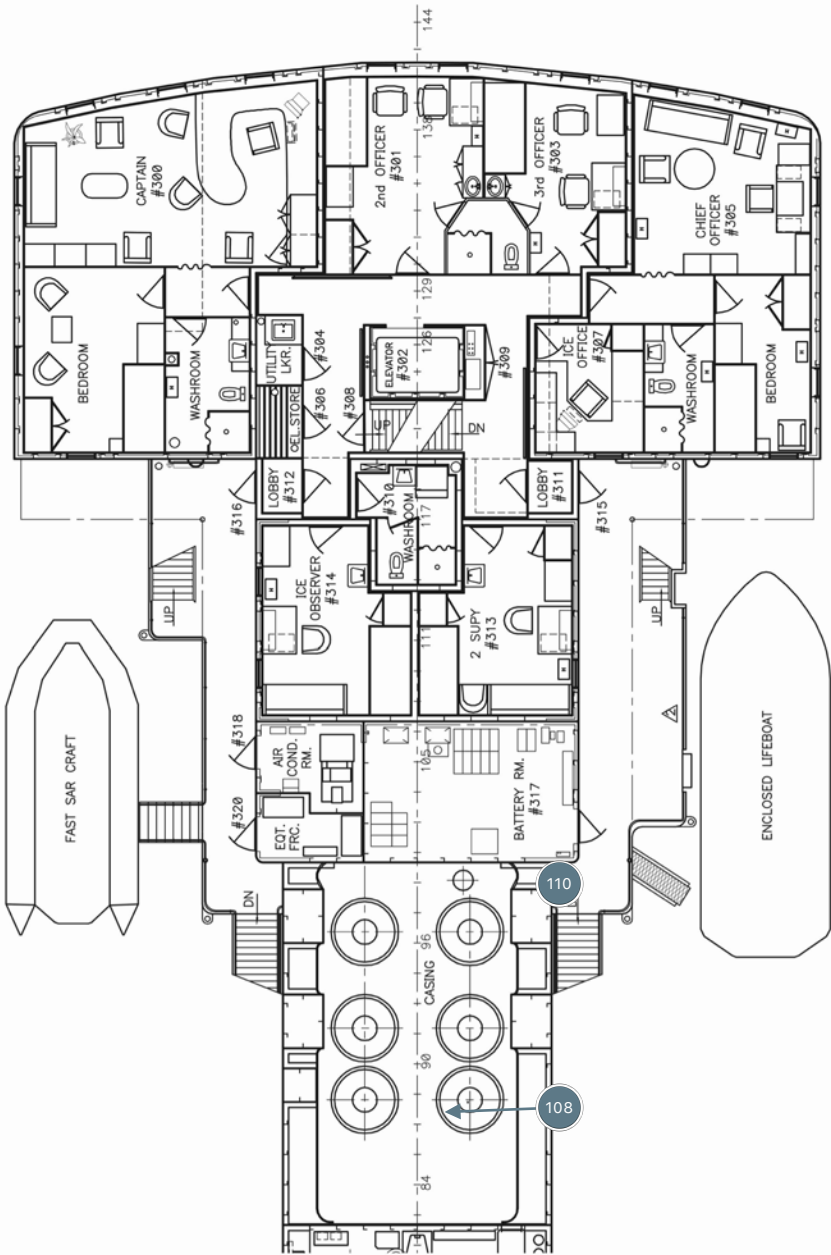
D-PONT DES OFFICIERS_AVANT

110 Tuyauterie
Vapeur (alimentation) — Rectiligne — Magnésie — 5 po. — 3 m. lin. — Officiers — Salle des cheminées — 0 — Pastille 5
Alexandre.Caza - 2017-06-29 13:31

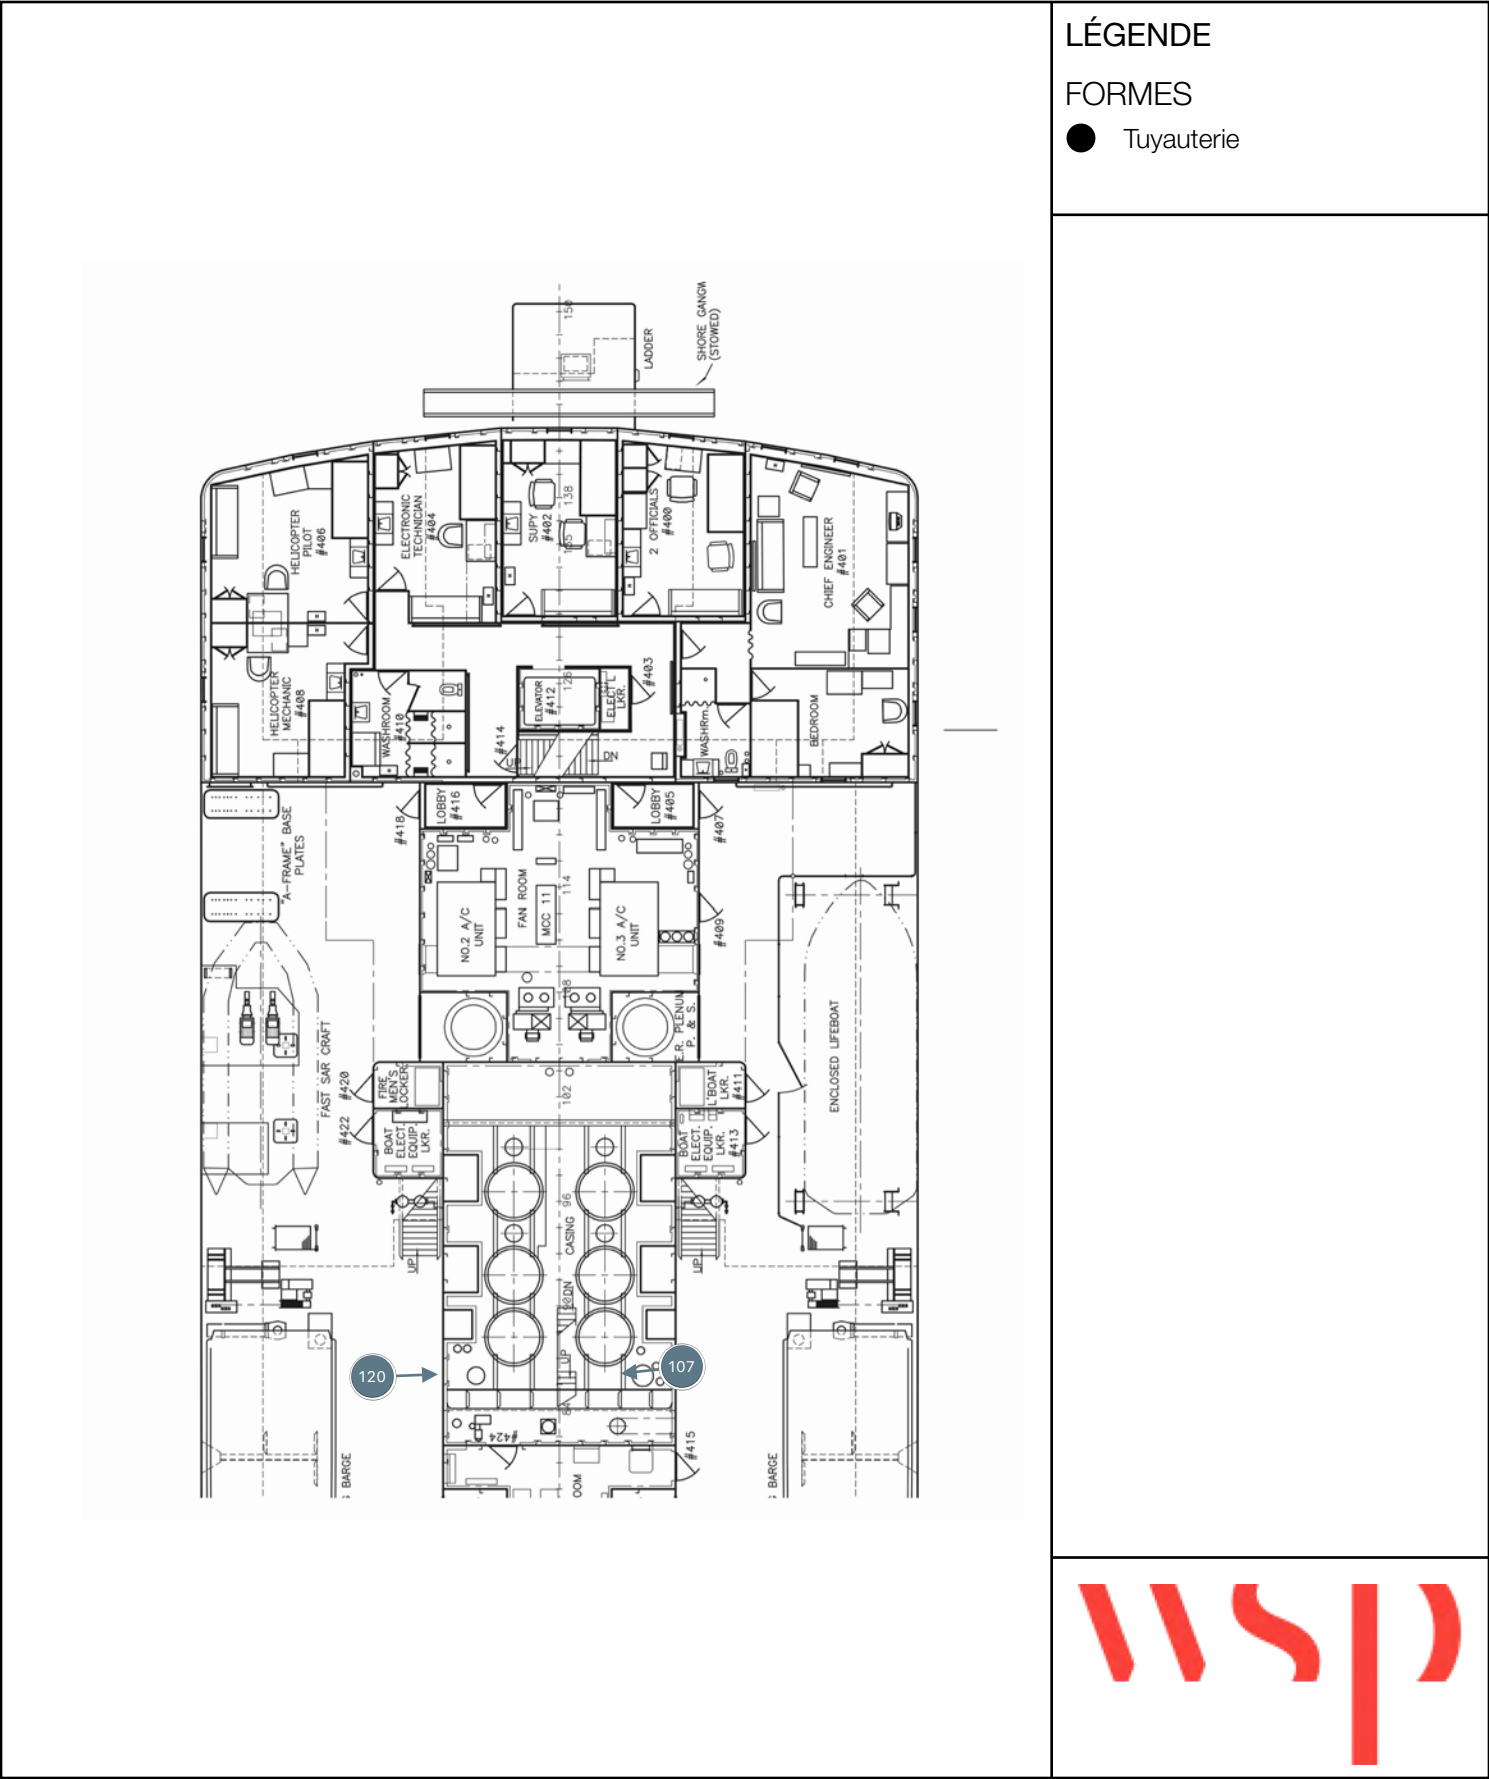
F-PONT DES EMBARCATIONS_AVANT

120 Tuyauterie
Échappement — Incinérateur — Irrégulière et rectiligne — Canevas et pâte cimentaire et magnésie — 22 po. — 0 m. lin. — Embarcations — Salle des machines — 409 — Pastille 34
Alexandre.Caza - 2017-06-30 09:13

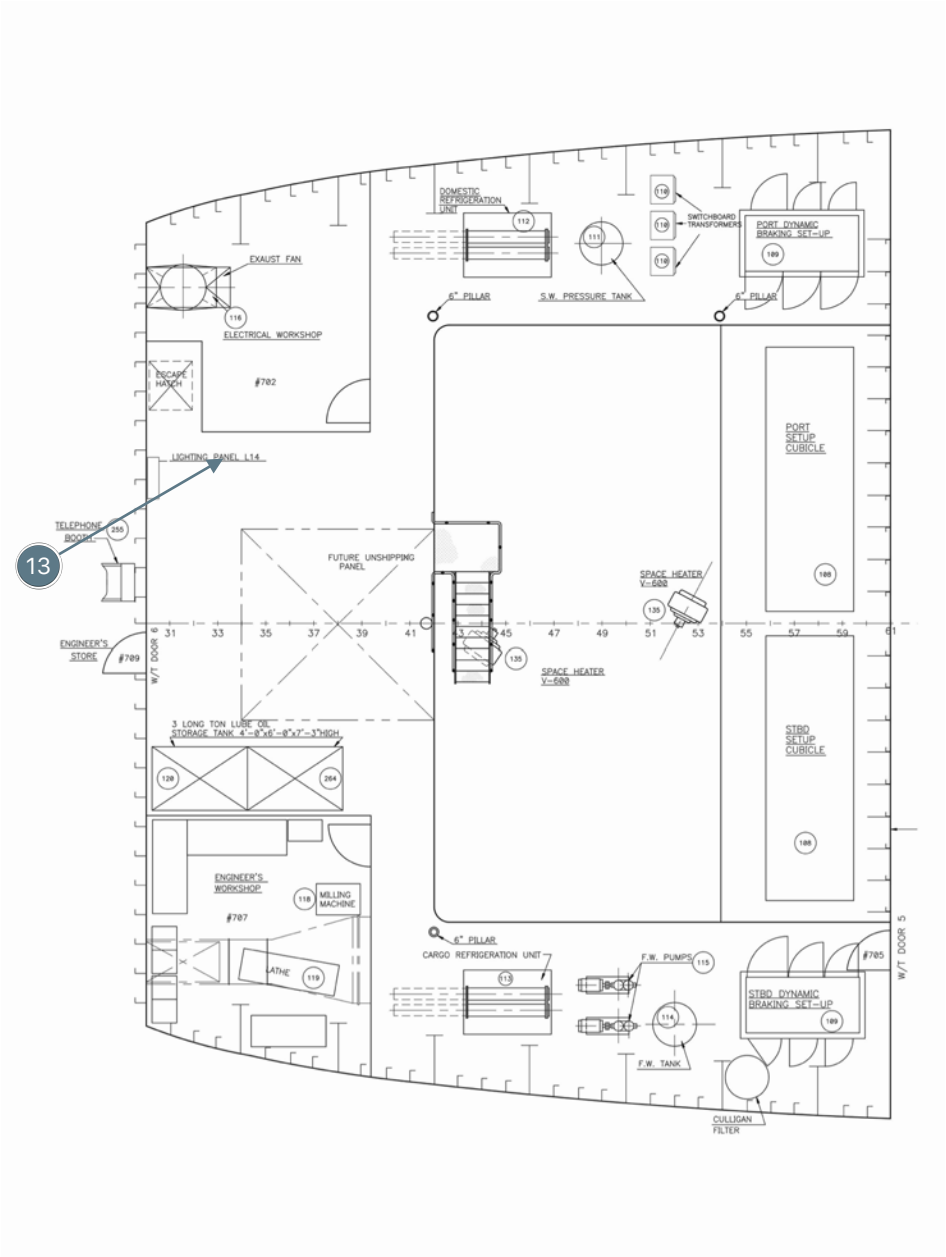
M-SALLE DES PROPULSEURS

13 Tuyauterie
Vapeur (alimentation) — Rectiligne — Magnésie — 5 po. — 35 m. lin. — Salle des propulseurs — Salle des propulseurs — 0 — Pastille 5
Chantal.Soulard - 2019-11-22 09:18

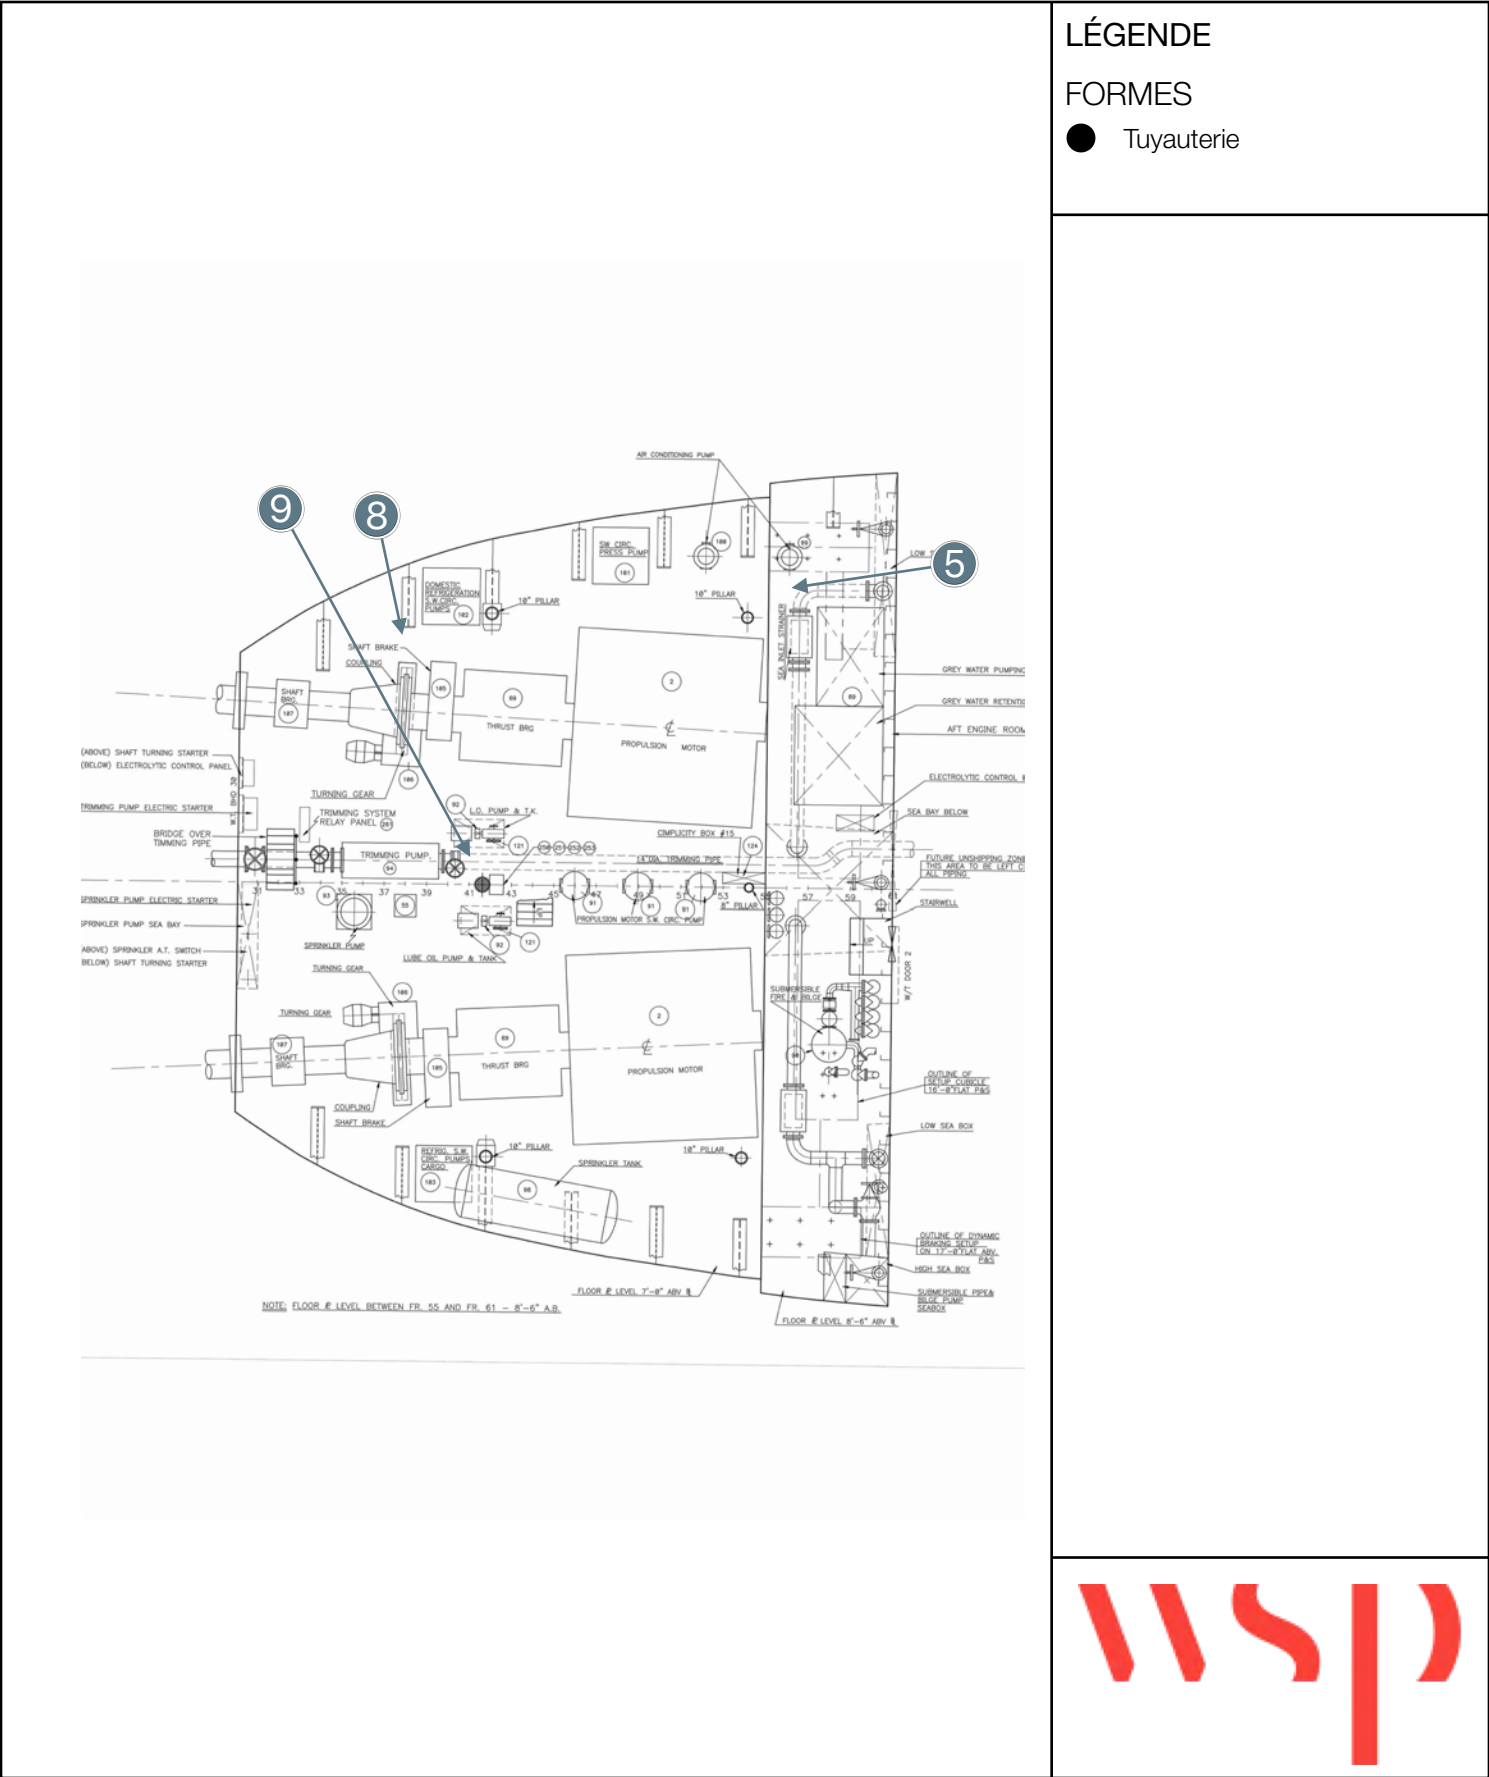
N-SALLE DES PROPULSEURS NIVEAU PLANCHER

8 Tuyauterie
Vapeur (alimentation) — Irrégulière — Canevas et pâte cimentaire — 4 po. — 6 unité — Salle des propulseurs — Salle des propulseurs — 0 — N/A
Chantal.Soulard - 2019-11-22 09:20
