## **EX HMCS CORMORANT**

### **Condition Survey, Pollution Risk Assessment & Towage Assessment**

**At Bridgewater, Nova Scotia  
10 & 27 July 2019**

**Our Ref: 20989.00/LOCC/CCG/R001/0**

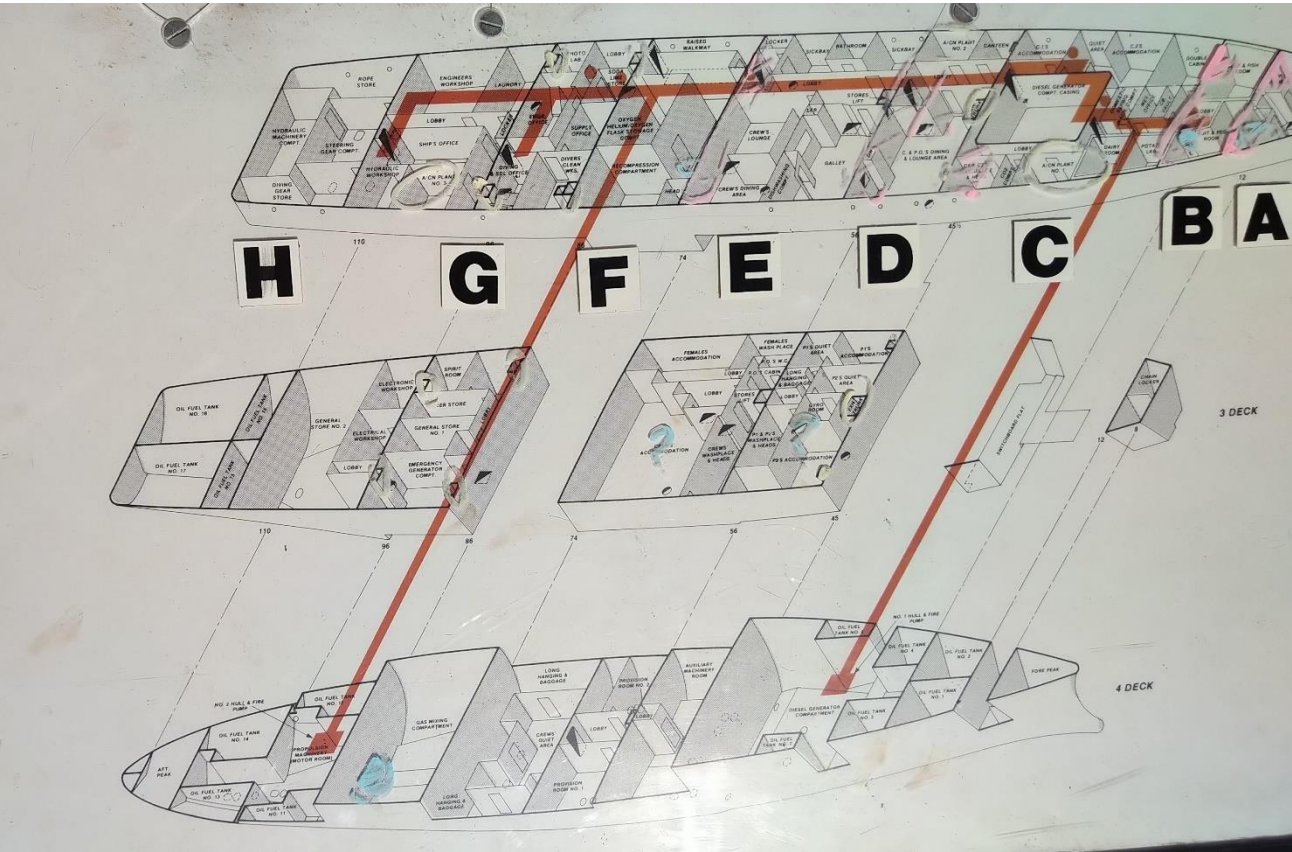
Figure 2 Tank Location on Damage Control Plan

- 4.3 A total of 116,649ltrs of water was calculated as being contained within tanks. Some of these tanks are designated as fuel tanks. We can find no record of the tanks having been cleaned prior to being ballasted. It is probable that the water in these tanks contains oil in quantities above 15ppm. In addition, the quality of the water contained within the ballast and fresh water tanks cannot be confirmed as oil free. Testing of individual tanks will be needed to confirm if the water in these tanks could be discharged without being processed.

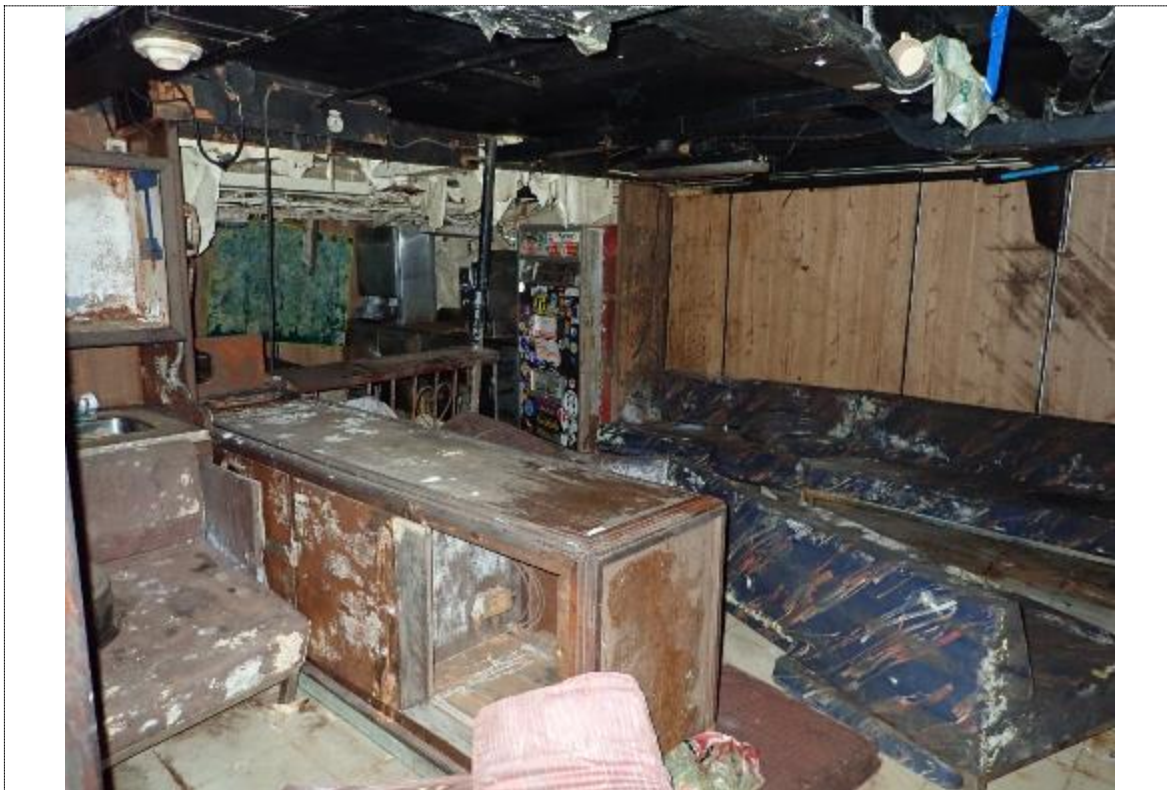
23. Lounge

Internally the vessel is in poor condition. It is clear that no remedial work was carried out post re-floating. There is mold evident in a number of locations and free water in several locations on deck 2 towards the stern of the vessel.
