DRAWINGS & SPECIFICATIONS
for

R.111921.001
RCMP Teslin, YK
Hazardous Building Material Abatement Project

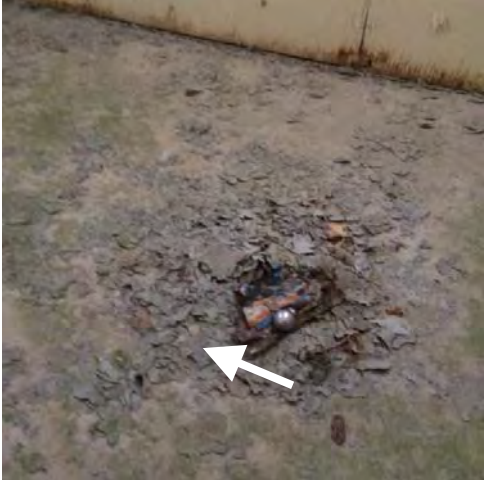
Identified LCP Description	Photo
<p>Blue paint on cement floor on main floor. This paint was observed to be in poor condition (bubbling, flaking or peeling).</p>	<p>No photo.</p>
<p>Grey paint on cement floor in interior basement. This paint was observed to be in poor condition (bubbling, flaking or peeling).</p>

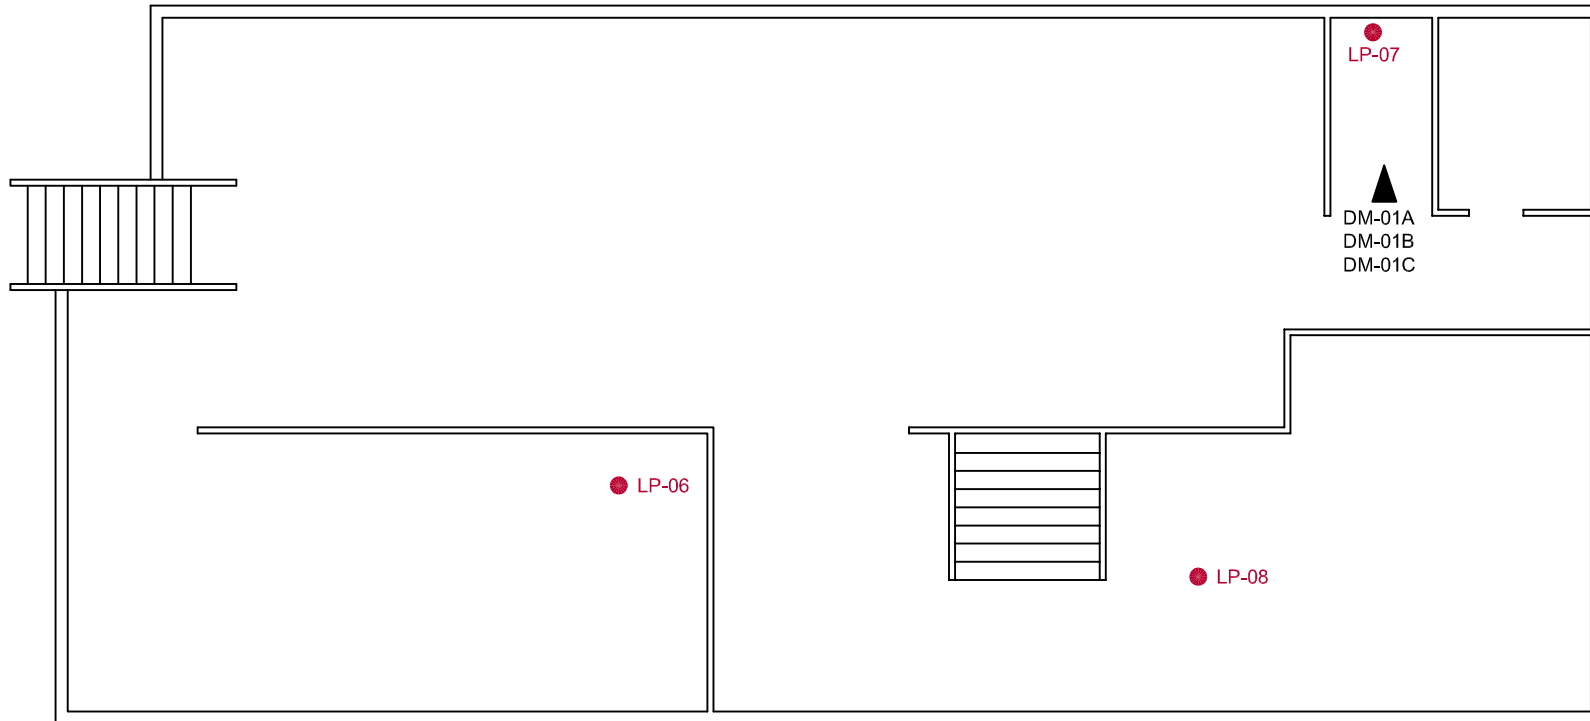
BUILDING 823223: OLD DETACHMENT BASEMENT

Identified Mould and/or Moisture Impacted Materials Description	Photo
<p>Moisture-impacted drywall was observed throughout the basement. The suspected source of moisture is condensation due to the building not being heated and/or insufficient ventilation/dehumidification.</p>

NOTES: 1. BROWN HVAC DUCT MASTIC THROUGHOUT IS ASBESTOS-CONTAINING.
2. SUSPECT MOULD PRESENT ON WALLS THROUGHOUT BASEMENT.

- Drywall materials within the basement that are impacted by moisture and suspect mould (the majority of, if not all drywall, approximately 500 square feet) should be removed accordance with applicable guidelines and accepted standards for such work (e.g., CCA 82). This will likely require the involvement of an experienced mould abatement contractor.
- The source of moisture is likely condensation due to the building not being heated and or insufficient ventilation/dehumidification. If these issues causing condensation are not planned to be addressed then mould and moisture impacted materials should not be replaced as the mould/moisture issues will likely reoccur.

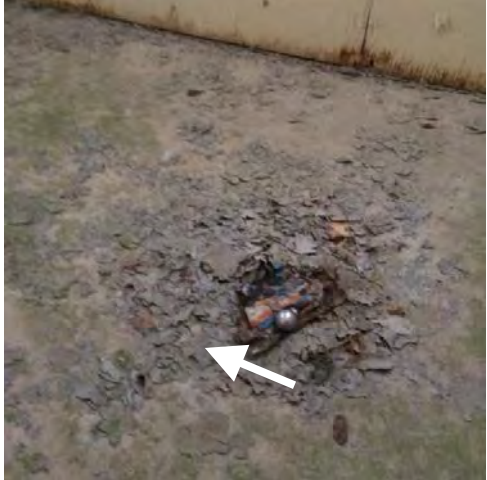
Identified LCP Description	Photo
<p>Blue paint on cement floor on main floor. This paint was observed to be in poor condition (bubbling, flaking or peeling).</p>	<p>No photo.</p>
<p>Grey paint on cement floor in interior basement. This paint was observed to be in poor condition (bubbling, flaking or peeling).</p>

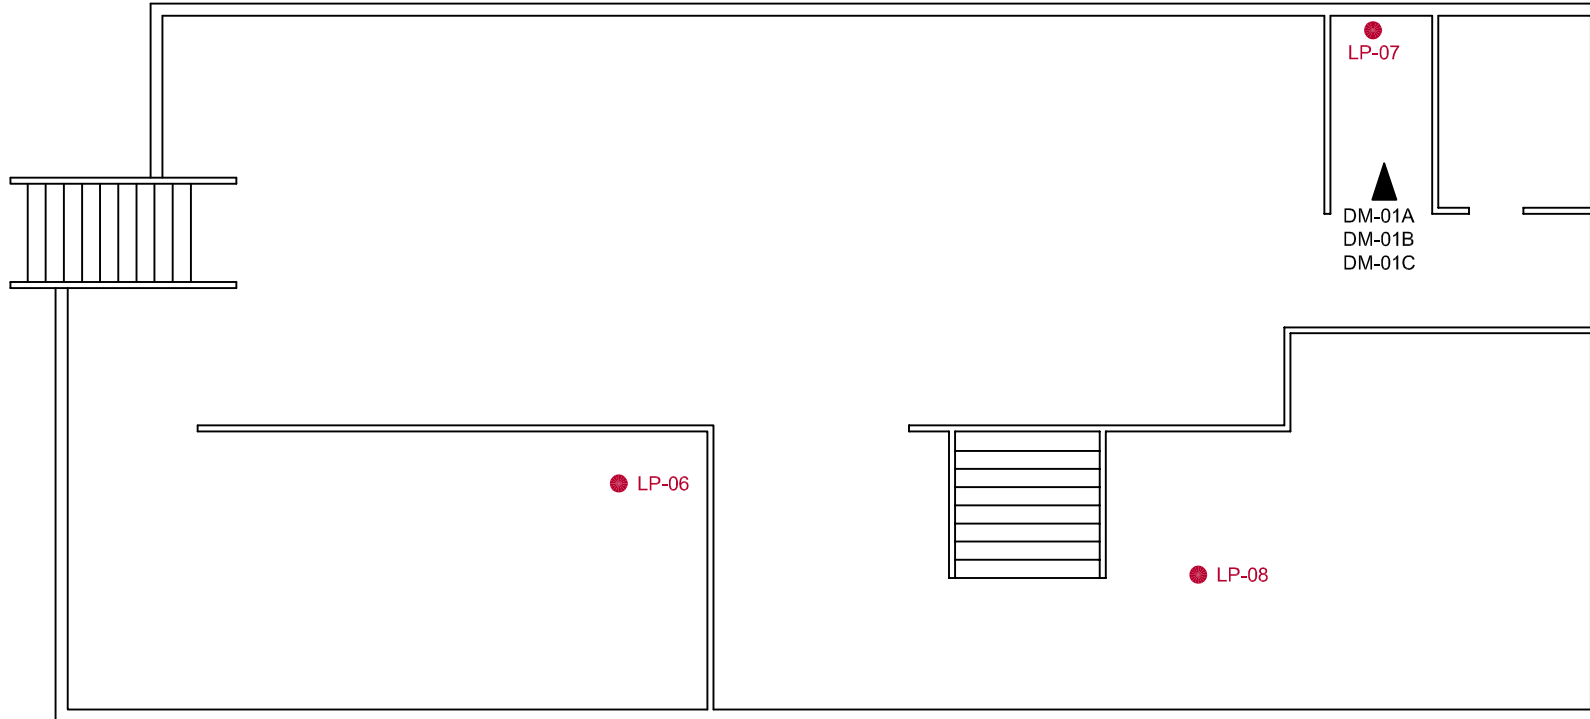
**BUILDING 823223: OLD DETACHMENT
BASEMENT**

NOTES: 1. BROWN HVAC DUCT MASTIC THROUGHOUT IS ASBESTOS-CONTAINING.
2. SUSPECT MOULD PRESENT ON WALLS THROUGHOUT BASEMENT.

- Drywall materials within the basement that are impacted by moisture and suspect mould (the majority of, if not all drywall, approximately 500 square feet) should be removed accordance with applicable guidelines and accepted standards for such work (e.g., CCA 82). This will likely require the involvement of an experienced mould abatement contractor.
- The source of moisture is likely condensation due to the building not being heated and or insufficient ventilation/dehumidification. If these issues causing condensation are not planned to be addressed then mould and moisture impacted materials should not be replaced as the mould/moisture issues will likely reoccur.

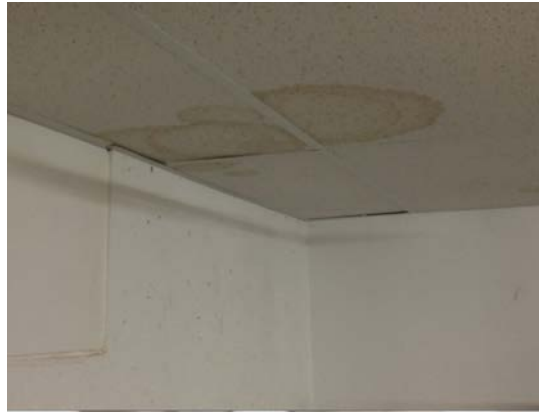
Identified Mould and/or Moisture Impacted Materials Description	Photo
<p>Water stained ceiling tiles observed in the basement by the oil storage tanks.</p> <p>Suspected source of moisture was pipe leaks in the ceiling space – or potentially condensation from HVAC systems and associated drip-pan overflow.</p>

- An assessment to determine the likely source(s) of water staining should be undertaken. Issues leading to moisture impacts and/or mould growth should be identified and addressed prior to reinstating building materials to areas where mould abatement is conducted, to avoid the potential for re-wetting of new materials, and repeated mould growth.

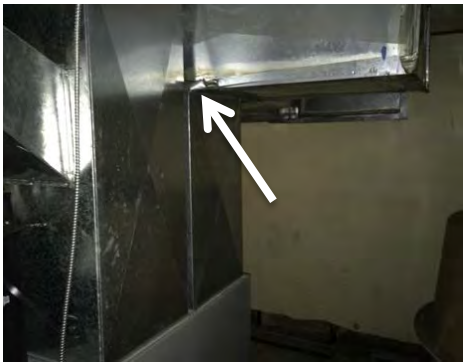
Identified ACM Description and Condition Information	
Brown duct mastic throughout	
% Type	0.90 % Chrysotile
Friability	Non-friable
Condition	Good

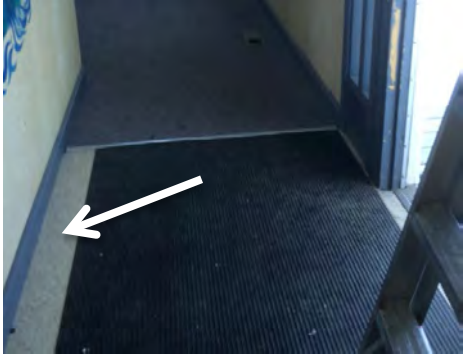
Identified ACM Description and Condition Information	
<p>Tan sheet flooring with grey dots in the front foyer, central stairwell to basement and stairwell to cells.</p> <p>% Type: 2.6% Chrysotile</p> <p>Friability: Non-friable in situ, friable during removal</p> <p>Condition: Good in most locations – observed to be cracking at the top of the central stairwell during the current assessment</p>

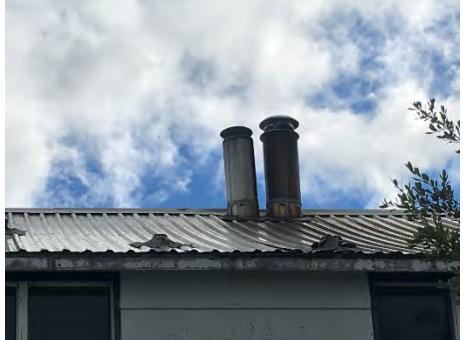
<p>Sealant on rooftop exhaust stack and plumbing vents. These materials were not sampled as safe access to the roof of the subject building was not available. As these materials are known to have been manufactured with asbestos, they should be presumed to be asbestos-containing unless proven otherwise by laboratory analysis.</p> <p>% Type: Unknown - PACM</p> <p>Friability: Non-Friable</p> <p>Condition: Presumed good</p>

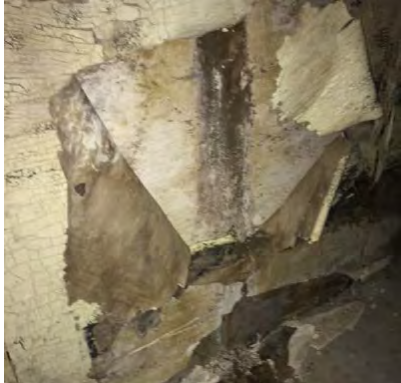
Identified Mould and and/or Moisture-Impacted Materials Description	Photo
Suspect mould on drywall was observed throughout the basement. The suspected source of moisture is condensation due to the building not being heated and/or insufficient ventilation/dehumidification.

When demolition work within the subject building proceeds, it is expected that mould and/or moisture impacted building materials, will be removed and disposed of during that process. Due to the actual or potential presence of mould on building materials in the building (particularly pertaining to drywall walls in the basement), and if those impacted materials are to be removed by hand, demolition workers should be notified of the potential presence of mould and be provided with respiratory protection and/or other personal protective equipment as deemed necessary for the work that they will be conducting.

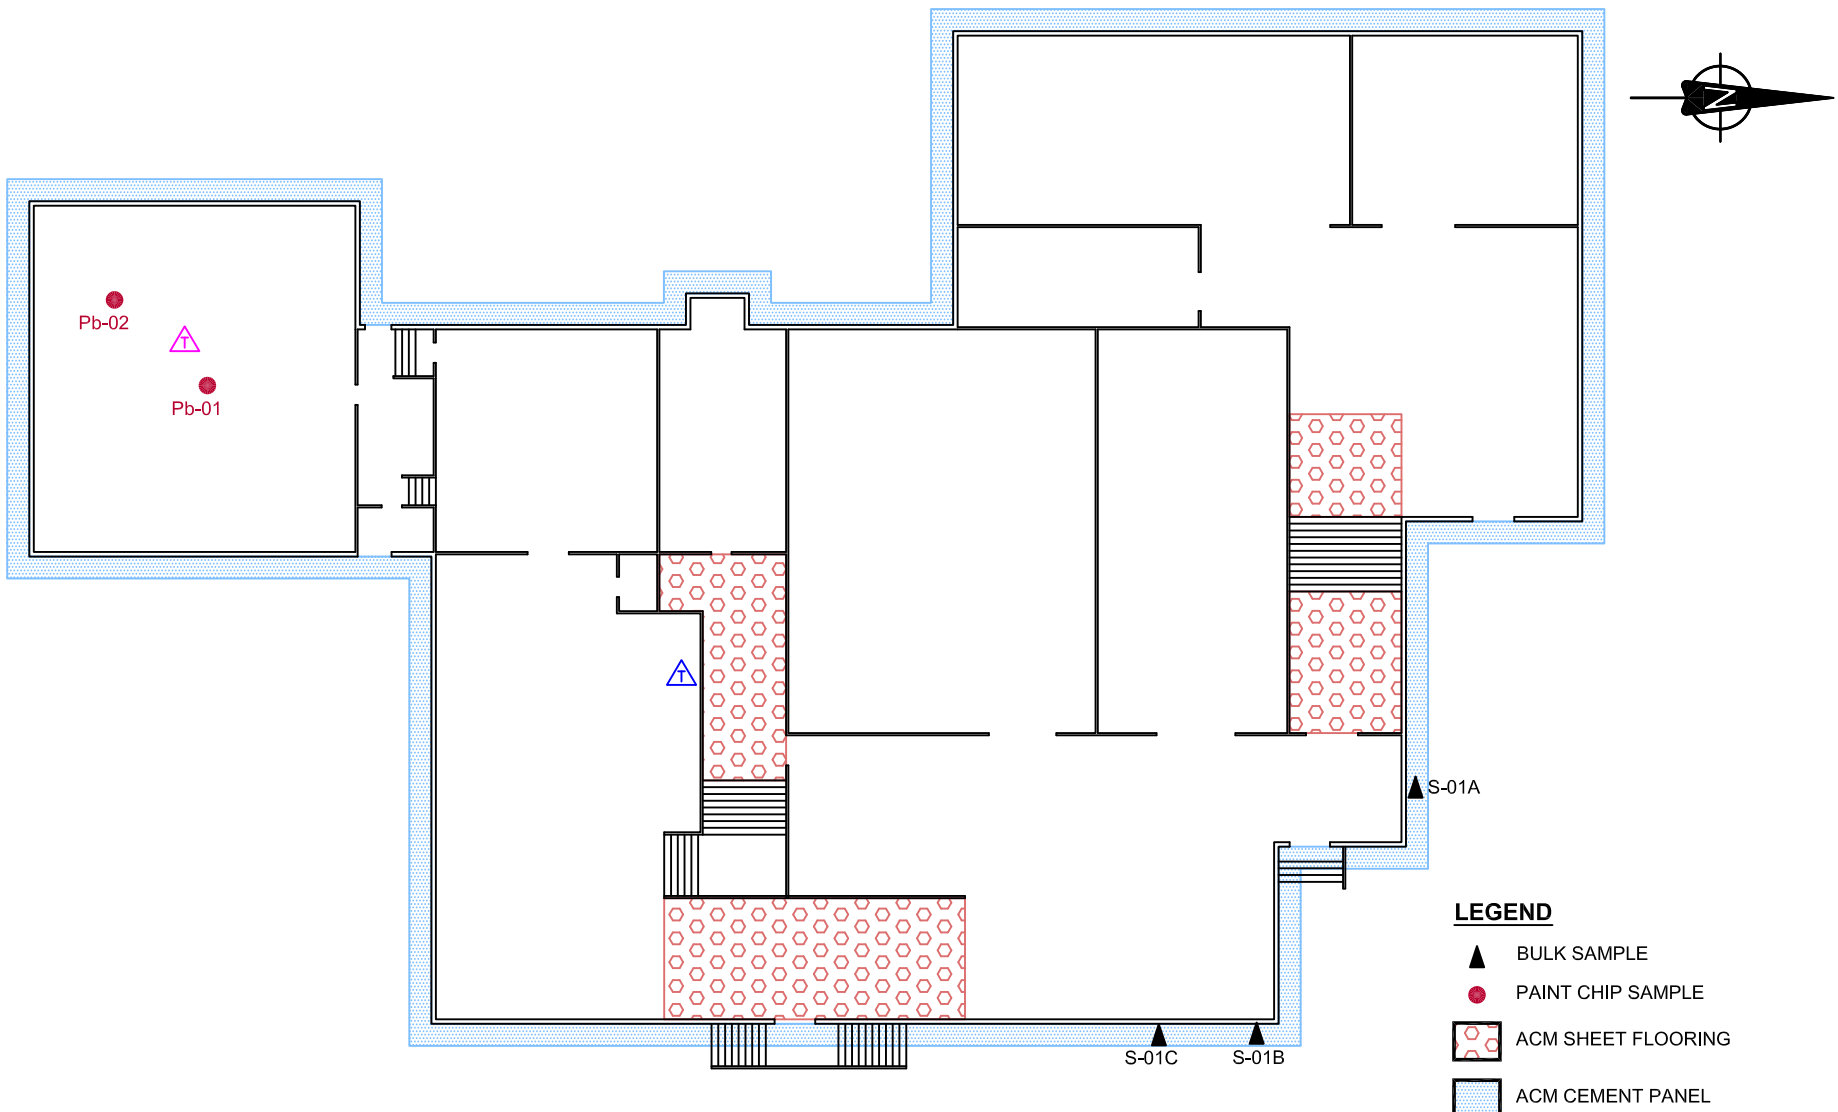
**BUILDING 823223: OLD DETACHMENT
MAIN FLOOR**

NOTES: 1. BROWN HVAC DUCT MASTIC THROUGHOUT IS ASBESTOS-CONTAINING.
2. THIS DRAWING ILLUSTRATES SUPPORTING INFORMATION SPECIFIC TO A STANTEC CONSULTING LTD. REPORT AND MUST NOT BE USED FOR OTHER PURPOSES.

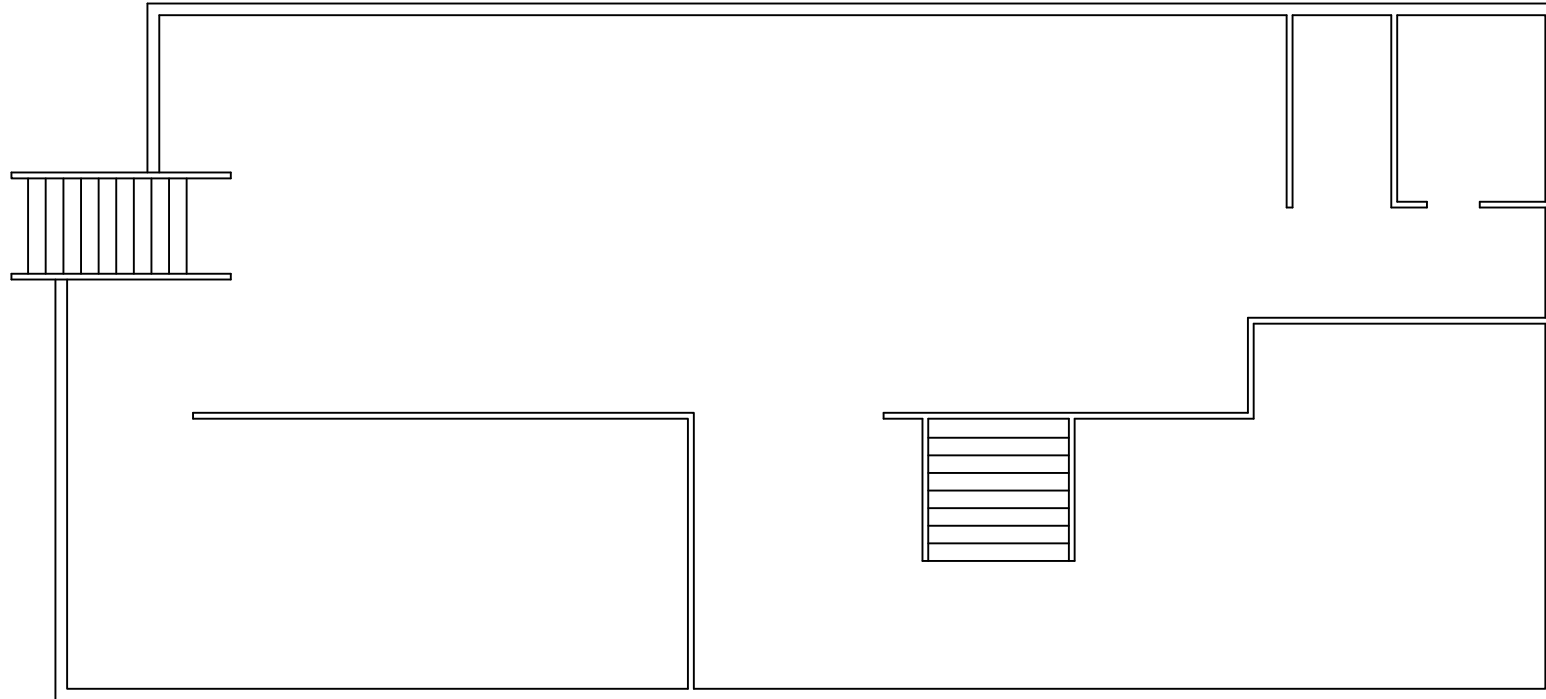
**BUILDING 823223: OLD DETACHMENT
BASEMENT**

- NOTES:** 1. BROWN HVAC DUCT MASTIC THROUGHOUT IS ASBESTOS-CONTAINING.
 2. SUSPECT MOULD PRESENT ON WALLS THROUGHOUT BASEMENT.
 3. THIS DRAWING ILLUSTRATES SUPPORTING INFORMATION SPECIFIC TO A STANTEC CONSULTING LTD. REPORT AND MUST NOT BE USED FOR OTHER PURPOSES.

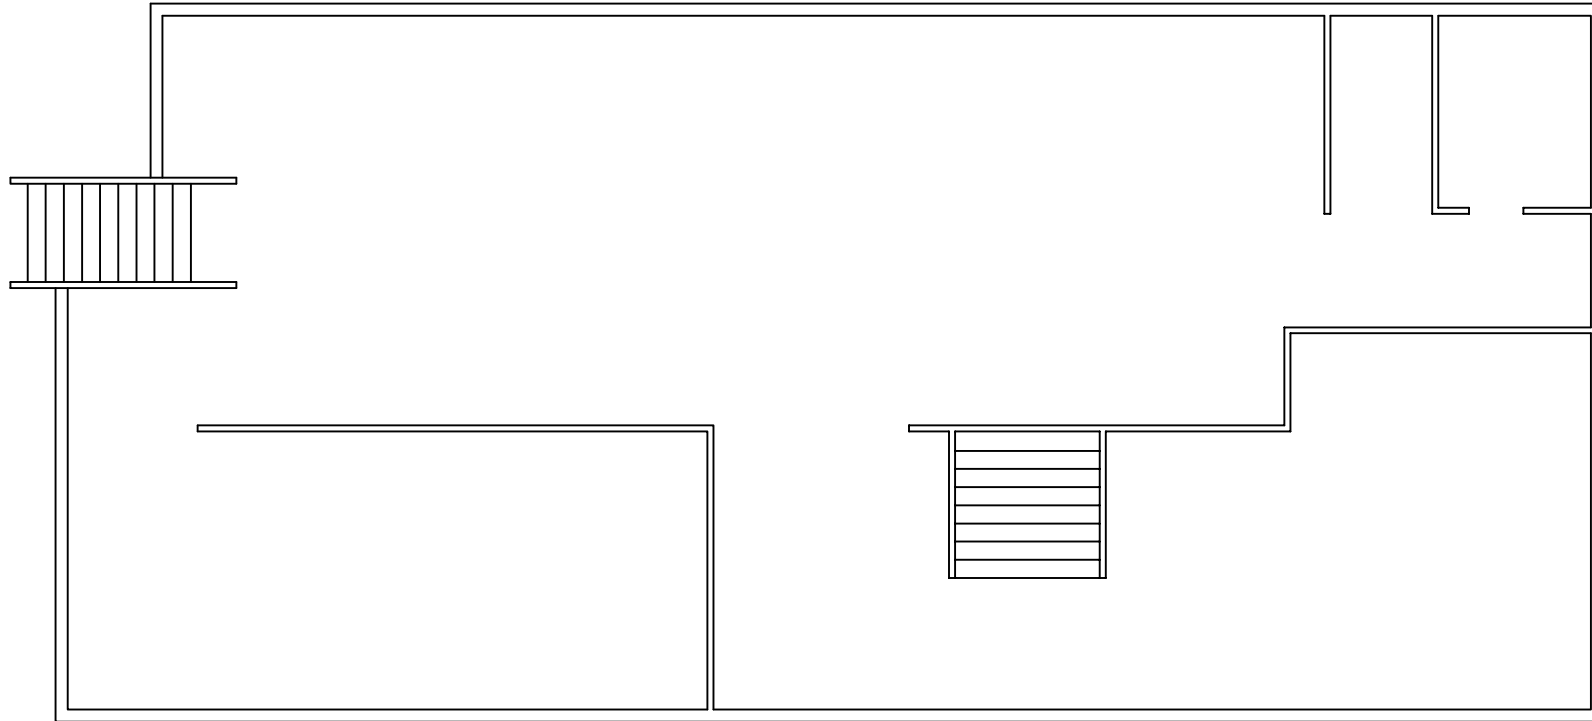
**BUILDING 823223: OLD DETACHMENT
BASEMENT**

- NOTES:** 1. BROWN HVAC DUCT MASTIC THROUGHOUT IS ASBESTOS-CONTAINING.
 2. SUSPECT MOULD PRESENT ON WALLS THROUGHOUT BASEMENT.
 3. THIS DRAWING ILLUSTRATES SUPPORTING INFORMATION SPECIFIC TO A STANTEC CONSULTING LTD. REPORT AND MUST NOT BE USED FOR OTHER PURPOSES.

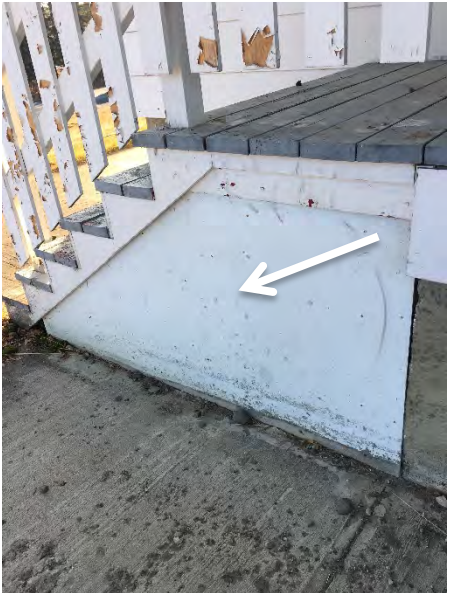
Cement panel on exterior lower walls of the subject building	
% Type	25% Chrysotile
Friability	Non-friable in situ
Condition	Good

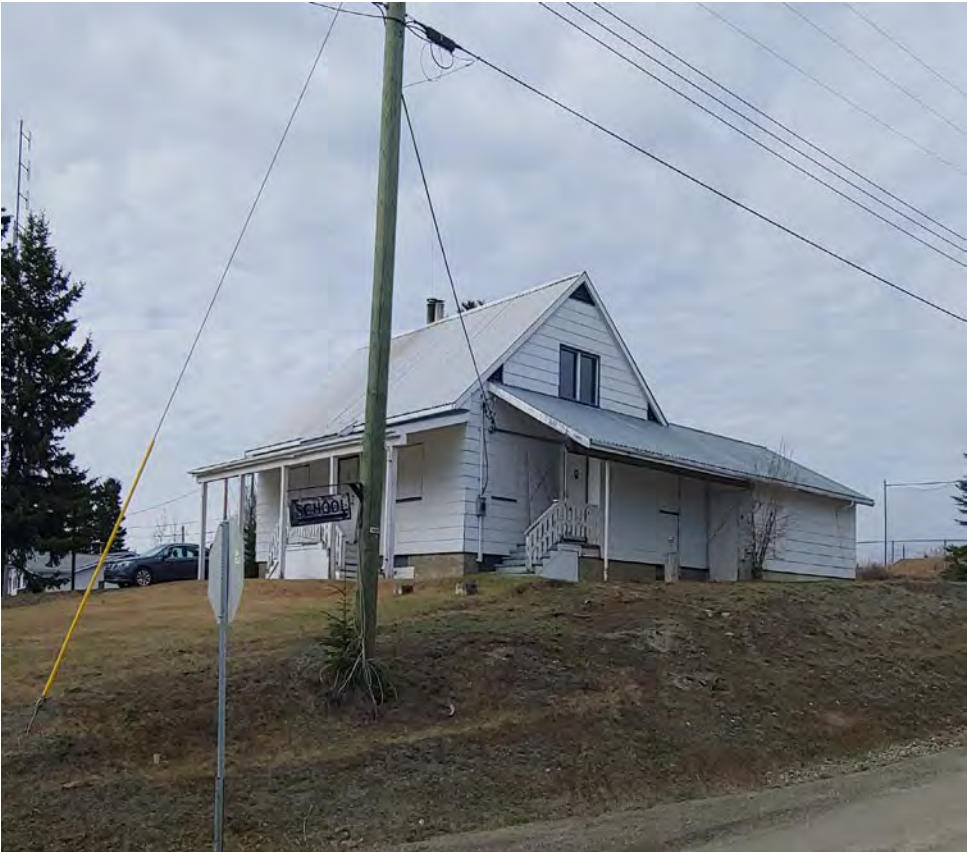
Item:	Description:	Comments:
1.0	General	
	<p>1. This observation report has been prepared at the request of RCMP M Division in response to queries raised by Stantec Consulting to assist with their preparation of a scope of work for hazardous materials abatement on this building.</p> <p>2. Exterior view from NE of the old Detachment that has been boarded up. Exterior wall areas appear to be approximately 3200 sf (not excluding windows and doors):</p>

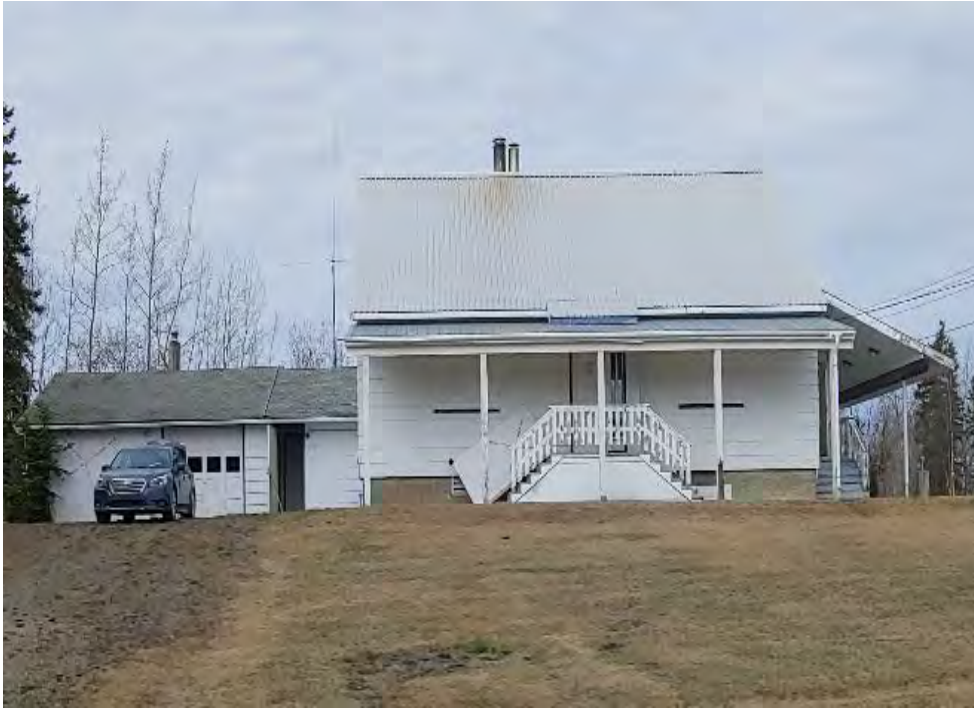
3. Front elevation:

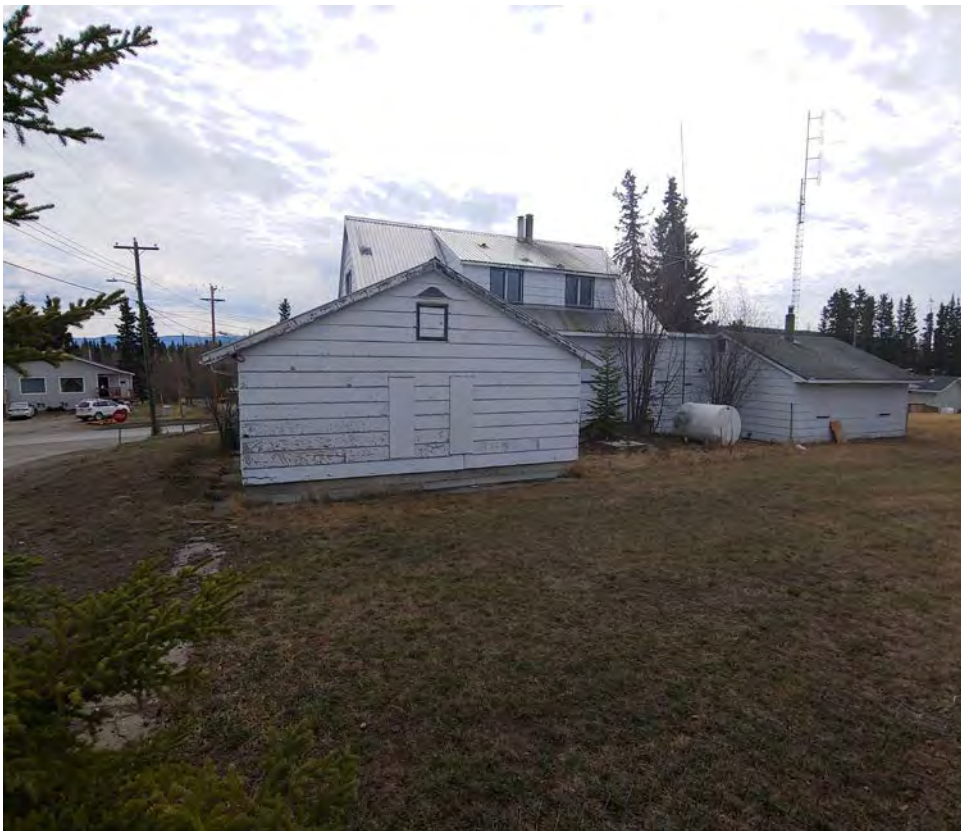
4. Rear elevation:

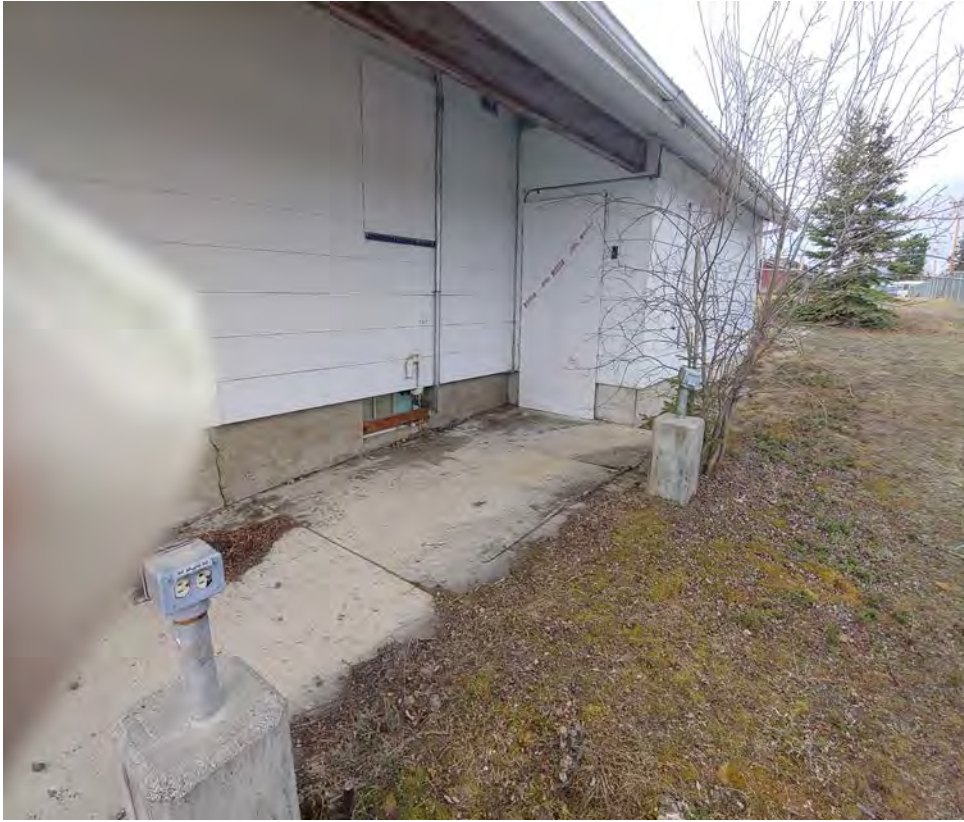
5. Cellblock addition:

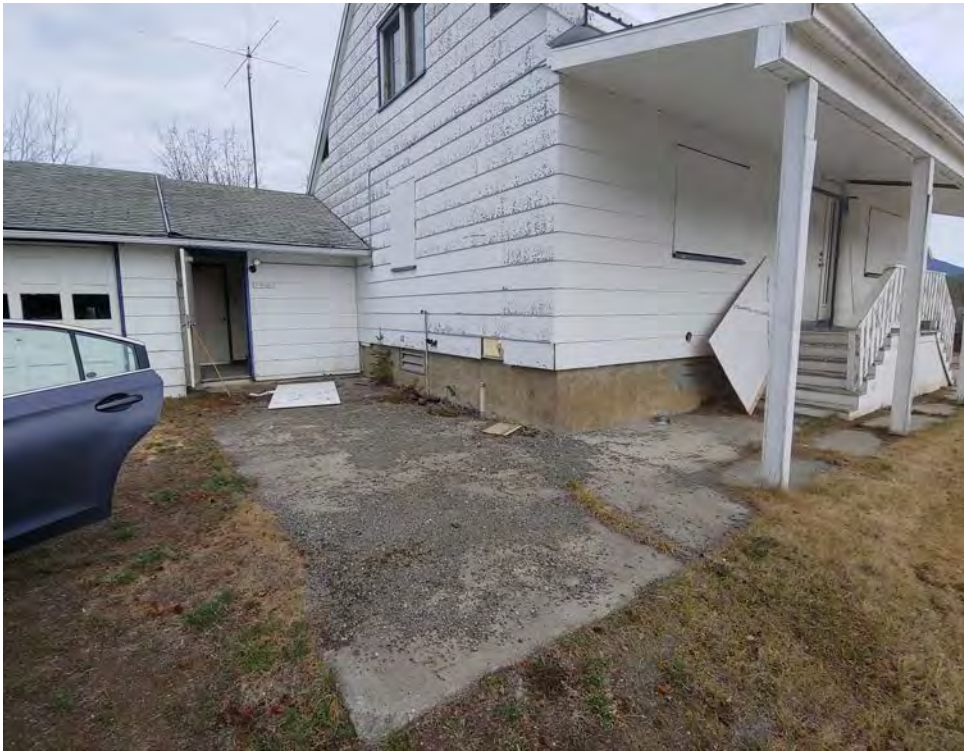
6. Residence side of building:

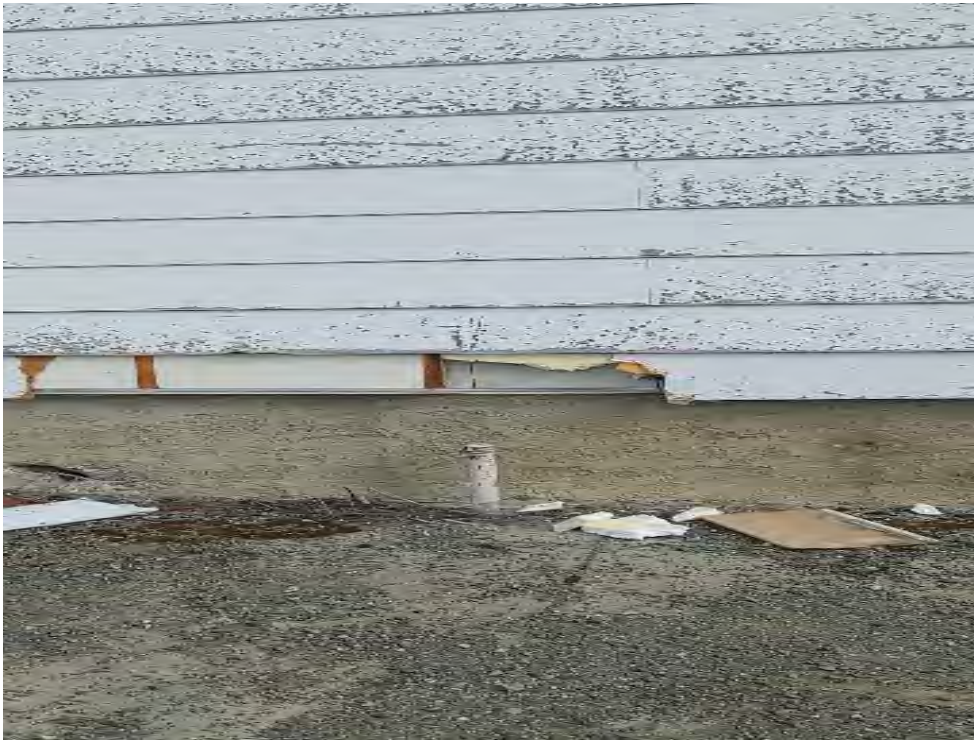
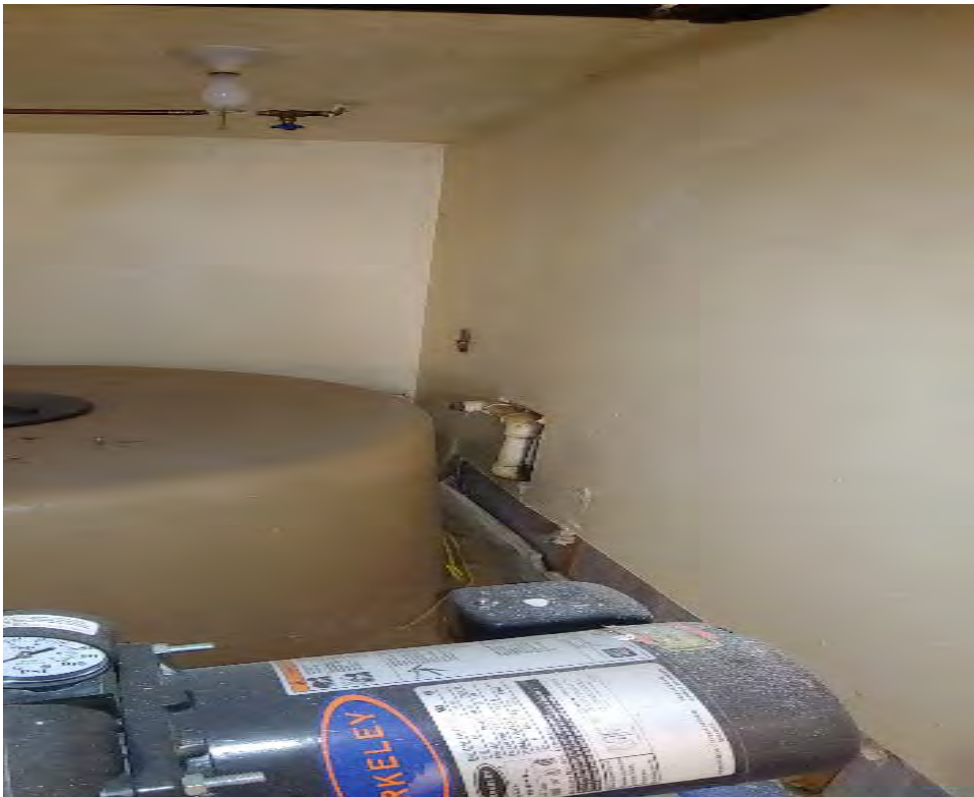
1. It appears there may have been a fuel tank located inside the building at one time:

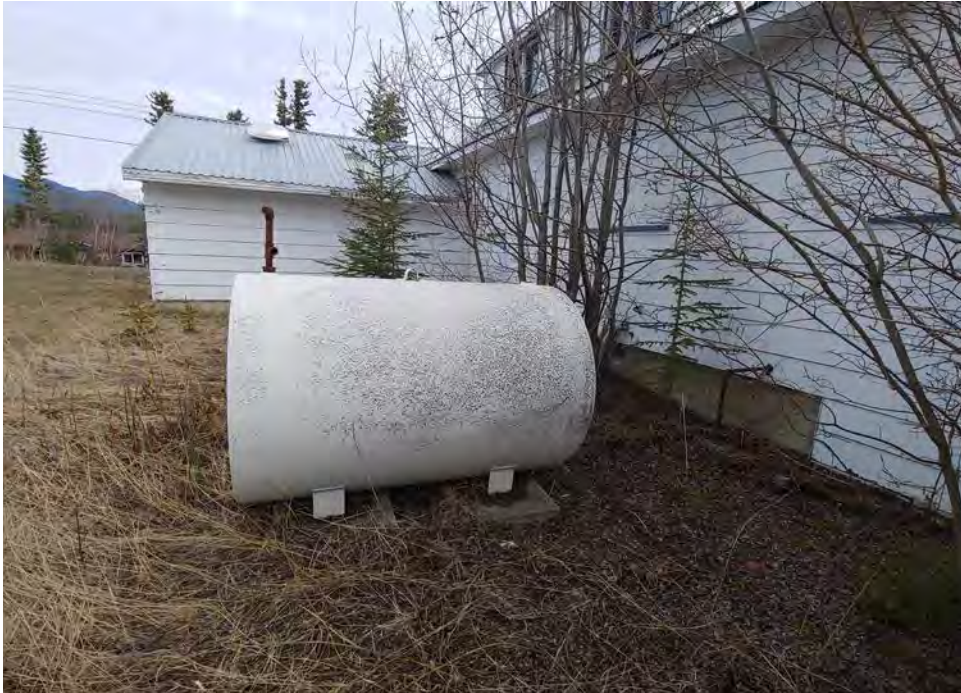
2. There is an abandoned, disconnected fuel tank outside the building:

3. It would be prudent to review the perimeter of the foundation excavations when demolition is underway to determine if there are any other fuel lines evident that could indicate the presence of an underground fuel oil tank.

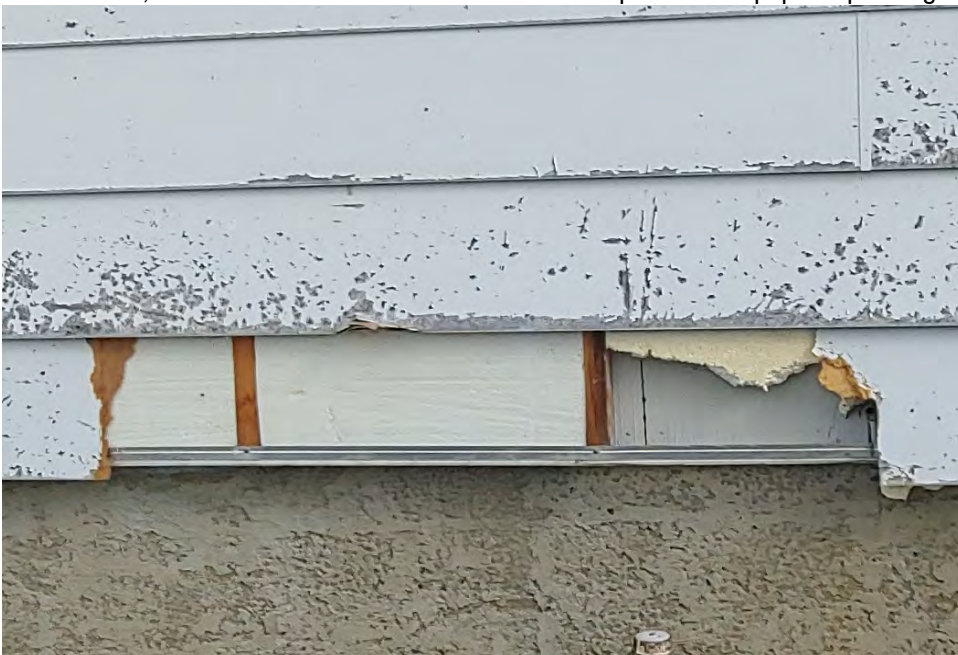
1. The exterior wall assembly appears to be comprised of a 2x4 framed wall, shiplap sheathing, asbestos cement shingle siding, 2x2 strapping @ 2' o.c., 1 1/2" beadboard insulation between and pressboard paper lap siding:

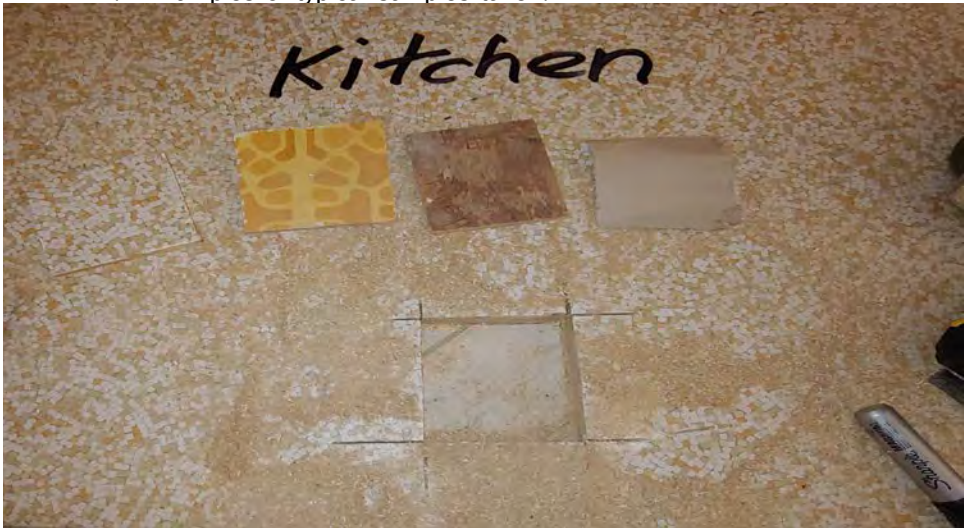
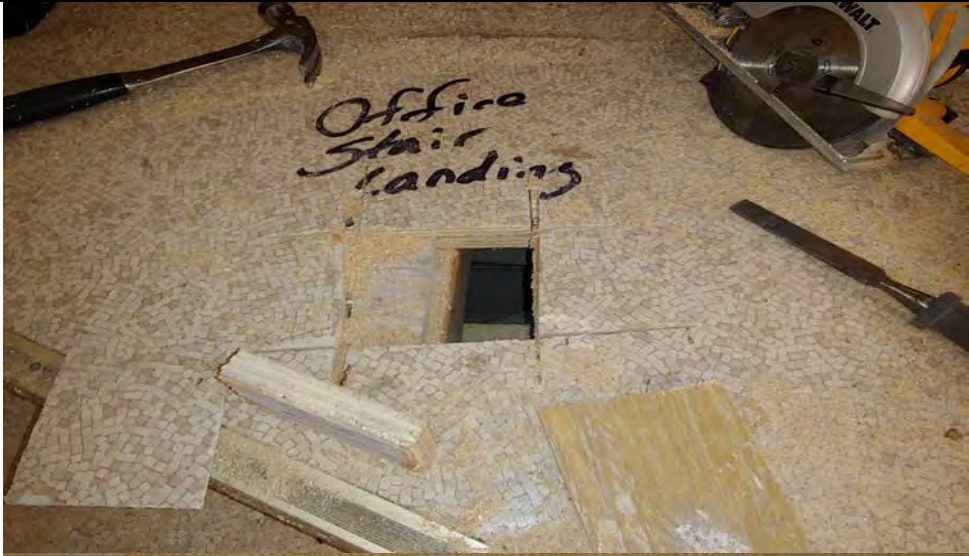
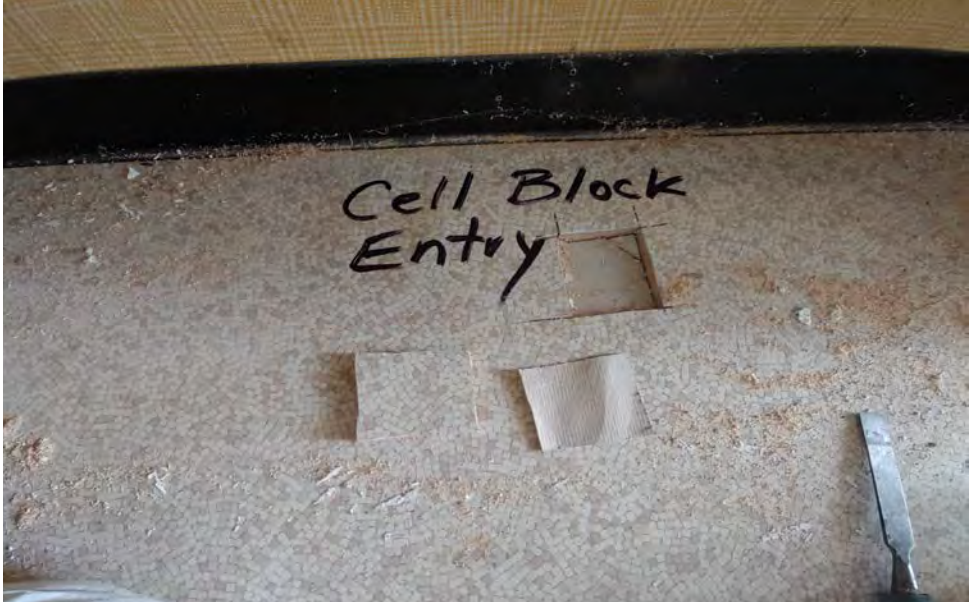
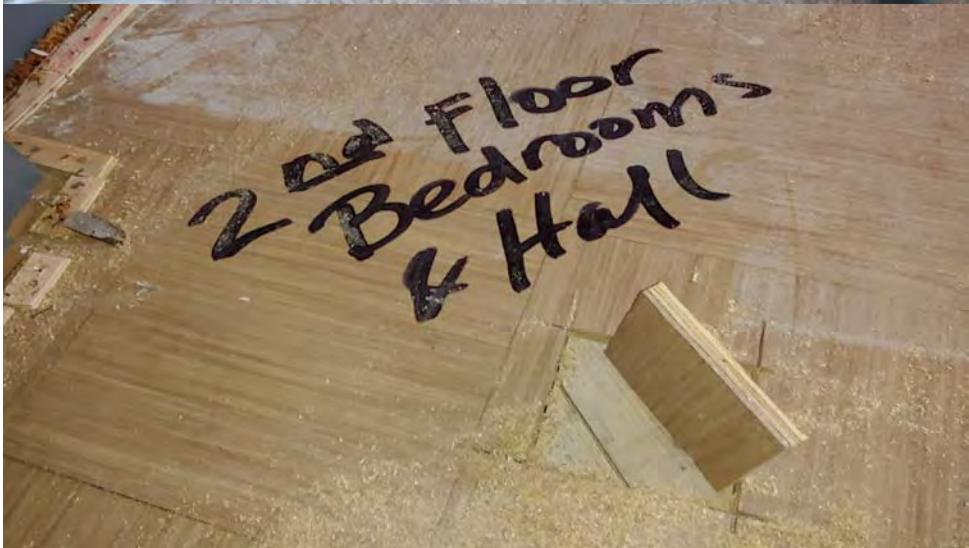
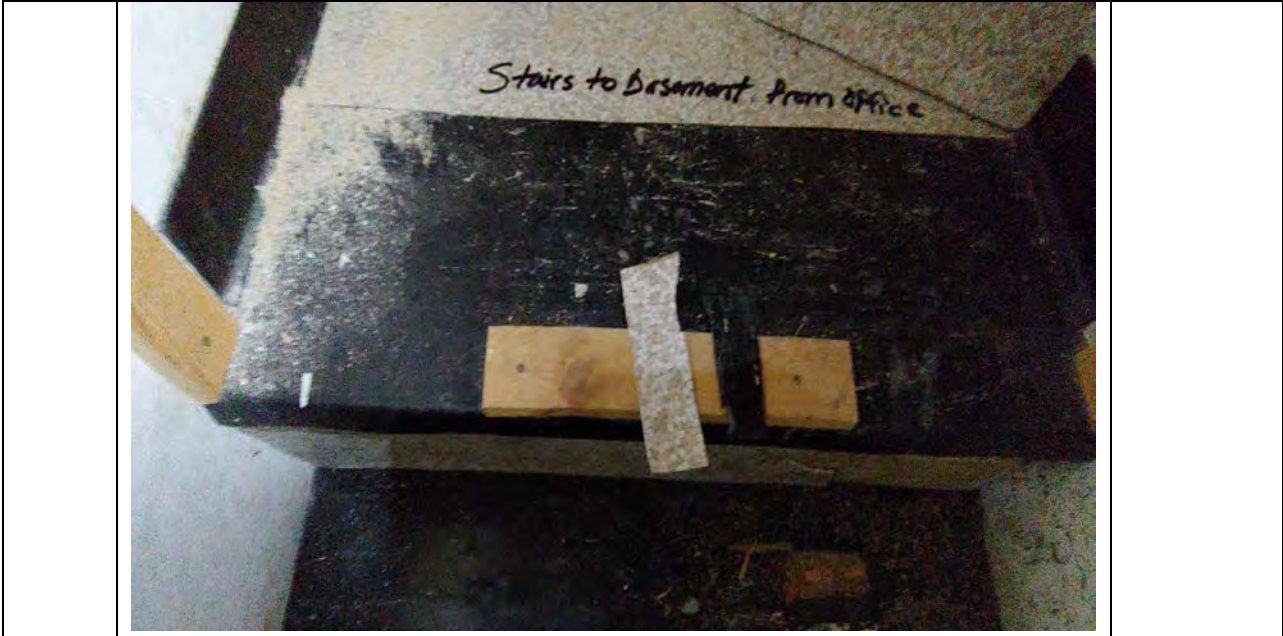
5.0	<p align="center">Interior Flooring Materials</p>	
	<p>1. The residence and office areas appear to have a brown floor tile (potentially ACM) as the base flooring layer throughout the main and 2nd floors. Carpet has been applied over the floor tile in the living room, offices and bedrooms. Layer(s) of RSF has been applied over the floor tile in the kitchen and office stair landing. Flooring samples were collected in all rooms for verification testing of ACM's. Flooring composition by layer was recorded..</p> <p>2. Examples of typical samples taken:</p>

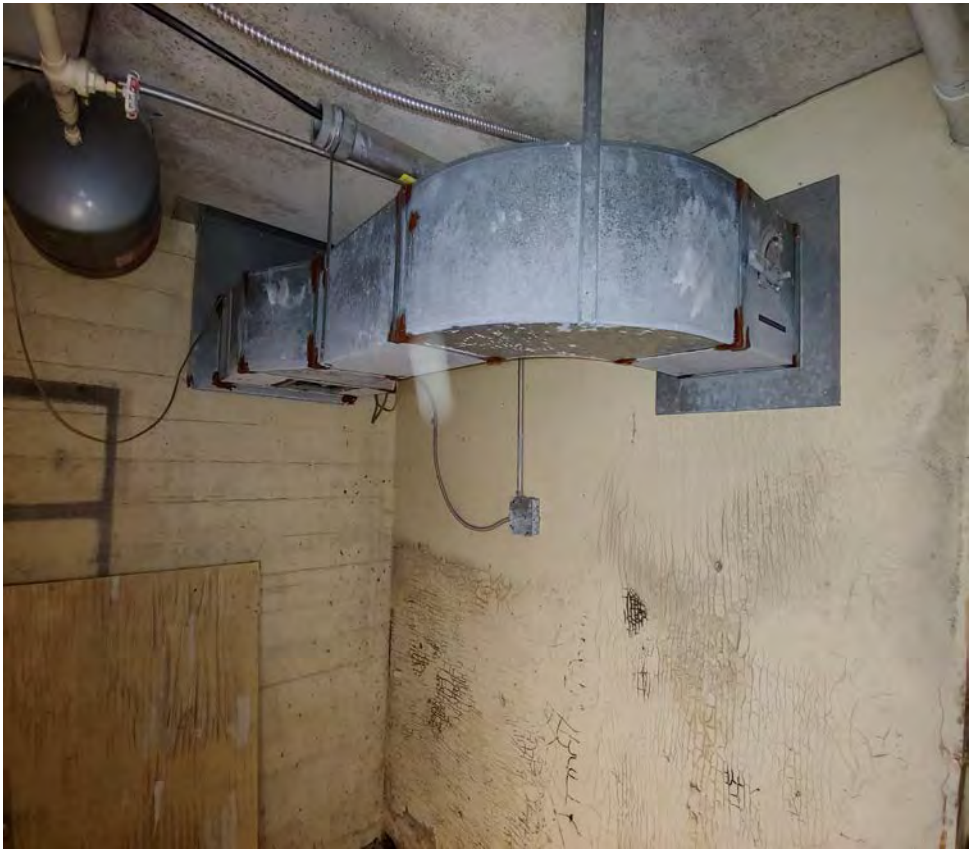
1. ACM mastic was observed in spot locations on the 10" x 10" fresh air ductwork located at the SW corner of the main basement area (where the laundry sink is located). There appeared to be approximately 12' of affected ductwork:

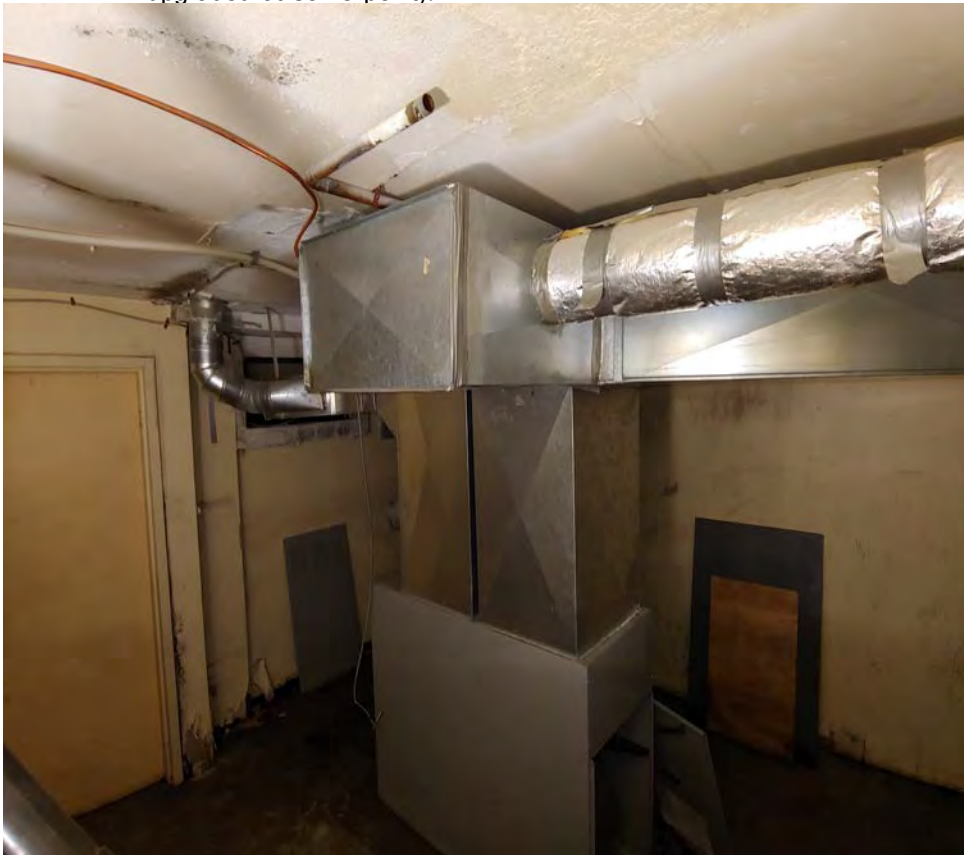
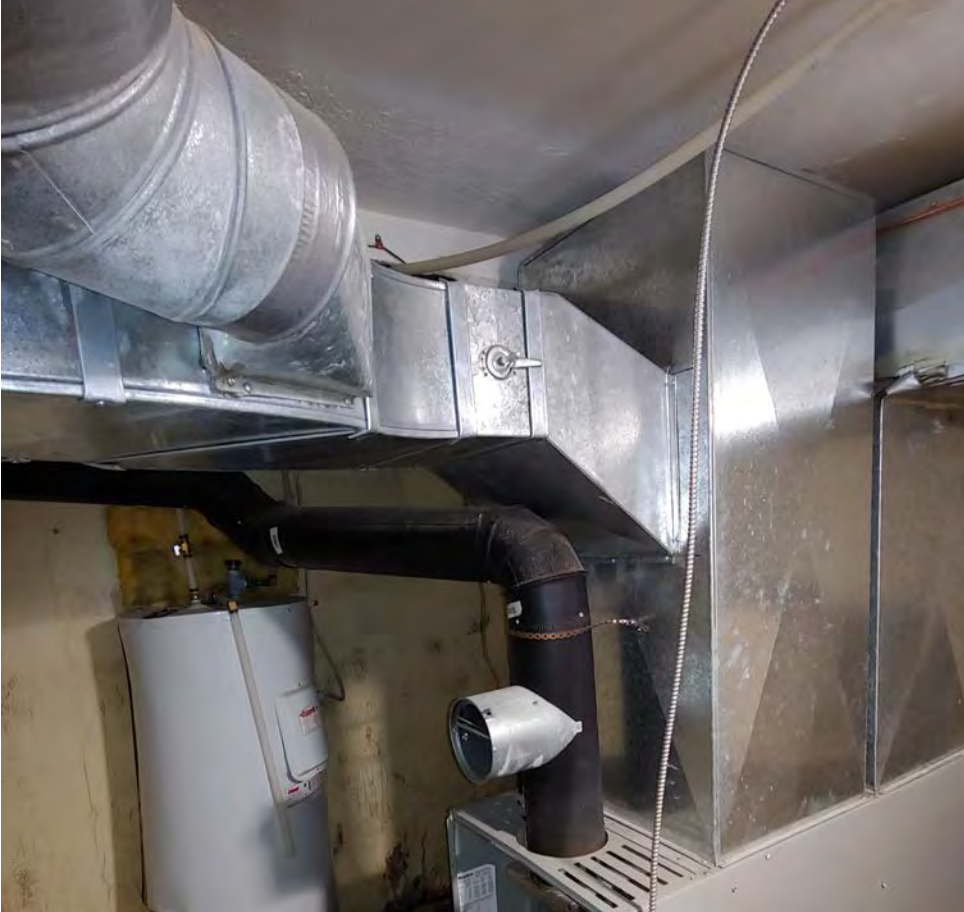
2. There was no brown mastic apparent on the forced air furnace and ductwork (it appeared the furnace and ductwork may have been upgraded at some point):
