Asbestos and Lead Reassessment Survey

Burlington Lift Bridge

Hamilton, Ontario

FINAL REPORT

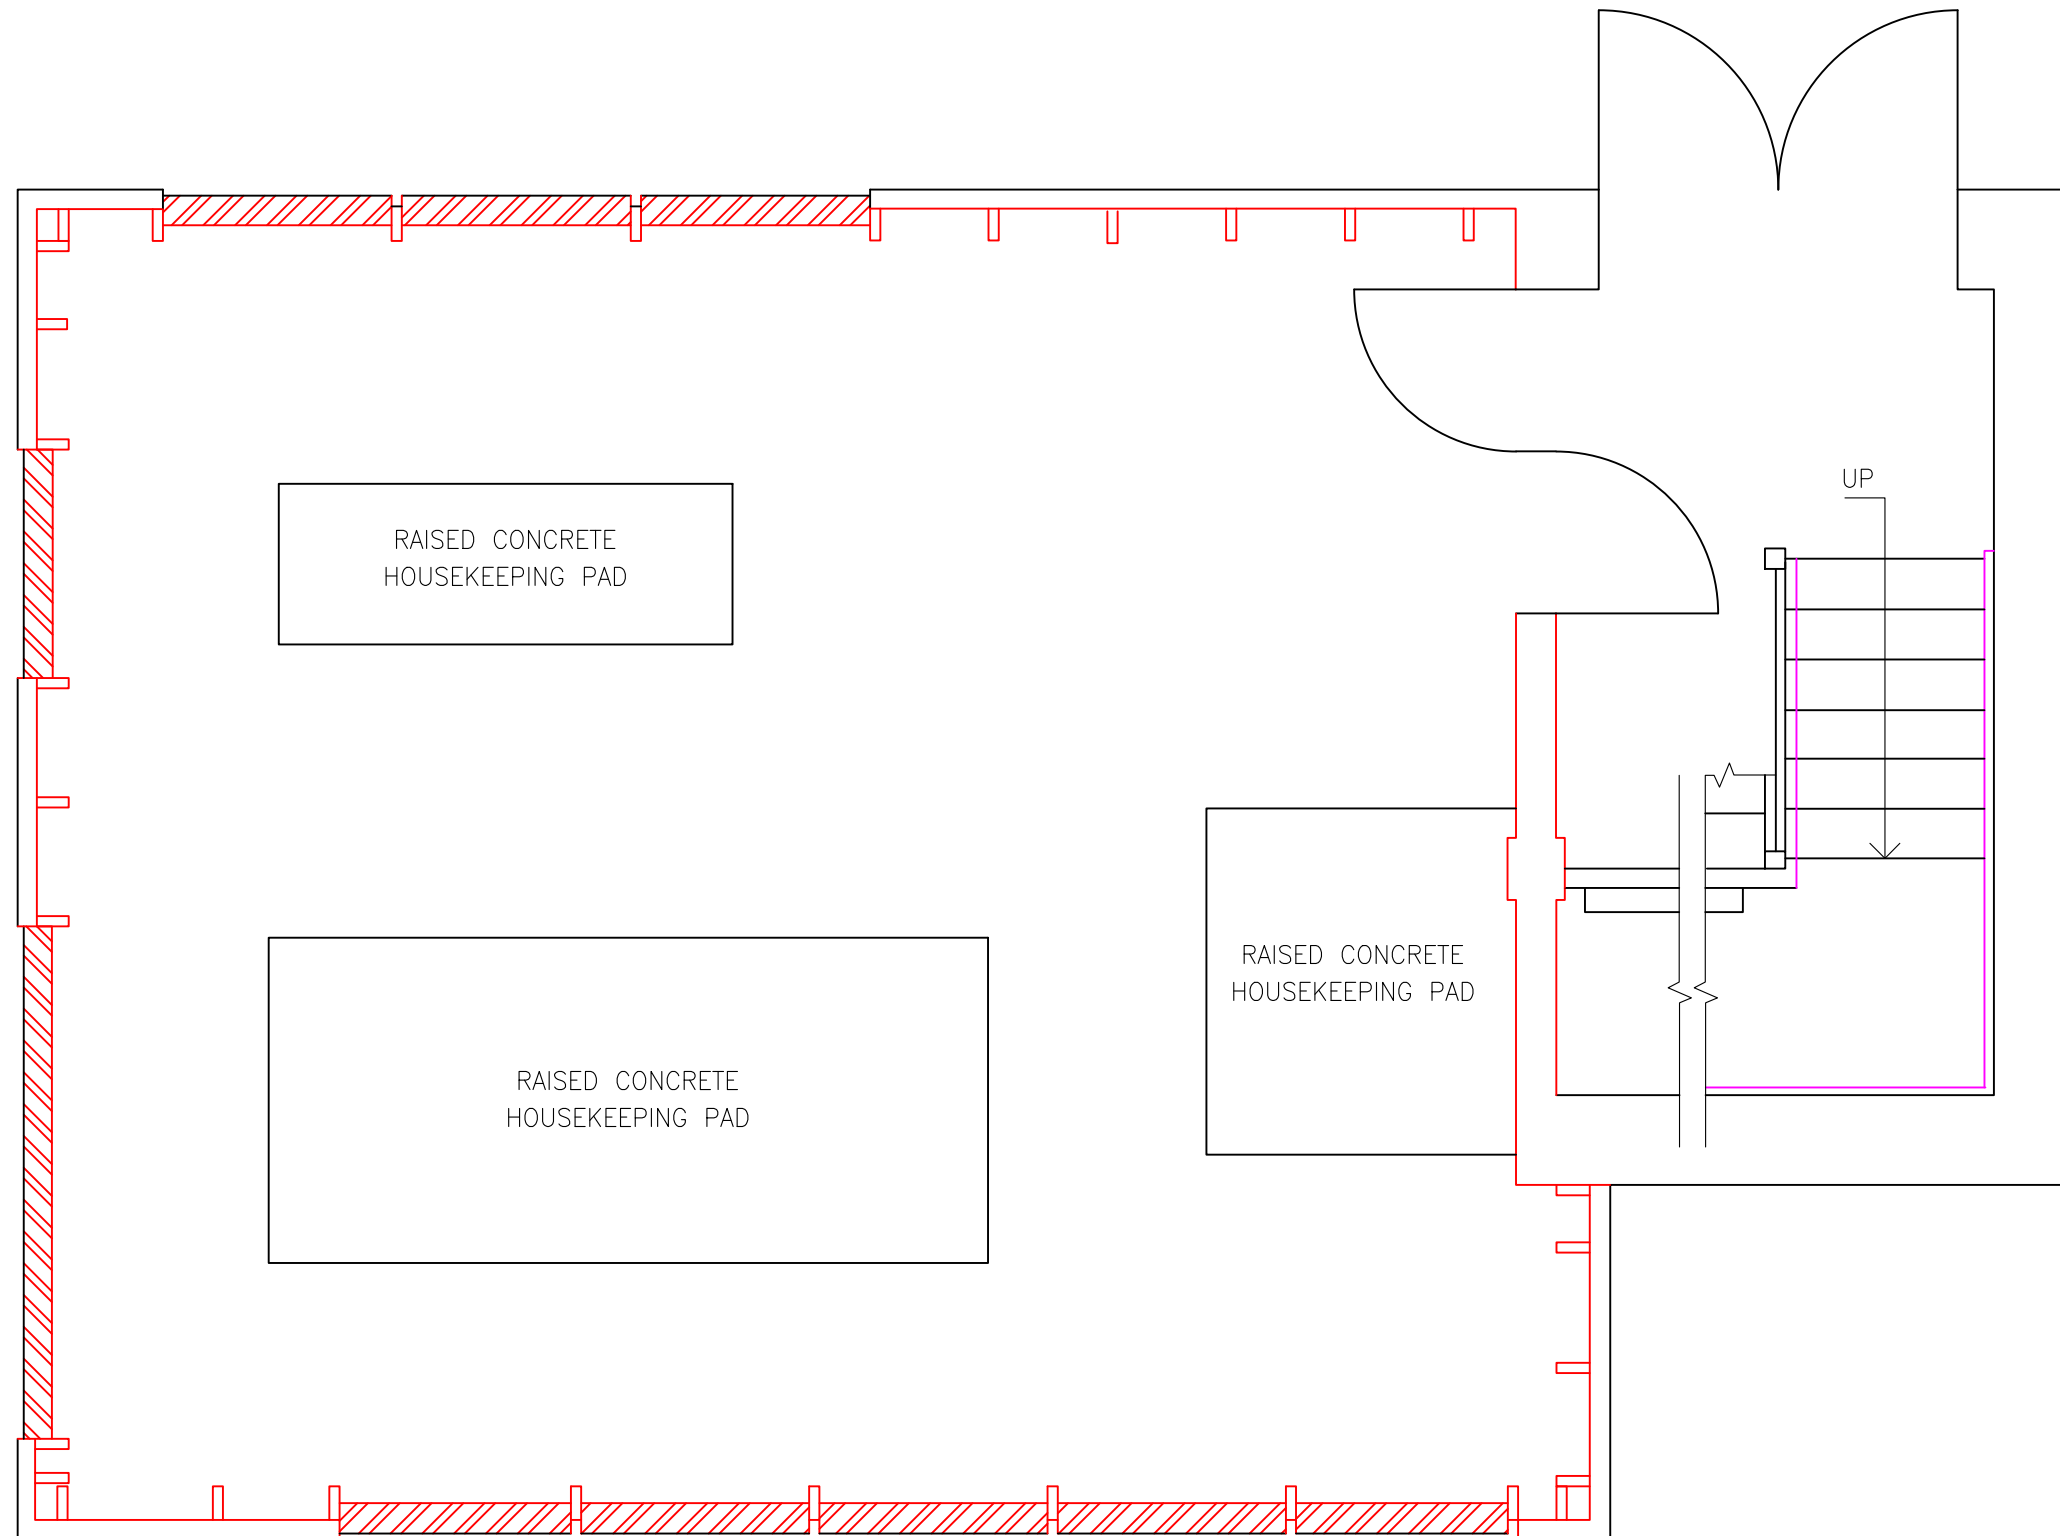
DRAWN BY: ROB SAJKUNOVIC	PROJECT No. 18-890
SCALE: AS NOTED	DWG. No. FIGURE 2
DATE: MARCH, 2018

LEAD-CONTAINING GREY RAILING PAINT *

* NOTE: LEAD CONTAINING PAINT APPLICATION WAS PAINTED OVER WITH A PAINT APPLICATION TO IMPROVE ITS EXISTING CONDITION.
LEAD-CONTAINING PAINT APPLICATION IS STILL PRESENT

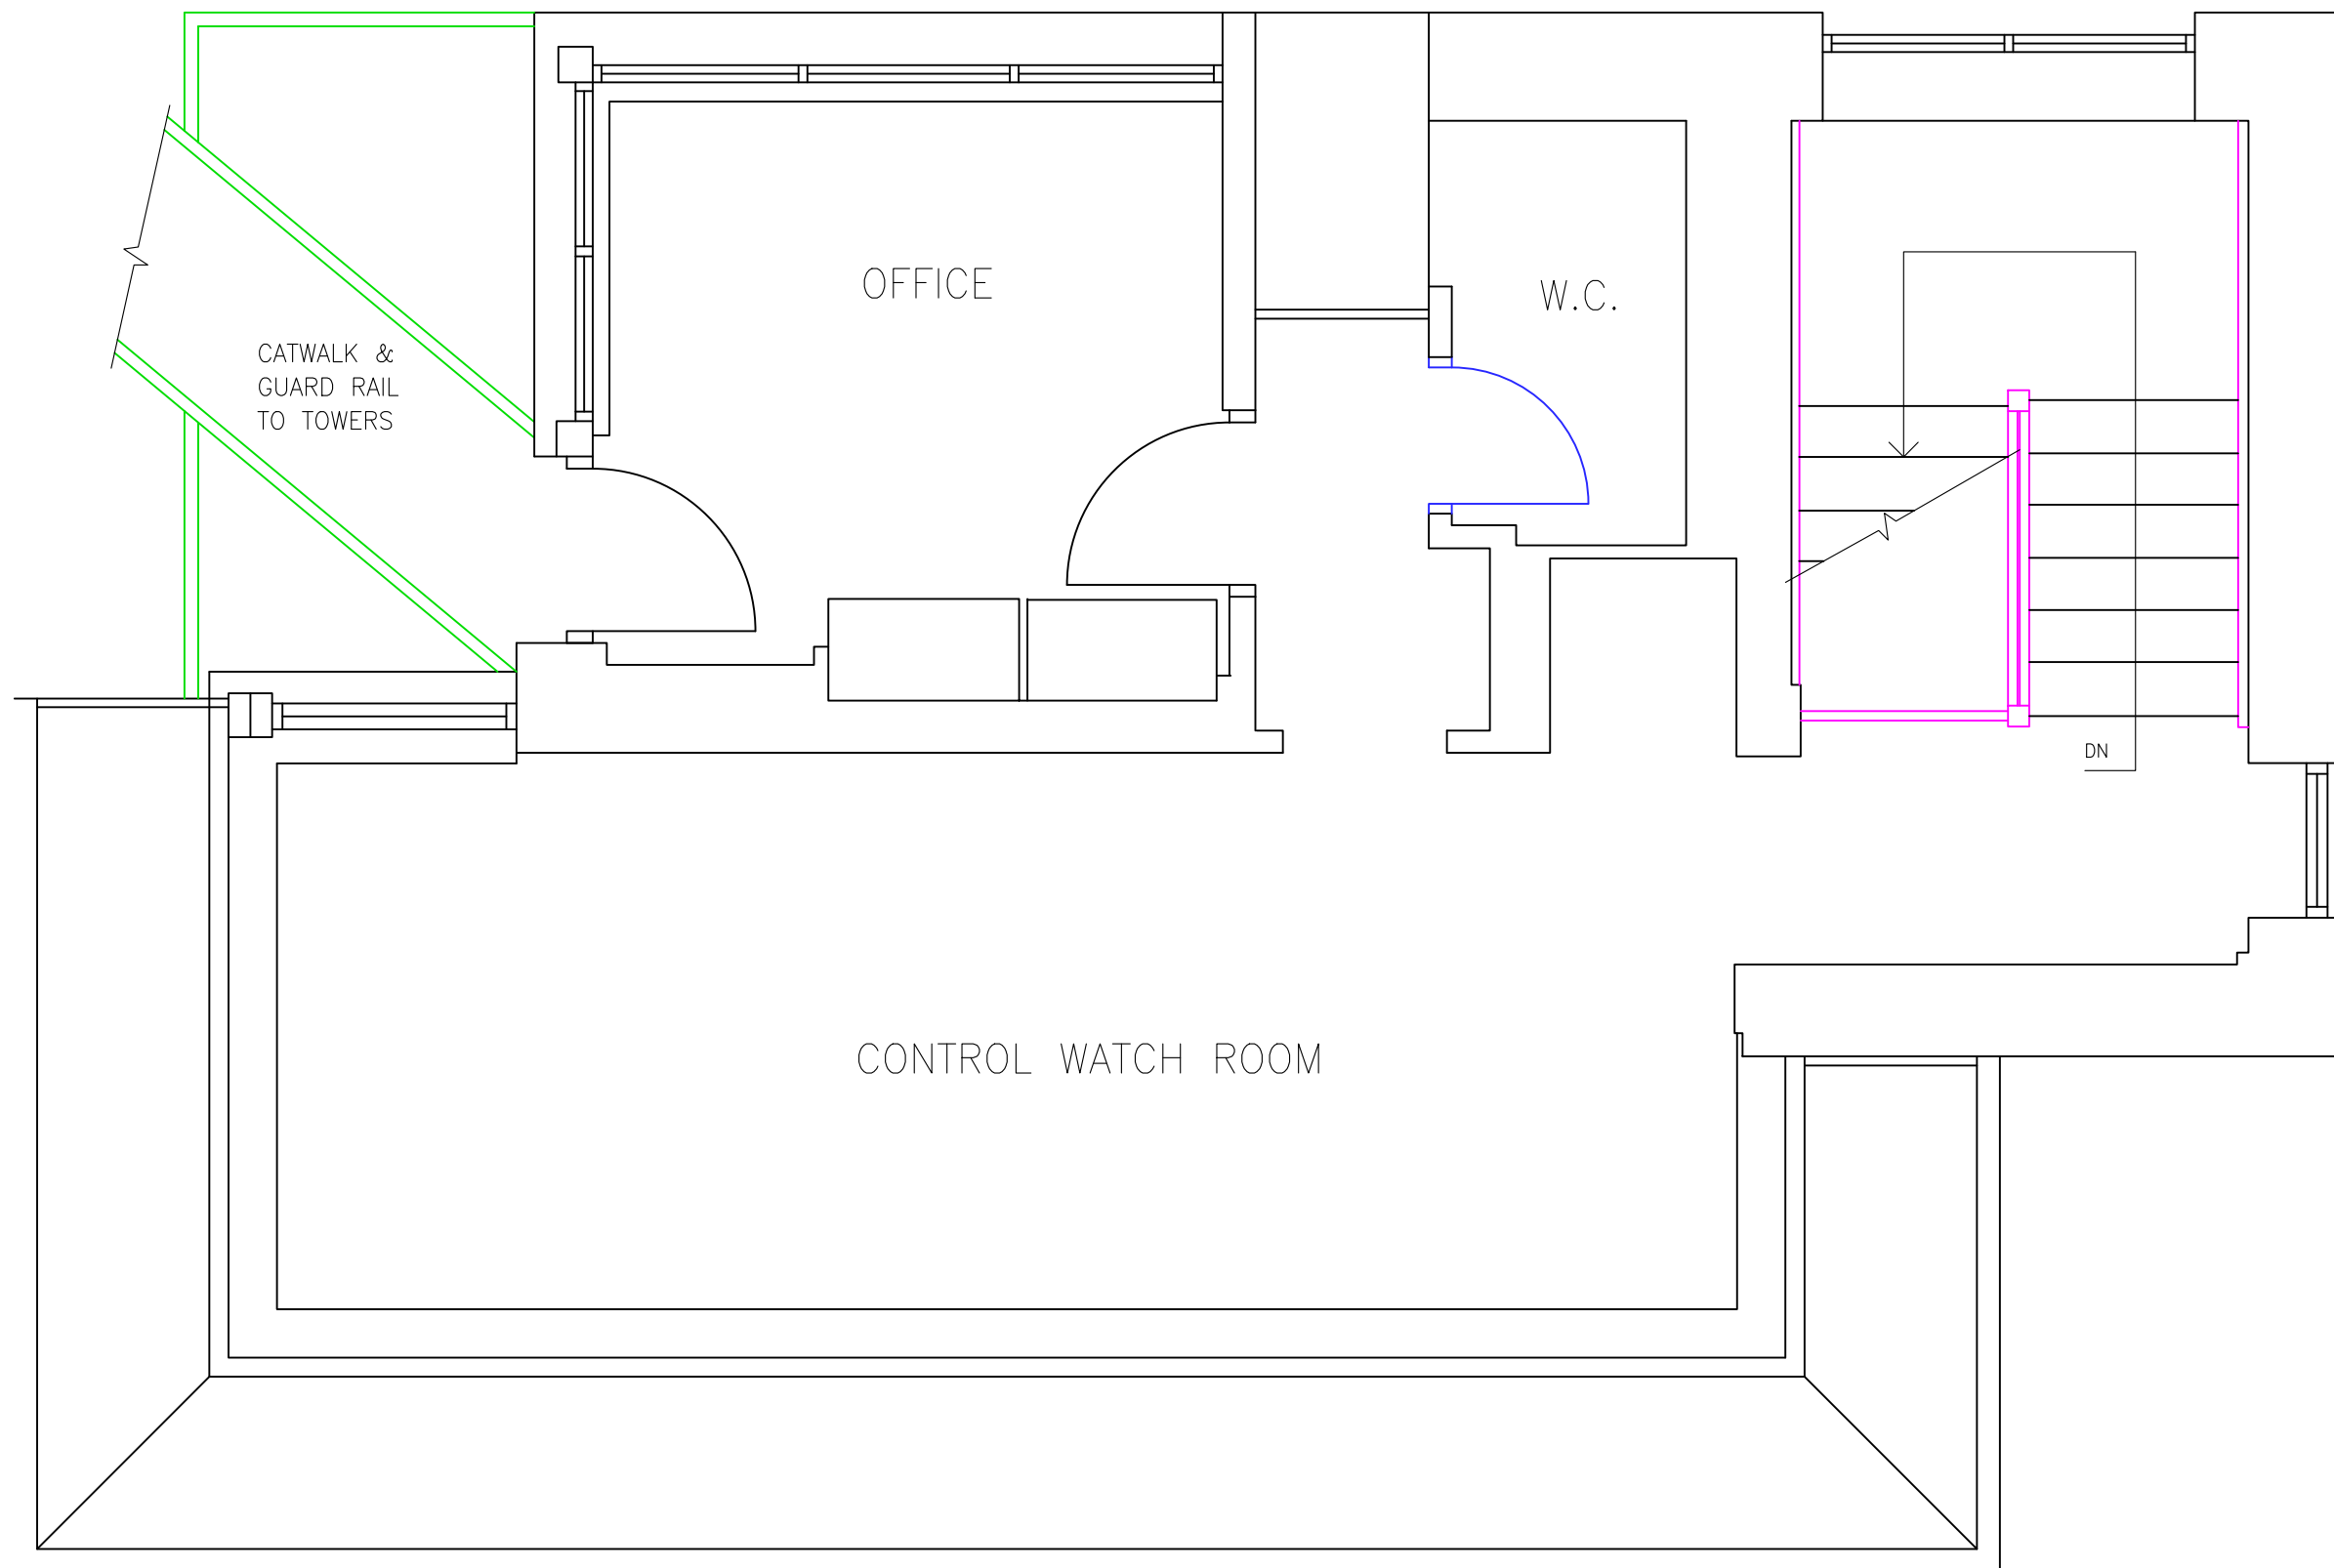
DRAWN BY: ROB SAJKUNOVIC	PROJECT No. 18-890
SCALE: AS NOTED	DWG. No. FIGURE 4
DATE: MARCH, 2018

- LEAD-CONTAINING GREY RAILING PAINT *
- LEAD-CONTAINING GREEN CATWALK PAINT
- BEIGE PAINT OVER LEAD-CONTAINING GREENISH GREY DOOR PAINT *

* NOTE: LEAD CONTAINING PAINT APPLICATION WAS PAINTED OVER WITH A PAINT APPLICATION TO IMPROVE ITS EXISTING CONDITION. LEAD-CONTAINING PAINT APPLICATION IS STILL PRESENT

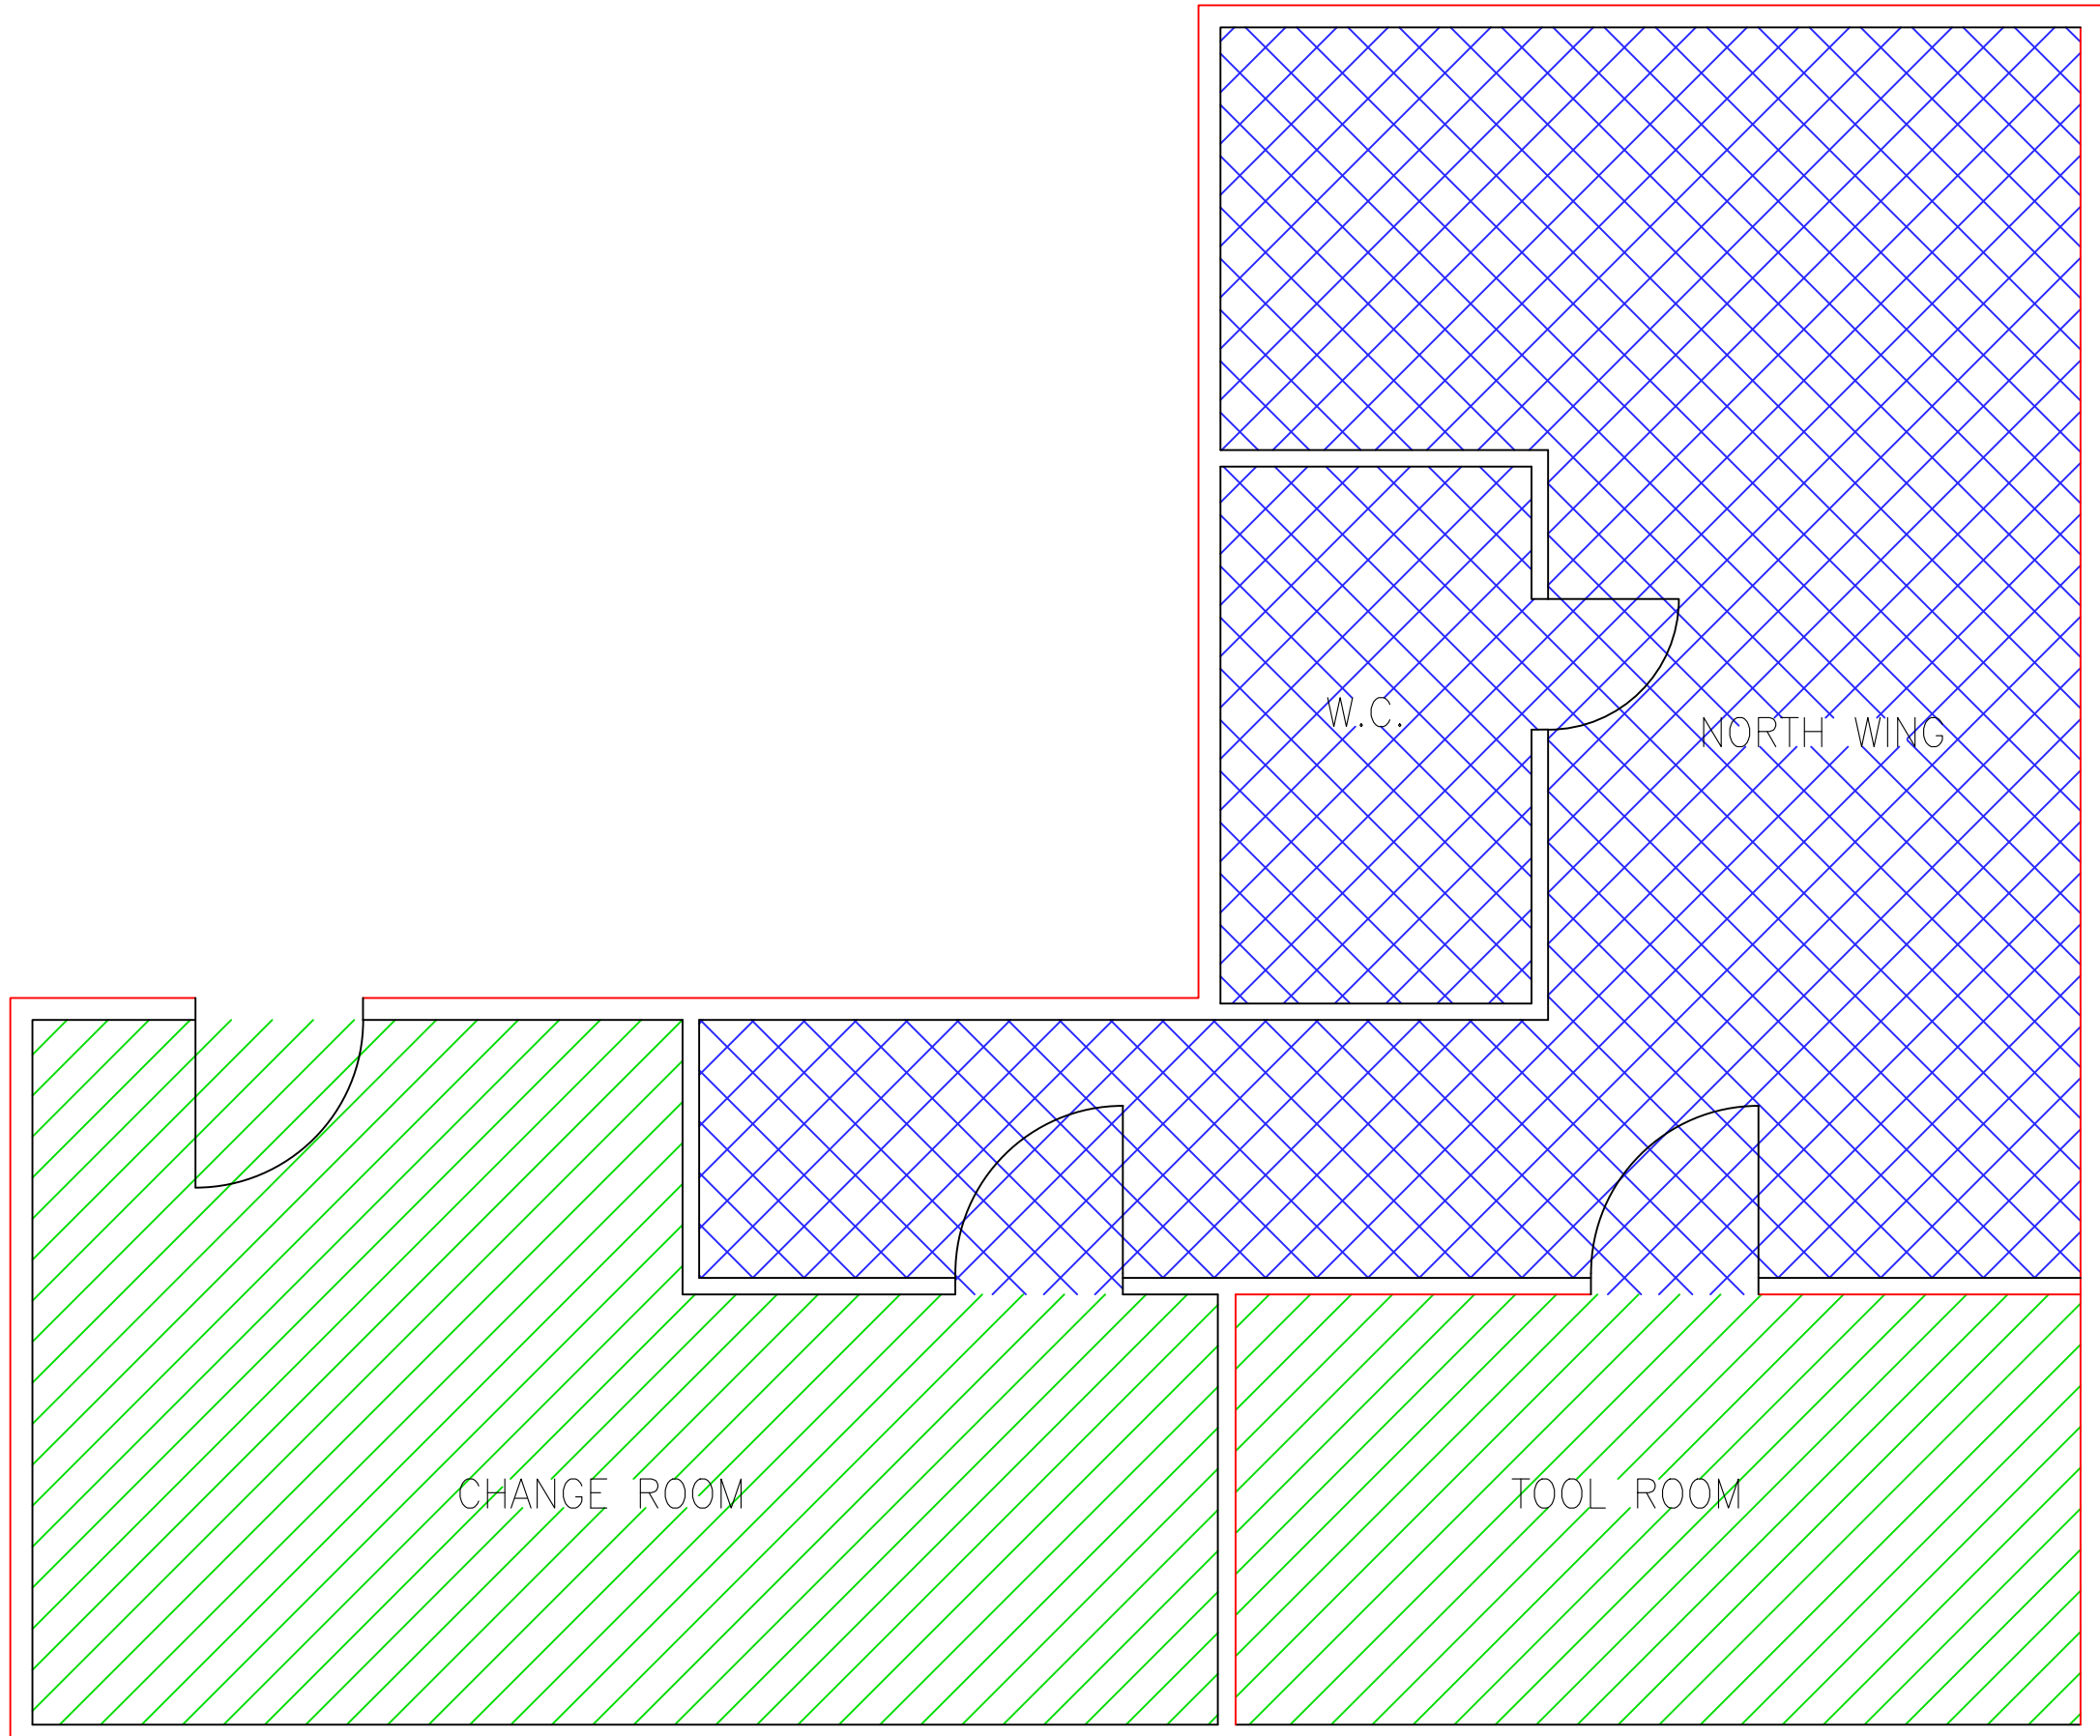
DRAWN BY: ROB SAJKUNOVIC	PROJECT No. 18-890
SCALE: AS NOTED	DWG. No. FIGURE 5
DATE: MARCH, 2018

LEAD-CONTAINING WHITE/BEIGE OVER GREY EXTERIOR WALL PAINT

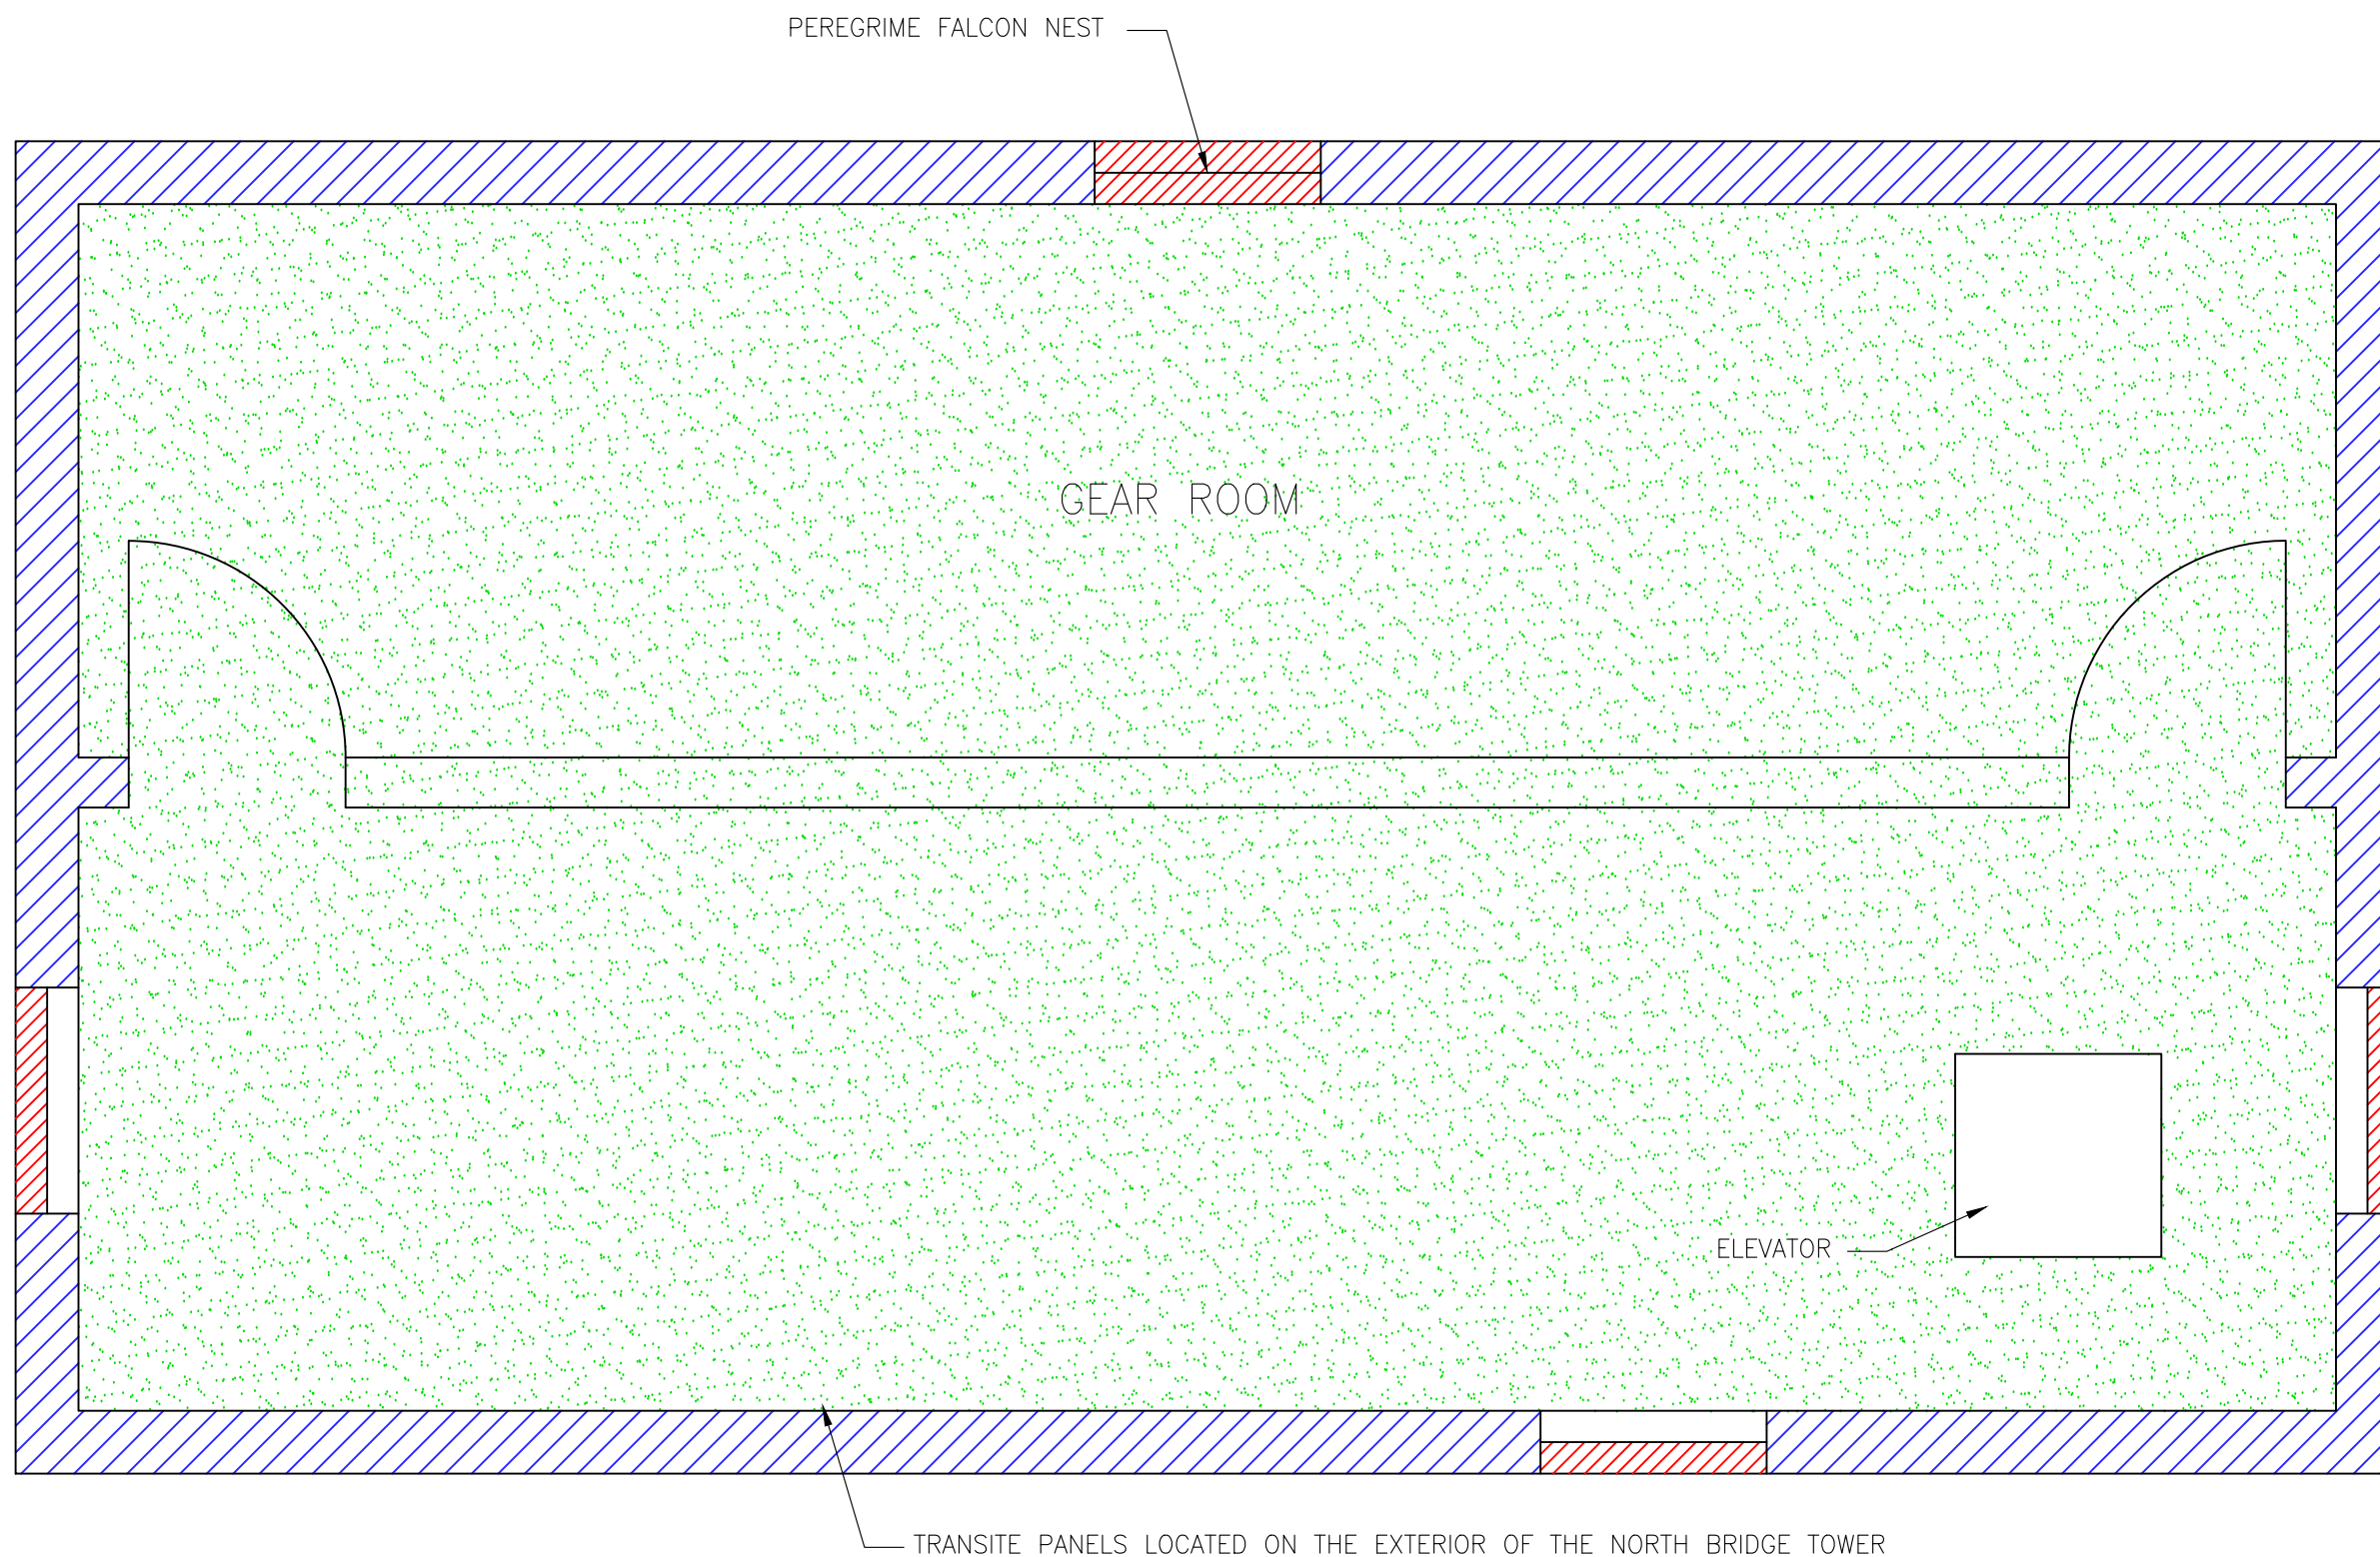
DRAWN BY: ROB SAJKUNOVIC	PROJECT No. 18-890
SCALE: AS NOTED	DWG. No. FIGURE 7
DATE: MARCH, 2018

VARIOUS LEAD-CONTAINING PAINTS APPLIED TO BOLLARDS, WALL AND FLOOR

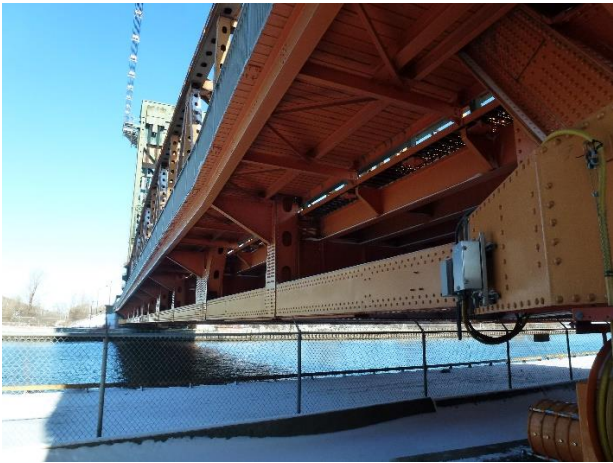
North tower yellow paint on the bollards	Assumed ²	Good	Good	Bollards re-painted in 2011. Assuming lead paint remains beneath new paint.	Photo 3
	North tower green exterior paint	Assumed ²	Fair – Poor	Fair - Poor	Limited visibility of exterior cladding paint from windows, and ground Visible paint appears to range from Fair to Poor condition.	Photo 22
Bridge	Lift span and towers (red primer)	Assumed	Fair	Fair	The entire lift span structure observed to have moderate peeling, flaking, etc. The red primer at the ‘splash- zone’ has been removed and repainted. Ten feet above the deck was repainted.	Photo 9

Photo 9: Lift bridge
