Hazardous Building Materials Assessments

6 Buildings/Structures at the Victoria
Coast Guard Base, 25 Huron Street,
Victoria, BC

March 18, 2019

Public Services and Procurement
Canada
401-1230 Government Street
Victoria, BC V8W 3X4

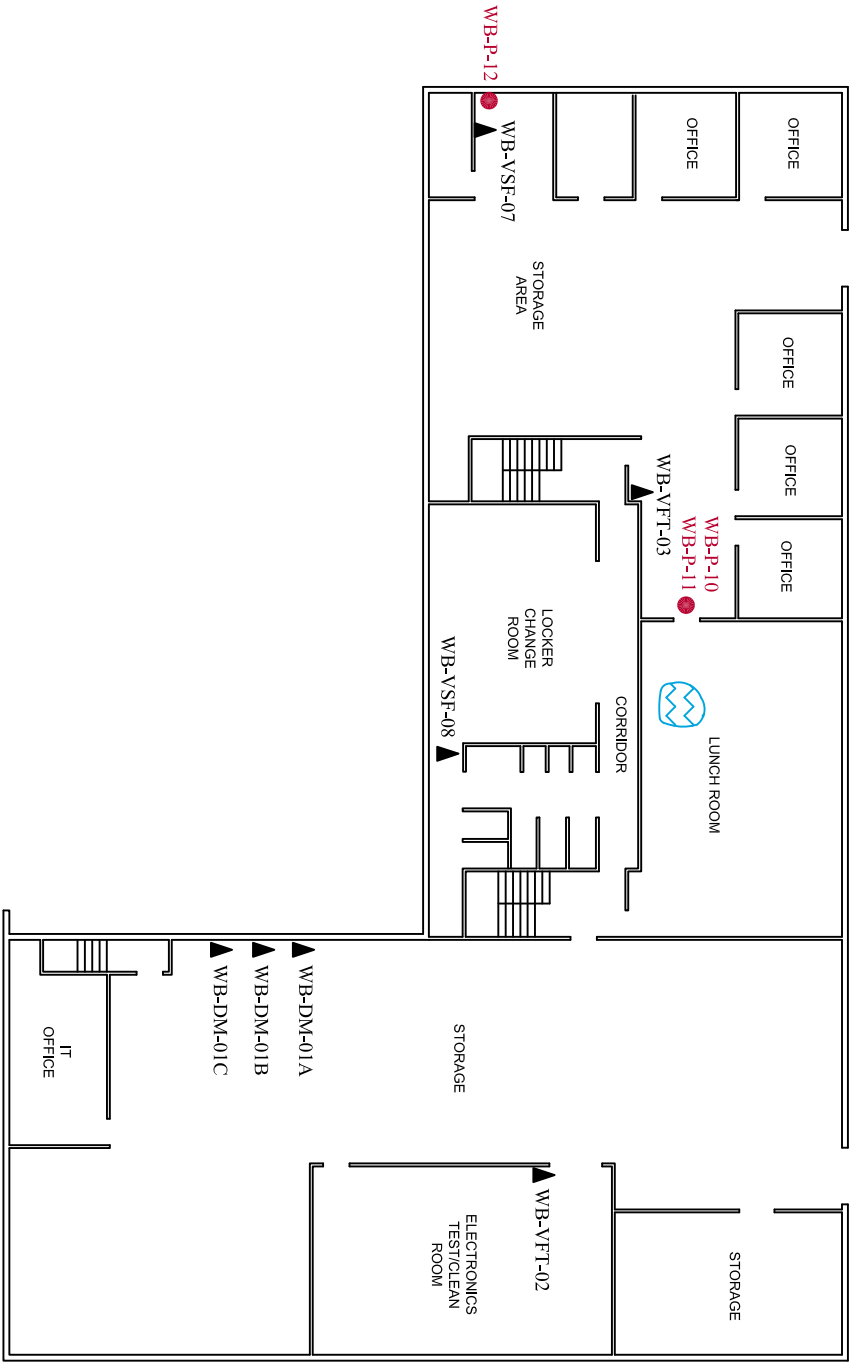
**MEZZANINE
WORKSHOP BUILDING**

- NOTES:**
1. GREY WINDOW PANE CAULKING APPLIED TO WINDOWS THROUGHOUT IS ASBESTOS-CONTAINING.
 2. BLACK MECHANICAL GASKETS ON PIPE FLANGES THROUGHOUT IS ASBESTOS-CONTAINING.
 3. THIS DRAWING ILLUSTRATES SUPPORTING INFORMATION SPECIFIC TO A STANTEC CONSULTING LTD. REPORT AND MUST NOT BE USED FOR OTHER PURPOSES.
