## Designated Substances Reports

Project #: NL7689

**HAZARDOUS MATERIALS ASSESSMENT**  
**Building 11**  
**308 Brookfield Road**  
**St. John's, NL**

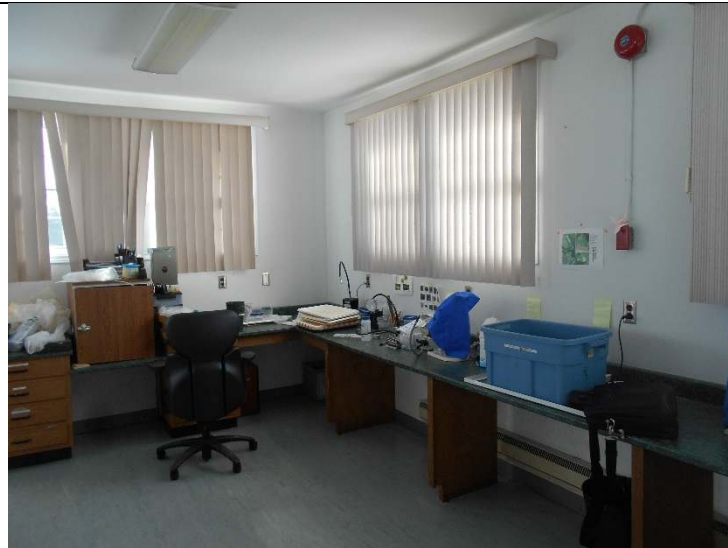
Drywall was observed on the walls and ceilings in Rooms 1 to 9 and on the walls in Rooms 10 to 12 (approximately 550 m<sup>2</sup>) (refer to Photo No. 7-4, 7-8, 7-10, 7-12, 7-15, 7-18, 7-20, 7-21, 7-23, 7-25, 7-27, and 7-30, Appendix B7). Drywall was observed to vary in condition from poor to fair throughout the site building. Examples of drywall in poor condition were observed in Rooms 4 and 7.

Photo 7-4: View of Room 1 (Lab Area)

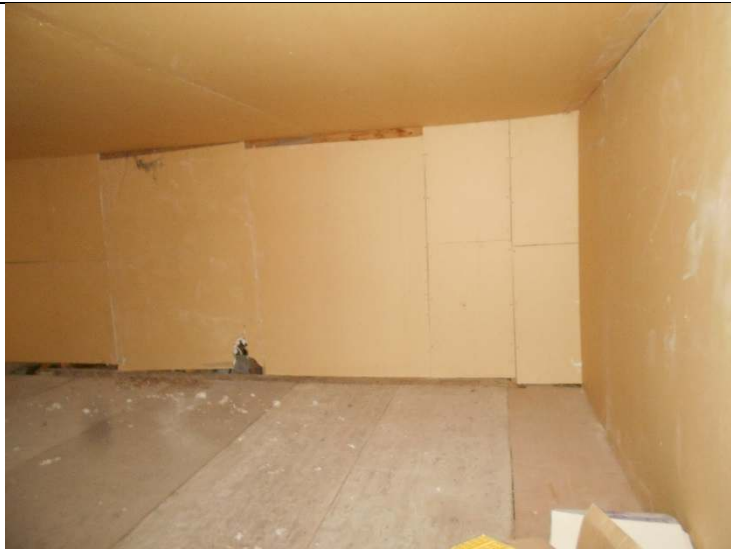
Photo 7-11: View of Room 4 (Attic)

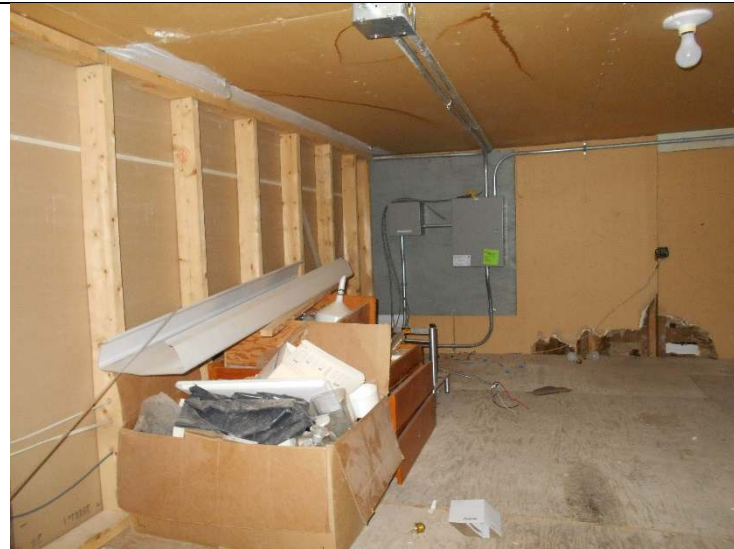
Photo 7-12: View of Room 4 (Attic)

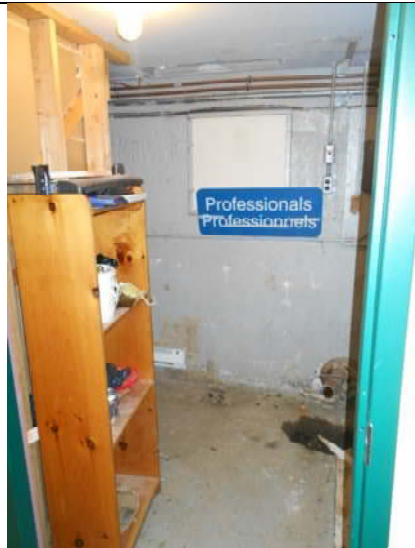
Photo 7-19: View of Room 7 (Janitor Closet)

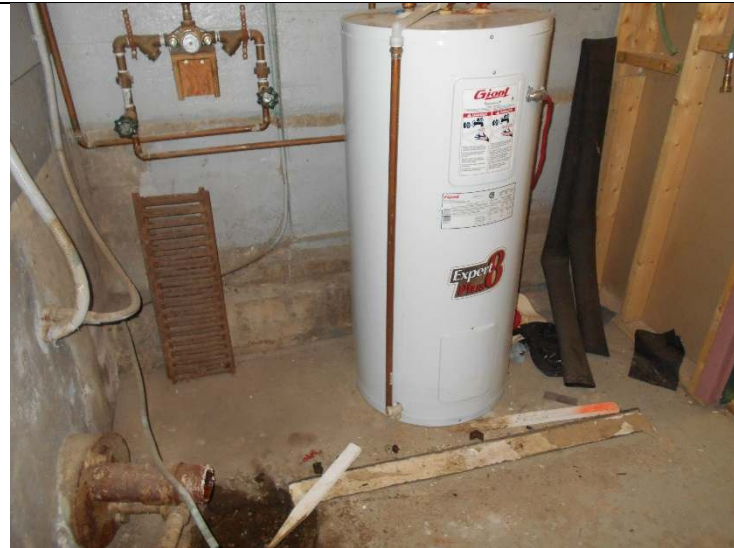
Photo 7-20: View of Room 7 (Janitor Closet)

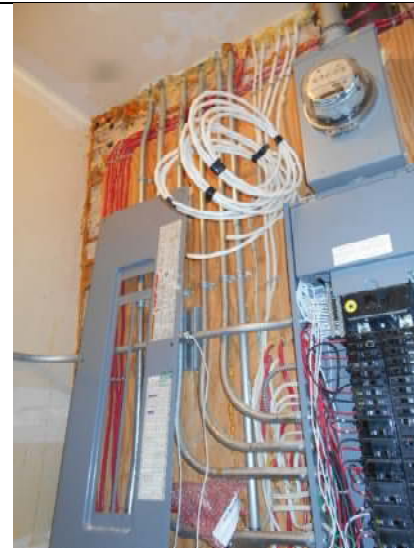
During the site visit, orange and yellow spray-applied foam insulation was observed around electrical panels in Room 9 (refer to Photo No. 7-24, Appendix B7). Due to the hazards involved with collecting samples around electrical equipment no samples of these materials were collected. Yellow spray applied foam insulation was also observed around an exterior door in Room 5 (refer to Photo No. 7-43, Appendix B7). No samples of this material were collected in order to preserve the insulation potential around the door. These spray-applied materials are not likely to contain asbestos.

Photo 7-24: View of Room 9 (Electrical Room)

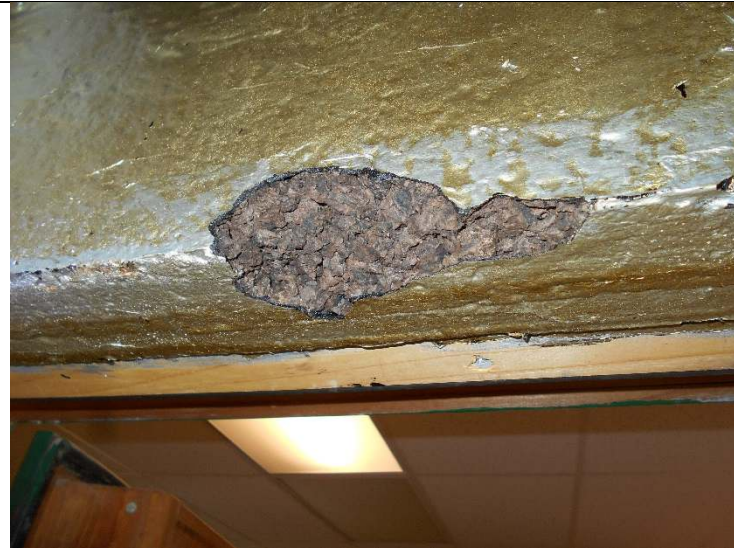
Tar was observed on the walls and ceiling in Room 13 (approximately 52 m<sup>2</sup>). The cork insulation containing the tar was observed to vary in condition from poor to fair (refer to Photo No. 7-34, Appendix B7).

Photo 7-34: view of damaged wall in Room 13

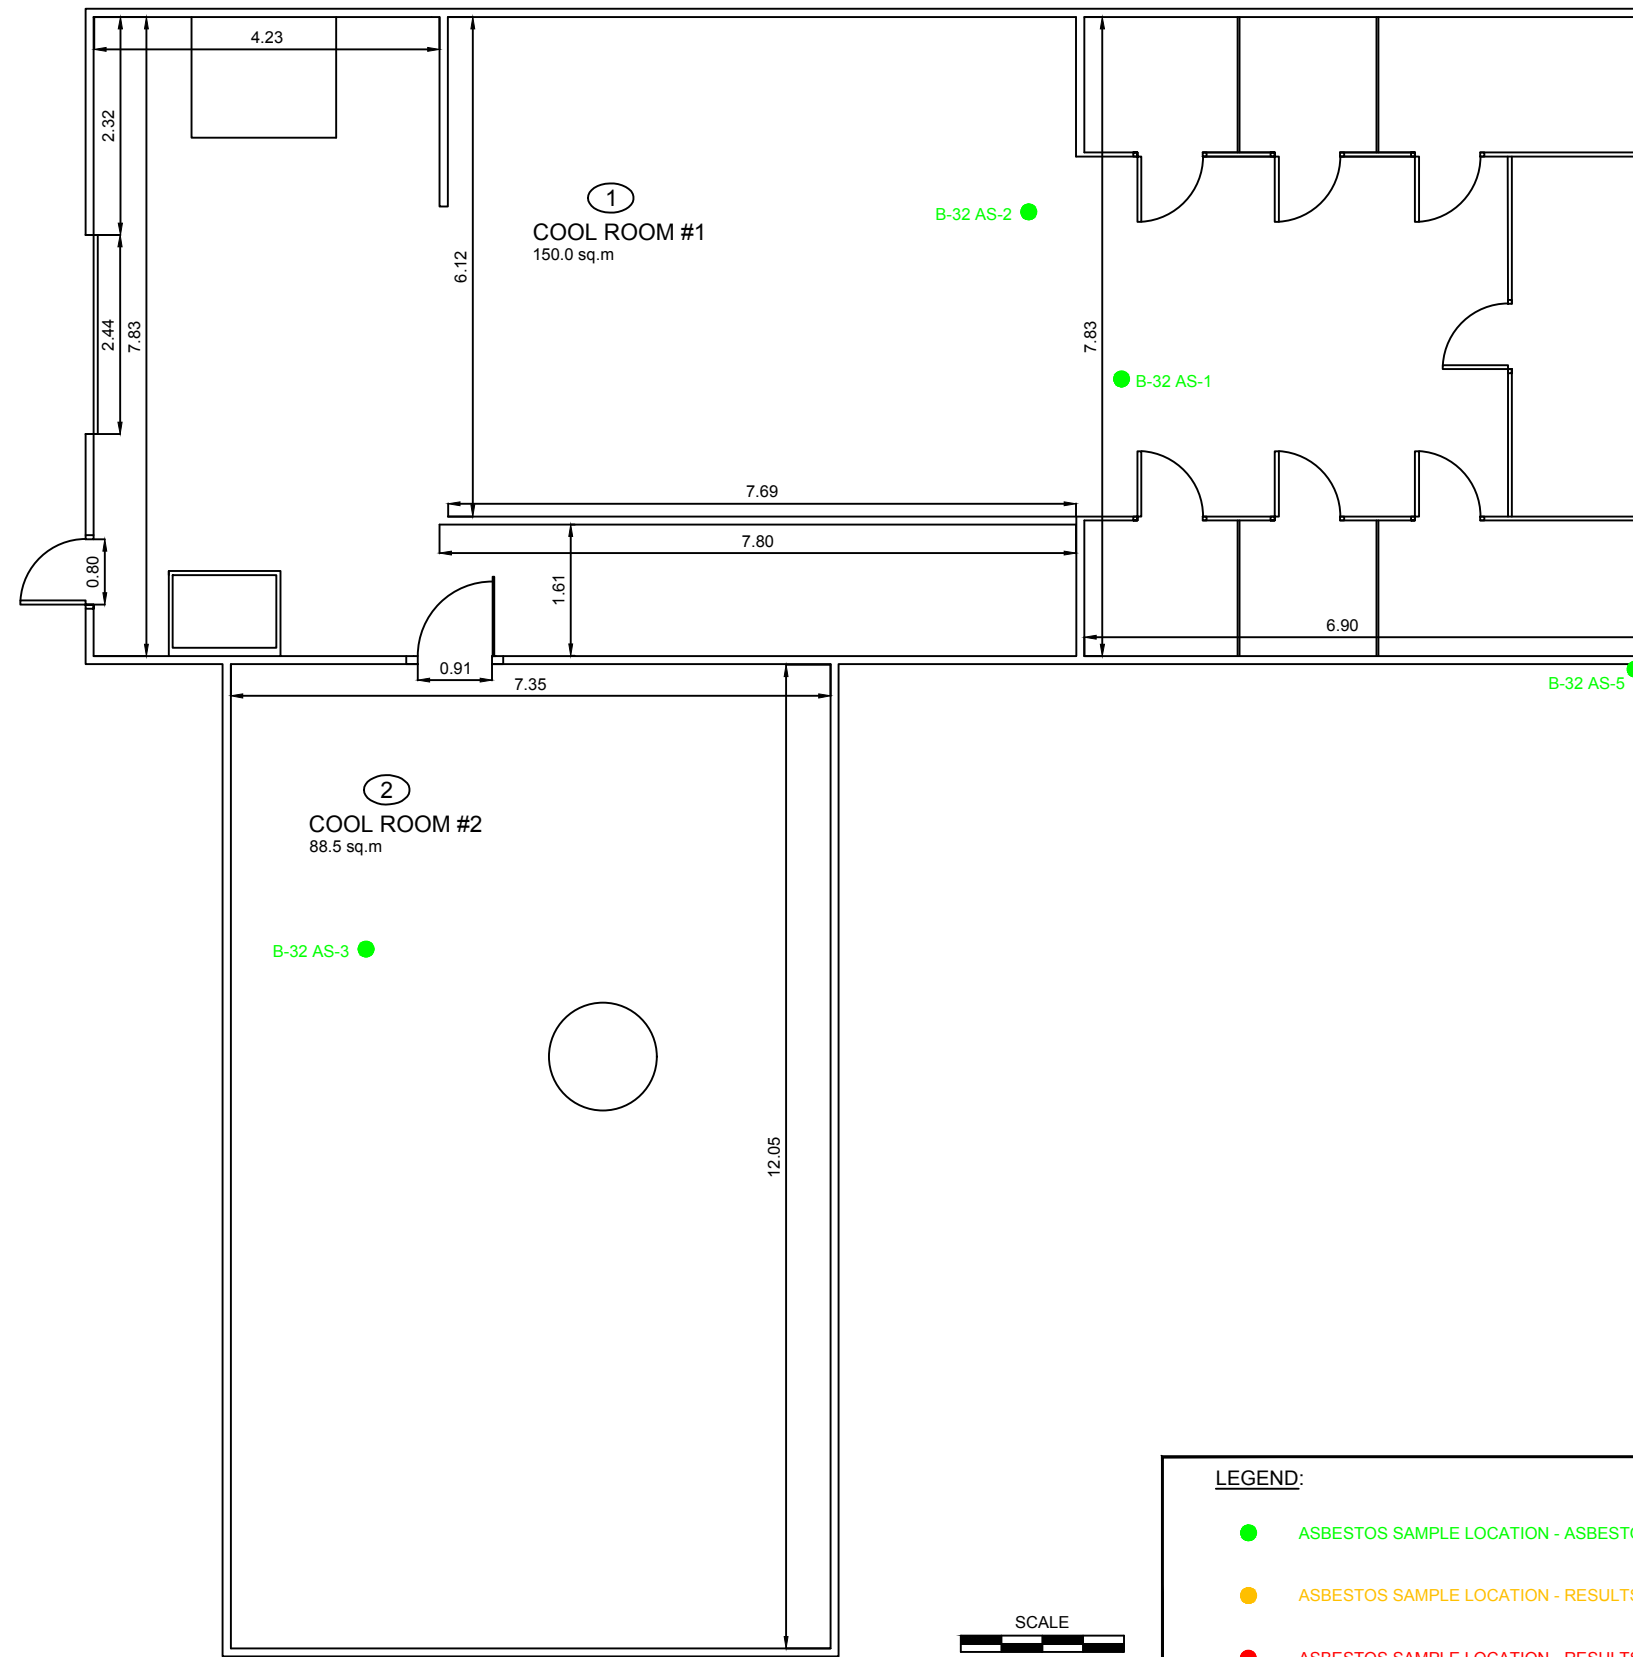
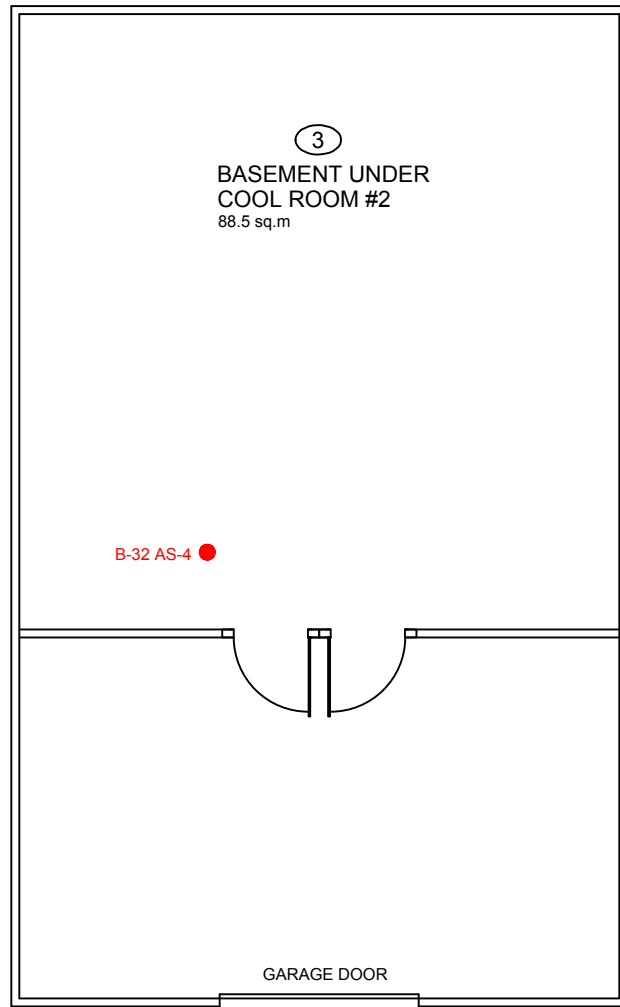
Figure No.  
17.1

During the ACMs Survey, a total of five (5) building material samples (AS-1 to AS-5) plus one blind field duplicate (B-32 DUP1, a duplicate of B-32 AS-2) were collected from the site building and analyzed for asbestos content (refer to Photos 17-23 to 17-27, Appendix B17). It is important to note that some building material samples (e.g., ceiling panel tape and adhesive) were split into layers and analyzed separately for asbestos content. Sample descriptions and analytical results are summarized in Table C17-1, Appendix C17. Sample locations and analytical results are illustrated on Figure 17.1, Appendix A17.

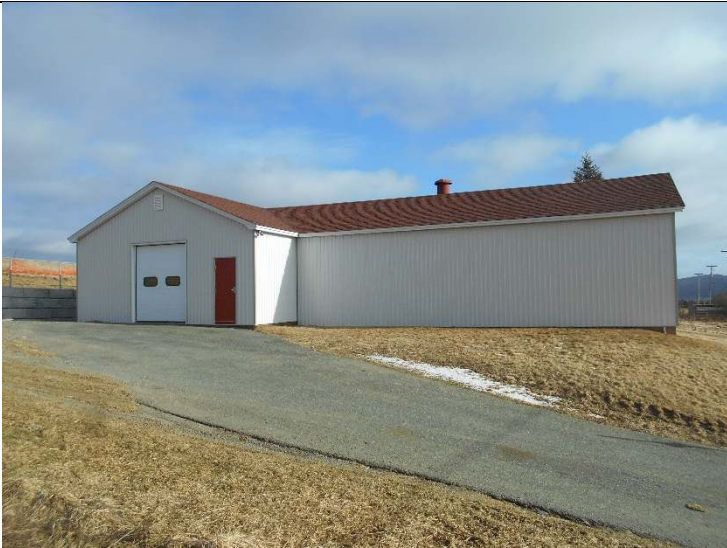
Photo 17-1: View of Building 32 facing east

- Interior core of fire-rated doors. Note: a metal label indicating a fire-rating was observed on the hinge side of the exterior metal door in Room 1 (refer to Photos 17-1 and 17-8, Appendix B17). A number of metal doors in Room 1 were locked and could not be checked for fire-rating tags.
- Internal components and insulation inside cooling system.

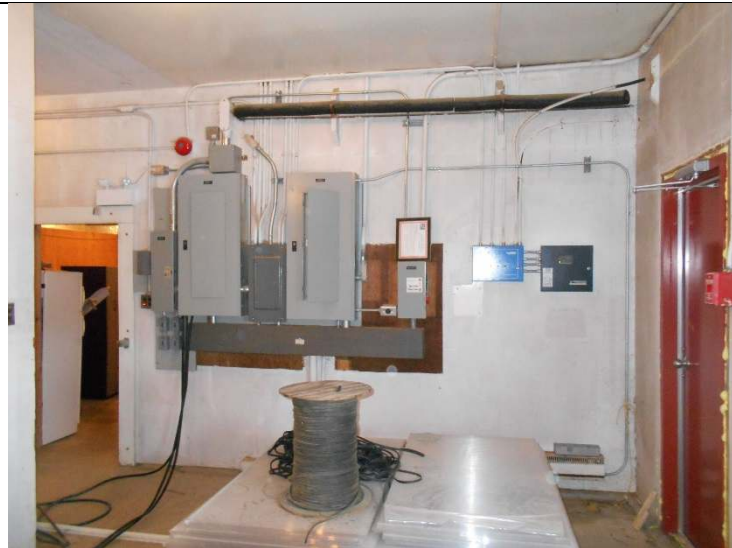
Photo 17-8: View of Room 1 (Cool Room)

Yellow spray applied foam insulation was observed around an exterior door in Room 1 (refer to Photo No. 17-8, Appendix B17). No samples of this material were collected in order to preserve the insulation potential around the door. This spray-applied material is not likely to contain asbestos.
