## **Hazardous Building Materials Assessment**

Parts of Millhaven Institution  
5775 Bath Road, Bath, Ontario

February 18, 2020

Pinchin File: 269554

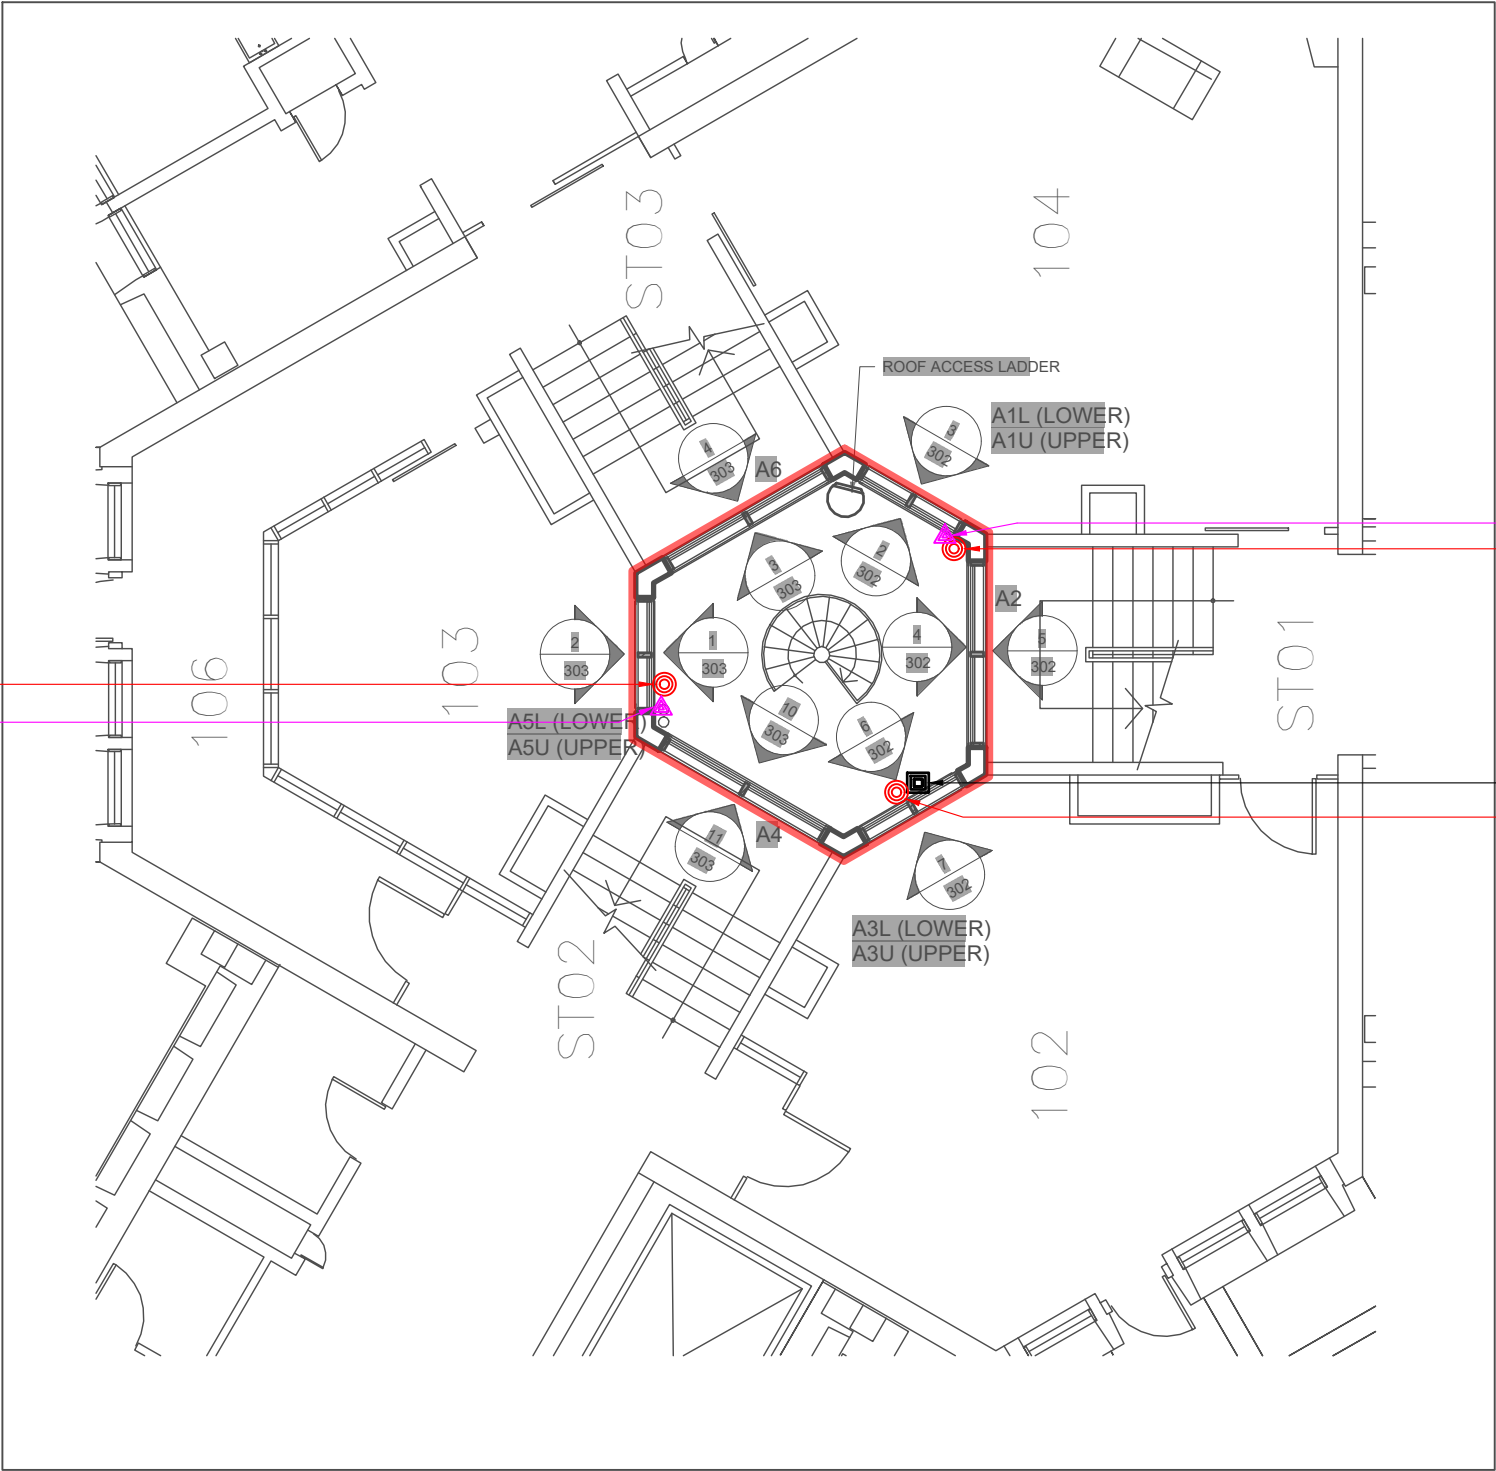
N CONTROL

- PCBs are presumed to be present in light ballasts; and
- Black butyl sealant present at window frames in N control are considered PCB solids, butyl sealants are in good condition.
