December 9, 2019

Subject: Designated Substances Survey – Update  
West Annex, Former Sir John Carling Building  
930 Carling Avenue, Ottawa, Ontario

DST File No.: GVOT-034335 - Phase 27.0

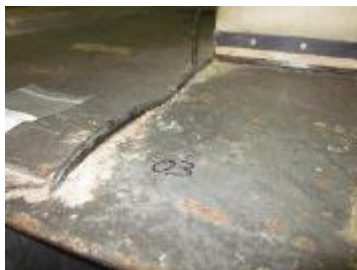
<b>Sample ID:</b>	Textured Wall Coat, Sub-Basement Mechanical Room, Basement Stairwell (19779-01A-E)	Remnant wall coat (remnant second layer of textured wall coat), Sub-Basement and Basement Mechanical Rooms and Open Areas (19779-02A-G)	White fibrous debris on and under Air Handling Unit, Sub-basement, Mechanical Room (19779-03)
<b>Photo:</b>

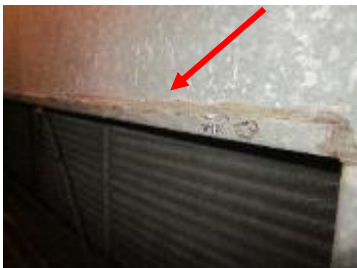
<b>Sample ID:</b>	White/Grey Caulking, Sub-basement, Mechanical Room (19779-04A-C)	Textured floor and associated layers, Sub-basement, Mechanical Room. Inside AHU (19779-05A-C)	12"x12" Vinyl floor tile, grey with white streaks, Sub-basement, open area (19779-06A-C)
<b>Photo:</b>

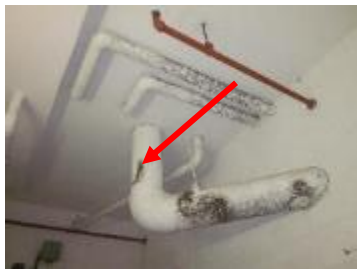
<b>Sample ID:</b>	Column Plaster, Sub-basement, open area (19779-07A-C)	12"x12" Vinyl floor tile, beige, Sub-basement (19779-08A-C)	Layered Cardboard Wrap Pipe Insulation, Stairwell: Sub-basement to Basement (19779-09A-C)

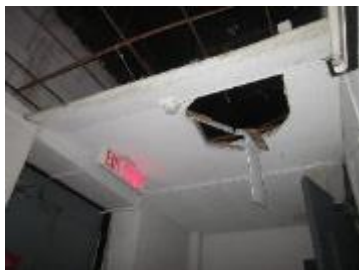
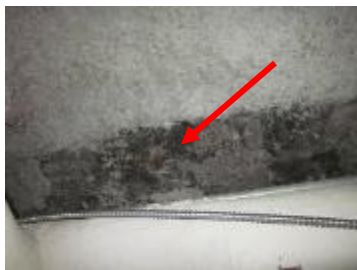
<b>Sample ID:</b>	Spray Fireproofing, First Floor, Ceiling (19779-10A-C)	Corrugated Pipe Insulation, Wall Radiator, Top of Stairwell from Basement to Sub-basement (19779-11A-C)	Tar Layer under Fireproofing, Basement, Mechanical Room (19779-12A-C)
<b>Photo:</b>

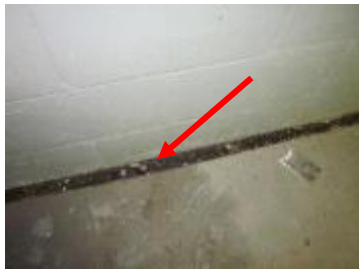
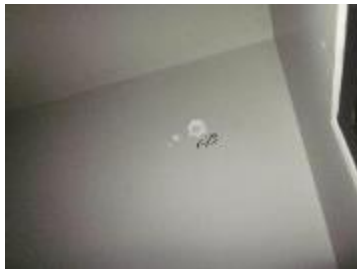
<b>Sample ID:</b>	Black Tar, Mechanical Room, Basement (19779-13A-C)	Textured Wall Coat, First Floor, Inside Kitchen Freezers (19779-14A-C)	Smooth Plaster, First Floor, Kitchen Area (19779-15A-C)
<b>Photo:</b>

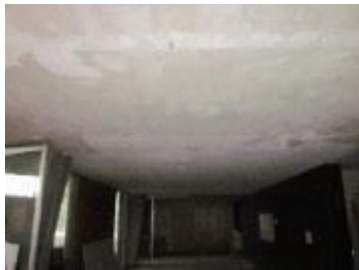
<b>Sample ID:</b>	Plaster Ceiling, First Floor, Entrance Lobby (19779-16A-C)	12"x12" Vinyl Floor Tile, Grey, First Floor, Entrance Lobby (19779-17A-C)	Column Stucco, First Floor Lobby and Exterior (19779-18A-C)

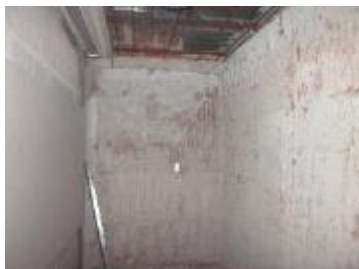
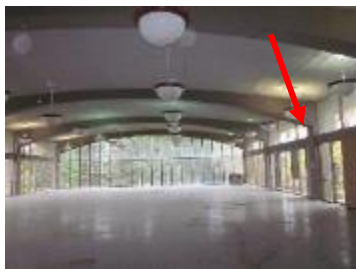
<b>Sample ID:</b>	Remnant Textured Wall Coat, First Floor, Storage Rooms (19779-19A-C)	Plaster Bulkhead, First Floor, Kitchen Area (19779-20A-C)	Plaster Wall and Ceiling Columns, First Floor, Kitchen/Cafeteria (19779-21A-G)
<b>Photo:</b>

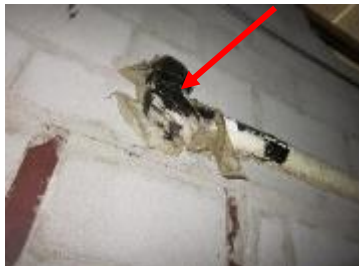
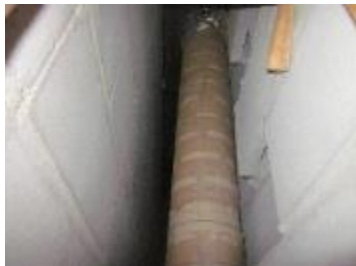
<b>Sample ID:</b>	Black Tar Styrofoam, First Floor, Kitchen Shaft (19779-22A-C)	Column, Compound Scratch Coat, Basement, Link (19779-23A-C)	Layered Cardboard Wrap, Basement Link (19779-24A-C)
<b>Photo:</b>

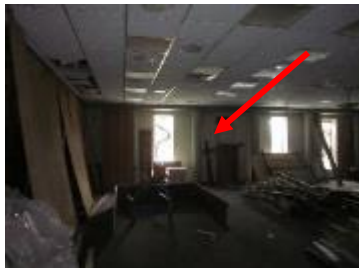
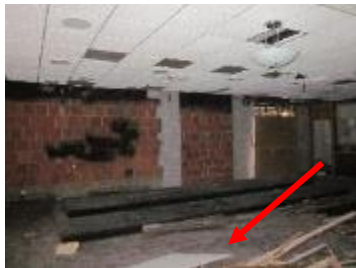
<b>Sample ID:</b>	Textured Wall Coat, First Floor, Former Conference Room (19779-25A-C)	Black Wall/Ceiling Mastic, First Floor, Link Corridor (19779-26A-C)	Carpet Mastic, First Floor, Former Conference Room (19779-27A-C)

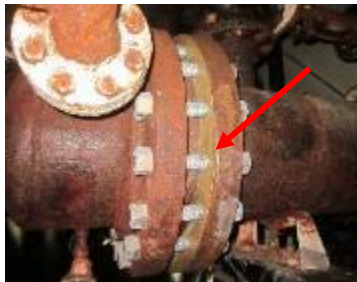
<b>Sample ID:</b>	Black Caulking, Granite Joints Exterior (19779-28A-C)	White Fibrous Electrical Wire Sheathing, First Floor, Kitchen (19779-29A-C)	Pipe Gasket, Sub-basement, Mechanical Room (19779-30A-C)
