# LASALLE CAUSEWAY BASCULE BRIDGE

## COUNTERWEIGHT REHABILITATION STUDY

### Inspection Report | FINAL DRAFT

PSPC Project No. R.108246.001

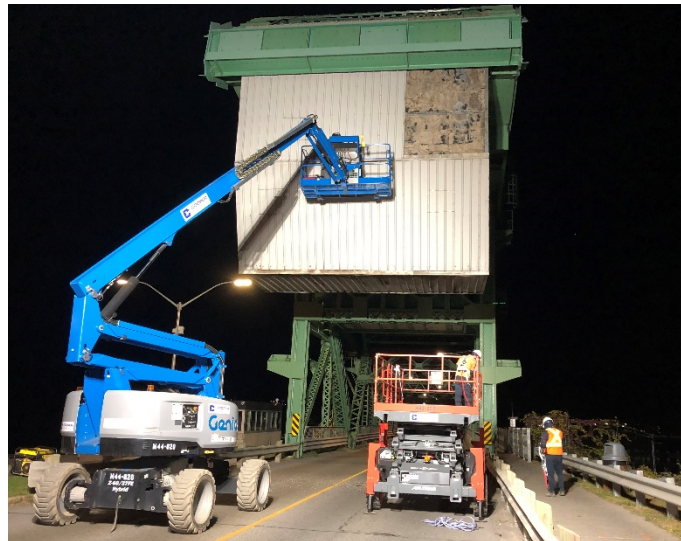
**Figure 3-1: Removal of Counterweight cladding. West face shown.**

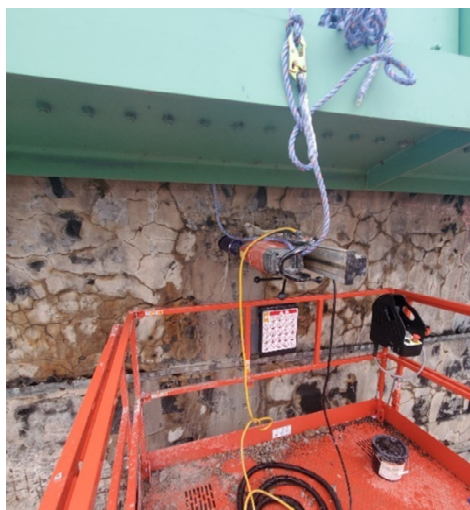
**Figure 3-3: Hilti coring machine mounted on Counterweight (core location C1 shown)**

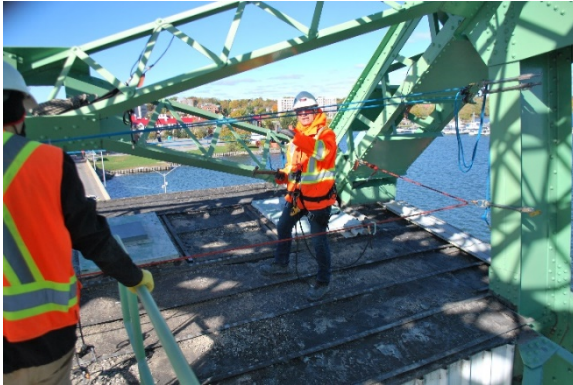
Upon removing steel cladding from the top face, it was observed that the concrete is covered with what appears to be roofing material/tar as presented in **Figure 4-3**.

Four individual compartments are also found on the top face as presented in **Figure 4-3**. The internal dimensions of the compartments are not known given the amount of debris inside and their varying size. Concrete was inspected inside each of these compartments, with metal debris noted, as presented in **Figure 4-5**. The metal debris has been noted during previous inspections of the Counterweight and may be removed during a long-term rehabilitation as the reason for its presence is unknown at this time.

**Figure 4-3: Top face covered with roofing material. North half of top face shown.**

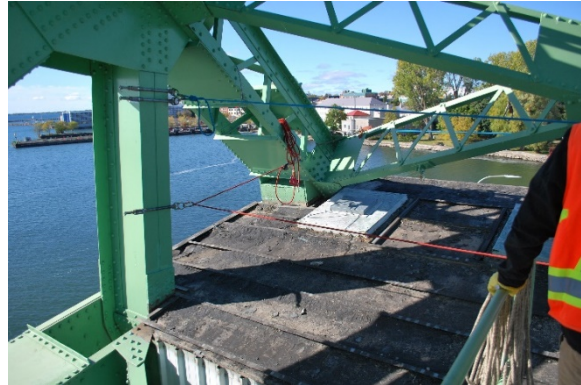
**Figure 4-4: Top face covered with roofing material. South half of top face shown.**

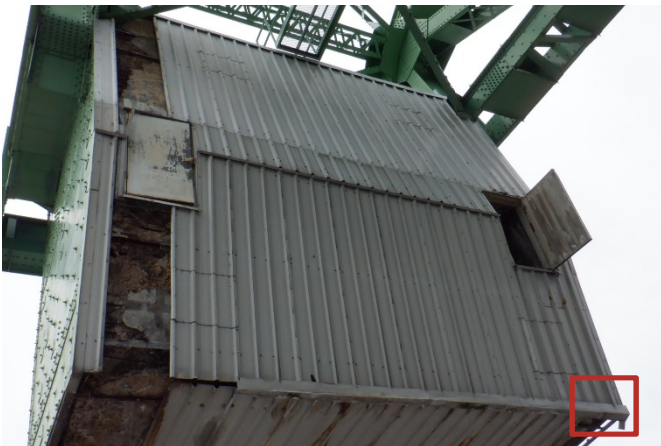
Two vertical panels (full height) were removed from the South end of the East face. Cladding was not removed from the entire face as strong conclusions as to the concrete condition were already established and it was determined that removing additional panels was unlikely to reveal further information. This also ensured that the bridge would be ready to safely reopen as scheduled. As observed on the West face, the underlying concrete is in poor condition showing areas of spalling, delamination, cracking and section loss as presented in **Figure 4-7**, **Figure 4-9**, and **Figure 4-11**. Exposed reinforcing steel showing generalized corrosion is present on the bottom corners of the East face where approximately 120 mm – 300 mm of concrete has been lost (see **Figure 4-9** and **Figure 4-11**).

**Figure 4-11: Concrete section loss at bottom North East bottom corner of East face.**

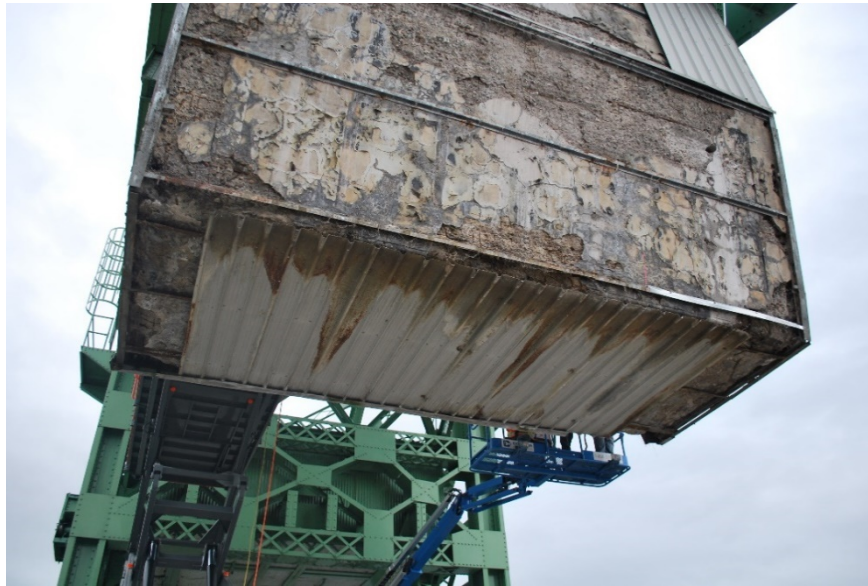
Two panels were also removed from the bottom face at the North and South ends. Overall, the underlying concrete is in a similar condition to the rest of Counterweight showing cracking, spalling, and delamination reaching depths in the range of 100 mm – 200 mm. To determine the condition of underlying reinforcement, a test pit 300 mm in depth was performed on the NorthEast corner of the bottom face. Reinforcing steel and mesh are in poor condition showing generalized corrosion on all faces in addition to localized areas of corrosion where approximately 25% of the diameter has been lost. Visible concrete loss was also visible in all four corners of the bottom face.

**Figure 4-15: Bottom face showing panels removed from North and South ends**

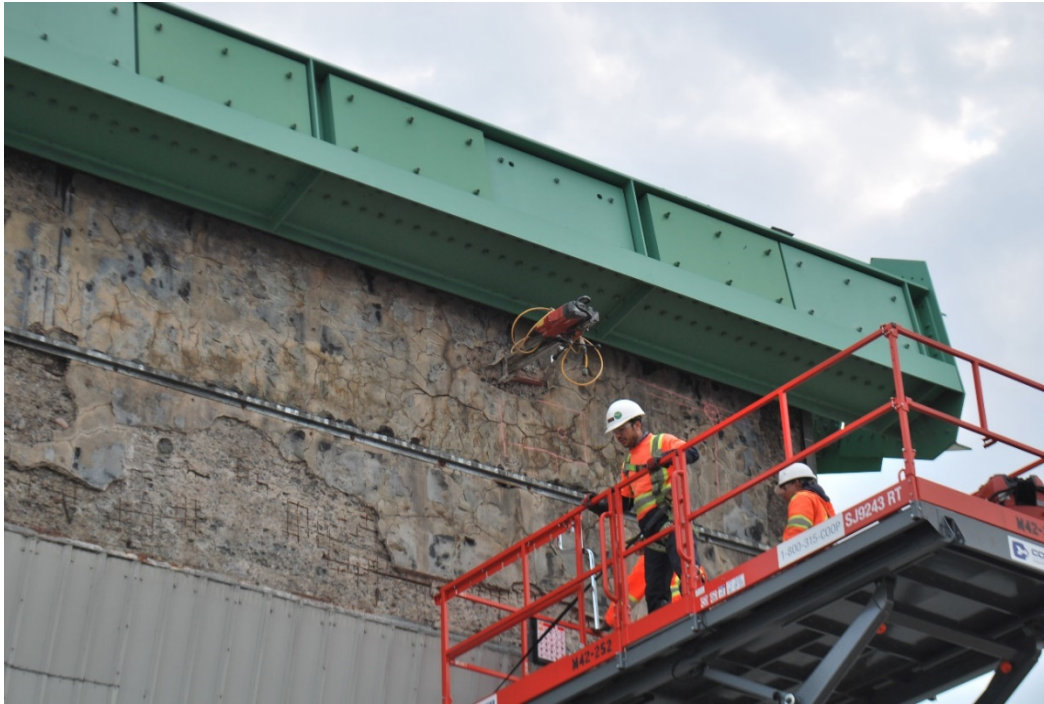
Figure A3 – Coring rig installed on West face at core location C1. A core approximately 2700mm in length was removed from this location.

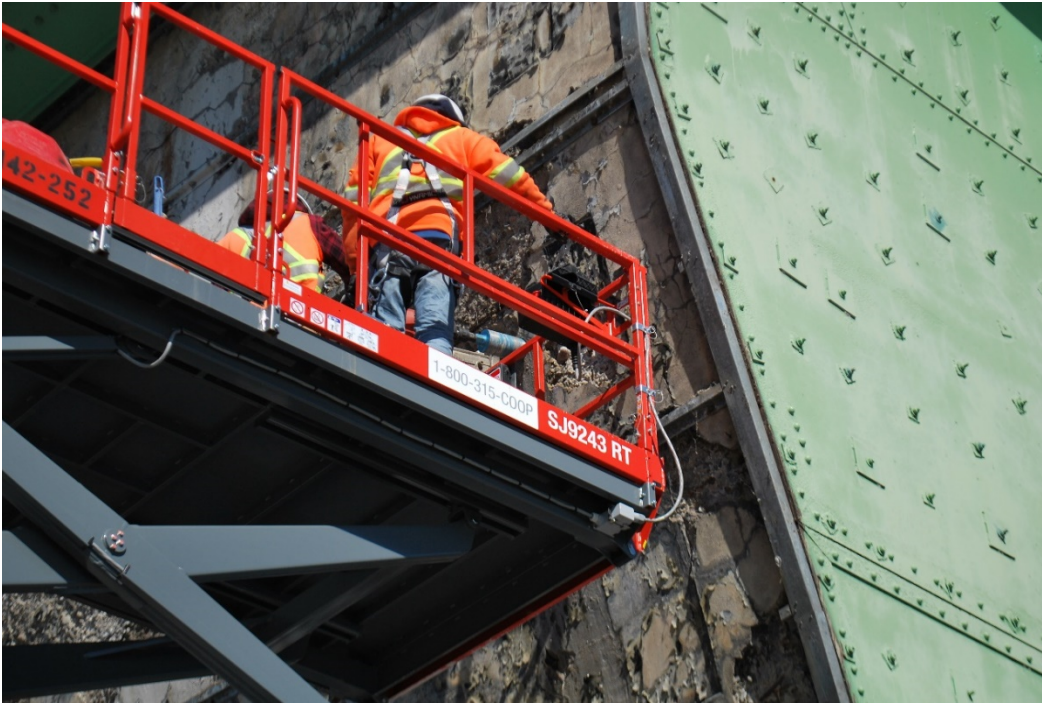
Figure A9 – Concrete coring in progress at core location C2. A core measuring approximately 2600mm was removed from this location. The opposite end of the core reached the South compartment on the East face.

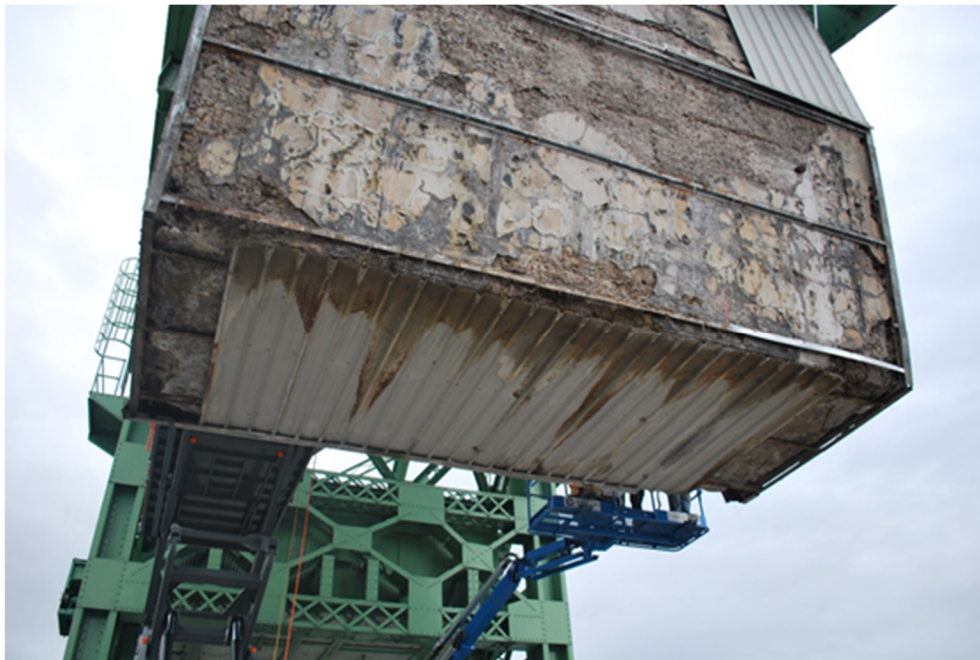
Figure A14 – Steel cladding removed from North and South ends of bottom face. Partial view of West face also shown.

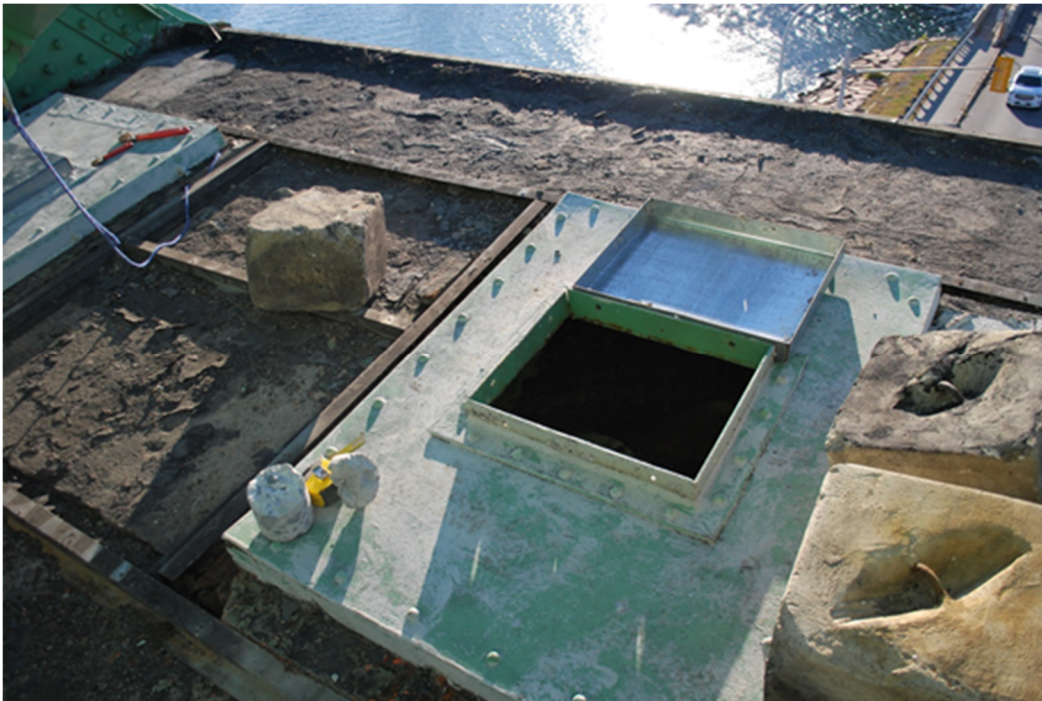
Figure A18 – Top face covered in roofing material. Door removed from one of four compartments located on the top face, which houses additional concrete weights.

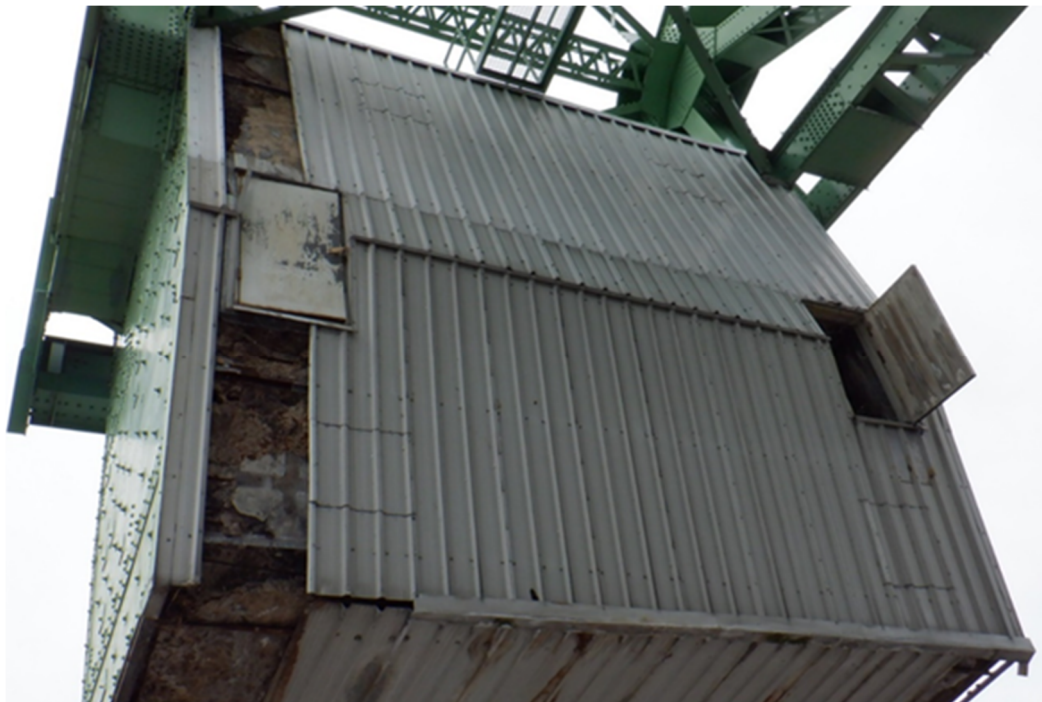
Figure A22 –Two compartments located on East face designated as South and North. Steel cladding removed from South side of East face. North compartment is where cores C3 and C4 were removed (see Figure A27).

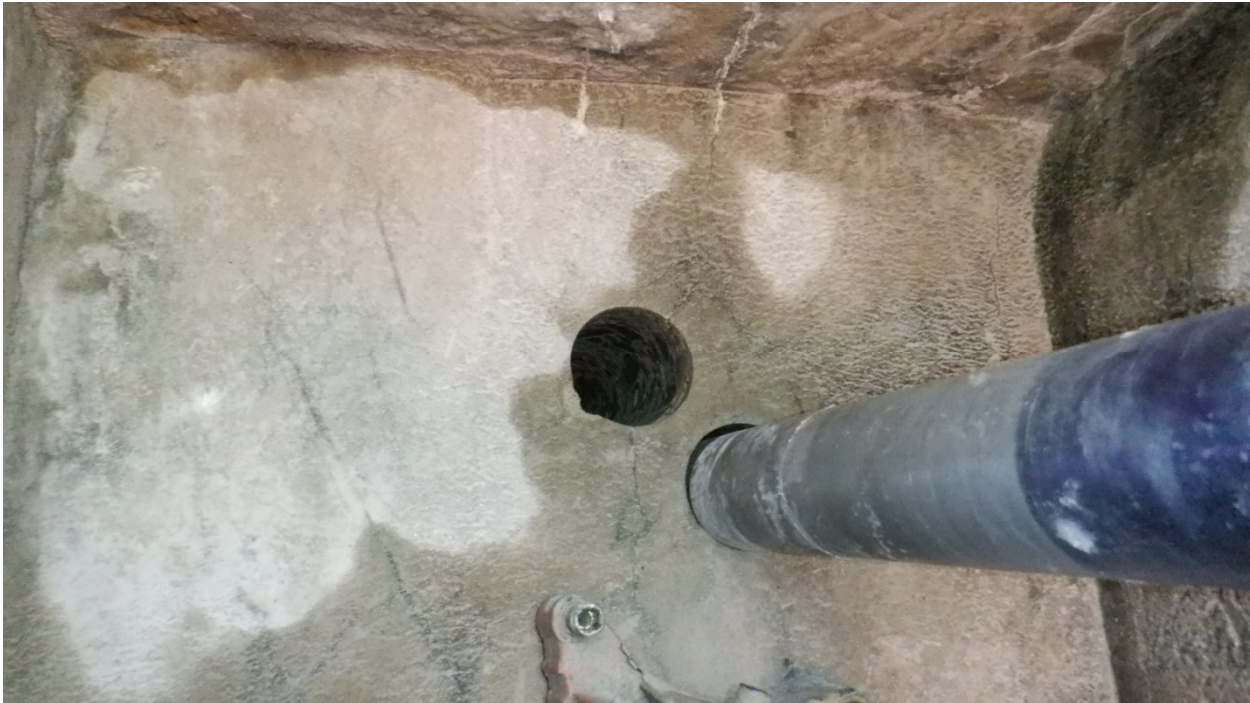
Figure A27 – Core holes C3 (left) and C4 (right) inside North compartment on East face. Please refer to the compartments in Figure A22.

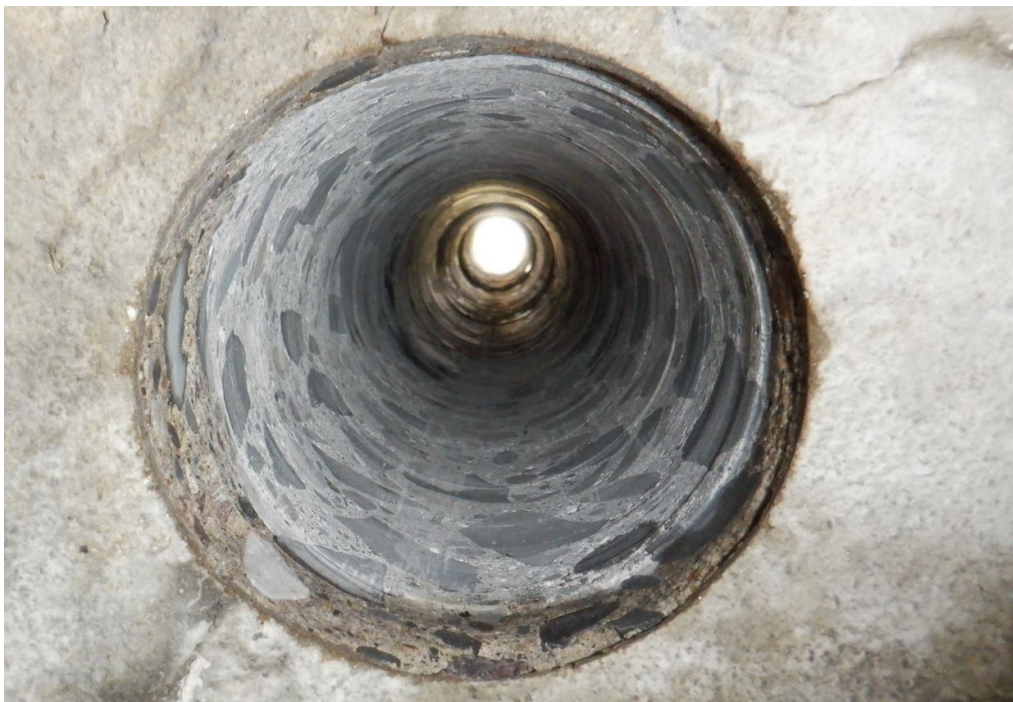
Figure A30 – Core hole C2 (full depth). Photograph taken from inside South compartment on East face. Photograph is looking in the West direction.

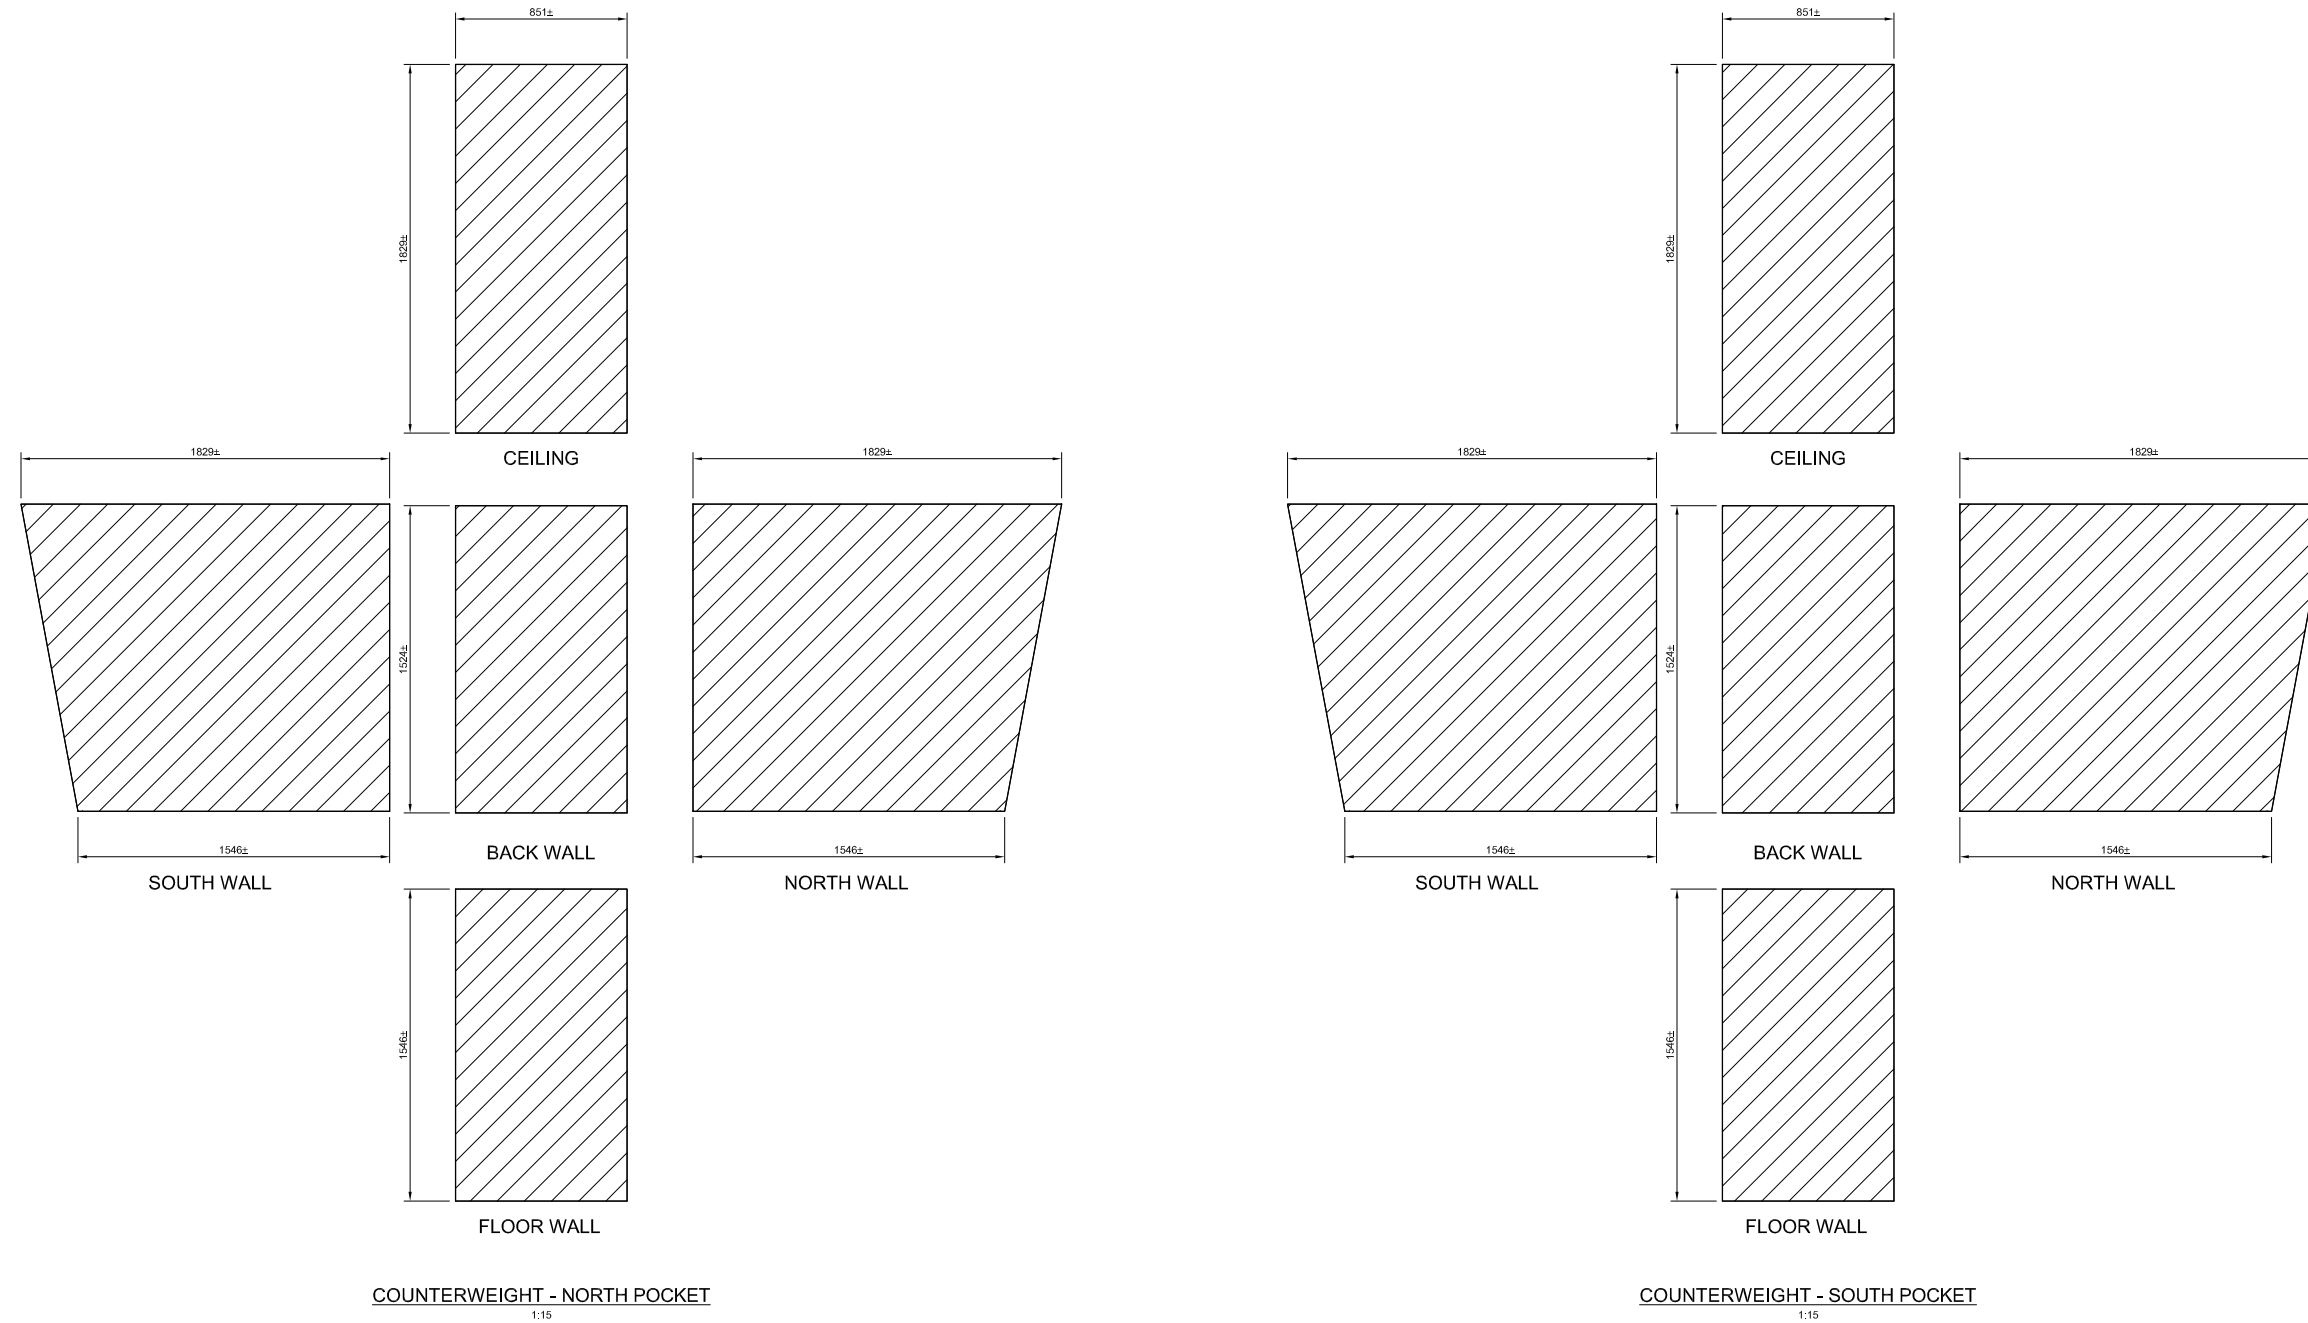
1. THIS DRAWING SHALL BE READ IN CONJUNCTION WITH ALL OTHER CONTRACT DRAWINGS.
2. IN ADDITION TO DELAMINATION, MAP CRACKING AND EFFLORESCENCE IS PRESENT ON THE CEILING OF BOTH COMPARTMENTS. MEDIUM SCALING IS FOUND ON ALL POCKET WALLS.

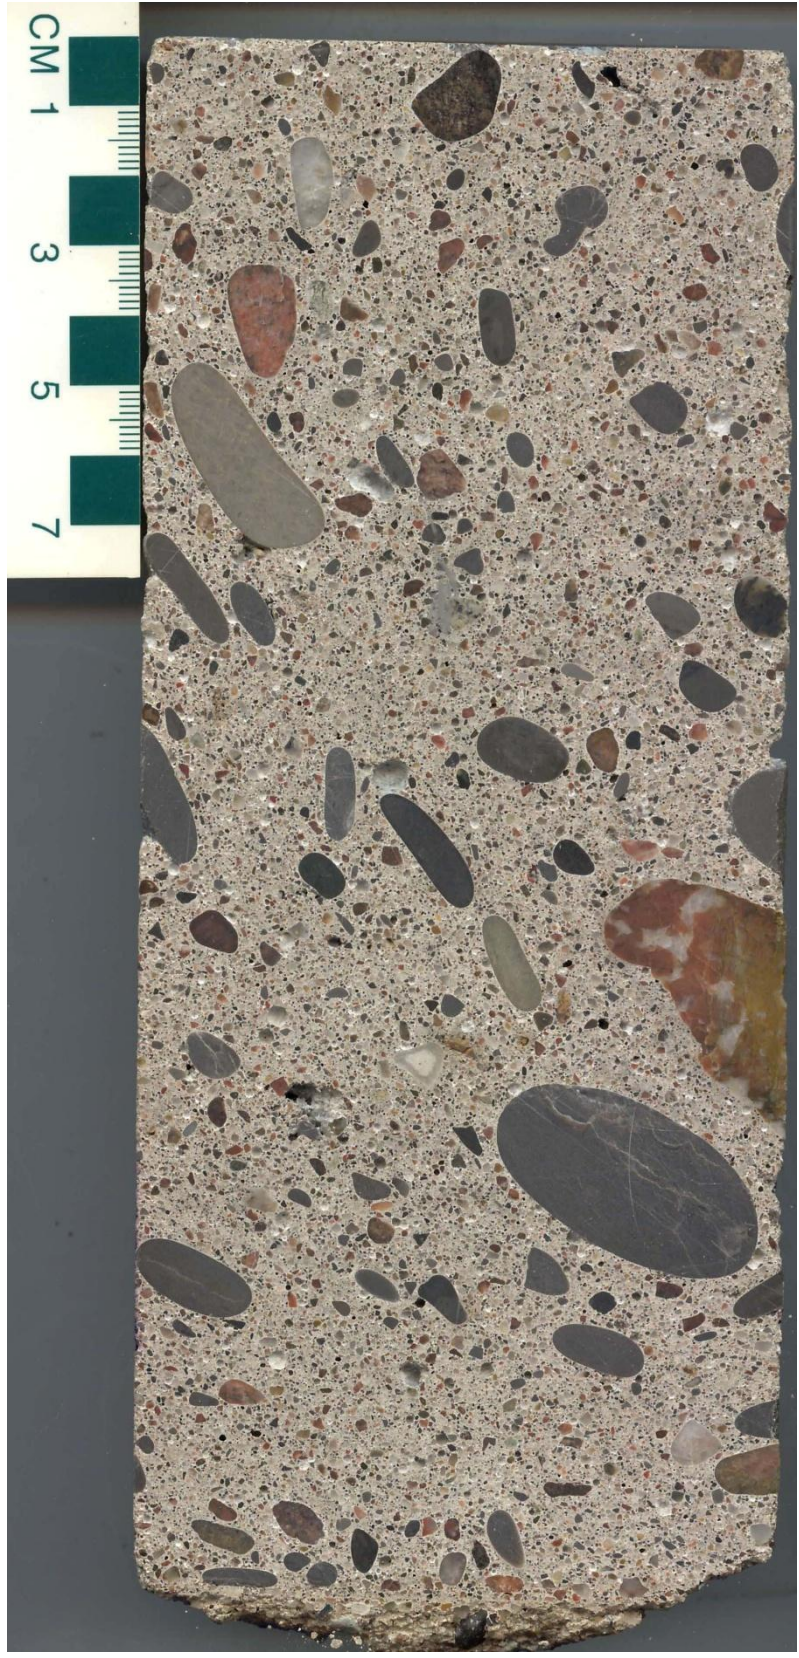
The concrete in both cores was generally poorly proportioned and moderately well consolidated. Core 1 showed a deficiency in coarse aggregate and some areas deficient in cement paste resulting in voids around poorly cemented fine aggregate. Core 2 showed an excess of coarse aggregate. On cutting with the diamond saw a clean cut was obtained with core 1 but core 2 showed fragmentation due to existing cracking.

Generally the concrete in core 1 was remarkably uncracked. A few minor cracks in the mortar and in the coarse aggregate were noted in the Damage Rating Index (Table 2) part of the examination. These cracks were no wider than 0.05 mm.

Figure 1: Core 1. Note preferred orientation of long axis of coarse aggregate particles.
