# LaSalle Causeway Bascule Bridge Main Trunnion Rehabilitation Study - Design Concept Report

Project Number: R. 099350.002

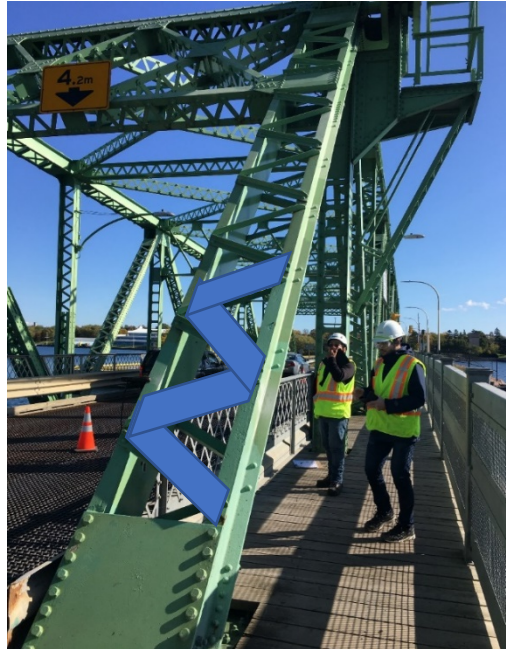
Figure 12 - Wide lacing alternative

However, it is unclear that the visibility would be improved significantly with wide lacing compared to perforated plates. A comparison can be made during detailed design when the exact plate sizes would be determined.

An alternative to the perforated plates would be to replace the existing lacing with a wider lacing that attaches to the channels with a regular pattern without an eccentric connection, meaning the centerline of each lacing intersects at a single point (see Figure 12).

At this concept stage, the perforated plate solution appears to be more convenient if the perforated areas are properly aligned.

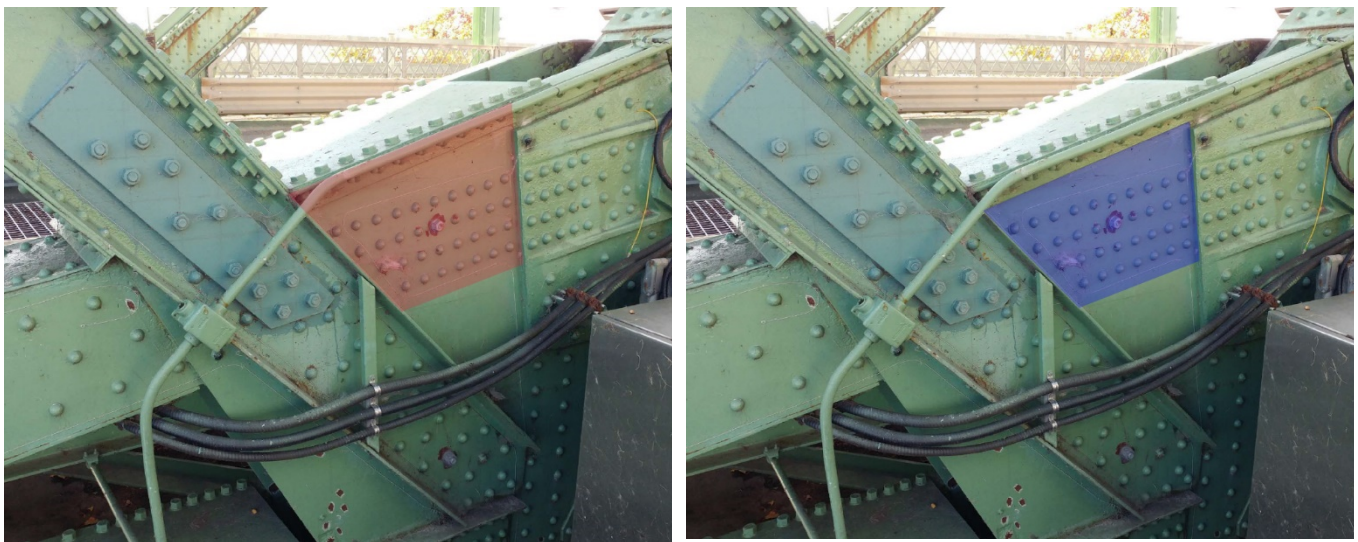
Figure 19 –Gusset Plate Strengthening Type A2 Alternative  
 (a) Left: Plate extending to the edge angle (b) Right: Plate serving as a shim placed first

- This alternative permits the strengthening, and better protection for durability purposes, of the area at the upper edge of the gusset plate, with access from the outside that is much easier than from the inside of the member. However, it does not strengthen the area of the gusset plate that is at the intersection of the diagonal 13-16 and the strut 14-15. Therefore, the proposed strengthening shown in Figure 18 is more favorable and it is our recommendation, because it creates a continuity on the gusset upper edge and transfers the forces directly to the collar plate.

- Add a plate on the outside of the gusset plate, in the area of the connection with the strut 14-15 (Figure 19).
- This plate should extend to the upper edge on the gusset and be bolted over the existing edge angle as shown in red in Figure 19 (a).

- As the edge angle is riveted on the gusset plate, a shim plate (in blue) will be required on the surface of the gusset plate to create a surface flush with the edge angle, permitting installation of the second plate (in red) over the edge angle, as shown in Figure 19 (b).

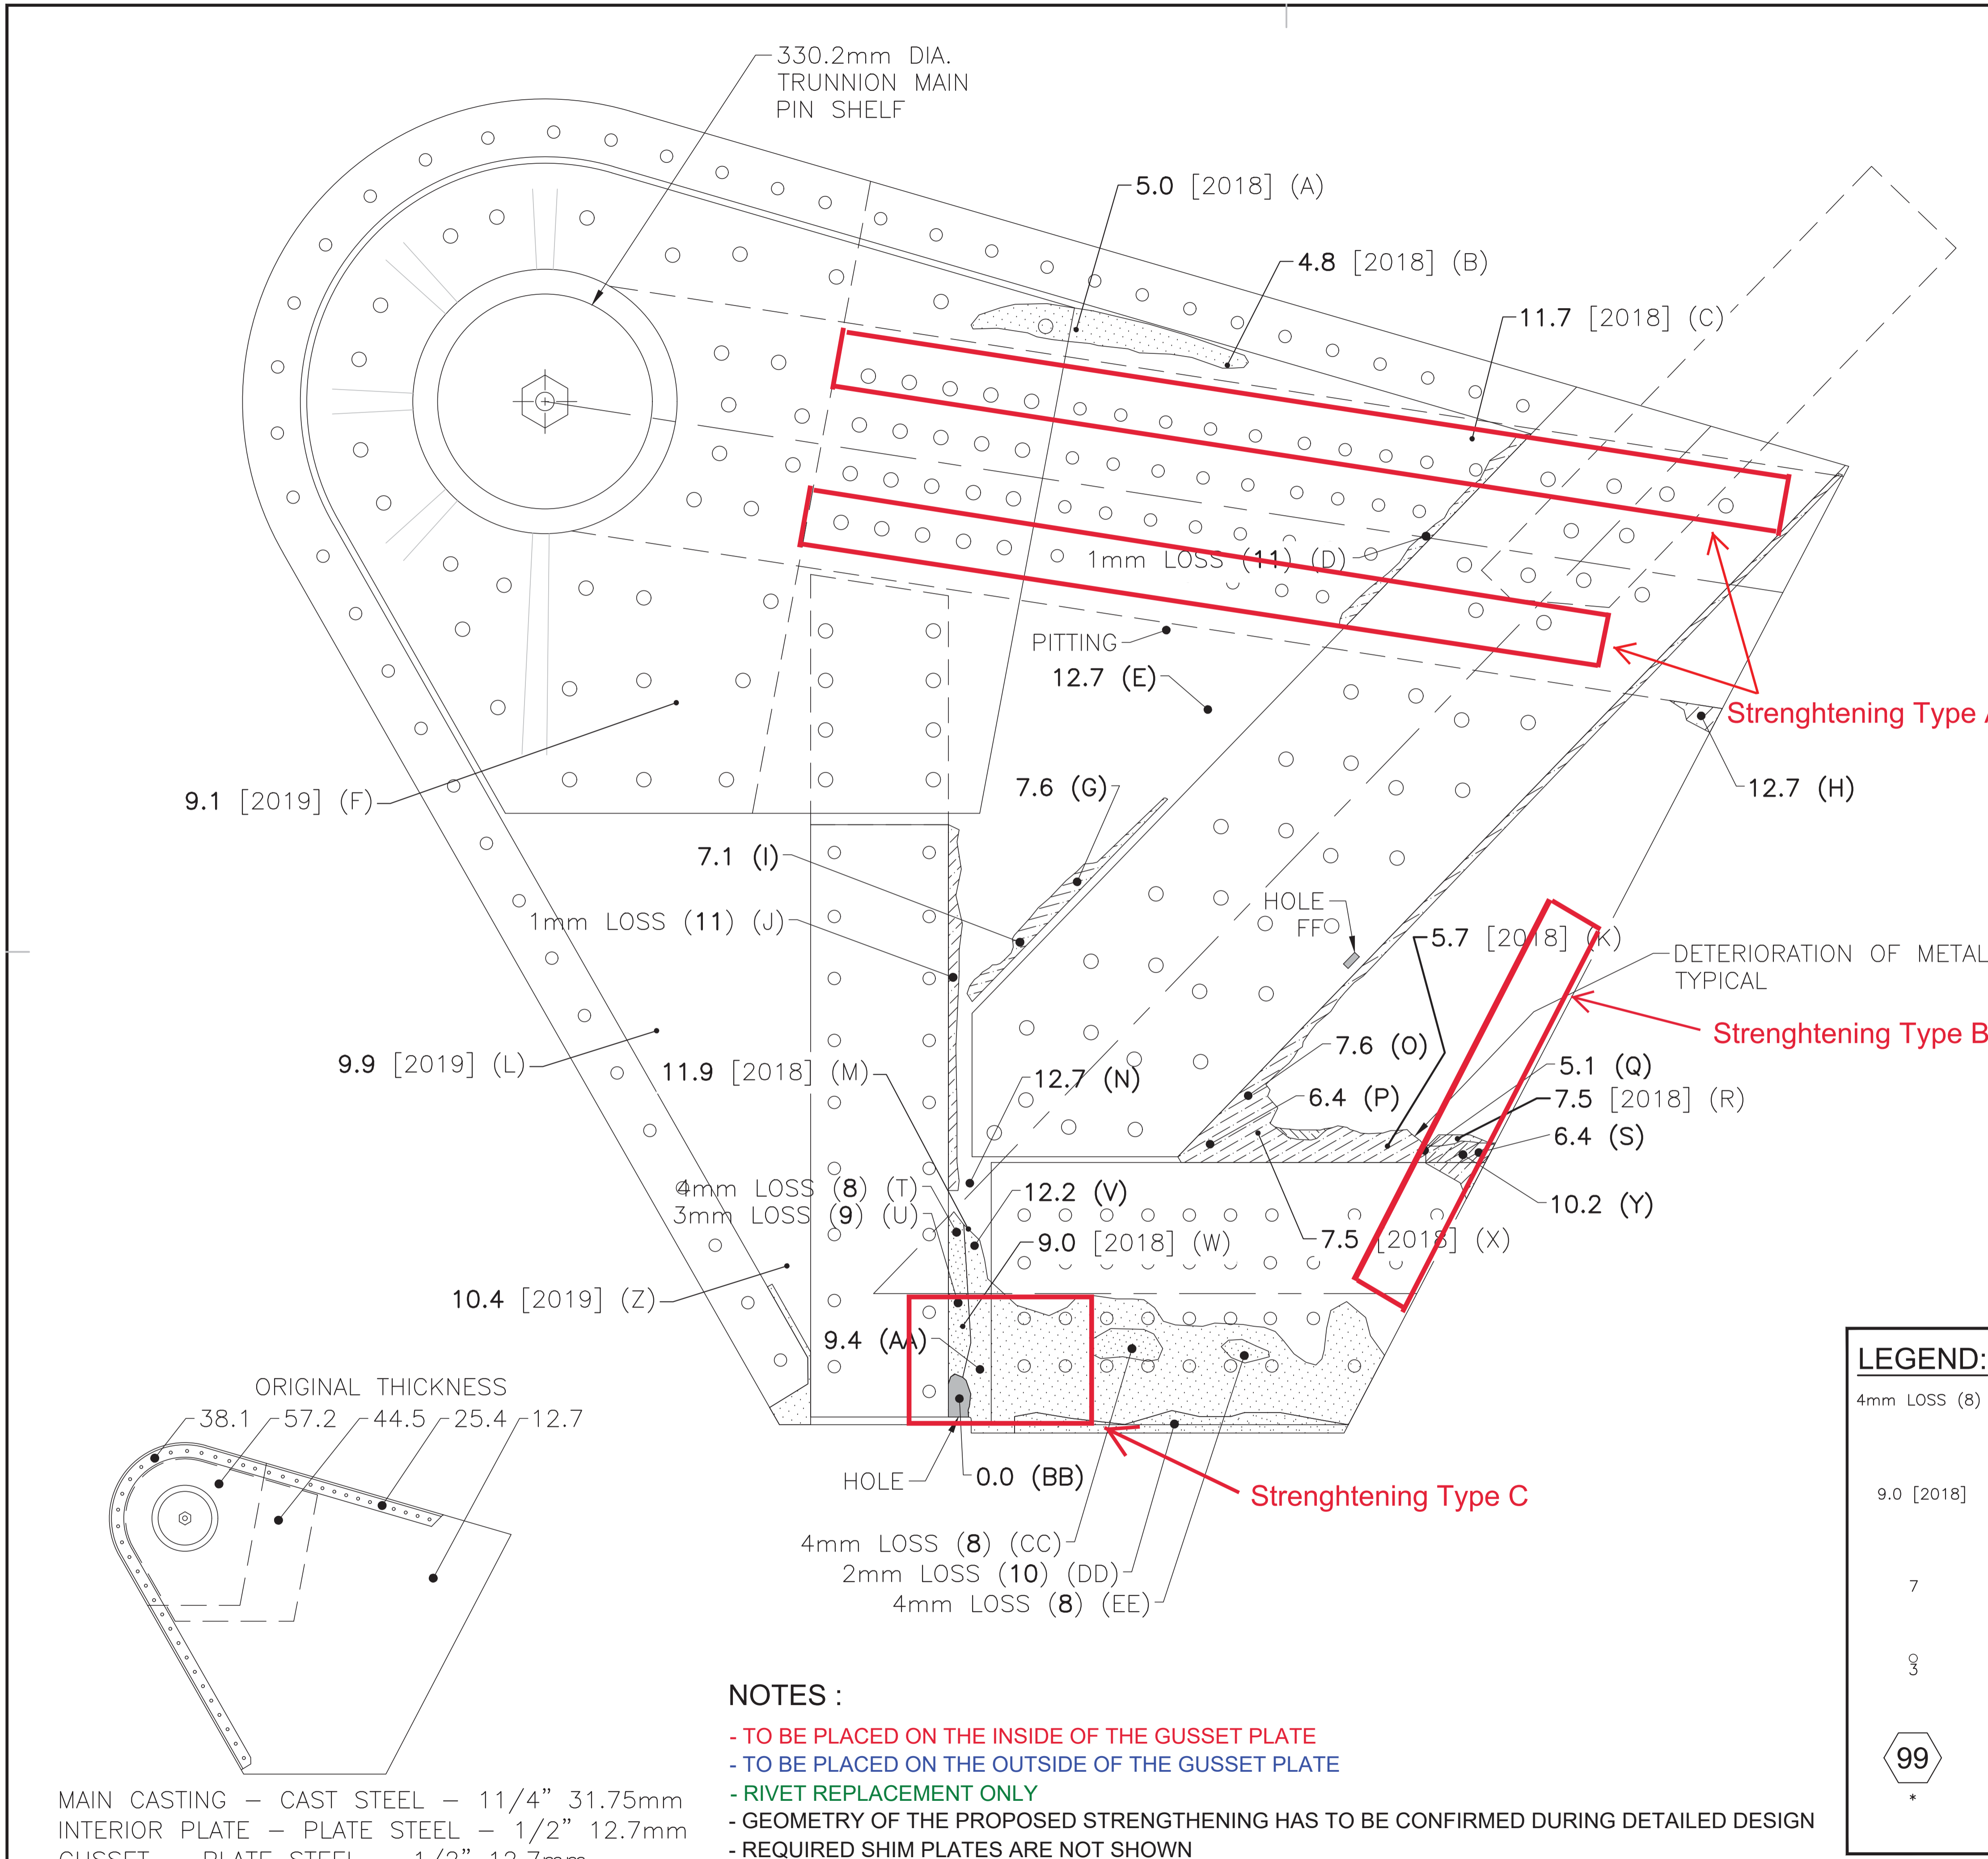
SOUTH TRUNNION EXTERIOR PLATE			
READING	ORIGINAL THICKNESS (mm)	REMAINING THICKNESS (mm)	PERCENT LOSS (%)
A	12.7	5	60.6
B	12.7	4.8	62.2
C	12.7	11.7	7.9
D	12.7	11	13.4
E	12.7	12.7	0.0
F	12.7	9.1	28.3
G	12.7	7.6	40.2
H	12.7	12.7	0.0
I	12.7	7.1	44.1
J	12.7	11	13.4
K	12.7	5.7	55.1
L	12.7	9.9	22.0
M	12.7	11.9	6.3
N	12.7	12.7	0.0
O	12.7	7.6	40.2
P	12.7	6.4	49.6
Q	12.7	5.1	59.8
R	12.7	7.5	40.9
S	12.7	6.4	49.6
T	12.7	8	37.0
U	12.7	9	29.1
V	12.7	12.2	3.9
W	12.7	9	29.1
X	12.7	7.5	40.9
Y	12.7	10.2	19.7
Z	12.7	10.4	18.1
AA	12.7	9.4	26.0
BB	12.7	0	100.0
CC	12.7	8	37.0
DD	12.7	10	21.3
EE	12.7	8	37.0
FF	12.7	0	100.0

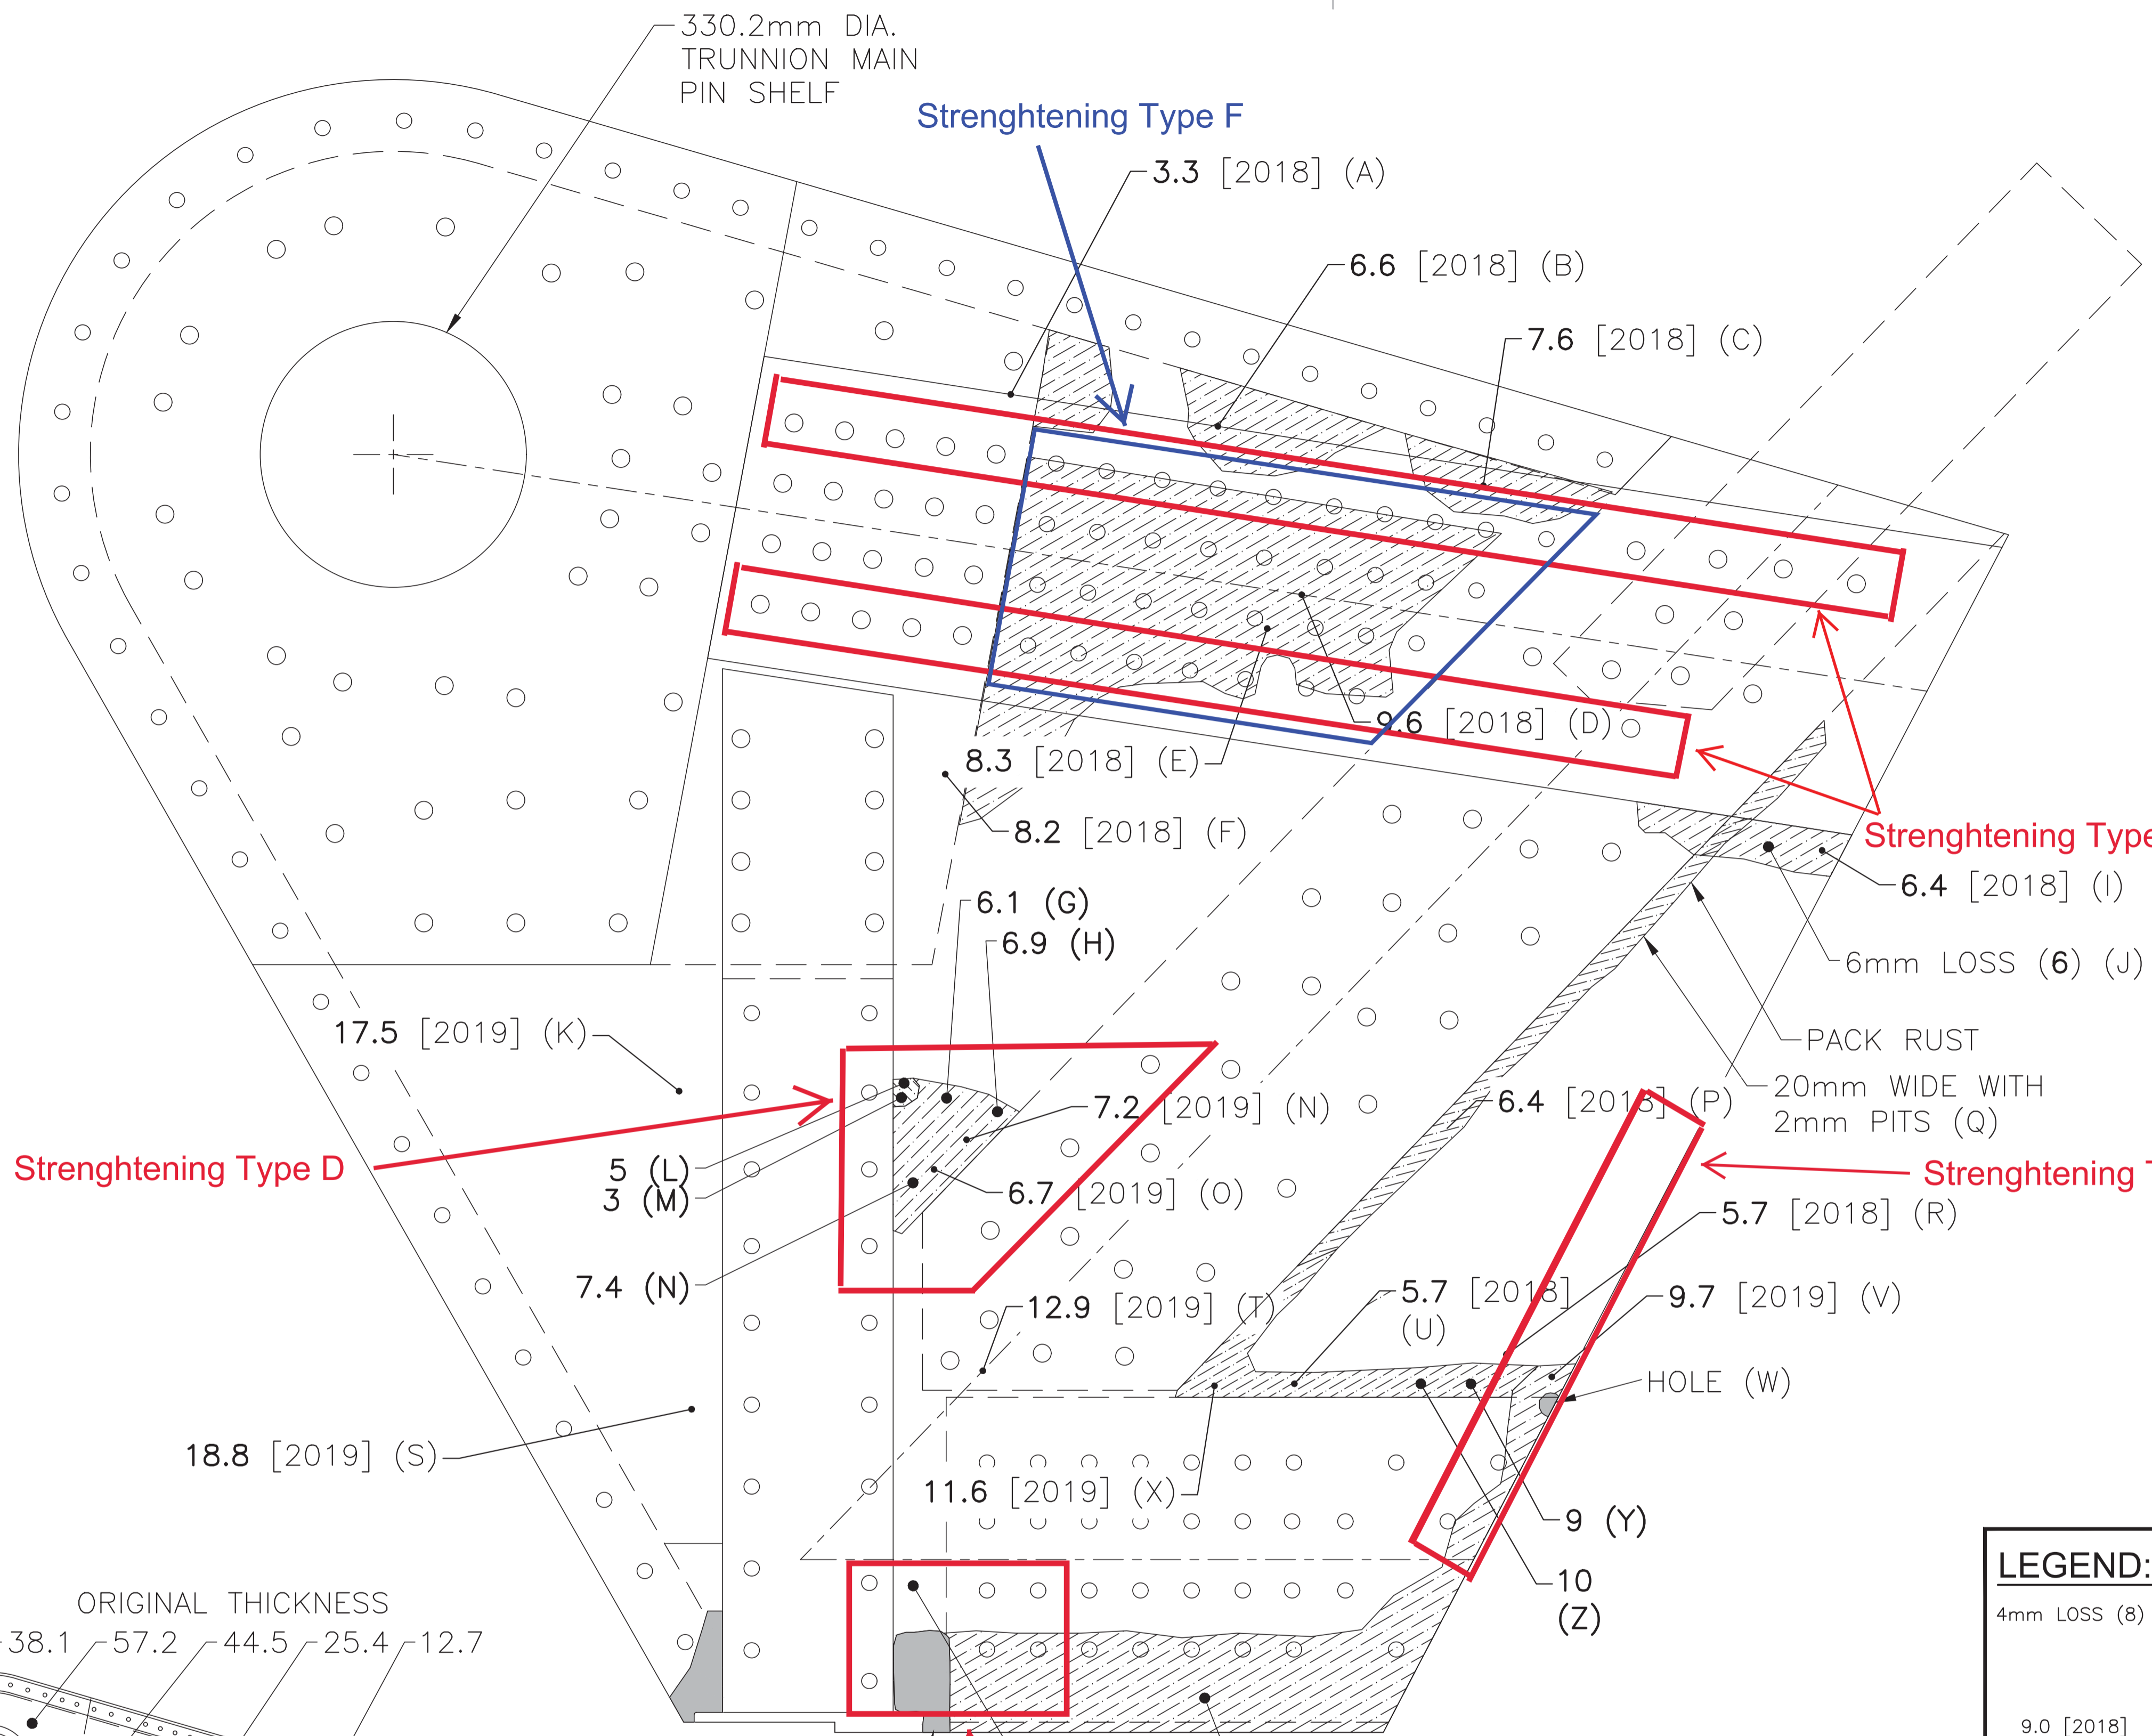
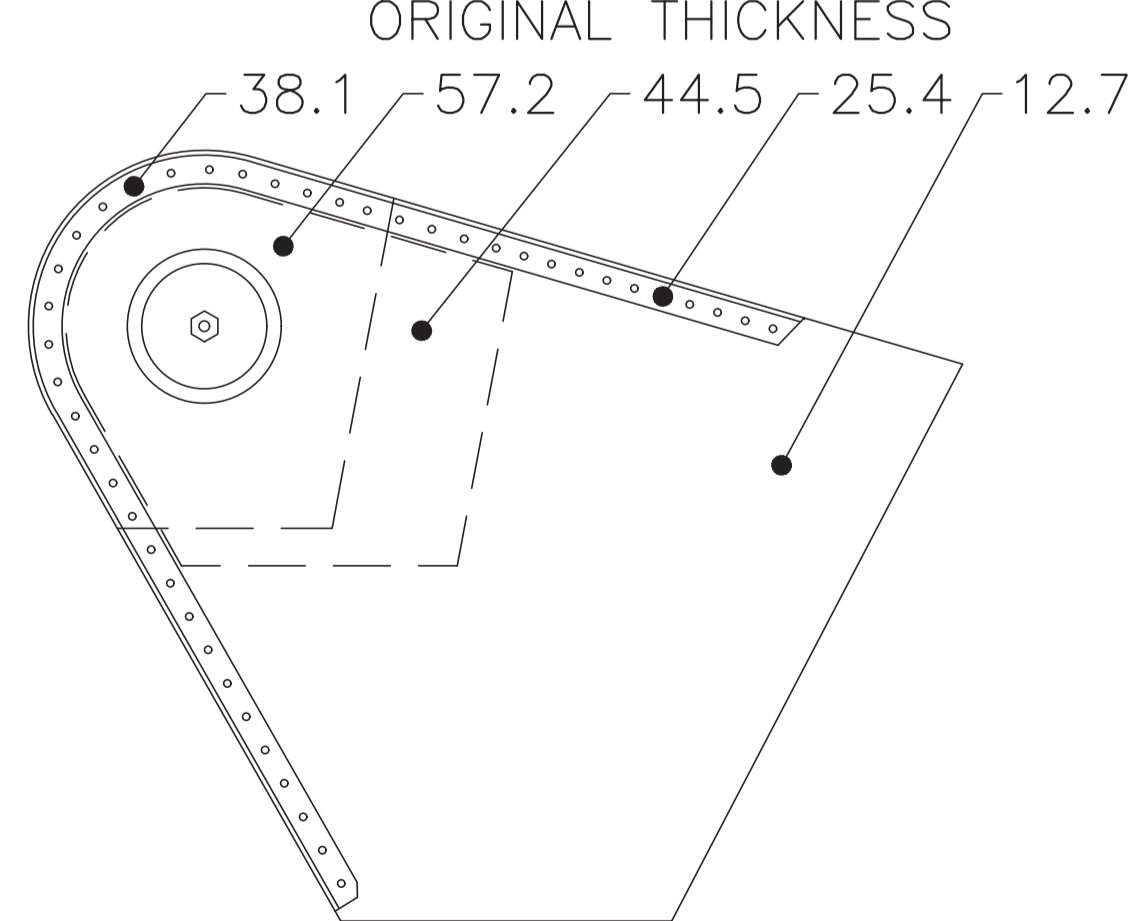
SOUTH TRUNNION INTERIOR PLATE			
READING	ORIGINAL THICKNESS (mm)	REMAINING THICKNESS (mm)	PERCENT LOSS (%)
A	12.7	3.3	74.0
B	12.7	6.6	48.0
C	12.7	7.6	40.2
D	12.7	9.6	24.4
E	12.7	8.3	34.6
F	12.7	8.2	35.4
G	12.7	6.1	52.0
H	12.7	6.9	45.7
I	12.7	6.4	49.6
J	12.7	6.0	52.8
K	23.8	17.5	26.5
L	12.7	5.0	60.6
M	12.7	3.0	76.4
N	12.7	7.4	41.7
O	12.7	6.7	47.2
P	12.7	6.4	49.6
Q	12.7	10.7	15.7
R	12.7	5.7	55.1
S	23.8	18.8	21.0
T	12.7	12.7	0.0
U	12.7	5.7	55.1
V	12.7	9.7	23.6
W	12.7	12.7	0.0
X	12.7	11.6	8.7
Y	12.7	9.0	29.1
Z	12.7	10.0	21.3
AA	12.7	12.7	0.0
BB	12.7	10.0	21.3
CC	12.7	11.0	13.4

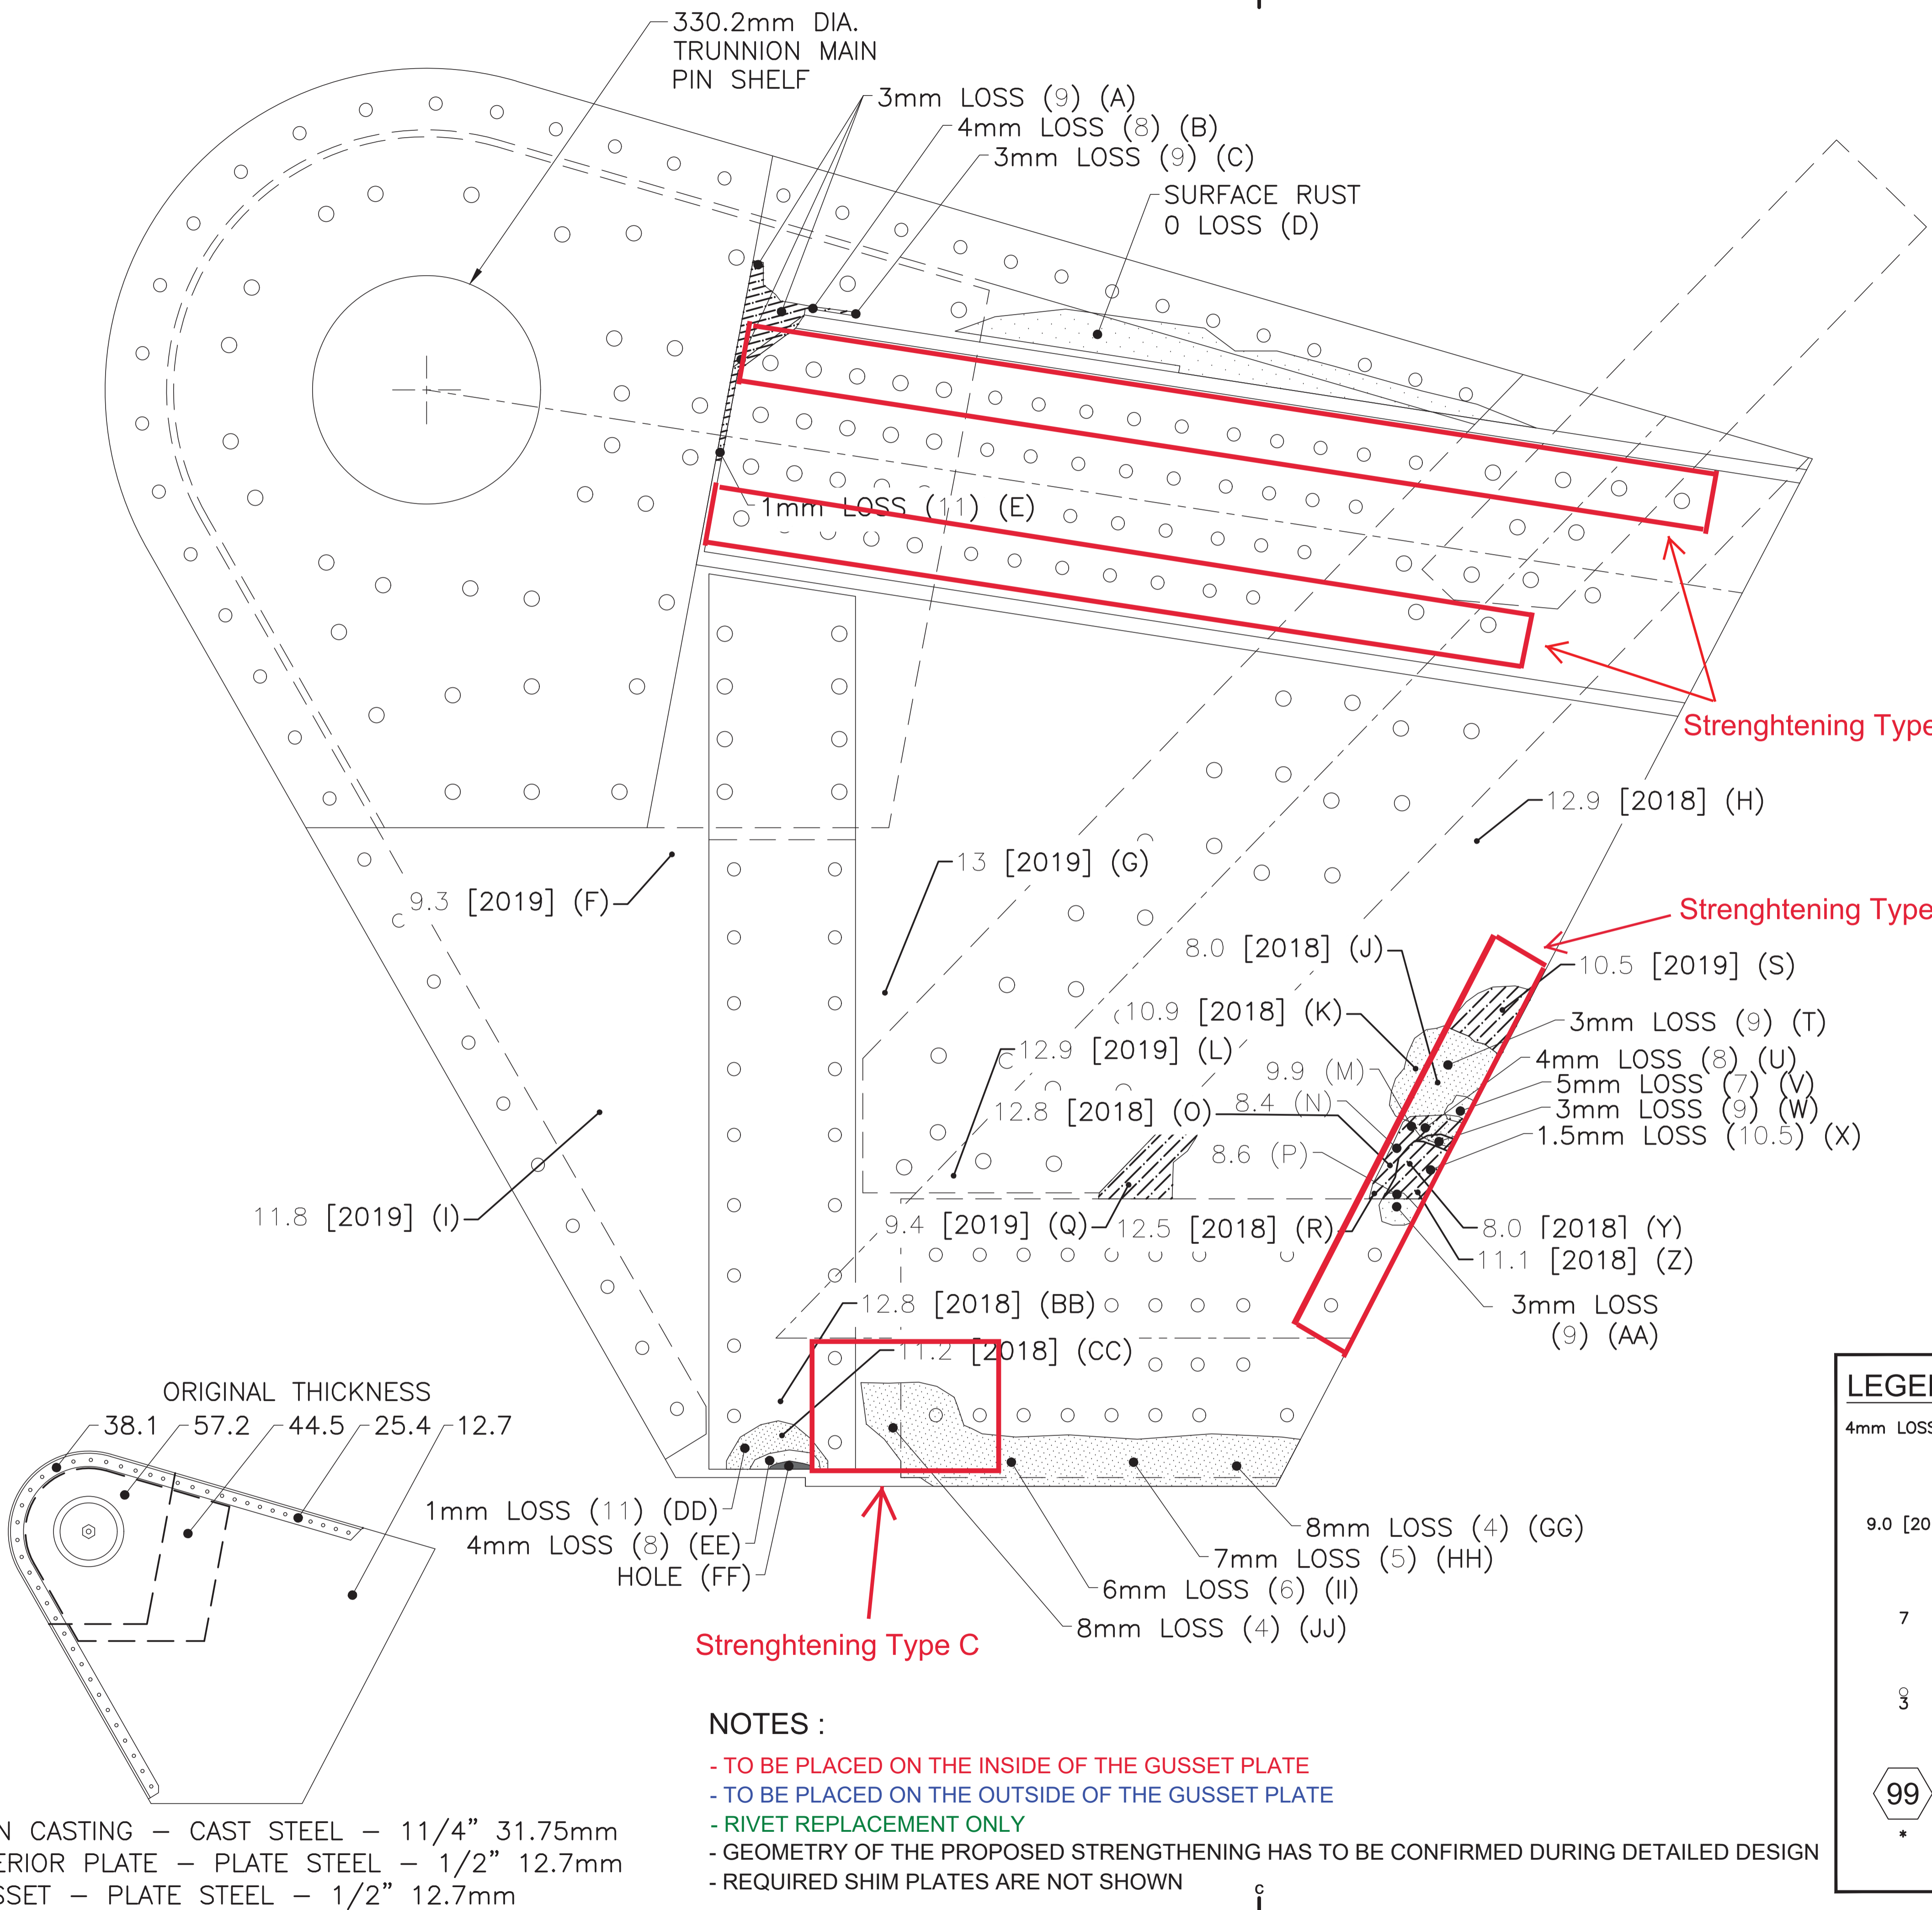
drawing NORTH TRUNNION FULL EXTERIOR PLATE DETERIORATION G H

NORTH TRUNNION EXTERIOR PLATE			
READING	ORIGINAL THICKNESS (mm)	REMAINING THICKNESS (mm)	PERCENT LOSS (%)
A	12.7	9.0	29.1
B	12.7	8.0	37.0
C	12.7	9.0	29.1
D	12.7	12.7	0.0
E	12.7	11.0	13.4
F	12.7	9.3	26.8
G	12.7	12.7	0.0
H	12.7	12.7	0.0
I	12.7	11.8	7.1
J	12.7	8.0	37.0
K	12.7	10.9	14.2
L	12.7	12.7	0.0
M	12.7	9.9	22.0
N	12.7	8.4	33.9
O	12.7	12.7	0.0
P	12.7	8.6	32.3
Q	12.7	9.4	26.0
R	12.7	12.5	1.6
S	12.7	10.5	17.3
T	12.7	9.0	29.1
U	12.7	8.0	37.0
V	12.7	7.0	44.9
W	12.7	9.0	29.1
X	12.7	10.5	17.3
Y	12.7	8.0	37.0
Z	12.7	11.1	12.6
AA	12.7	9.0	29.1
BB	12.7	12.7	0.0
CC	12.7	11.2	11.8
DD	12.7	11.0	13.4
EE	12.7	8.0	37.0
FF	12.7	12.7	0.0
GG	12.7	4.0	68.5
HH	12.7	5.0	60.6
II	12.7	8.0	37.0
JJ	12.7	4.0	68.5
