**XCG File No. 5-336-200-01**  
**COLE File No. 2018-0565**  
March 4, 2019

**DESIGNATED SUBSTANCES AND  
HAZARDOUS MATERIALS SURVEY  
PIN 673155  
7797 16<sup>TH</sup> AVENUE  
MARKHAM, ONTARIO**

**PUBLIC SERVICES AND PROCUREMENT CANADA**  
4900 Yonge Street  
11th Floor  
Toronto, Ontario M2N 6A6

**PARKS CANADA AGENCY  
ROUGE NATIONAL URBAN PARK**

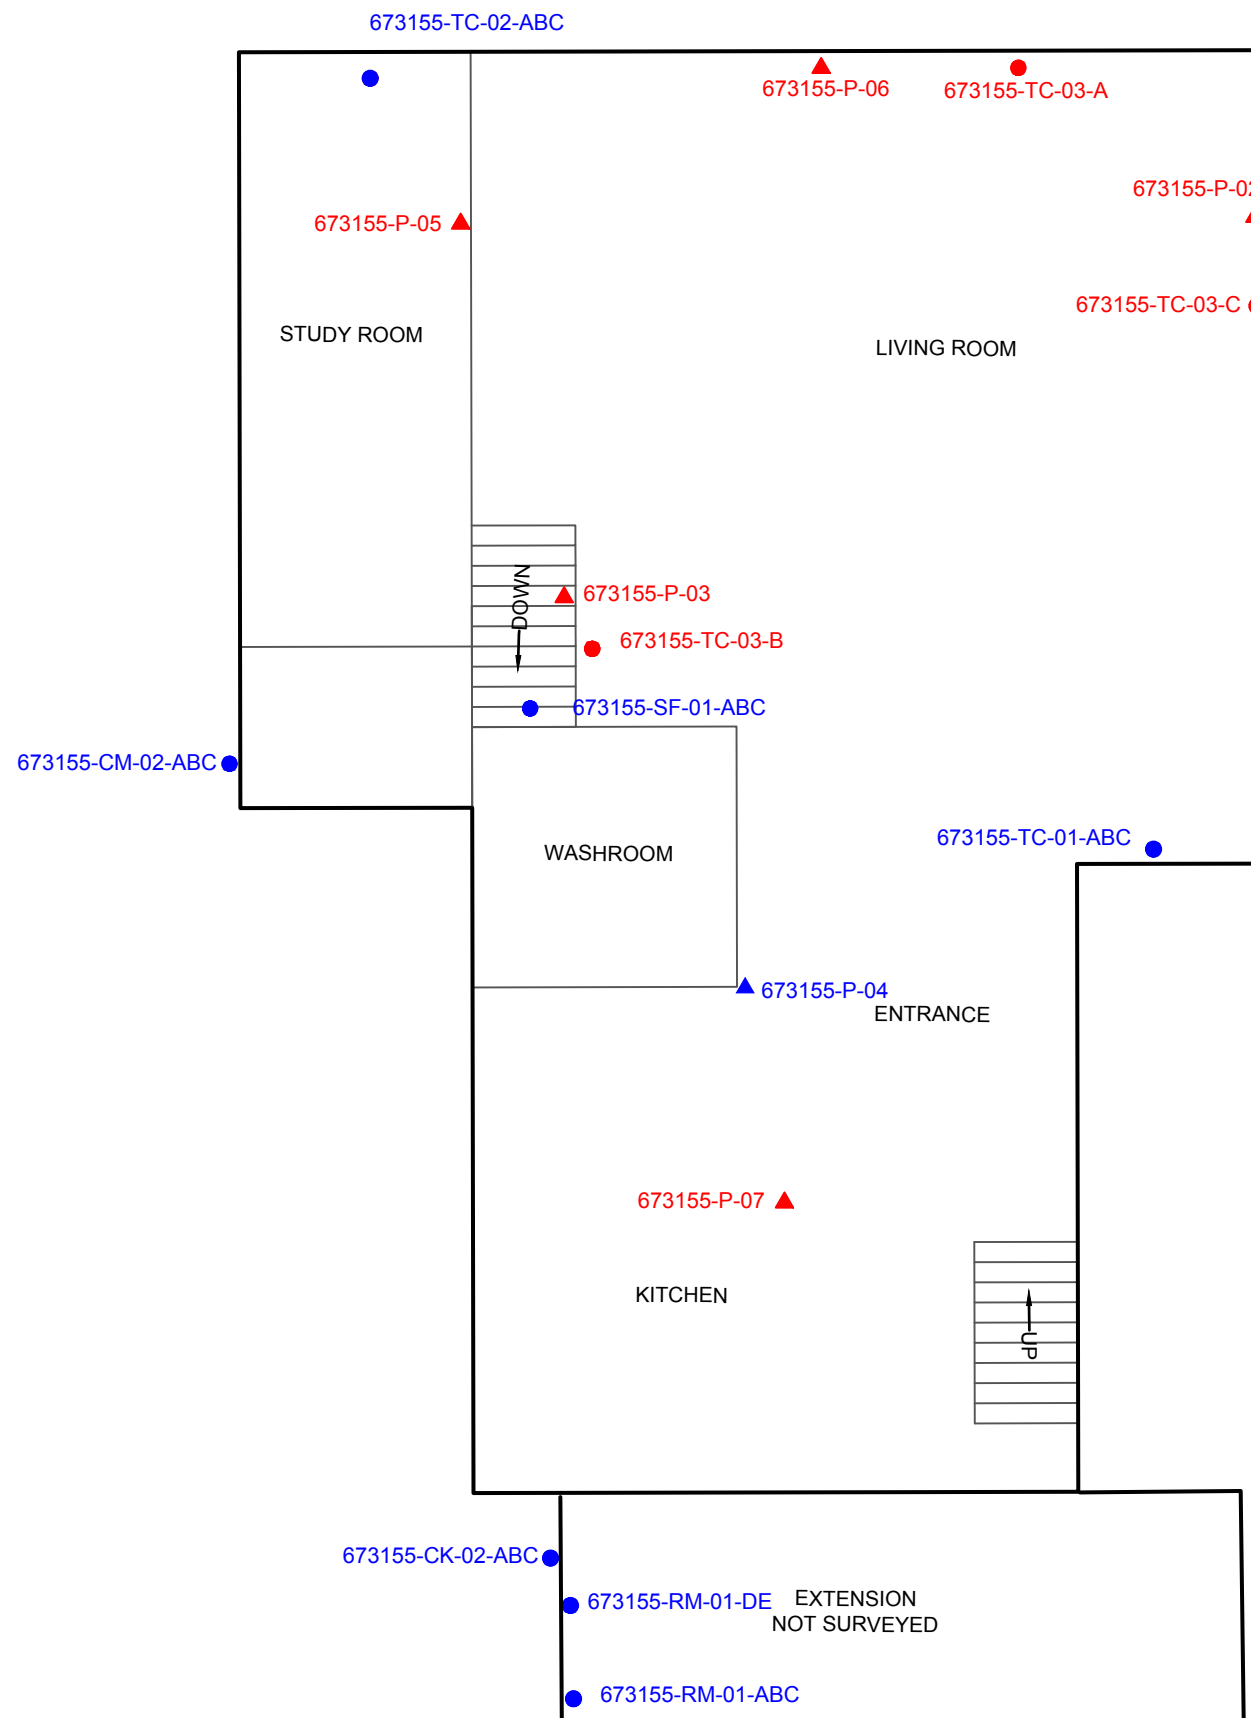
DATE	JOB NO.	FIGURE NO.
MAR. 2019	2018-0565	1

Figure 1 identifies the sample collection locations for both ACM and lead-based paint in the first floor of the subject building. Figure 2 identifies the sample collection locations for both ACM and lead-based paint on the second floor of the subject building. Figure 3 identifies the sample collection locations for both ACM and lead-based paint in the basement of the subject building. Figure 4 identifies the location of the confirmed designated substances on the first floor. Figure 5 identifies the location of the confirmed designated substances on the second floor. Figure 6 identifies the location of the confirmed designated substances in the basement. Laboratory certificates of analysis from the laboratory are provided in Appendix B. Select photographs showing ACM and lead-based paint locations within the building are presented in Appendix C.

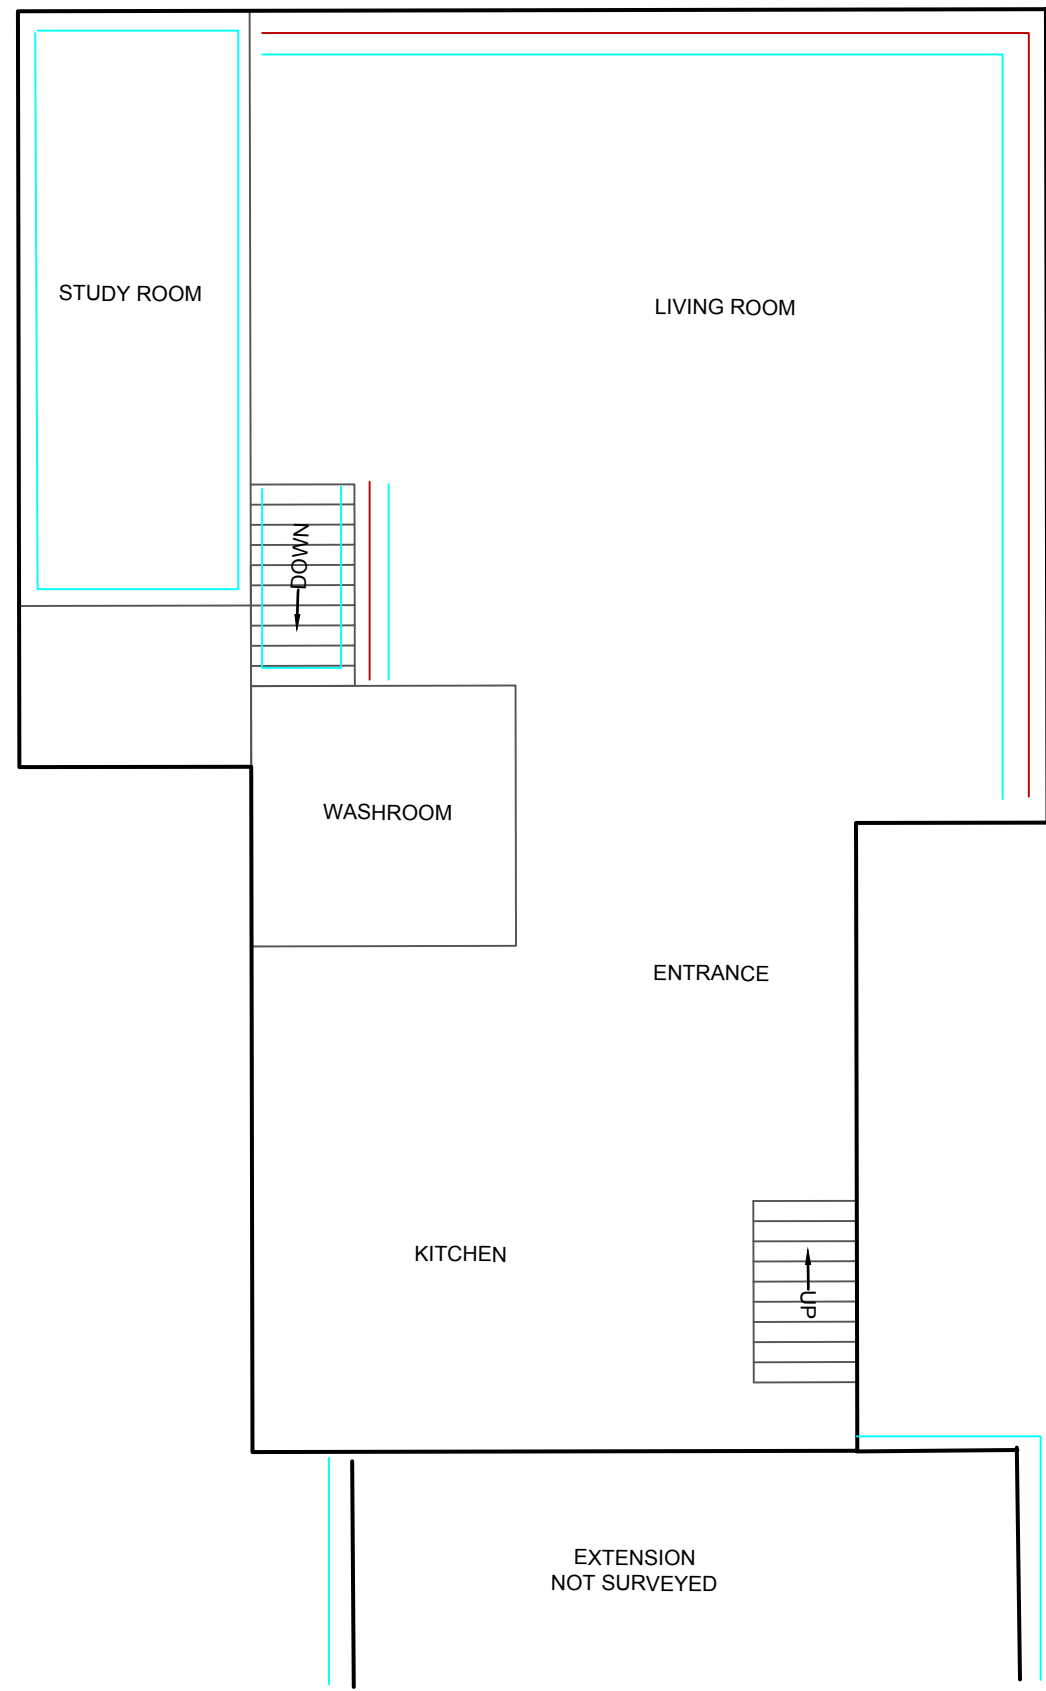
DATE	JOB NO.	FIGURE NO.
MAR. 2019	2018-0565	4

Figures 1, 2 and 3 identify sample collection locations for both ACM and lead-based paint at the subject building on the first floor, second floor and basement, respectively. Figures 4, 5 and 6 indicate confirmed designated substances and hazardous materials locations on the first floor, second floor, and basement, respectively.

— CONFIRMED LEAD CONTAINING PAINT (WALL)  
— LOCATION OF CONFIRMED ACM

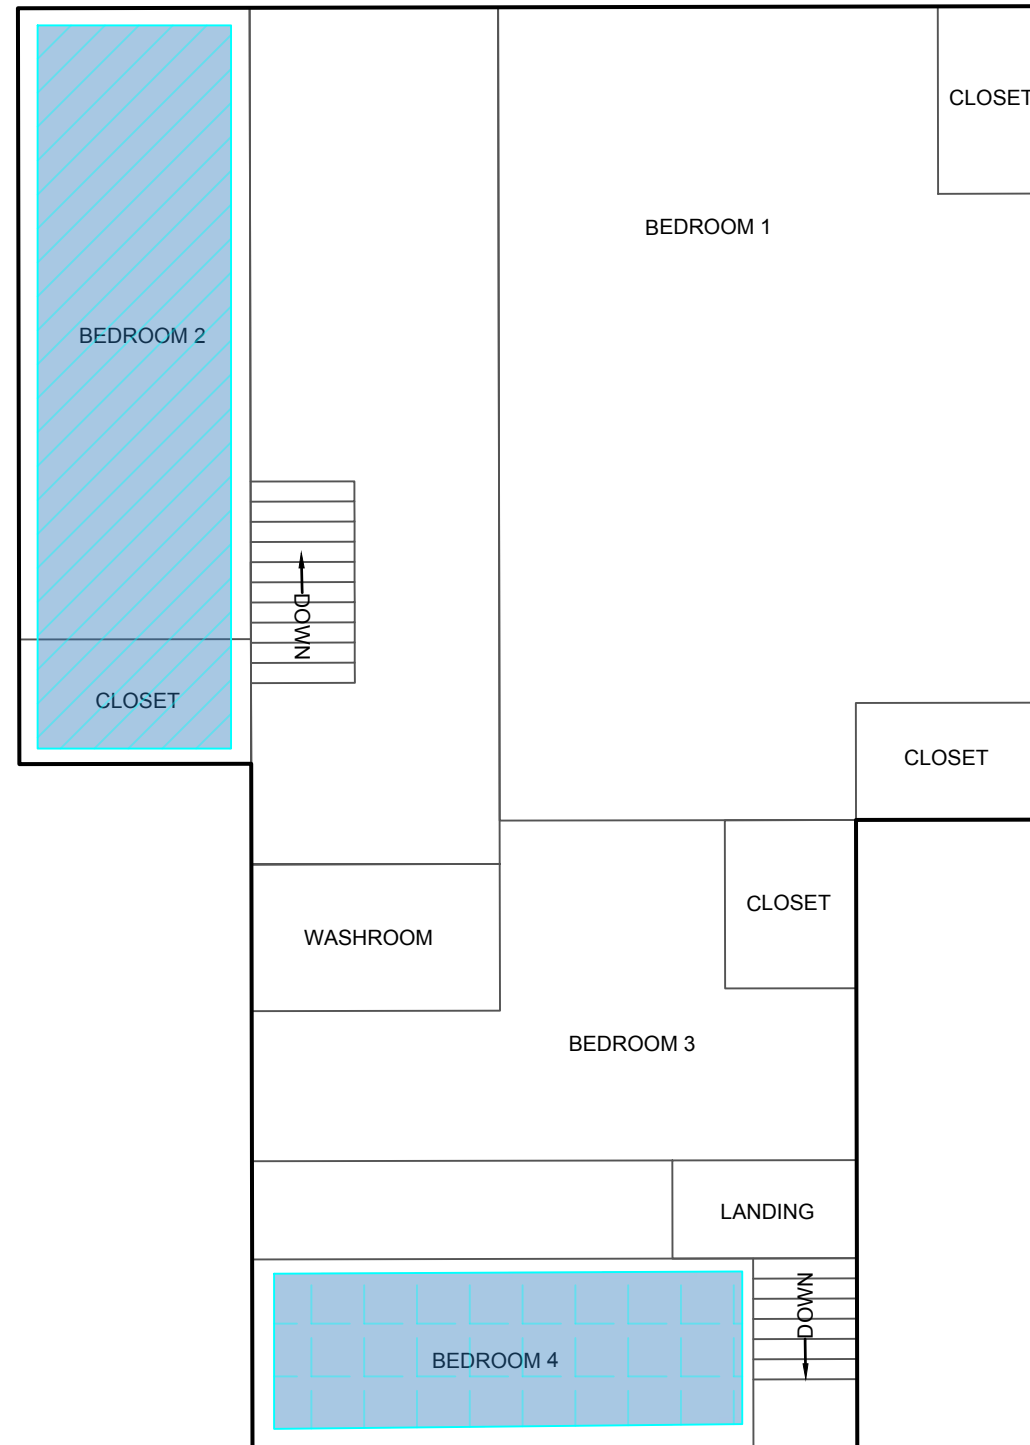
DATE	JOB NO.	FIGURE NO.
MAR. 2019	2018-0565	5

- CONFIRMED LEAD CONTAINING PAINT (FLOOR)
- CONFIRMED LEAD CONTAINING PAINT (CEILING)

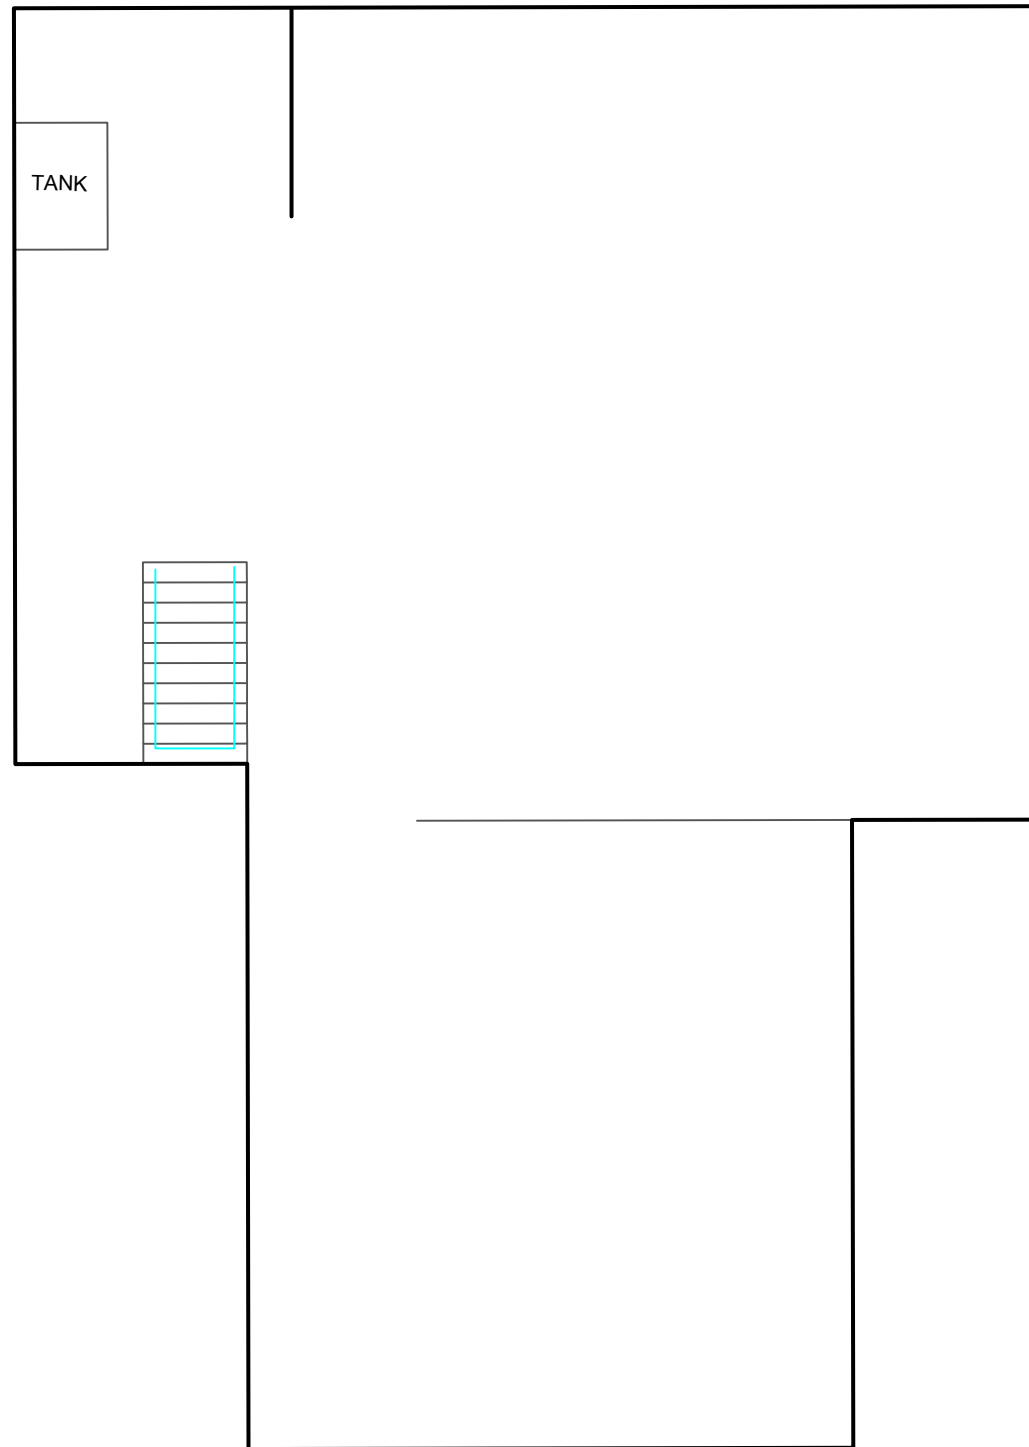
CONFIRMED LEAD CONTAINING PAINT (WALL)

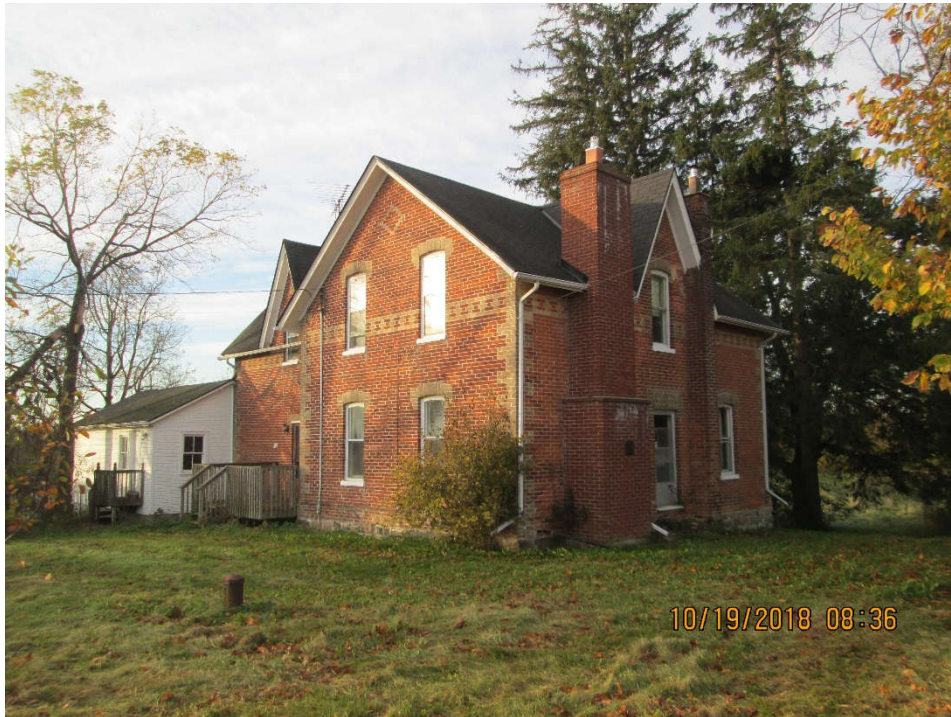
**Photo 1: View of the exterior of the residential dwelling.**
