XCG File No. 5-336-200-01

COLE File No. 2018-0565

January 31, 2019

**DESIGNATED SUBSTANCES AND
HAZARDOUS MATERIALS SURVEY
PIN 614185
1149 CONCESSION 2
UXBRIDGE, ONTARIO**

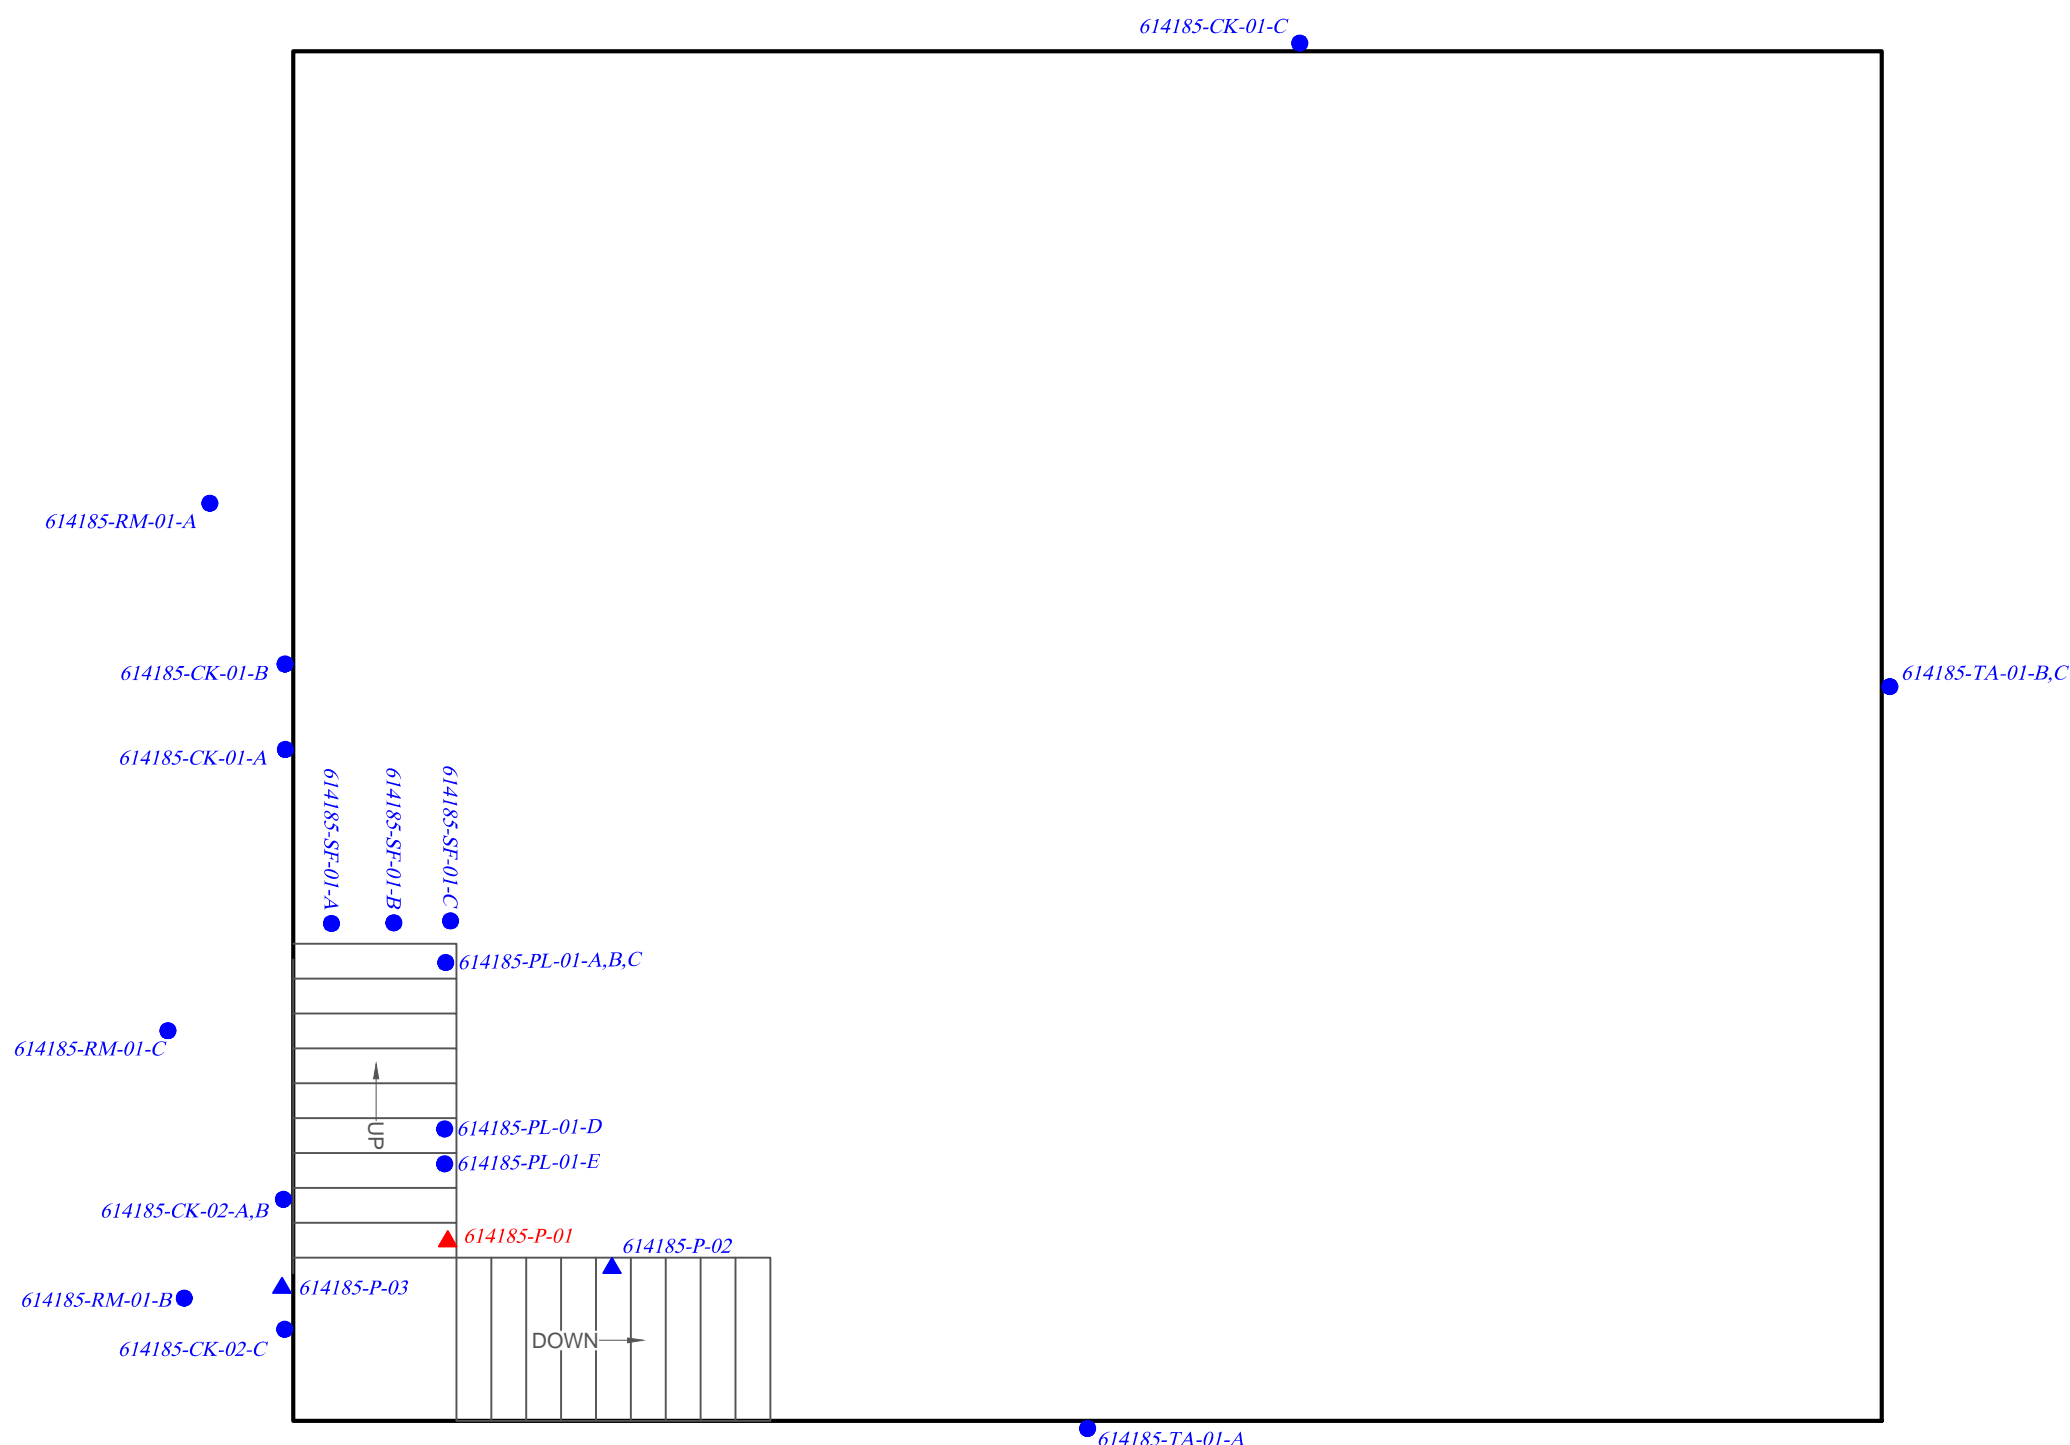
DATE	JOB NO.	FIGURE NO.
JAN. 2019	5-336-200-01	1

CONFIRMED LEAD-CONTAINING
PAINT (WALL)

NOTE:
DUE TO SAFETY CONCERNS, THE BUILDING WAS
NOT ENTERED. ADDITIONAL ACMS AND/OR
LEAD-CONTAINING PAINT MAY BE PRESENT
