**DESIGNATED SUBSTANCE AND
HAZARDOUS MATERIALS SURVEY
PIN: 633560
1968 Woodview Avenue, Toronto,
ON**

Rouge National Urban Park

March 18, 2020

Stantec Project No: 122151011
PSPC Project No: R.099832.001

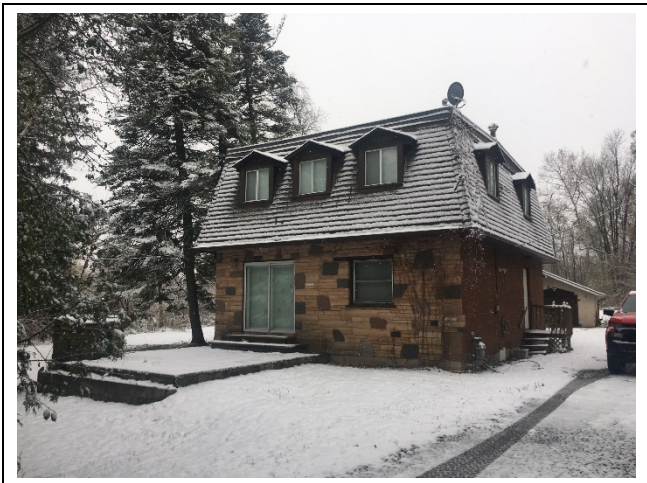
Photo 1: Exterior view of the house.

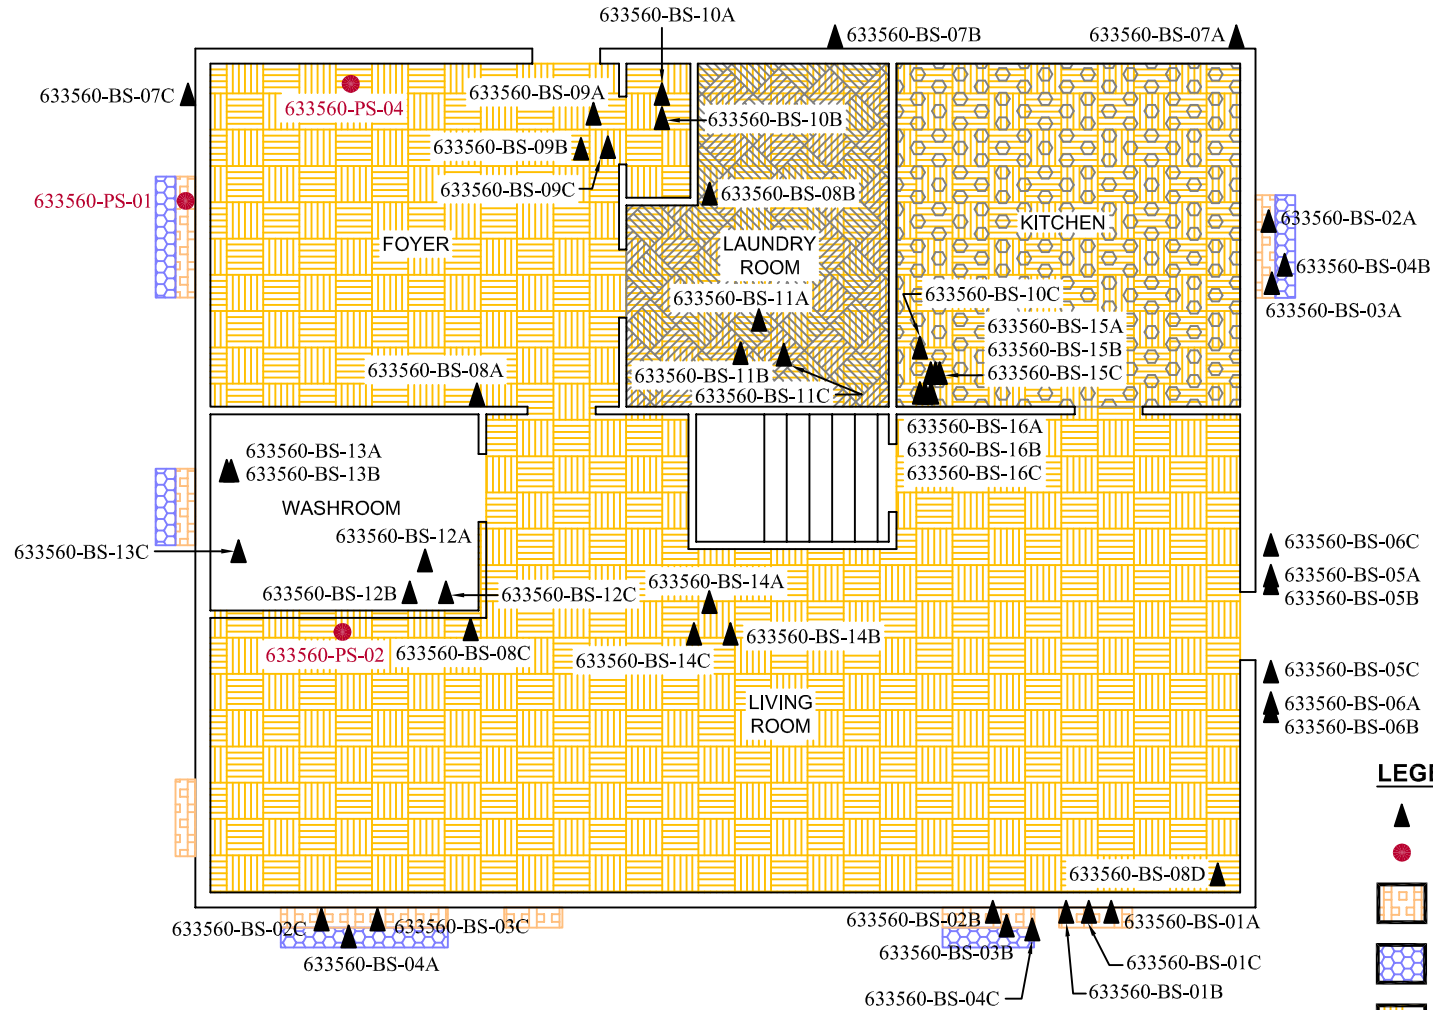
FIRST FLOOR

NOTES: 1. DRYWALL JOINT-FILL COMPOUND IS IDENTIFIED BY LABORATORY ANALYSIS TO BE ASBESTOS-CONTAINING.
 2. THIS DRAWING ILLUSTRATES SUPPORTING INFORMATION SPECIFIC TO A STANTEC CONSULTING LTD. REPORT AND MUST NOT BE USED FOR OTHER PURPOSES.
