**HAZARDOUS BUILDING MATERIALS ASSESSMENT
CARTWRIGHT FIELD OFFICE
DFRP# 56215
5 POINT ROAD, CARTWRIGHT,
NEWFOUNDLAND AND LABRADOR**

**Wood Environment & Infrastructure Solutions,
a Division of Wood Canada Limited**

March 2019

Wood Project #: TF17076811.1000

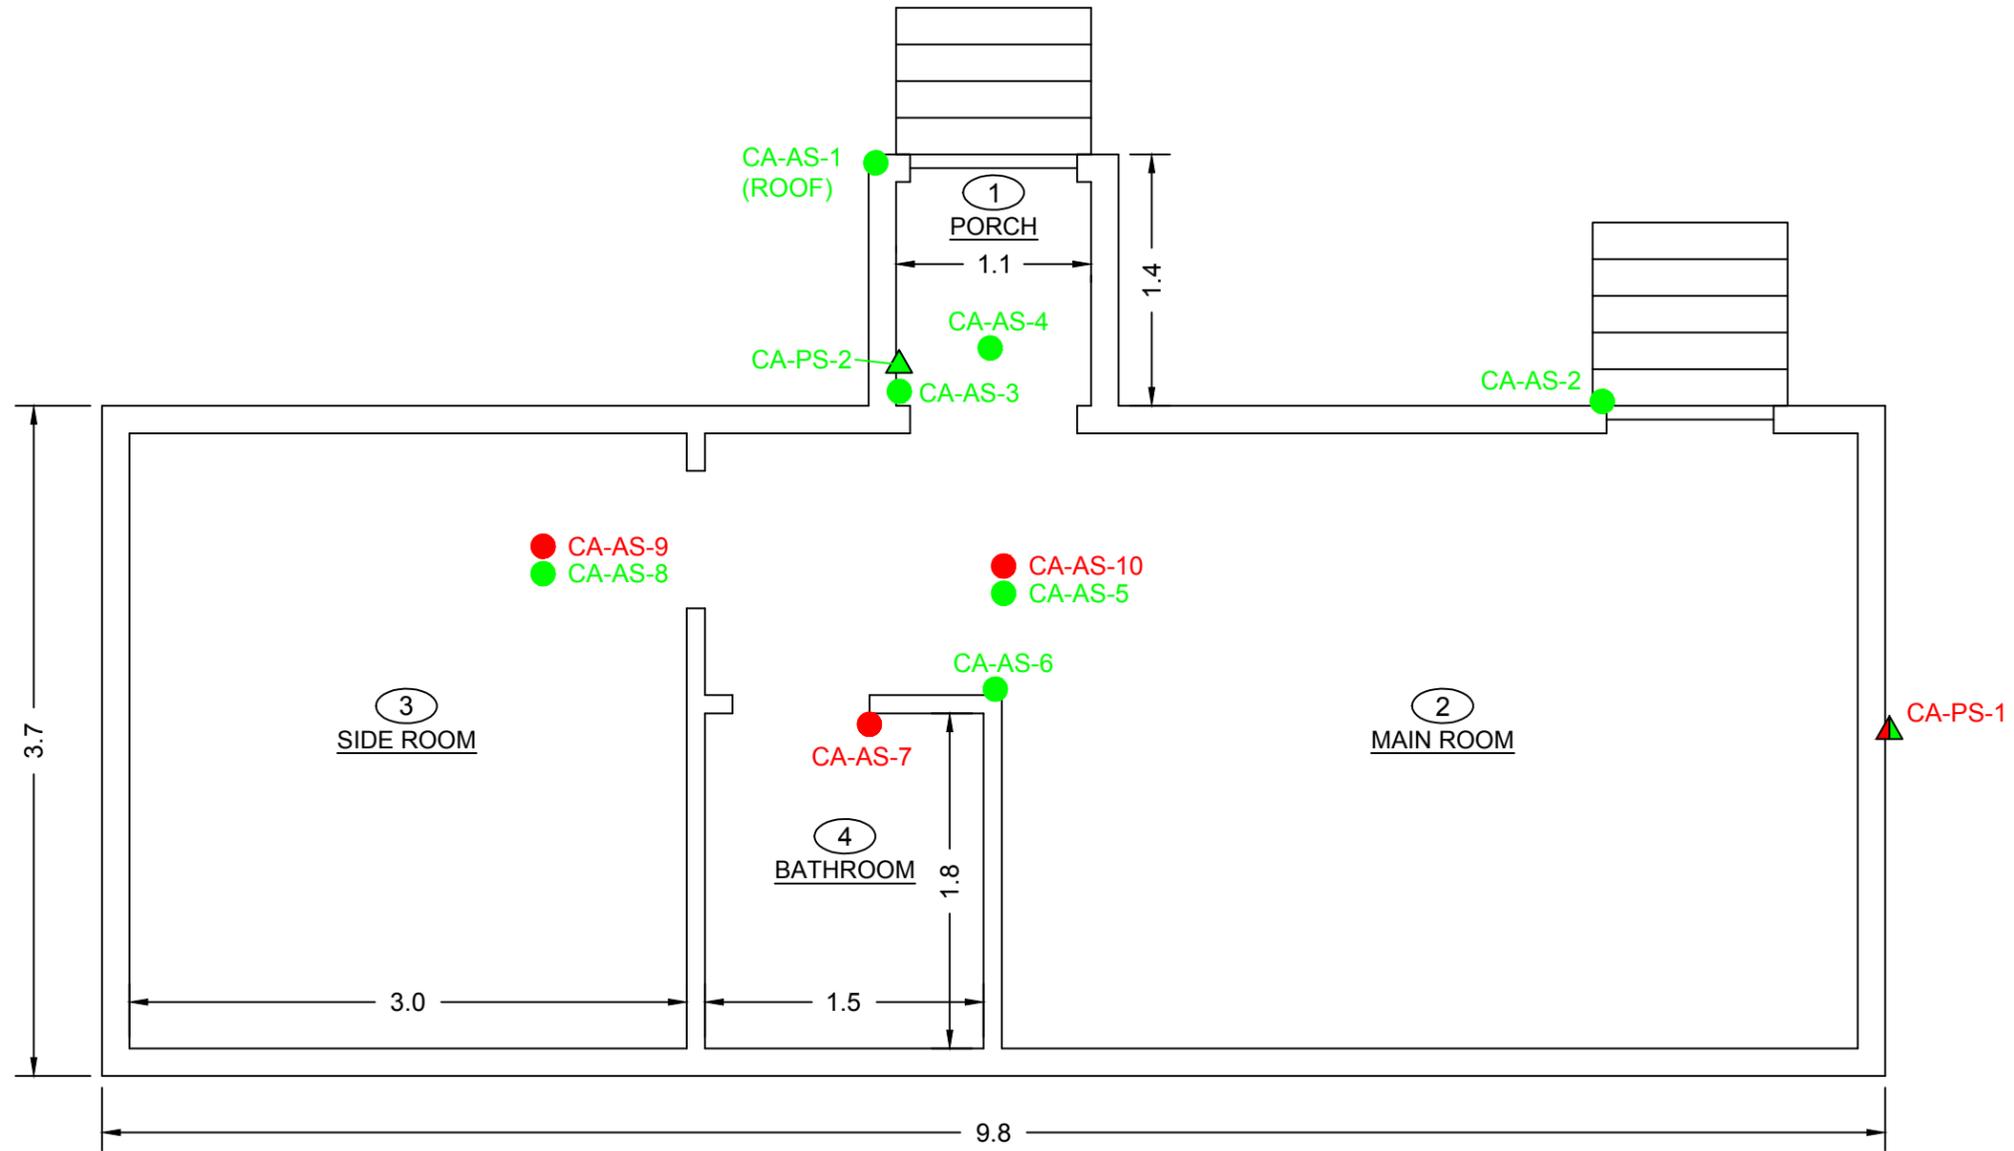
Figure No.
2

During the HBMA, 10 building material samples were collected from the Office Trailer (CA-AS-1 to CA-AS-10) and analyzed for asbestos content (refer to Photos 9 to 18, Appendix B). It should be noted that several samples were separated into sub-samples representing distinct material layers and re-labeled by the laboratory prior to analysis. Bulk sample descriptions and asbestos analytical results are summarized in Table C-1, Appendix C. Sample locations and analytical results are graphically illustrated in Figure 2, Appendix A.

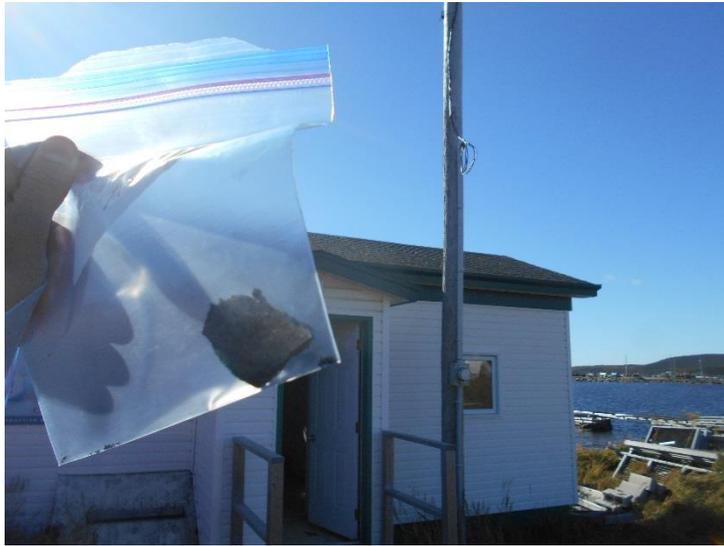
One sample of asphalt shingle (CA-AS-1) was collected from the roof of the Office Trailer and analyzed for asbestos content (refer to Photo 9, Appendix B).

Photo 9 – View of bulk samples CA-AS-1 (black asphalt shingle).

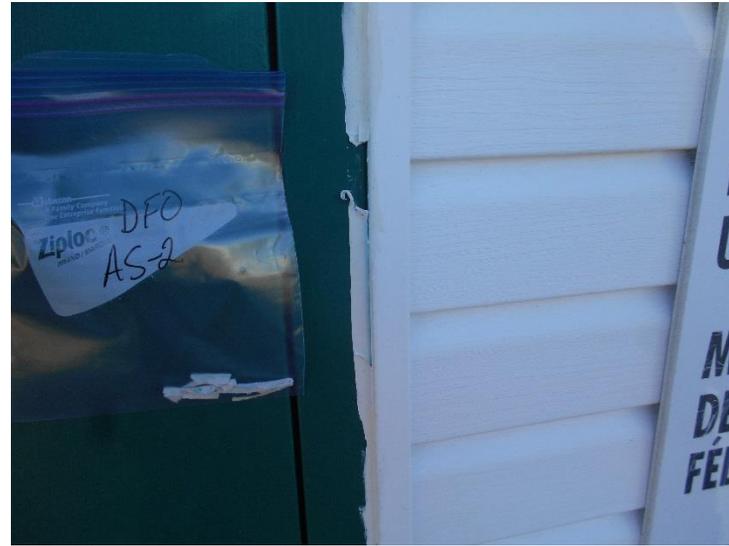
One sample of caulking (CA-AS-2) was collected from the Exterior of the Office Trailer and analyzed for asbestos content (refer to Photo 10, Appendix B).

Photo 10 – View of bulk sample CA-AS-2 (white caulking).

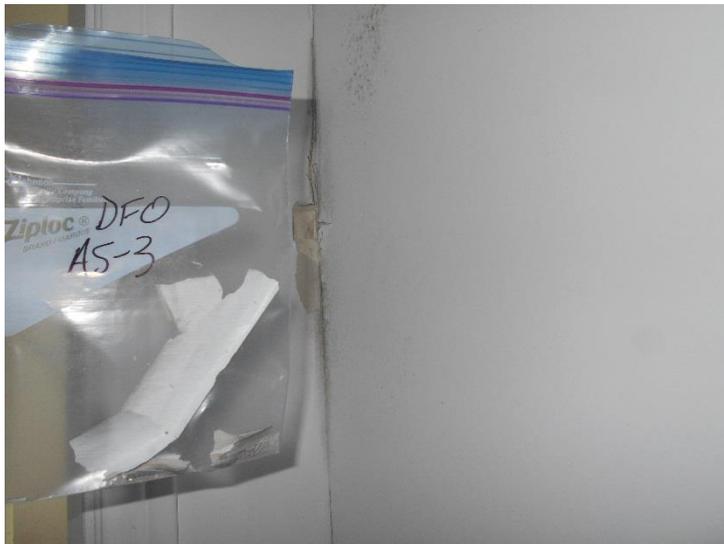
Two samples of drywall joint compound were collected from the Porch (CA-AS-3) and Main Room (CA-AS-6) of the Office Trailer and analyzed for asbestos content (refer to Photos 11 and 14, Appendix B).

Photo 11 - View of bulk sample CA-AS-3 (drywall joint compound).

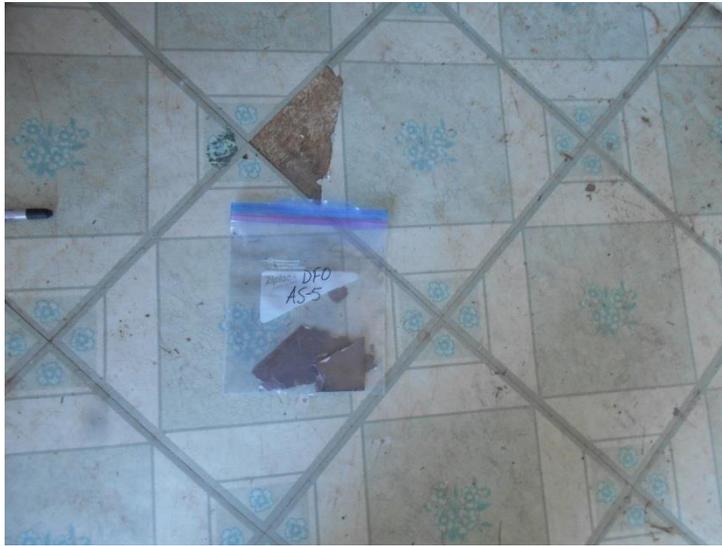
Photo 13 - View of bulk sample CA-AS-5 (green patterned vinyl floor tiles with brown mastic).

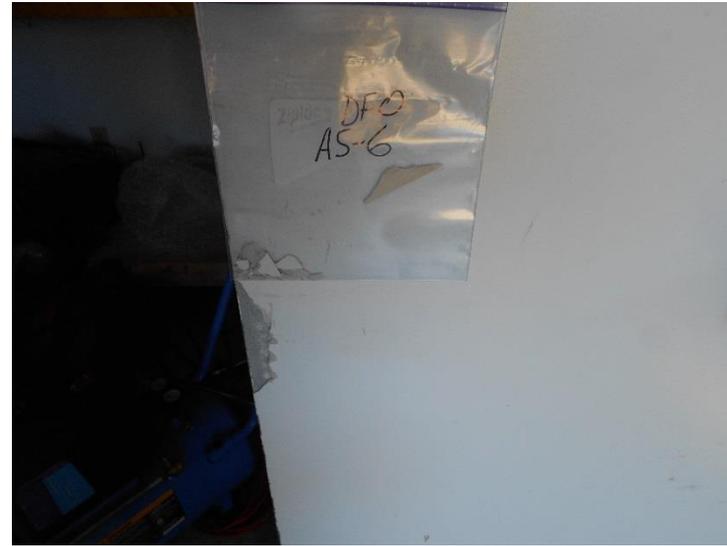
Photo 14 - View of bulk sample CA-AS-6 (drywall joint compound).

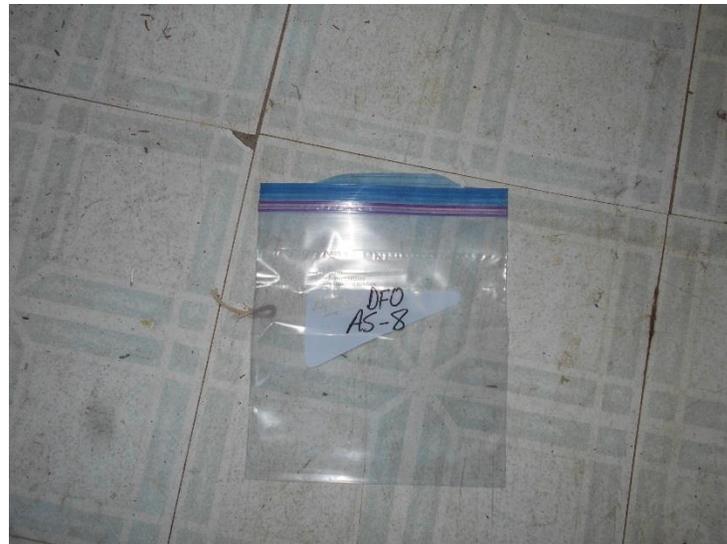
Photo 16 - View of bulk sample CA-AS-8 (green square pattern vinyl floor tile).

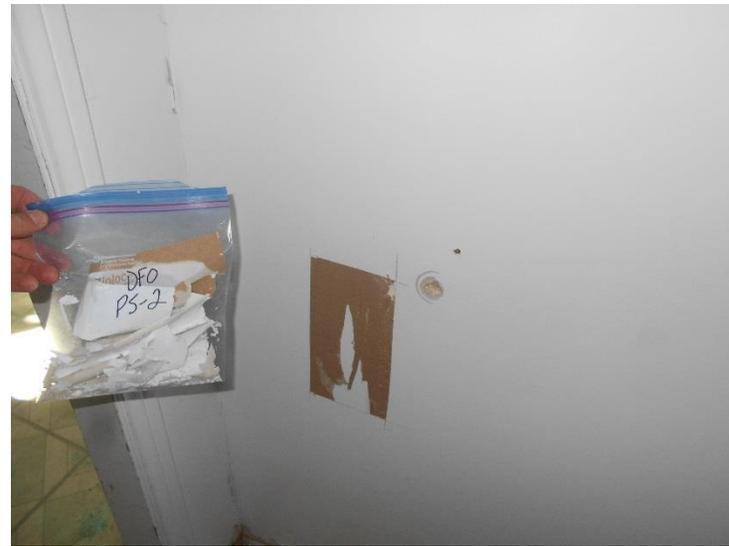
During the HBMA site visit, two paint samples (CA-PS-1 and CA-PS-2), plus one blind field duplicate sample (CA-PS-DUP1, a duplicate of CA-PS-1), were collected from painted surfaces of the Office Trailer and analyzed for lead, mercury, and PCB content (refer to Photos 19 and 20, Appendix B). Paint sample descriptions and analytical results are summarized in Tables C-2 to C-5, Appendix C. Sample locations and analytical results are graphically illustrated in Figure 2, Appendix A.

Photo 20 – View of paint sample CA-PS-2 (white paint).

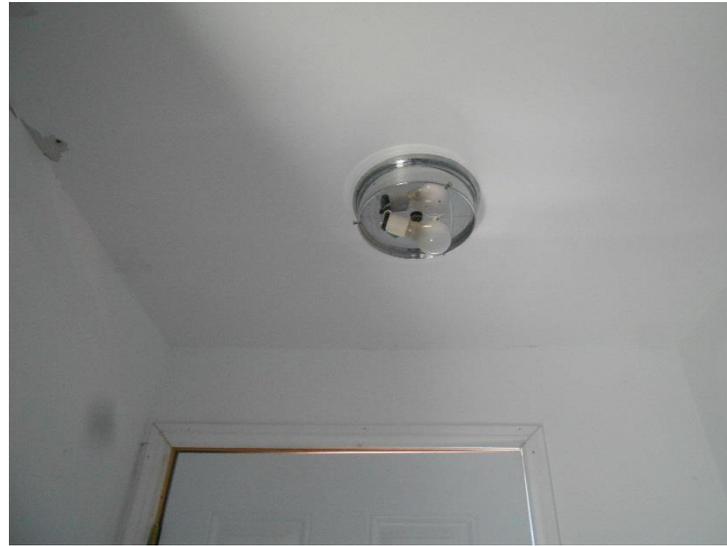
Photo 22 – View of incandescent light fixture observed in Room 1 (Porch).
