Date
October 14, 2021

Project #
60608868

**Subject: Kwetǫǫǫǫ (Rayrock) Remediation Project
2021 Field Investigation Summary – Test Pit Excavations**

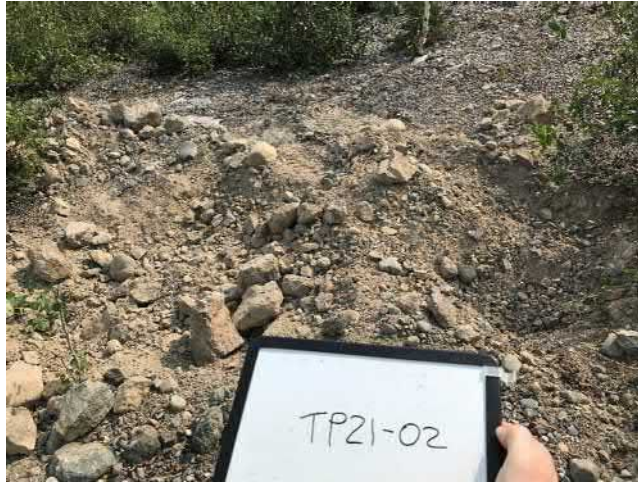
Photo 1: This image shows the extents of the ground disturbance that the excavator was able to create in the area of TP21-02. Large rocks prevented the machine from digging any deeper.	
Notes: <ul style="list-style-type: none"> • Large rocks just below the surface made it difficult to dig at this location. • Excavator was unable to excavate deeper than approximately 0.30m due to large rock obstructions. • The nearby areas directly surrounding this location gave the same result when attempted to excavate. • Uncertain how much deeper the sand and rock continue before reaching the bedrock surface in this area.

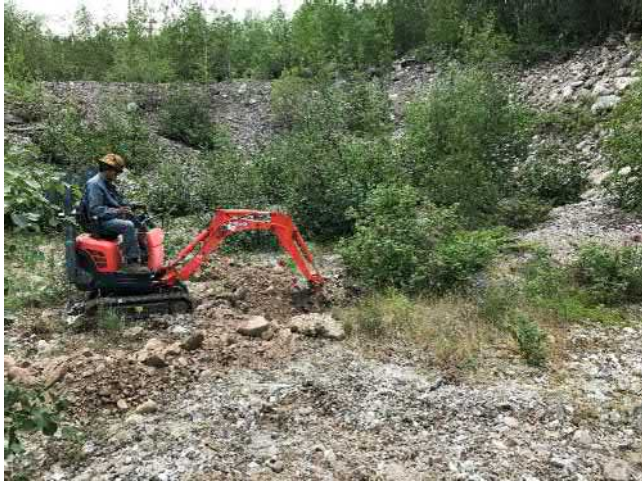
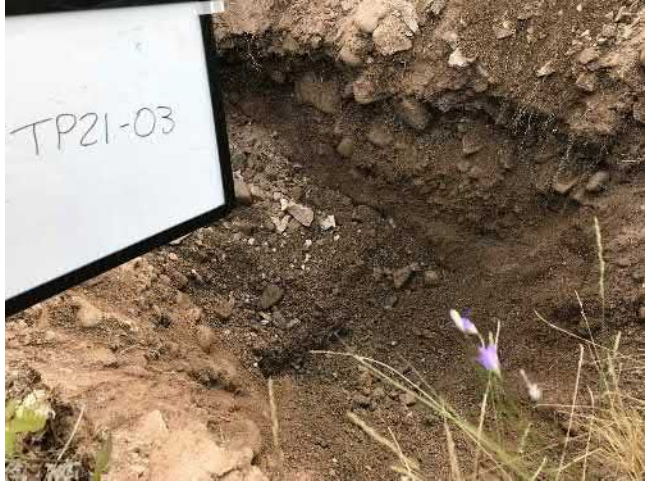
Photo 2: Image shows the location of TP21-03 with waste rock slopes to the NW and SW of the excavated pit.	Photo 3: Excavated TP21-03 until contact with a large rock prevented the machine from continuing deeper. 1.10 metres below ground surface (mbgs) was reached.
Notes: <ul style="list-style-type: none"> Excavator was able to dig to approximately 1.10 mbgs before contacting a large rock and preventing any further excavation. Large rock contacted at 1.10 mbgs was estimated as a non-bedrock cobble. Uncertain how much deeper the sand and rock continue before reaching the bedrock surface in this area.

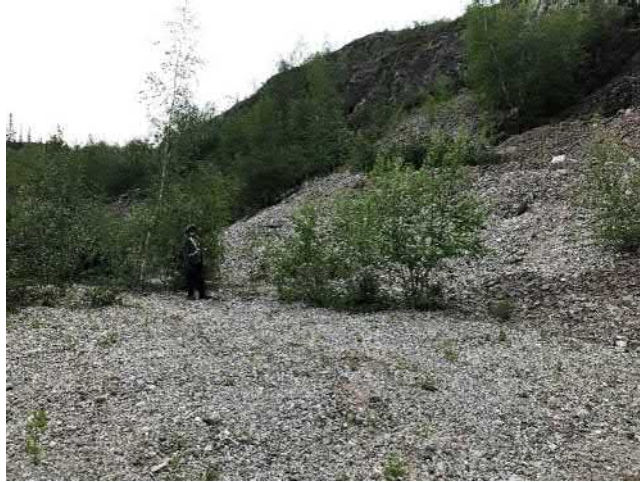
Photo 4: Wildlife monitor standing in the general area proposed for TP21-04. Test pit was not excavated as the adit is nearby and there was potential for rocks sliding from the slope above if excavation were to occur. See notes below.	
Notes: <ul style="list-style-type: none"> TP21-04 was not excavated because the adit is nearby and the potential for rocks to slide from the slope above if excavation proceeded was noted. The ground surface elevation in the area of proposed TP21-04 is similar the ground surface elevation at nearby test pits TP21-05A and TP21-05B therefore, sub-surface results may be similar to those pits. Material in this location is the same as what was discovered in test pits TP21-05A and TP21-05B.

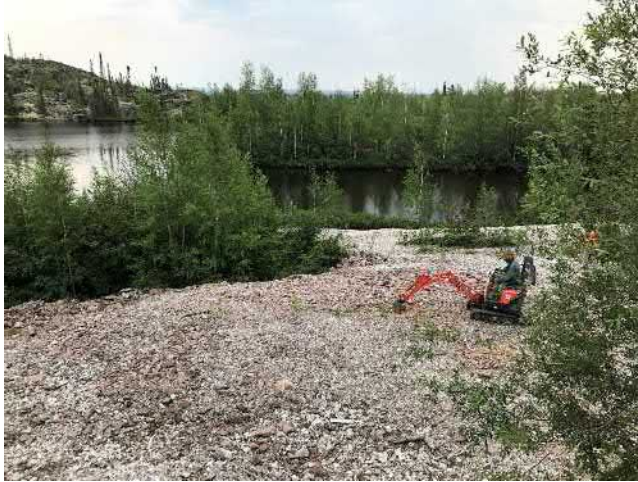
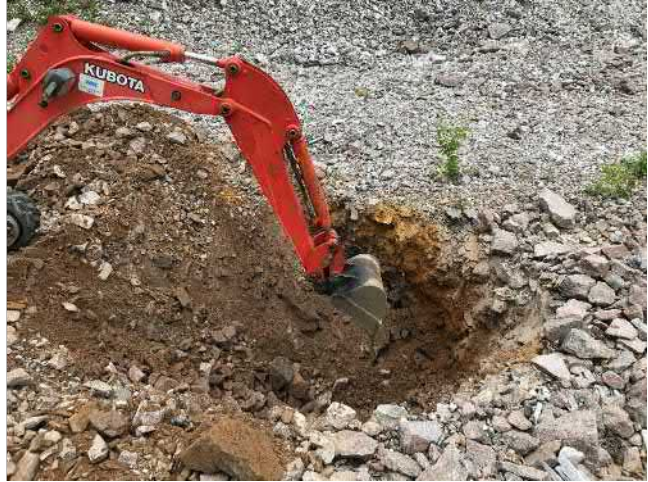
Photo 5: Image shows the location of TP21-05A with Mill Lake to the SE.	Photo 6: Excavated TP21-05A until contact with a large rock prevented the machine from continuing deeper. 1.10 metres below ground surface (mbgs) was reached.
Notes: <ul style="list-style-type: none"> Excavator was able to dig to approximately 1.10 mbgs before contacting a large rock and preventing any further excavation. Orange sand and some debris (cloth and wood) were discovered while digging this test pit. Large rock contacted at 1.10 mbgs was estimated as a non-bedrock cobble. Uncertain how much deeper the sand and rock continue before reaching the bedrock surface in this area. Moved west to the toe of the waste rock slope to attempt another excavation in the area (TP21-05B).

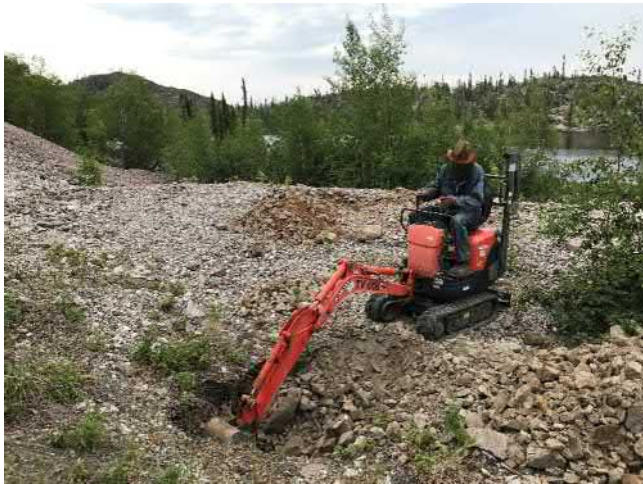
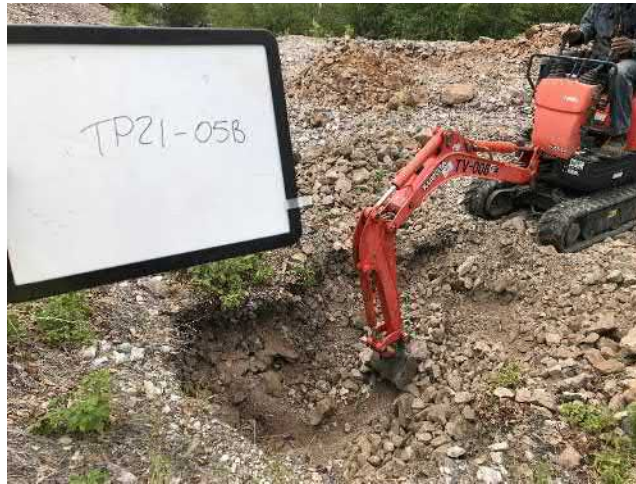
Photo 7: Image shows the location of TP21-05B with TP21-05A in the background nearby.	Photo 8: Excavated TP21-05B until contact with a hard rock surface prevented the machine from continuing deeper. 1.15 metres below ground surface (mbgs) was reached.
Notes: <ul style="list-style-type: none"> Excavator was able to dig to approximately 1.15 mbgs before contacting a hard rock surface and preventing any further excavation. Uncertain of whether or not the hard rock surface contacted was large cobbles or bedrock (expect cobbles). Excavation depths were limited by the size of equipment used to dig the pits. Uncertain of the depth to bedrock. Estimate rocks and sand continue to a depth of up to 3 mbgs before a bedrock surface is contacted in the area of TP21-05A and TP21-05B.

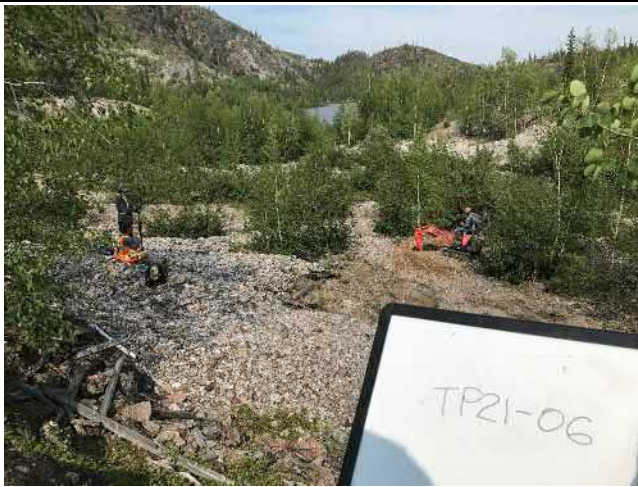
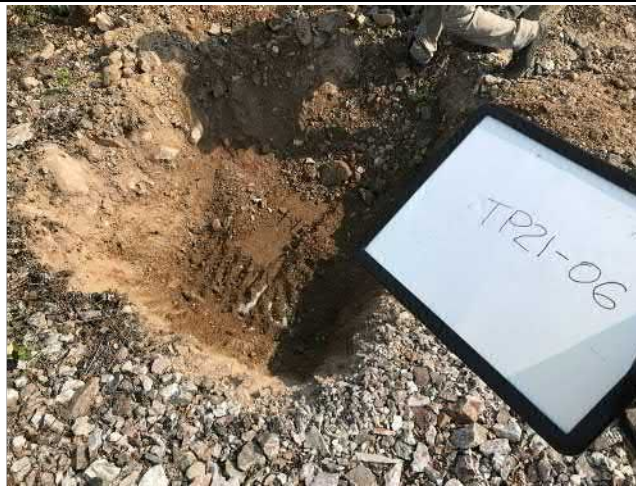
Photo 9: Image shows the location of TP21-06 with Mill Lake in the distance to the NE and a waste rock slope to the west.	Photo 10: Excavated TP21-06 until contact with what seemed to be the bedrock surface. 0.75 metres below ground surface (mbgs) was reached.
Notes: <ul style="list-style-type: none"> Excavator was able to dig to approximately 0.75 mbgs before contacting assumed bedrock surface.

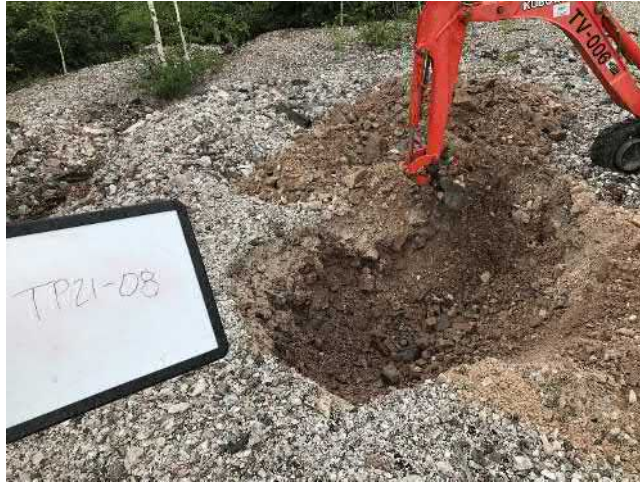
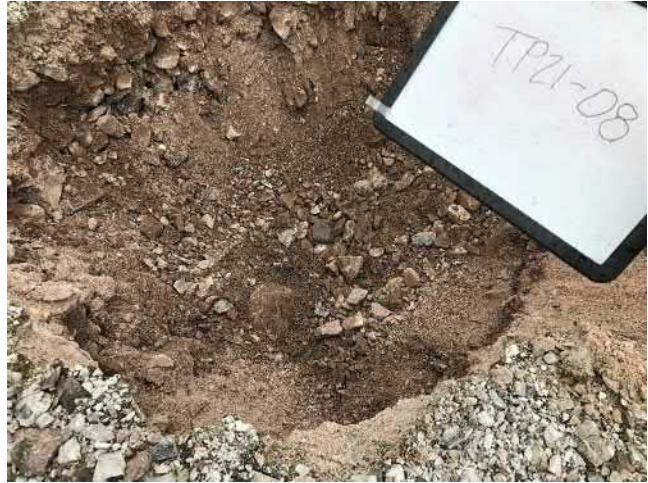
Photo 13: Image shows the excavation of TP21-08.	Photo 14: Excavated TP21-08 until contact with a large rock prevented the machine from continuing deeper. 1.10 metres below ground surface (mbgs) was reached.
Notes: <ul style="list-style-type: none"> Excavator was able to dig to approximately 1.10 mbgs before contacting a large rock and preventing any further excavation. Large rock contacted at 1.10 mbgs was estimated as a non-bedrock cobble. Uncertain how much deeper the sand and rock continue before reaching the bedrock surface in this area. Moved to the SE to attempt excavation of another pit (TP21-09).

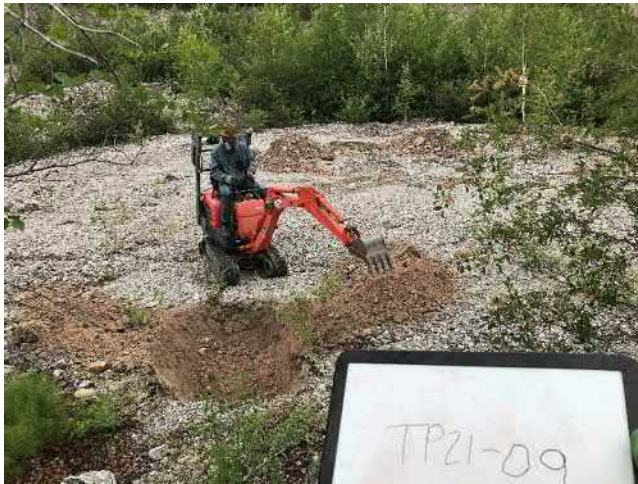
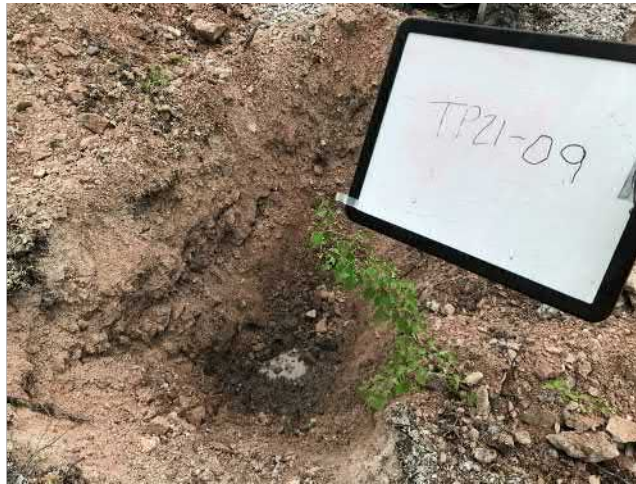
- **Groundwater:** Groundwater was noted to enter the test pits at two locations (TP21-09 and TP21-12). AECOM notes that the water levels in these test pits coincided closely with the elevation of Mill Lake (~215.0 metres above sea level).

Photo 15: Image shows the location of TP21-09 with TP21-08 to the NW in the background.	Photo 16: Excavated TP21-09 until contact with groundwater. 1.10 metres below ground surface (mbgs) was reached.
Notes: <ul style="list-style-type: none"> Excavator was able to dig to approximately 1.10 mbgs before contacting groundwater which continued to fill the hole as we attempted to excavate further. AECOM notes that the depth that groundwater was encountered is the approximate elevation of Mill Lake (215.0 m). Brown sand material changed colour around 1.0 mbgs to a wet grey/black coloured sand material. Uncertain how much deeper the sand and rock continue before reaching the bedrock surface in this area.

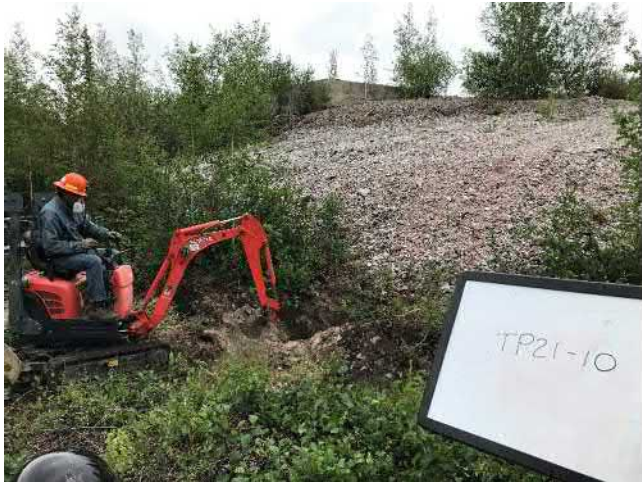
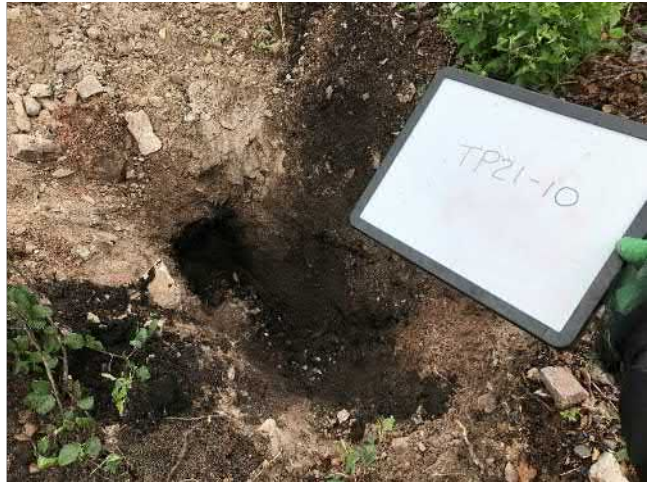
Photo 17: Image shows the location of TP21-10 with waste rock slope to the east of the excavated pit.	Photo 18: Excavated TP21-10 until a depth of 1.20 mbgs was reached. Native organic material was contacted around 0.65 mbgs and continued to total depth of the pit.
Notes: <ul style="list-style-type: none"> Excavator was able to dig to approximately 1.20 mbgs before running out of arm length to continue digging safely. Sand and rocks were apparent through the first 0.50m of excavation but stopped at 0.65 mbgs where native organic material started. Uncertain how much deeper the organics continue until bedrock surface can be reached.

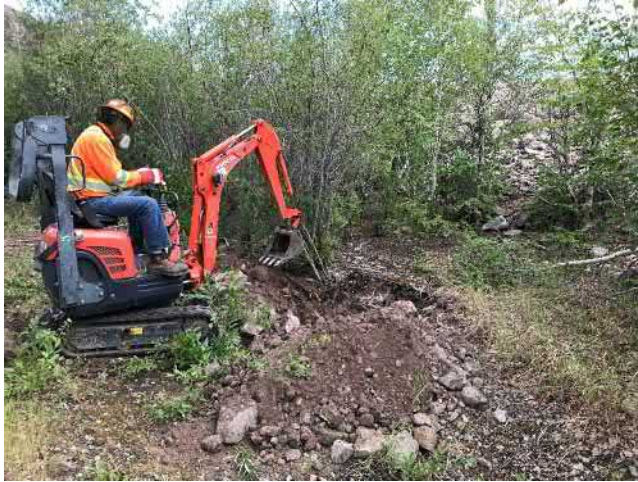
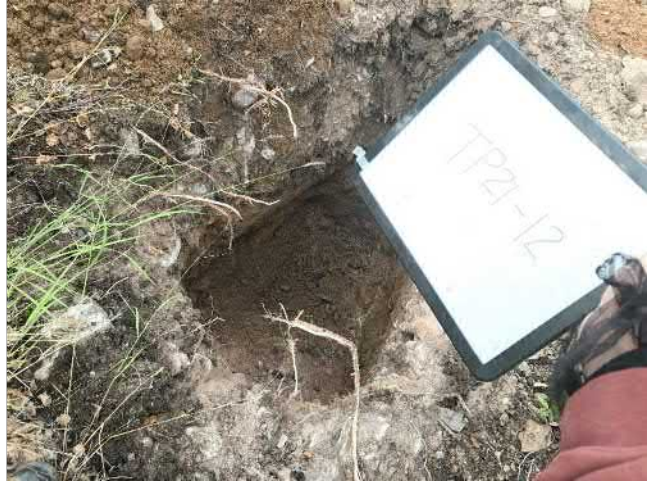
Photo 21: Image shows the location of TP21-12 on the east side of the trail surrounded by willows.	Photo 22: Excavated TP21-12 until the excavator was unable to dig any deeper (arm length reached). 1.60 metres below ground surface (mbgs) was reached.
Notes: <ul style="list-style-type: none"> Excavator was able to dig to approximately 1.60 mbgs before reaching its maximum arm length. Majority of the test pit was filled with sand mixed with some rock. Sand colour got darker as depth increased. <u>Groundwater was noticed at approximately 1.25 mbgs.</u> Uncertain how much deeper the sand and rock continue before reaching the bedrock surface in this area.

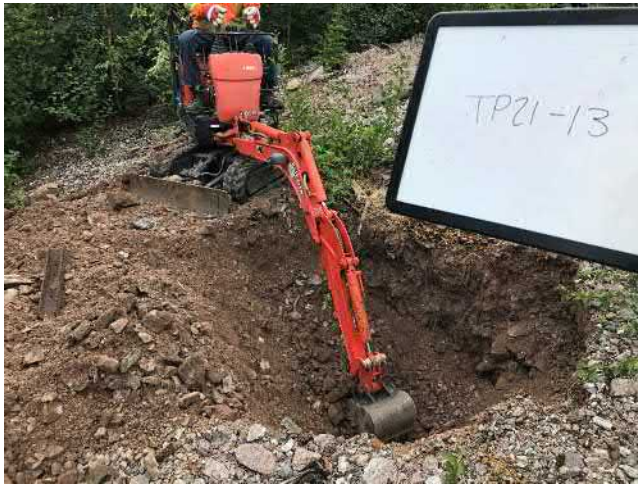
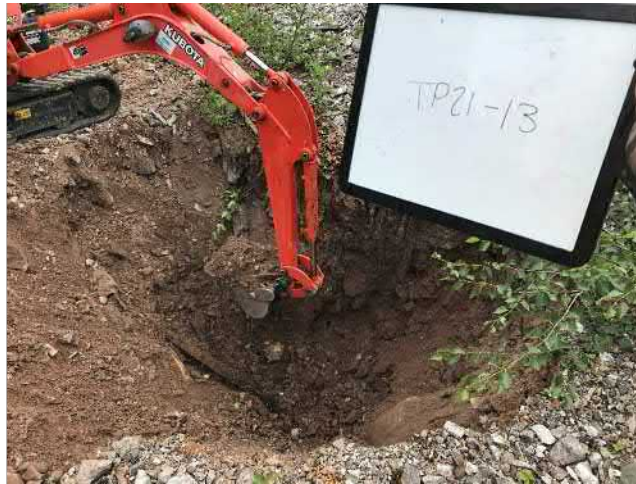
Photo 23: Image shows the excavation of TP21-13.	Photo 24: Excavated TP21-13 until contact with large rocks and arm length limitations prevented the machine from continuing deeper. 1.50 metres below ground surface (mbgs) was reached.
Notes: <ul style="list-style-type: none"> Excavator was able to dig to approximately 1.50 mbgs before contacting large rocks and reaching excavator arm length maximum prevented any further excavation. Large metals and wood debris were evident in this test pit. Uncertain how much deeper the sand and rock continue before reaching the bedrock surface in this area.

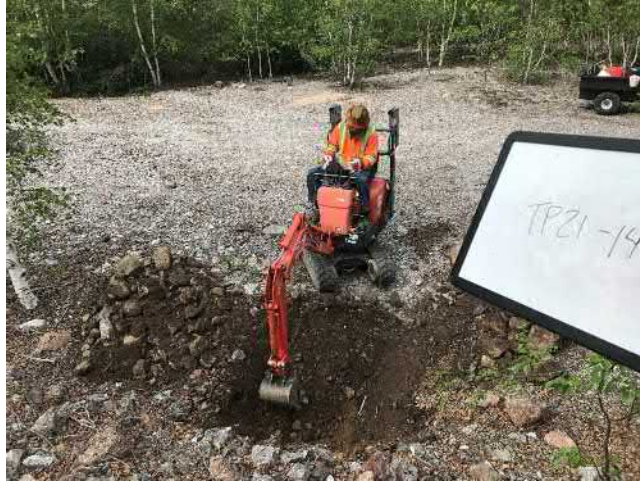
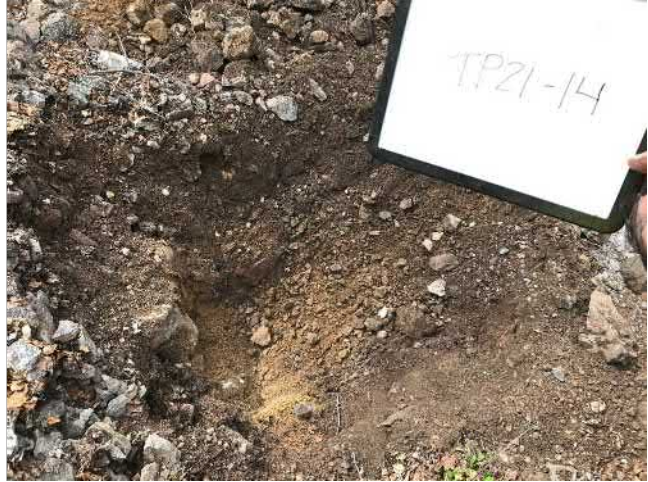
Photo 25: Image shows the location of TP21-14 facing NW. TP21-14 is at the base of a waste rock and bedrock slope to the SE.	Photo 26: Excavated TP21-14 until contact with a rock surface prevented the machine from continuing deeper. 0.90 metres below ground surface (mbgs) was reached.
Notes: <ul style="list-style-type: none"> Excavator was able to dig to approximately 0.90 mbgs before contacting the rock surface preventing any further excavation. Rock surface contacted at 0.90 mbgs is likely the bedrock surface. The surrounding area contains bedrock at the surface in some locations and there are large bedrock formations sloping up to the SE from this test pit.

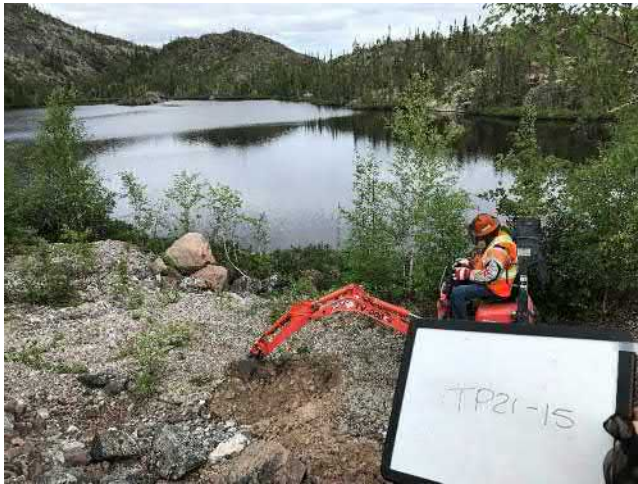
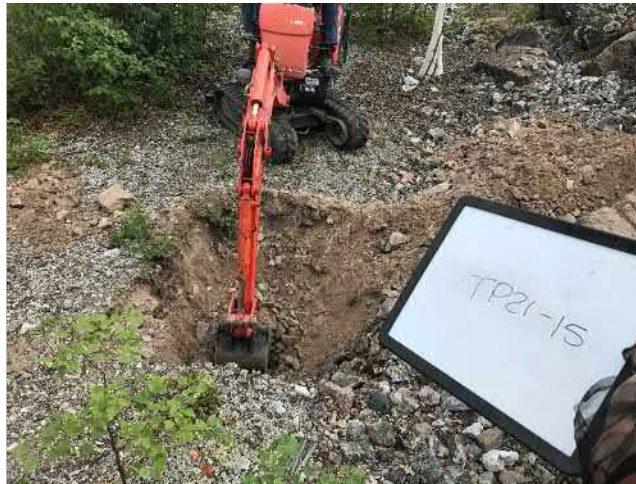
Photo 27: Image shows the location of TP21-15 with Mill Lake in the background to the NE.	Photo 28: Excavated TP21-15 until contact with large rocks prevented the machine from continuing deeper. 0.80 metres below ground surface (mbgs) was reached.
Notes: <ul style="list-style-type: none"> Excavator was able to dig to approximately 0.80 mbgs before contacting large rocks, preventing any further excavation. Large rocks contacted at 0.80 mbgs was estimated as non-bedrock cobbles. Uncertain how much deeper the sand and rock continue before reaching the bedrock surface in this area.

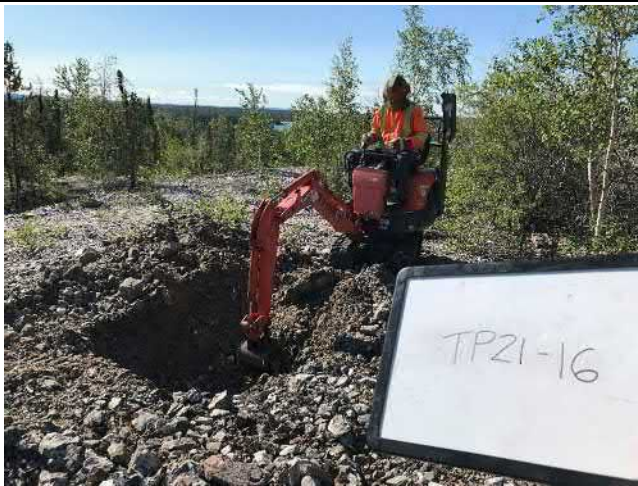
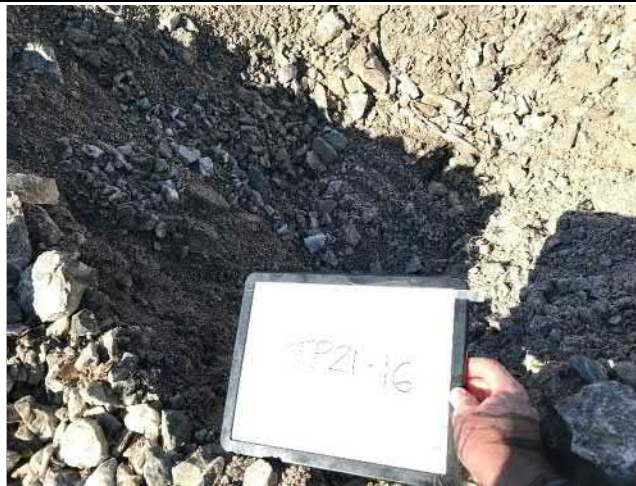
Photo 29: Image shows the excavation of TP21-16.	Photo 30: Excavated TP21-16 until contact with rock surface prevented the machine from continuing deeper. 0.75 metres below ground surface (mbgs) was reached.
Notes: <ul style="list-style-type: none"> Excavator was able to dig to approximately 0.75 mbgs before contacting a rock surface, preventing any further excavation. Rock surface contacted at 0.75 mbgs was estimated to be the bedrock surface but could be cobbles. Uncertain how much deeper the sand and rock continue before reaching the bedrock surface if refusal surface is cobbles.

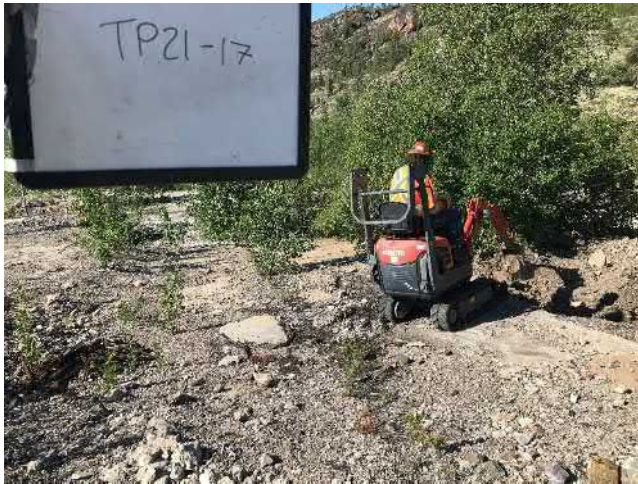
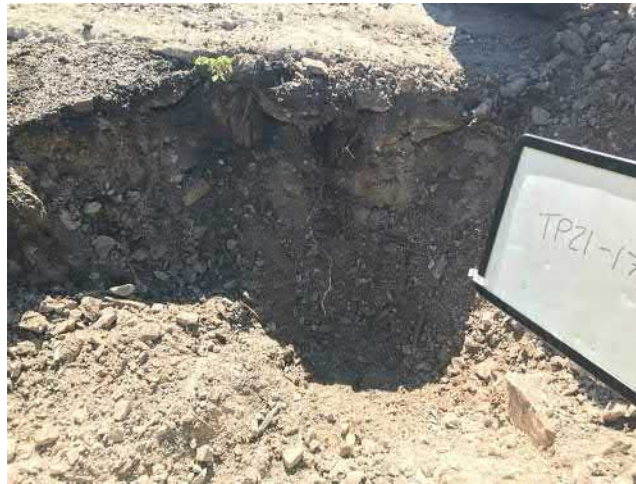
Photo 31: Image shows the location of TP21-17 excavated to the NW of the concrete ramp going up to the old mill foundations.	Photo 32: Excavated TP21-17 until contact with large rocks prevented the machine from continuing deeper. 1.10 metres below ground surface (mbgs) was reached.
Notes: <ul style="list-style-type: none"> Excavator was able to dig to approximately 1.10 mbgs before contacting large rocks, preventing any further excavation. Wooden debris was noticed within the test pit. Wooden beams seem to be lined up below the concrete ramp to provide support when the concrete slabs were constructed. Large rock contacted at 1.10 mbgs was estimated as a non-bedrock cobble. Uncertain how much deeper the sand and rock continue before reaching the bedrock surface in this area.

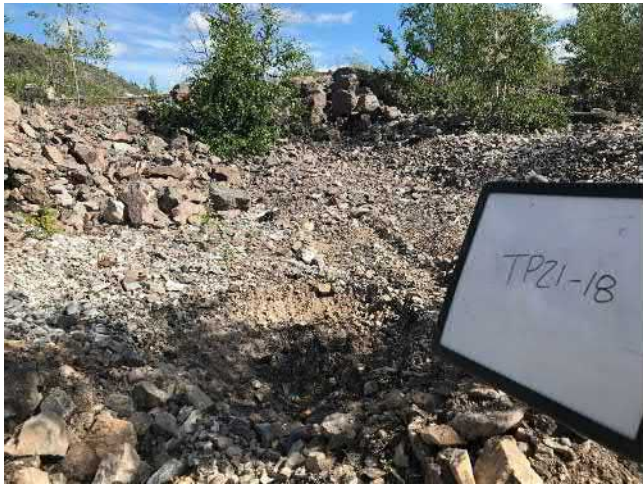
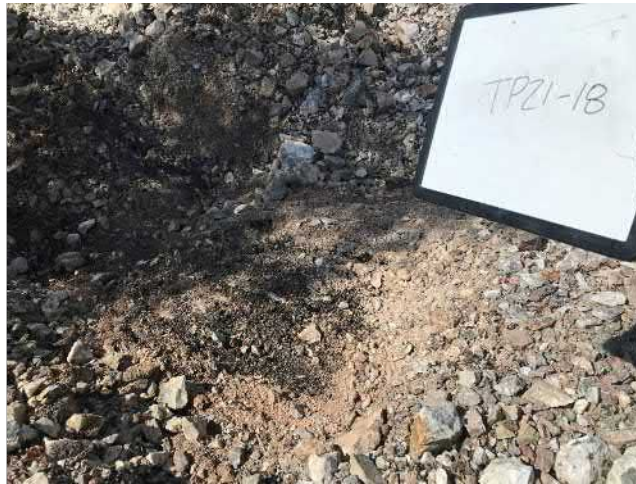
<p>Photo 33: Image shows the location of TP21-18 which was excavated in the base of a crater in the waste rock to the SW of the old mill foundations.</p>	<p>Photo 34: Excavated TP21-18 until contact with the rock surface prevented the machine from continuing deeper. 0.15 metres below ground surface (mbgs) was reached.</p>
Notes: <ul style="list-style-type: none"> Excavator was able to dig to approximately 0.15 mbgs before contacting a rock surface, preventing any further excavation. Height of the surrounding waste rock slopes were estimated to be around 1.5 to 2.0 m from the surface elevation of TP21-18. Rock surface contacted at 0.15 mbgs was estimated to be the bedrock surface.

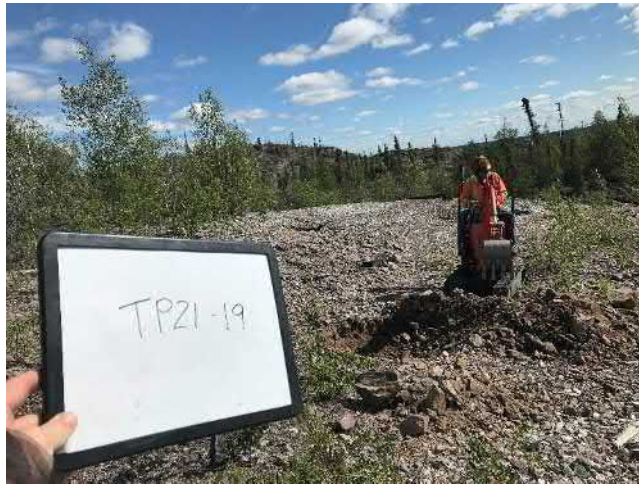
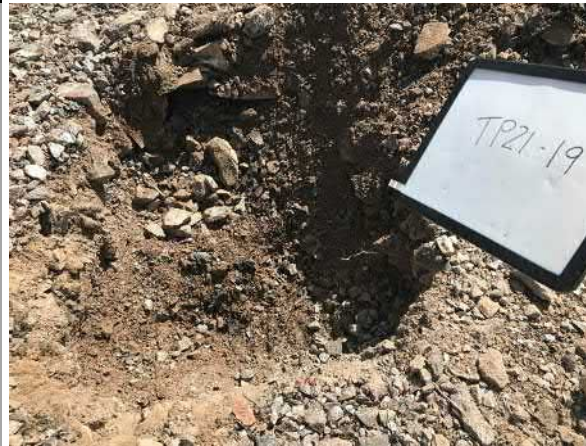
Photo 35: Image shows the location of TP21-19 located to the SE of the old mill foundations.	Photo 36: Excavated TP21-19 until contact with the rock surface prevented the machine from continuing deeper. 1.00 metres below ground surface (mbgs) was reached.
Notes: <ul style="list-style-type: none"> Excavator was able to dig to approximately 1.00 mbgs before contacting the rock surface, preventing any further excavation. Some metal debris was found in this test pit. Rock surface contacted at 1.00 mbgs was estimated to be the bedrock surface.

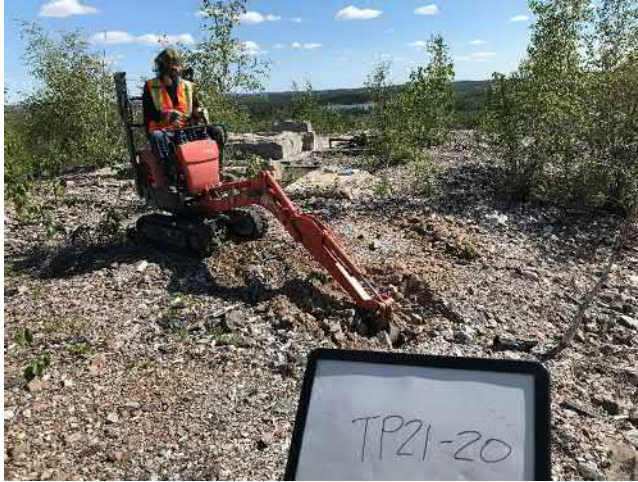
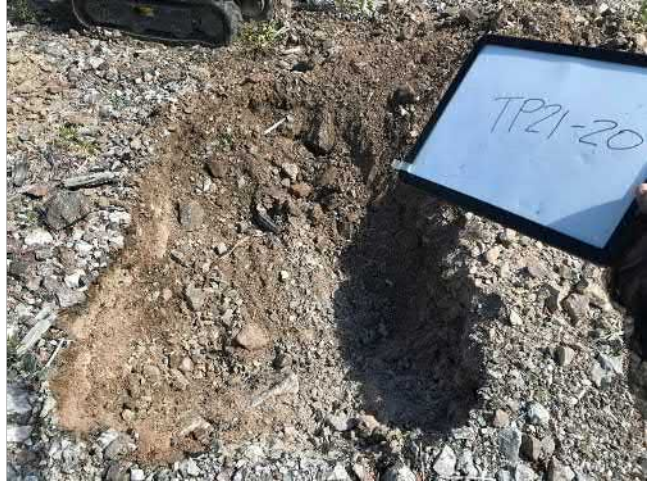
Photo 37: Image shows the location of TP21-20 with the old powerhouse foundation in the background to the east.	Photo 38: Excavated TP21-20 until contact with large rocks prevented the machine from continuing deeper. 0.65 metres below ground surface (mbgs) was reached.
Notes: <ul style="list-style-type: none"> Excavator was able to dig to approximately 0.65 mbgs before contacting large rocks and preventing any further excavation. Large rocks contacted at 0.65 mbgs was estimated as non-bedrock cobbles but could potentially be the bedrock surface. Moved slightly to the north and began another test pit (TP21-21).

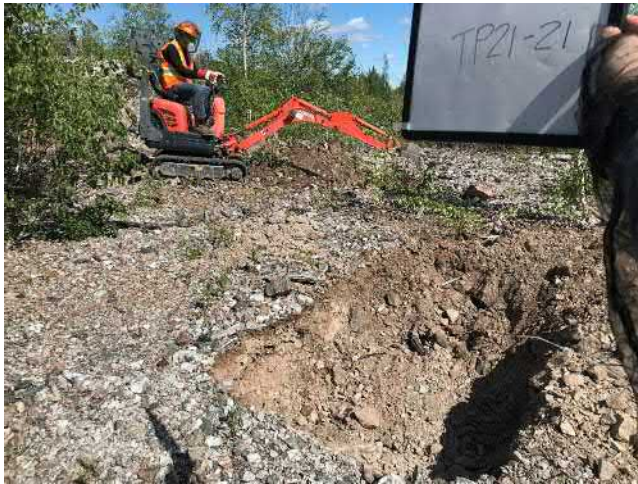
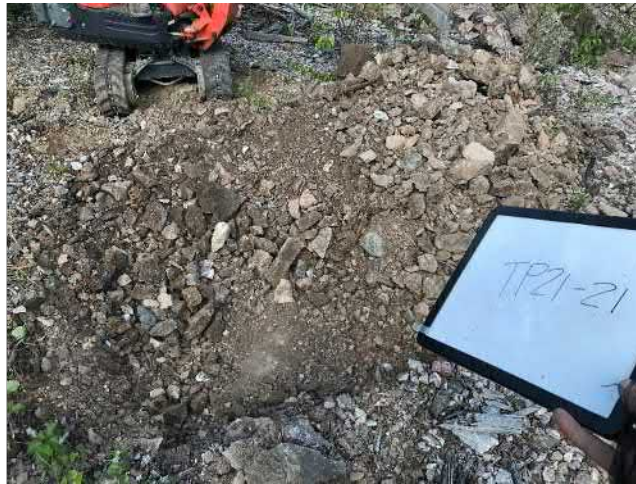
Photo 39: Image shows the excavation TP21-21 proceeding with TP21-20 to the south in the foreground of the photo.	Photo 40: Excavated TP21-21 until contact with large rocks prevented the machine from continuing deeper. 0.60 metres below ground surface (mbgs) was reached.
Notes: <ul style="list-style-type: none"> Excavator was able to dig to approximately 0.60 mbgs before contacting large rocks, preventing any further excavation. Large rocks contacted at 0.60 mbgs confirm and are consistent with the findings in TP21-20. These large rocks may potentially be the bedrock surface. Uncertain how much deeper the sand and rock continue before reaching the bedrock surface in this area if the large rocks contacted are cobbles.

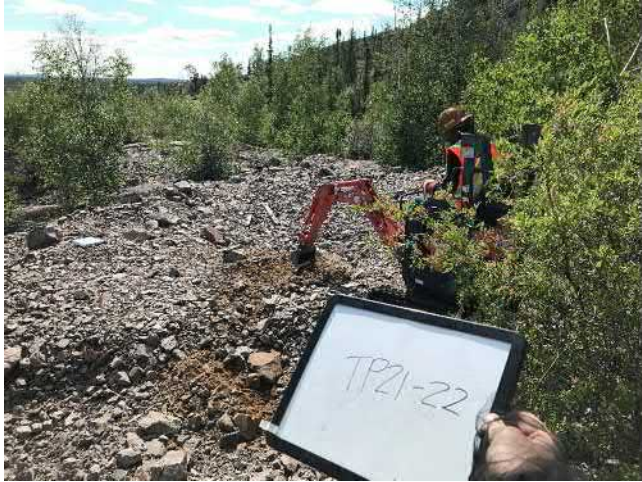
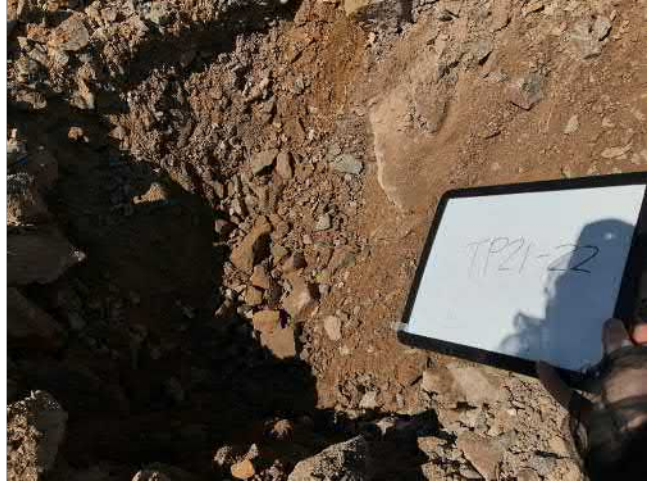
Photo 41: Image shows the location of TP21-22 with the old powerhouse foundation to the south in the background.	Photo 42: Excavated TP21-22 until contact with rock surface prevented the machine from continuing deeper. 1.30 metres below ground surface (mbgs) was reached.
Notes: <ul style="list-style-type: none"> Excavator was able to dig to approximately 1.30 mbgs before contacting the rock surface, preventing any further excavation. Rock surface contacted at 1.30 mbgs was estimated to be the bedrock surface.

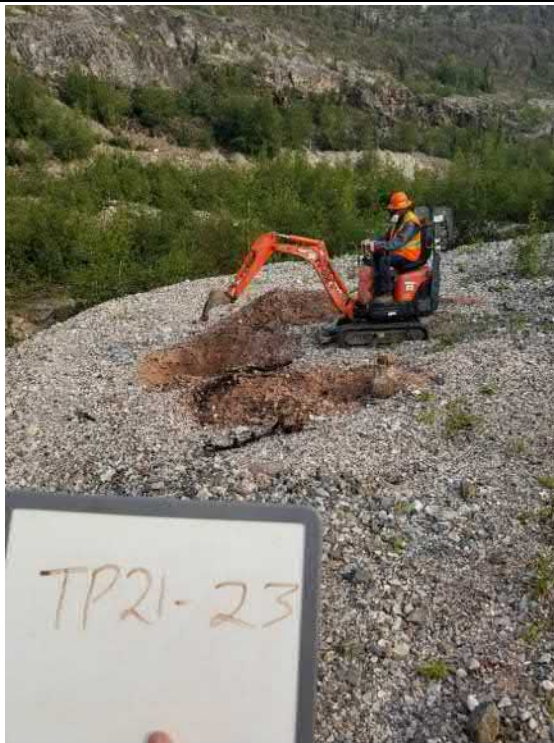
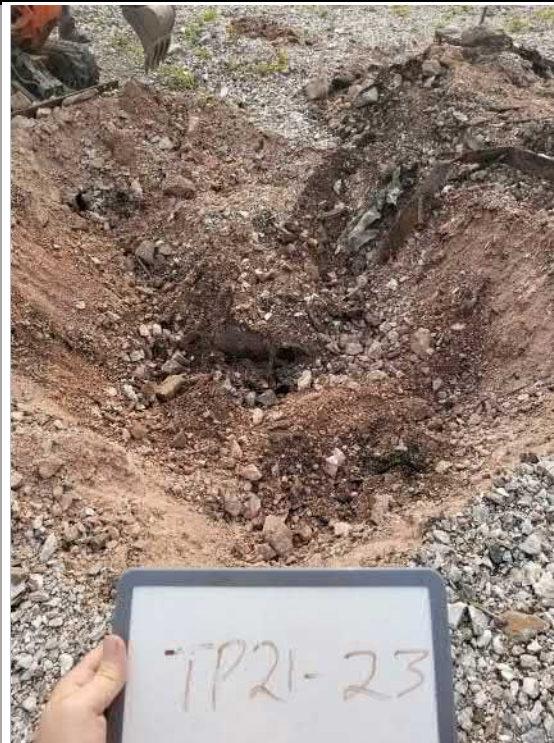
<p>Photo 43: Image shows the location of TP21-23 located west of the old mill foundation along the waste rock pile edge that slopes down to the west (trail at bottom).</p>	<p>Photo 44: Excavated TP21-23 until contact with large concrete debris prevented the machine from continuing deeper. 0.90 metres below ground surface (mbgs) was reached.</p>
<p>Notes:</p> <ul style="list-style-type: none"> Excavator was able to dig to approximately 0.90 mbgs before contacting large concrete debris, preventing any further excavation. Uncertain how much deeper the sand and rock continue before reaching the bedrock surface. It appears to be >3.0 mbgs to bedrock as the waste rock is piled high in this area.

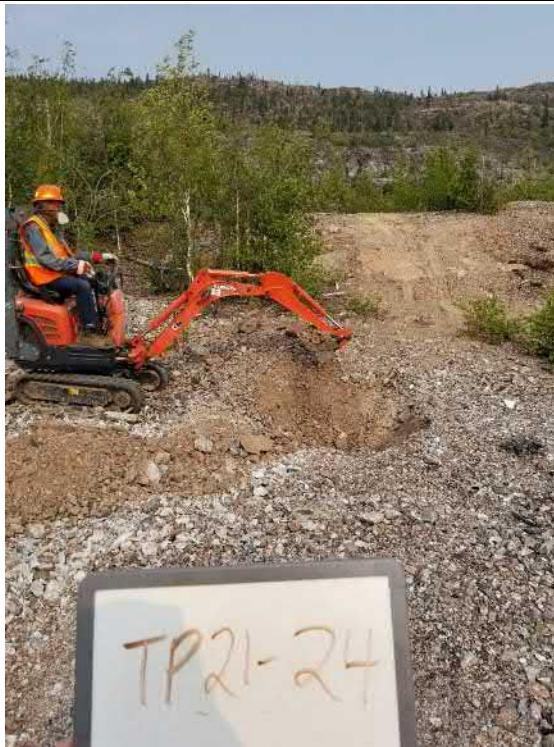
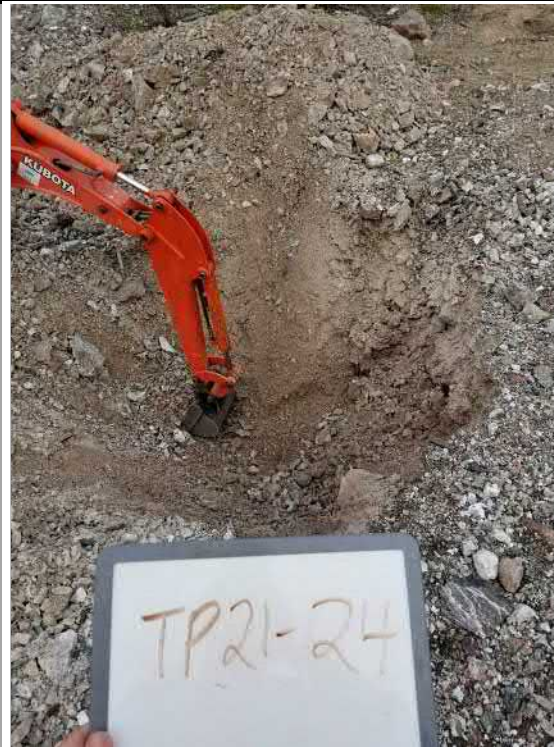
<p>Photo 45: Image shows the location of TP21-24 on top of the waste rock slope to the east of the old mill foundations.</p>	<p>Photo 46: Excavated TP21-24 until contact with rock surface prevented the machine from continuing deeper. 1.05 metres below ground surface (mbgs) was reached.</p>
Notes: <ul style="list-style-type: none"> Excavator was able to dig to approximately 1.05 mbgs before contacting the rock surface, preventing any further excavation. Rock surface contacted at 1.05 mbgs was estimated to be the bedrock surface.

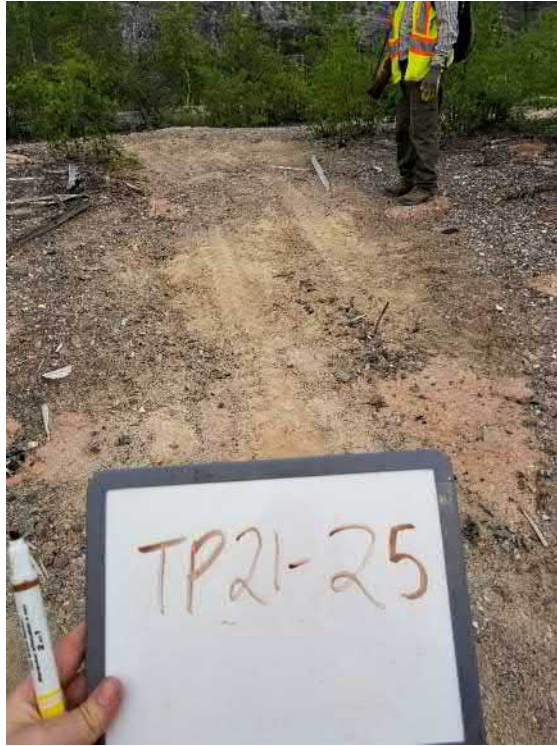
Photo 47: Image shows the location of TP21-25 where no excavation took place since bedrock was visible at the surface.	
Notes: <ul style="list-style-type: none"> Bedrock was noticed at the surface or covered by 0.1 to 0.2 m of rocks and sand in this area. No excavation was required.

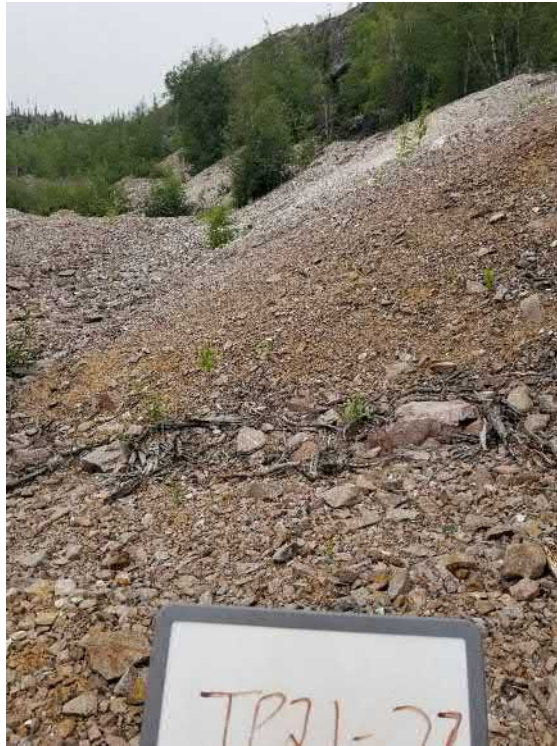
Photo 49: Image shows the proposed location of TP21-27 with waste rock slopes to the NW.	
Notes: <ul style="list-style-type: none"> Excavator was unable to safely proceed to this location due to the steepness of the waste rock slope to the NW. No excavation was advanced in this area.

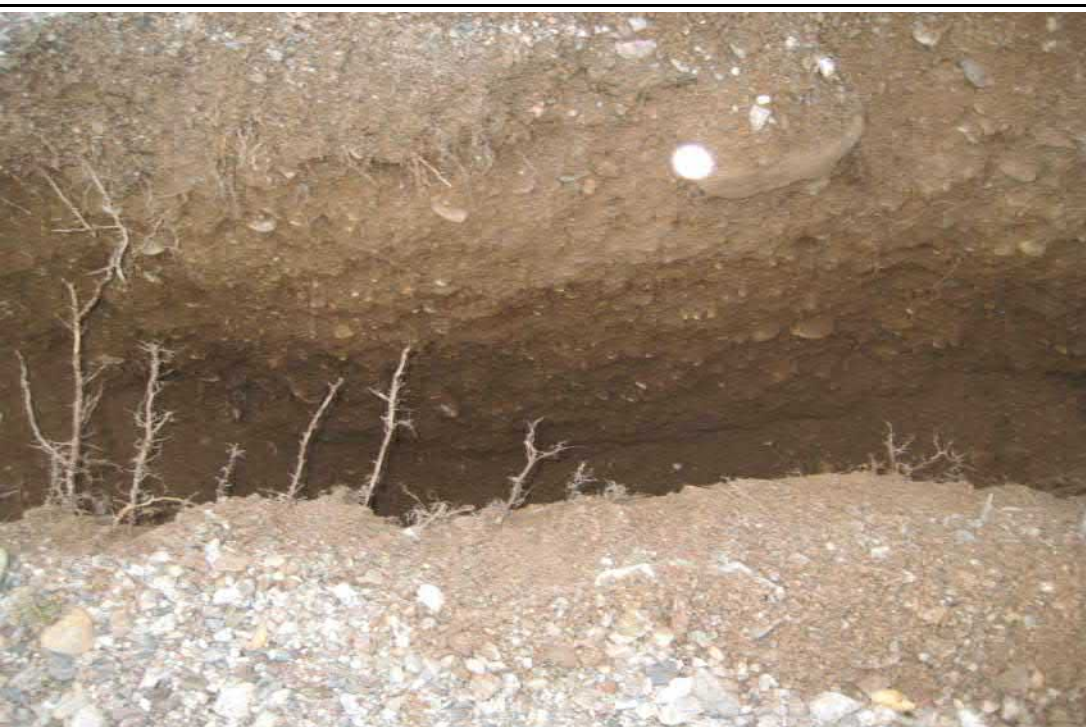
Area 6 Mill	0.0 - 0.24m	Brown, moist, SAND , medium to coarse, some angular cobble and gravel	GR	Sa-1	PHCs/BTEX 0.0 - 0.24	9 uR/hr	0 ppm			
Date: 30-Sep-13 Logged by: LS Method: Can-Dig Excavator Location: Rayrock, NWT			Test Pit: TP13-7			SAMPLES			COMMENTS	PHOTO
Area 6 CRUSHER			Type	Sample I.D.	Analysis & Depth of Sample (m)

Area	Depth (m)	Description			Parameters	Gamma	Gastech	No evidence of environmental impacts (staining or odour). TP completed on bedrock.

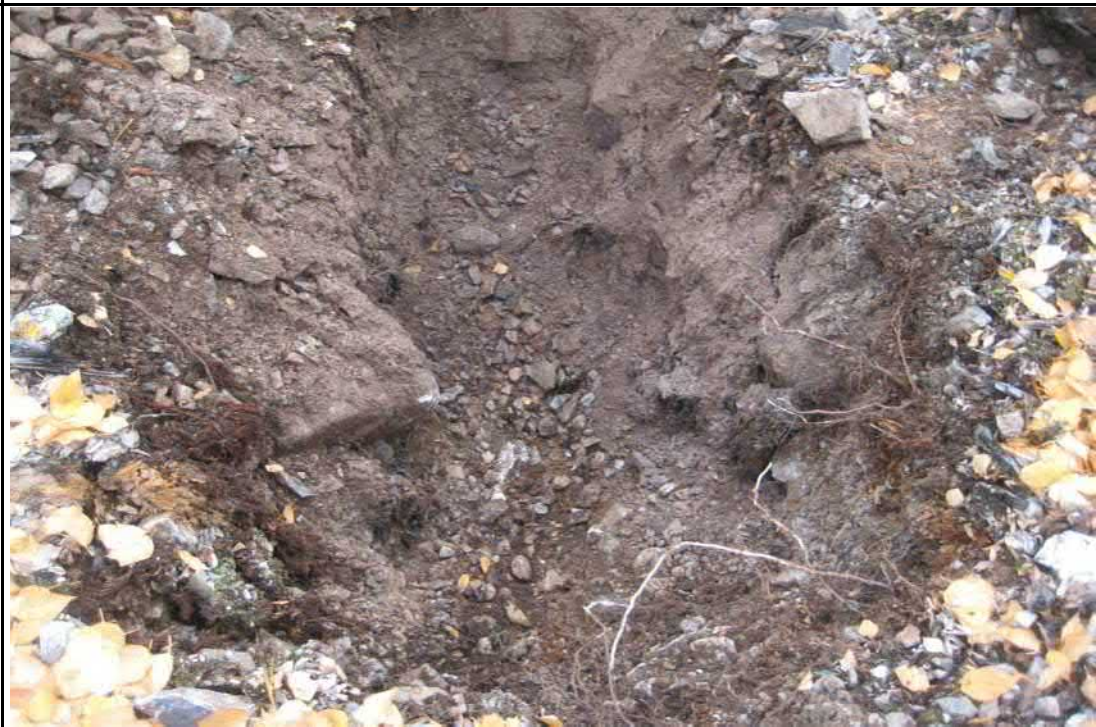
0.10 - 1.0m	Brown, moist, SAND, medium to coarse, some rounded gravel, angular cobble and boulders, trace construction debris at bottom of TP	GR	Sa-1	PHCs/BTEX 0.9 - 1.0			6.5 uR/hr	0 ppm	
Date: 1-Oct-13 Logged by: LS Method: Can-Dig Excavator Location: Rayrock, NWT			Test Pit: TP13-10 Area 5 POL & Drainage			SAMPLES			COMMENTS	PHOTO
Type	Sample I.D.	Analysis & Depth of Sample (m)								
Area	Depth (m)	Description	Parameters	Gamma	Gastech					
Area 5 POL & Drainage Zone	0.0 - 0.28m	Brown, moist, SAND, some construction debris, medium to coarse sand and angular cobbles and boulders				Downgradient of former fuel oil tanks. No evidence of environmental impacts (staining or odour). TP incomplete due to boulders.

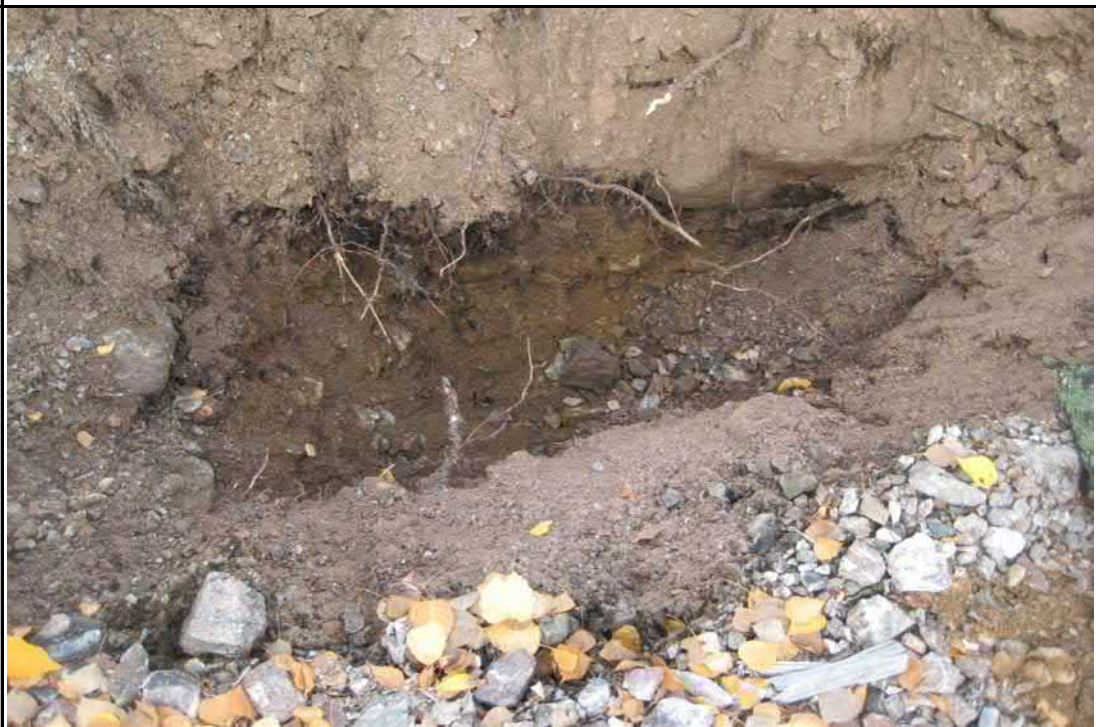
0.28 - 1.17m	Brown, moist, SAND, medium to coarse, angular cobble and boulder	GR	Sa-1	PHCs/BTEX 1.0 - 1.17			30 uR/hr	0 ppm	
Date: 1-Oct-13 Logged by: LS Method: Can-Dig Excavator Location: Rayrock, NWT			Test Pit: TP13-11 Area 5 POL & Drainage			SAMPLES			COMMENTS	PHOTO
Type	Sample I.D.	Analysis & Depth of Sample (m)								
Area	Depth (m)	Description	Parameters	Gamma	Gastech					
Area 5 POL & Drainage Zone	0.0 - 0.91m	Brown, moist, SAND, medium to coarse, some roots, angular gravel & cobbles, some boulders				Downgradient of former fuel oil tanks. No evidence of environmental impacts (staining or odour). TP completed on bedrock.

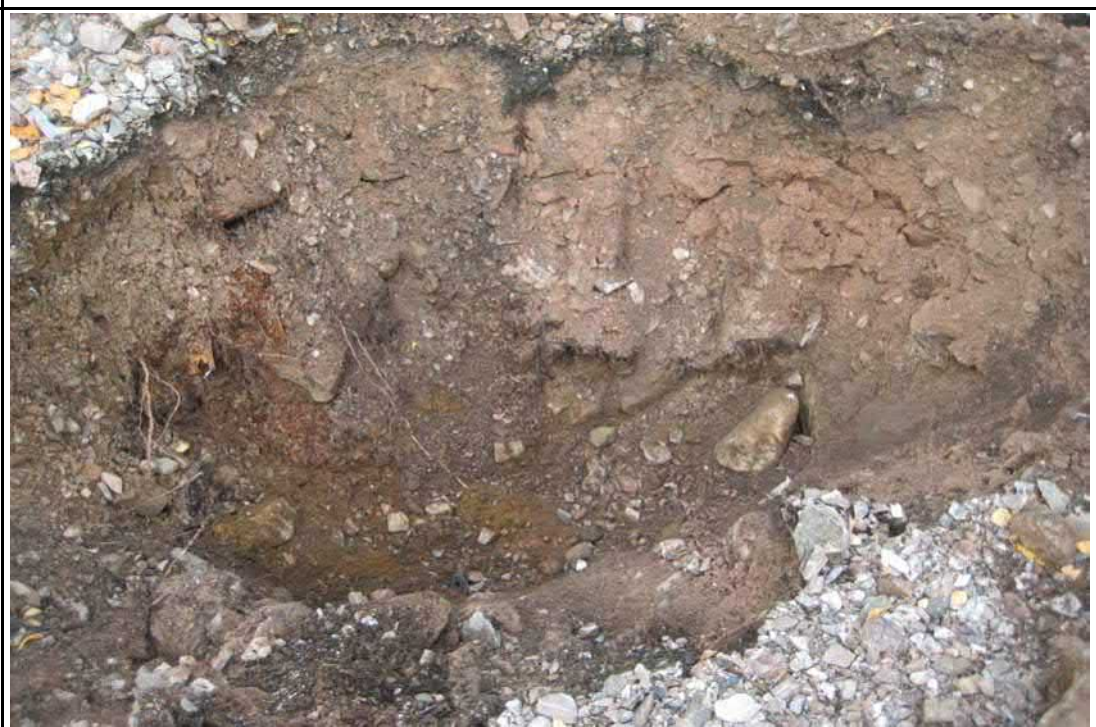
0.91 - 1.20m	Black, moist, PEAT, some round gravel								
	1.20 - 1.80m	Brown to dark brown, moist, SAND, medium to coarse, some rounded cobble and boulders, some oxidation	GR	Sa-1	PHCs/BTEX 1.7 - 1.8			9 uR/hr	0 ppm	
Date: 1-Oct-13 Logged by: LS Method: Can-Dig Excavator Location: Rayrock, NWT			Test Pit: TP13-12 Area 5 POL & Drainage			SAMPLES			COMMENTS	PHOTO
Type	Sample I.D.	Analysis & Depth of Sample (m)								
Area	Depth (m)	Description	Parameters	Gamma	Gastech					
Area 5 POL & Drainage Zone	0.0 - 0.50m	Brown, moist, SAND, medium to coarse, some angular cobbles and boulders				Downgradient of former fuel oil tanks. No evidence of environmental impacts (staining or odour). TP complete on bedrock.
