Date
October 14, 2021

Project #
60608868

**Subject: Kwetǫǫǫǫ (Rayrock) Remediation Project
2021 Field Investigation Summary – Test Pit Excavations**

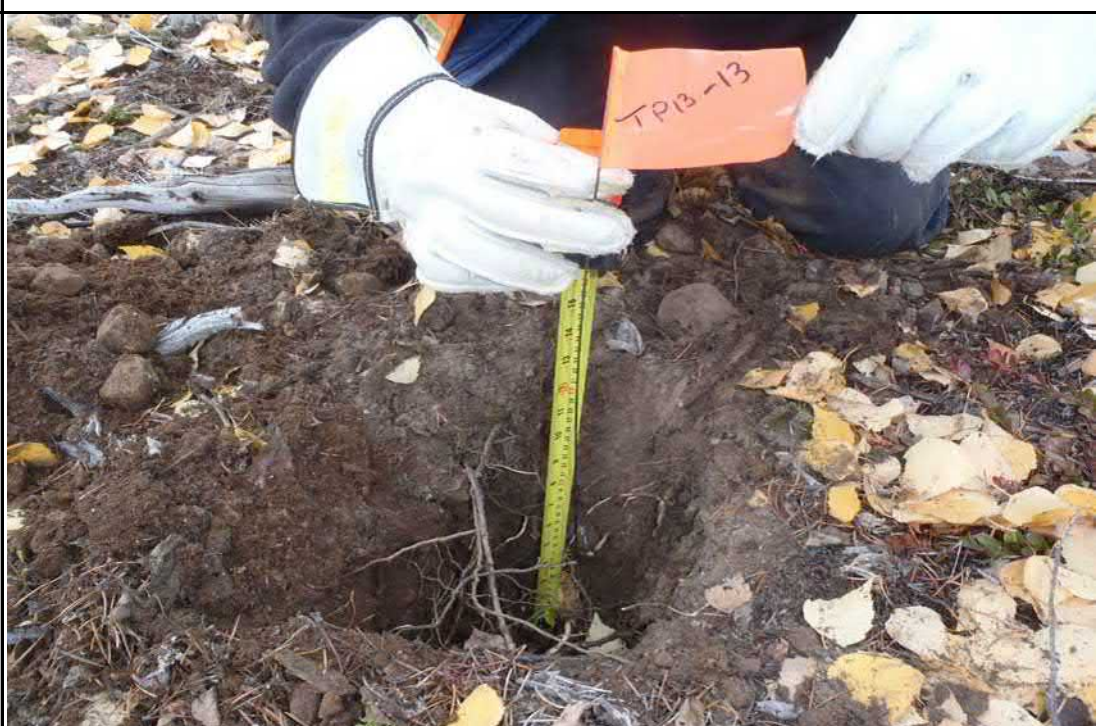
0.50 - 0.60m	Black, moist, PEAT, some dark brown to red medium to coarse sand and rounded gravel								
	0.60 - 1.30m	Dark brown, SAND and GRAVEL, medium to coarse, some rounded cobble, some oxidation	GR	Sa-1	PHCs/BTEX 1.2 - 1.3			12 uR/hr	0 ppm	
Date: 29-Sep-13 Logged by: GCY Method: Hand Dug Location: Rayrock, NWT			Test Pit: TP13-13 Area 4 Mill Drainage			SAMPLES			COMMENTS	PHOTO
Type	Sample I.D.	Analysis & Depth of Sample (m)								
Area	Depth (m)	Description	Parameters	Gamma	Gastech					
Area 4 Mill Drainage	0.0 - 0.13m	MOSS - organic-rich, abundant roots, some rounded gravel to 0.1 m	OR	Sa-1	PHCs/BTEX 0 - 0.13	16 uR/hr	0 ppm	Downgradient of former fuel oil tanks. No evidence of environmental impacts (staining or odour). TP completed on bedrock.

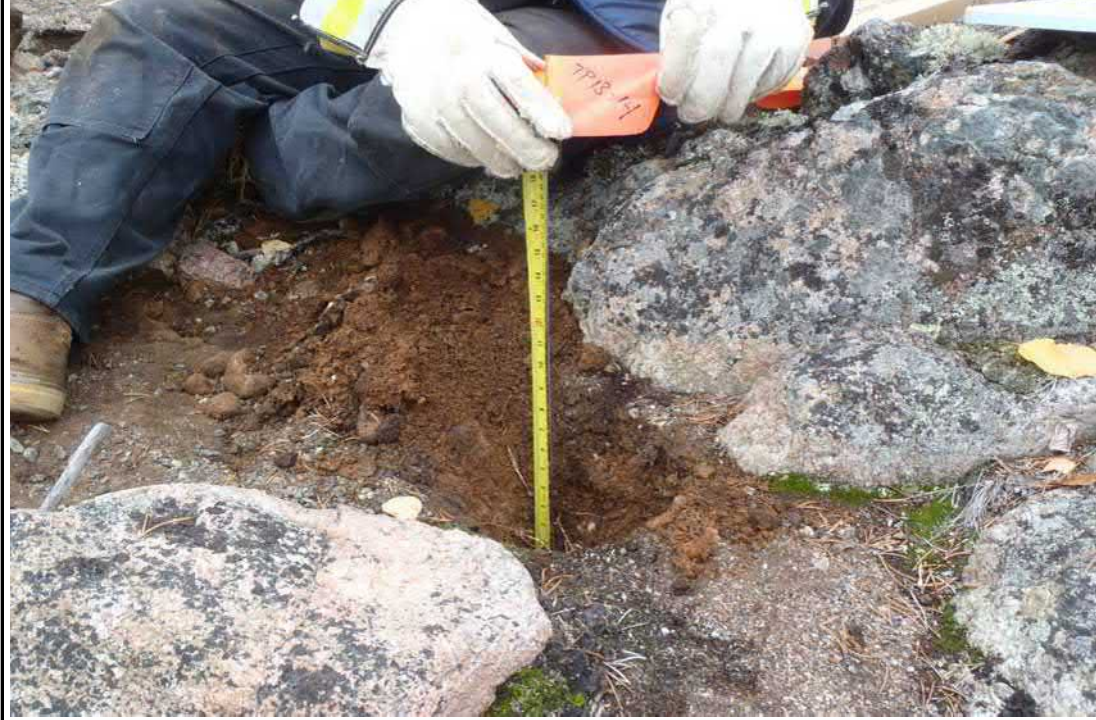
0.13 - 0.24m	Dark brown, damp, SAND and MOSS, trace to some rounded gravel	SA	Sa-2	PHCs/BTEX 0.13 - 0.24	9 uR/hr	0 ppm			
Date: 29-Sep-13 Logged by: GCY Method: Hand Dug Location: Rayrock, NWT			Test Pit: TP13-14 Area 4 Mill Drainage			SAMPLES			COMMENTS	PHOTO
Type	Sample I.D.	Analysis & Depth of Sample (m)								
Area	Depth (m)	Description	Parameters	Gamma	Gastech					
Area 4 Mill Drainage	0.0 - 0.15m	Reddish brown, damp, SAND, some gravel and samll cobbles	GR	Sa-1 & DUP # 7	PHCs/BTEX 0 - 0.15	6 uR/hr	0 ppm	No evidence of environmental impacts (staining or odour). Completed on bedrock.

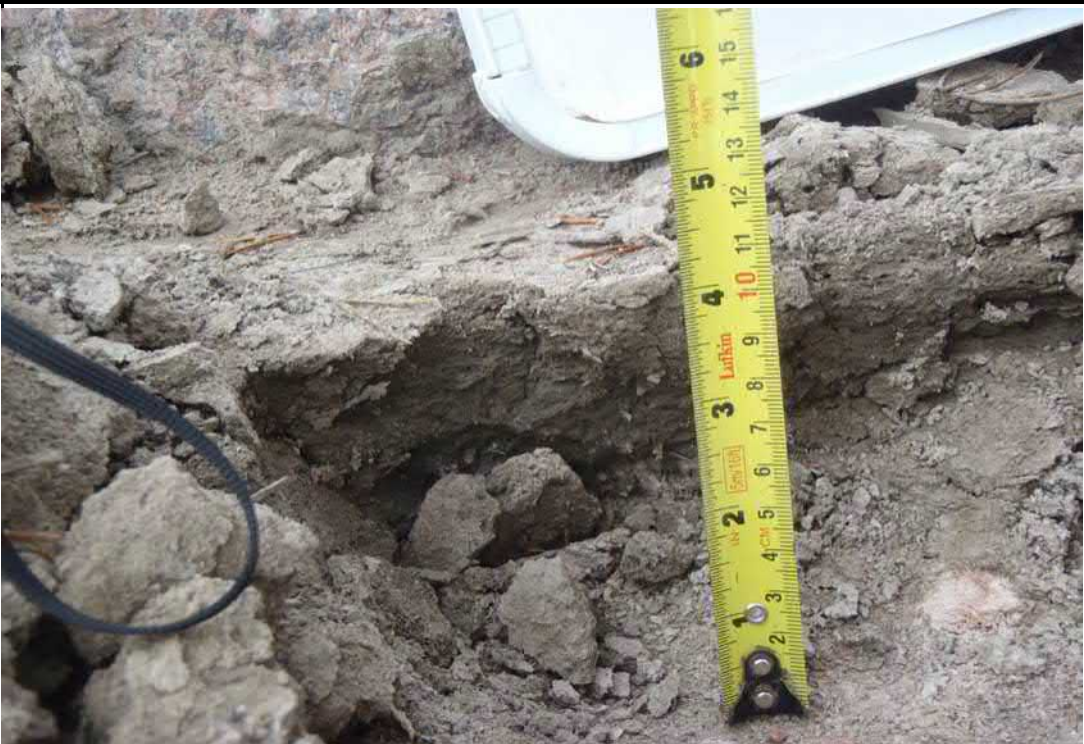
FORMER RAYROCK MINE SITE TEST PIT LOGS - METALS									
Date: 1-Oct-13 Logged by: GCY Method: Hand Dig Location: Rayrock, NWT			Test Pit: SA13-1					COMMENTS	PHOTO
			Type	Sample I.D.	Analysis & Depth of Sample (m)				
Area	Depth (m)	Description			Parameters	Gamma	Gastech	Tailings Spill. Complete on Bedrock @ 0.075m. No evidence of environmental impact (staining or odour).

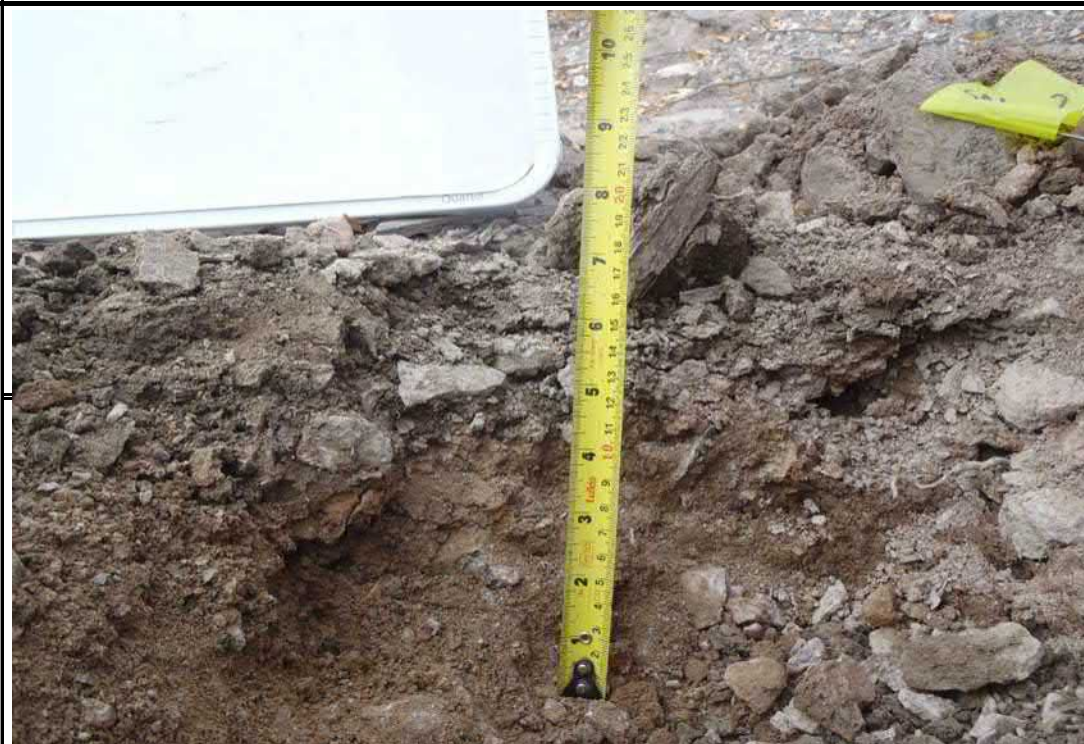
Area 5 POL & Drainage Zone	0.0 - 0.075m	Dark greyish brown, damp, SILTY SAND , fine, trace rootletts	SA	Sa-1	Metals - Soils	10 uR/hr	0 ppm		
Date: 1-Oct-13 Logged by: GCY Method: Hand Dig Location: Rayrock, NWT			Test Pit: SA13-2					COMMENTS	PHOTO
			Type	Sample I.D.	Analysis & Depth of Sample (m)				
Area	Depth (m)	Description			Parameters	Gamma	Gastech	Tailings Spill. Complete on Bedrock @ 0.20m. No evidence of environmental impact (staining or odour).

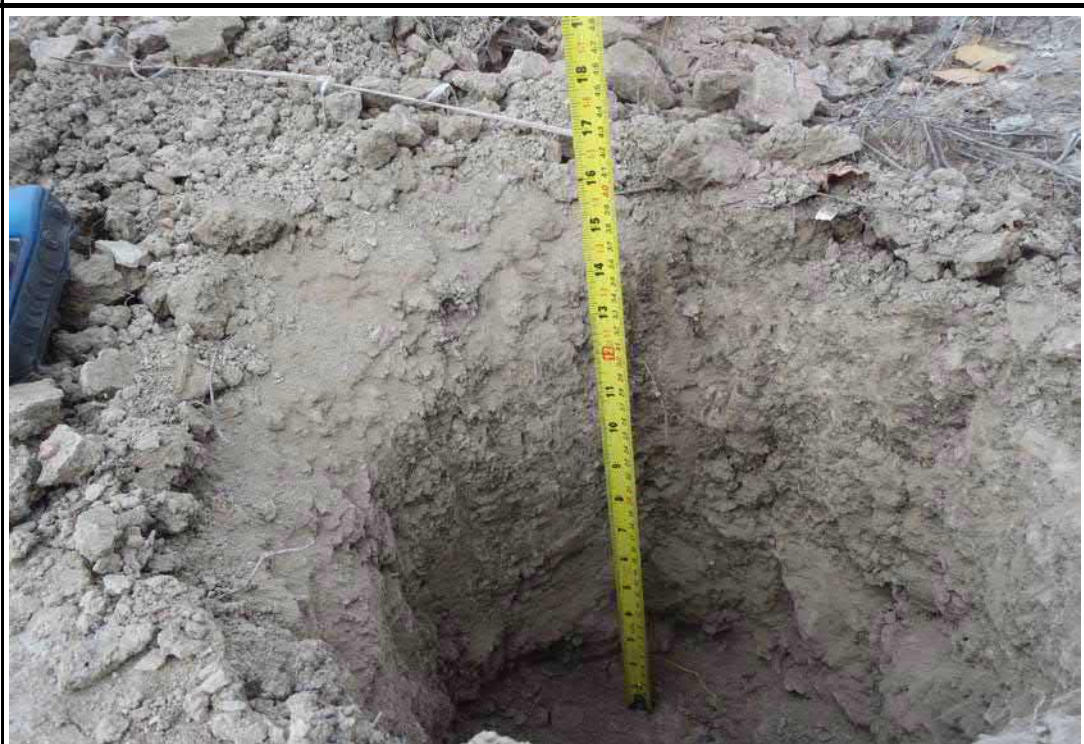
0.075 - 0.20m	Reddish brown, damp, SAND and GRAVEL, medium to coarse, trace cobbles	GR	Sa-2	Metals	9 uR/hr	0 ppm		
Date: 1-Oct-13 Logged by: GCY Method: Hand Dig Location: Rayrock, NWT			Test Pit: SA13-3					COMMENTS	PHOTO
			Type	Sample I.D.	Analysis & Depth of Sample (m)				
Area	Depth (m)	Description			Parameters	Gamma	Gastech	Tailings Spill. Complete on Bedrock @ 0.40m. No evidence of environmental impact (staining or odour).

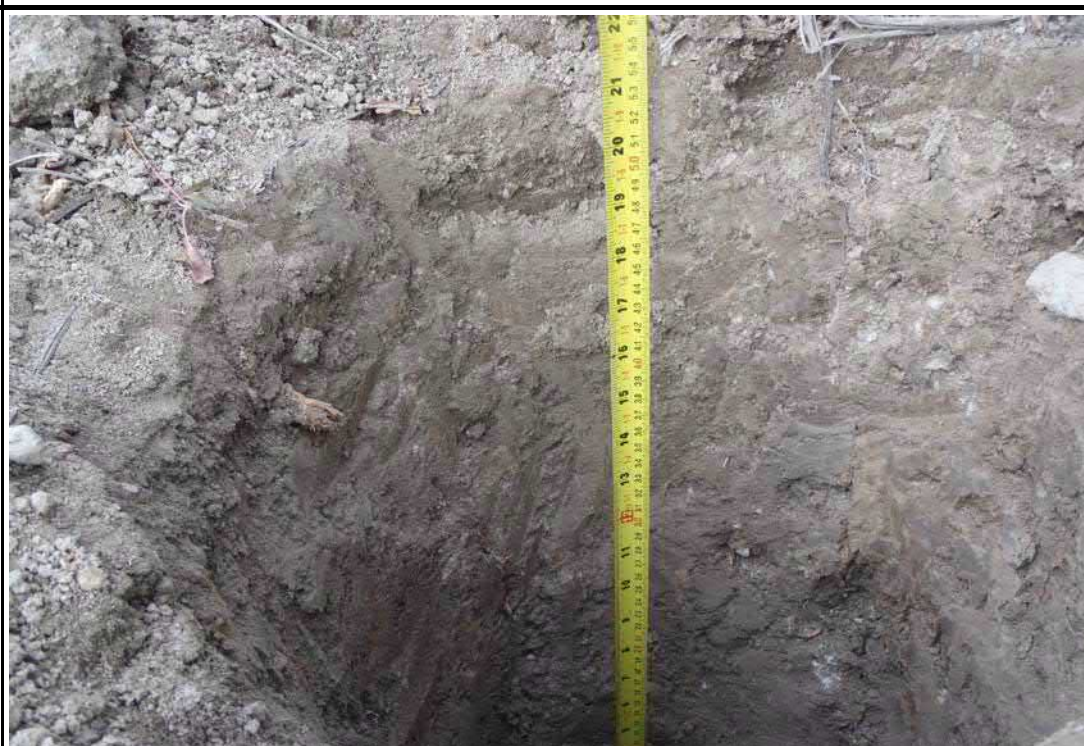
Area 5 POL & Drainage Zone	0.0 - 0.40m	Dark greyish brown, damp, SILTY SAND, fine, trace rootletts and gravel	SA	Sa-1	Metals - Soils	6 uR/hr	0 ppm		
Date: 1-Oct-13 Logged by: GCY Method: Hand Dig Location: Rayrock, NWT			Test Pit: SA13-4					COMMENTS	PHOTO
			Type	Sample I.D.	Analysis & Depth of Sample (m)				
Area	Depth (m)	Description			Parameters	Gamma	Gastech	Tailings Spill. Complete on Bedrock @ 0.50m. No evidence of environmental impact (staining or odour).

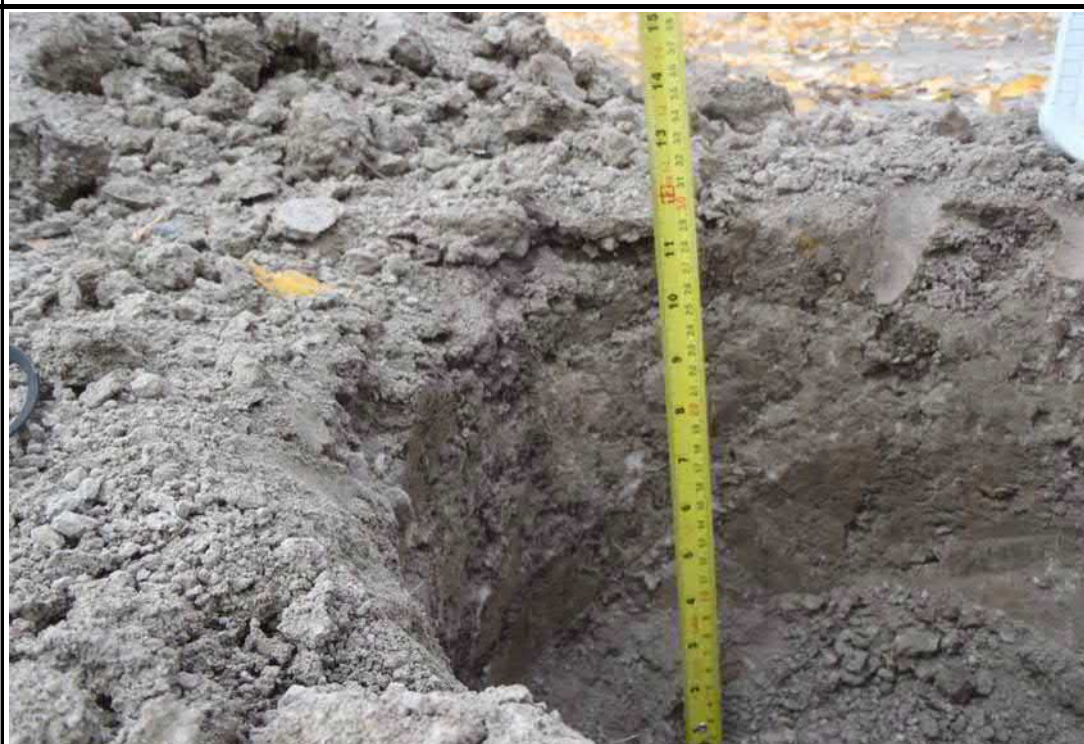
Area 3 Lodging (2)	0.0 - 0.50m	Dark greyish brown, damp, SILTY SAND, fine, trace gravel	SA	Sa-1	Metals - Soils	6 uR/hr	0 ppm		
Date: 1-Oct-13 Logged by: GCY Method: Hand Dig Location: Rayrock, NWT			Test Pit: SA13-5					COMMENTS	PHOTO
			Type	Sample I.D.	Analysis & Depth of Sample (m)				
Area	Depth (m)	Description			Parameters	Gamma	Gastech	Tailings Spill. Complete on Bedrock @ 0.30m. No evidence of environmental impact (staining or odour).

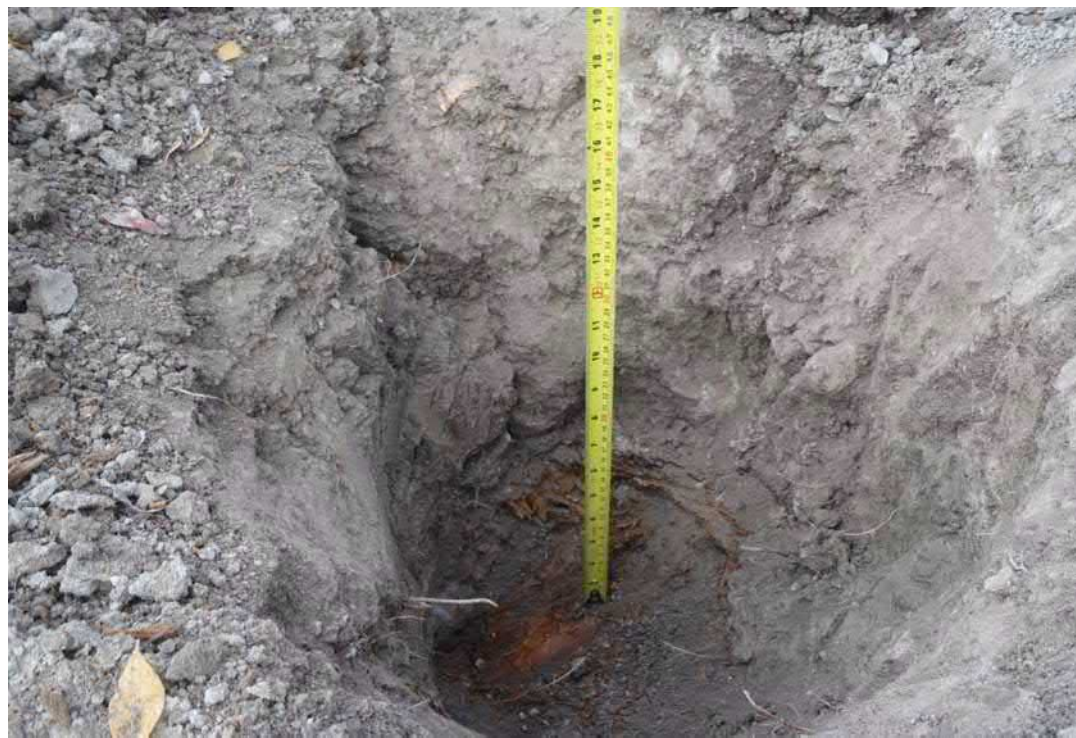
Date: 1-Oct-13 Logged by: GCY Method: Hand Dig Location: Rayrock, NWT			Test Pit: SA13-6					SAMPLES		COMMENTS	PHOTO
			Type	Sample I.D.	Analysis & Depth of Sample (m)						
Area	Depth (m)	Description			Parameters	Gamma	Gastech				
Area 3 Lodging (2)	0.0 - 0.40m	Dark greyish brown, damp, SILTY SAND , fine, some to trace rootlets	SA	Sa-1	Metals - Soils	6 uR/hr	0 ppm			Tailings Spill. Test Pit was Hand Dug to 0.4m and was incomplete due to wood debris. CANDIG Excavator extended test pit, removed wood directly on bedrock. Complete on Bedrock @ 0.55m. No evidence of environmental impact (staining or odour).

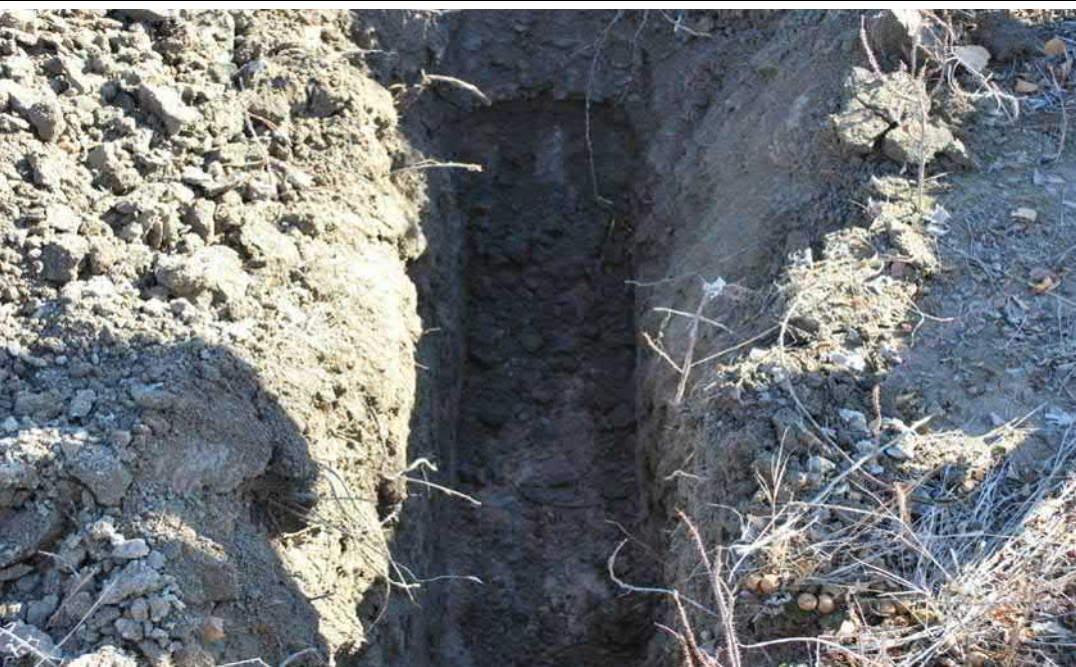
Date: 2-Oct-13 Logged by: LS Method: Can-Dig Location: Rayrock, NWT			Test Pit: SA13-7					SAMPLES		COMMENTS	PHOTO
			Type	Sample I.D.	Analysis & Depth of Sample (m)						
Area	Depth (m)	Description			Parameters	Gamma	Gastech				
Area 3 Lodging (2)	0.0 - 0.90m	Brownish grey, damp, SAND, medium to fine, some angular cobbles	SA	Sa-1	Metals - Soils	6 uR/hr	0 ppm			Tailings Spill. Complete on Bedrock @ 0.90m. No evidence of environmental impact (staining or odour).

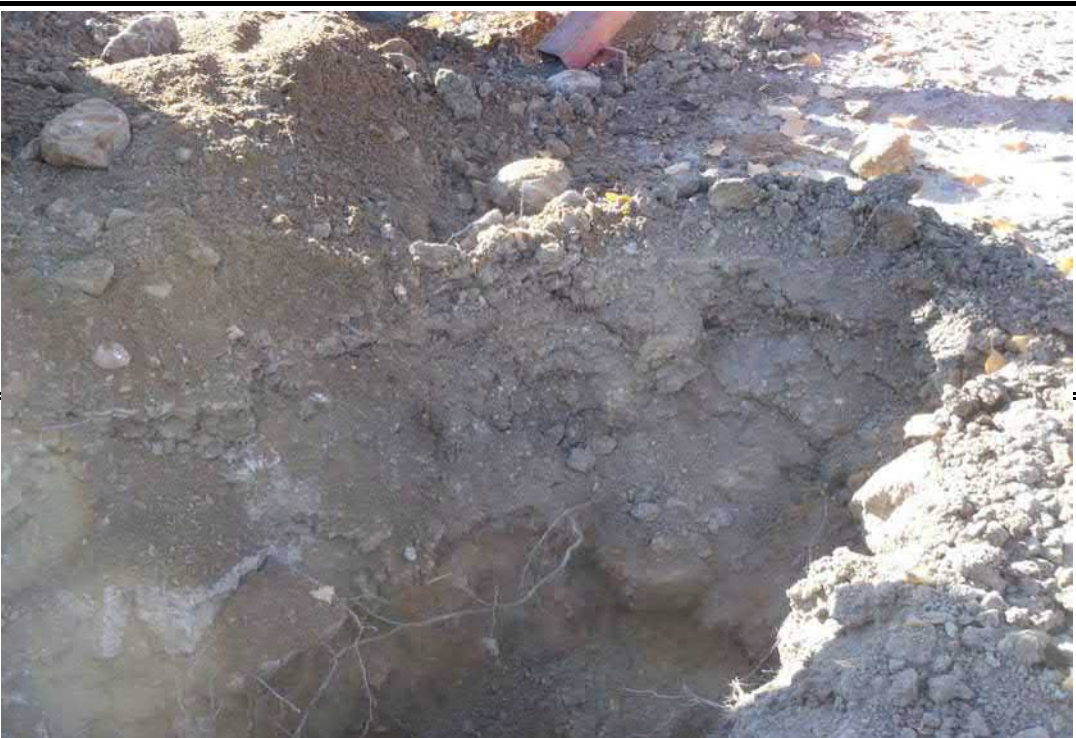
Date: 2-Oct-13 Logged by: GCY Method: Hand Dig Location: Rayrock, NWT			Test Pit: SA13-8					SAMPLES		COMMENTS	PHOTO
			Type	Sample I.D.	Analysis & Depth of Sample (m)						
Area	Depth (m)	Description			Parameters	Gamma	Gastech				
Area 3 Lodging (2)	0.0 - 0.40m	Dark greyish brown, damp, SILTY SAND, fine, some cobbles/boulders	SA	Sa-1	Metals - Soils	6 uR/hr	0 ppm			Tailings Spill. Complete on Bedrock @ 0.70m. No evidence of environmental impact (staining or odour).

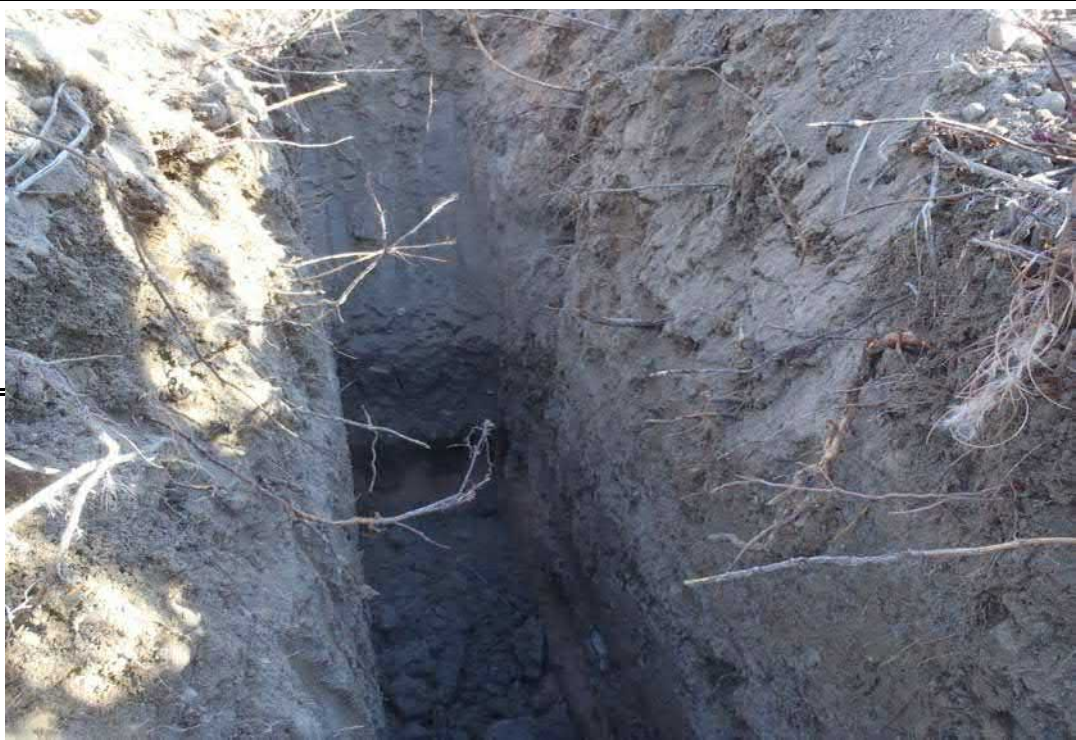
0.40 - 0.70m	Brown, damp, SAND and GRAVEL, coarse, some cobbles	GR	Sa-2	Metals - Soils	5 uR/hr	0 ppm				
Date: 2-Oct-13 Logged by: GCY Method: Hand Dig Location: Rayrock, NWT			Test Pit: SA13-9					SAMPLES		COMMENTS	PHOTO
			Type	Sample I.D.	Analysis & Depth of Sample (m)						
Area	Depth (m)	Description			Parameters	Gamma	Gastech				
Area 3 Lodging (2)	0.0 - 1.0m	Dark greyish brown, damp to dry, SILTY SAND, fine, trace cobbles	SA	Sa-1 & Dup # 6	Metals - Soils	6 uR/hr	0 ppm			Tailings Spill. Complete on Bedrock @ 1.40m. No evidence of environmental impact (staining or odour).

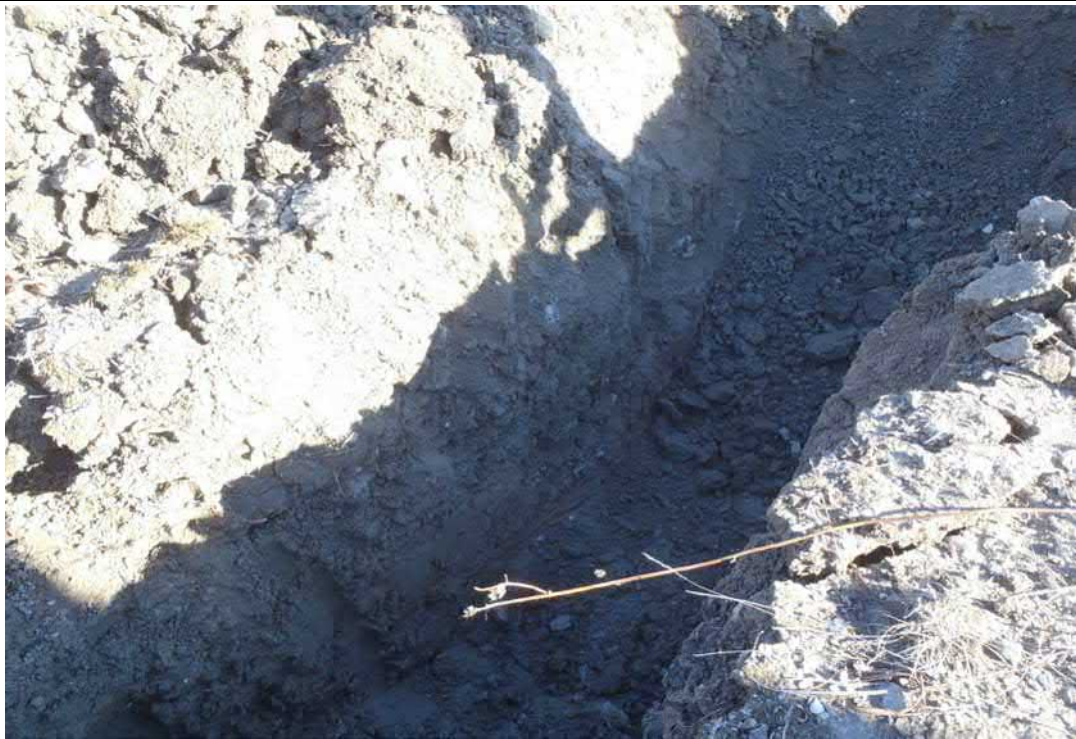
1.0 - 1.40m	Pinkish brown, damp, SAND , medium	SA	Sa-2	Metals - Soils	29 uR/hr	0 ppm				
Date: 2-Oct-13 Logged by: LS Method: Can-Dig Excavator Location: Rayrock, NWT			Test Pit: SA13-10					SAMPLES		COMMENTS	PHOTO
			Type	Sample I.D.	Analysis & Depth of Sample (m)						
Area	Depth (m)	Description			Parameters	Gamma	Gastech				
Area 3 Lodging (2)	0.0 - 0.60m	Dark greyish brown, SILTY SAND , fine, trace angular gravel	SA	Sa-1	Metals - Soils	5 uR/hr	0 ppm			Tailings Spill. Complete on Bedrock @ 0.20m. No evidence of environmental impact (staining or odour).

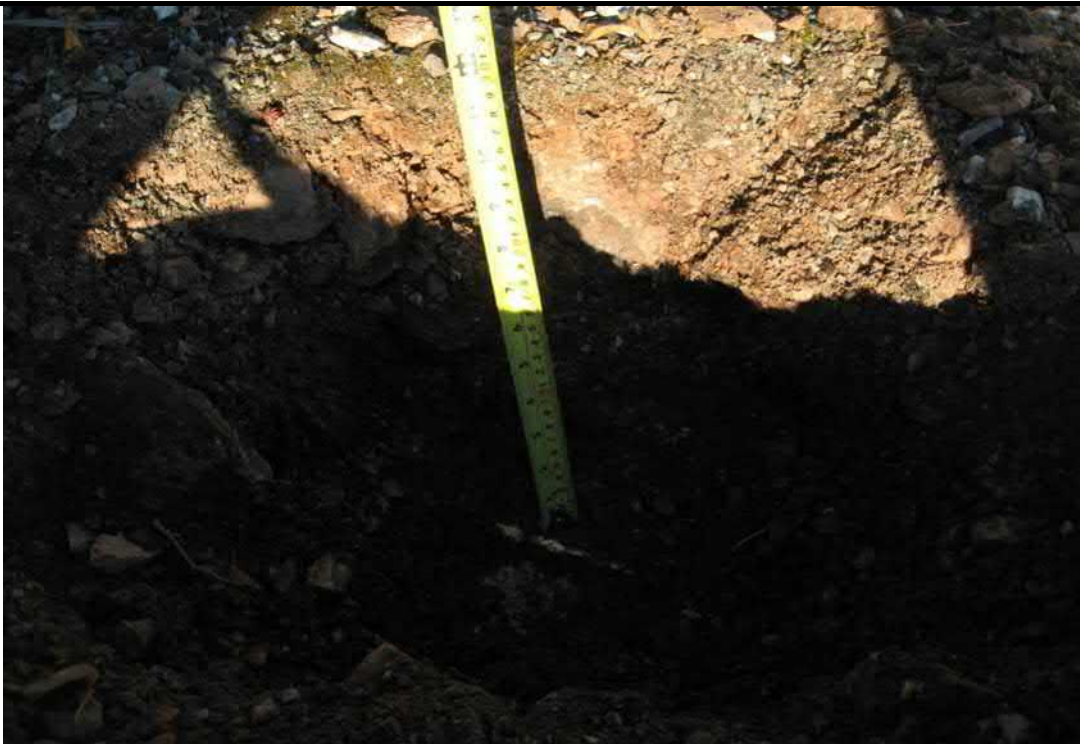
Date: 2-Oct-13 Logged by: CR Method: Hand Dig Location: Rayrock, NWT			Test Pit: SA13-12		SAMPLES			COMMENTS	PHOTO
			Type	Sample I.D.	Analysis & Depth of Sample (m)				
Area	Depth (m)	Description			Parameters	Gamma	Gastech		
Area 3 Lodging (2)	0.0 - 0.25m	Dark brown, moist to damp, SANDY SILT, some gravel, organics, trace roots	SAML	Sa-1	Metals - Soils	9 uR/hr	0 ppm	Complete on Bedrock @ 0.25m. No evidence of environmental impact (staining or odour).

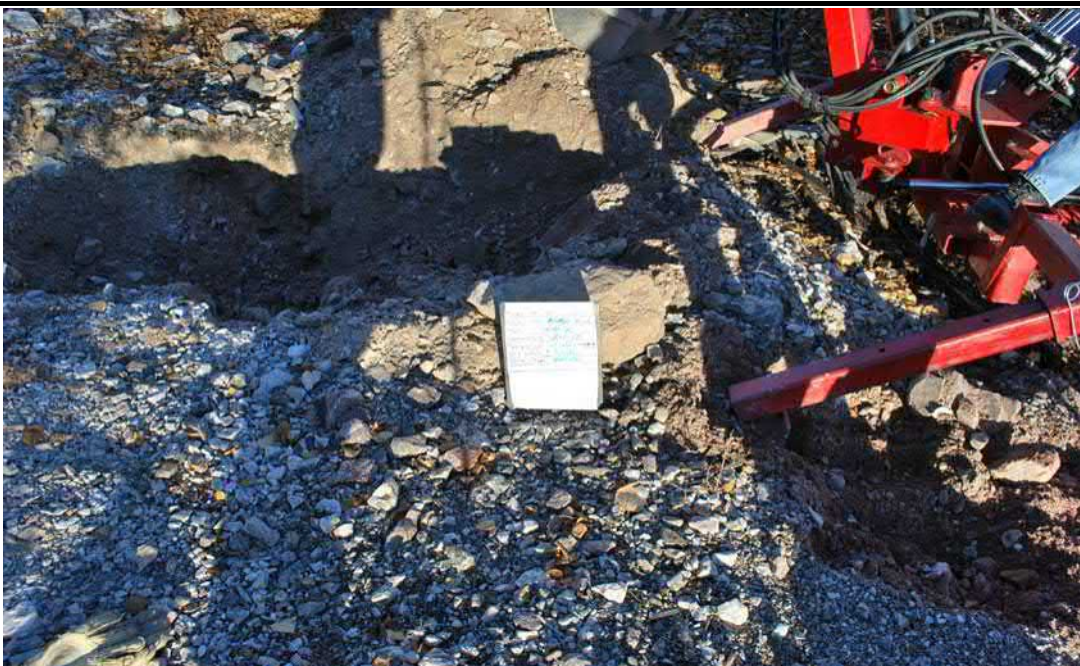
Date: 2-Oct-13 Logged by: LS Method: Can-Dig Excavator Location: Rayrock, NWT			Test Pit: SA13-13		SAMPLES			COMMENTS	PHOTO
			Type	Sample I.D.	Analysis & Depth of Sample (m)				
Area	Depth (m)	Description			Parameters	Gamma	Gastech		
Area 6 Mill	0.0 - 0.25m	Dark brown to black, damp, SAND and GRAVEL, medium coarse, no odour.	GR	Sa-1	Metals - Soils	10 uR/hr	0 ppm	Water level at 0.075m, test pit incomplete due to boulders and water. No evidence of environmental impact (staining or odour). Samples taken from adjacent TP13-44.

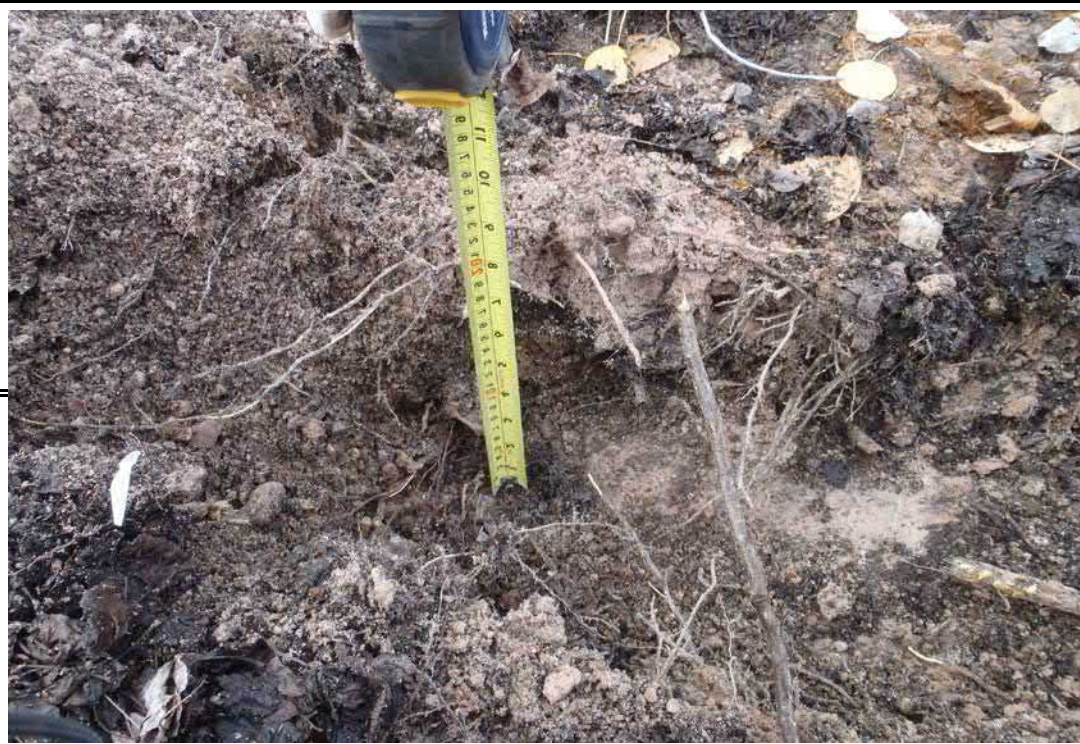
Date: Logged by: Method: Location: Rayrock, NWT			Test Pit: SA13-15		SAMPLES			COMMENTS	PHOTO
			Type	Sample I.D.	Analysis & Depth of Sample (m)				
Area	Depth (m)	Description			Parameters	Gamma	Gastech		
Area 7 Tailings Line (2)	0.0 - 0.15m	Pinkish brown, moist, SAND, fine to medium, trace silt and roots	SA	Sa-1	Metals - Soils	38 uR/hr	0 ppm	Complete on Bedrock @ 0.25m. No evidence of environmental impact (staining or odour).

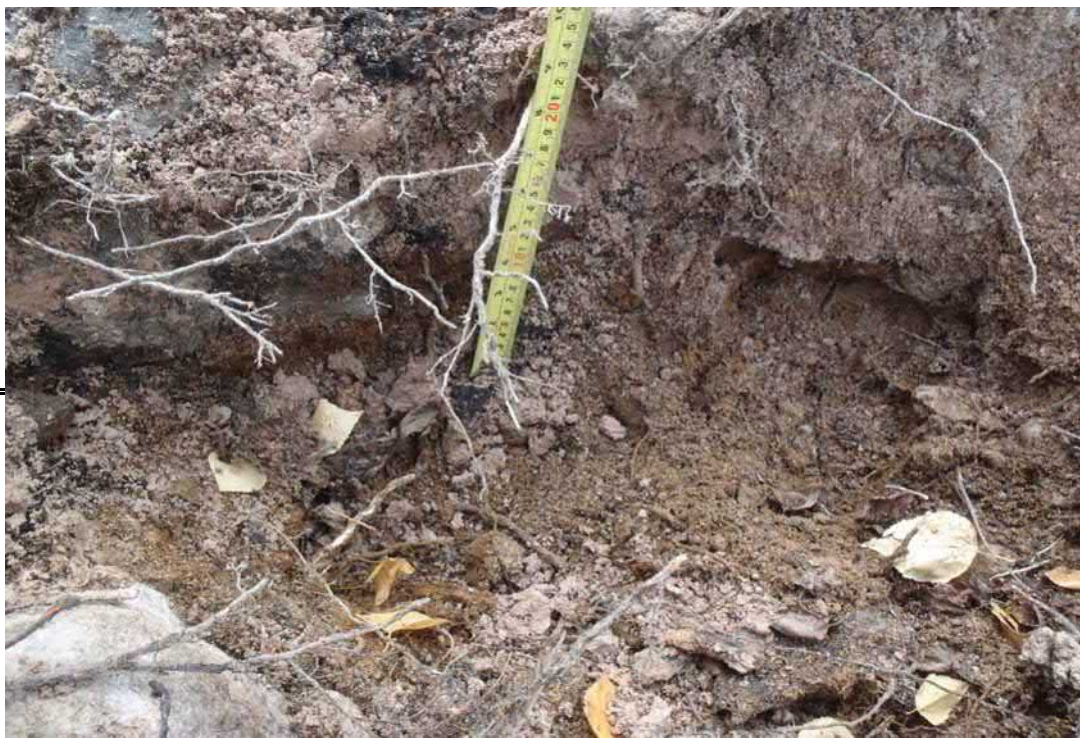
Date: Logged by: Method: Location:			Test Pit: SA13-16			SAMPLES		COMMENTS	PHOTO
Rayrock, NWT			Type	Sample I.D.	Analysis & Depth of Sample (m)				
Area	Depth (m)	Description			Parameters	Gamma	Gastech	Complete on Bedrock @ 0.25m. No evidence of environmental impact (staining or odour).

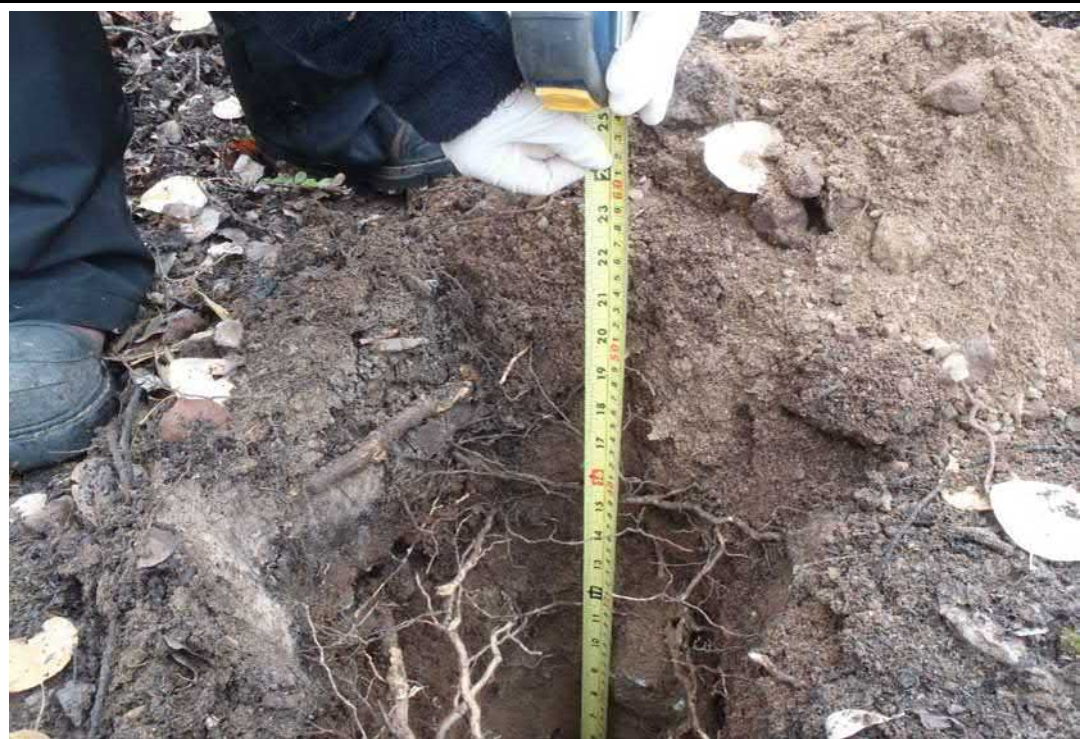
0.15 - 0.25m	Brown, moist, SANDY SILT , medium, trace roots	SA-ML	Sa-2	Metals - Soils	16 uR/hr	0 ppm		
Date: Logged by: Method: Location:			Test Pit: SA13-17			SAMPLES		COMMENTS	PHOTO
3-Oct-13 CR Hand Dig Rayrock, NWT			Type	Sample I.D.	Analysis & Depth of Sample (m)				
Area	Depth (m)	Description			Parameters	Gamma	Gastech	Complete on Bedrock @ 0.50m. No evidence of environmental impact (staining or odour).

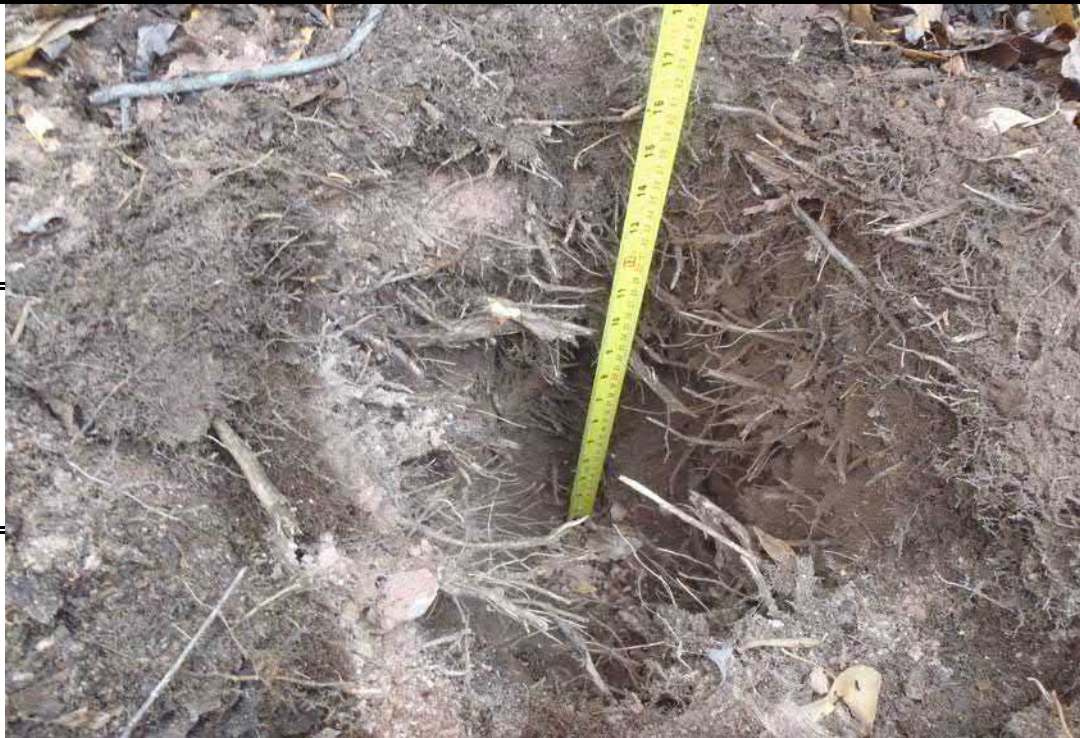
Area 7 Tailings Line (2)	0.0 - 0.50m	Brown, moist, SAND , medium to coarse, some gravel and cobbles, trace silt and roots	SA	Sa-1	Metals - Soils	7.5 uR/hr	0 ppm		
Date: Logged by: Method: Location:			Test Pit: SA13-18			SAMPLES			
3-Oct-13 CR Hand Dig Rayrock, NWT			Type	Sample I.D.	Analysis & Depth of Sample (m)				
Area	Depth (m)	Description			Parameters	Gamma	Gastech	Complete on Bedrock @ 0.40m. No evidence of environmental impact (staining or odour).

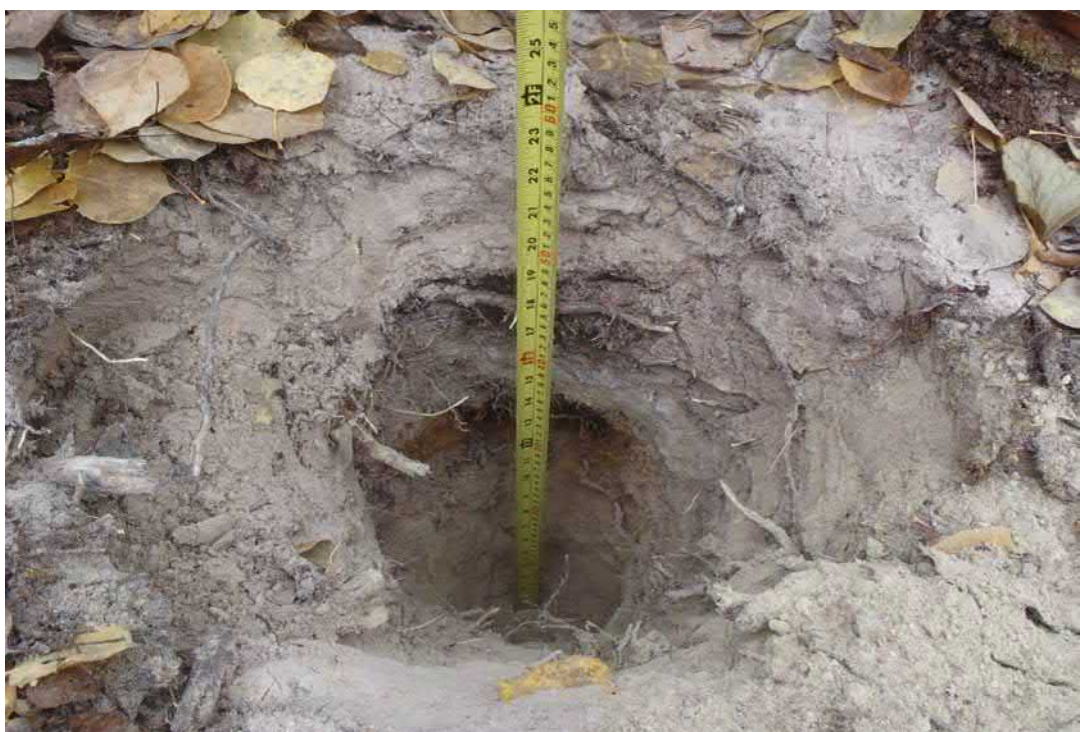
0.15 - 0.25m	Dark drown, FOREST MATT , lots of roots	PT						
	0.25 - 0.40m	Dark brown, damp, SAND , medium to fine, some organics	SA	Sa-2	Metals - Soils	14 uR/hr	0 ppm		
Date: Logged by: Method: Location:			Test Pit: SA13-19			SAMPLES		COMMENTS	PHOTO
3-Oct-13 CR Hand Dig Rayrock, NWT			Type	Sample I.D.	Analysis & Depth of Sample (m)				
Area	Depth (m)	Description			Parameters	Gamma	Gastech	No evidence of environmental impact (staining or odour). Borehole incomplete due to access.

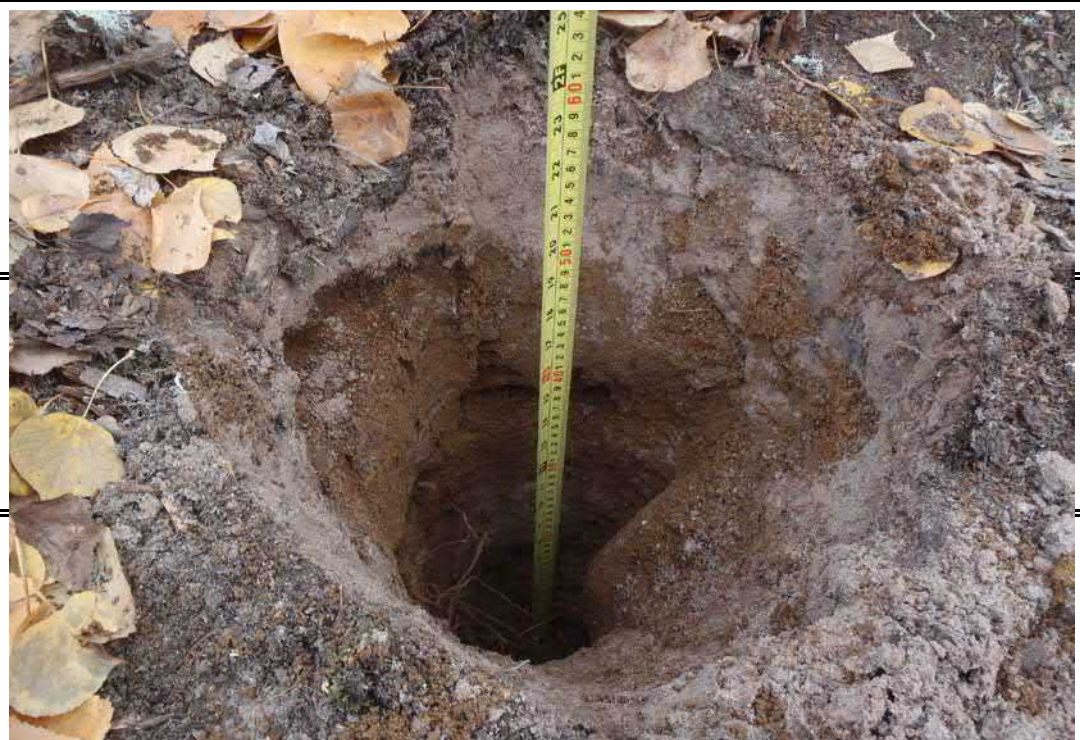
0.30 - 0.60m	Beige, dry, SAND , fine to medium	SA	Sa-3 & DUP # 8	Metals - Soils	9 uR/hr	0 ppm		
Date: Logged by: Method: Location:			Test Pit: SA13-20			SAMPLES		COMMENTS	PHOTO
3-Oct-13 CR Hand Dig Rayrock, NWT			Type	Sample I.D.	Analysis & Depth of Sample (m)				
Area	Depth (m)	Description			Parameters	Gamma	Gastech	Complete on Bedrock @ 0.57m. No evidence of environmental impact (staining or odour).

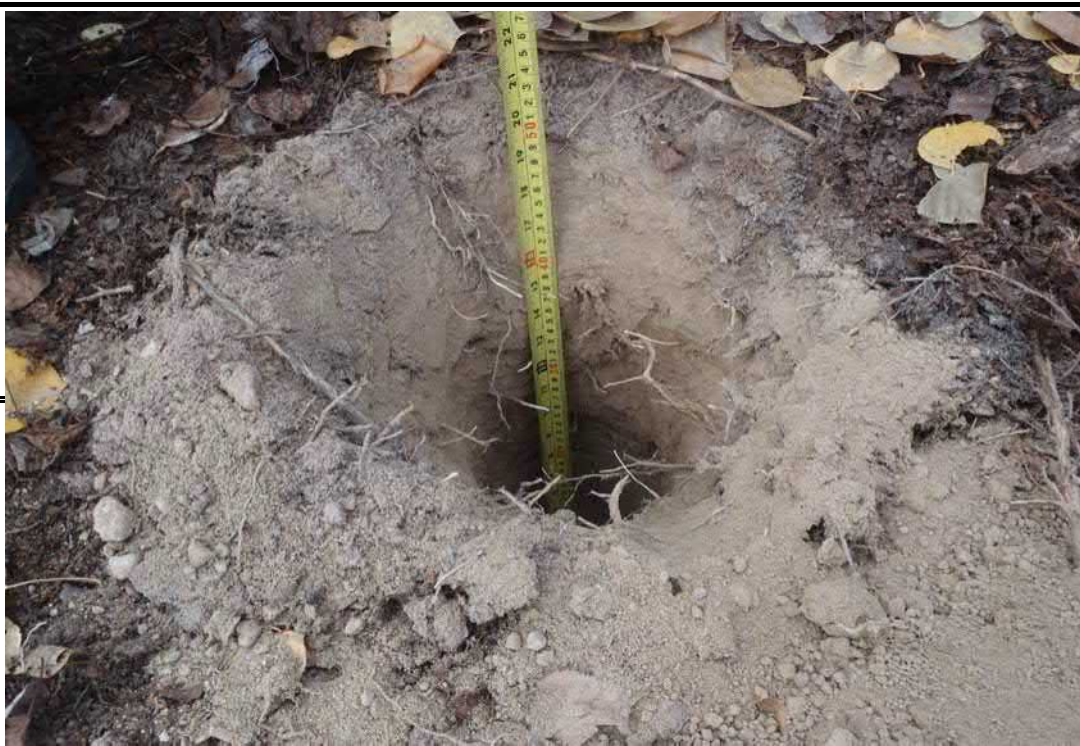
FORMER RAYROCK MINE SITE TEST PIT LOGS - METALS										
Date: 3-Oct-13 Logged by: CR Method: Hand Dig Location: Rayrock, NWT			Test Pit: SA13-21					SAMPLES	COMMENTS	PHOTO
Type	Sample I.D.	Analysis & Depth of Sample (m)								
Area	Depth (m)	Description			Parameters	Gamma	Gastech			
Area 7 Tailings Line (2)	0.0 - 0.13m	Pinkish brown, moist, SAND , medium to coarse, trace roots	SA	Sa-1	Metals - Soils	14 uR/hr	0 ppm	No evidence of environmental impact (staining or odour). Borehole incomplete due to access.

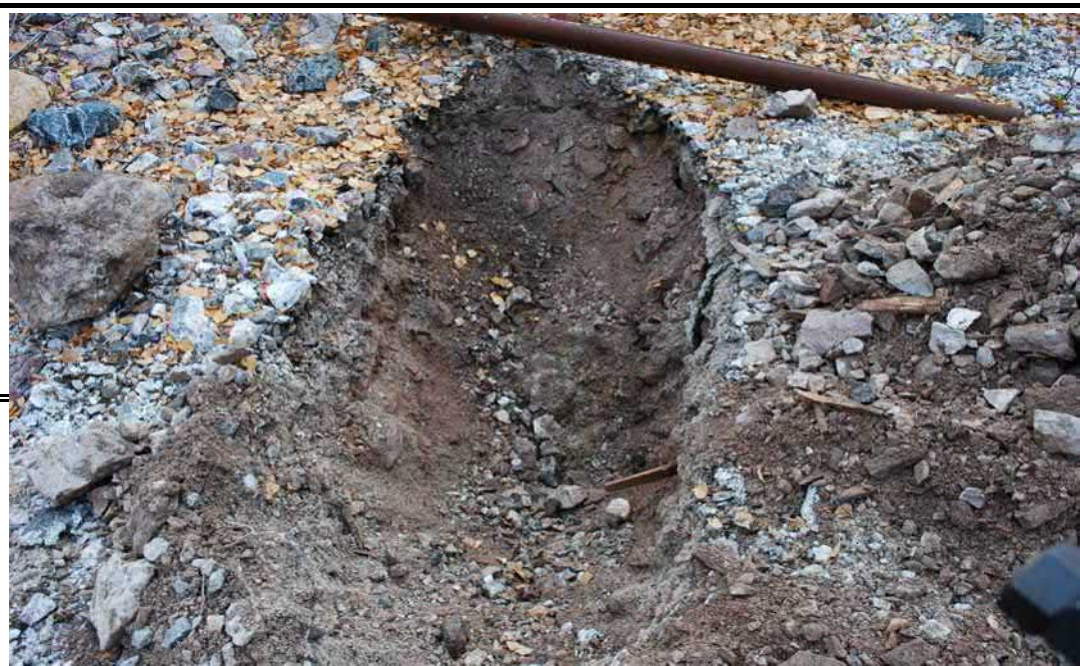
0.17 - 0.57m	Beige, dry, SAND , trace roots and angular gravel	SA	Sa-2	Metals - Soils	7 uR/hr	0 ppm			
Date: 3-Oct-13 Logged by: LS Method: Can-Dig Excavator Location: Rayrock, NWT			Test Pit: SA13-22					SAMPLES	COMMENTS	PHOTO
Type	Sample I.D.	Analysis & Depth of Sample (m)								
Area	Depth (m)	Description			Parameters	Gamma	Gastech			
Area 6 Mill	0.0 - 0.30m	Pinkish grey, SAND , medium to coarse, some cobbles and gravel, some construction debris and metal	SA	Sa-1	Metals - Soils	62 Ur/hr	0 ppm	Complete on Bedrock @ 0.95m. No evidence of environmental impact (staining or odour).

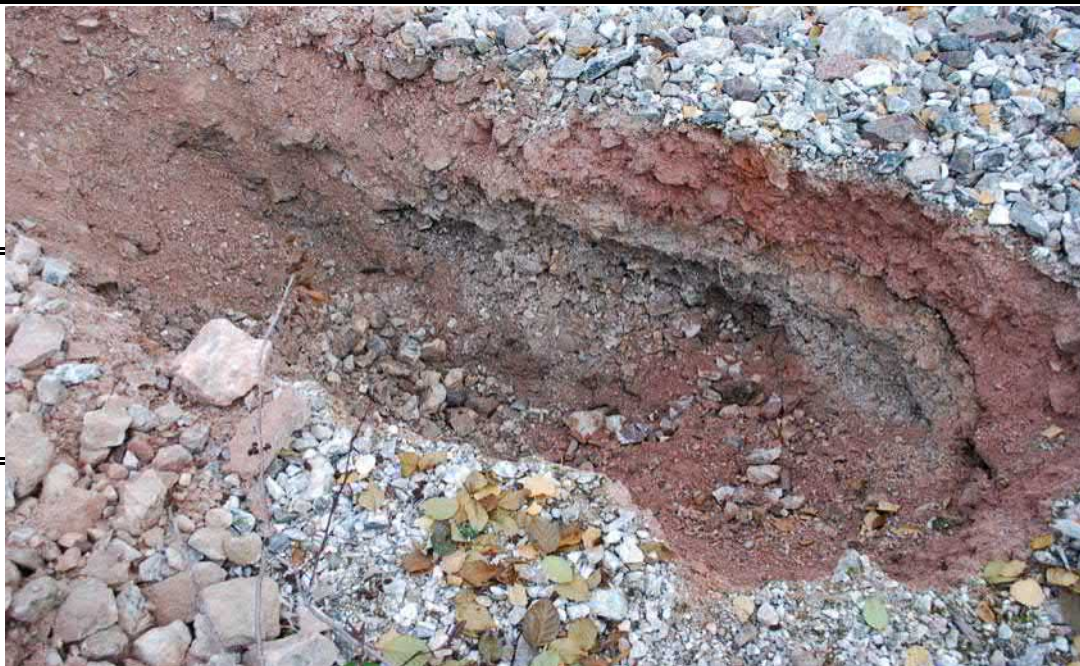
0.3 - 0.95m	Brown, SAND , medium to coarse, some angular cobbles and gravel, some silty fine sand on bedrock.	SA	Sa-2	Metals - Soils	35 uR/hr	0 ppm			
Date: 3-Oct-13 Logged by: LS Method: Can-Dig Excavator Location: Rayrock, NWT			Test Pit: SA13-23					SAMPLES	COMMENTS	PHOTO
Type	Sample I.D.	Analysis & Depth of Sample (m)								
Area	Depth (m)	Description			Parameters	Gamma	Gastech			
Area 6 Mill	0 - 0.12m	Reddish brown, damp, SAND , medium to coarse, some cobbles and boulders	SA	Sa-1	Metals - Soils	7.5 uR/hr	0 ppm	Complete on Bedrock @ 1.05m. No evidence of environmental impact (staining or odour).

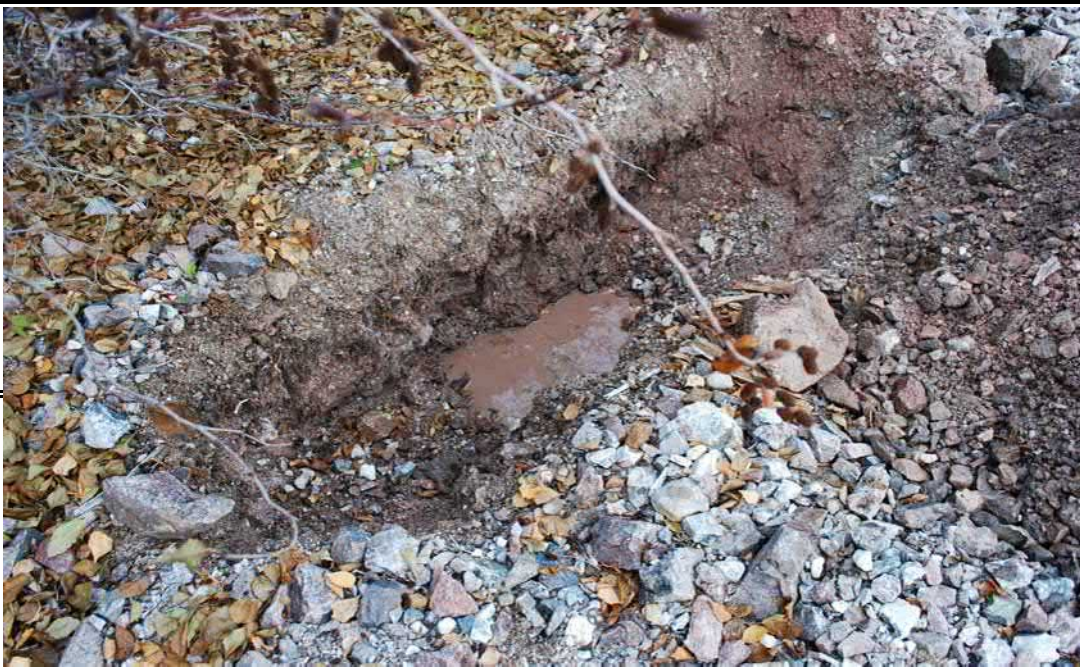
0.65 - 1.05m	Brown, SAND and GRAVEL , medium to coarse	GR	Sa-3	Metals - Soils	14 uR/hr	0 ppm			
Date: 3-Oct-13 Logged by: LS Method: Can-Dig Excavator Location: Rayrock, NWT			Test Pit: SA13-24					SAMPLES	COMMENTS	PHOTO
Type	Sample I.D.	Analysis & Depth of Sample (m)								
Area	Depth (m)	Description			Parameters	Gamma	Gastech			
Area 6 Mill	0 - 0.2m	Pinkish brown, moist, SAND and GRAVEL , some cobbles, trace roots	GR	Sa-1	Metals - Soils	6 uR/hr	0 ppm	Water level @ 0.3m. Test pit incomplete. No evidence of environmental impact (staining or odour).

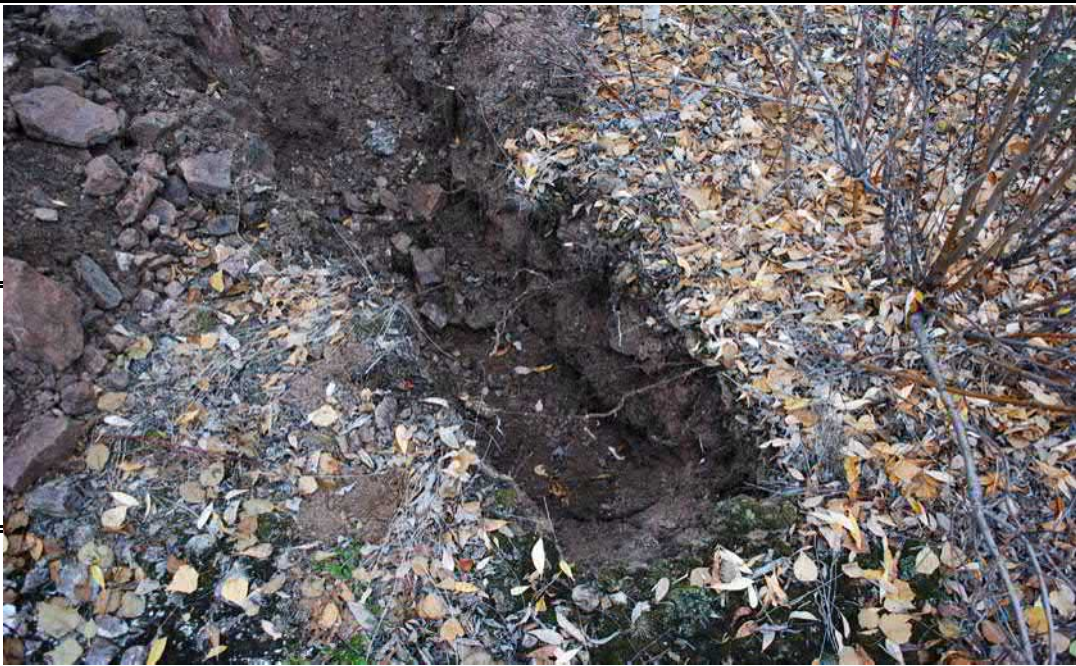
0.75 - 0.90m	Concrete foundation								
	0.90 - 1.80m	Brown, moist, SAND and GRAVEL, some angular cobbles and boulders, trace wood timbers and metal	SA	Sa-1	Metals - Soils	15 uR/hr	0 ppm			
Date: 3-Oct-13 Logged by: CR Method: Hand Dig Location: Rayrock, NWT			Test Pit: SA13-27					SAMPLES	COMMENTS	PHOTO
Type	Sample I.D.	Analysis & Depth of Sample (m)								
Area	Depth (m)	Description			Parameters	Gamma	Gastech			
Area 6 Mill	0.0 - 0.40m	Brown, moist, SAND, medium to coarse, some gravel and organics	SA	Sa-1	Metals - Soils	9 uR/hr	0 ppm		Complete on Bedrock @ 0.70m. No evidence of environmental impact (staining or odour).
