Date
October 14, 2021

Project #
60608868

**Subject: Kwetǫǫǫǫ (Rayrock) Remediation Project
2021 Field Investigation Summary – Test Pit Excavations**

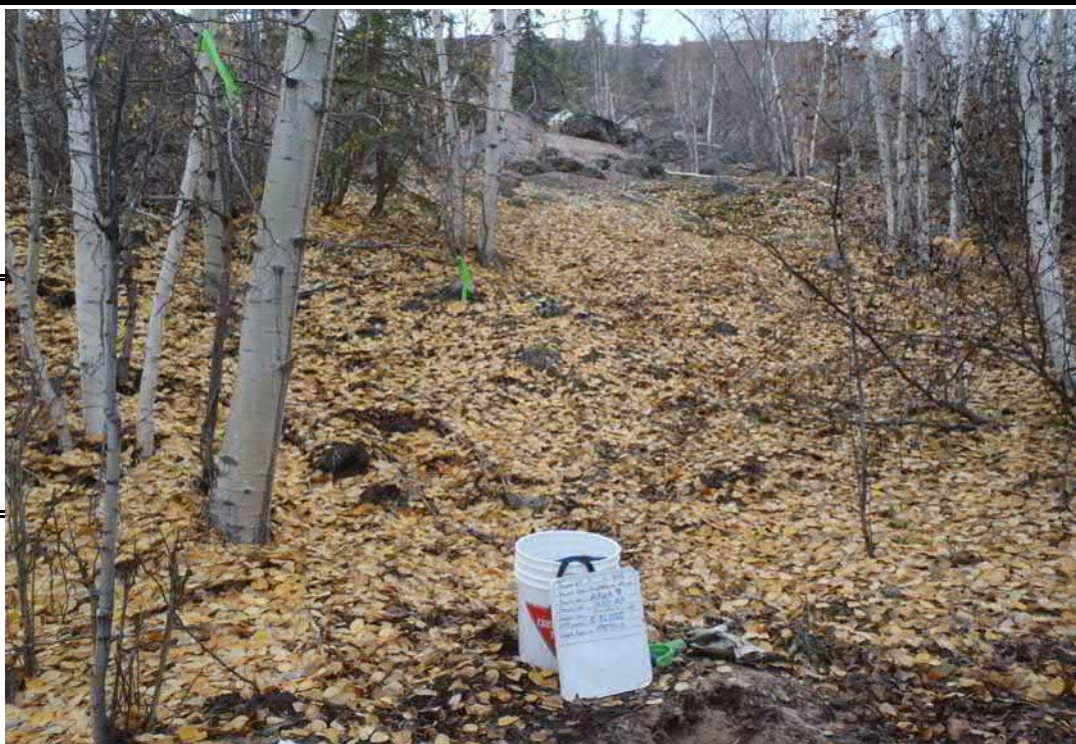
0.40 - 0.50m	Black to dark brown, moist, PEAT	PT							
	0.50 - 0.70m	Brown, moist, SAND, medium to coarse, trace fine sand	SA	Sa-2	Metals - Soils	8 uR/hr	0 ppm			
Date: 3-Oct-13 Logged by: CR Method: Hand Dig Location: Rayrock, NWT			Test Pit: SA13-28					SAMPLES	COMMENTS	PHOTO
Type	Sample I.D.	Analysis & Depth of Sample (m)								
Area	Depth (m)	Description			Parameters	Gamma	Gastech			
Area 7 Tailings Line (2)	0 - 0.15m	Pinkish brown, moist, SAND, medium coarse, trace roots	SA	Sa-1	Metals - Soils	22 uR/hr	0 ppm		Complete on Bedrock @ 0.45m. No evidence of environmental impact (staining or odour).

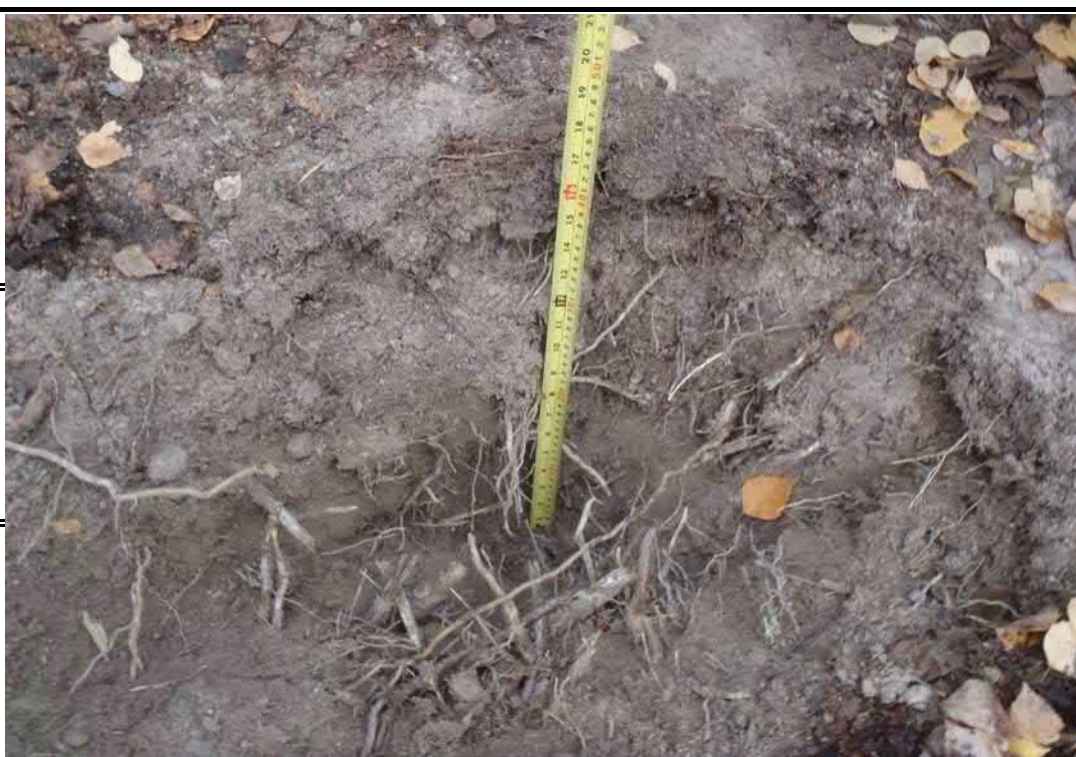
0.15 - 0.18m	Dark brown, moist, FOREST MAT, lots of roots	PT							
	0.18 - 0.45m	Brown, moist, SAND, medium to coarse, trace gravel, roots and silt	SA	Sa-2	Metals - Soils	11 uR/hr	0 ppm			
Date: 3-Oct-13 Logged by: CR Method: Hand Dig Location: Rayrock, NWT			Test Pit: SA13-29					SAMPLES	COMMENTS	PHOTO
Type	Sample I.D.	Analysis & Depth of Sample (m)								
Area	Depth (m)	Description			Parameters	Gamma	Gastech			
Area 7 Tailings Line (2)	0 - 0.15m	Pinkish brown, moist, SAND, medium to coarse, trace roots	SA	Sa-1	Metals - Soils	12.5 uR/hr	0 ppm		Complete on Bedrock @ 0.40m. No evidence of environmental impact (staining or odour).

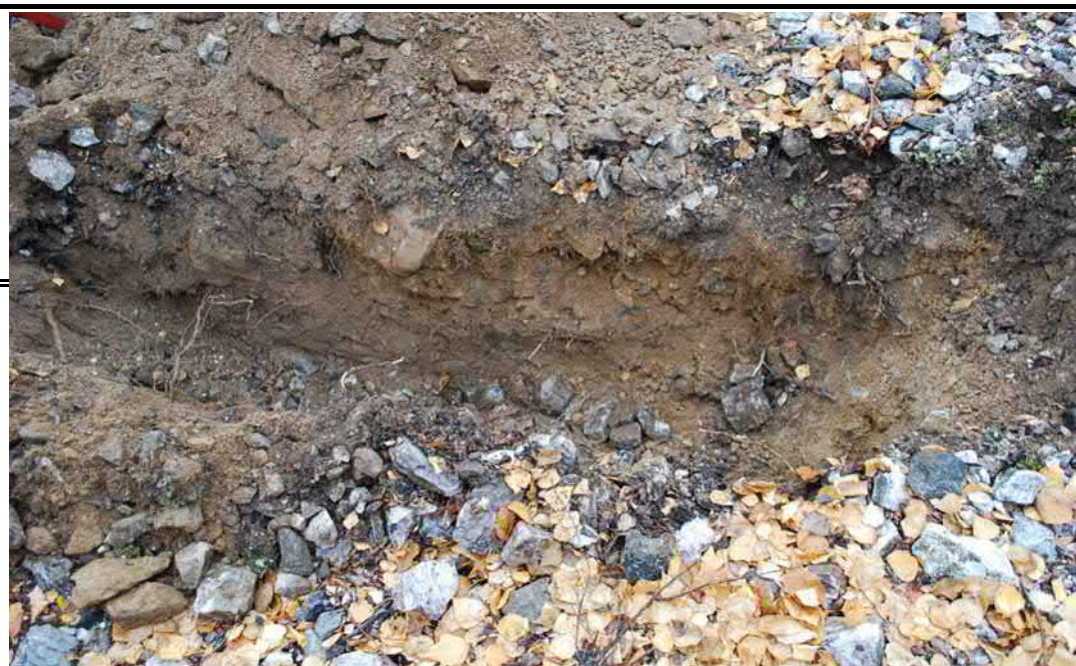
0.15 - 0.20m	Dark brown, moist, FOREST MAT	PT							
	0.20 - 0.40m	Brown, moist, SAND, medium to coarse, trace gravel and roots	SA	SA-2	Metals - Soils	7 uR/hr	0 ppm			
Date: 4-Oct-13 Logged by: LS Method: Can-Dig Excavator Location: Rayrock, NWT			Test Pit: SA13-30					SAMPLES	COMMENTS	PHOTO
Type	Sample I.D.	Analysis & Depth of Sample (m)								
Area	Depth (m)	Description			Parameters	Gamma	Gastech			
Area 6 Mill	0.0 - 0.15m	Dark brown to black, PEAT, trace roots, medium to fine sand and cobbles	PT	Sa-1	Metals - Soils	32 uR/hr	0 ppm		Complete on Bedrock @ 0.85m. No evidence of environmental impact (staining or odour).

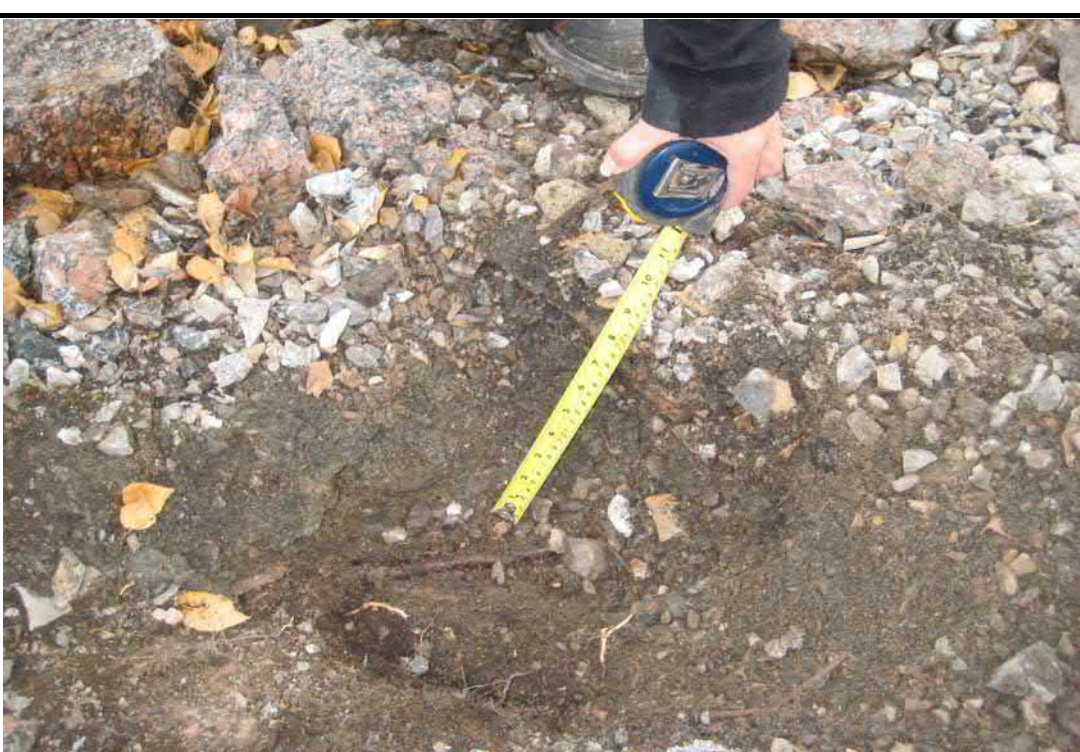
Date: 4-Oct-13 Logged by: CR Method: Hand Dig Location: Rayrock, NWT			Test Pit: SA13-41		SAMPLES			COMMENTS	PHOTO		
			Type	Sample I.D.	Analysis & Depth of Sample (m)						
Area	Depth (m)	Description			Parameters	Gamma	Gastech				
Area 6 Mill	0.0 - 0.20m	Dark brown to grey, moist, SAND and GRAVEL , trace silt and roots	GR	Sa-1	Metals - Soils	11 uR/hr	0 ppm	Complete on Bedrock @ 0.20m. No evidence of environmental impact (staining or odour).

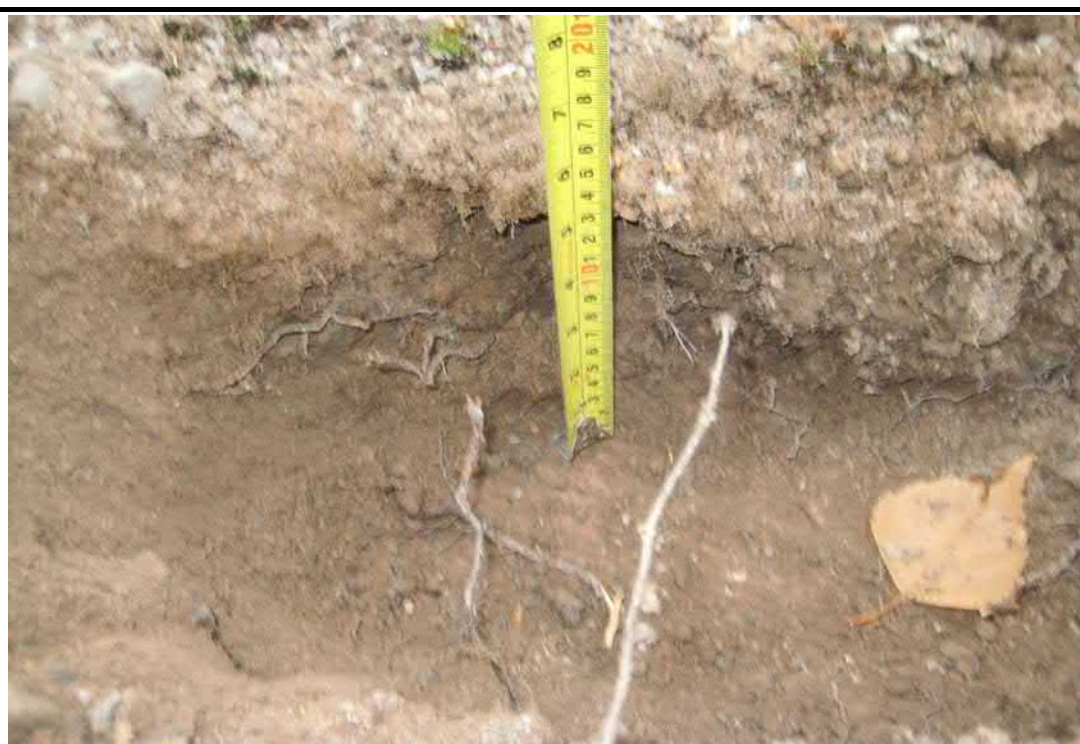
Date: 4-Oct-13 Logged by: CR Method: Hand Dig Location: Rayrock, NWT			Test Pit: SA13-42		SAMPLES			COMMENTS	PHOTO		
			Type	Sample I.D.	Analysis & Depth of Sample (m)						
Area	Depth (m)	Description			Parameters	Gamma	Gastech				
Area 6 Mill	0.0 - 0.15m	Brown, moist, SAND and GRAVEL , medium to coarse , trace roots	GR	Sa-1	Metals - Soils	13 uR/hr	0 ppm	Complete on Bedrock @ 0.15m. No evidence of environmental impact (staining or odour).

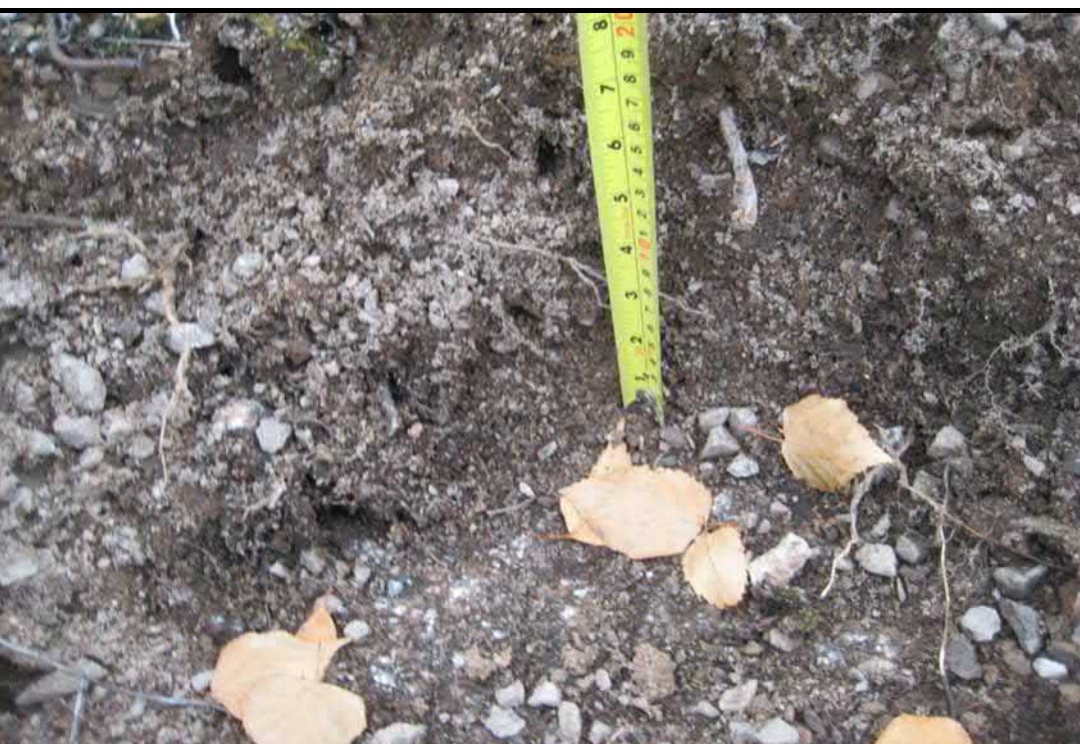
Date: 4-Oct-13 Logged by: CR Method: Hand Dig Location: Rayrock, NWT			Test Pit: SA13-43		SAMPLES			COMMENTS	PHOTO

Type	Sample I.D.	Analysis & Depth of Sample (m)						
Area	Depth (m)	Description			Parameters	Gamma	Gastech				
Area 6 Mill	0 - 0.20m	Brown to dark brown, moist, SAND , medium to coarse, some silt and gravel, trace roots and organics	SA	Sa-1	Metals - Soils	13 uR/hr	0 ppm	Complete on Bedrock @ 0.20m. No evidence of environmental impact (staining or odour).

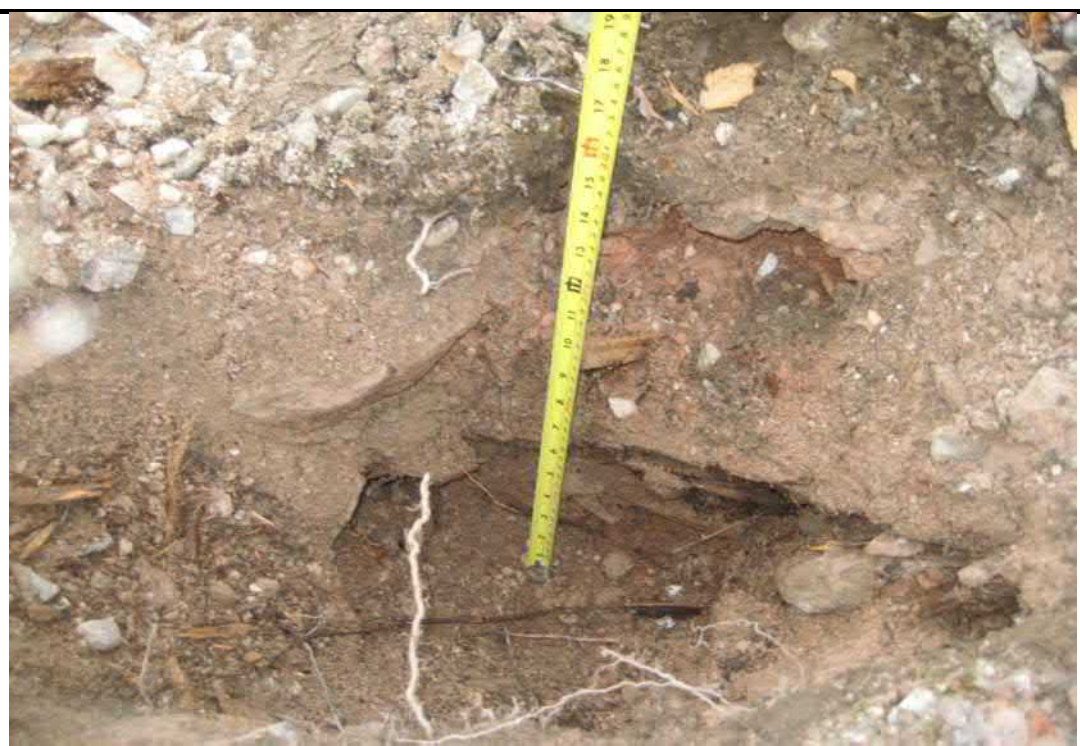
Date: 4-Oct-13 Logged by: Cr Method: Hand Dig Location: Rayrock, NWT			Test Pit: SA13-44		SAMPLES			COMMENTS	PHOTO		
			Type	Sample I.D.	Analysis & Depth of Sample (m)						
Area	Depth (m)	Description			Parameters	Gamma	Gastech				
Area 6 Mill	0.0 - 0.04m	Brown to dark brown, moist, SANDY SILT , medium to coarse, some gravel, trace roots	SA-ML	Sa-1	Metals - Soils	24 uR/hr	0 ppm	Complete on Bedrock @ 0.45m. No evidence of environmental impact (staining or odour).

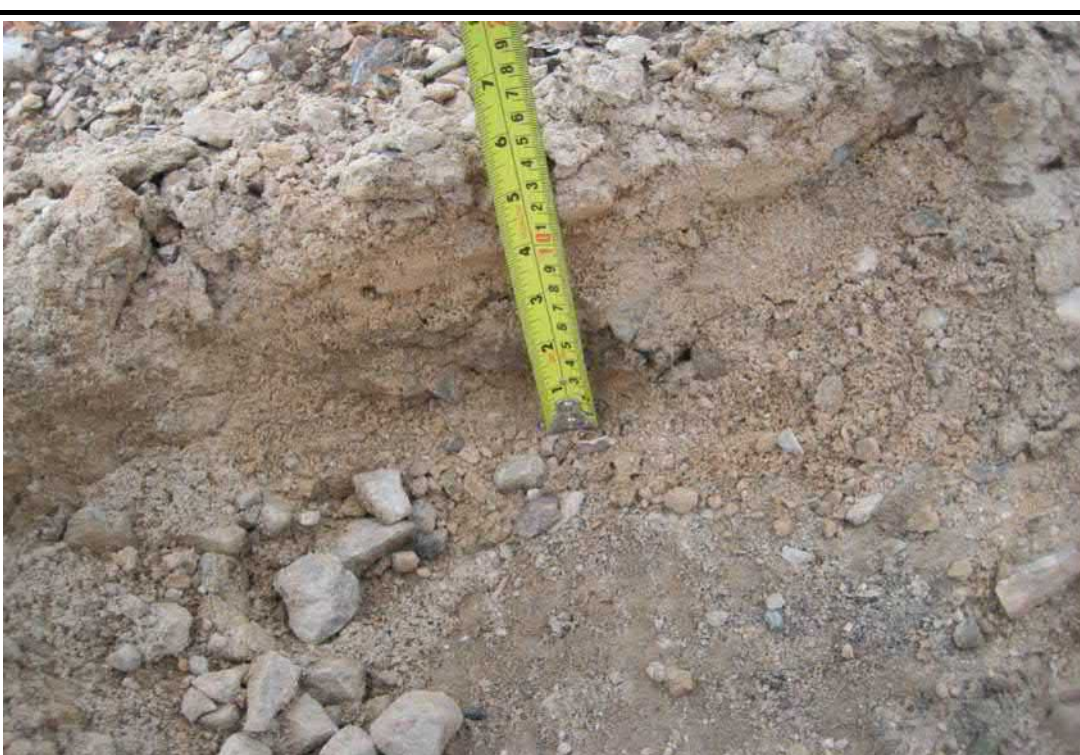
0.04 - 0.10m	Reddish brown, moist, SAND , coarse, some gravel, trace angular cobbles	SA	Sa-2	Metals - Soils	10 uR/hr	0 ppm				
	0.10 - 0.45m	Brown, moist, SAND , medium to coarse, some gravel, trace silt , wood in bottom of TP	SA	Sa-3	Metals - Soils	11 uR/hr	0 ppm				
Date: 4-Oct-13 Logged by: CR Method: Hand Dig Location: Rayrock, NWT			Test Pit: SA13-45		SAMPLES			COMMENTS	PHOTO		
			Type	Sample I.D.	Analysis & Depth of Sample (m)						
Area	Depth (m)	Description			Parameters	Gamma	Gastech				
Area 6 Mill	0.0 - 0.15m	Pinkish brown, moist, SAND , fine to medium, trace gravel	SA	Sa-1	Metals - Soils	130 uR/hr	0 ppm	Complete on Bedrock @ 0.15m. No evidence of environmental impact (staining or odour).

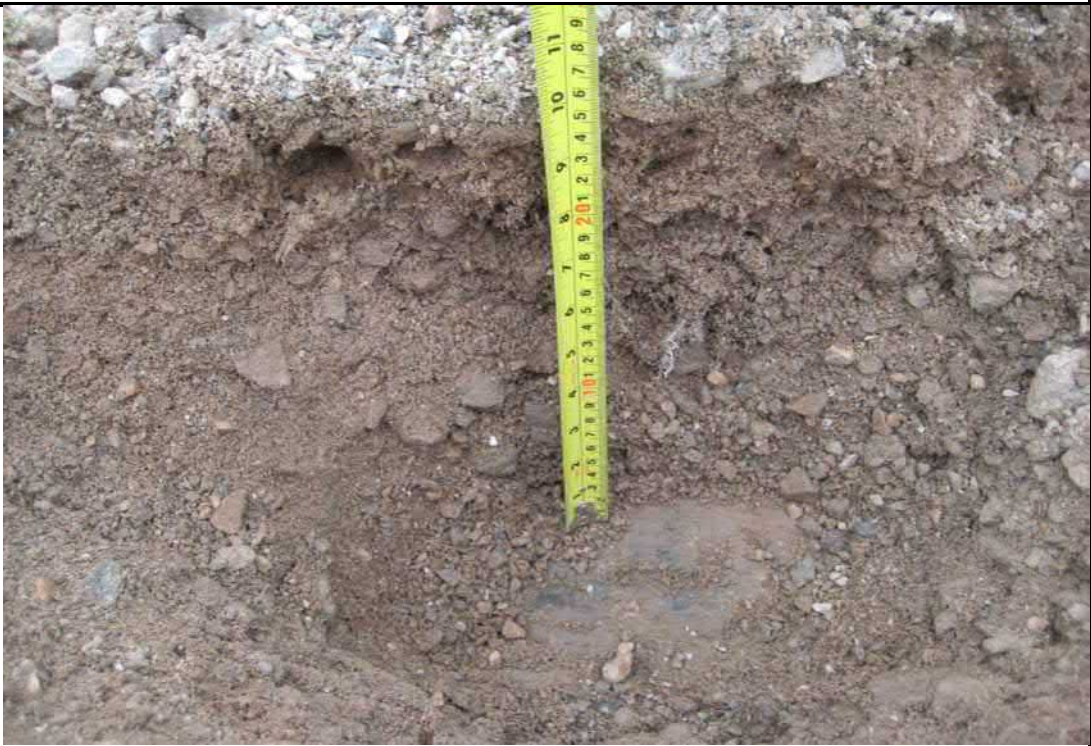
FORMER RAYROCK MINE SITE TEST PIT LOGS - METALS									
Date: 4-Oct-13 Logged by: CR Method: Hand Dig Location: Rayrock, NWT			Test Pit: SA13-46					COMMENTS	PHOTO
			Type	Sample I.D.	Analysis & Depth of Sample (m)				
Area	Depth (m)	Description			Parameters	Gamma	Gastech	Complete on Bedrock @ 0.26m. No evidence of environmental impact (staining or odour).

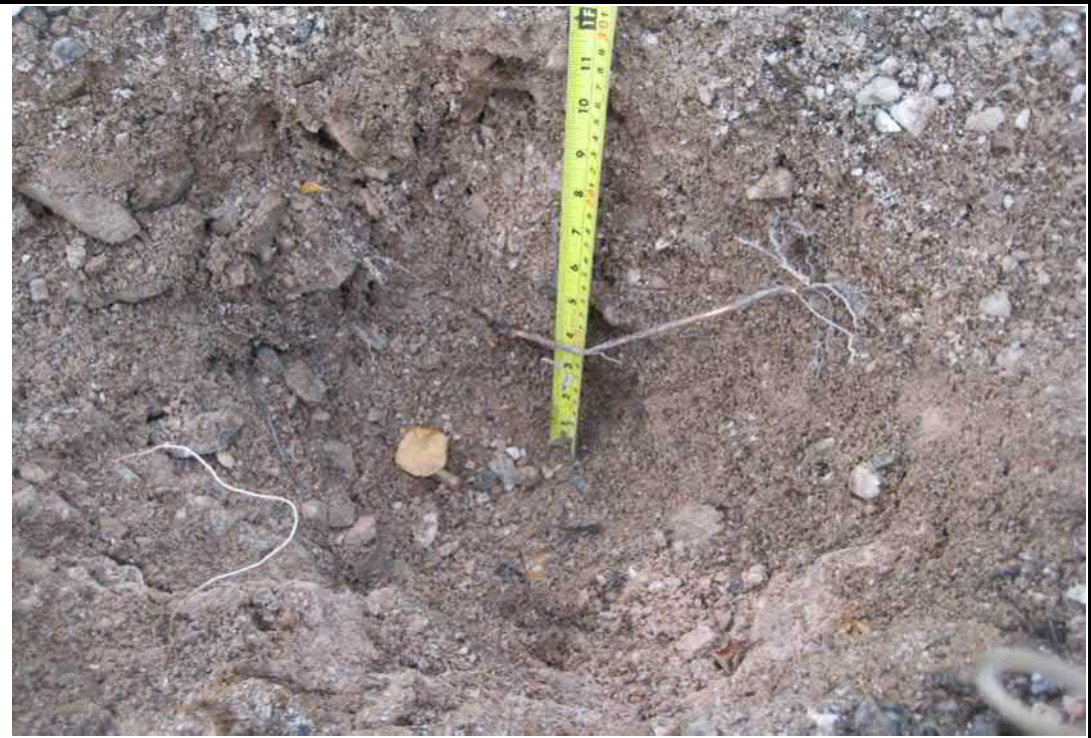
Area 6 Mill	0.0 - 0.26m	Brown, moist, SAND and GRAVEL & COBBLES , coarse , trace silt	GR	Sa-1	Metals - Soils	20 uR/hr	0 ppm		
Date: 4-Oct-13 Logged by: CR Method: Hand Dig Location: Rayrock, NWT			Test Pit: SA13-47					COMMENTS	PHOTO
			Type	Sample I.D.	Analysis & Depth of Sample (m)				
Area	Depth (m)	Description			Parameters	Gamma	Gastech	Complete on Bedrock @ 0.37m. No evidence of environmental impact (staining or odour).

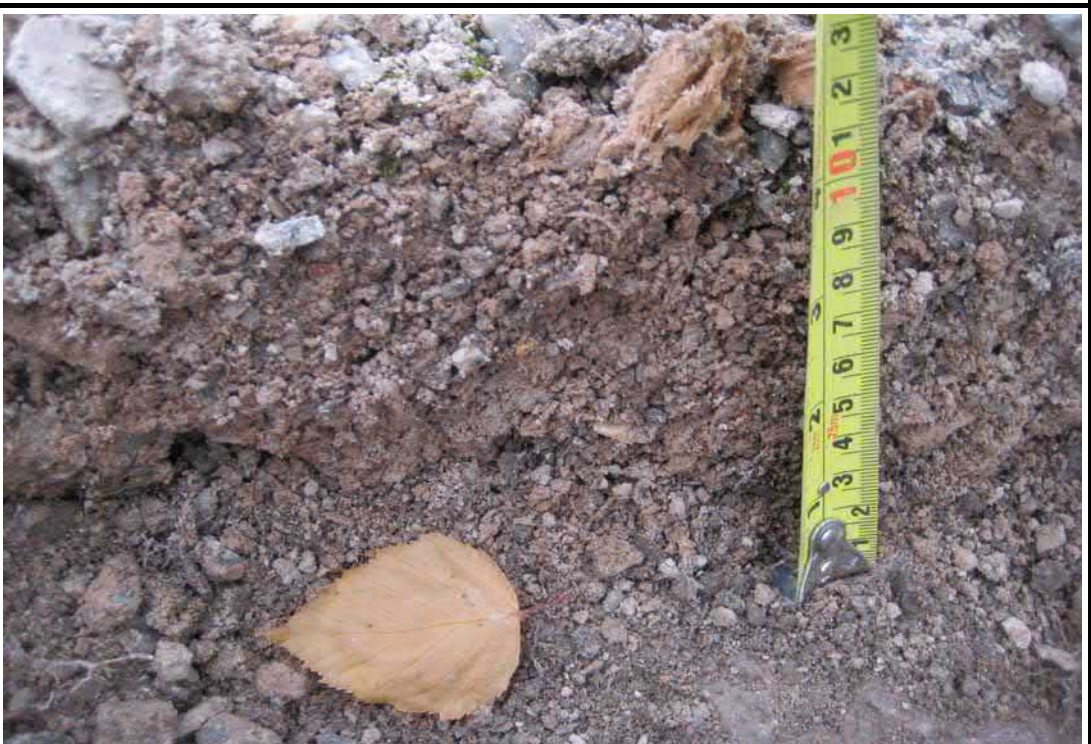
0.07 - 0.22m	Beige, moist, SAND and GRAVEL , coarse	GR	Sa-2	Metals - Soils	9 uR/hr	0 ppm		
	0.22 - 0.37m	Brown, moist, SAND and GRAVEL , coarse, trace silt, roots and cobbles		Sa-3	Metals - Soils	16 uR/hr	0 ppm		
Date: 4-Oct-13 Logged by: CR Method: Hand Dig Location: Rayrock, NWT			Test Pit: SA13-48					COMMENTS	PHOTO
			Type	Sample I.D.	Analysis & Depth of Sample (m)				
Area	Depth (m)	Description			Parameters	Gamma	Gastech	Complete on Bedrock @ 0.13m. No evidence of environmental impact (staining or odour).

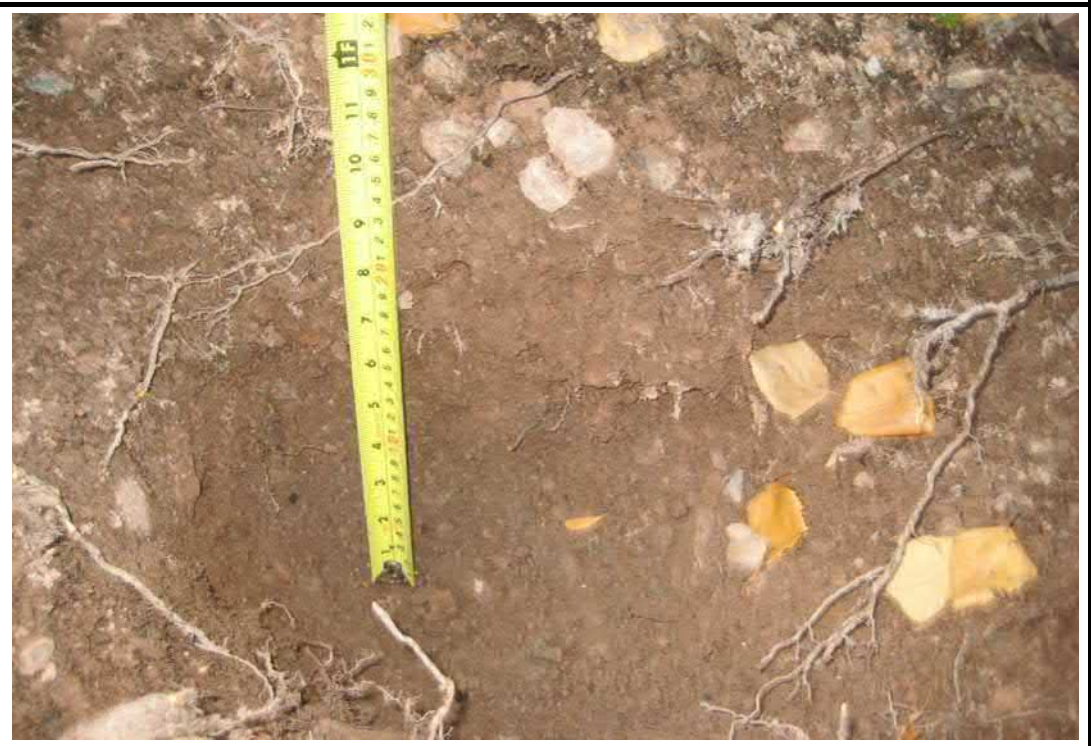
Area 6 Mill	0.0 - 0.13m	Pinkish brown, moist, SAND , medium to coarse, trace gravel	SA	Sa-1	Metals - Soils	49 uR/hr	0 ppm		
Date: 4-Oct-13 Logged by: CR Method: Hand Dig Location: Rayrock, NWT			Test Pit: SA13-49					COMMENTS	PHOTO
			Type	Sample I.D.	Analysis & Depth of Sample (m)				
Area	Depth (m)	Description			Parameters	Gamma	Gastech	Complete on Bedrock @ 0.32m. No evidence of environmental impact (staining or odour).

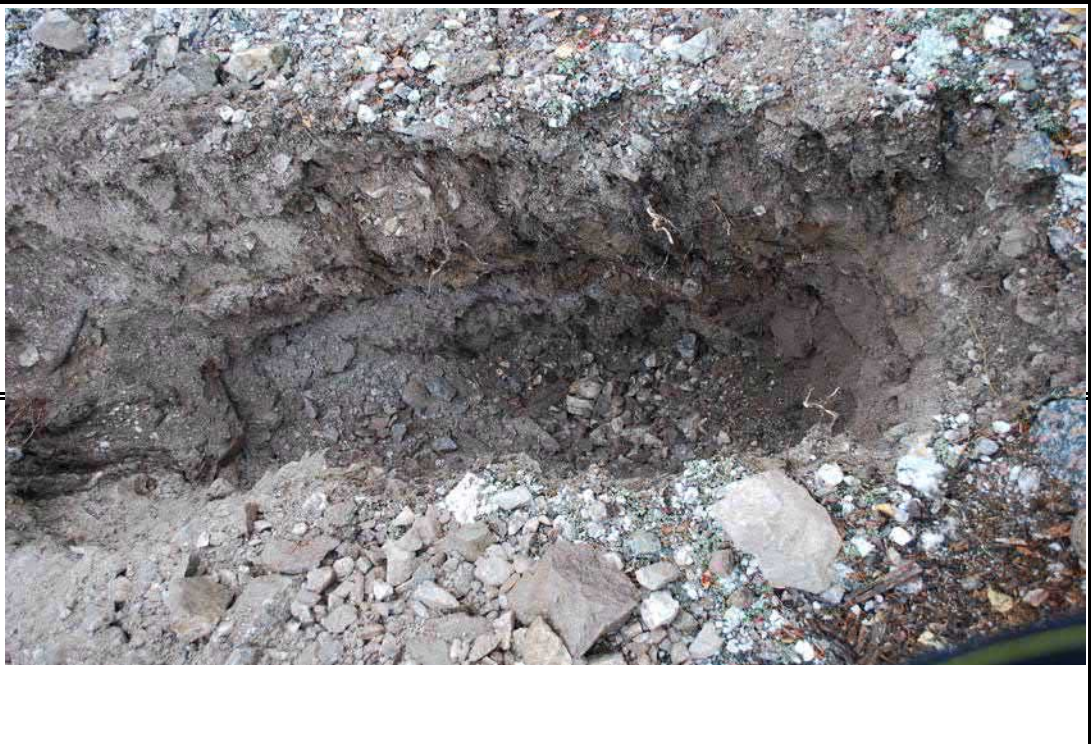
Area 6 Mill	0.0 - 0.32m	Brown, moist, SANDY SILT , some gravel, trace roots	SA-ML	Sa-1	Metals - Soils	9 uR/hr	0 ppm		
Date: 5-Oct-13 Logged by: LS Method: Can-Dig Excavator Location: Rayrock, NWT			Test Pit: SA13-50					COMMENTS	PHOTO
			Type	Sample I.D.	Analysis & Depth of Sample (m)				
Area	Depth (m)	Description			Parameters	Gamma	Gastech	Complete on Bedrock @ 1.50m. No evidence of environmental impact (staining or odour).

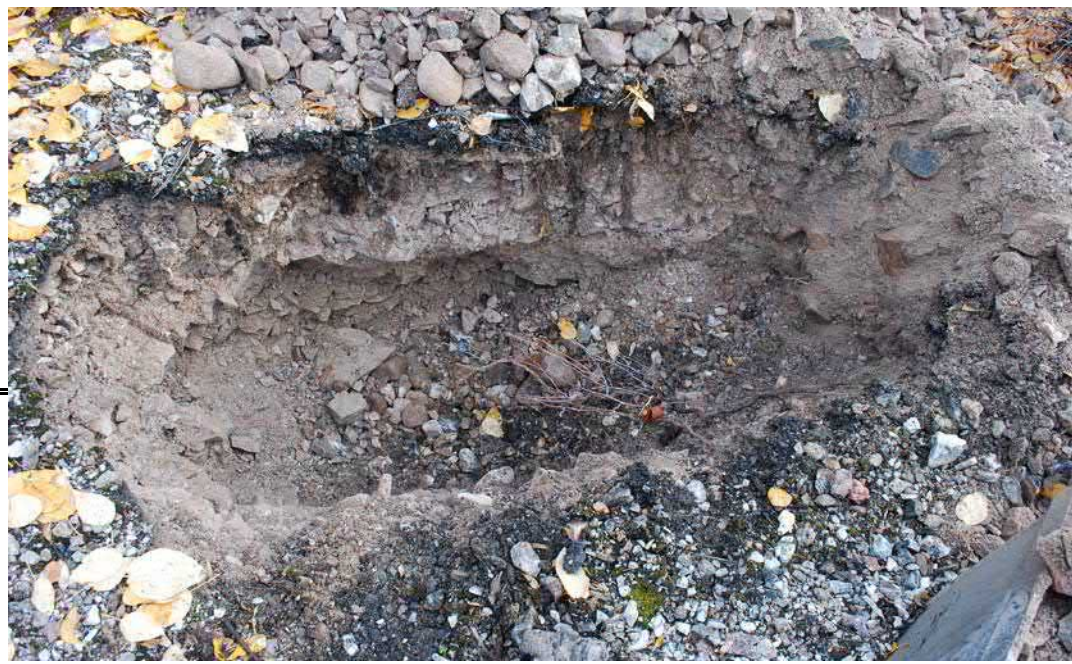
Date: 5-Oct-13 Logged by: LS Method: Can-Dig Excavator Location: Rayrock, NWT			Test Pit: SA13-56					SAMPLES		COMMENTS	PHOTO
			Type	Sample I.D.	Analysis & Depth of Sample (m)						
Area	Depth (m)	Description			Parameters	Gamma	Gastech				
Area 6 Mill	0.0 - 0.50m	Greyish brown, damp to moist, SAND , medium to coarse, some angular cobbles and gravel	SA	Sa-1	Metals - Soils	9 uR/hr	0 ppm			Incomplete due to large cobbles @ 1.0m. No evidence of environmental impact (staining or odour).

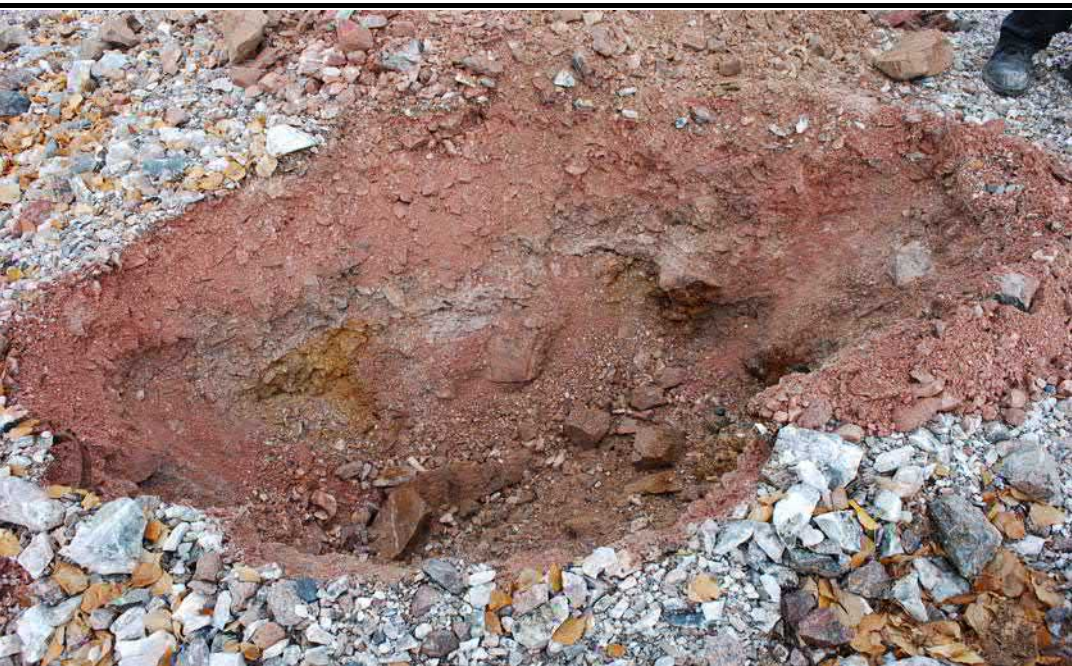
0.50-1.0m	Brown, moist, SAND , medium to coarse, some angular cobbles and gravel	SA	Sa-2	Metals - Soils	8 uR/hr	0 ppm				
Date: 5-Oct-13 Logged by: LS Method: Can-Dig Excavator Location: Rayrock, NWT			Test Pit: SA13-57					SAMPLES		COMMENTS	PHOTO
			Type	Sample I.D.	Analysis & Depth of Sample (m)						
Area	Depth (m)	Description			Parameters	Gamma	Gastech				
Area 6 Mill	0.0 - 0.50m	Reddish brown, damp to moist, SAND , medium to coarse, some angular cobbles and gravel, some oxidization	SA	Sa-1	Metals - Soils	9 uR/hr	0 ppm			Incomplete due to large cobbles @ 1.50m. No evidence of environmental impact (staining or odour).

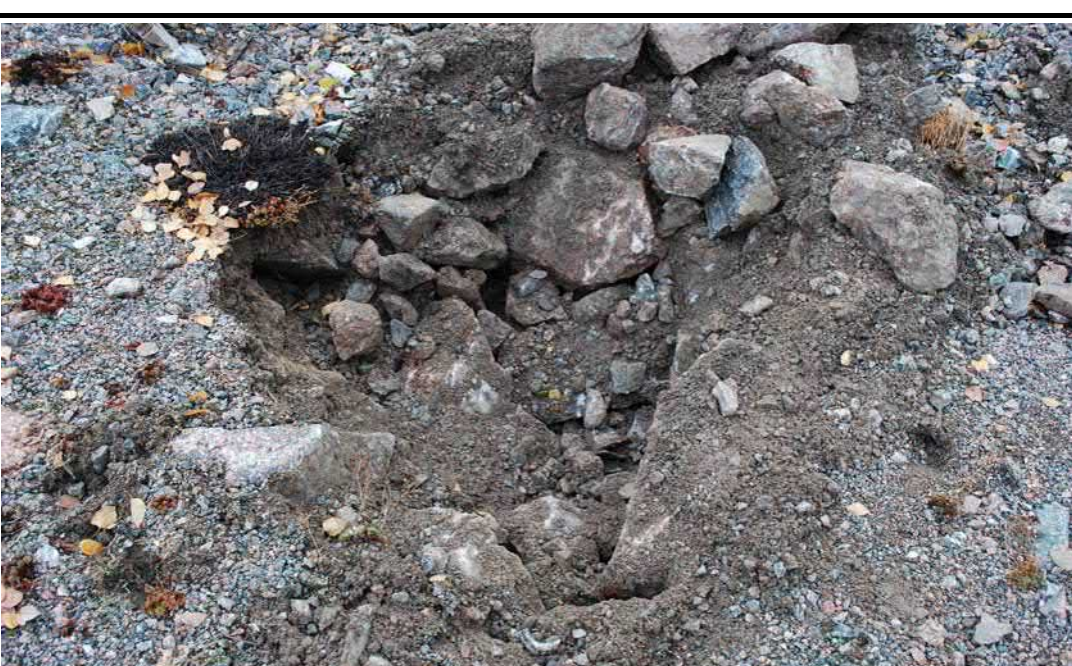
0.50 - 1.50	Brown, damp, SAND , medium to coarse, some angular cobbles and gravel	SA	Sa-2	Metals - Soils	14 uR/hr	0 ppm				
Date: 5-Oct-13 Logged by: LS Method: Can-Dig Excavator Location: Rayrock, NWT			Test Pit: SA13-58					SAMPLES		COMMENTS	PHOTO
			Type	Sample I.D.	Analysis & Depth of Sample (m)						
Area	Depth (m)	Description			Parameters	Gamma	Gastech				
Area 6 Mill	0.0 - 0.50m	Brown, damp, SAND , medium to coarse, some angular boulders and cobbles and gravel	SA	Sa-1	Metals - Soils	7.5 uR/hr	0 ppm			Incomplete due to large cobbles @ 0.50m. No evidence of environmental impact (staining or odour).

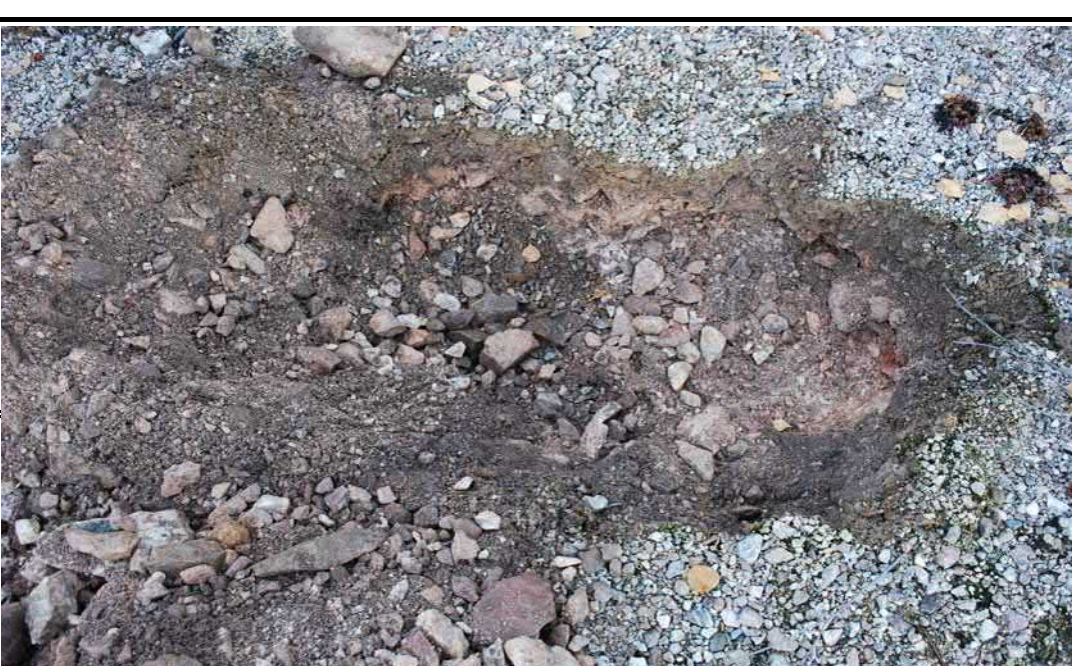
Date: 5-Oct-13 Logged by: LS Method: Can-Dig Excavator Location: Rayrock, NWT			Test Pit: SA13-59					SAMPLES		COMMENTS	PHOTO
			Type	Sample I.D.	Analysis & Depth of Sample (m)						
Area	Depth (m)	Description			Parameters	Gamma	Gastech				
Area 6 Mill	0.0 - 0.20m	Dark greyish brown, damp, SAND , medium to coarse, some angular cobbles and gravel	SA	Sa-1	Metals - Soils	15 uR/hr	0 ppm			Complete on Bedrock @ 0.40m. No evidence of environmental impact (staining or odour).

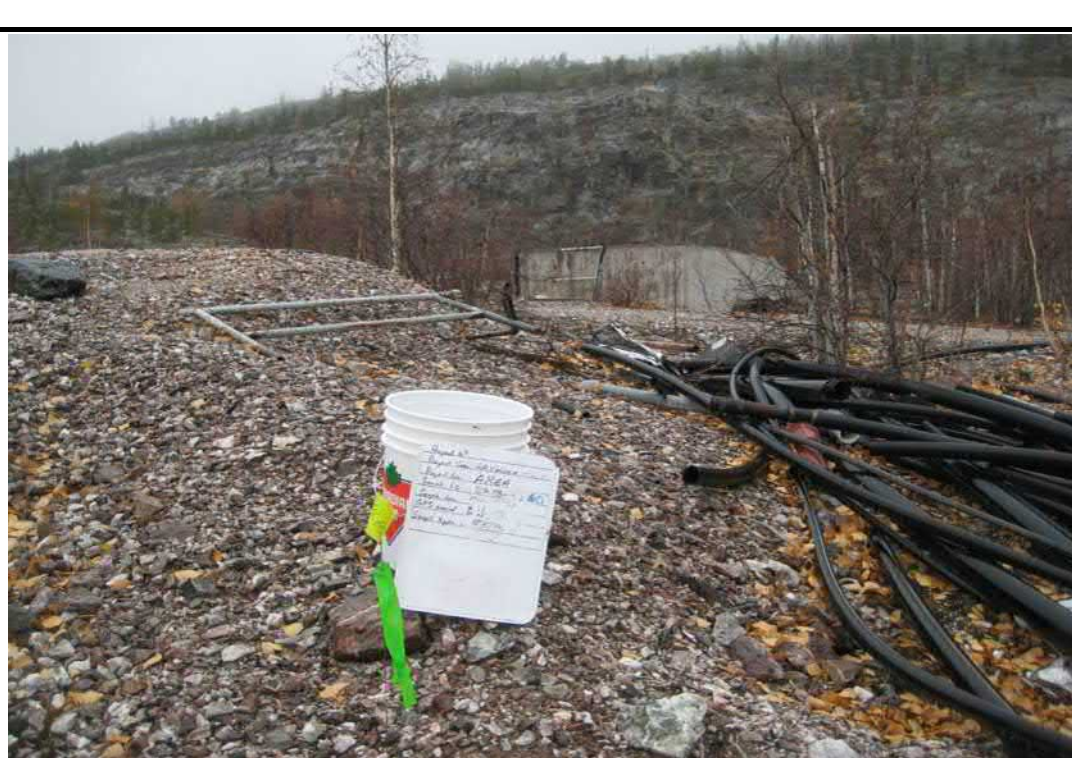
0.20 - 0.40m	Pinkish brown, damp, SAND , medium to coarse, some gravel and angular cobbles	SA	Sa-2	Metals - Soils	10 uR/hr	0 ppm				
Date: 5-Oct-13 Logged by: CR Method: Hand Dig Location: Rayrock, NWT			Test Pit: SA13-60					SAMPLES		COMMENTS	PHOTO
			Type	Sample I.D.	Analysis & Depth of Sample (m)						
Area	Depth (m)	Description			Parameters	Gamma	Gastech				
Area 6 Mill	0.0 - 0.45m	Light brown, damp, SAND and GRAVEL , coarse, some large cobbles	GR	Sa-1	Metals - Soils	20 uR/hr	0 ppm			Complete on Bedrock @ 0.45m. No evidence of environmental impact (staining or odour).

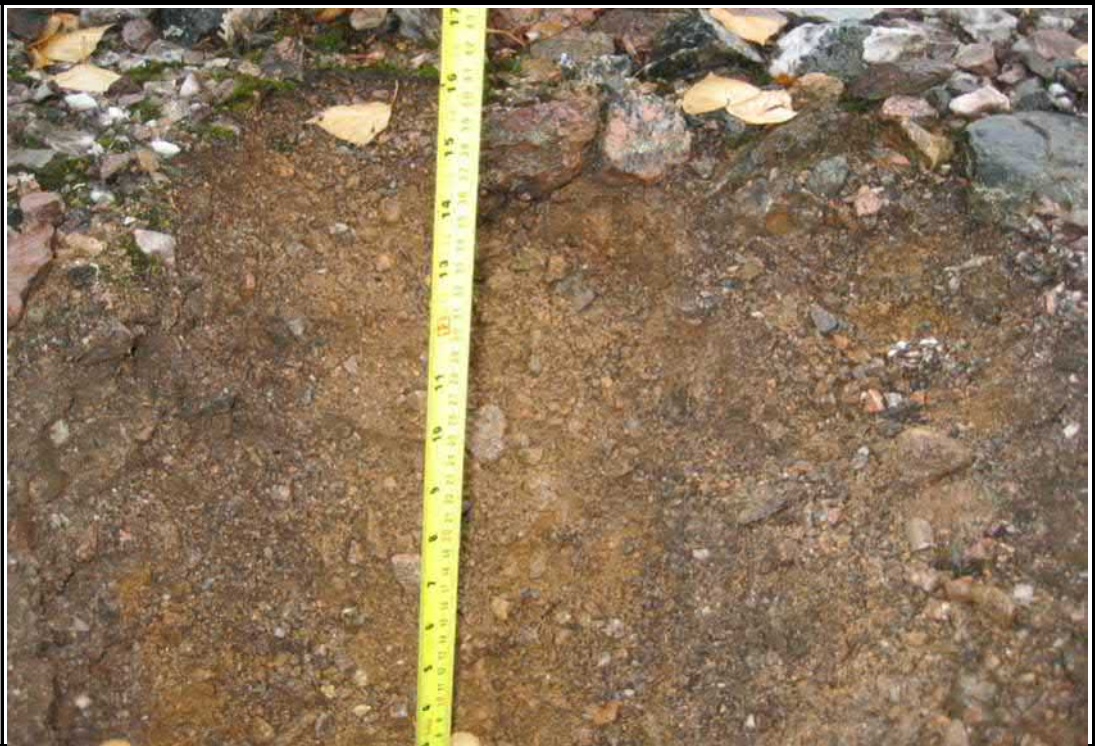
Type	Sample I.D.	Analysis & Depth of Sample (m)				
Area	Depth (m)	Description			Parameters	Gamma	Gastech		
Area 6 Mill	0.0 - 0.20m	Dark brown, moist to wet, SAND and GRAVEL , medium to coarse, trace roots	GR	Sa-1	Metals - Soils	7 uR/hr	0 ppm	Complete on Bedrock @ 0.20m. No evidence of environmental impact (staining or odour).	 
Date: 5-Oct-13 Logged by: CR Method: Hand Dig Location: Rayrock, NWT			Test Pit: SA13-64		SAMPLES			COMMENTS	PHOTO
			Type	Sample I.D.	Analysis & Depth of Sample (m)				
Area	Depth (m)	Description			Parameters	Gamma	Gastech		
Area 6 Mill	0.0 - 0.30m	Oxidized brown, damp to moist, SAND and GRAVEL , medium to coarse, trace roots	GR	Sa-1 & DUP # 11	Metals - Soils	26 uR/hr	0 ppm	Complete on Bedrock @ 0.30m. No evidence of environmental impact (staining or odour).

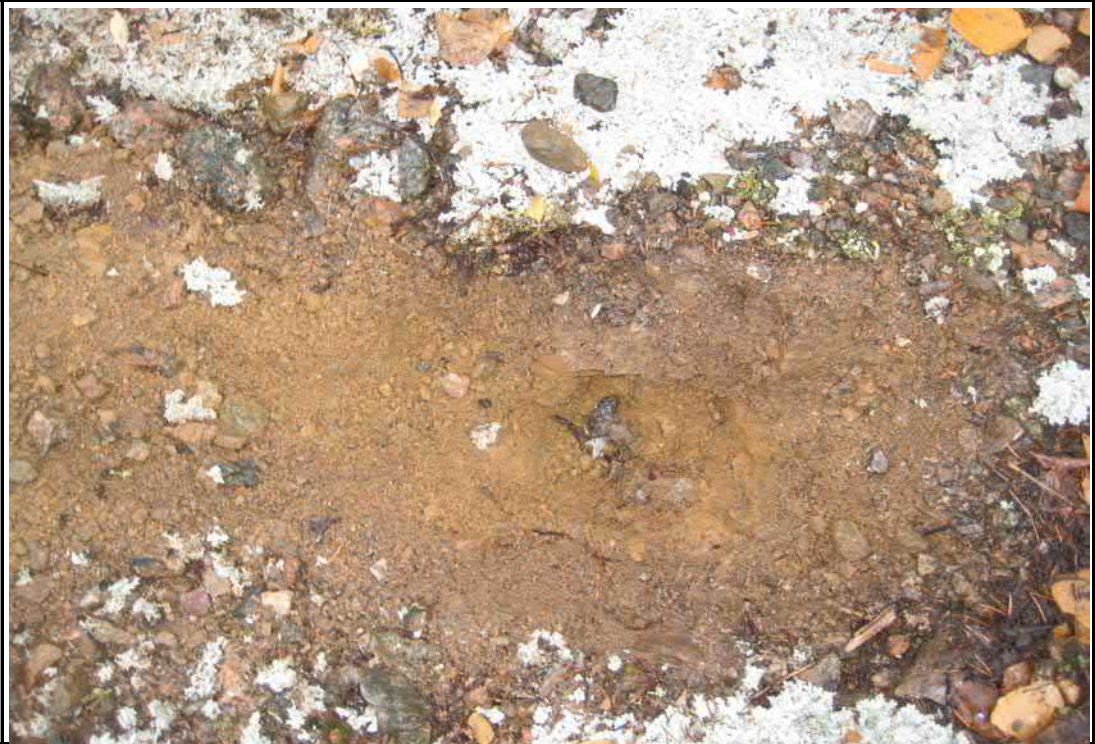
Date: 5-Oct-13 Logged by: CR Method: Hand Dig Location: Rayrock, NWT			Test Pit: SA13-65		SAMPLES			COMMENTS	PHOTO

Type	Sample I.D.	Analysis & Depth of Sample (m)				
Area	Depth (m)	Description			Parameters	Gamma	Gastech		
Area 6 Mill	0.0 - 0.30m	Oxidized brown, moist, SAND and GRAVEL , medium to coarse, trace roots	GR	Sa-1	Metals - Soils	20 uR/hr	0 ppm	Complete on Bedrock @ 0.30m. No evidence of environmental impact (staining or odour).

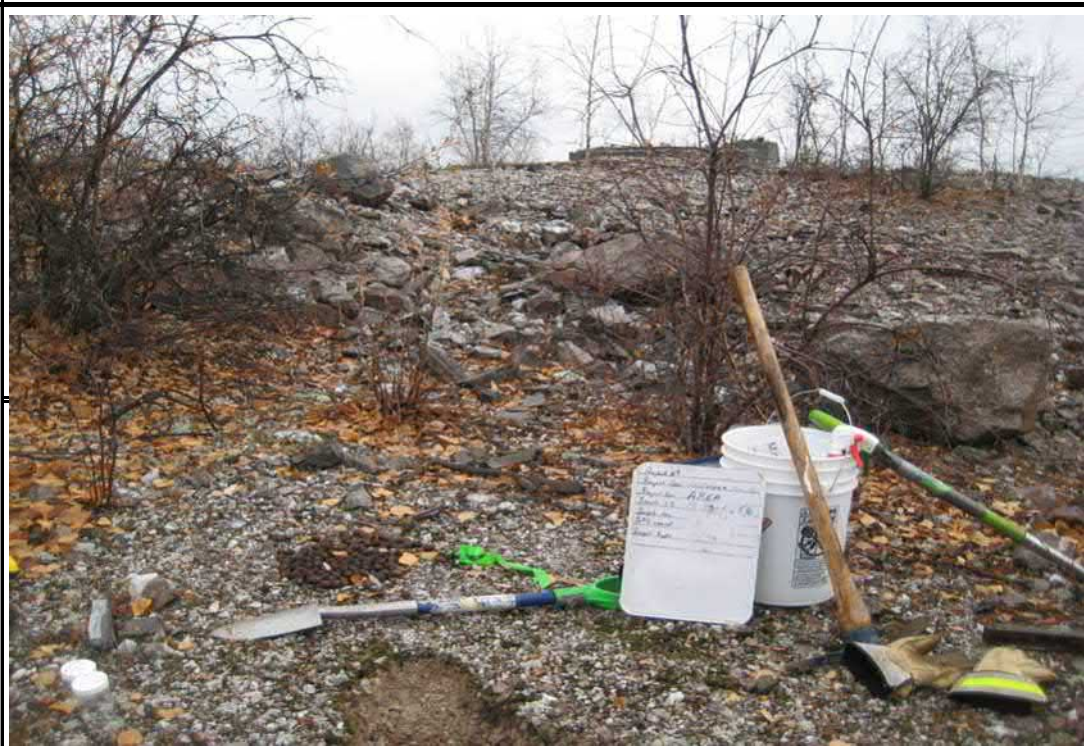
FORMER RAYROCK MINE SITE										
TEST PIT LOGS - METALS										
Date: 5-Oct-13 Logged by: CR Method: Hand Dig Location: Rayrock, NWT			Test Pit: SA13-66					SAMPLES	COMMENTS	PHOTO
			Type	Sample I.D.	Analysis & Depth of Sample (m)					
Area	Depth (m)	Description			Parameters	Gamma	Gastech			
Area 6 Mill	0.0 - 0.10m	Beige, damp, SAND and GRAVEL , coarse	GR	Sa-1	Metals - Soils	6 uR/hr	0 ppm	Complete on Bedrock @0.30m. No evidence of environmental impact (staining or odour).

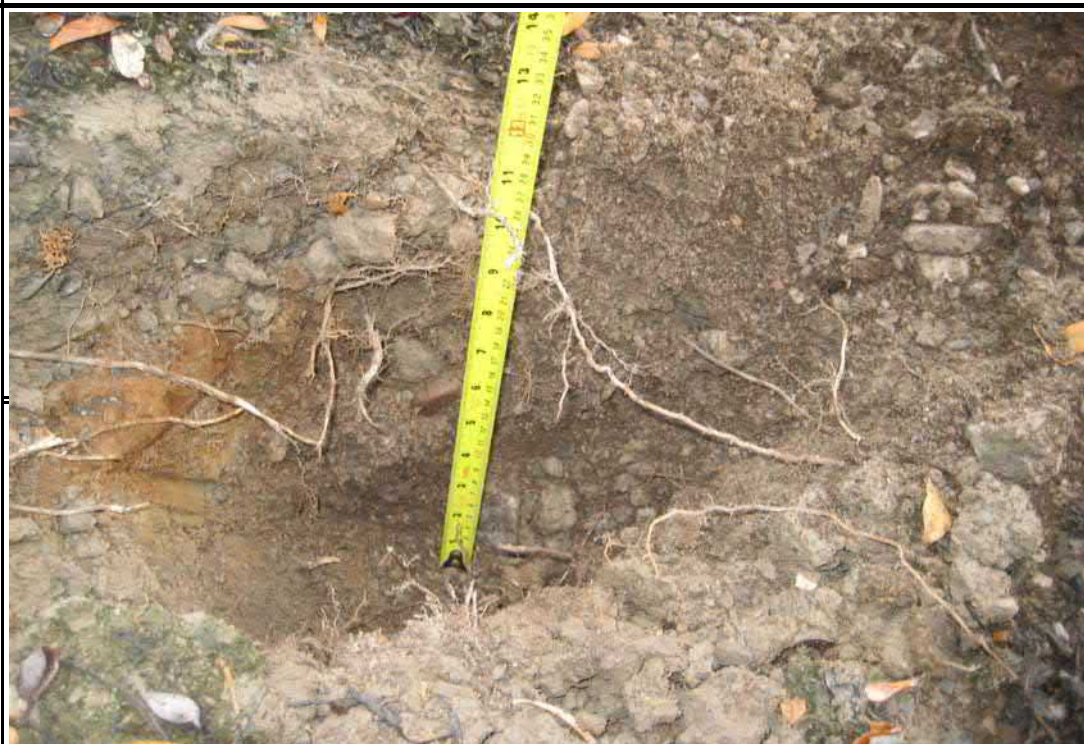
0.10 - 0.30m	Brown, moist, SAND , medium to coarse, trace gravel, cobbles and roots	SA	Sa-2	Metals - Soils	6 uR/hr	0 ppm			
Date: 5-Oct-13 Logged by: CR Method: Hand Dig Location: Rayrock, NWT			Test Pit: SA13-67					SAMPLES	COMMENTS	PHOTO
			Type	Sample I.D.	Analysis & Depth of Sample (m)					
Area	Depth (m)	Description			Parameters	Gamma	Gastech			
Area 1 Lodging (1)	0.0 - 0.10m	Brownish grey, damp, SILTY SAND , fine, trace clay, trace roots	ML-SA	Sa-1	Metals - Soils	6.5 uR/hr	0 ppm	Complete on Bedrock @ 0.30m. No evidence of environmental impact (staining or odour).

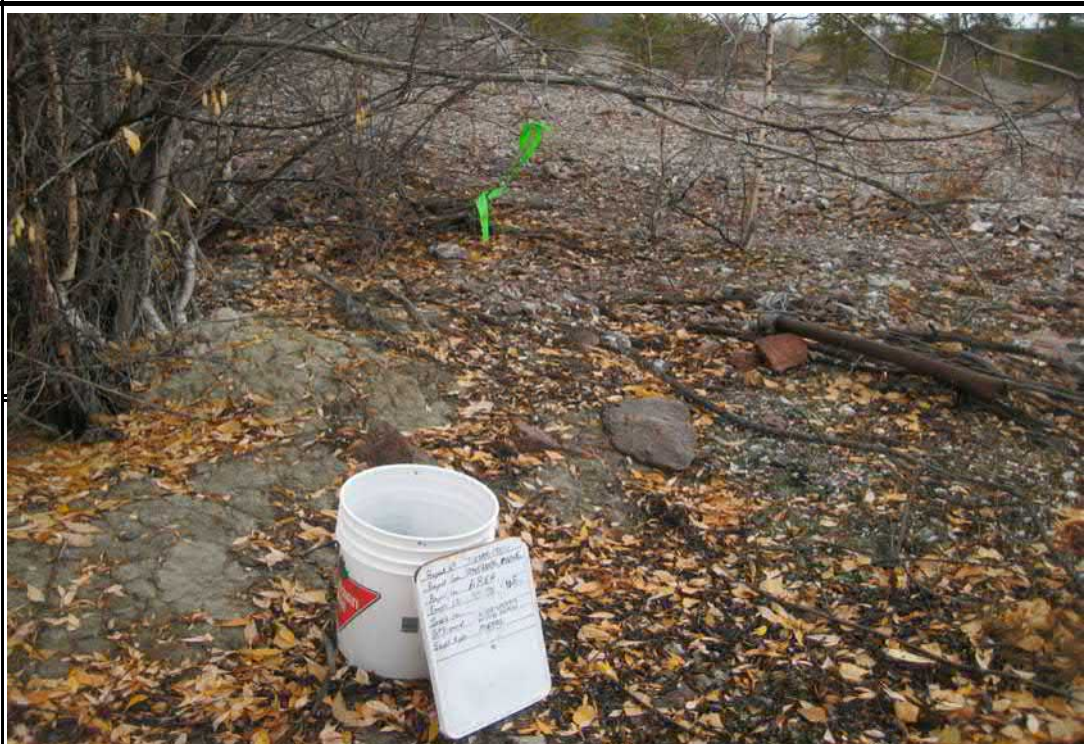
0.10 - 0.30m	Brown, damp, SAND , fine to medium, some cobbles, trace gravel.	SA	Sa-2	Metals - Soils	8 uR/hr	0 ppm			
Date: 5-Oct-13 Logged by: CR Method: Hand Dig Location: Rayrock, NWT			Test Pit: SA13-68					SAMPLES	COMMENTS	PHOTO
			Type	Sample I.D.	Analysis & Depth of Sample (m)					
Area	Depth (m)	Description			Parameters	Gamma	Gastech			
Area 1 Lodging (1)	0.0 - 0.10m	Brown to grey, damp, SILTY SAND , fine, trace clay and roots	ML-SA	Sa-1	Metals - Soils	5.5 uR/hr	0 ppm	Complete on Bedrock @ 0.30m. No evidence of environmental impact (staining or odour).

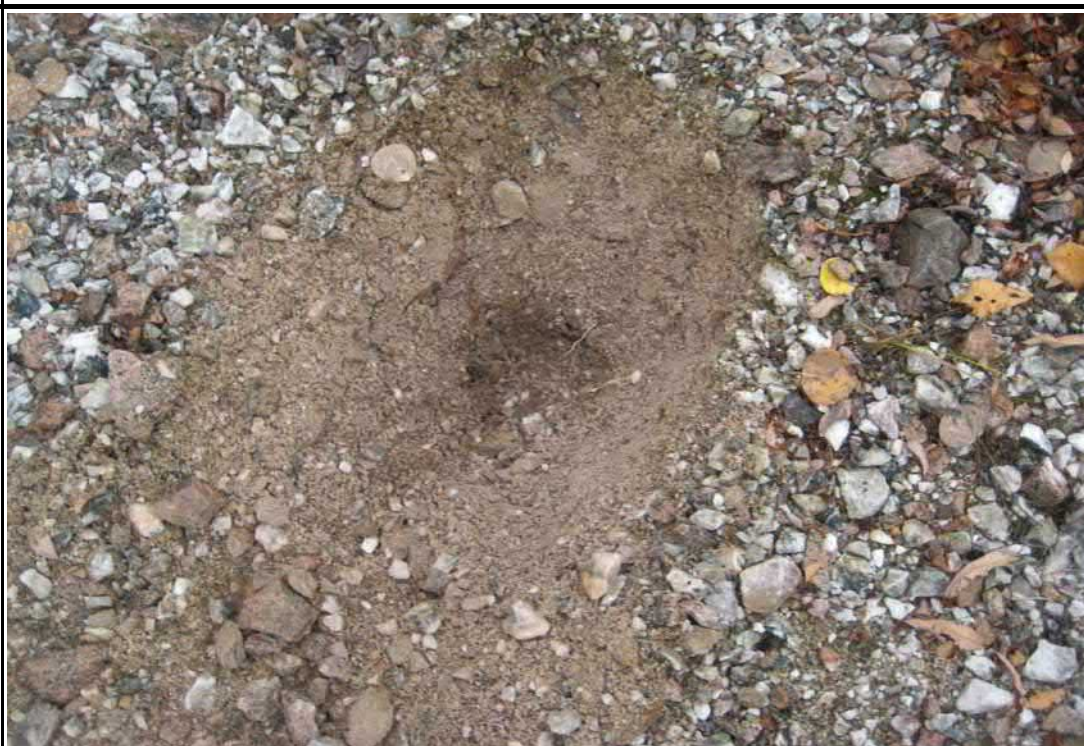
0.10 - 0.30m	Dark brown, moist, SILTY SAND , trace gravel and roots	ML-SA	Sa-2	Metals - Soils	6 uR/hr	0 ppm			
Date: 5-Oct-13 Logged by: CR Method: Hand Dig Location: Rayrock, NWT			Test Pit: SA13-69					SAMPLES	COMMENTS	PHOTO
			Type	Sample I.D.	Analysis & Depth of Sample (m)					
Area	Depth (m)	Description			Parameters	Gamma	Gastech			
Area 2 Tailings Line (1)	0.0 - 0.30m	Pinkish brown, moist, SAND and GRAVEL , coarse, some cobbles, trace roots	GR	Sa-1	Metals - Soils	9 uR/hr	0 ppm	Complete on Bedrock @ 0.30m. No evidence of environmental impact (staining or odour).
