# Inspection Report and Concept Repair Design

**SOLICITATION No.:**  
**PEQ754-161278/001/PWL:**  
**Burlington Canal Lift Bridge**  
**Engineering Services**

**PROJECT No.:**  
**R.081864.001**  
**Urgent Steel Deck Grating Repairs**

April, 2017

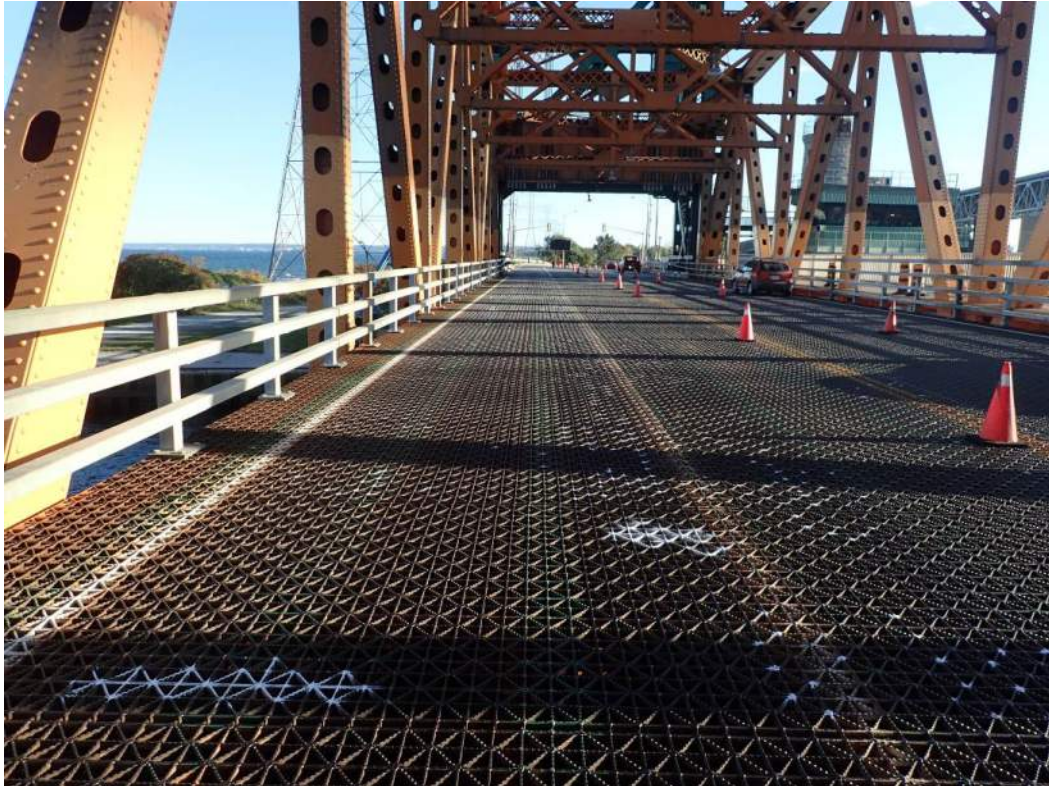
This visual inspection was made from the top side of the deck. The panels were checked for structural discontinuity, vibrations and sound response by means of a rubber mallet. MH validated the dimensions of the existing grating and components relevant to the deck repair. Deck deficiencies were marked with temporary spray paint. Each panel was then photographed including close of details of failure modes. (See photos 1 and 2 of **Appendix B – Inspection**

**Photo 1:** Typical BCLB Grating view with Traffic Control during inspection

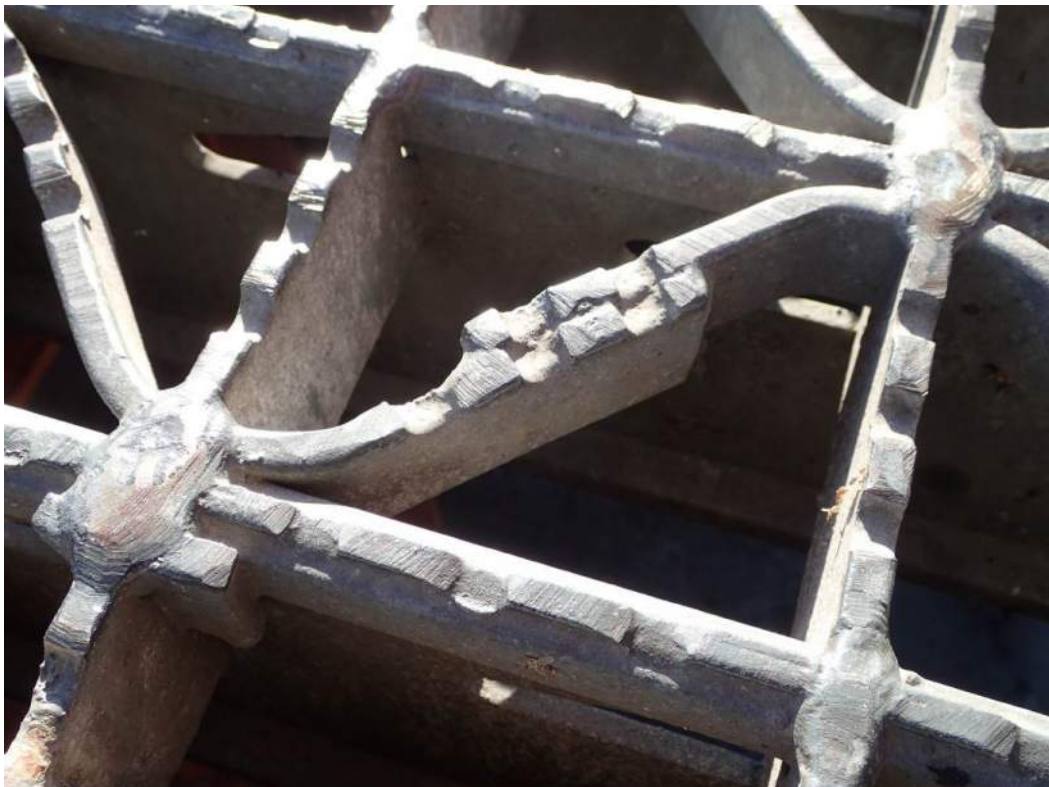
The Test Panel E1 was checked for any signs of performance deficiencies. All the structural members and connections of the panel were visually checked for, but not limited to, damages listed in point 5.1 of this Report. It was noted that the Test Panel was sturdier and less prone to vibrations than the other panels. There were no structural deficiencies noted for the Test Panel E1. (See photos 3 to 6 of **Appendix B**)

**Photo 4:** Test Panel detail

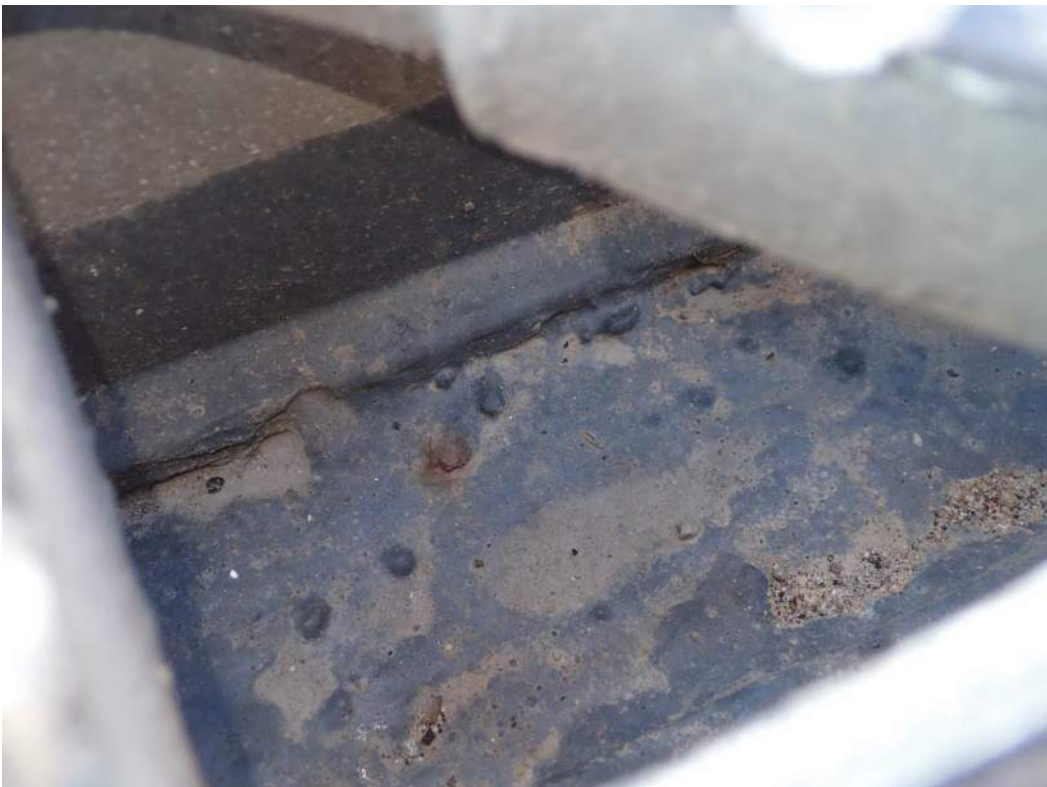
**Photo 6:** Test Panel – Typical M-beam to stringer connection

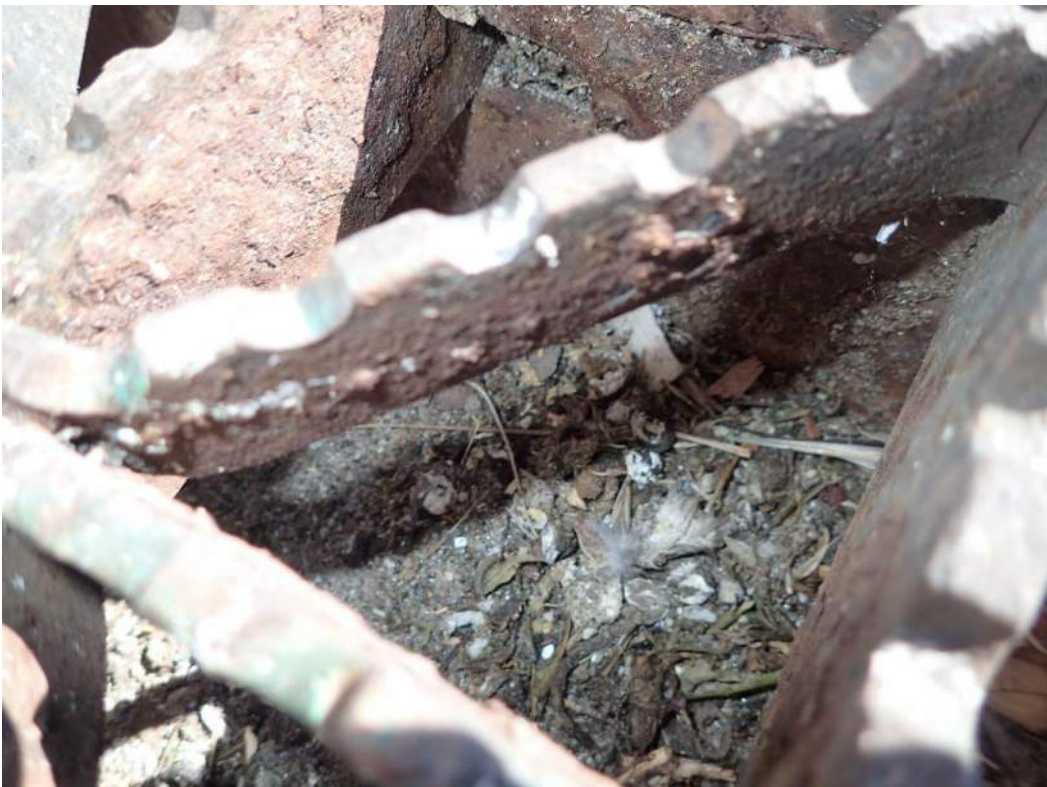
**Photo 26:** Debris – typical - mostly at end panels (A, C, D, F)
