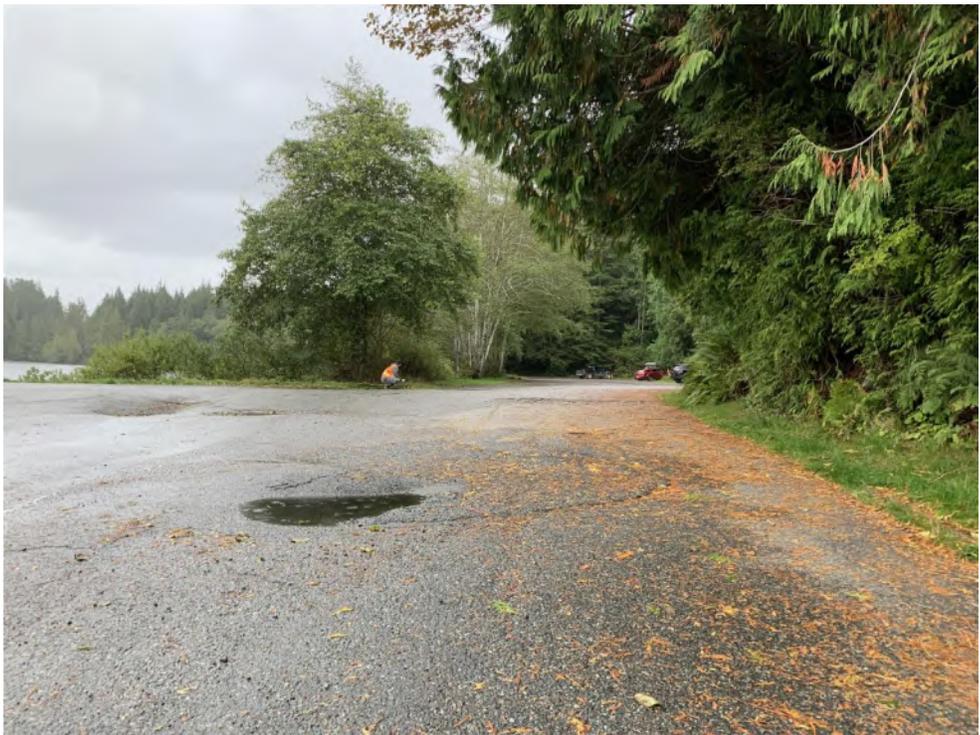
Photo Location: Grice Bay Parking Lot			
Direction: South			
Survey Date: 9/28/2021			
Comments: Parking Log			
Photograph ID: 4

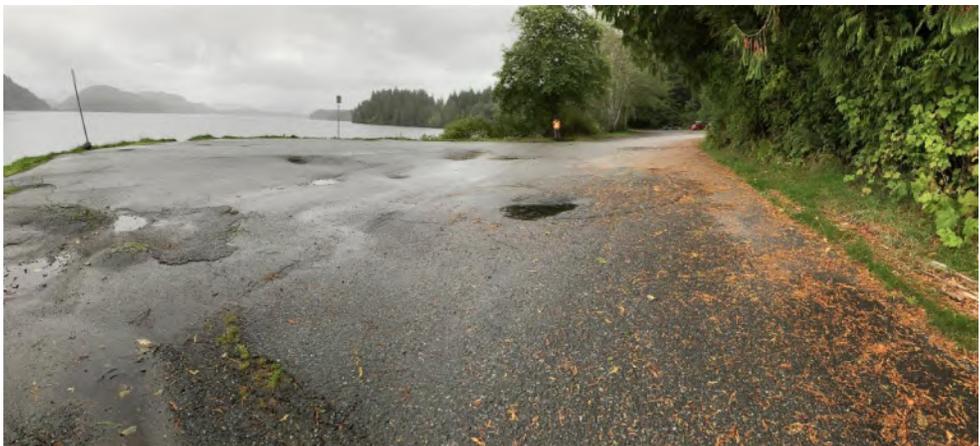
Photo Location: Grice Bay Parking Lot			
Direction: South			
Survey Date: 9/28/2021			
Comments: Parking Lot

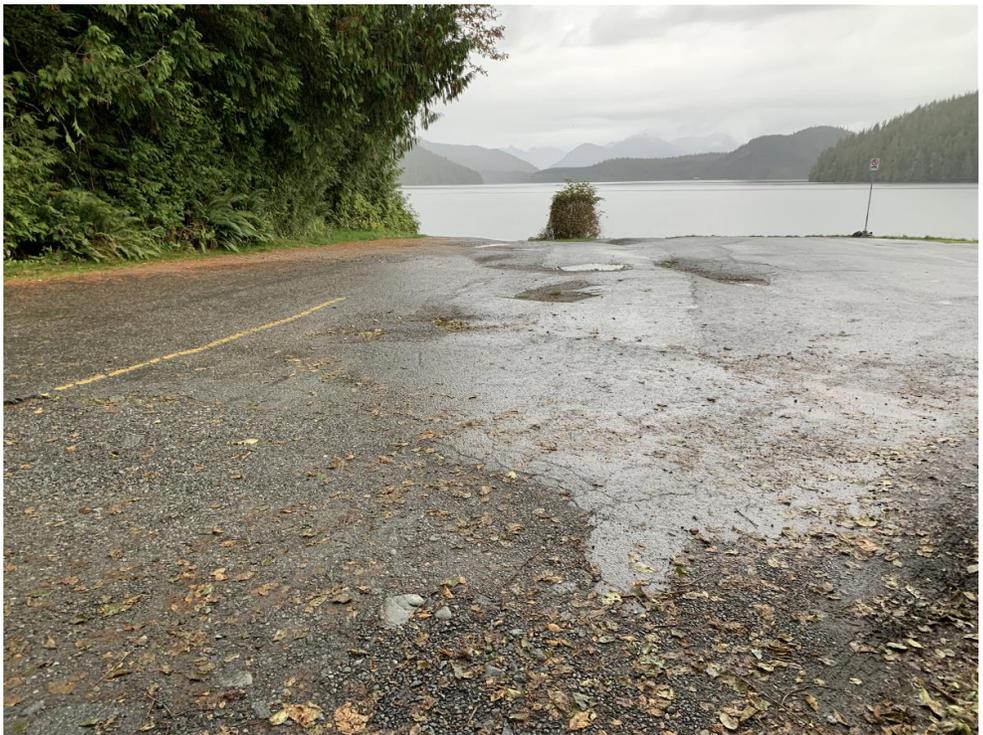
Photo Location: Grice Bay Parking Lot			
Direction: North			
Survey Date: 9/28/2021			
Comments: Boat Launch Turn-Around			
Photograph ID: 8

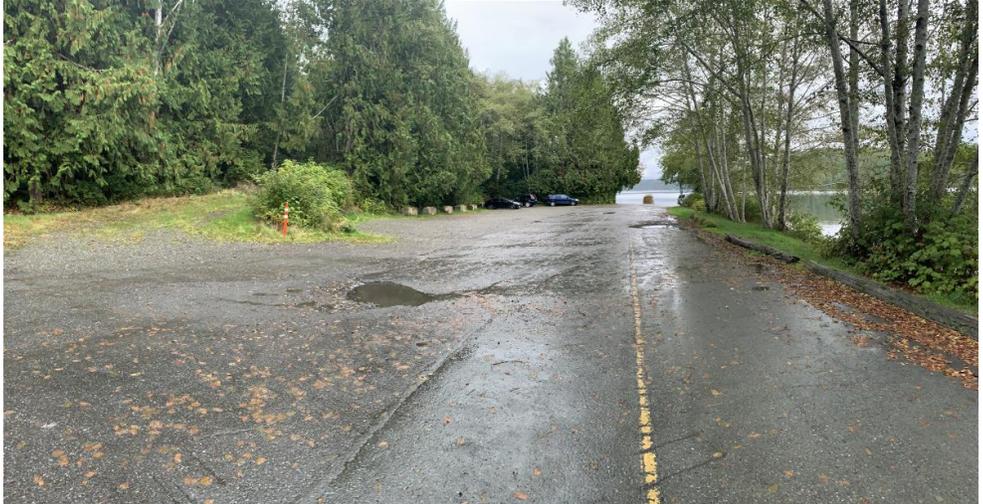
Photo Location: Grice Bay Parking Lot			
Direction: North			
Survey Date: 9/28/2021			
Comments: Road to boat launch/parking lot.

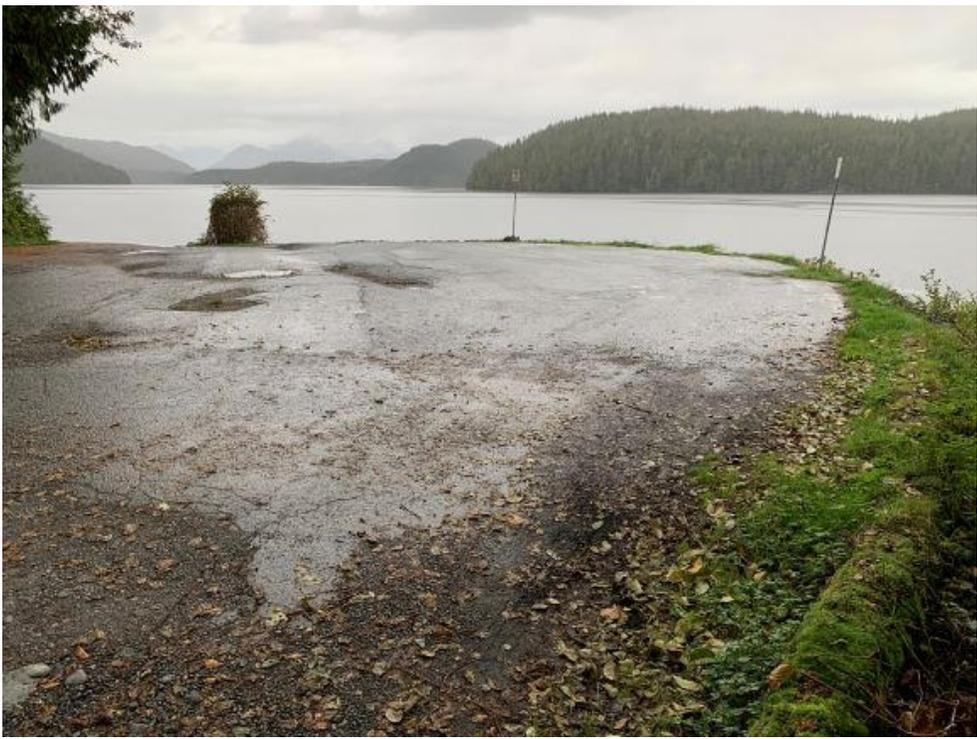
Photo Location: Grice Bay Parking Lot			
Direction: North			
Survey Date: 9/28/2021			
Comments: Boat Launch Turn-Around			
Photograph ID: 10

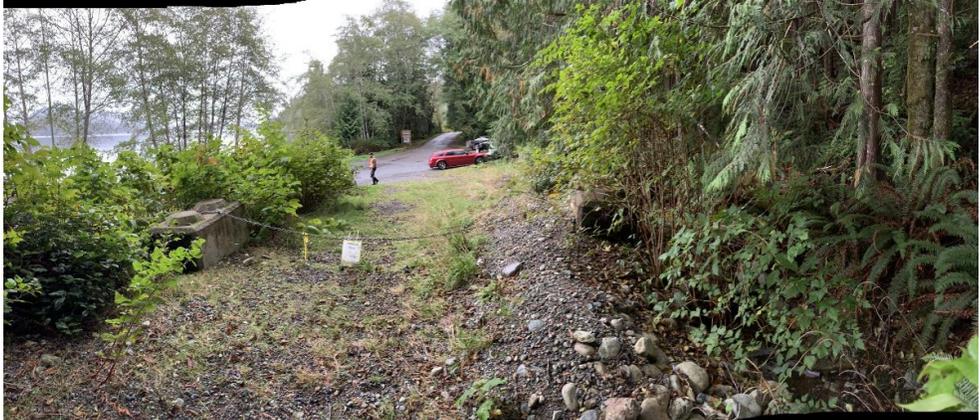
Photo Location: Grice Bay Parking Lot			
Direction: South			
Survey Date: 9/28/2021			
Comments: Start of McLean Point Access Road

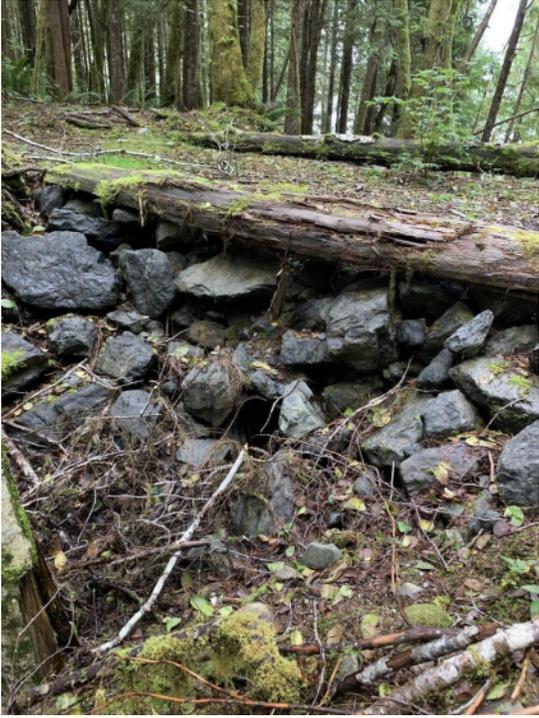
Photo Location: McLean Point Access Road			
Direction: South			
Survey Date: 9/28/2021			
Comments: Example of creek crossing and culvert structure.			
Photograph ID: 26

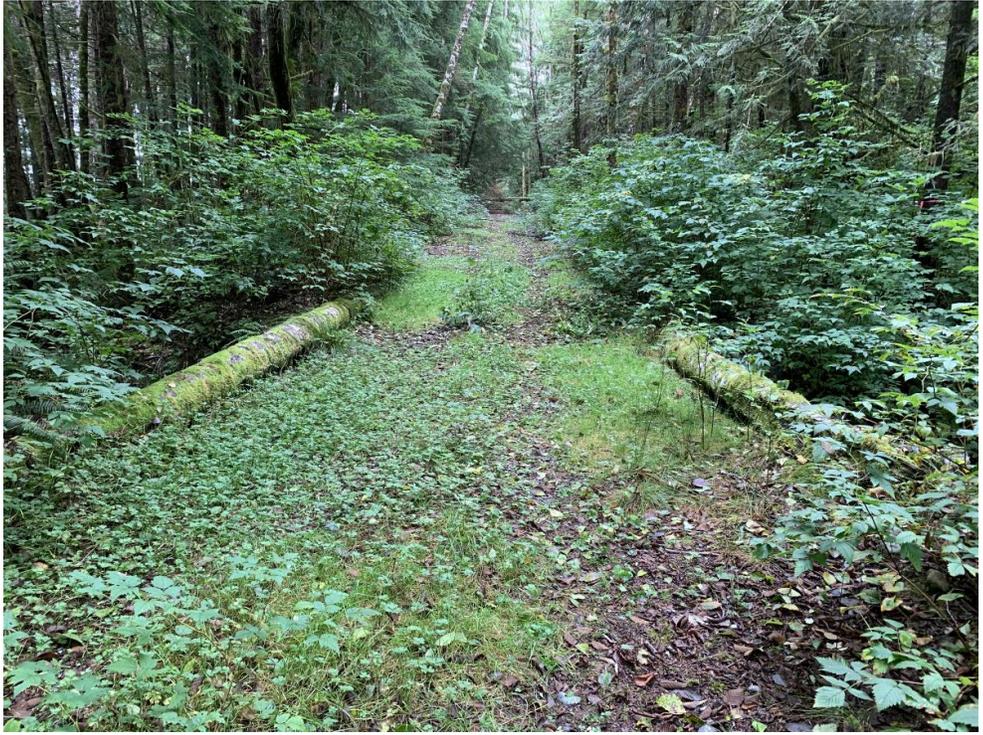
Photo Location: McLean Point Access Road			
Direction: Towards McLean Point			
Survey Date: 9/28/2021			
Comments: Access Road			
Photograph ID: 28

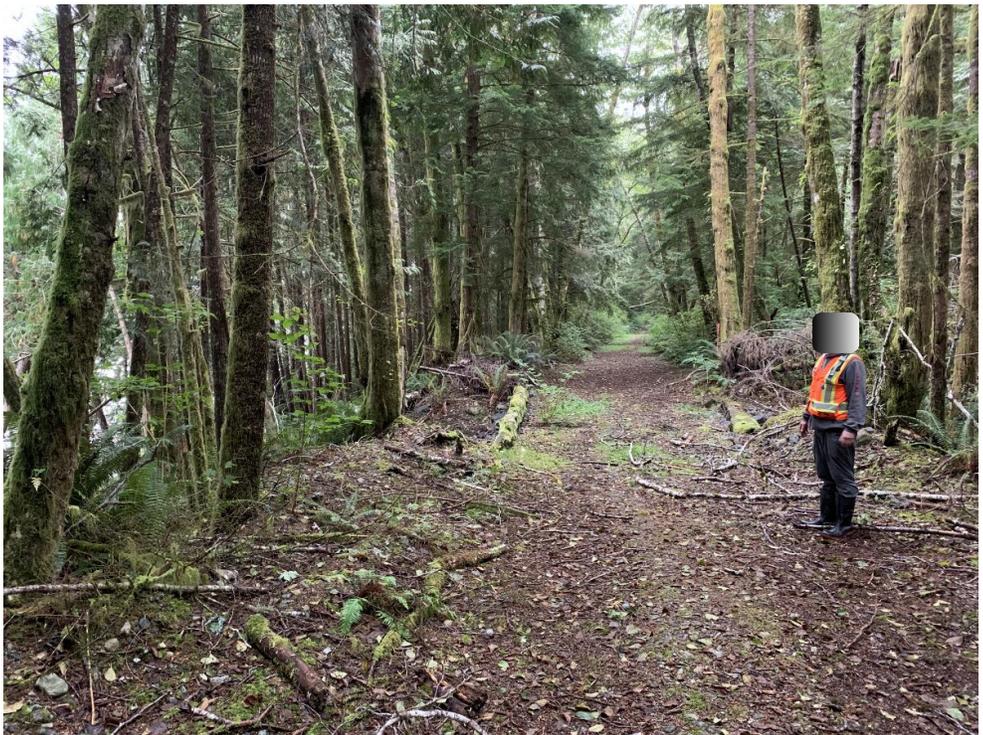
Photo Location: McLean Point Access Road			
Direction: Towards McLean Point			
Survey Date: 9/28/2021			
Comments: Access Road			
Photograph ID: 30

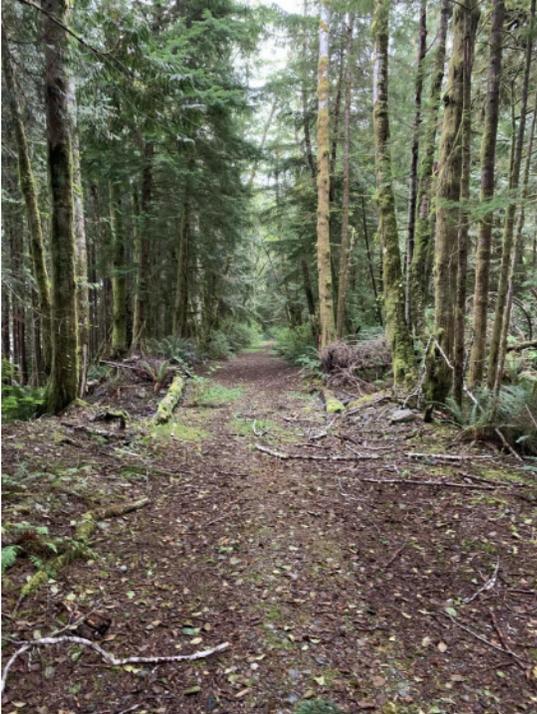
Photo Location: McLean Point Access Road			
Direction: Towards McLean Point			
Survey Date: 9/28/2021			
Comments: Access Road

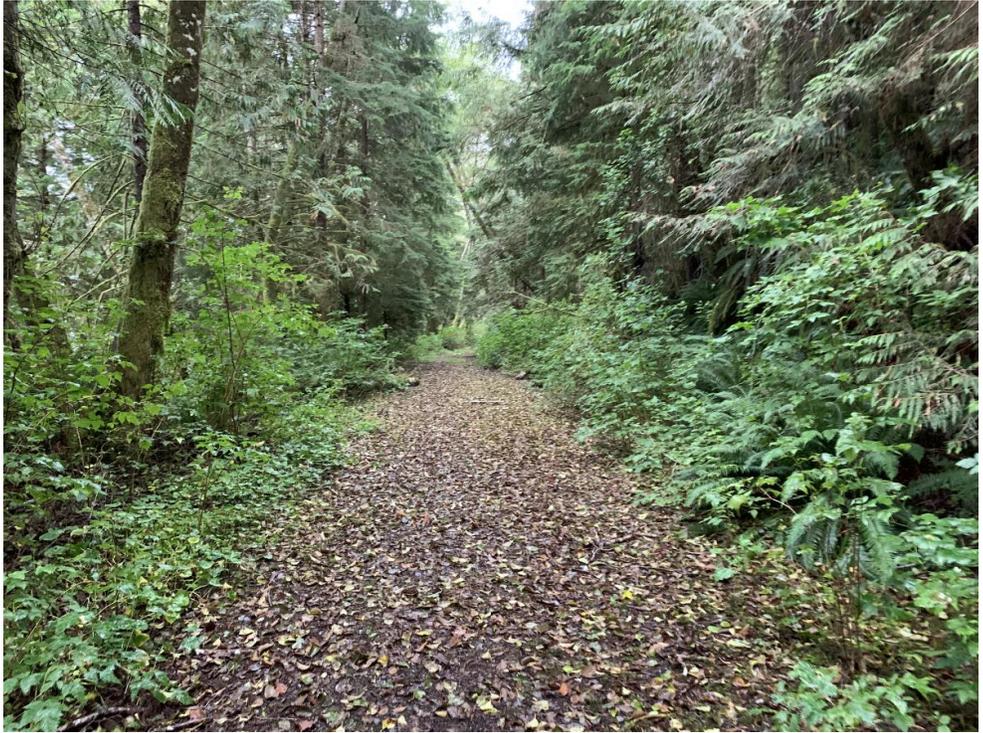
Photo Location: McLean Point Access Road			
Direction: Towards McLean Point			
Survey Date: 9/28/2021			
Comments: Access Road			
Photograph ID: 32

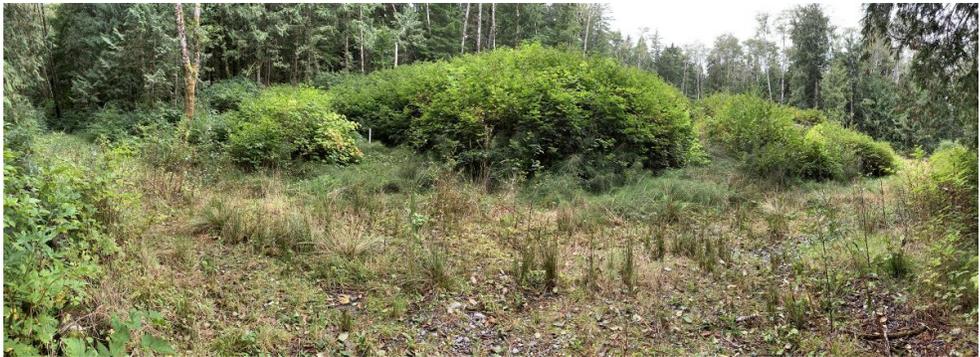
Photo Location: McLean Point			
Direction:			
Survey Date: 9/28/2021			
Comments: McLean Point. Bushes and successive growth in clearing between mature trees to be removed by others prior to contract.

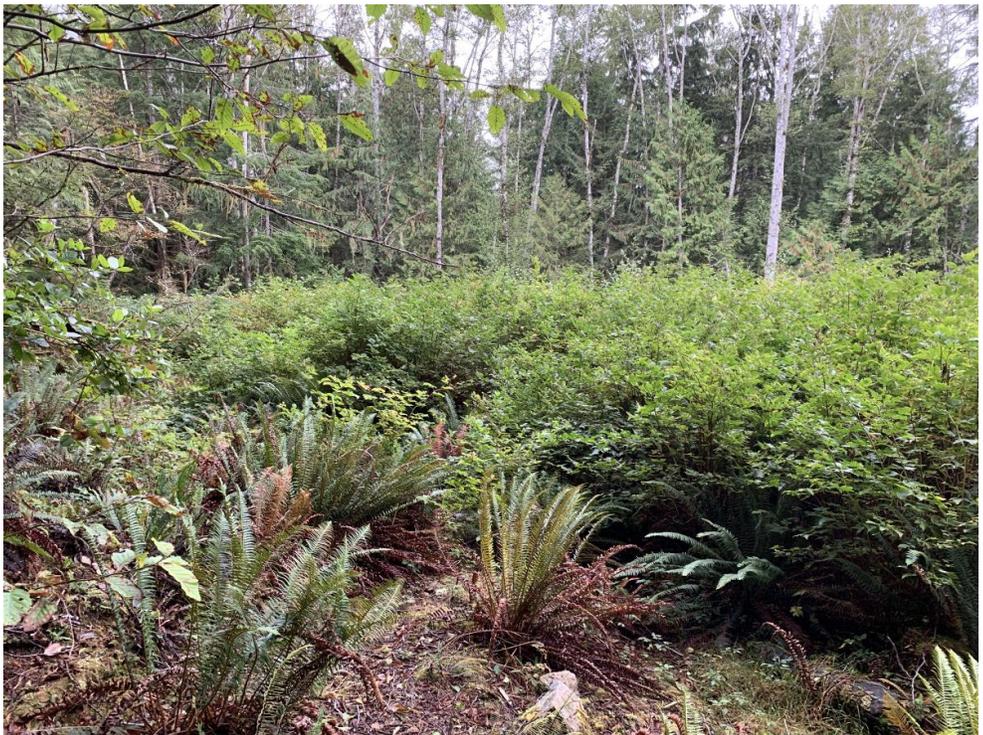
Photo Location: McLean Point			
Direction:			
Survey Date: 9/28/2021			
Comments: McLean Point. Bushes and successive growth in clearing between mature trees to be removed by others prior to contract.			
Photograph ID: 36

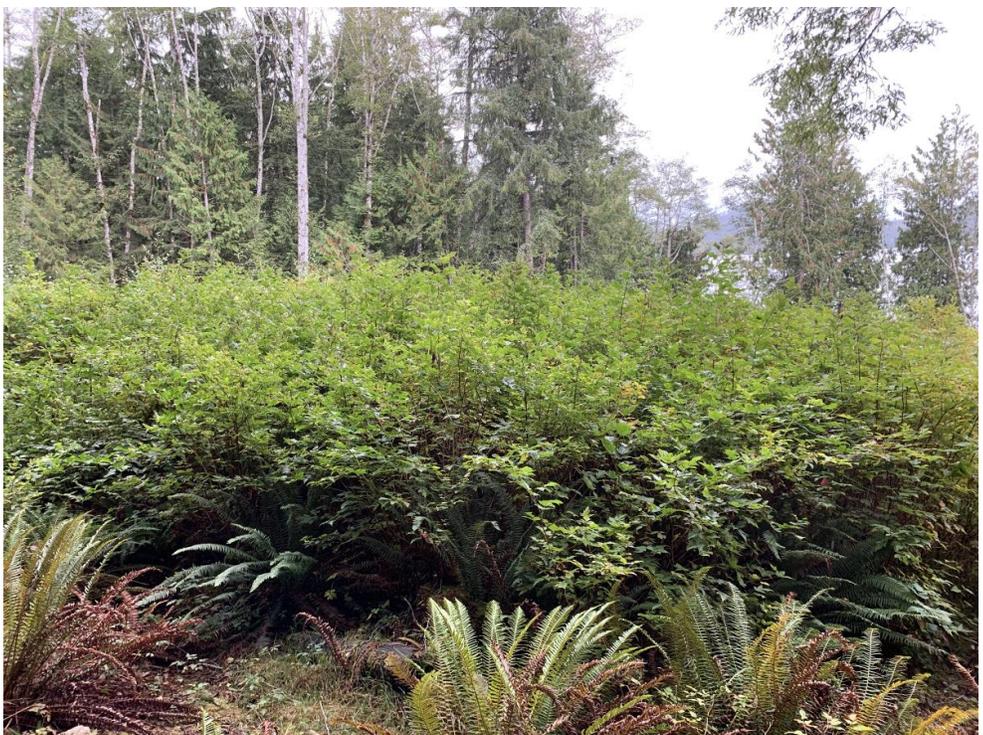
Photo Location: McLean Point			
Direction:			
Survey Date: 9/28/2021			
Comments: McLean Point. Bushes and successive growth in clearing between mature trees to be removed by others prior to contract.

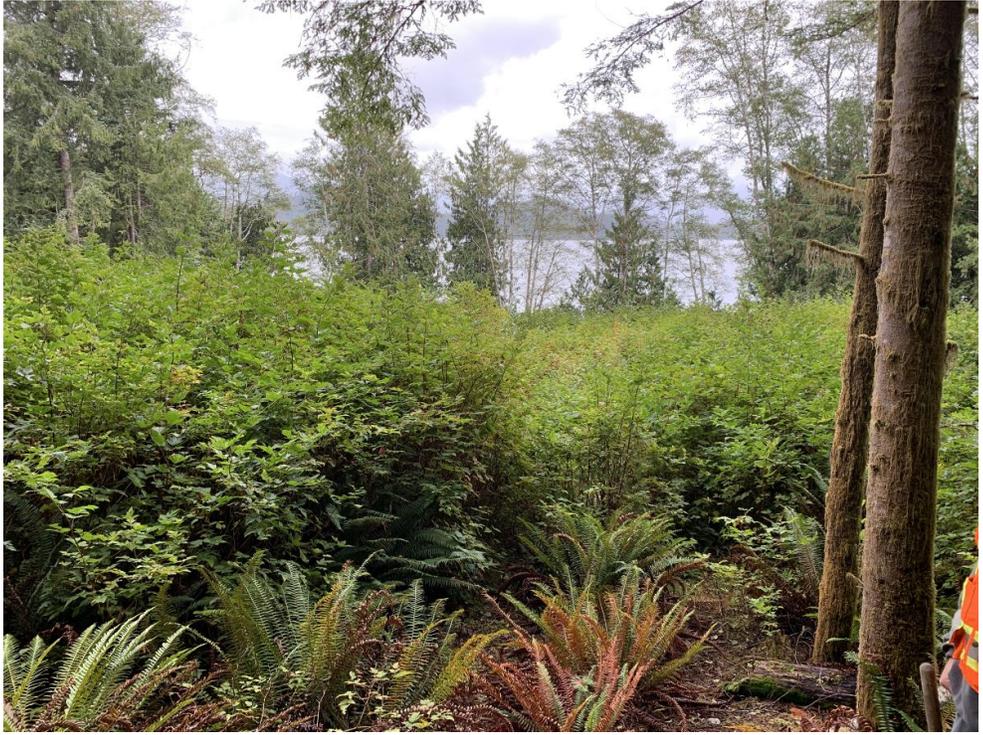
Photo Location: McLean Point			
Direction:			
Survey Date: 9/28/2021			
Comments: McLeanPoint. Bushes and successive growth in clearing between mature trees to be removed by others prior to contract.			
Photograph ID: 38

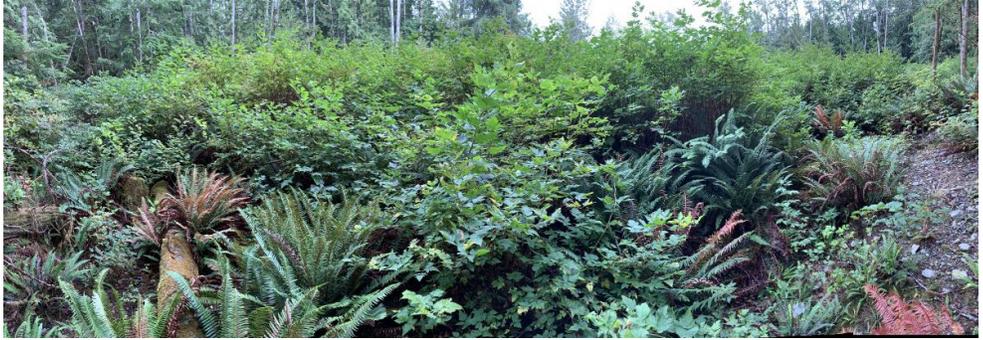
Photo Location: McLean Point			
Direction:			
Survey Date: 9/28/2021			
Comments: McLeanPoint. Bushes and successive growth in clearing between mature trees to be removed by others prior to contract.

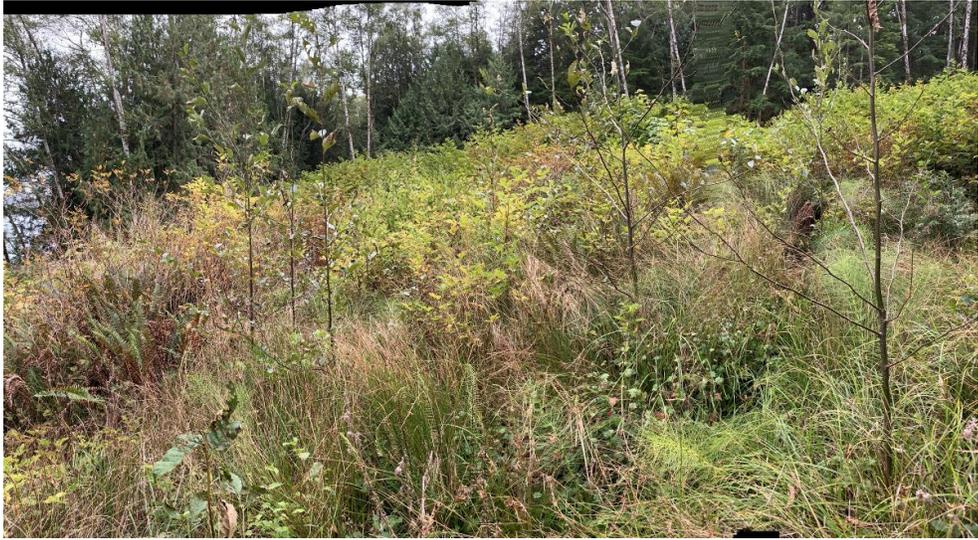
Photo Location: McLean Point			
Direction:			
Survey Date: 9/28/2021			
Comments: McLean Point. Bushes and successive growth in clearing between mature trees to be removed by others prior to contract.			
Photograph ID: 40

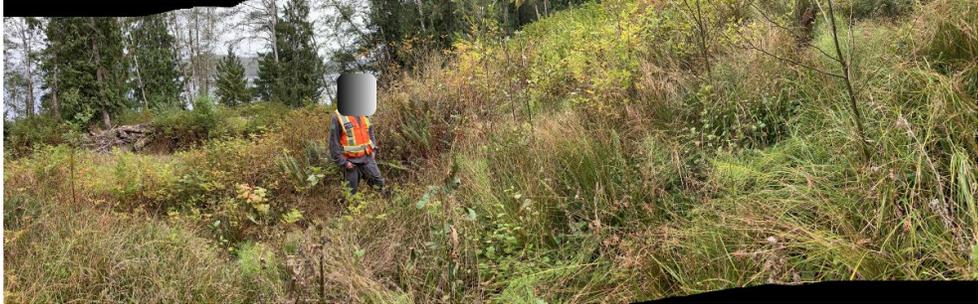
Photo Location: McLean Point			
Direction:			
Survey Date: 9/28/2021			
Comments: McLean Point. Bushes and successive growth in clearing between mature trees to be removed by others prior to contract.

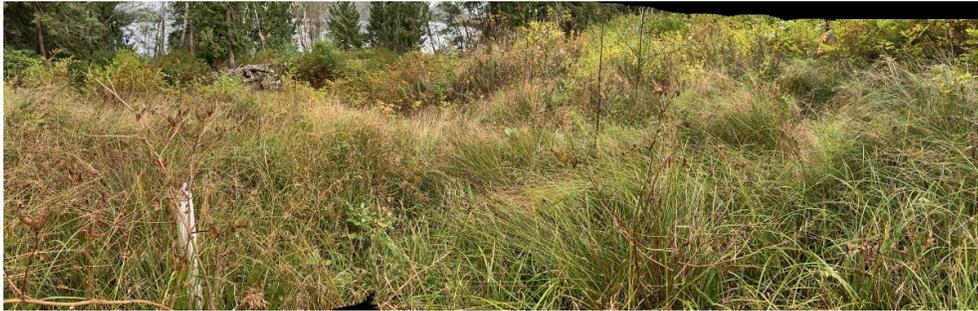
Photo Location: McLean Point			
Direction:			
Survey Date: 9/28/2021			
Comments: McLean Point. Bushes and successive growth in clearing between mature trees to be removed by others prior to contract.			
Photograph ID: 42

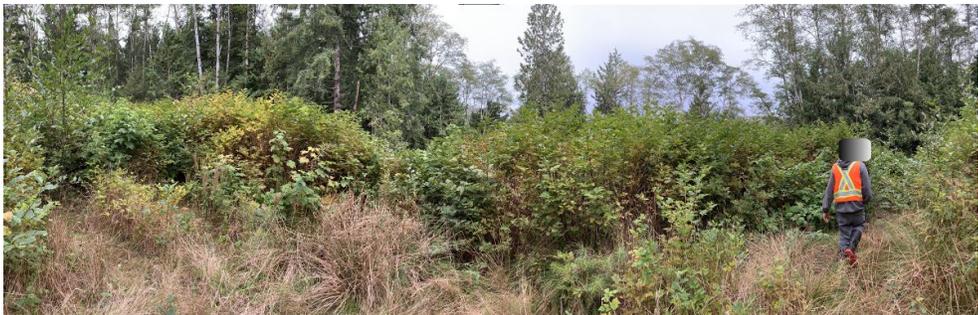
Photo Location: McLean Point			
Direction:			
Survey Date: 9/28/2021			
Comments: McLean Point. Bushes and successive growth in clearing between mature trees to be removed by others prior to contract.

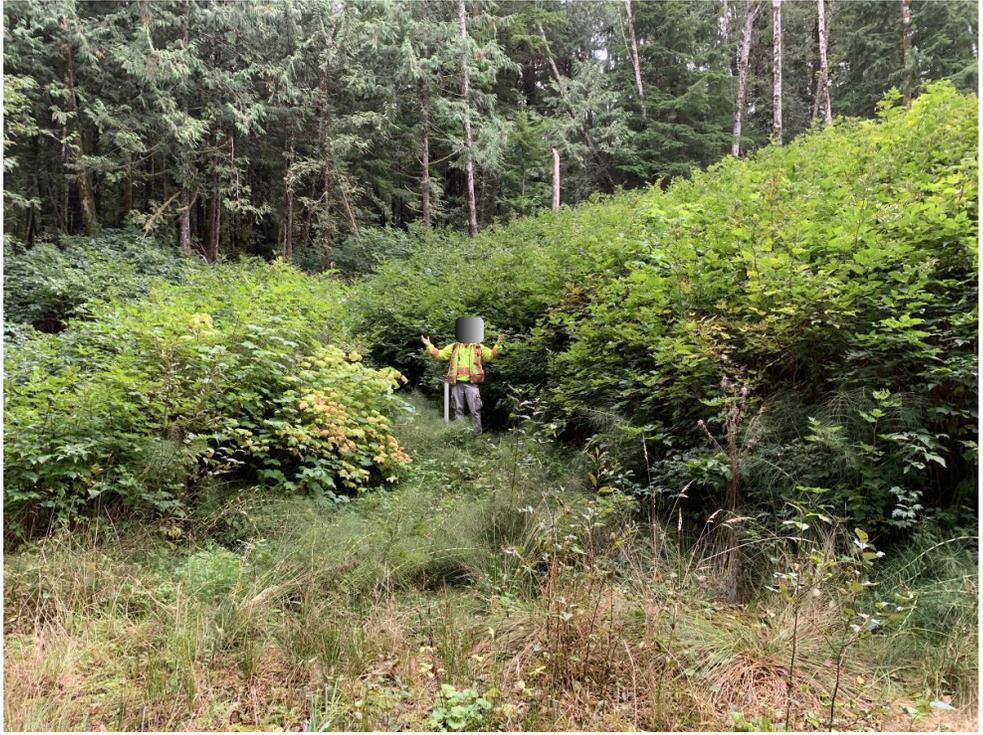
Photo Location: McLean Point			
Direction:			
Survey Date: 9/28/2021			
Comments: Monitoring Well			
Photograph ID: 44

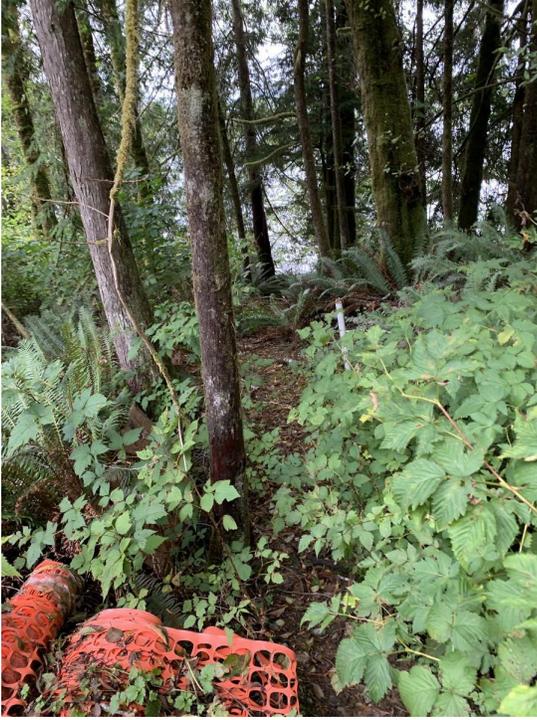
Photo Location: McLean Point			
Direction:			
Survey Date: 9/28/2021			
Comments: Monitoring Well

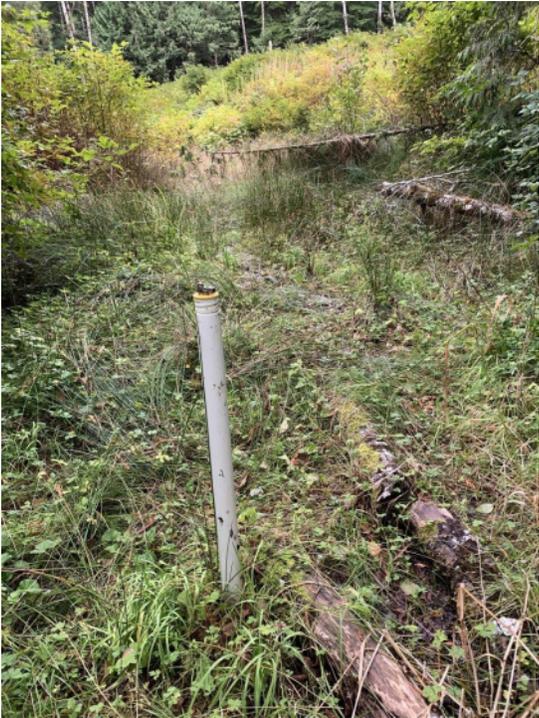
Photo Location: McLean Point			
Direction:			
Survey Date: 9/28/2021			
Comments: Monitoring Well

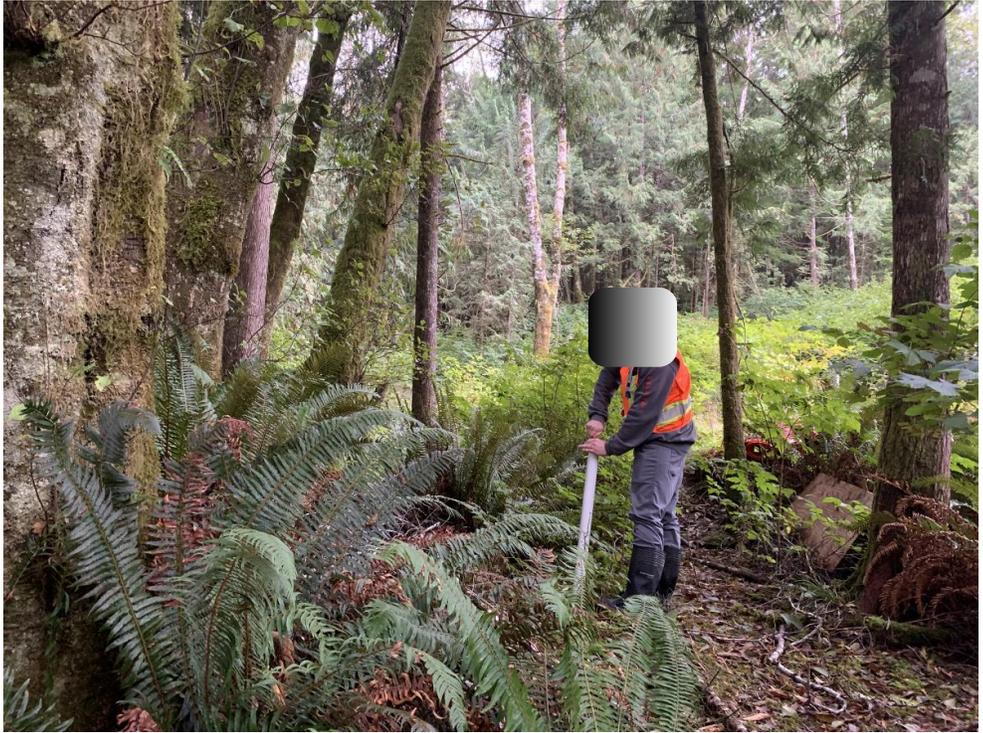
Photo Location: McLean Point			
Direction:			
Survey Date: 9/28/2021			
Comments: Monitoring Well			
Photograph ID: 48

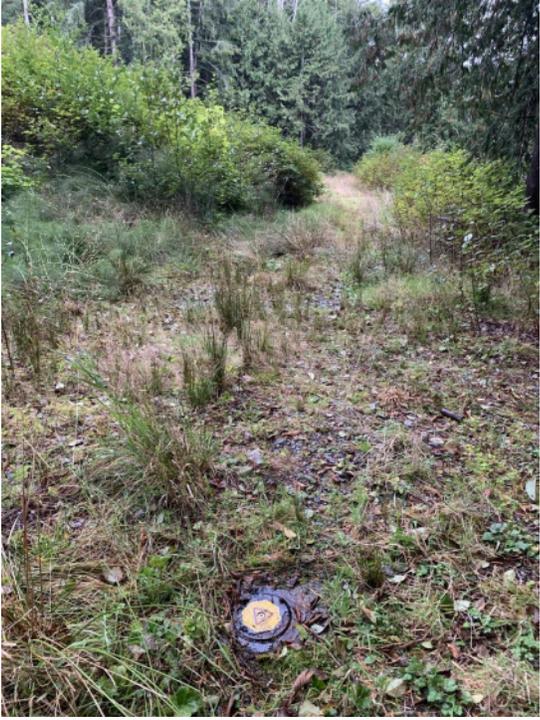
Photo Location: McLean Point			
Direction:			
Survey Date: 9/28/2021			
Comments: Flush mount monitoring well

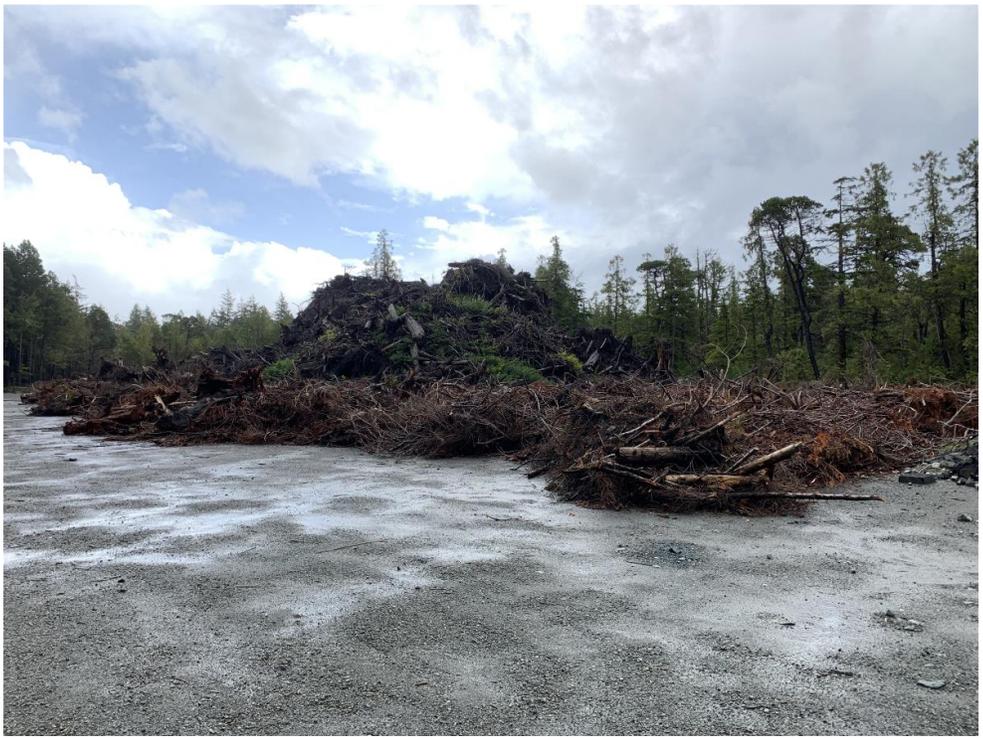
Photo Location: Radar Hill			
Direction:			
Survey Date: 9/30/2021			
Comments: Woody Debris for use at McLean Point (does not include low piled material in forefront)			
Photograph ID: 50

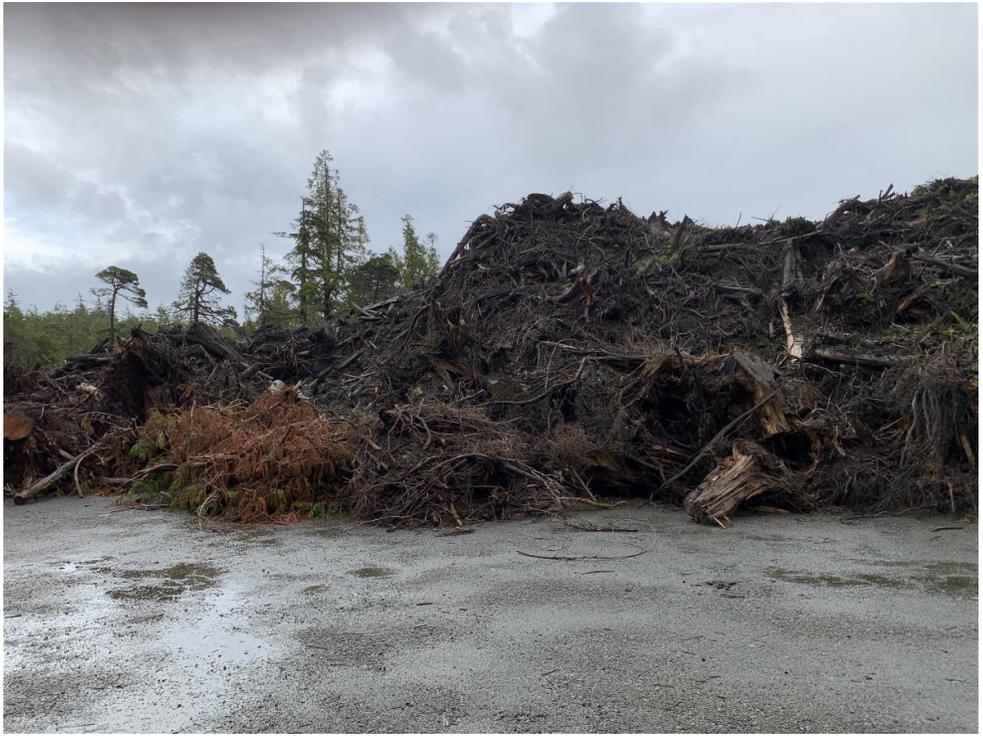
Photo Location: Radar Hill			
Direction:			
Survey Date: 9/30/2021			
Comments: Woody Debris for use at McLean Point (does not include low piled material in forefront)

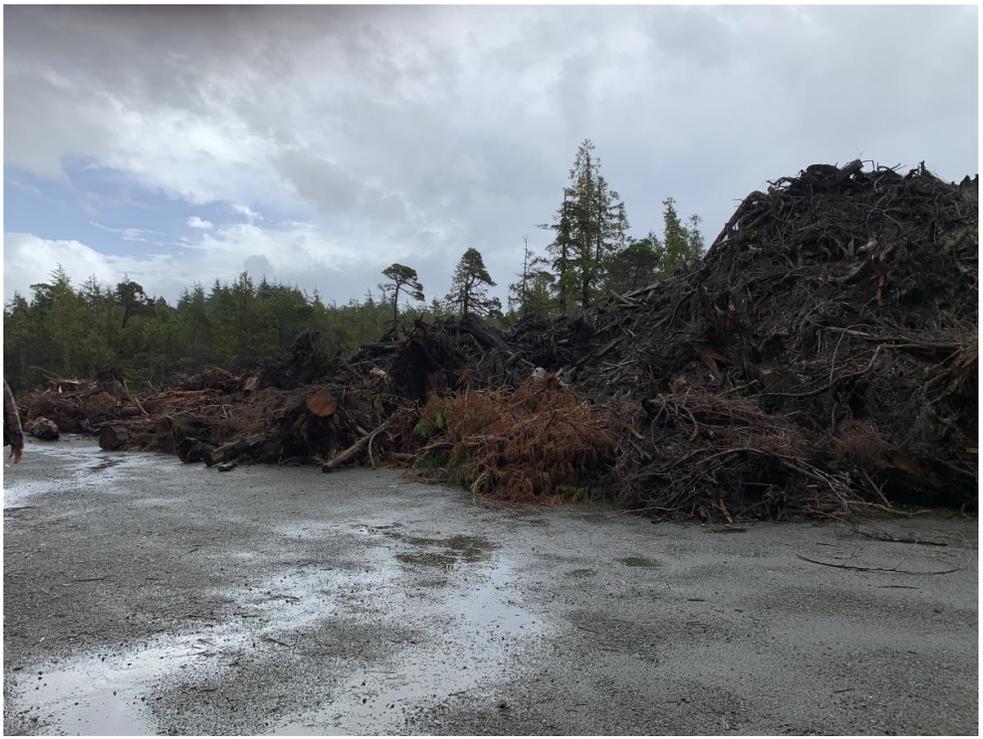
Photo Location: Radar Hill			
Direction:			
Survey Date: 9/30/2021			
Comments: Woody Debris for use at McLean Point (does not include low piled material in forefront)			
Photograph ID: 52

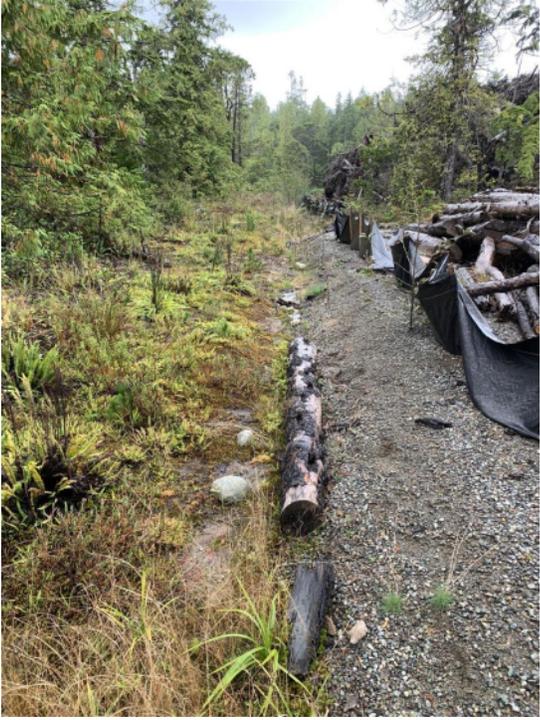
Photo Location: Radar Hill			
Direction:			
Survey Date: 9/30/2021			
Comments: ESC measures at Radar Hill

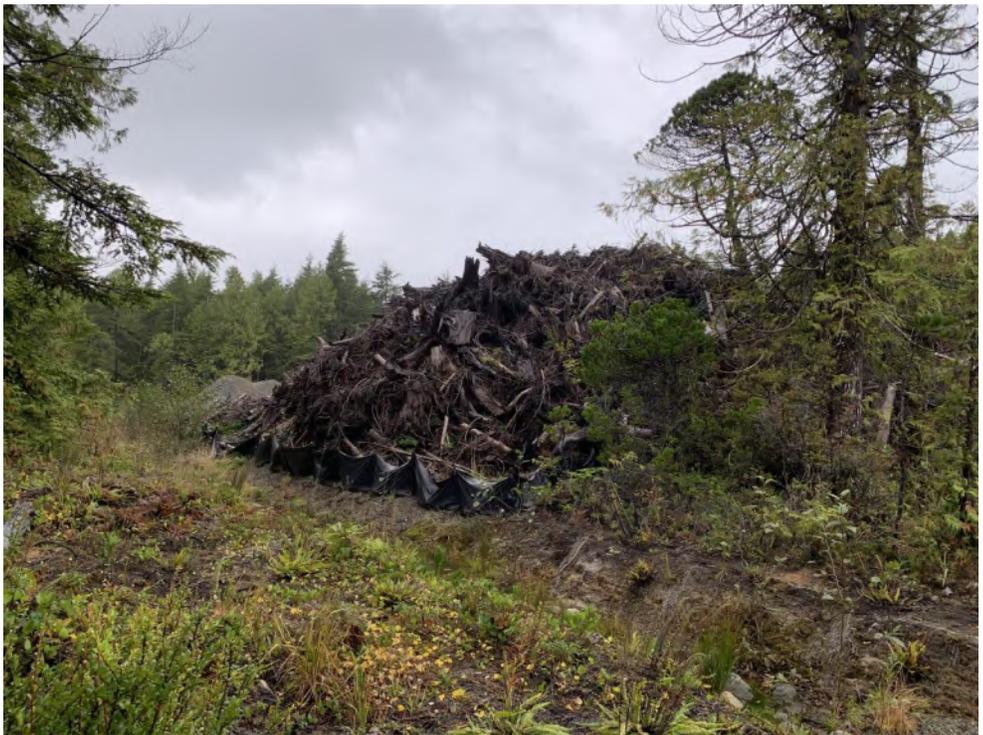
Photo Location: Radar Hill			
Direction:			
Survey Date: 9/30/2021			
Comments: Woody Debris pile			
Photograph ID: 56

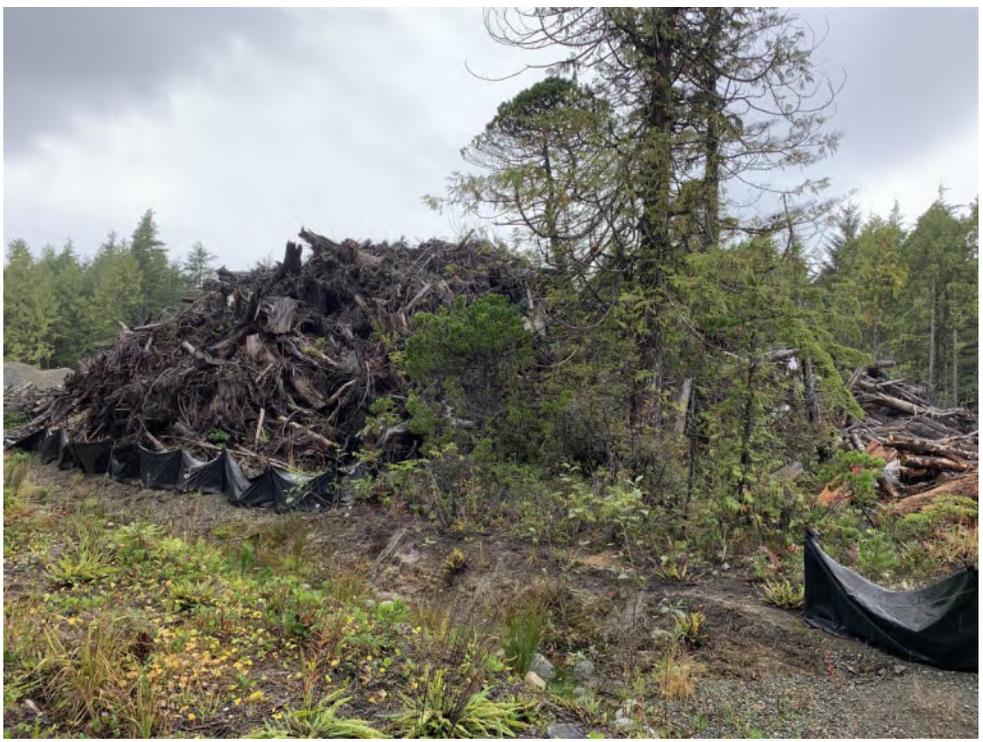
Photo Location: Radar Hill			
Direction:			
Survey Date: 9/30/2021			
Comments: Woody Debris pile

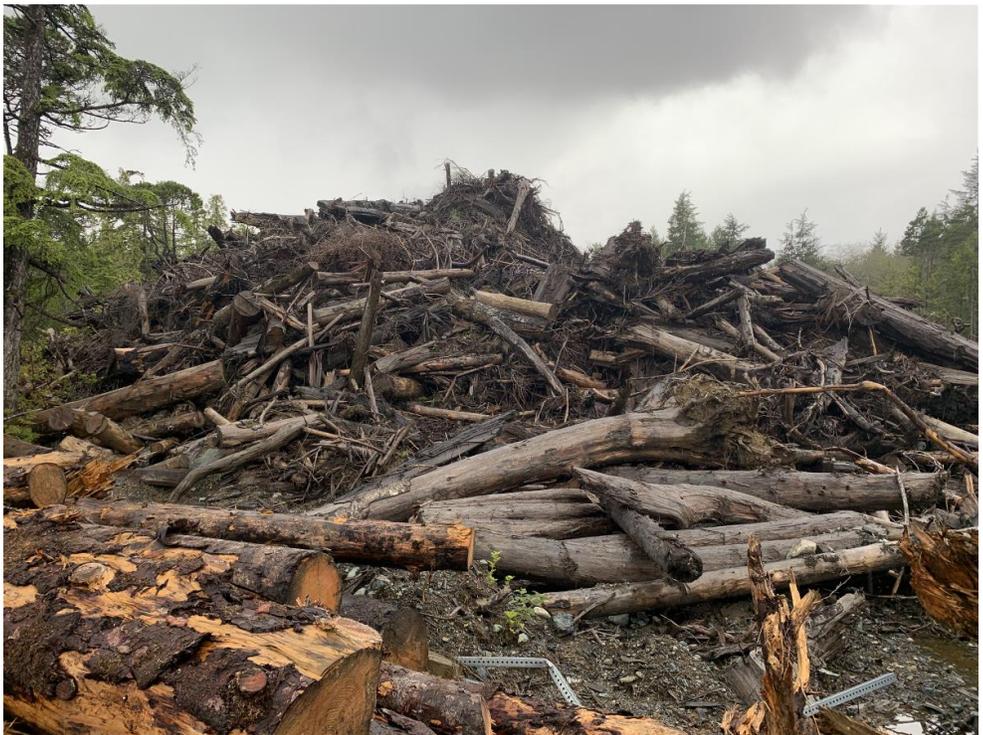
Photo Location: Radar Hill			
Direction:			
Survey Date: 9/30/2021			
Comments: Woody Debris for use at McLean Point (does not include low piled material in front)			
Photograph ID: 58

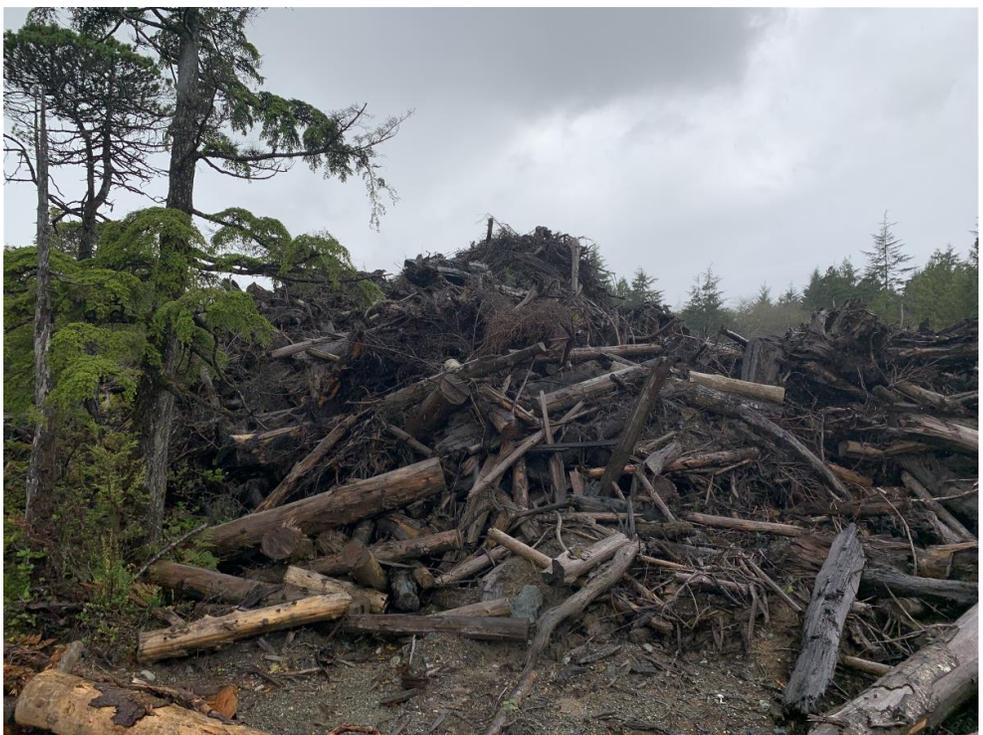
Photo Location: Radar Hill			
Direction:			
Survey Date: 9/30/2021			
Comments: Woody Debris for use at McLean Point.

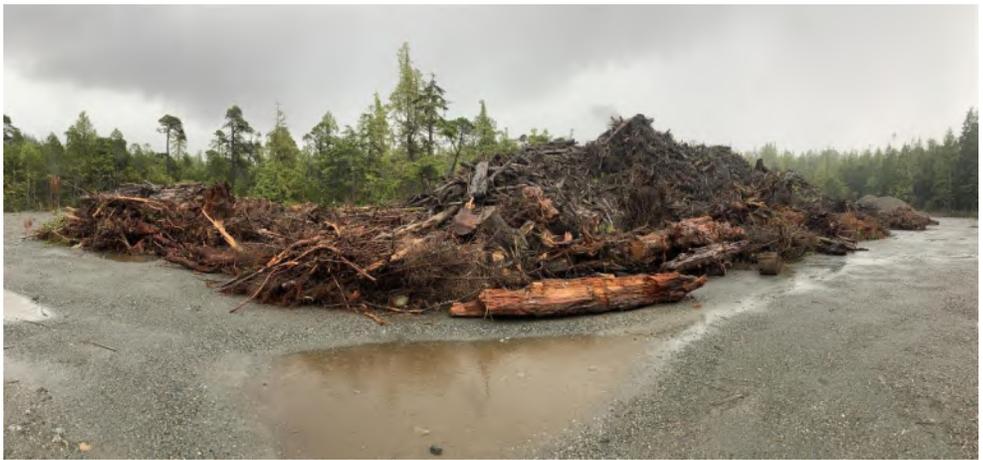
Photo Location: Radar Hill			
Direction:			
Survey Date: 9/30/2021			
Comments: Woody Debris for use at McLean Point (does not include low piled material in front)

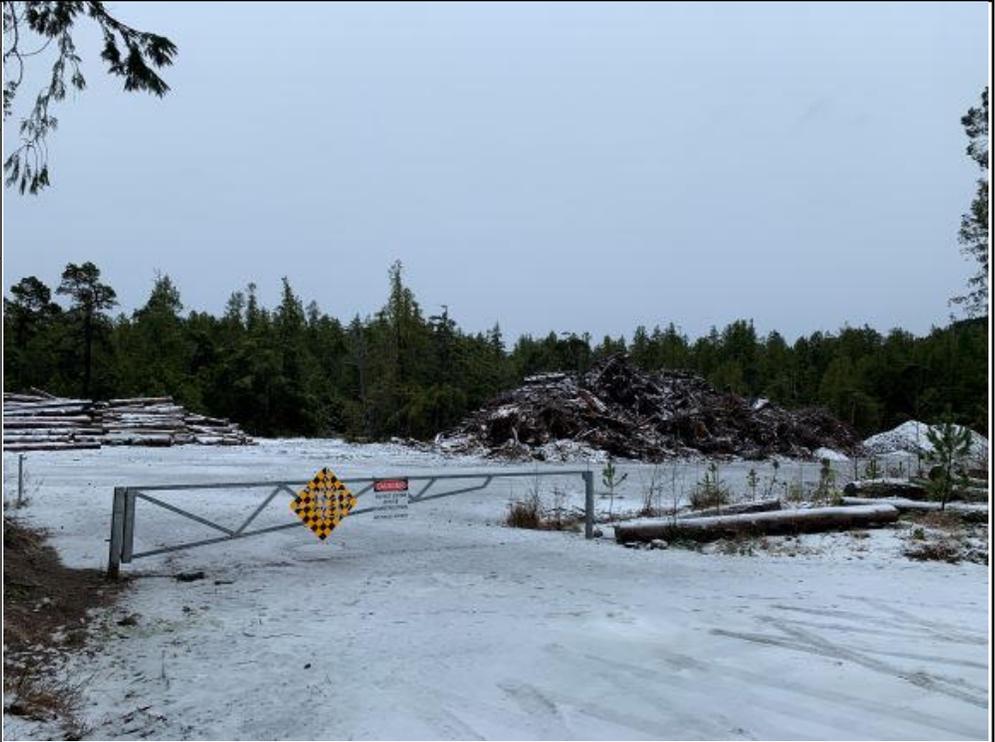
Photo Location: Radar Hill			
Direction:			
Survey Date: 12/05/2021			
Comments: updated photo: Woody Debris for use at McLean Point. Timber to left of frame and aggregate to right of frame Not In Contract. Note access gate #1.			
Photograph ID: 61

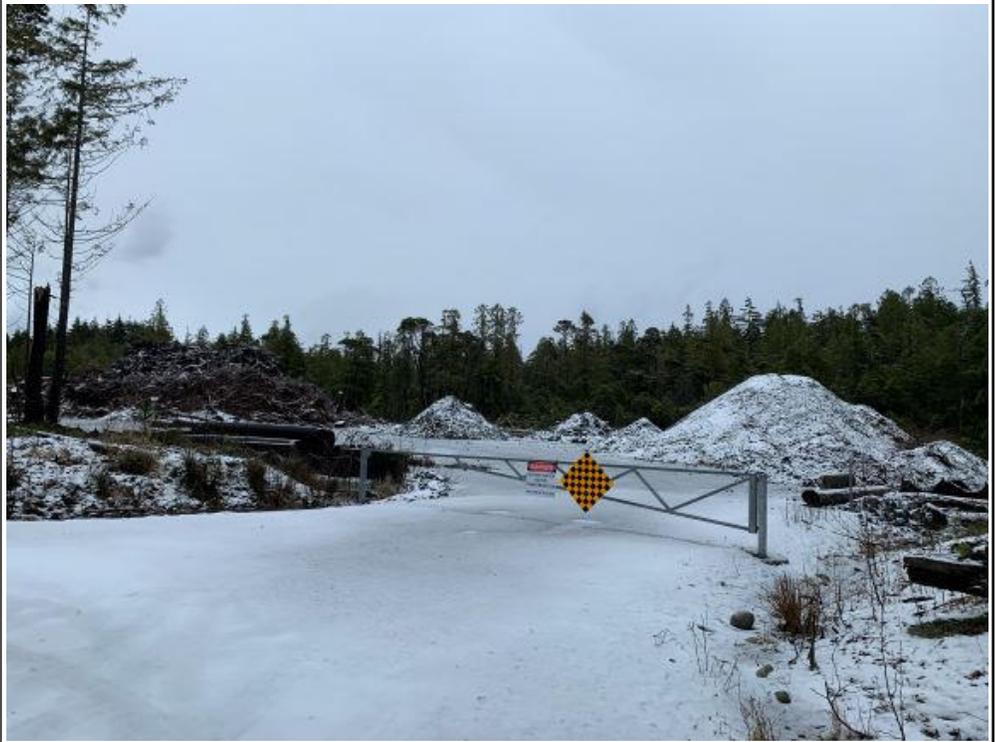
Photo Location: Radar Hill			
Direction:			
Survey Date: 12/05/2021			
Comments: updated photo: Woody Debris for use at McLean Point. Aggregate to right of frame Not In Contract. Note access gate #2.
