HAMILTON BANKER

Condition Survey, Pollution Risk, Vessel Removal, Towing & Disposal Assessment

**At Colliers, Newfoundland
24 February 2020**

Date: 23 April 2020

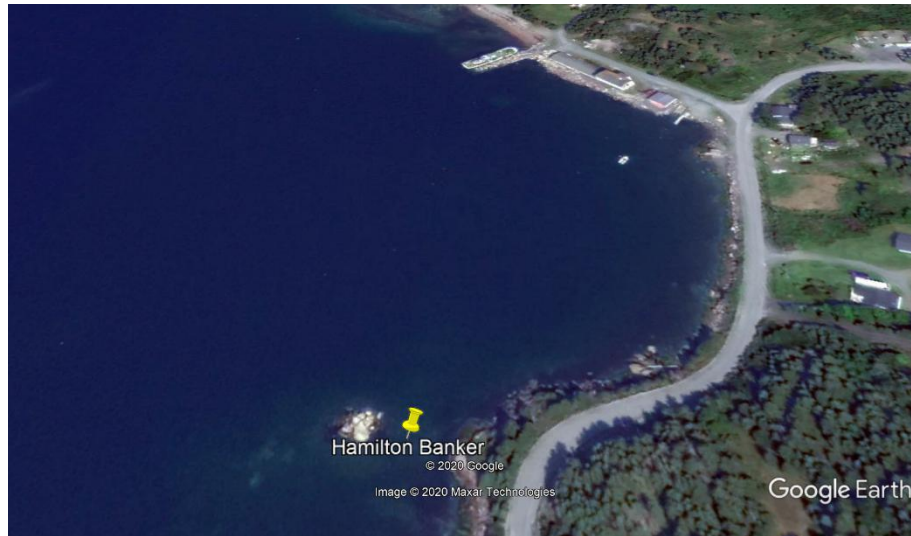
Figure 1: Google Earth image of Colliers showing location of vessel

2.1.1 Colliers is a small coastal town on the Avalon peninsula in Newfoundland. The vessel is aground between a rocky outcrop and the eastern shoreline which is rocky in nature. There is a coastal road running parallel to the shoreline and a stone constructed jetty about 250m NE from the vessel location. The opposite side of the bay is just over 1 km distance.

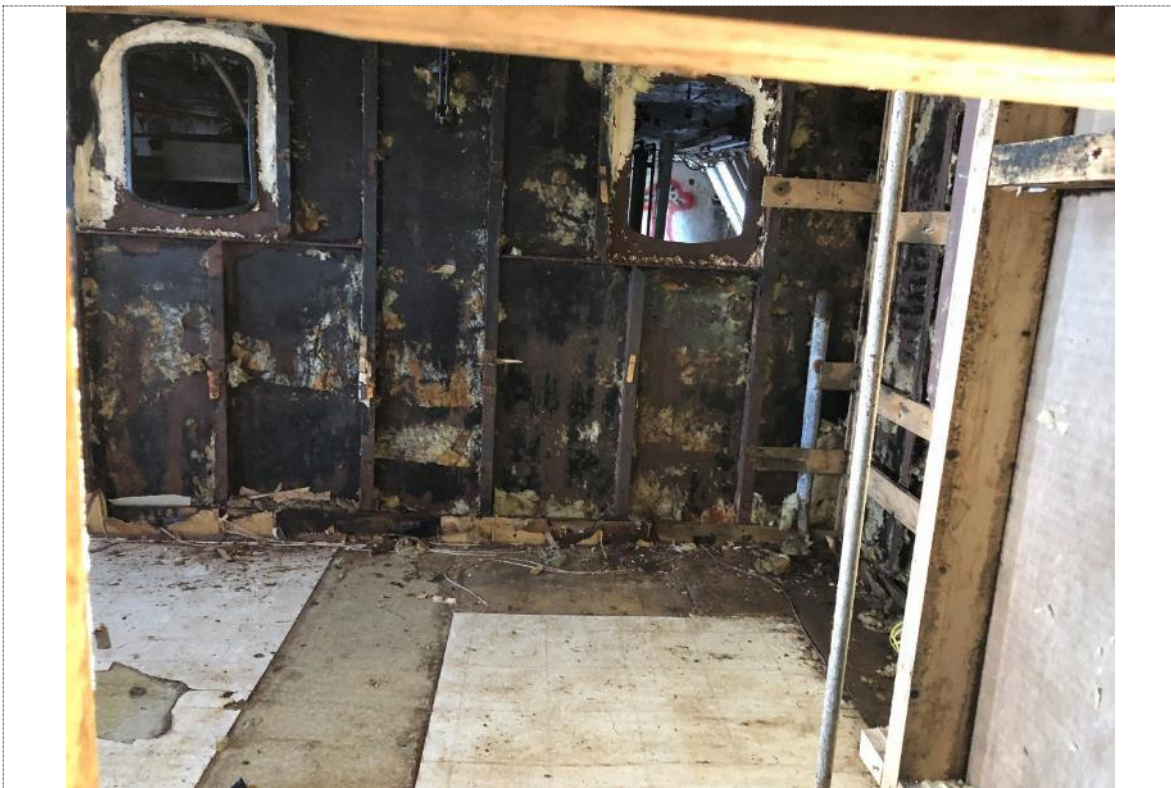
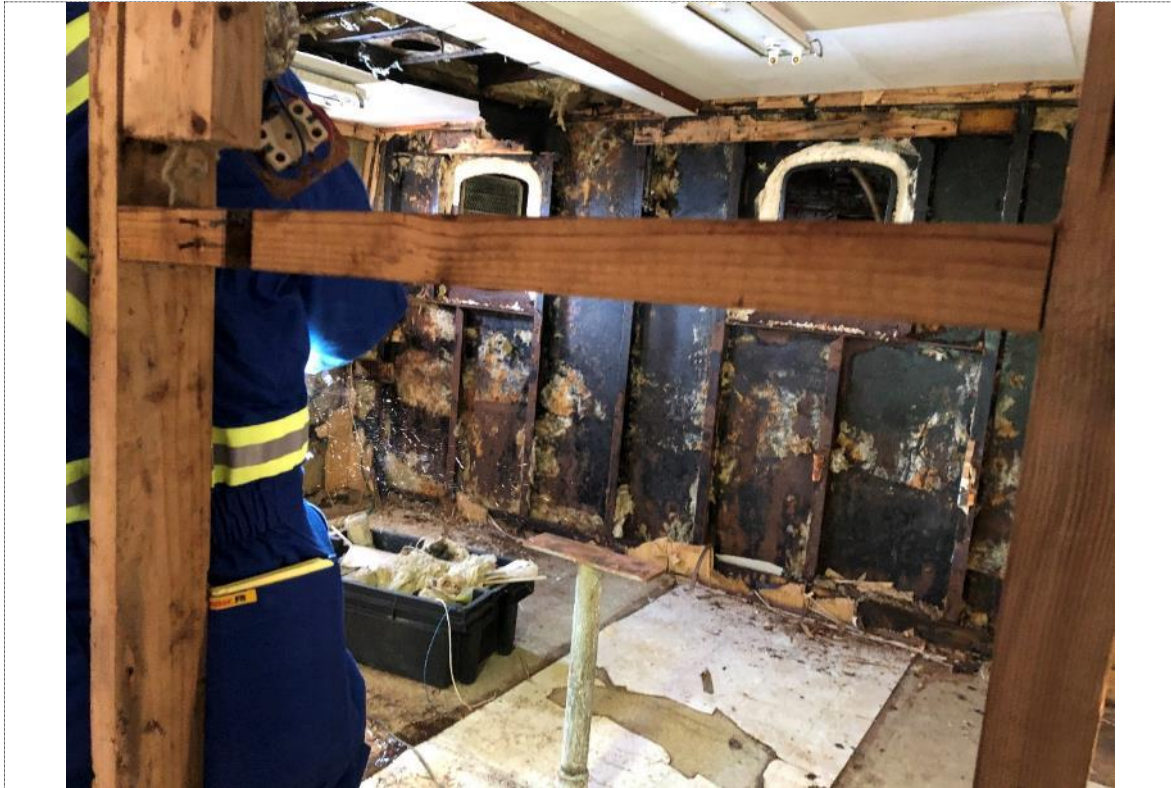
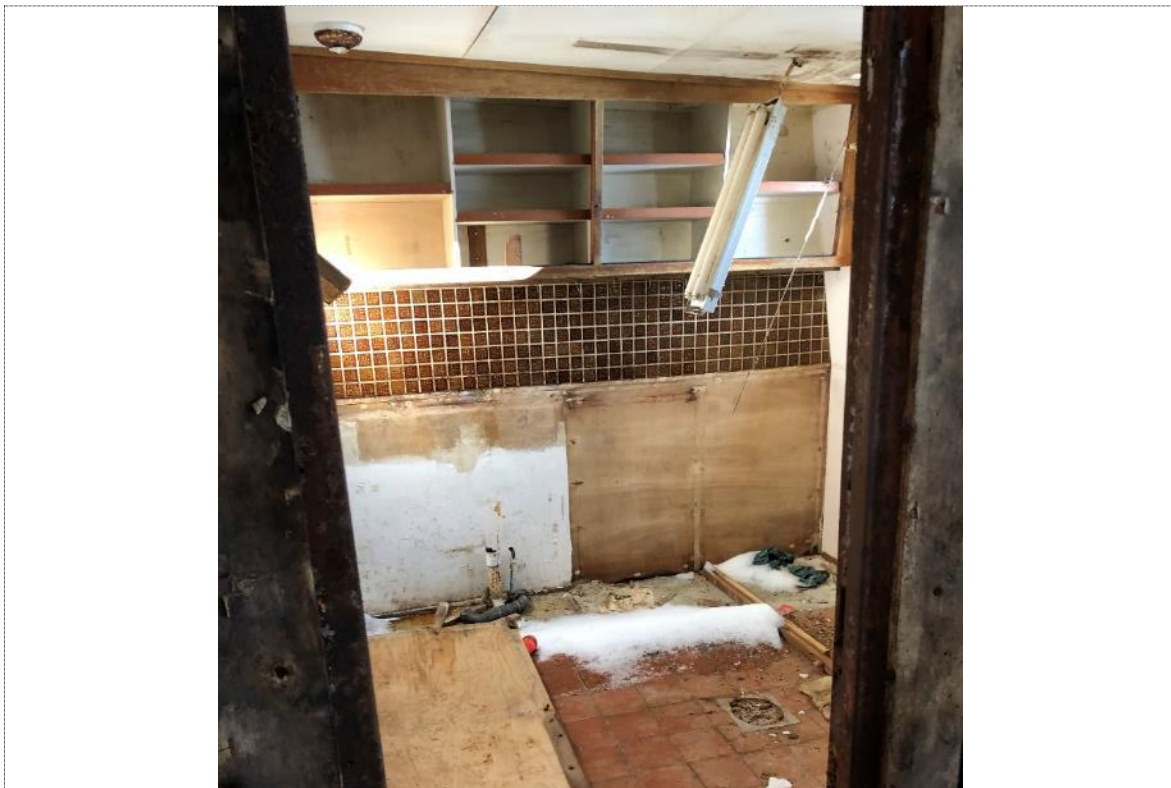
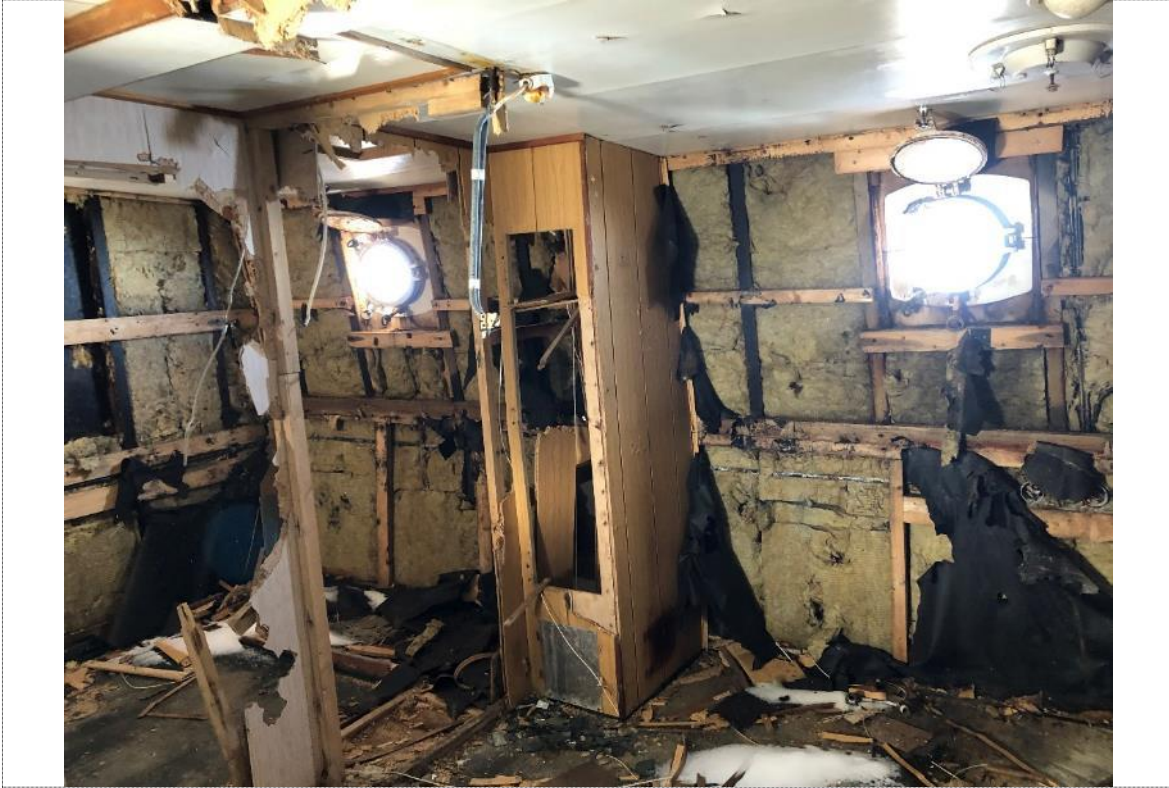
- 3.5.1 The galley and mess, as well as captain/officers' quarters, were found to be cosmetically poor. Wall panels and portions of ceiling panels had been removed. Debris was noted throughout. Multiple portholes on the port side were found partially open.
- 3.5.2 Water and floating debris were visible through the stairwell to the lower accommodation area. Water appeared to be 4-5-foot-deep at the base of the stairwell.
- 3.5.3 Water with a thick layer of oil/sludge was visible through the engine room access.

6. Accommodation space (1)

7. Accommodation space (2)

8. Accommodation space (3)

9. Accommodation space (4)

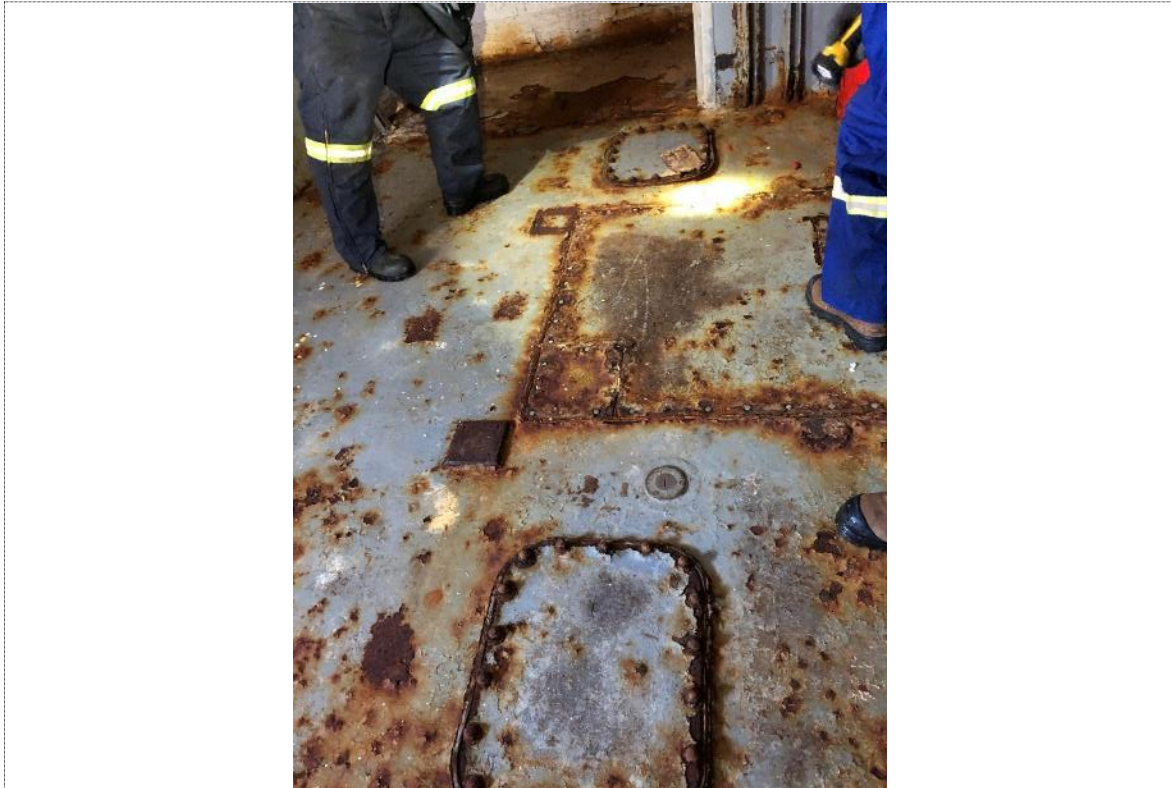
ribbons of paint flaking off. The deck contained filler caps for the port and starboard fuel tanks as well as access hatches. Deck coating was in poor condition.

15. Port and starboard fuel tank access hatches and filler caps – aft fantail area

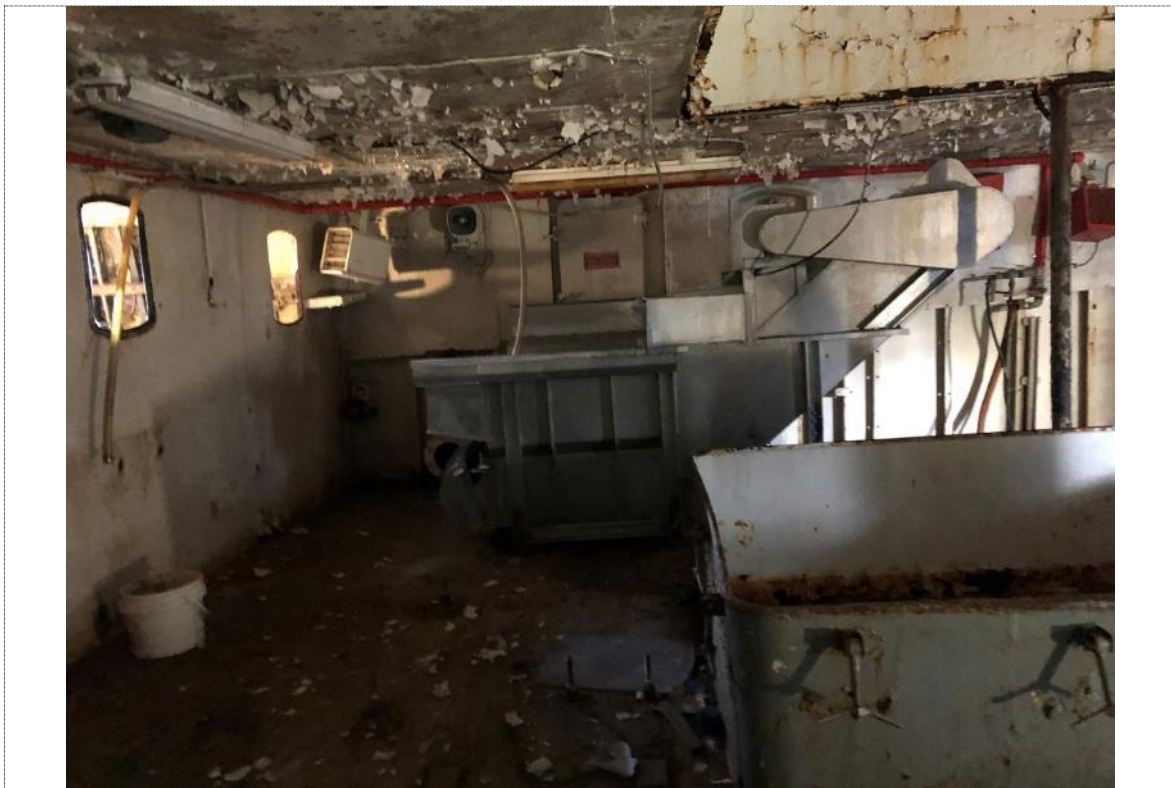
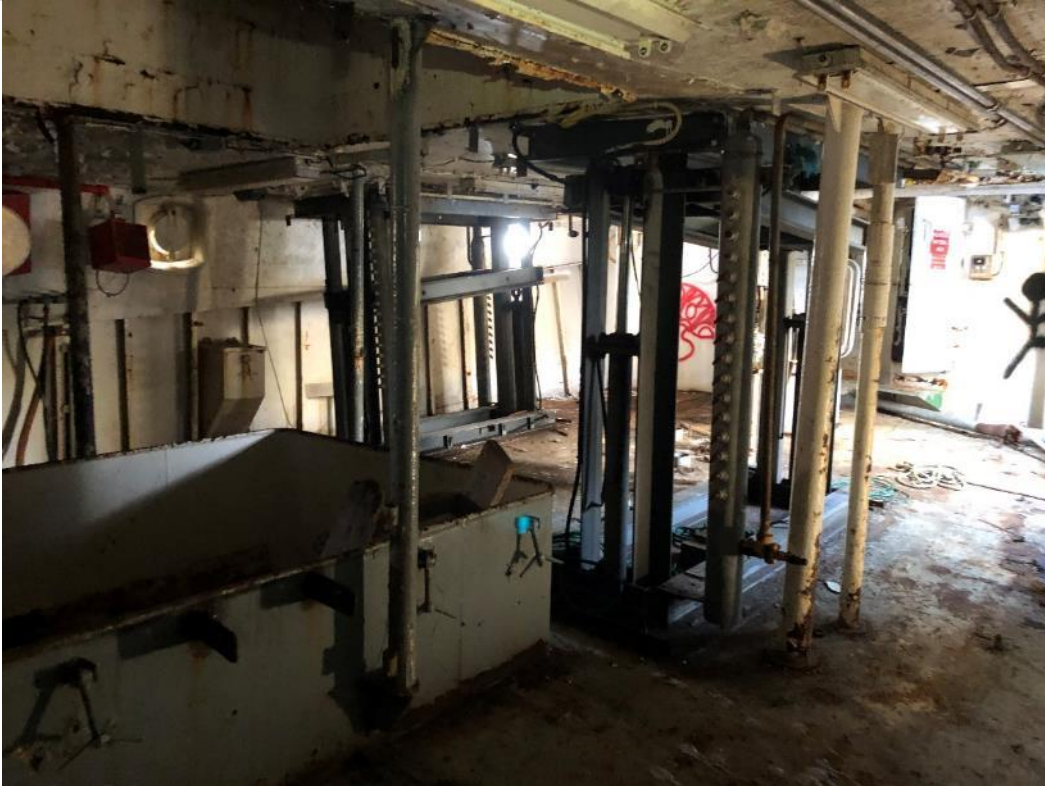
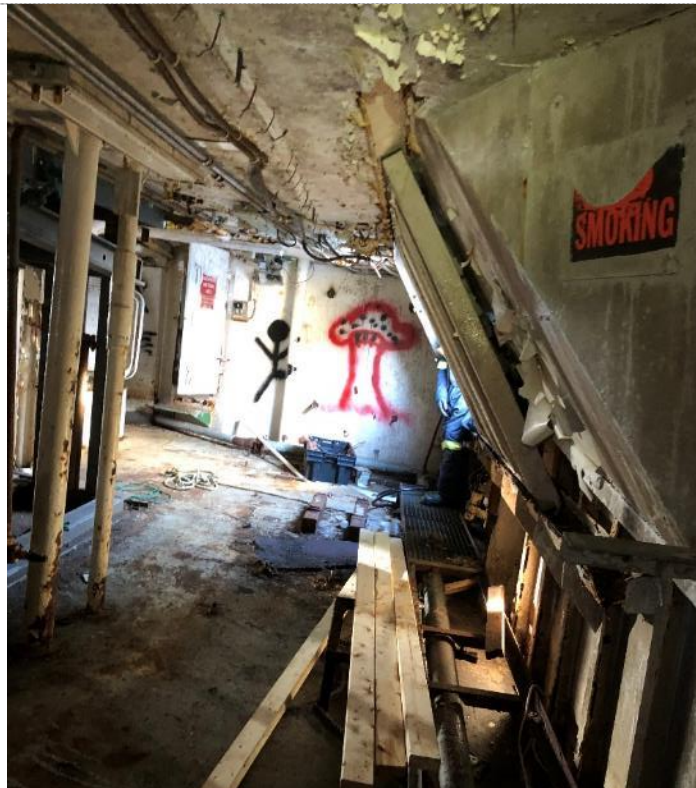
3.7.1 The forward process area was found in okay cosmetic condition. The ceilings had ribbons of paint flaking off. Overboards on the port and starboard sides, as well as trawl opening on starboard side, were found open.

16. Processing Deck (1)

17. Processing deck (2)

18. Processing Deck (3)

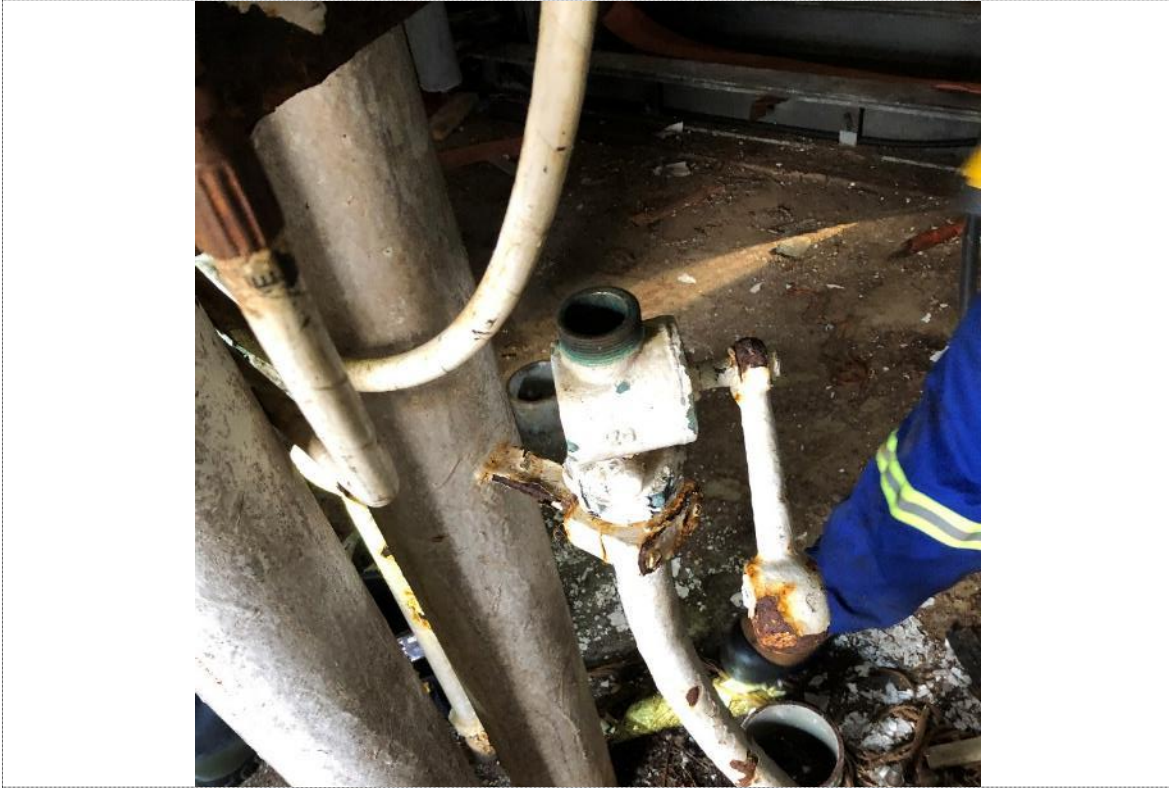
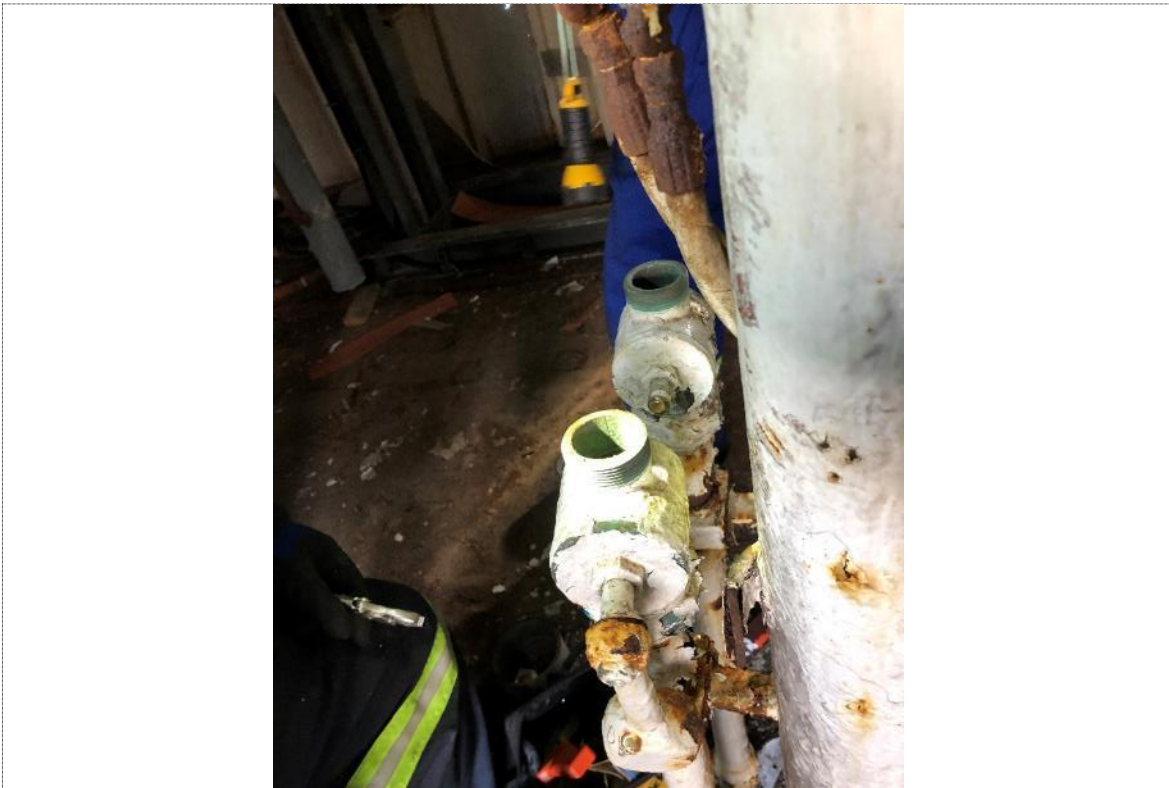
- 3.1.3 Attempts were made to sound all accessible tanks via sounding pipes. Fuel filler caps for the port-aft and port-starboard fuel tanks, located in the aft fantail area, were also unscrewed. Sounding pipes (3 in total) found in the forward processing area, assumed to be related to the freezer system, were cut and re-sealed with wooden plugs. No tanks, other than those already open, were opened for inspection. Some of the sounding pipes were found to be blocked by ice.

25. Pipes on processing deck prior to cutting to take sounding (1)

26. Pipes on processing deck – prior to cutting to take sounding (2)

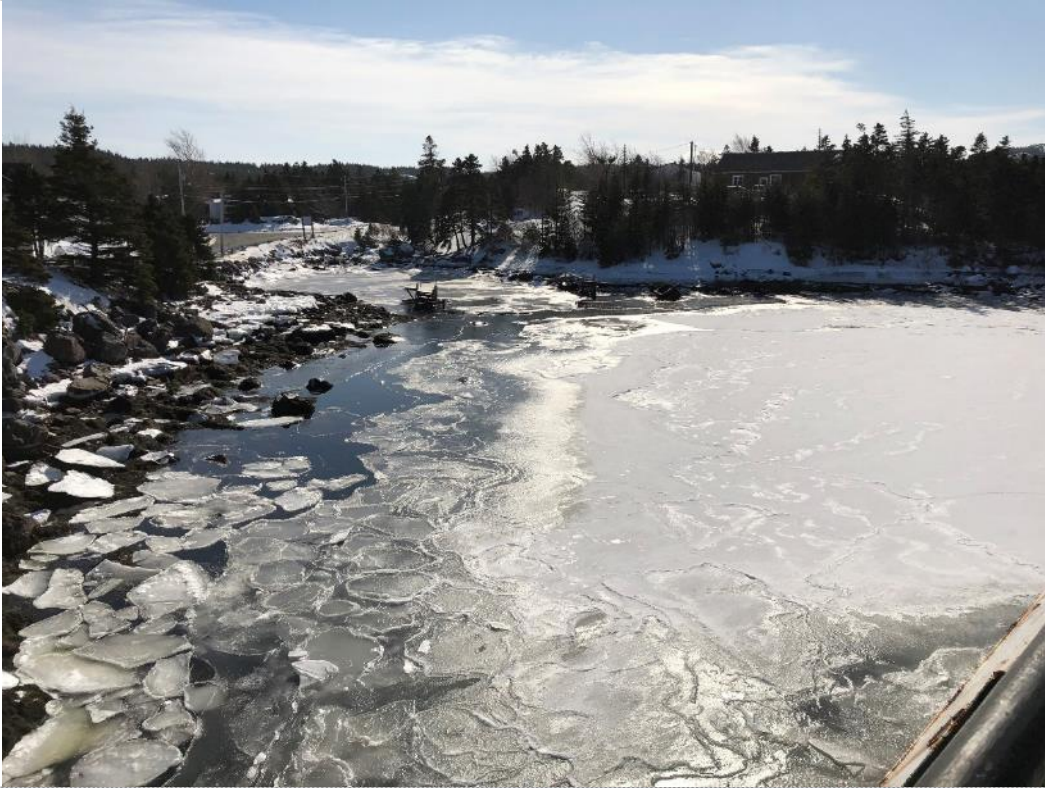
27. View from main deck port side – road visible

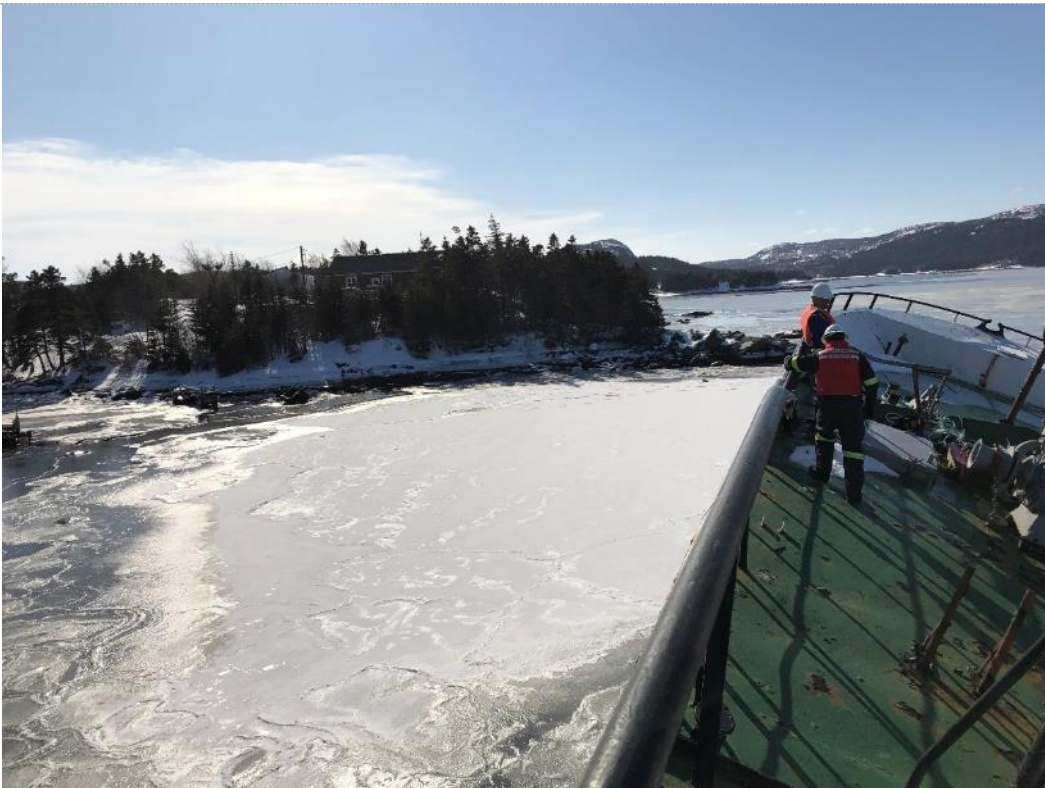
28. View from main deck port side – looking forward

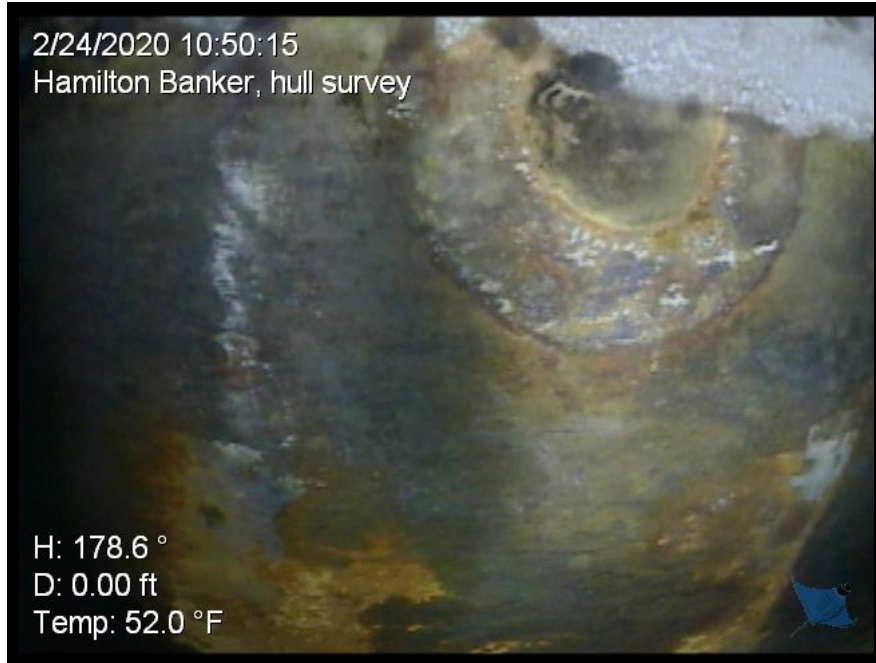
The ROV survey found that the rudder had sheared off and was lying on the seabed, the propeller was badly damaged, shell plating on the port and starboard sides showed significant damage and the hull was breached with a crack port side aft. The bilge keel was missing on the port side and set up on the starboard side. The bow section was found without any damage.

Figure 5 - Starboard side hull penetration.

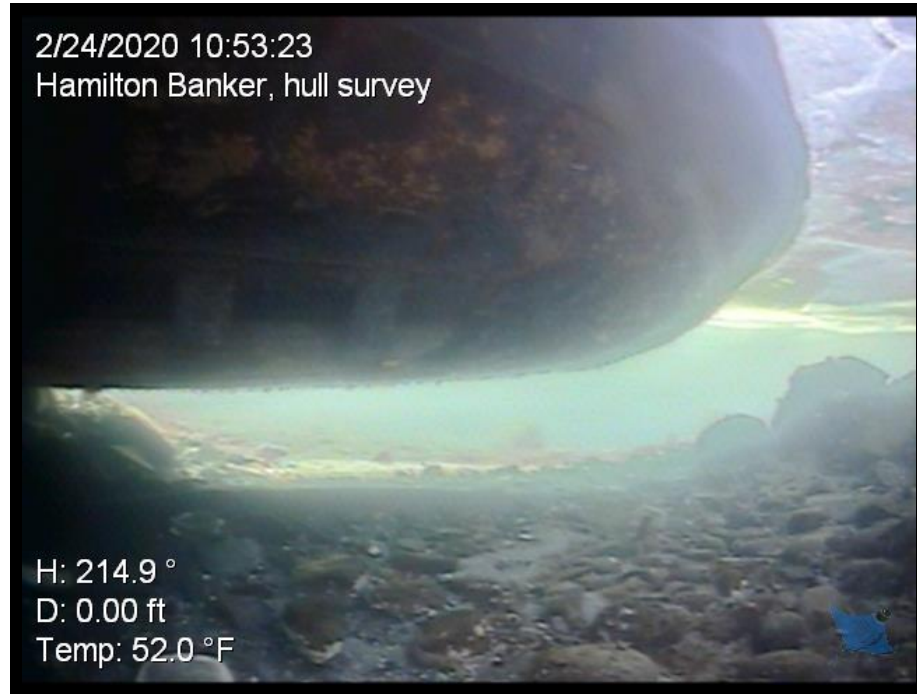
Figure 7 - Starboard side bow location.

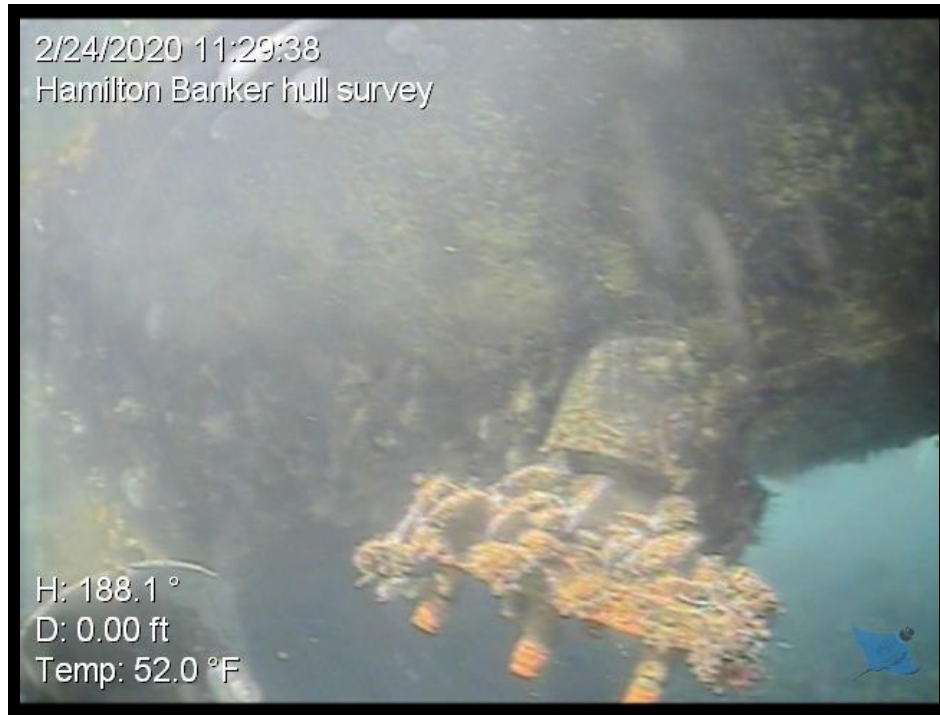
- The aft area of the vessel was surveyed and found to have depths of 5 to 6 meters. There were two large boulders observed at this location; as well as, the dislodged rudder.

Figure 9 - Rudder stock connection point.
