DESIGNATED SUBSTANCES REPORT

**The Supreme Court of Canada
301 Wellington Street
Ottawa, Ontario**

PSPC SOA No: EN438-140932/001/FK

DST File No.: GV-OT-040333

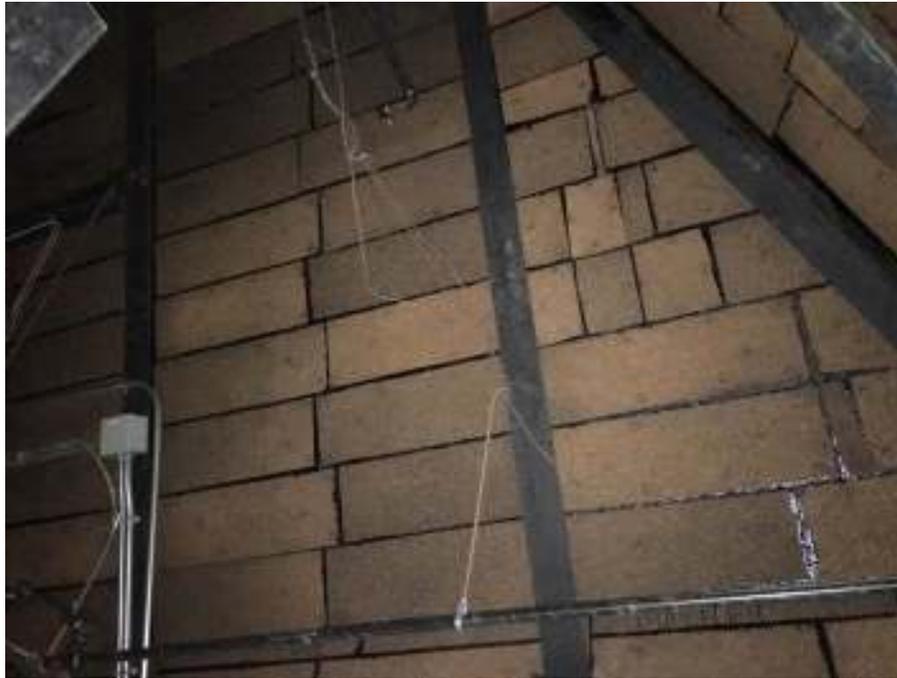
Photo 24: Tar and cork materials lining the interior roof structure above the 3rd floor was confirmed by laboratory analysis to not contain asbestos.

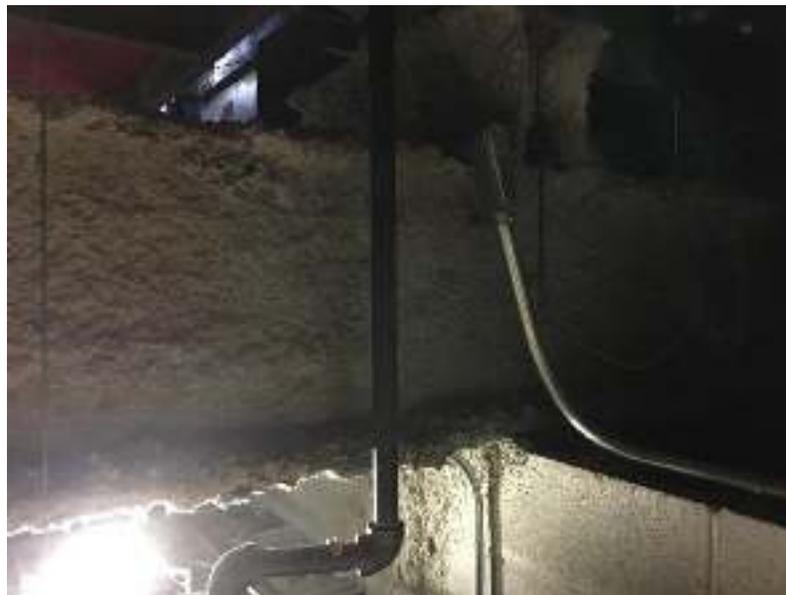
Photo 25: Spray fireproofing on beams and columns of the 3rd Floor and above was confirmed by laboratory analysis to not contain asbestos.

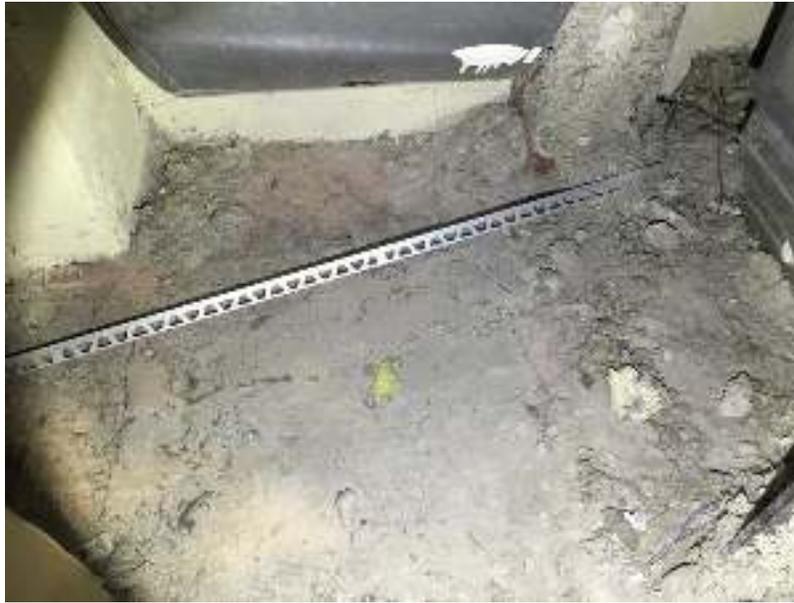
Photo 26: 3rd Floor fill and textured cementitious coat on column were confirmed by laboratory analysis to not contain asbestos.

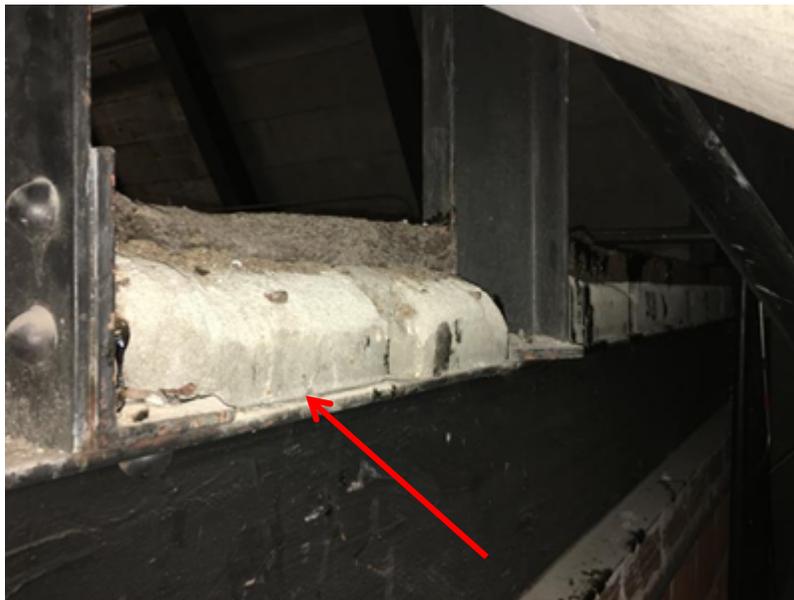
Photo 27: Cementitious floor fill beneath cork floors throughout the 1st Mechanical Floor, was confirmed by laboratory analysis to not contain asbestos.

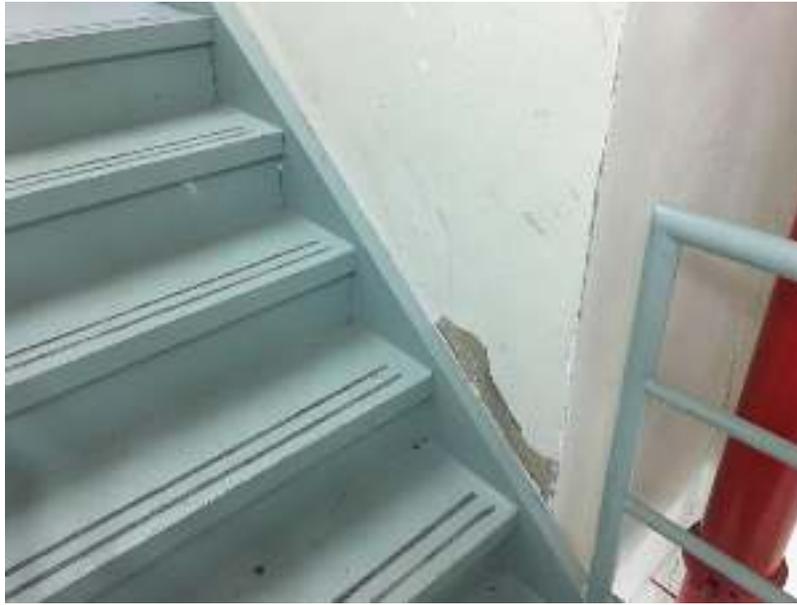
Photo 28: Textured cementitious wall parge in building stairwells was confirmed by laboratory analysis to not contain asbestos.

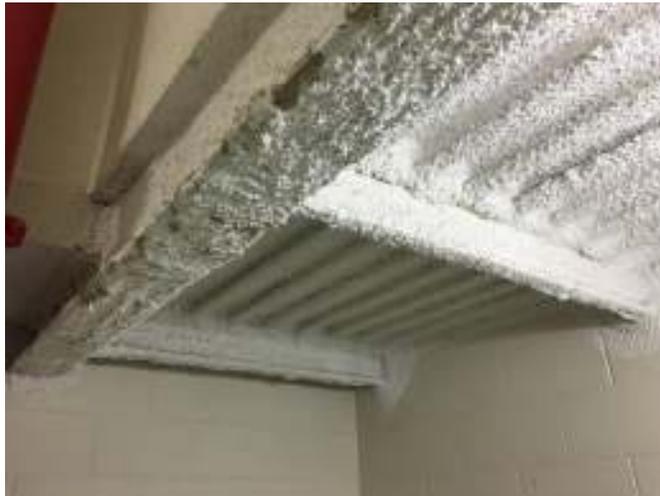
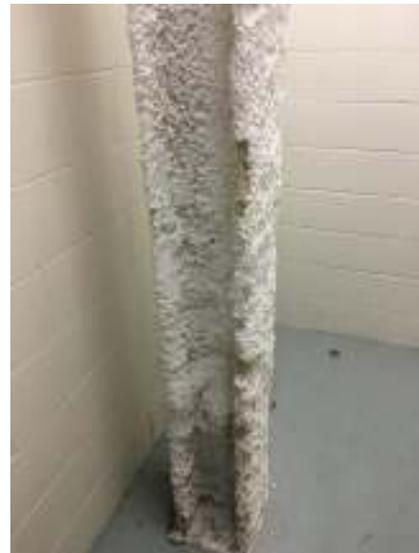
Photo 29 and 30: Spray fireproofing on bottom of northwest stairwell landing and throughout select areas of Second Mechanical Floor, was confirmed by laboratory analysis to not contain asbestos.

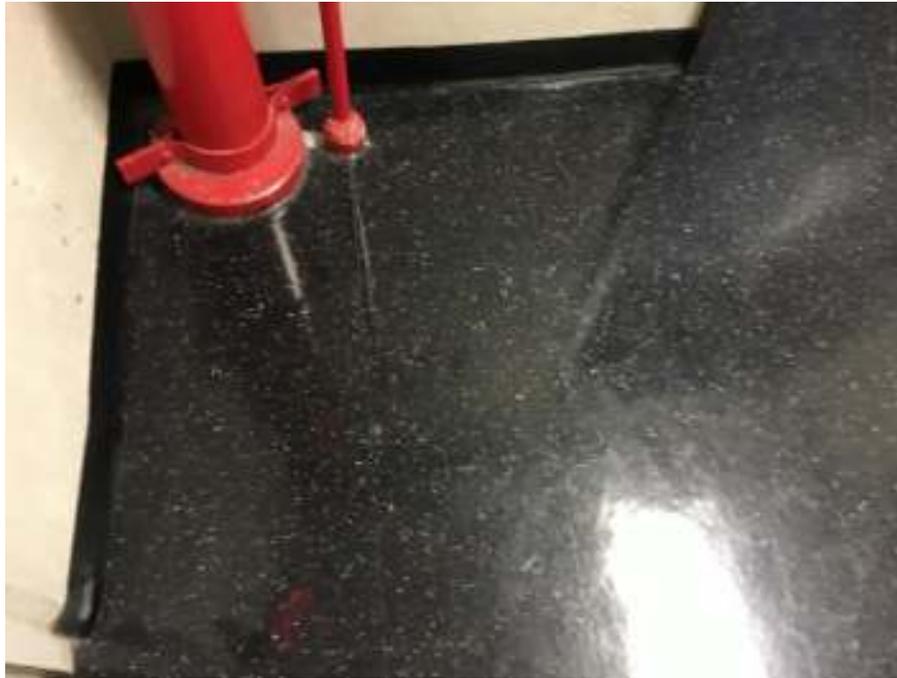
Photo 31: 12"x12" Vinyl floor tiles, black with white dots observed in select elevator lobbies, and stack 1 and 2 library areas was confirmed to not contain asbestos.

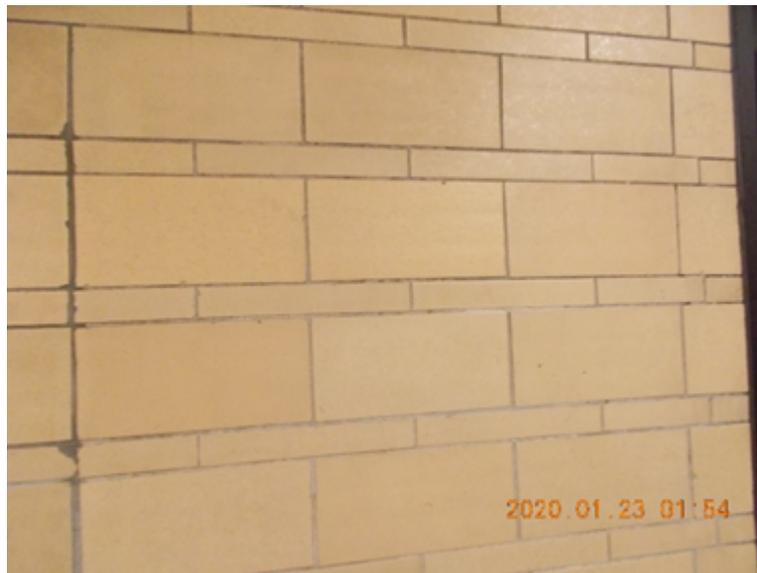
Photo 38: Mortar associated with tan glazed blocks (large and small) located in the basement north wall are confirmed to be non asbestos.
