Addendum No. 2

Project #: 20-078
Project Name: CFIA Lethbridge re-roofing

**ASBESTOS SURVEY
CFIA FACILITY: LETHBRIDGE
ALBERTA**

KGS Group 17-0006-013
March 2018

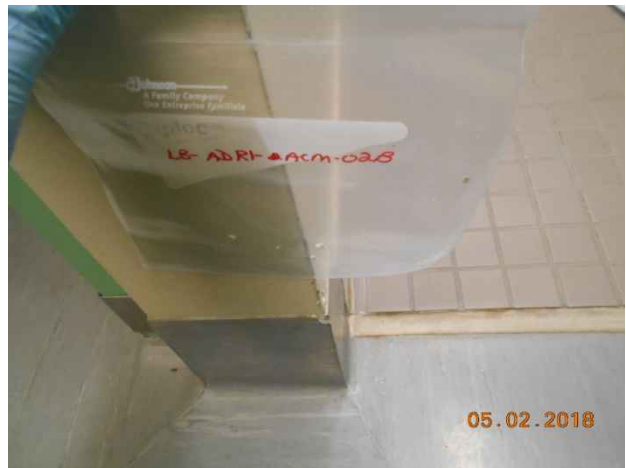
Photo 4. Sample location LB-ADRI-ACM-02B; drywall mud joint compound in R.137 (Woman's Washroom).

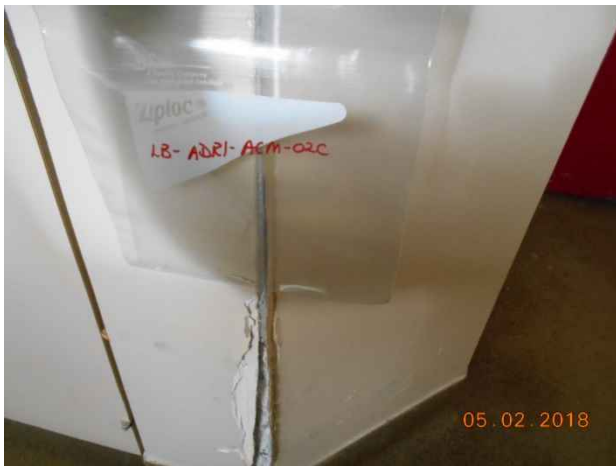
Photo 5. Sample location LB-ADRI-ACM-02C; drywall mud joint compound in hallway near R.402.

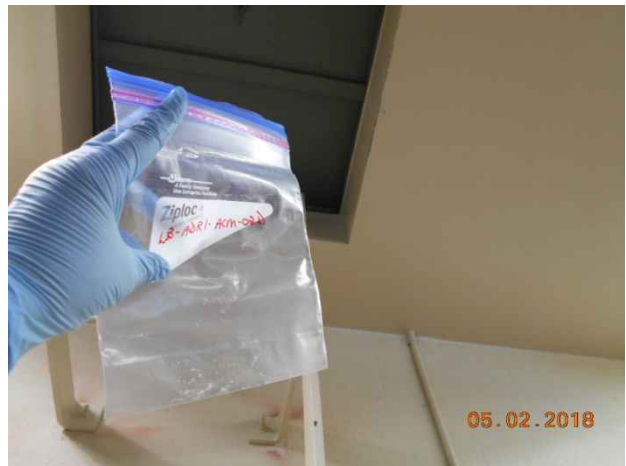
Photo 6. Sample location LB-ADRI-ACM-02D; drywall mud joint compound in R.427.

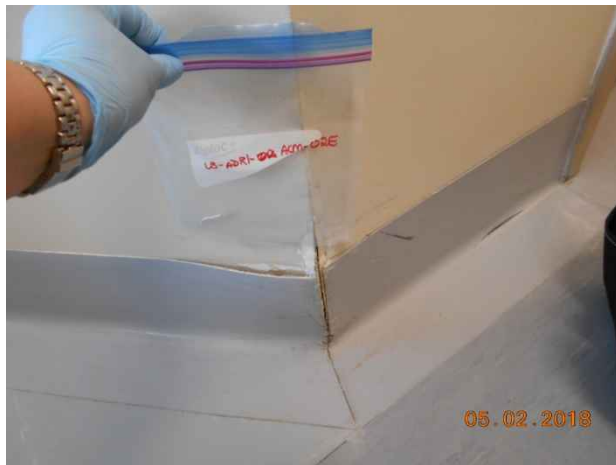
Photo 7. Sample location LB-ADRI-ACM-02E; drywall mud joint compound in hallway near R.170.

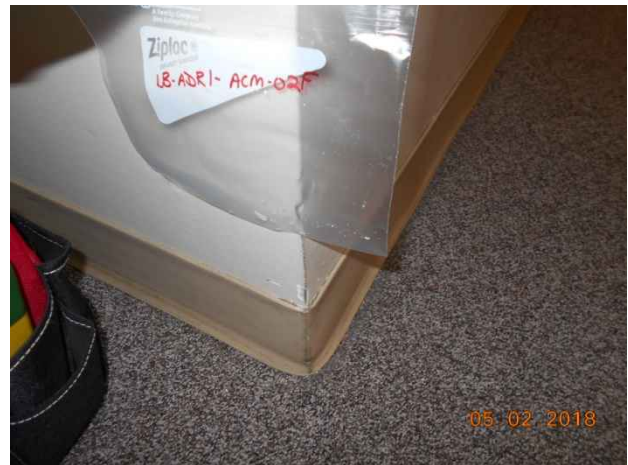
Photo 8. Sample location LB-ADRI-ACM-02F; drywall mud joint compound in hallway near R.107.

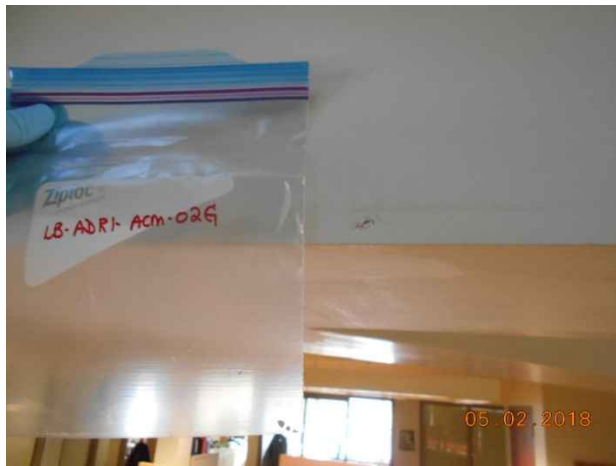
Photo 9. Sample location LB-ADRI-ACM-02G; drywall mud joint compound by front reception (Level 100).

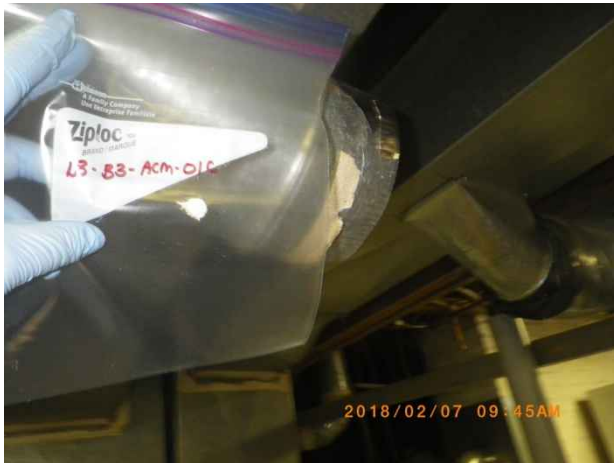
Photo 30. Sample location LB-B3-ACM-01B; paper-wrap around ducting (sample not analyzed based on confirmed asbestos in sample LB B3-ACM-01A).

LB-B3-ACM-01A						
Maxxam ID: SX9630			Date Analyzed: 2018/02/22			
	<u>P.O.B</u>	<u>Sample Morphology</u>	<u>Asbestos</u>		<u>Other Fibres</u>	<u>Particulate</u>
Layer 1	100	Homogeneous off-white fibrous mix	Chrysotile	50%	Cellulose 5%	Non-Fibrous

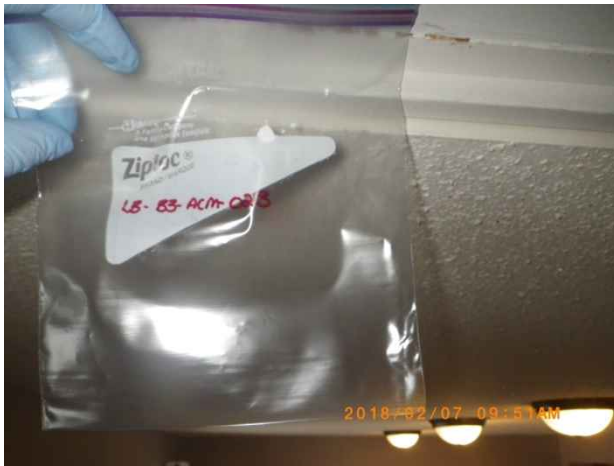
Photo 32. Sample location LB-B3-ACM-02A; textured ceiling plaster at second floor staircase. **Confirmed asbestos-containing material (2% Chrysotile).**

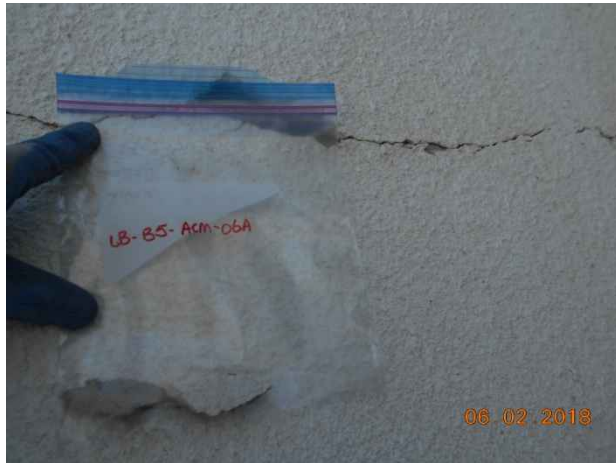
Photo 55. Sample location LB-B5-ACM-06A; exterior wall plaster.

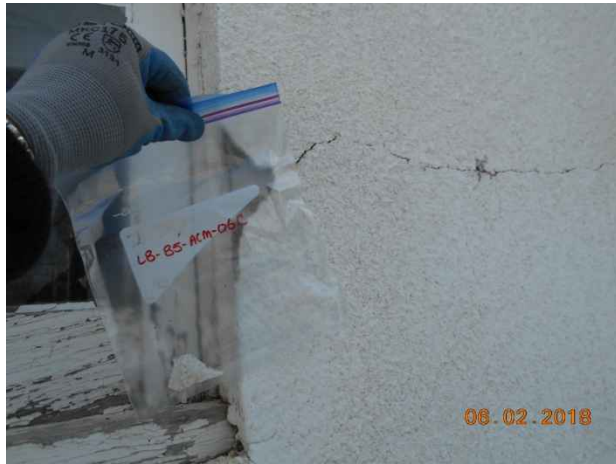
Photo 57. Sample location LB-B5-ACM-06C; exterior wall plaster.

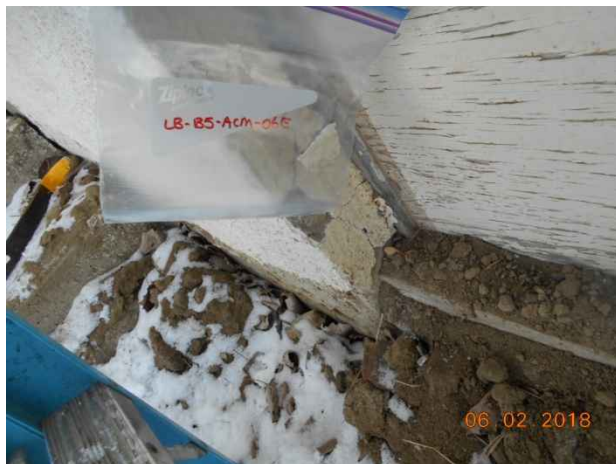
Photo 59. Sample location LB-B5-ACM-06E; exterior wall plaster.

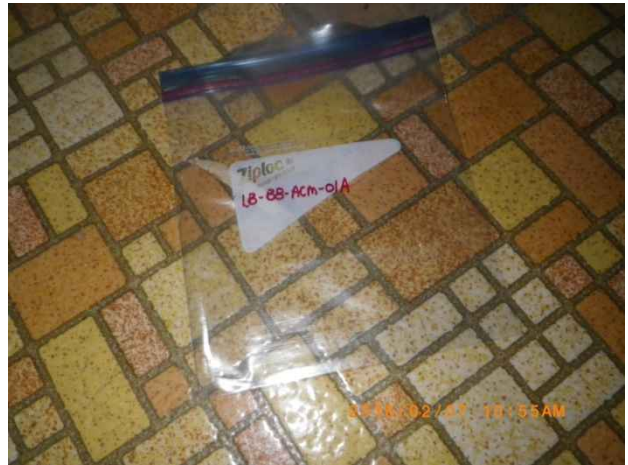
Photo 62. Sample location LB-B8-ACM-01A; yellow brick pattern vinyl flooring.

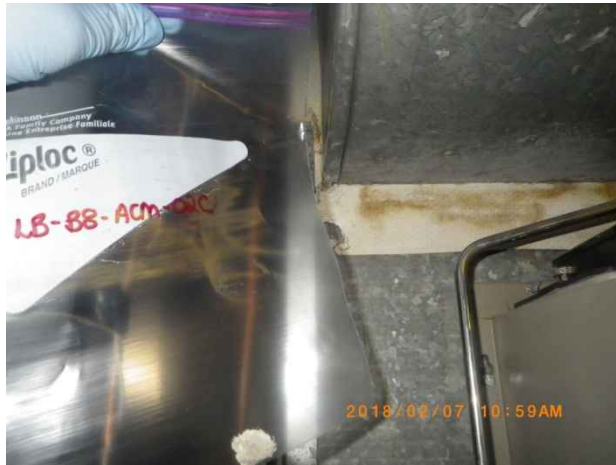
Photo 67. Sample location LB-B8-ACM-02C; paper-wrap around ducting (sampled not analyzed base on confirmed asbestos in sample LB-B8-ACM-02A).

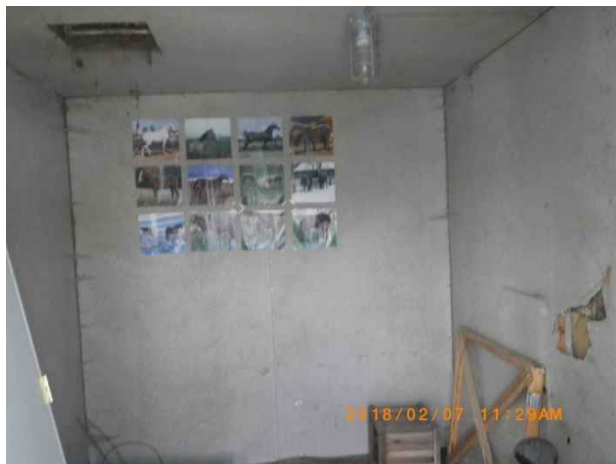
Photo 71. Sample locations LB-B11-ACM-03A to C; interior cement/transite board. **Confirmed asbestos-containing materials (25% Chrysotile).**

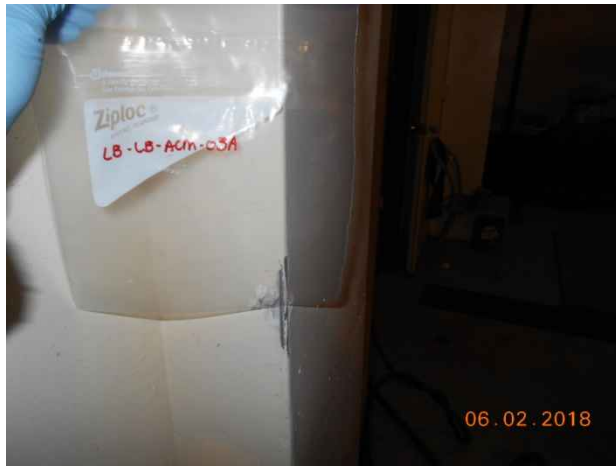
Photo 75. Sample locations LB-LB-ACM-03A to C; interior wall plaster. **Confirmed asbestos-containing material (2% Chrysotile).**

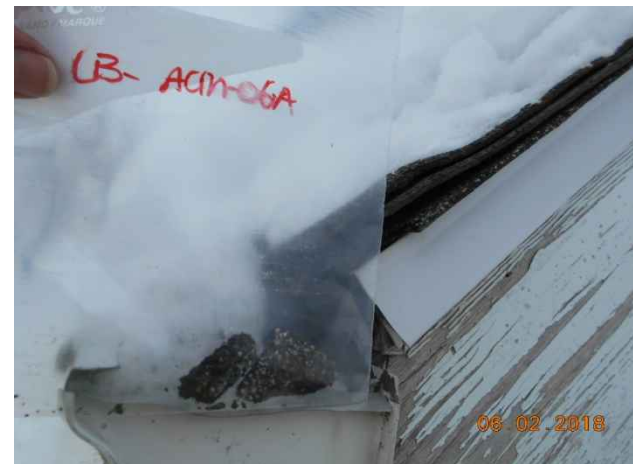
Photo 78. Sample locations LB-LB-ACM-06A to C; multicolour roof shingles (bottom layer).

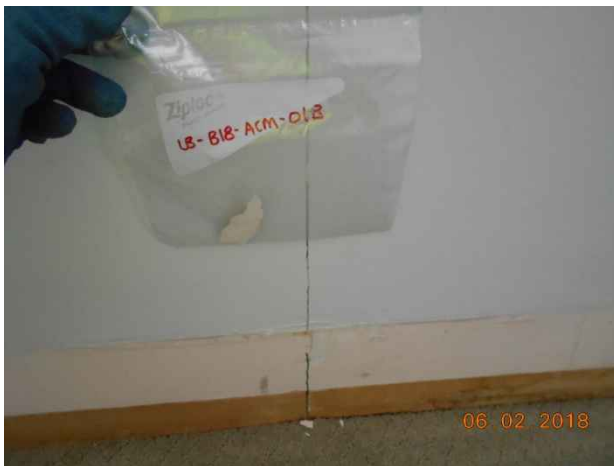
Photo 83. Sample location LB-B18-ACM-01B; drywall mud joint compound from upstairs wall. **Confirmed asbestos-containing material (1% Chrysotile).**

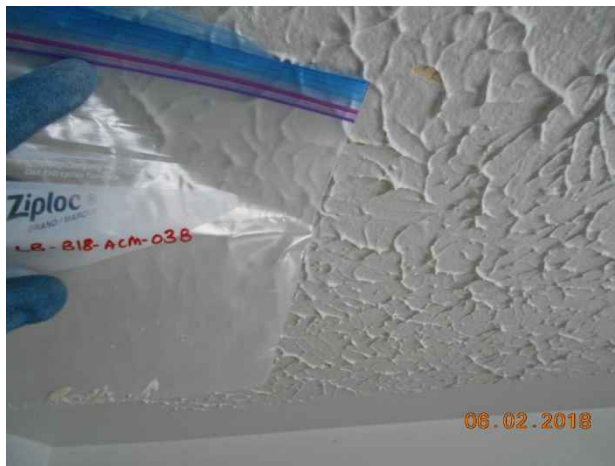
Photo 89. Sample location LB-B18-ACM-03B; textured ceiling plaster from living room (sample not analyzed based on confirmed asbestos in sample LB-B18-ACM-03A).

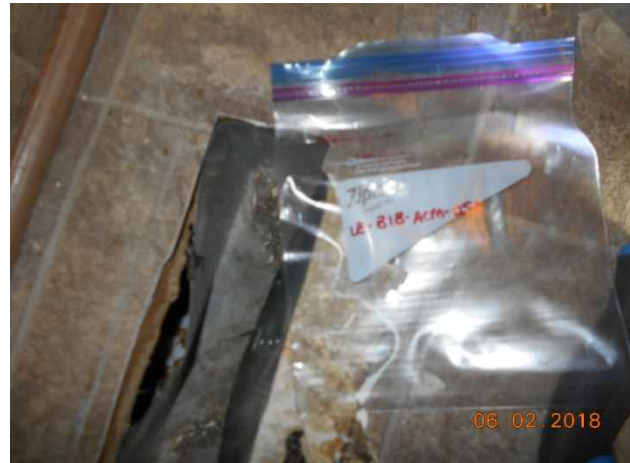
Photo 92. Sample locations LB-B18-ACM-05A to C; pebble pattern vinyl floor tile (second layer) in bathroom. **Confirmed asbestos-containing material (35% Chrysotile).**

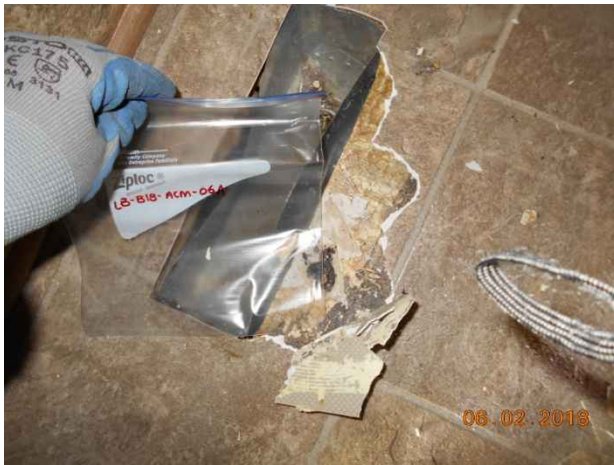
Photo 93. Sample locations LB-B18-ACM-06A to C; grey-red floor tile and fibrous mix in bathroom (third layer). **Confirmed asbestos-containing material (30% Chrysotile).**

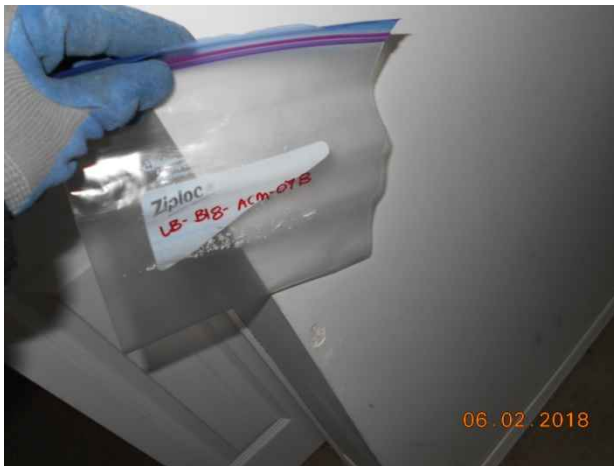
Photo 95. Sample location LB-B18-ACM-07B; drywall mud joint compound in basement rear bedroom.

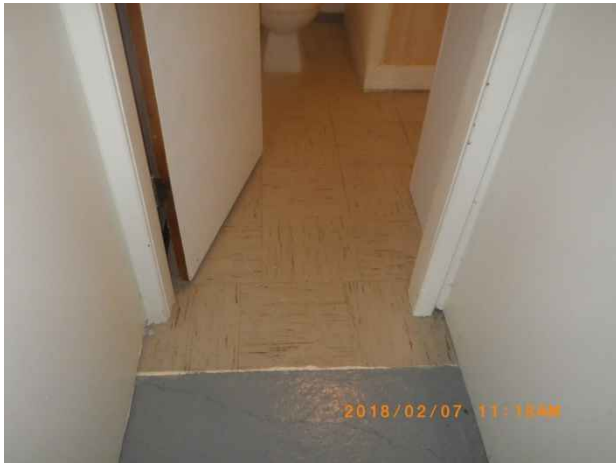
Photo 99. Tan 12"x12" floor tile in basement bathroom.

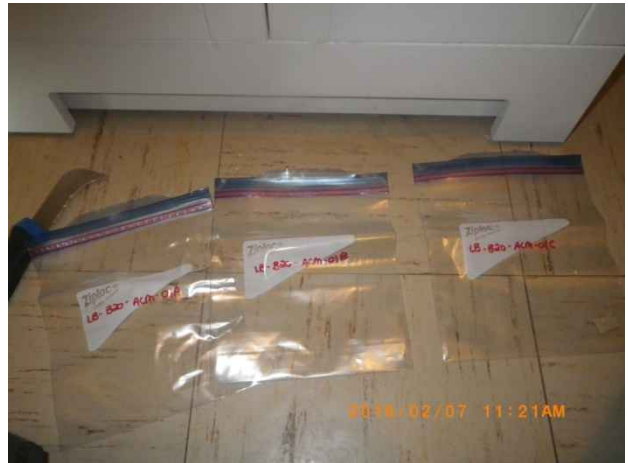
Photo 100. Sample locations LB-B20-ACM-01A to C; tan 12"x12" floor tile in basement. **Confirmed asbestos-containing material (4% Chrysotile).**

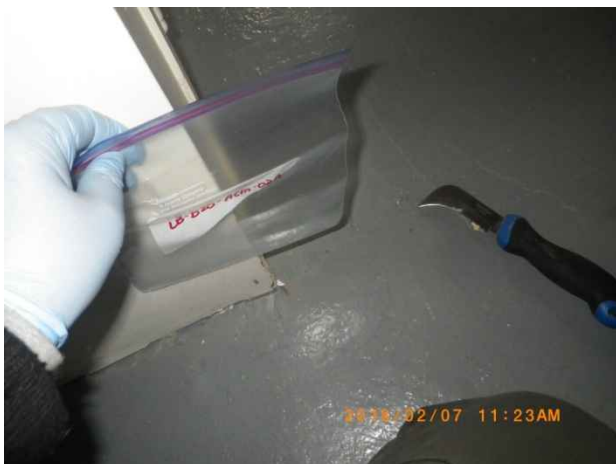
Photo 101. Sample location LB-B20-ACM-02A; drywall mud joint compound by basement bathroom.

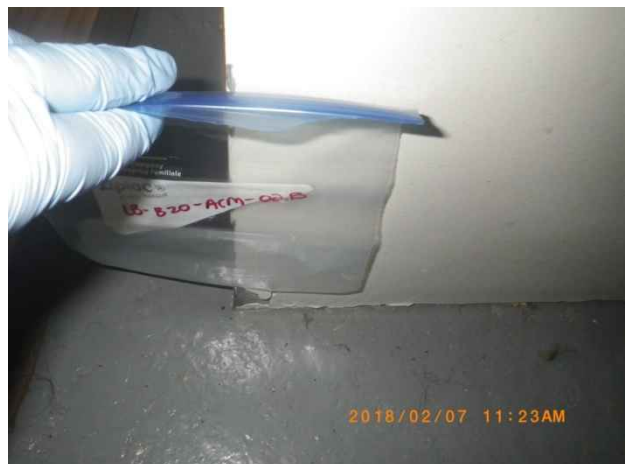
Photo 102. Sample location LB-B20-ACM-02B; drywall mud joint compound by basement bathroom.

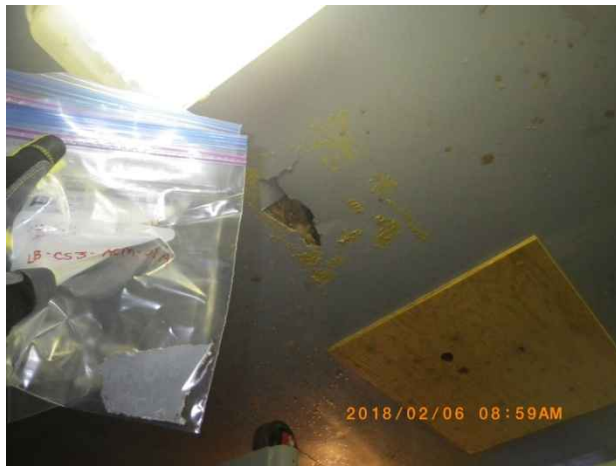
Photo 105. Sample locations LB-CS3-ACM-01A to C; grey ceiling board. **Confirmed asbestos-containing material (30% Chrysotile).**

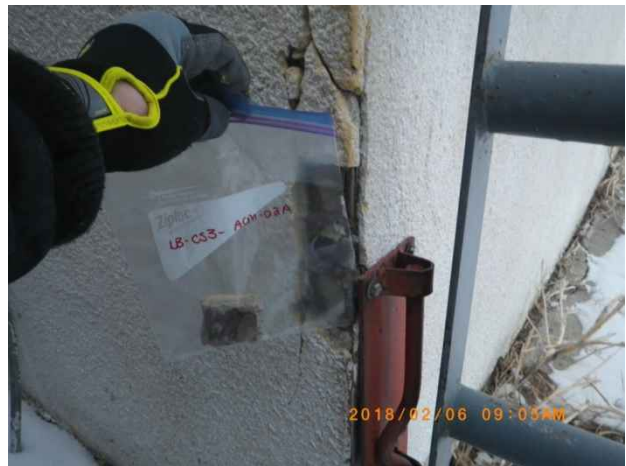
Photo 106. Sample location LB-CS3-ACM-02A; exterior plaster (multiple layers).

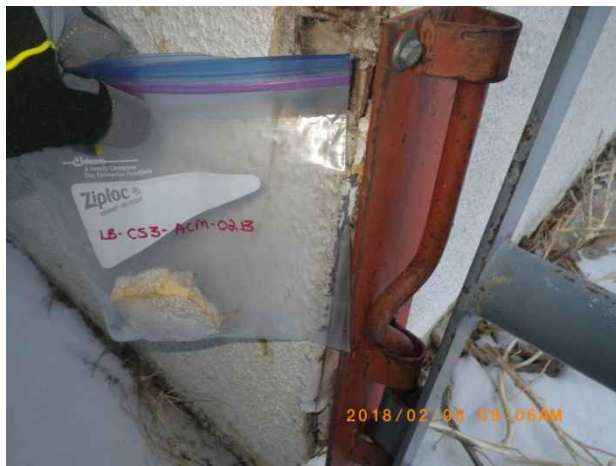
Photo 107. Sample location LB-CS3-ACM-02B; exterior plaster (multiple layers).

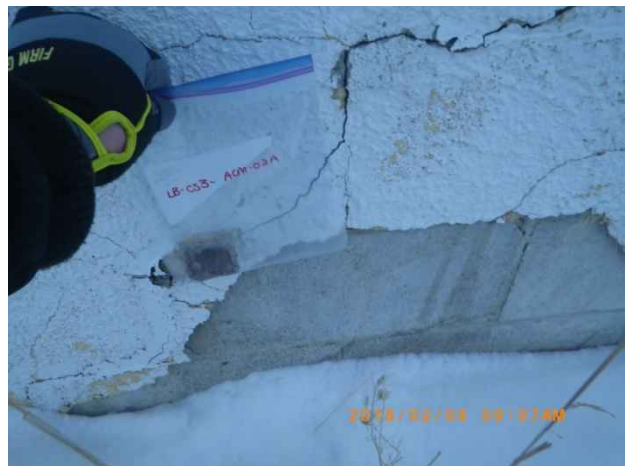
Photo 108. Sample location LB-CS3-ACM-02C (mis-labeled in image); exterior plaster (multiple layers).

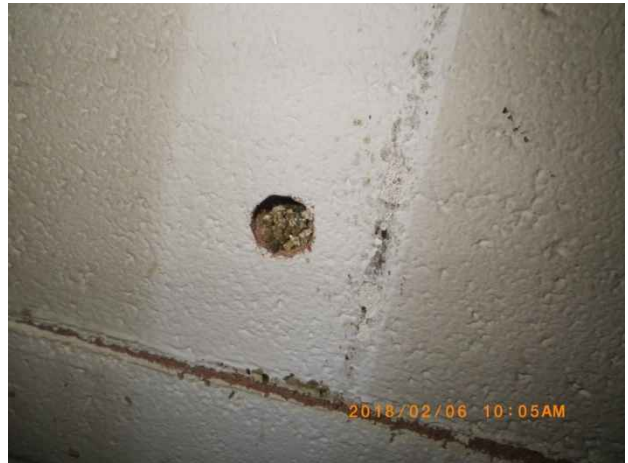
Photo 110. Pre-existing hole in cinder block wall inside the Dry Storage.

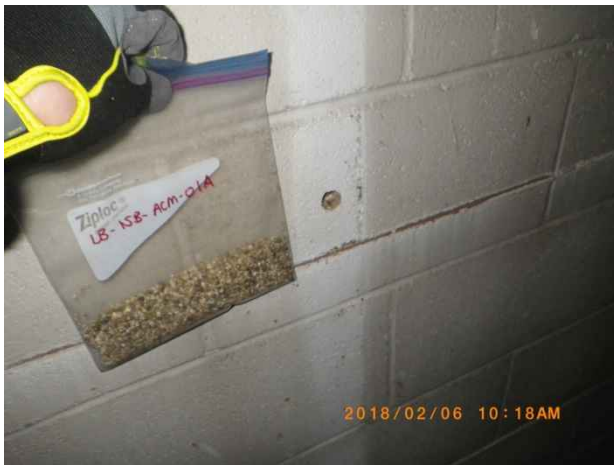
Photo 111. Sample locations LB-ISB-ACM-01A to C; wall insulation. **Confirmed asbestos-containing material (1% Actinolite – Vermiculite).**
