# STRUCTURAL REHABILITATION PROJECT FOR CULVERT STRUCTURES

TERRA NOVA NATIONAL PARK,  
NEWFOUNDLAND AND LABRADOR

PROJECT NO. 1099

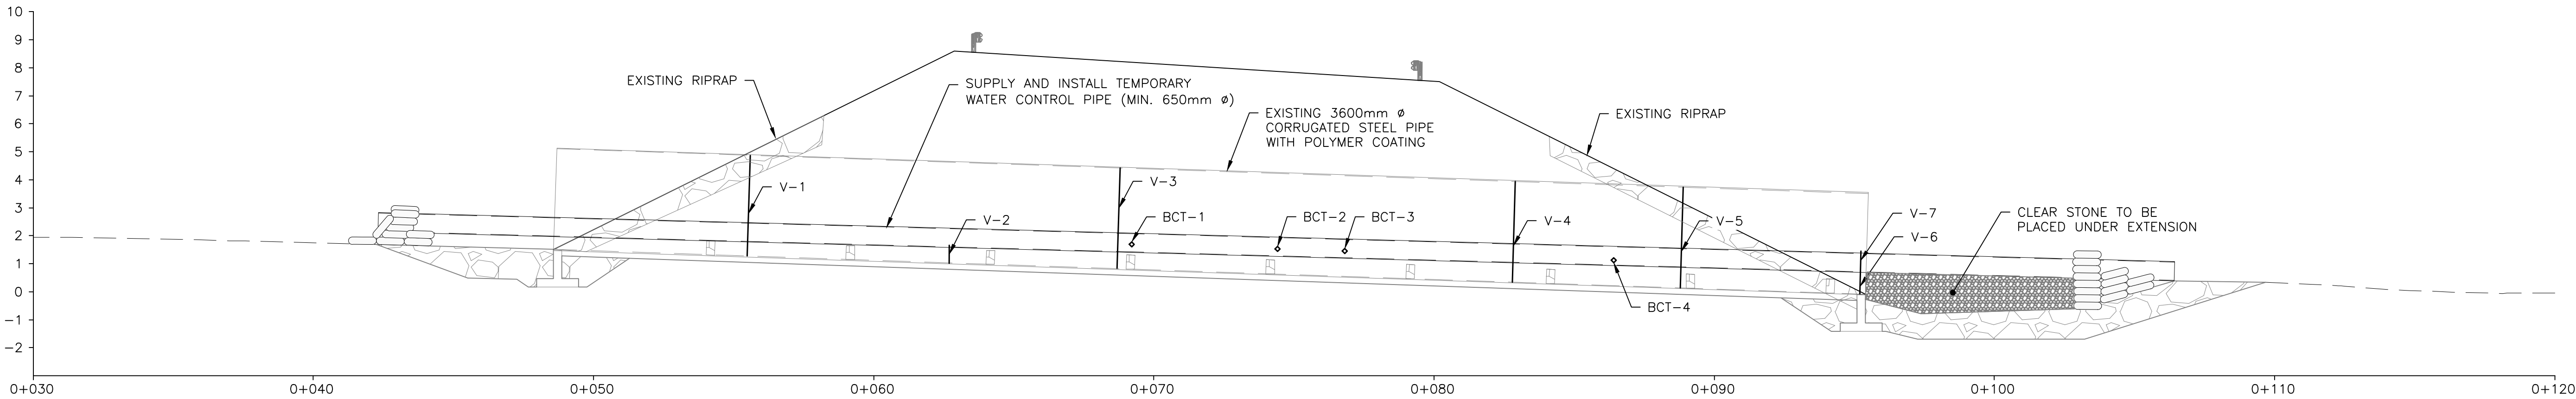
PROFILE VIEW  
SCALE: 1:125

PLATTERS COVE PIPE CONDITION - VISUAL VOIDS				
VOID	X (RELATIVE TO INLET)	Y (RELATIVE TO PIPE BOTTOM)	PIPE WALL	TYPE OF ANOMALY AND DESCRIPTION
V-1	6.90m	-	-	OFFSET JOINT BY APPROX. 40mm WITH VISIBLE COUPLER
V-2	14.10m	275mm	WEST EAST	OFFSET JOINT BY APPROX. 50mm
V-3	20.10m	-	-	OFFSET JOINT BY APPROX. 30mm WITH VISIBLE COUPLER AND LVL 3 WATER INFILTRATION EVIDENT
V-4	34.20m	-	-	OFFSET JOINT BY APPROX. 60mm WITH VISIBLE COUPLER
V-5	40.20m	-	-	OFFSET JOINT BY APPROX. 50mm WITH VISIBLE COUPLER
V-6	46.80m	275mm	WEST	LVL 3 WATER INFILTRATION AT BOLT
V-7	46.80m	550mm	EAST	LVL 3 WATER INFILTRATION AT BOLT
PLATTERS COVE PIPE CONDITION - BCT VOIDS				
BCT-1	20.60m	825mm	WEST	LVL 3 WATER INFILTRATION AT SEAM
BCT-2	25.80m	825mm	EAST	LVL 3 WATER INFILTRATION AT BOLT
BCT-3	28.20m	825mm	WEST	LVL 3 WATER INFILTRATION AT BOLT
BCT-4	37.80m	825mm	WEST	LVL 2 WATER INFILTRATION AT SEAM

- VOIDS TO BE FILLED WITH CLSM. INJECTION PLAN SHALL BE APPROVED BY THE ENGINEER. BOTH VISUAL AND BCT VOIDS TO BE INJECTED.
- INJECTION LOCATION TO BE CONFIRMED BY CONTRACTOR ON SITE.
- MINIMUM TEMPORARY WATER CONTROL FLOW = 0.43m<sup>3</sup>/s.
- SUPPLY AND INSTALL TEMPORARY WATER CONTROL PIPE (MINIMUM  $\phi$  = 650mm)
