ADDENDUM No. 1

BUILDING ENVELOPE REMEDIATION
Project No. R.060702.001

Project title / Titre du projet: **GULF OF GEORGIA CANNERY BUILDING ENVELOPE REPAIR**

Drawing title / Titre du dessin: **SITE PLAN**

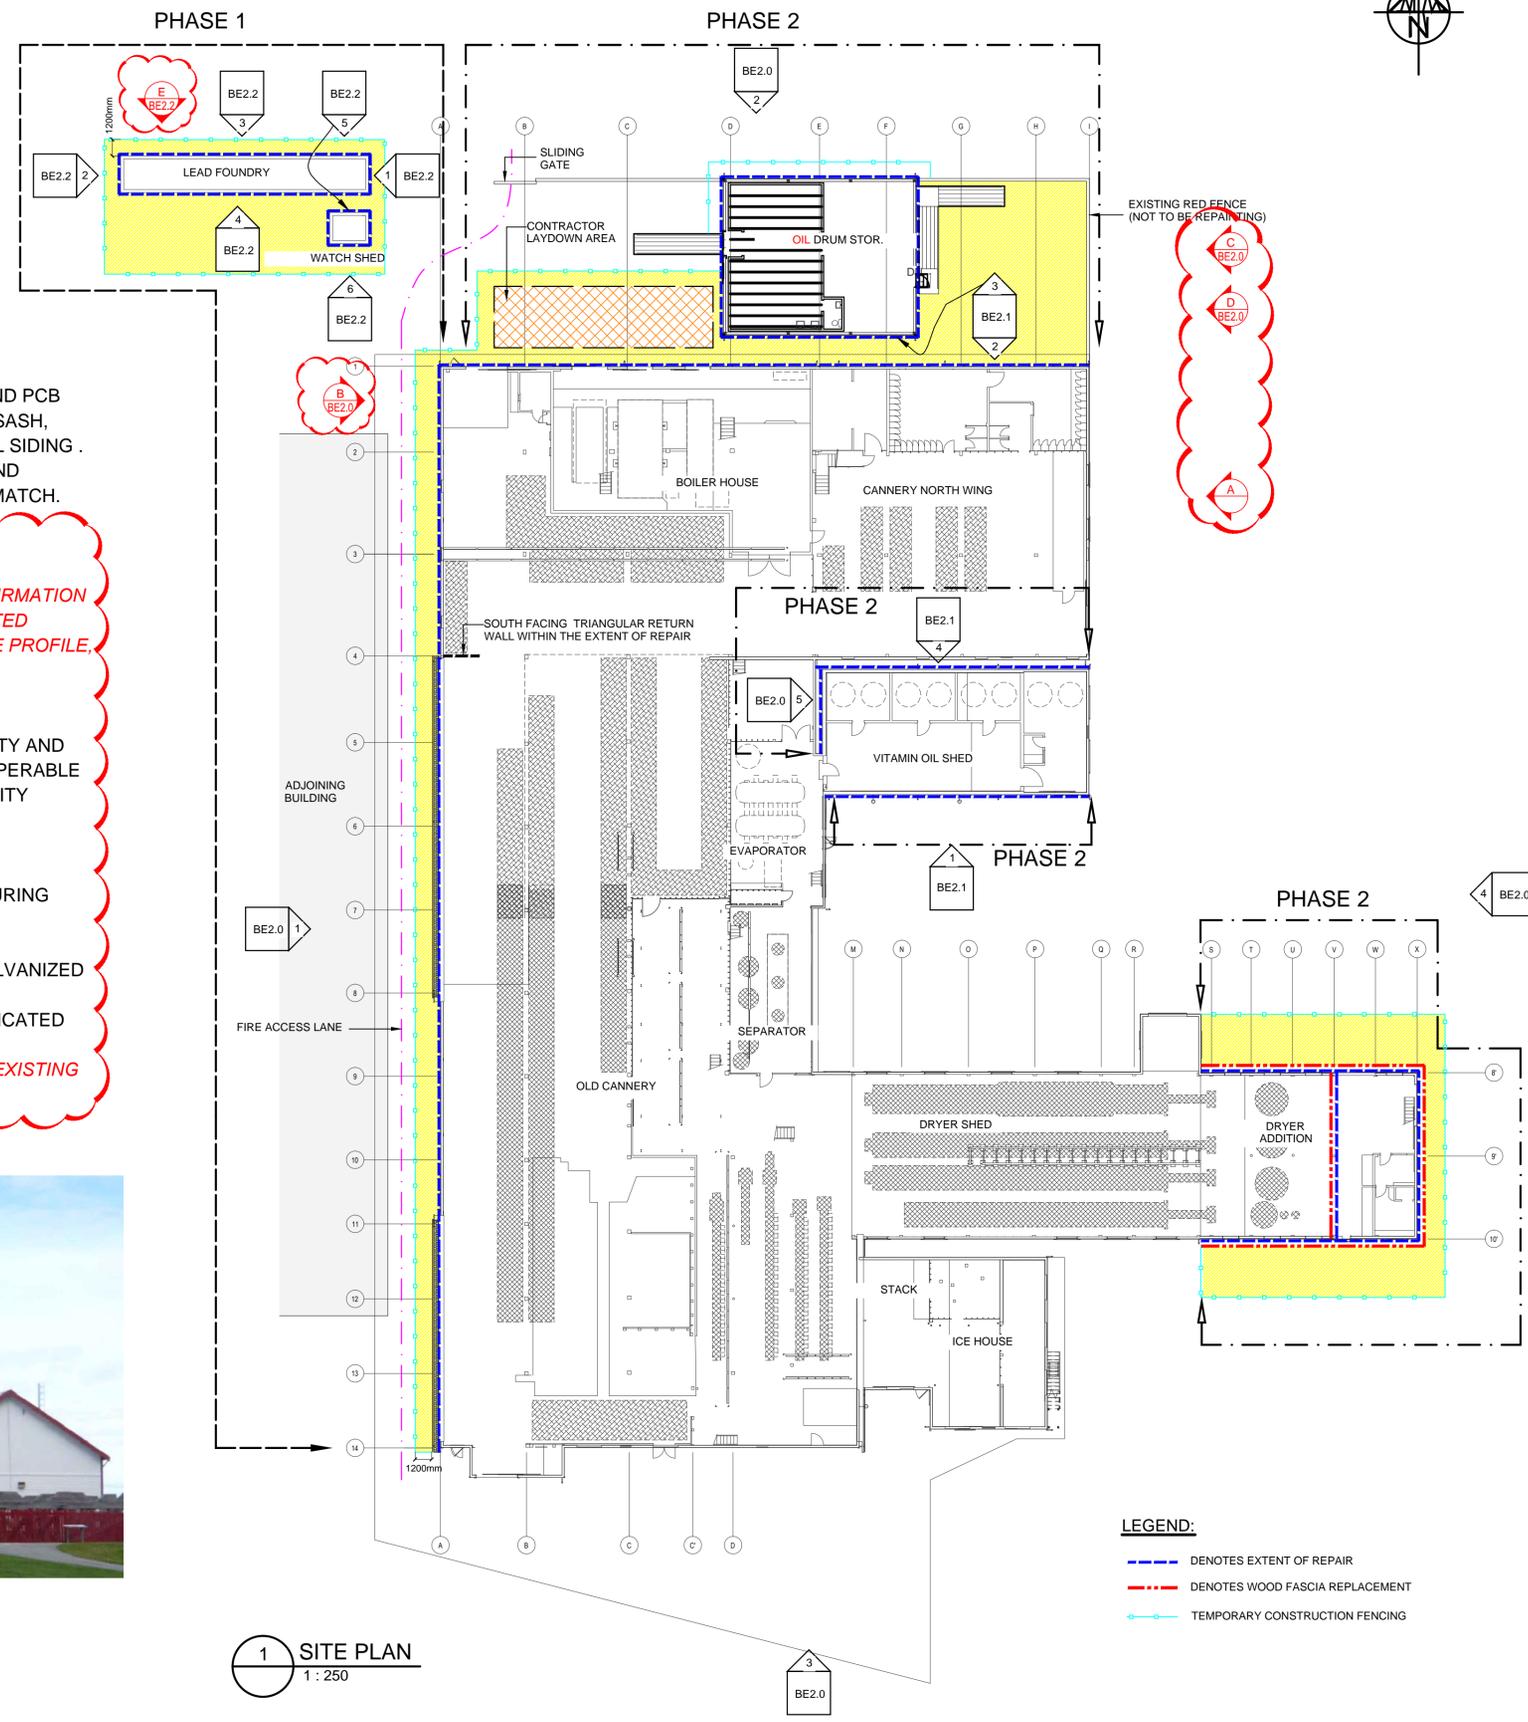
1 SITE PLAN
 1 : 250

SUMMARY OF REPAIR

2. REMOVAL AND DISPOSAL OF EXISTING DETERIORATED FASCIA AS INDICATED AND INSTALLATION OF MARINE GRADE PLYWOOD OF SAME DIMENSIONS, PAINTED TO MATCH.
3. IDENTIFY TO DEPARTMENT REPRESENTATIVE LOCATIONS OF ALL EXISTING DETERIORATED WOOD SIDING, TRIMS, SILLS, FASCIA AND BOXES WHICH ARE NOT ACCEPTABLE SUBSTRATES FOR REPAINTING. UPON REVIEW AND WRITTEN CONFIRMATION FROM DEPARTMENTAL REPRESENTATIVE, REMOVE AND DISPOSE OF DETERIORATED SUBSTRATES AND INSTALL NEW MARINE GRADE FIR WOOD SUBSTRATES OF SAME PROFILE, SIZE, THICKNESS. PAINT TO FINISH.

4. TEMPORARY REMOVAL OF EXISTING OPERABLE WOOD FRAME WINDOWS AND REPLACEMENT OF EXISTING INTERIOR AND EXTERIOR GLAZING PUTTY AND SEALANTS. REMOVAL OF WOOD ROT FROM WINDOW FRAMES, PATCHED WITH PUTTY AND REPAINTED. REINSTALLATION OF WINDOW FRAMES WITH SASHES RENDERED INOPERABLE WITH FASTENERS. TEMPORARY REMOVAL AND REINSTALLATION EXISTING SECURITY GRILLES AS INDICATED (LEAD FOUNDRY AND WATCH SHED).

5. CLEANING AND REPAIR OF INTERIOR WOOD GUTTERS WITH MEMBRANE WHERE INDICATED (LEAD FOUNDRY AND WATCH SHED).
6. TEMPORARY REMOVAL OF EXISTING SIGNAGE, GUTTERS AND DOWNSPOUTS DURING REMEDIATION. REINSTALLATION OF ALL REMOVED ITEMS UPON COMPLETION OF REMEDIATION WORK.

7. REPAIR AND REPAINTING OF FOUR SMALL WOOD BOXES AS INDICATED AND GALVANIZED METAL FENCING AS INDICATED.
8. REMOVAL AND STORAGE OF EXISTING SECURITY GRILLES ON WINDOWS AS INDICATED (CANNERY BUILDING - NORTH AND WEST ELEVATIONS).

9. SOFFITS AND RAFTERS OF ALL AREAS INCLUDED IN SCOPE OF WORK TO HAVE EXISTING PAINT REMOVED AND REPAINTED.

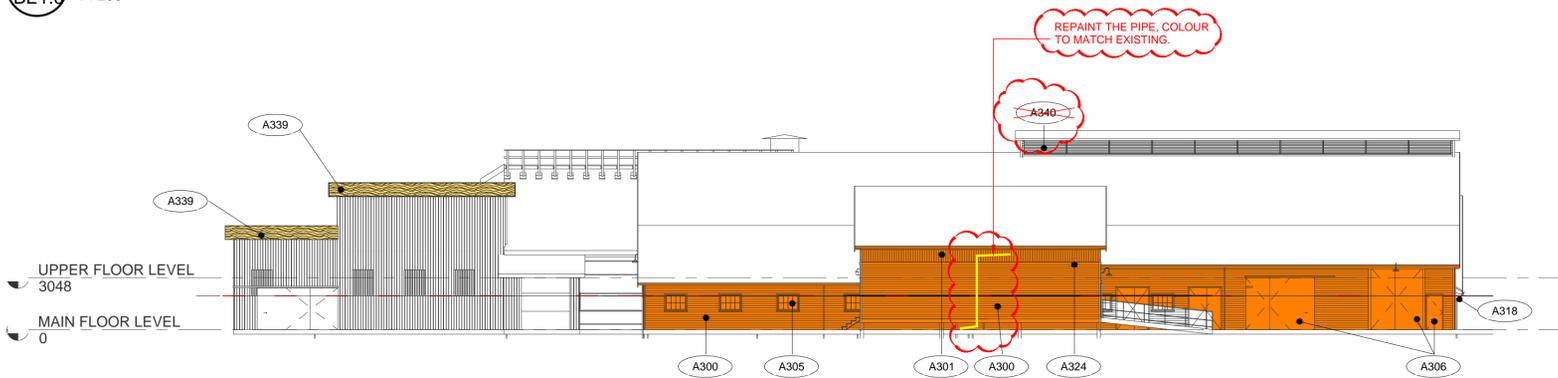
2 NORTH
 BE1.0 1:200

NOTE: SMALL WOOD BOXES TO BE REPAIRED AND REPAINTED.

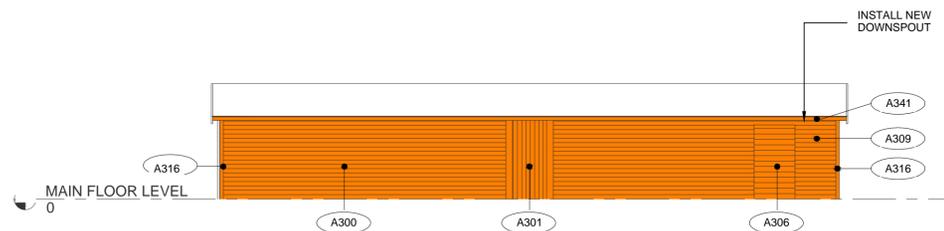
3 NORTH ELEVATION
BE1.0 1:100 (@LEAD FOUNDRY)

NOTE: INSTALL NEW
DOWNSPOUT AND
WATERPROOFING DETAILS
